Subject: Deteriorated Plaster Finishes

- Applicable Standards:**
2. Retention of Historic Character
 5. Preservation of Distinctive Features, Finishes and Craftsmanship
 6. Repair/Replacement of Deteriorated or Missing Features Based on Evidence

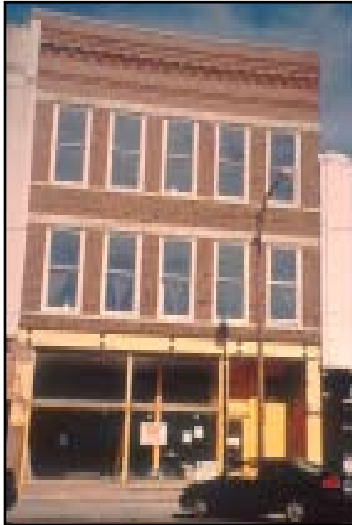
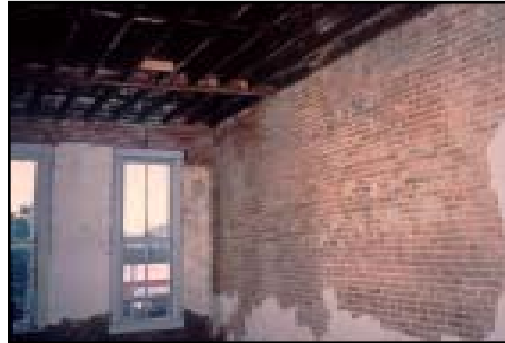
Application 1 (*Incompatible treatment, exposed brick*): Built c. 1900, this small, three-story, brick structure was rehabilitated for retail use on the first floor, with residential use above. Historically, the walls were finished plaster. However, after years of deferred maintenance, when rehabilitation work began much of the plaster was in a very deteriorated condition and only patches of it remained on the walls. As part of the rehabilitation, the owner kept what remained of the plaster in its as found condition in the apartments on the upper floors. This treatment was determined to be incompatible with the historic character of the building. In order for the project to meet the Standards the owner was required to repair the plaster or replace it with gypsum board.

Left and center: Deferred maintenance had resulted in considerable damage to the finished plaster on the upper floors of this small commercial building.

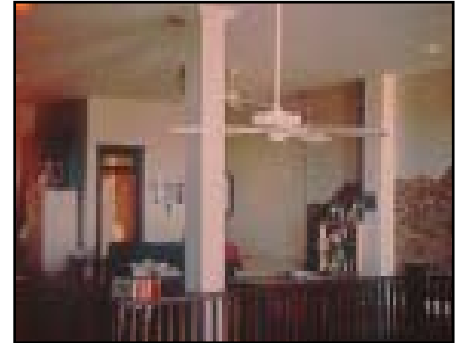
Right: Because the plaster walls helped to define the historic character of the interior, the deteriorated plaster had to be repaired or replaced with gypsum board in order for the rehabilitation project to meet the Standards.

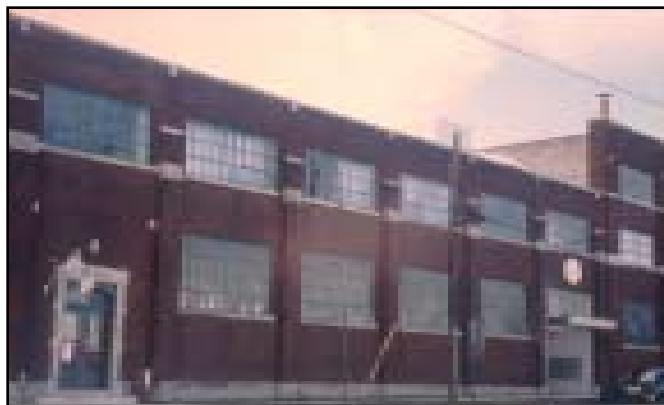
This small manufacturing building had brick walls in the industrial spaces, but several offices on the first floor had finished plaster walls.

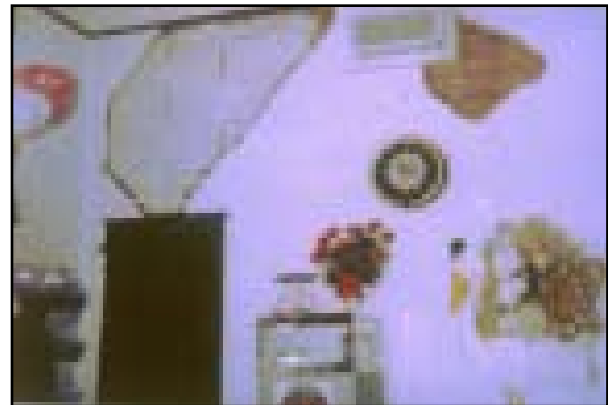
Application 2 (*Incompatible treatment, exposed lath*): Even historic industrial and warehouse buildings may sometimes contain finished interior spaces. Although the upper floors and most of the first floor of this 1927 factory were rough, unfinished spaces typical of this type of structure, a portion of the first floor which was used for an office always had plastered walls. The building was recently rehabilitated for residential apartments upstairs with several retail spaces on the first floor. One of the tenants in a first floor retail space left a jagged portion of lath exposed when repairing the plaster walls, apparently, as a decorative accent. This treatment was determined not to meet the Standards. Re-plastering the exposed lath re-established the finished plaster wall which characterized this historic office space, and allowed the rehabilitation project to be certified.

During the rehabilitation, a tenant left an area of the wood lath exposed when repairing the plaster walls in an office space. This treatment was not compatible with the historic character of this traditionally finished space, and the plaster had to be repaired before the project could meet the Standards.
