## Preservation Tech Notes

### METALS

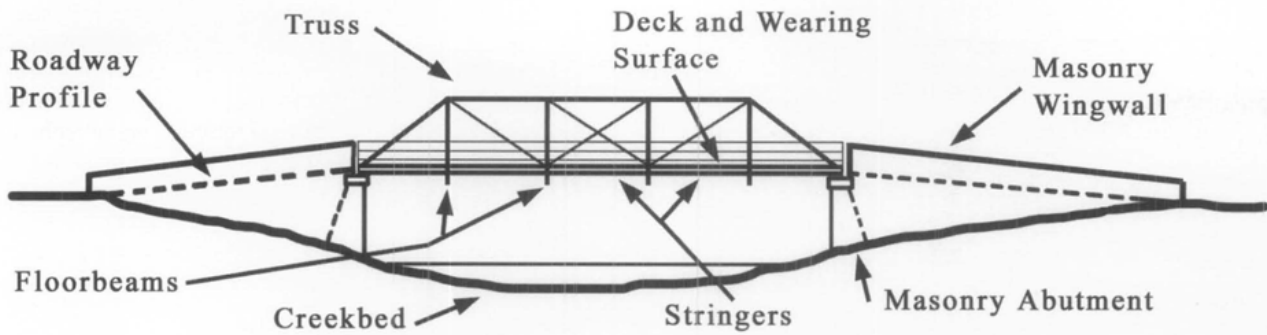
Figure 1. Drawing of Wilson's Bridge showing major structural and site components. Drawing: Chester County Engineering Department.

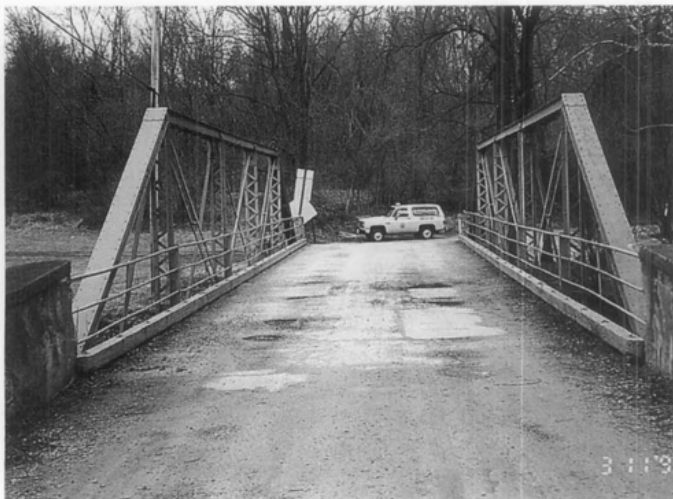
Figure 2. Before rehabilitation, Wilson's Bridge had an asphalt wearing surface that was delaminating from the deck below. Extensive cracks and numerous potholes were also present.

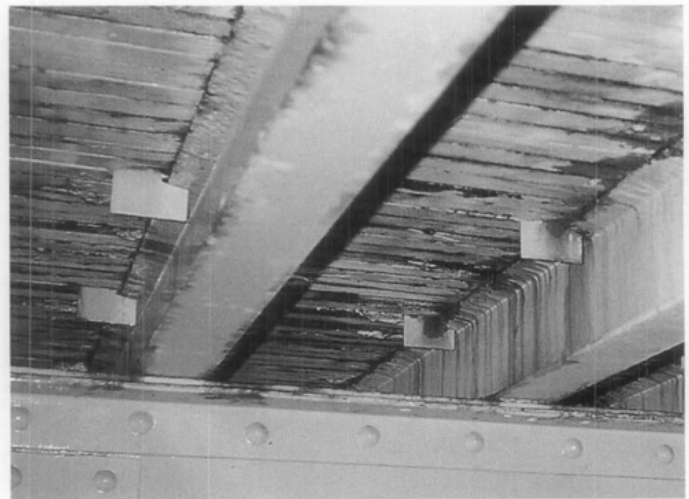
Figure 3. A view of the underside of Wilson's Bridge before rehabilitation. The timber nail laminated deck sat on steel "I-beam" stringers which, in turn, were supported by wrought iron floor beams. Failure of the wearing surface had allowed water to penetrate the laminated deck planks causing further deterioration to both the deck and the stringers below.

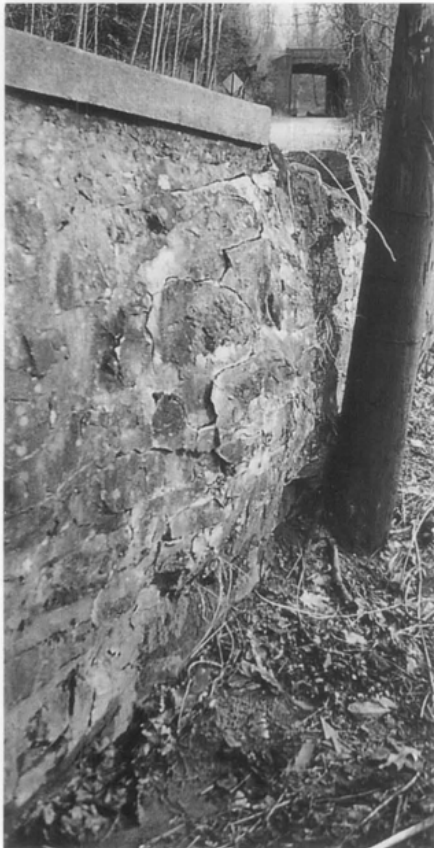
Figure 4. The Wilson Bridge wingwalls had loose and crumbling mortar joints. Much of the wall surface required removal of this deteriorated material and significant repointing.

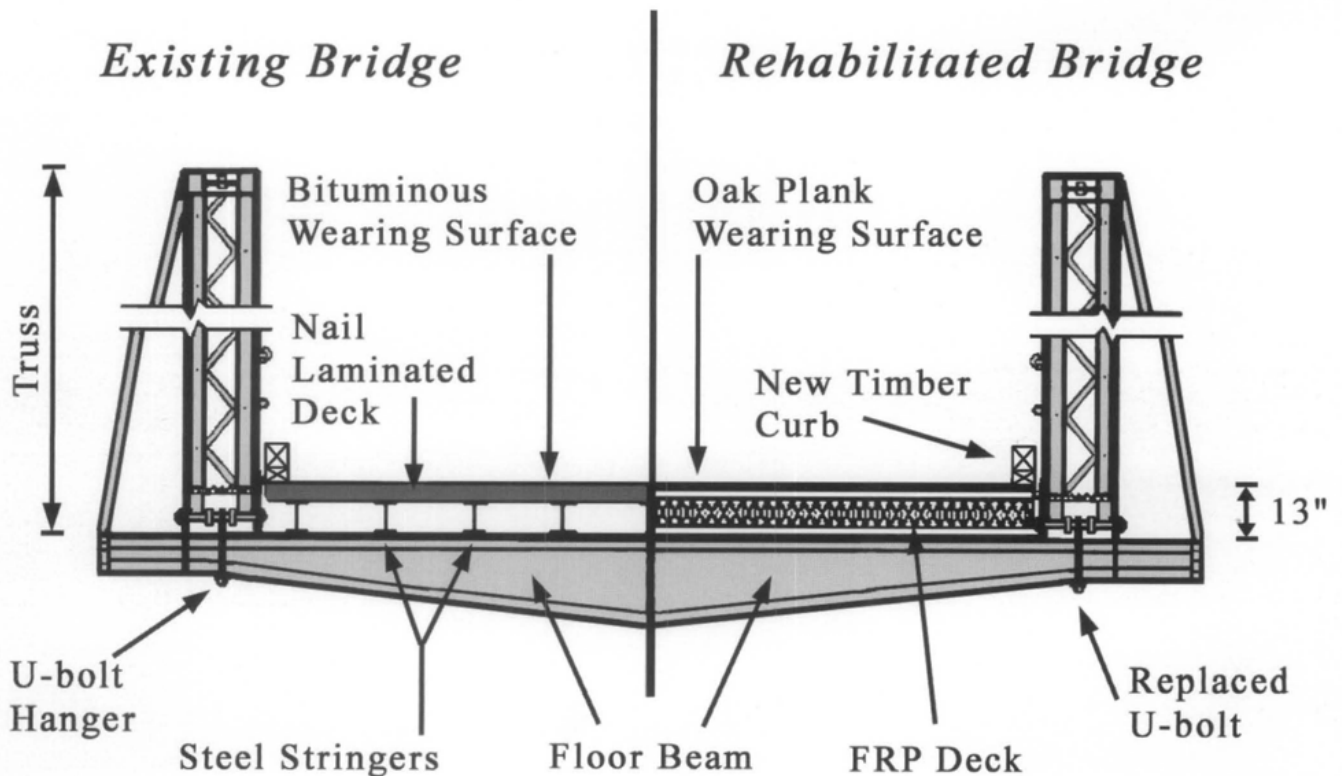
Figure 5. A section drawing of the Wilson's Bridge. The left side shows the construction of the span before rehabilitation, while the right side shows removal of the stringers and the installation of an FRP deck with a plank wearing surface. Both systems were approximately thirteen inches thick. Drawing: Chester County Engineering Department.

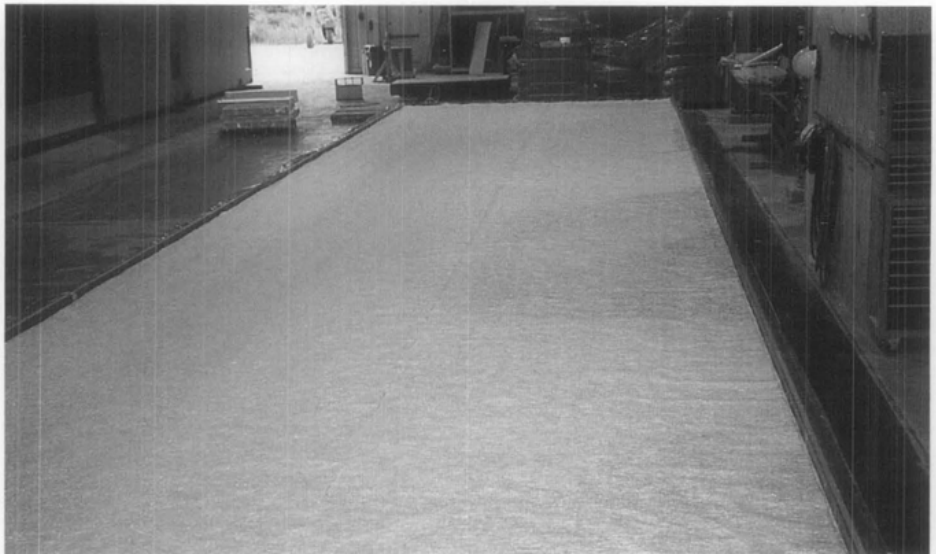
Figure 6. Taken at the composite manufacturer, this photo shows layers of fiberglass arranged around the deck core and placed in the mold. The mold was then infused with a resin that sealed the layers into a one-piece panel. Photo: Hayati Catbas, Hardcore Composites.

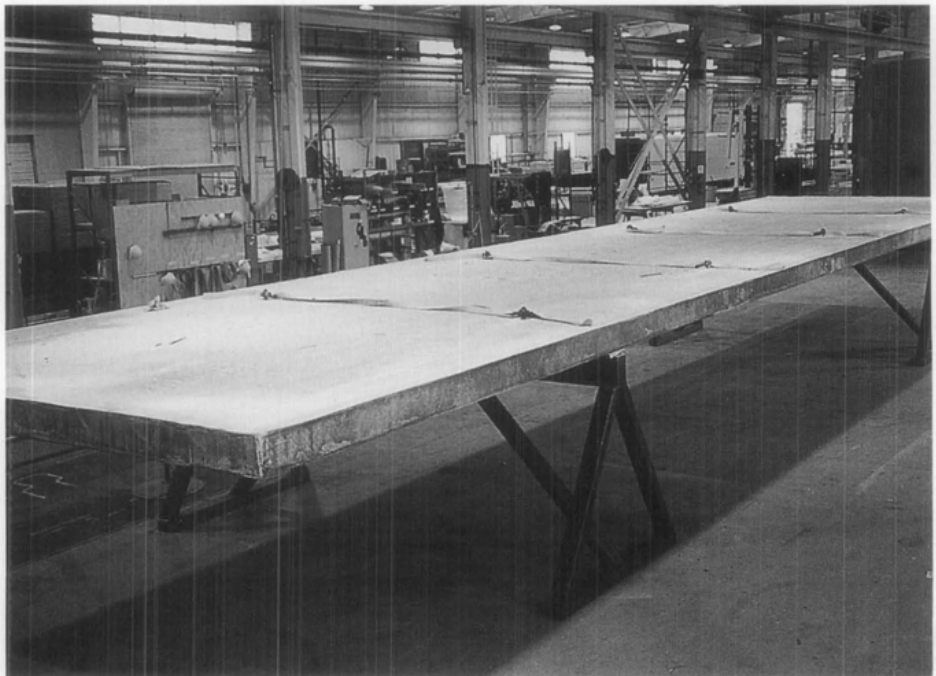
Figure 7. After the panel had set into a solid mass, workers removed it from the mold and sanded and finished all surfaces. The last steps included painting the deck and installing the oak plank wearing surface. Photo: Hayati Catbas, Hardcore Composites.

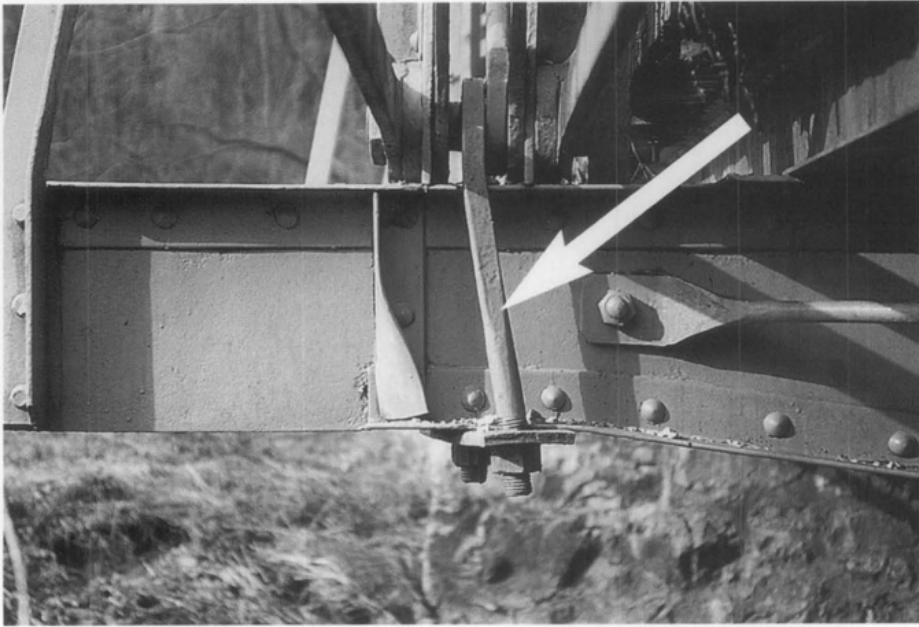
Figure 8. U-bolts connected each of the four floor beams to the superstructure above. Prior to rehabilitation, some bolts, like the one in the photo, showed signs of impact damage. The engineers determined that all of the wrought iron bolts were near the threshold of their stress level and called for replacement with high-strength steel U-bolts of the same dimensions.

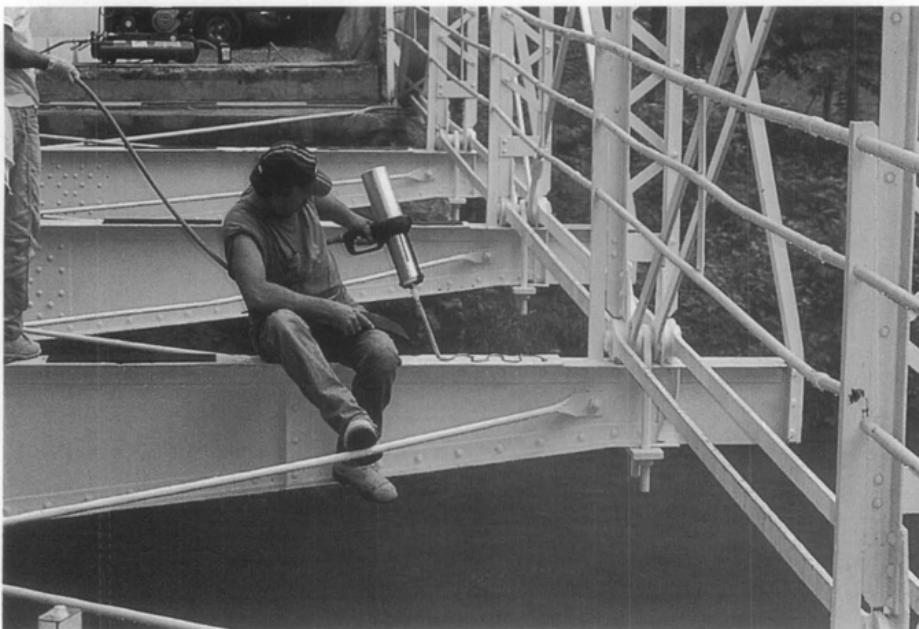
Figure 9. A worker applied adhesive to the floor beams where each of the bearing pads would be positioned. Four pads were installed on each floor beam to cushion the deck, evenly distribute loads to the floor beam and provide a secure fit between beam and deck.

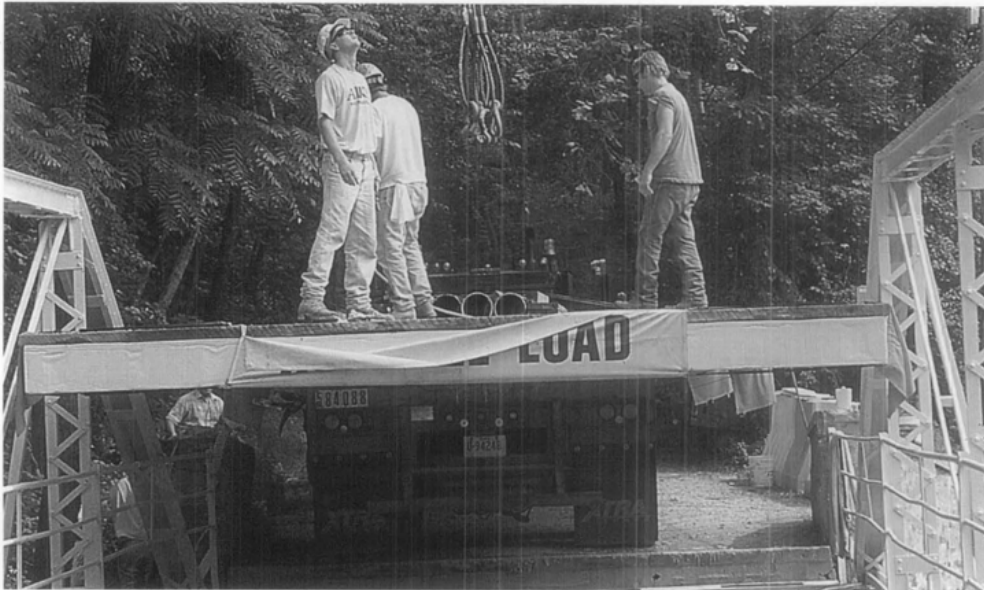
Figure 10. When the deck arrived at the site, the trailer was backed onto the bridge approach and crane cables secured to the deck. Although the road beyond that side of the bridge is a dead end, the truck driver was able to maneuver across a vacant site to get the deck on the opposite side of the creek.

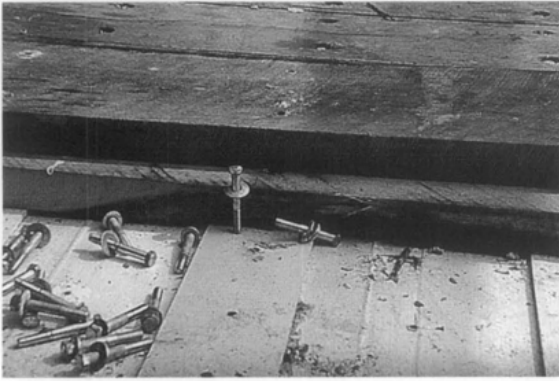
Figure 13. After the deck was locked to the floor beams and the crane cables removed, remaining oak planks that made up the wearing surface were bolted to the composite deck.

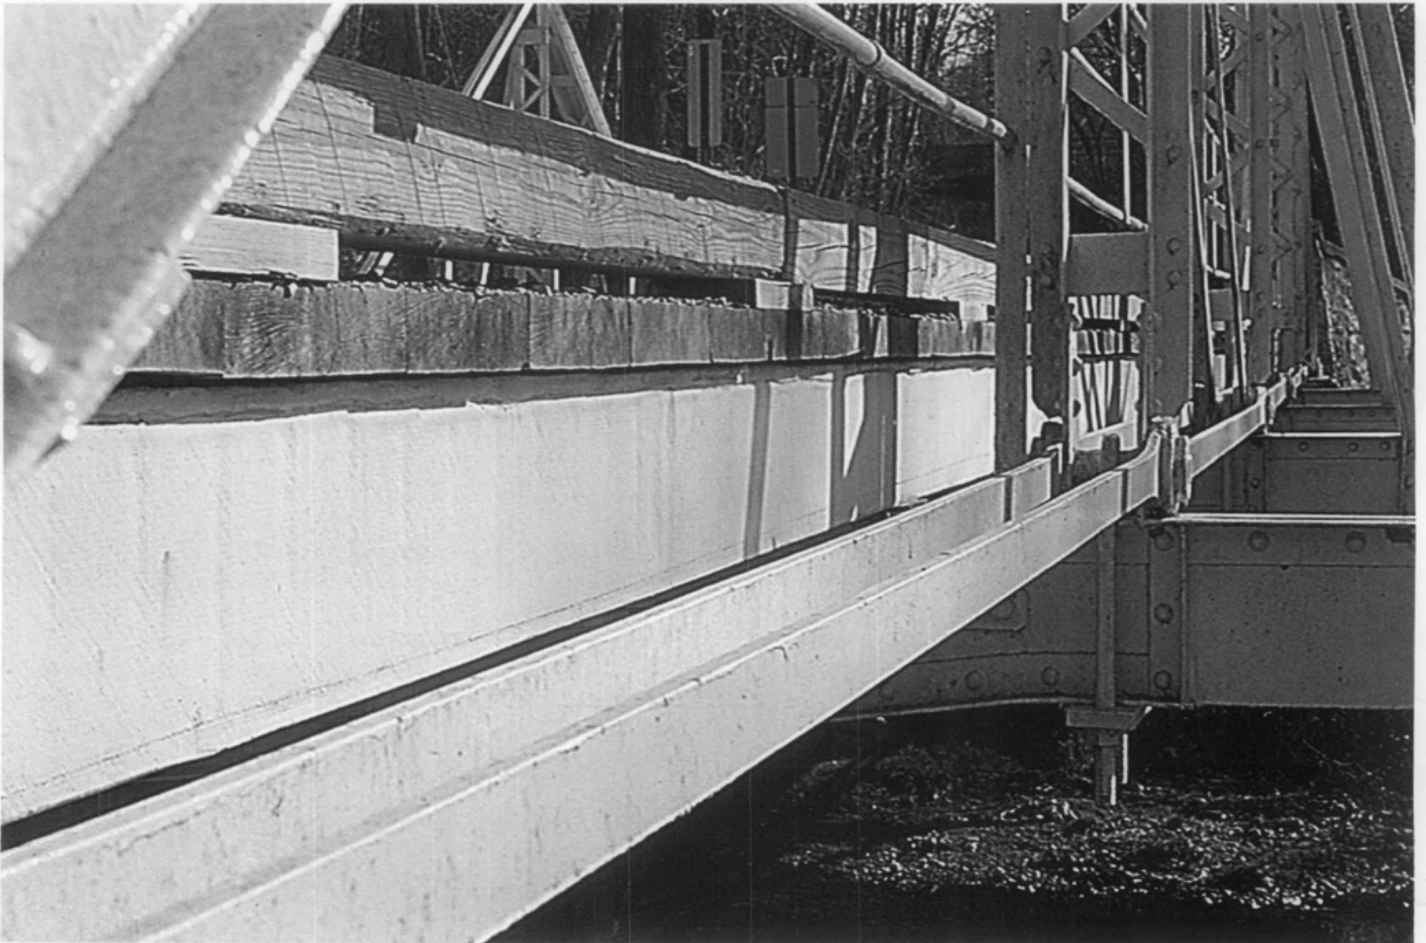
Figure 14. The composite deck, painted to match the superstructure, is visually compatible with the historic bridge as it originally appeared with timber stringers. The new deck and wearing surface are the same thickness as the previous system of steel stringers, nail-laminated deck, and bituminous surface. Photo: Chad Randl.

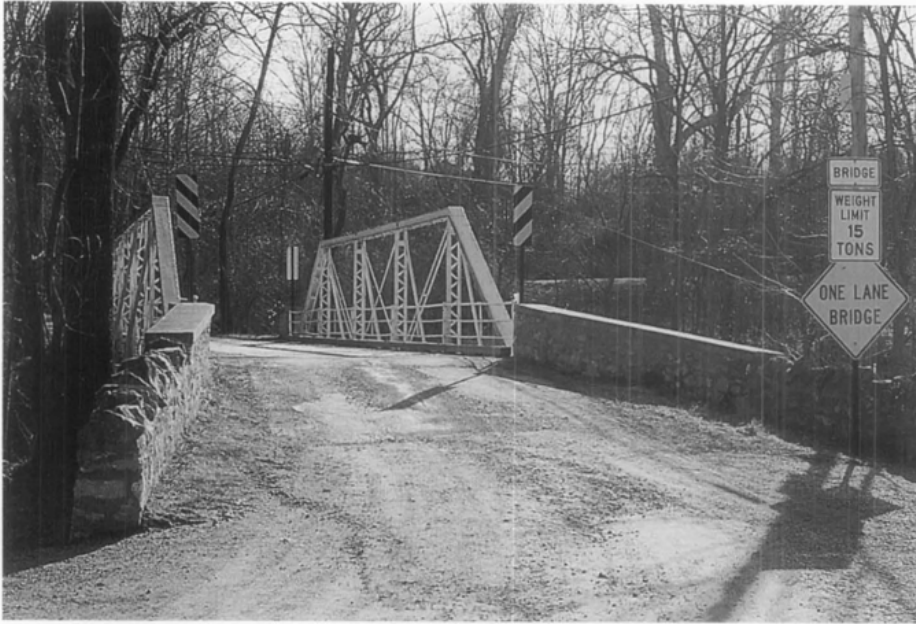
Figure 15. The landscape surrounding Wilson's Bridge has changed little since the span was constructed in the 1800s. The use of a composite deck and plank wearing surface in place of the deteriorated, fourth generation deck was an innovative solution that allowed the bridge to remain in place and in use with little change to its historic character. Photo: Chad Randl.
