## LAWRENCE-WENTWORTH HOUSE

# Tech Notes

NUMBER 6

### Replacement Wooden Sash and Frames With Insulating Glass and Integral Muntins

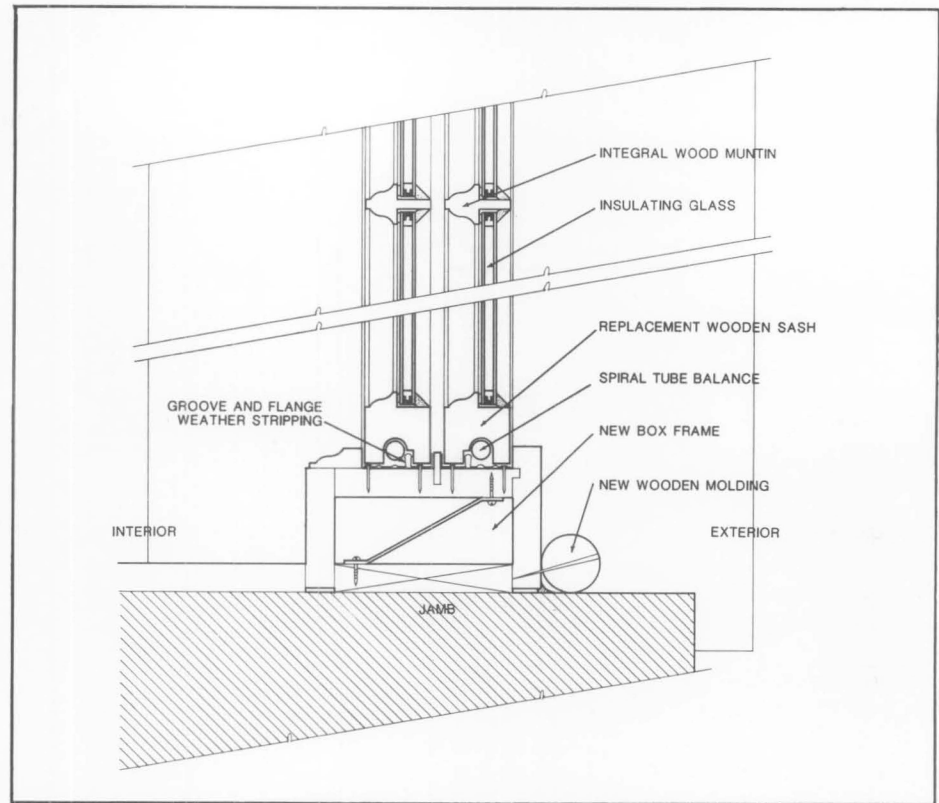
The selected replacement sash were designed to have two individual lights of insulating glass in each sash with an integral (as opposed to a "fake" or applied) muntin. Based on the experience gained by the Lowell Historic Preservation Commission in previous projects, the muntin of the new sash was made only 1" wide, closely matching the appearance of the historic  $\frac{3}{4}$ " wide vertical muntins remaining in the upper floor windows (see figure 1). This slight change in muntin width is hardly noticeable. The results might have been different if the old and new sash had existed side by side; if the number of panes had been greater and the panes themselves been smaller; or if the historic muntins had been thinner.

The new sash were made  $1\frac{3}{4}$ " thick, an increase of  $\frac{3}{8}$ " over the historic sash, in order to allow a sufficiently deep rabbet in which to set the  $\frac{7}{16}$ " insulating glass and to provide added support for the double weight of the glass.

Figure 1. The wooden replacement windows had two individual lights of insulating glass in each sash with an integral (as opposed to "fake") muntin. Drawing: Penelope S. Watson

The historic windows in the Lawrence-Wentworth House were balanced in standard fashion with sash weights and pulleys. Since many were missing on the first floor, less costly spiral tube balances were specified for the new windows (see figure 1). The spiral tube balances were attached at their top to the face of the jamb near the top of the window. The longer balance tube for the lower sash, therefore, is visible above the closed lower sash inside the building, just as the sash cord is exposed on a weight balanced sash. The tube balances, however, are not seen from the exterior and their use permitted a more energy efficient window frame. The empty boxes, which would have held the sash weights, were filled with insulation; air infiltration was further reduced since there were no pulley mortises in the frame.

The spiral balances also allowed the use of a less expensive L-shaped, shop-fabricated frame, and the look of the historic box frame was accomplished with masonry-anchored nailers, steel framing clips, and flat interior casing stock (see figure 1).

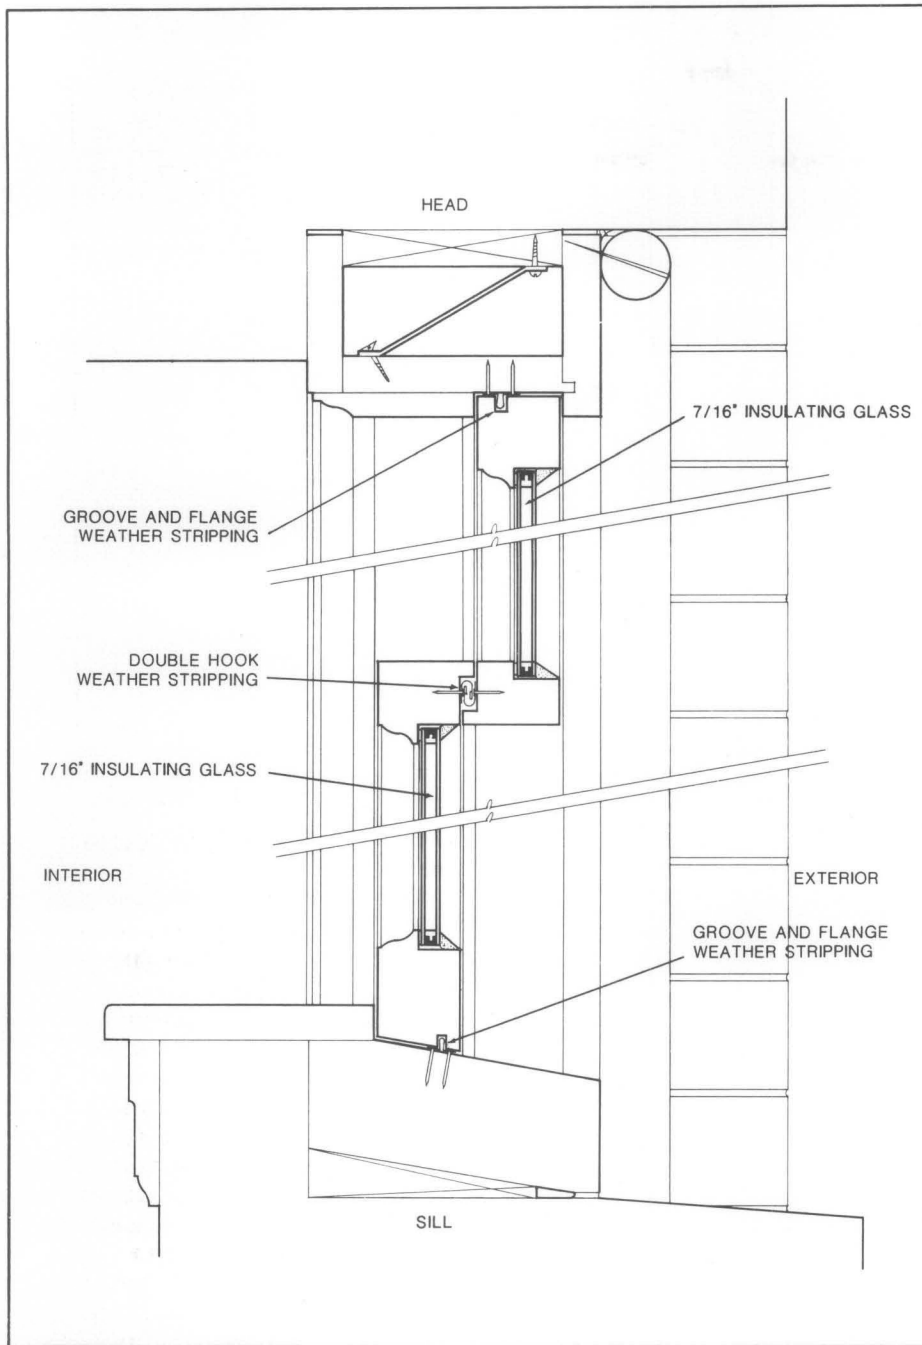
from rolled zinc sheets, were installed in preference to a less permanent vinyl, foamed plastic, or spring-metal weather stripping. At the heads, jambs and sills, the weather stripping consists of a continuous flange over which fit the grooved rails and stiles. At the meeting rail, the weather stripping consists of two interlocking hooks (see figure 2). The weather stripping protrudes only a short distance above and below the meeting rails along the jambs and is almost totally concealed when the windows are shut. It is extremely durable and is virtually unaffected by corrosion or chemical decomposition.

Figure 2. Several types of zinc weather stripping were used. Drawing: Penelope S. Watson

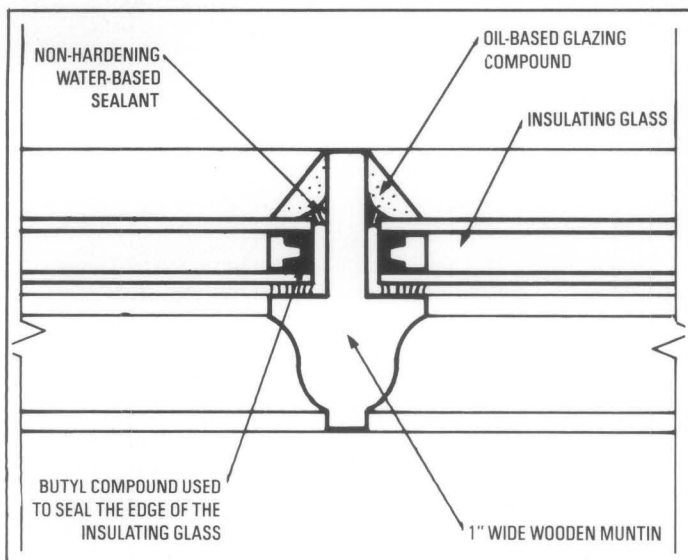
The sealed insulating glass units, installed in the fabricator's shop, were first caulked with a thin bead of non-hardening water-based (containing no oil) sealant. The sealant was applied at the corner of the glass unit so as not to touch the butyl compound used to seal the edge of the insulating glass (see figure 3). The water-based sealant serves as an important barrier between the separate butyl-seal on the insulating glass and the standard oil-based glazing compound as used in the actual glazing. The oil-based glazing compound was chosen in preference to the standard wood molding strips to provide a cheaper, more flexible and more weather-resistant

Figure 3. Glazing detail shows how the non-hardening water-based glazing sealant was used to separate the butyl compound (used to seal the insulating glass) from the oil-based glazing compound. Drawing: Penelope S. Watson

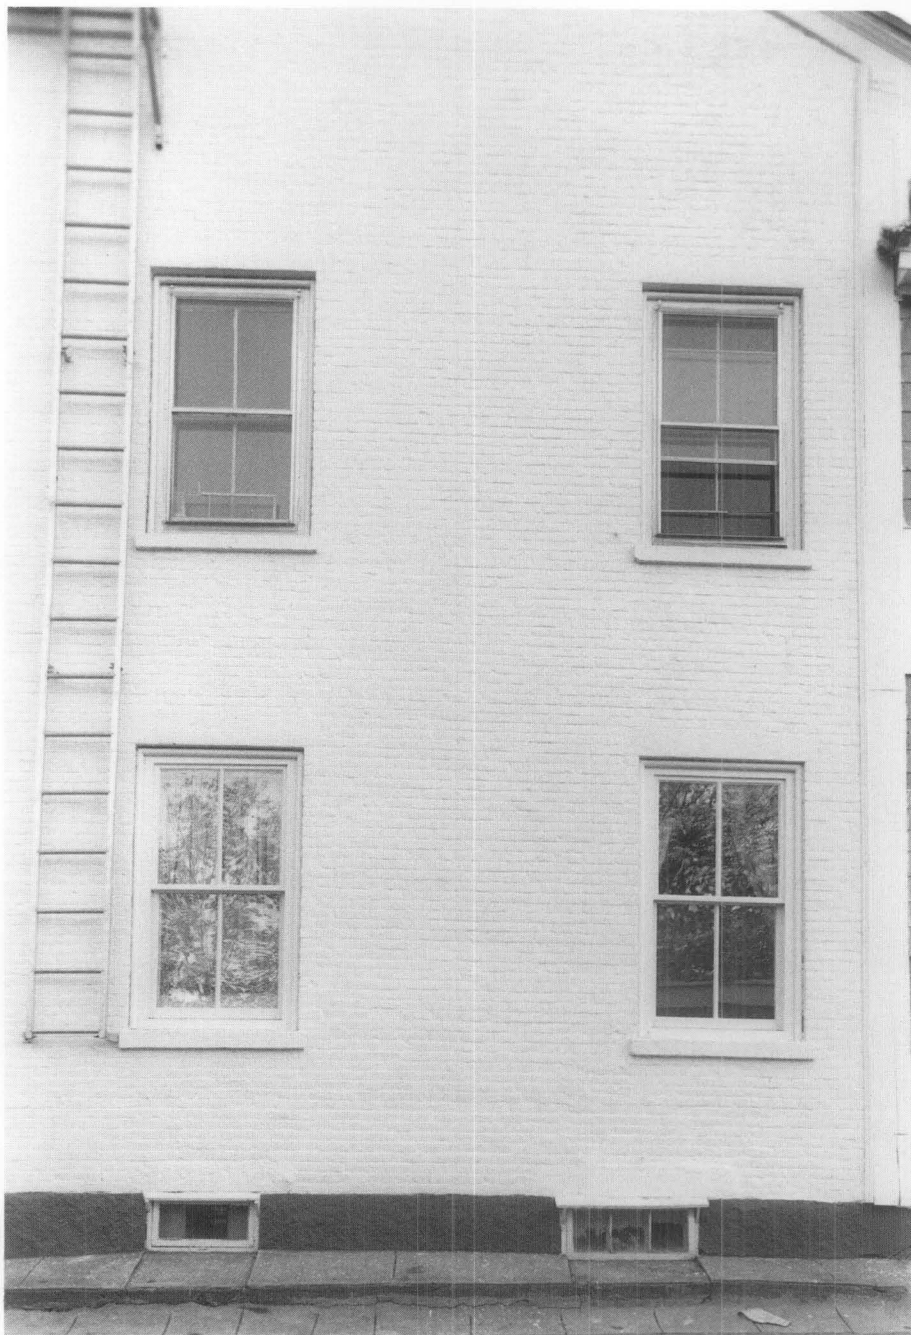
The new wooden frame was thus identical in appearance to the historic frame on the building. The width of the historic frame was reproduced along with the wooden brick molding used to trim the exterior of the masonry openings (see figure 4).

**Figure 4. The new wooden windows on the first floor with insulating glass installed closely matched the historic windows which were preserved on the upper floor. Photo: Charles Parrott**
