Tech Notes

WINDOWS

NUMBER 13

Aluminum Replacement Windows with Sealed Insulating Glass and Trapezoidal Muntin Grids

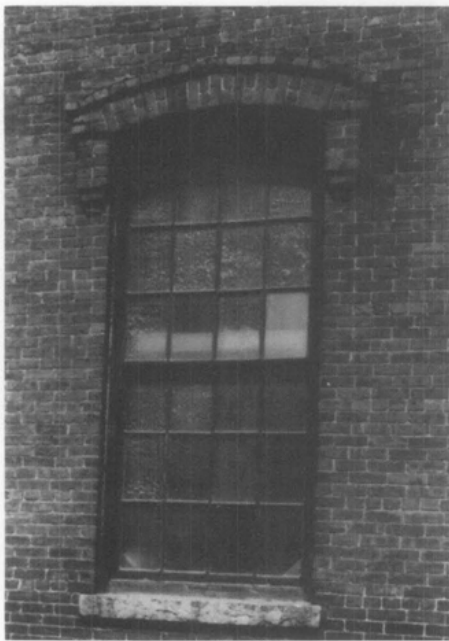
The long unbroken pattern of some 900 small-paned windows dominates the facades of these buildings and is clearly their most significant architectural element. At the time of the conversion to an office complex, the original double-hung windows, arranged with 12-over-12 lights, had survived in Mills Nos. 6 and 8, but virtually all the sash and some of the frames had been removed from Mill No. 5 (see figure 1).

Figure 1. The original wooden double-hung windows consisted of 12 lights in both the upper and lower sash. Photo: Charles Parrott

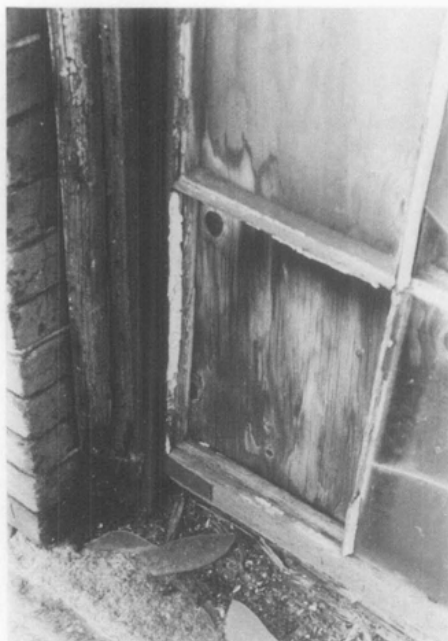
The first step was to evaluate the condition of the original windows that had survived in Mills Nos. 6 and 8 to establish whether the historic windows were repairable. Based on an indepth inspection, the windows were judged beyond reasonable repair due to their deteriorated condition (see figure 2). Once the decision to replace the historic sash had been reached, consideration was given to replacing them with matching custom-made wooden windows. The developers obtained a quotation of \$875 per window for fabrication and installation of 900 matching wooden replacement units, with integral muntins in a 12 light configuration and the addition of an interior storm panel. Due to cost, the developers decided to consider other alternatives.

Figure 2. The condition of the windows varied considerably. Shown here is a typical case where the frame, sill and sash were beyond repair. Photo: Charles Fisher

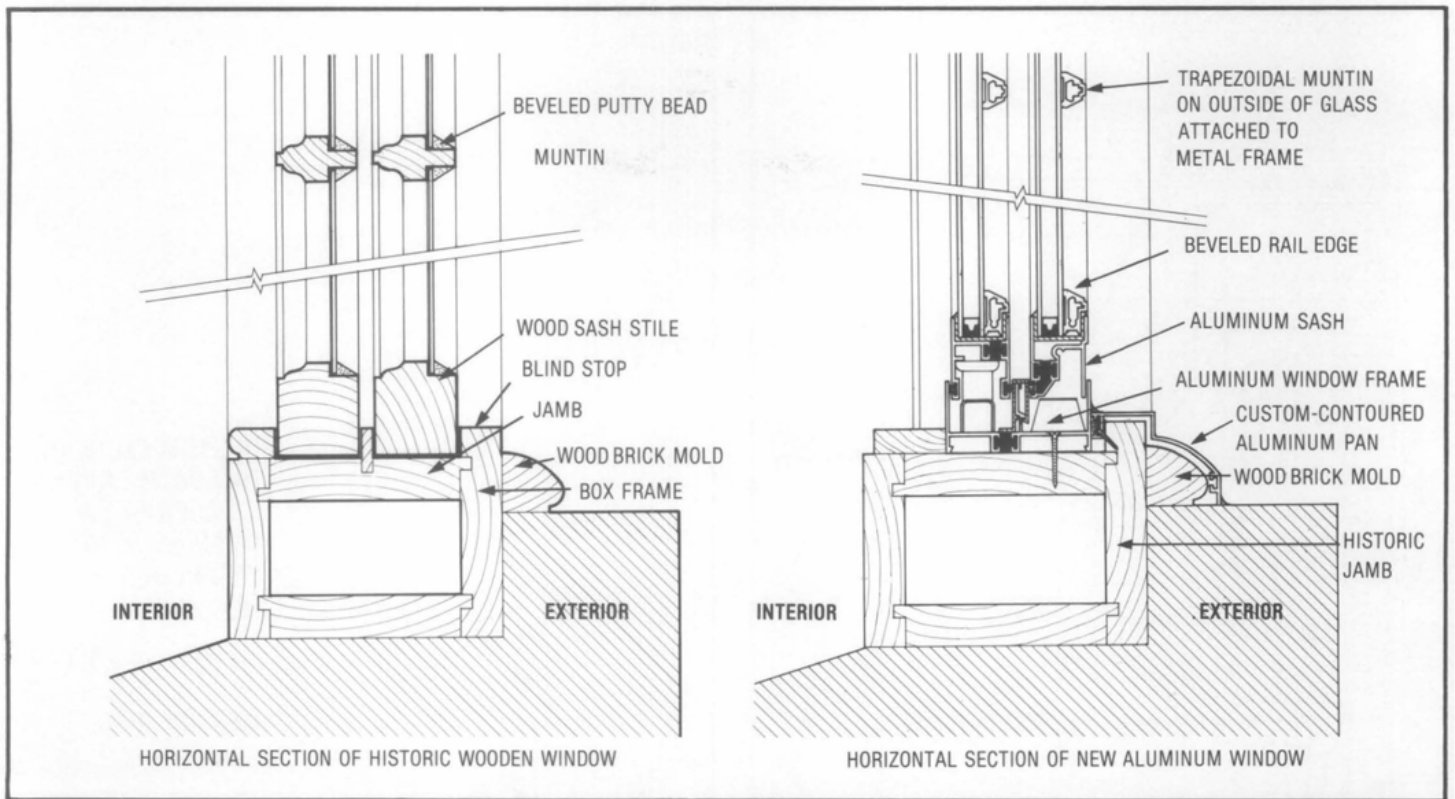
Figure 3. Horizontal section of both the original wooden window and the replacement aluminum window. Drawings: Penelope Watson

The historic wooden frames were retained and used as a structural sub-frame on which to fasten the new aluminum trim and frame members. A custom extruded aluminum pan was used that fitted snugly around the exposed face of the original frame and maintained the face width and depth of the casing at both jamb and head. The original wooden brick molding (which covers the joint between the masonry and the window frame) was fitted with a custom-extruded aluminum pan (see figure 3).

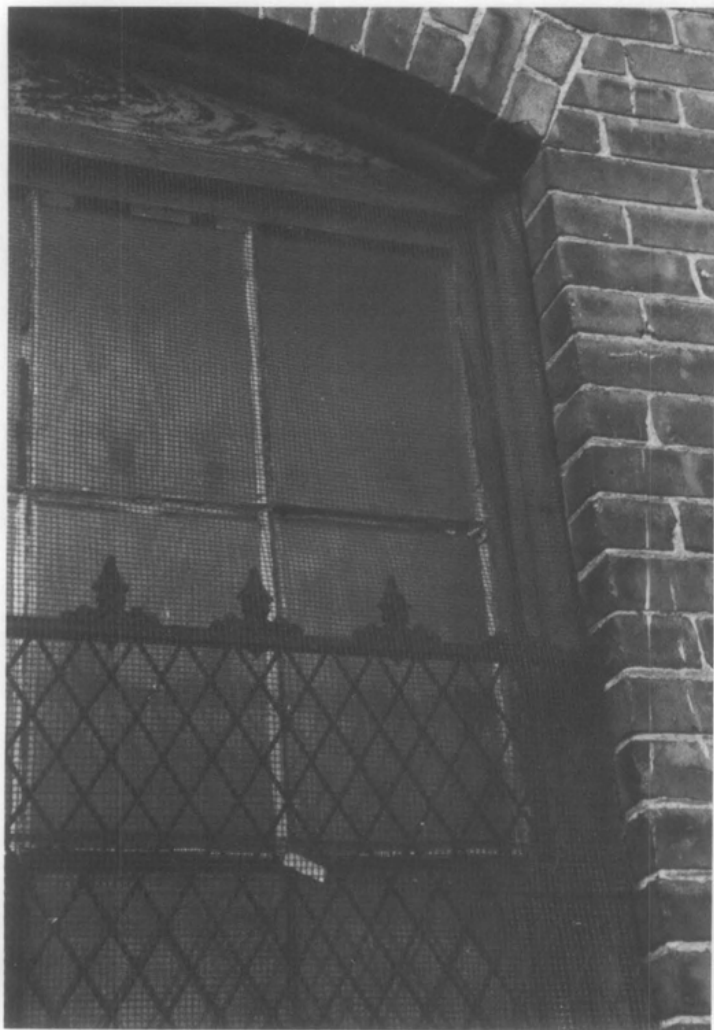
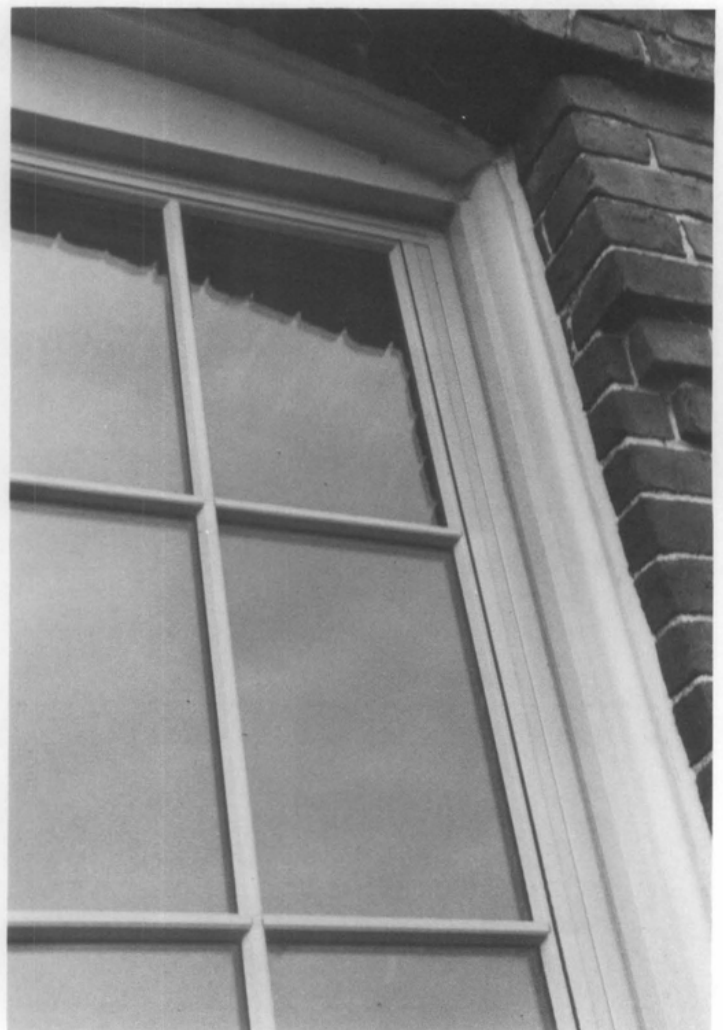
Figure 4. A custom-extruded aluminum pan was installed, duplicating the brick molding detail and, at the head of the frame, custom bent to follow the segmental curve of the masonry opening. Photos: Charles Fisher

result, the face width of the new upper sash stiles (which visually includes the vertical face of the new aluminum frame) is wider (2 1/2" vs. 1 1/2") than the face width of the historic sash (see figure 4). At the lower sash, the new frame stands out as an additional member not present in the historic windows.

At the head of the wooden frame, the aluminum pan was constructed in two pieces, both custom extrusions. The flat face of the lower piece was cut on a curve to follow the segmental curve of the masonry opening. The upper piece, which replaced the original brick molding, was custom-bent to the segmental curve and blind attached to the lower piece of aluminum (see figure 4). An additional aluminum pan was fitted tightly to the original wooden window sill (see figure 5).

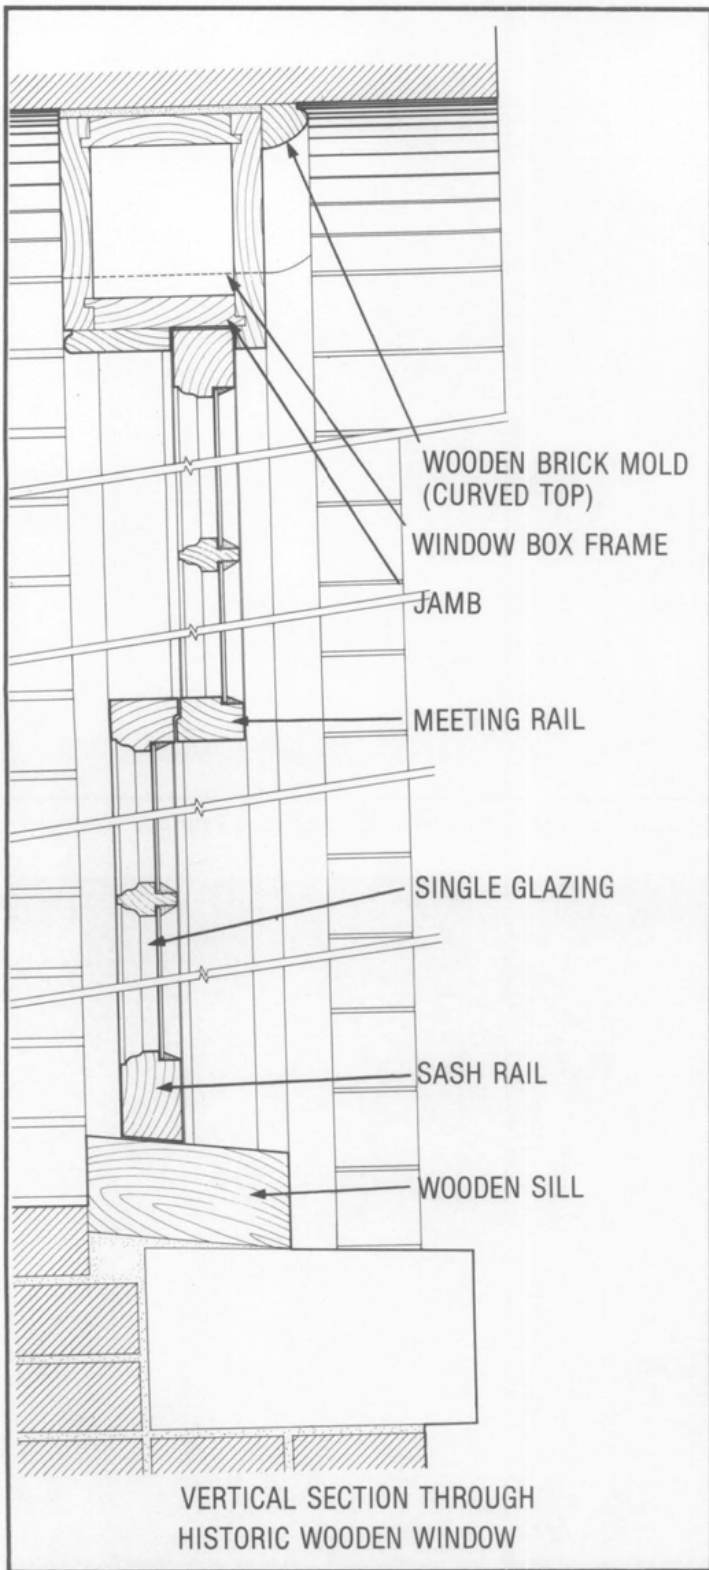
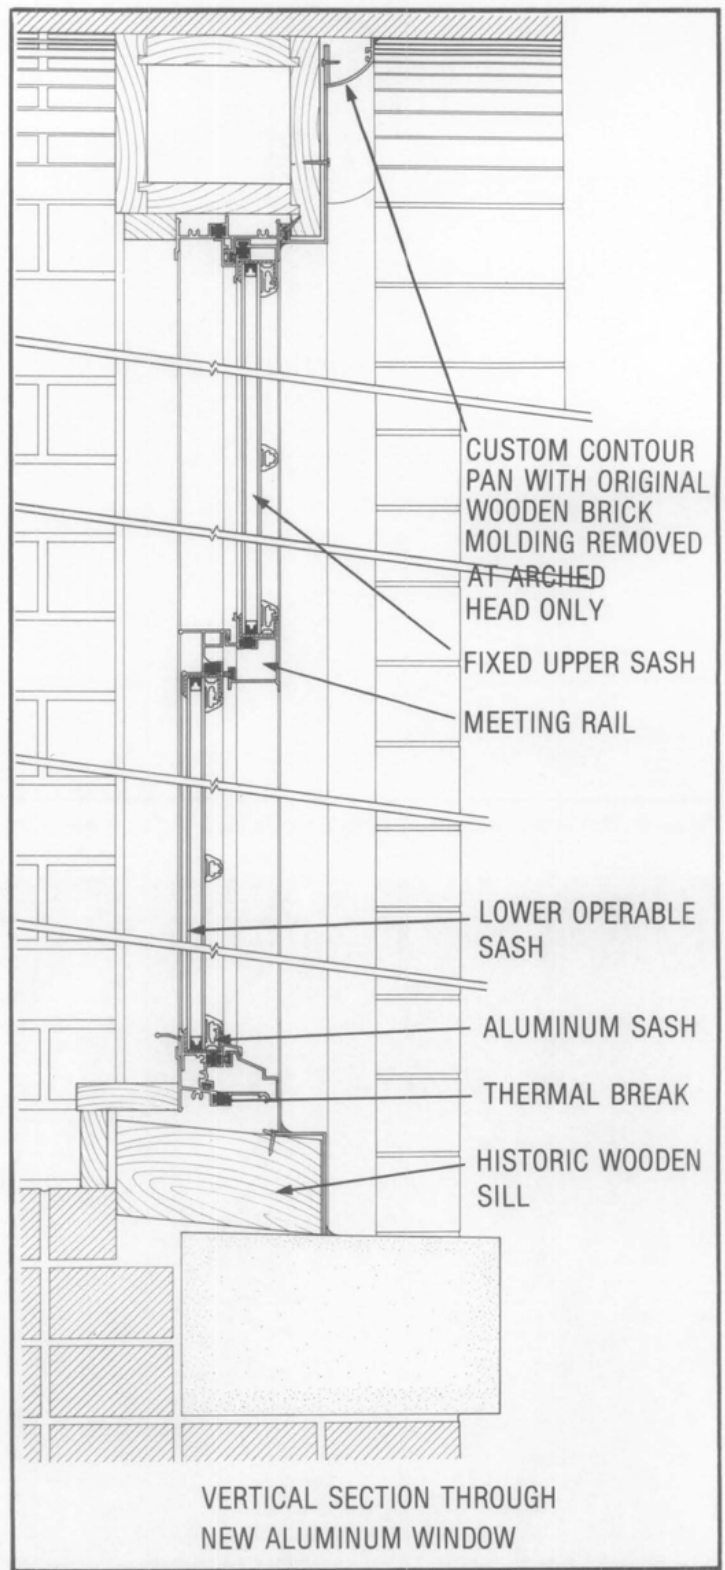
Figure 5. Vertical section of both the original wooden window and the replacement aluminum window. Drawings: Penelope Watson

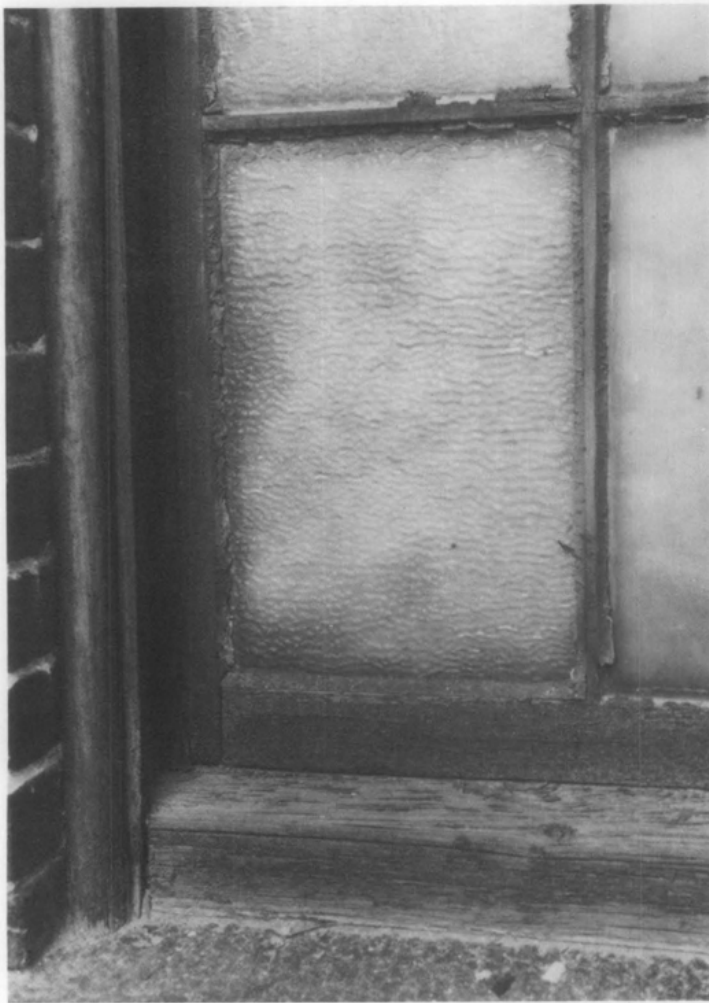
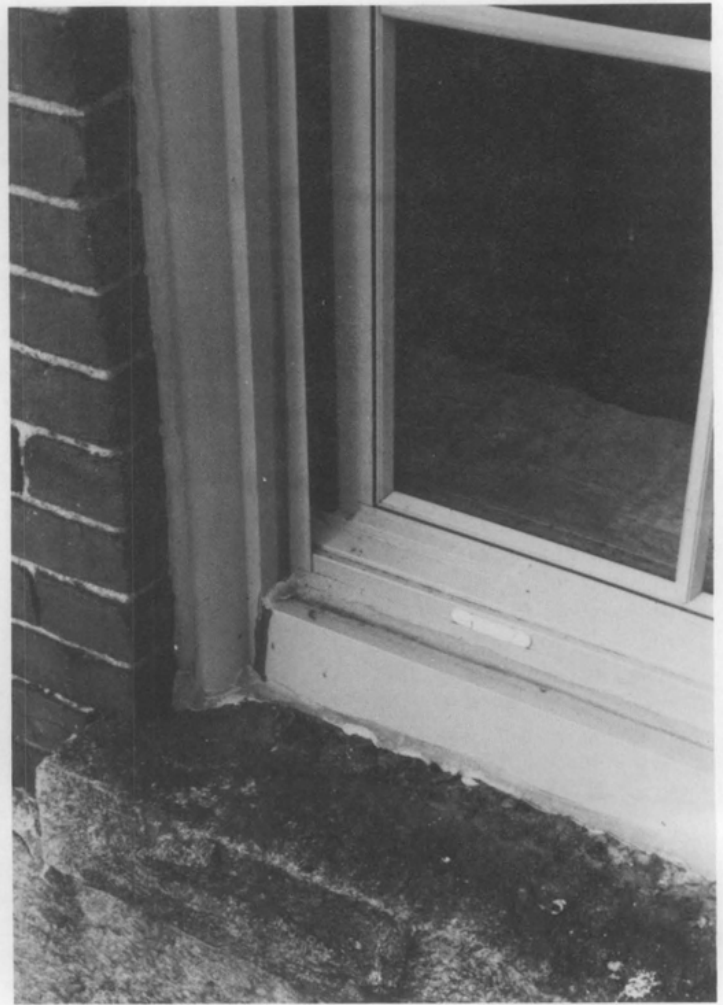
When the aluminum window frame was inserted, it included its own sill in the place where the bottom rail abutted the sill of the original window. This second sill unfortunately added an element not present in the original window (see figure 6).

Figure 6. The manufacturer's stock window used for the project unfortunately created the appearance of a double sill, which the historic window never had. Photos: Charles Fisher

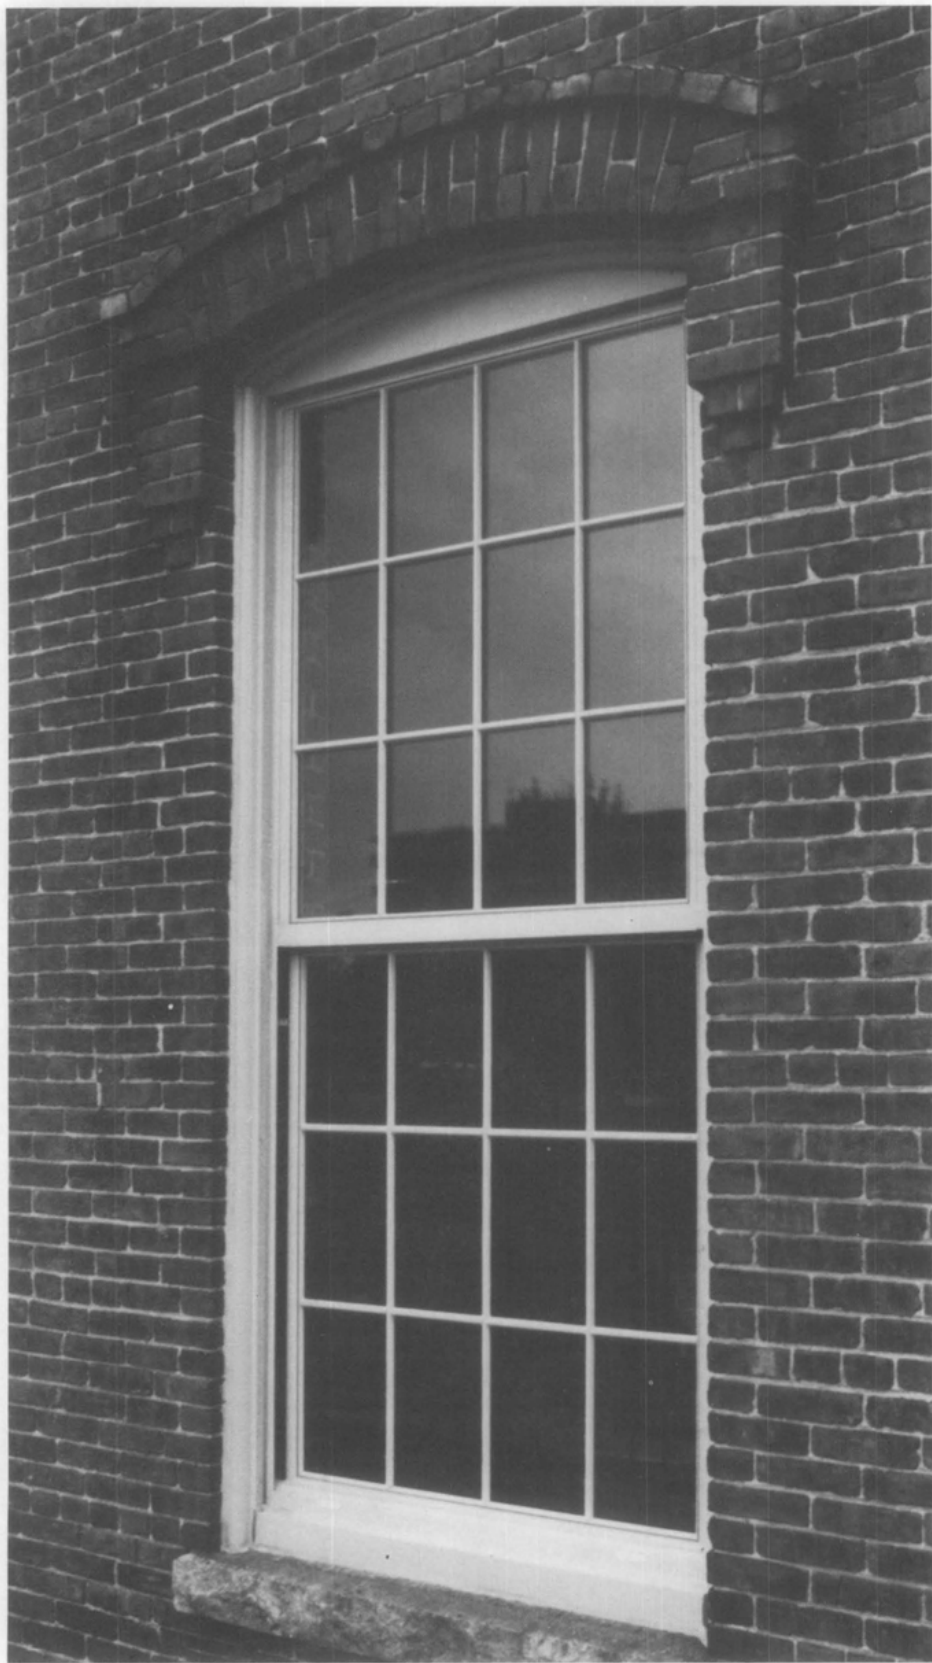
For purposes of preserving the historic appearance of the building, matching the visual details of the historic wooden windows at the Suffolk Mills was of foremost importance. It was felt that the aluminum window maintained the overall appearance of the original window. This was achieved by retaining the historic frame width, using custom aluminum brick moldings (including a curved head molding), setting the two sash in offset glazing planes as in the traditional double hung window, incorporating an exterior grid on each sash simulating the trapezoidal muntins of an authentic wooden window, and using appropriate paint color (see figure 7).

Figure 7. Replacement window after installation. Photo: Charles Parrott
