Tech Notes

NUMBER 15

Interior Storms for Steel Casement Windows

THE DRAKE HOTEL (DRAKE TOWER) Philadelphia, Pennsylvania

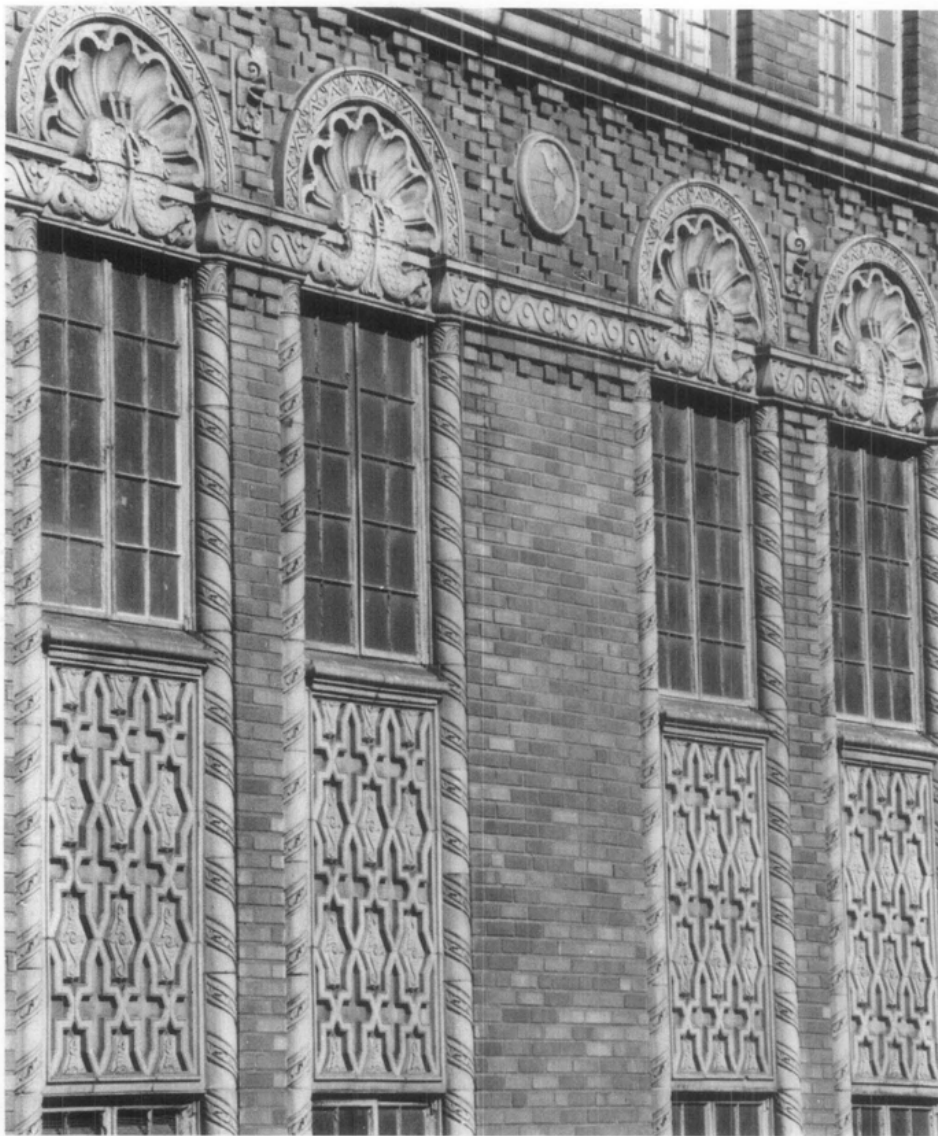
The Drake Tower, as it is known today, has over 1600 steel casement windows, richly adorned with terra cotta detail on the lower and uppermost floors (see figure 1). In between, the wall is simply detailed, characterized by the expanse of masonry and the organization and appearance of the steel casement windows with their multi-pane configuration and vertical meeting line. During the recent renovation, the steel casement windows were maintained and their energy performance enhanced inexpensively through addition of interior storm windows.

Figure 1. The steel casement windows on the lower and uppermost floors were richly adorned with terra cotta detail. Photo: Mort Bond/National Register Collection.

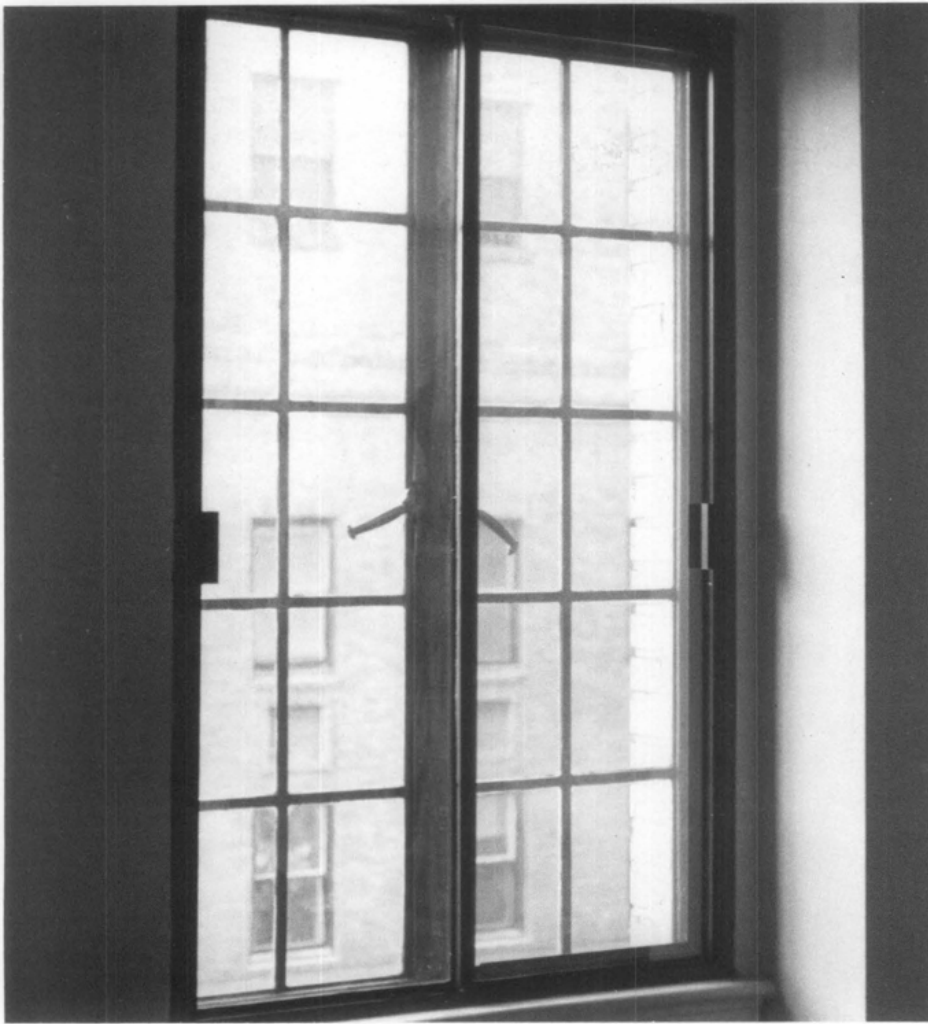
Figure 2. A horizontally sliding storm window unit was installed on the inside of the casement windows for improved energy performance. Photo: Christina Henry.

A system to improve the energy performance of the windows was developed by the architect, based on an approach that the firm had specified for other similar projects. It involved the installation of a new horizontally sliding storm window unit, mounted on the interior of the window jamb. The 2 storm panels would run the full height of the opening and would slightly overlap to allow for an effective weather seal (see figure 2). The intersection of the 2 storm panels thus would align at the vertical mullion of the existing paired casement windows. Since the interior face of the steel mullion was 2¼ inches wide, the visual impact on the windows of the intersection of the frames of the two storm panels would be minimal. For insect control, especially on the lower floors, a screen panel half the width of the opening was specified, set within a third track of the aluminum subframe (see figure 3).

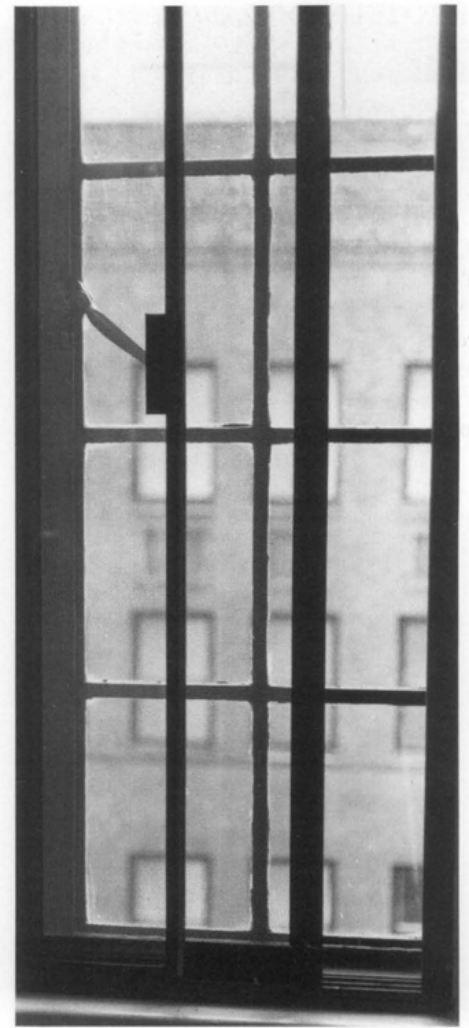
Figure 3. View of the storm unit showing a screen panel and one of the glazed panels partially opened. Photo: Christina Henry.

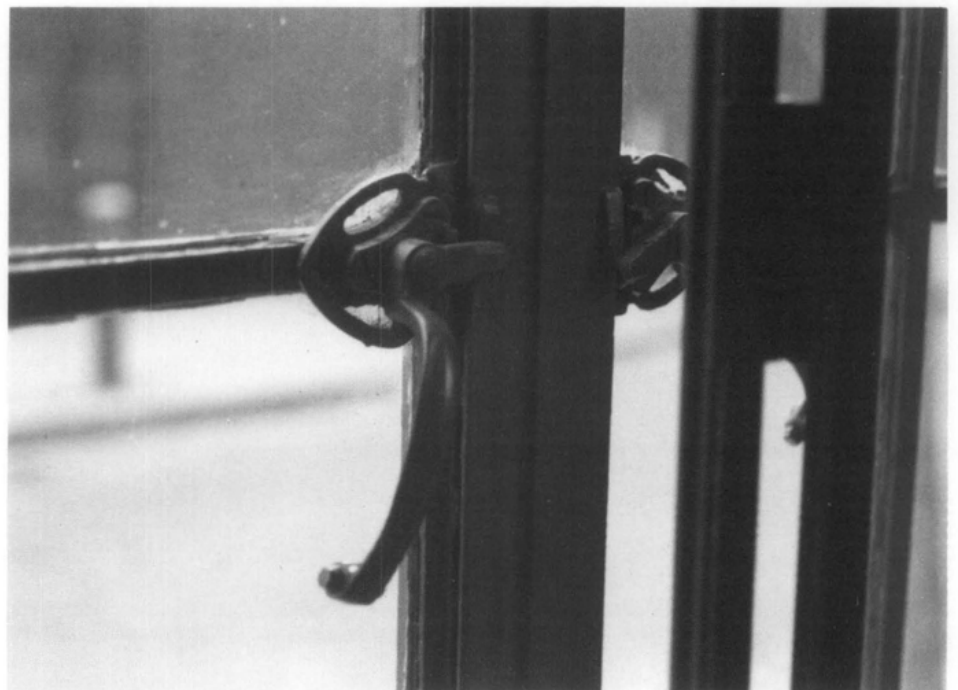
Figure 4. The hardware was cleaned and oiled as part of the maintenance and repair work undertaken on the steel casements. Photo: Charles Fisher.

The steel casement windows required basic maintenance work. This work included cleaning, repainting where necessary, limited replacement of cracked glass, and the application of an anti-corrosive paint. The hardware was cleaned and oiled (see figure 4), and the frames caulked on the exterior both to keep water from entering and rusting the steel subframe as well as to reduce air infiltration. The relatively tight closure of the cleaned and repainted casements, coupled with the planned installation of the interior storm unit, rendered the additional expense of retrofitting weatherstripping to the casements unnecessary.

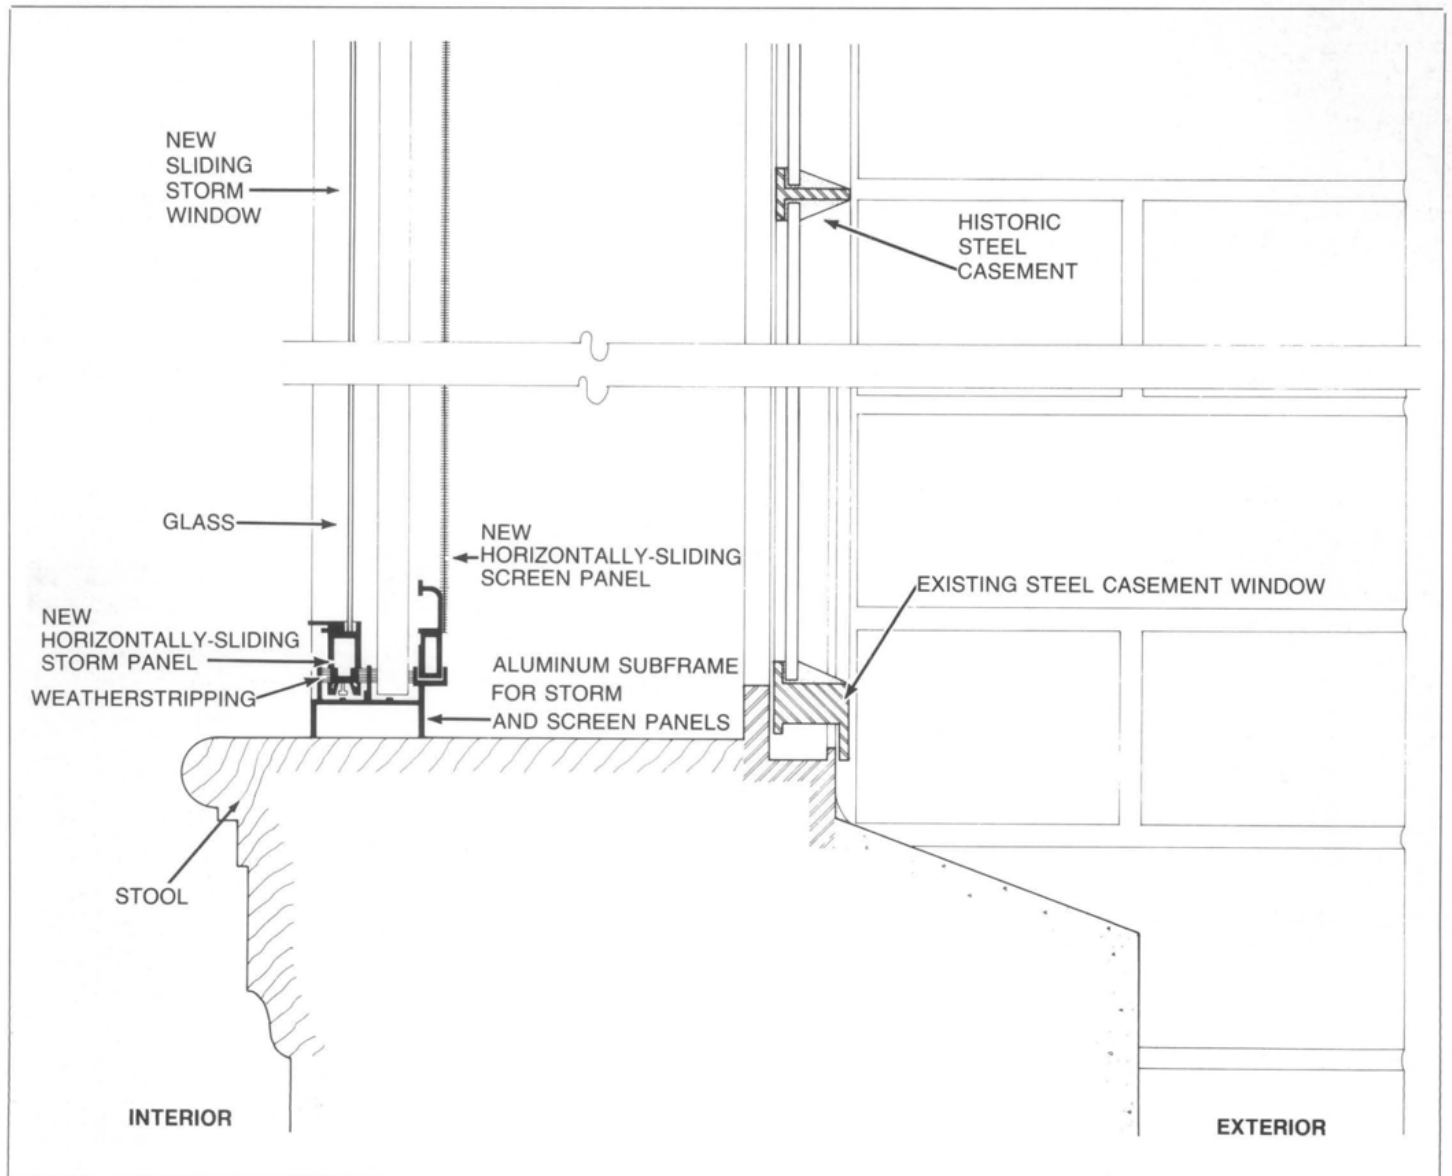
Figure 5. The interior storm window system consisted of an aluminum subframe and sliding aluminum-frame panels with glazed and screened units. Drawing: Christina Henry.

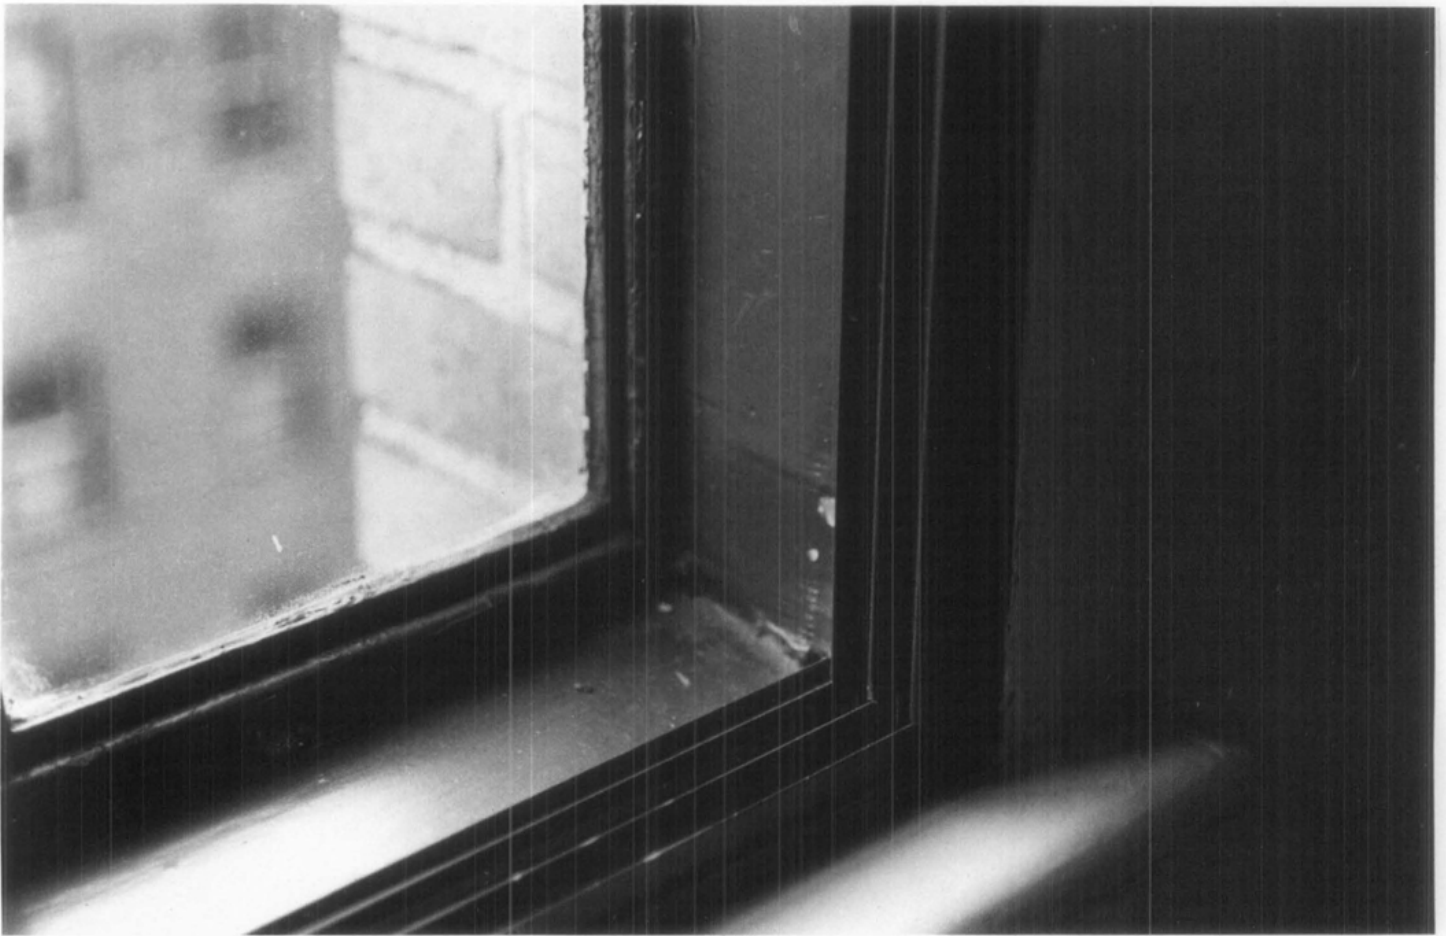
Figure 6. The subframe had to be squared off when installed in each window opening to prevent racking of the sliding panels.
Photo: Christina Henry.

Several important factors were taken into account to ensure the successful installation and operation of the storm windows. First, care was taken to make sure that the aluminum window section was thick enough to prevent racking of the sliding sash. For the 3' by 4¾' opening, a 5/8" thick sash frame was used, set into an aluminum 1½" subframe screwed to the existing jamb (see figure 5). Openings larger than these may require thicker frames. Second, correct installation procedures were essential to ensure that the slider unit functioned properly. This required that each subframe be squared off when installed in the existing jamb, since changes in alignment may have

occurred to the window opening over the years (see figure 6).

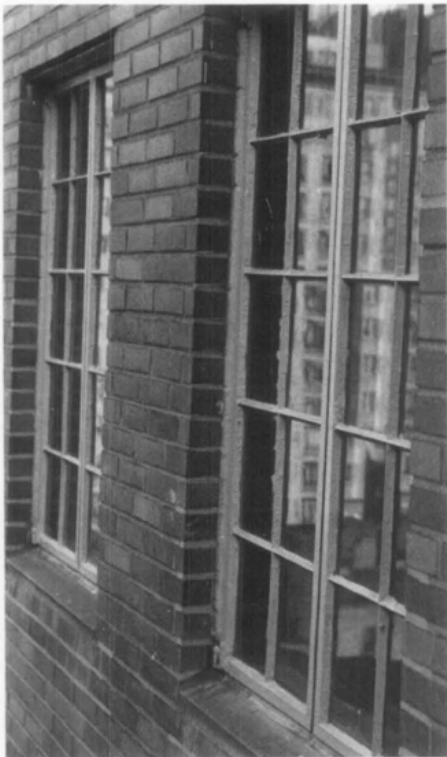
The installation of the storm units had little visual impact on the exterior appearance of the Drake (see figure 7). This is largely due to the selection of an interior application, use of a dark color for the storm frames, the alignment of the intersection of the two storm panels at a point behind the steel mullion on the historic window, and the setback of the storm unit nearly flush with the interior wall. On the inside, the storms are neatly set within

Figure 7. The dark frame color and careful installation of the interior storm window resulted in little visual impact on the exterior appearance of the building.
Photo: Charles Fisher.

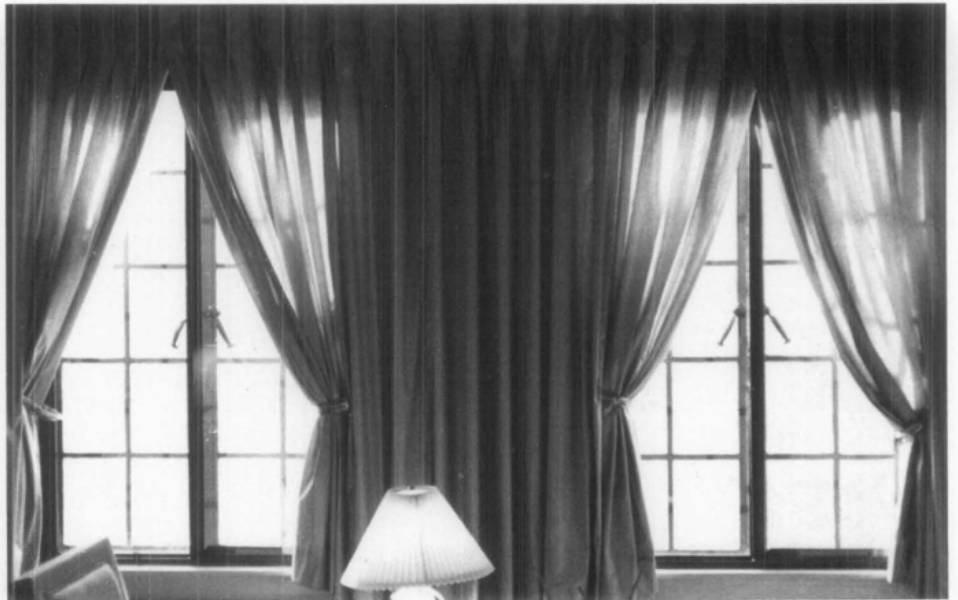
the opening and aesthetically are not disruptive (see figure 8).

Figure 8. The storm units are neatly set within the opening and aesthetically are not disruptive. Photo: Charles Fisher.
