Tech Notes

NUMBER 16

Repairing and Upgrading Multi-Light Wooden Mill Windows

SAWYER MILLS Dover, New Hampshire

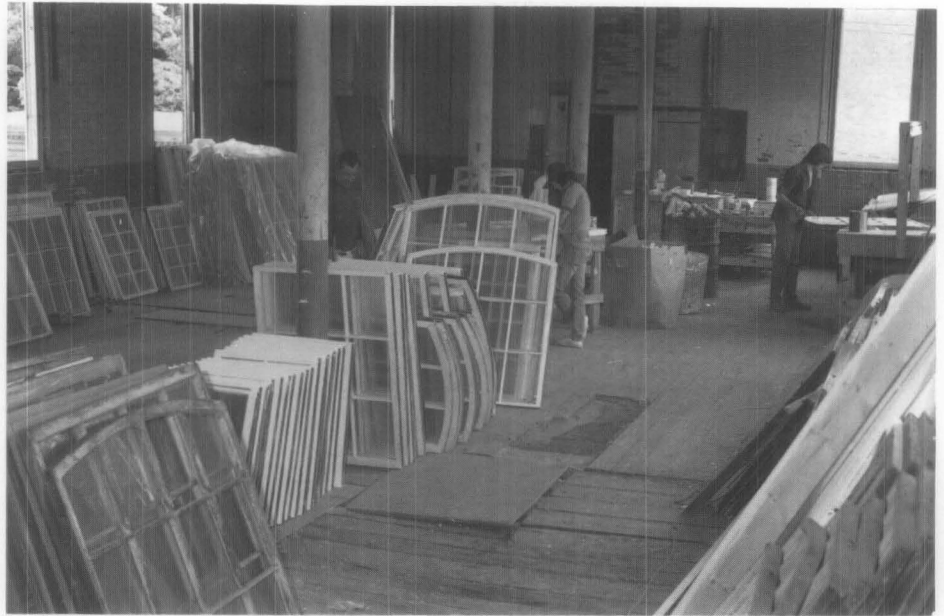
Figure 1. Window repair shop in operation. Photo: Christopher Cross

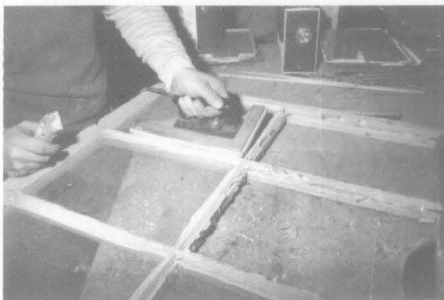
Figure 3. Electric deglazing irons were used to remove hardened putty so glass could be removed and the sash frames repaired. Photo: Christopher Closs

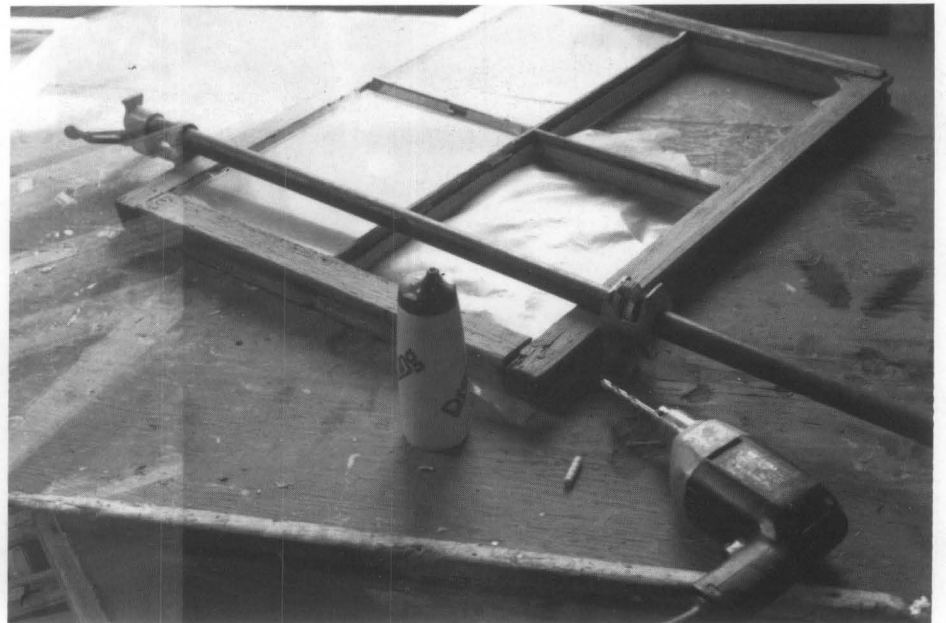
The most typical problem encountered was loose or failed mortise and tenon joints; this was remedied by drilling out the old pegs with a slightly oversize bit and then drawing the sash frame together tightly with pipe clamps (see figure 4). Fluted,

Figure 4. The basic repair: cleaning sash frame and drilling out pegs to tighten corner joints. Glue purchased in bulk was transferred to squeeze-bottles for ease of application. Oversize bit and new hardwood dowel shown ready for use. Glazing has not yet been completely removed. Photo: Christopher Closs

hardwood cabinet dowels, liberally coated with waterproof glue, were then driven in to secure the joints. To allow for natural movement, the mortise and tenon joints were not glued. In some instances, deteriorated tenons were cut off and bored out, and new tenons installed, using glue to secure the tenons in their seats but not inside the joints. This worked well providing the receiving mortises were sound. If muntins required selective replacement, this was done before clamping. It was critically important to "true" each sash square before re-pinning the corner joints.

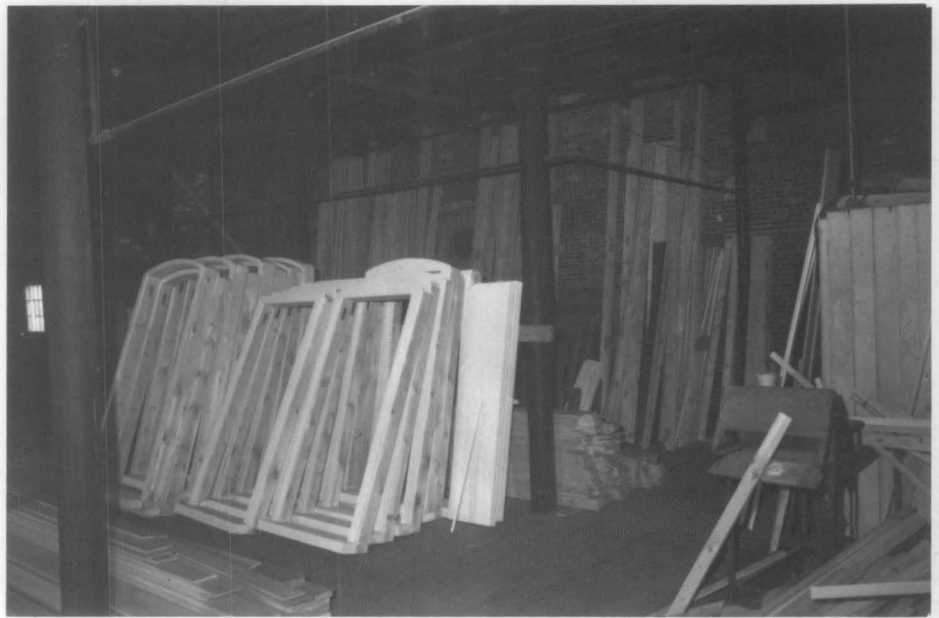
Figure 6. Newly milled replacement window frames awaiting installation. Photo: Christopher Closs

New matching wood sash, manufactured in Springfield, Massachusetts, were required to fill three hundred openings where the originals were missing or beyond repair (see figure 6). Deliveries of the new sash were scheduled to match the installation

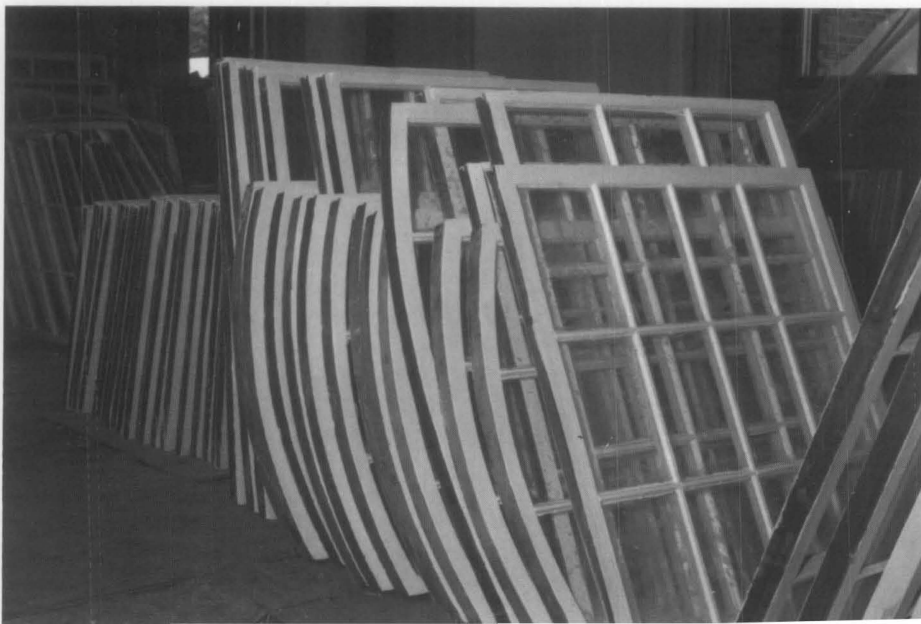
Figure 5. Repaired sash primed and awaiting reinstallation. Glass was cleaned of smudges after final installation. Photo: Christopher Closs

Once the sash for a complete window were made structurally sound, frames were hand-sanded and fully primed with a shellac-based sealer. Sash were then reglazed in conventional manner and stacked to await final finish with two coats of exterior-grade, oil-based paint (see figure 5). The wood edges of the sash were left

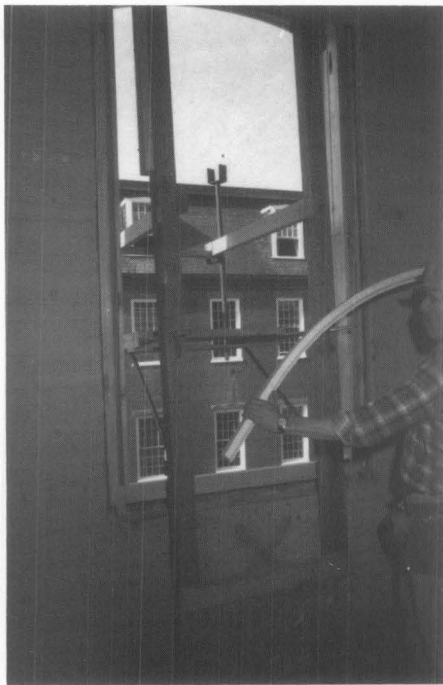
Figure 7. "Gun carriage" (scaffolding) in use by the window re-installation crew who are preparing to replace missing brickmold with replacement made by the millwork shop. Note saw kerfs used to create arc in molding for use in the window head (same method as used in the original molding). Photo: Christopher Closs

The re-installation crew was responsible for repairing or installing new frames, mounting brickmolds and installing repaired and new sash. Two "gun carriages" were constructed to facilitate frame installation and to ensure safety for the crews (see figure 7). Each carriage served as a cantilevered work platform (if fitted with dolly wheels they would have resembled a naval gun carriage). They permitted the installation crew to work safely on the exterior of the window opening without staging (much of this work had to be done over the river). The carriages had stops on the interior, were counter balanced, and were moved from opening to opening as frame repairs and brickmold work proceeded.

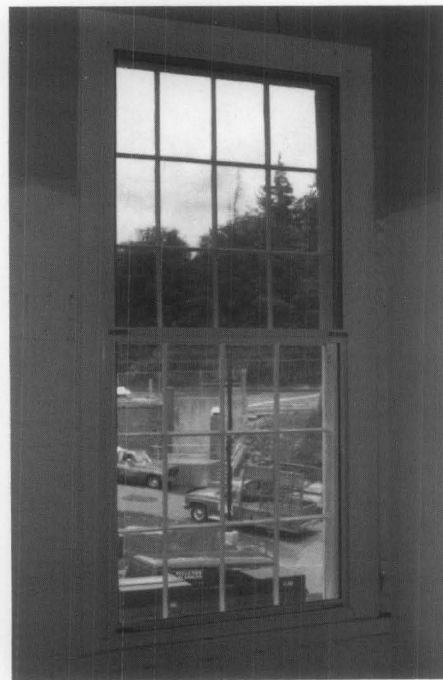
Figure 8. Typical interior aluminum combination storm window unit with insect screen shown at top. Beveled stops around the perimeter were added and the windows were caulked to provide for a good energy seal. Photo: Christopher Closs

The installation of the aluminum interior storms occurred after the primary windows were in place (see figure 8). Installation of the storm windows was monitored carefully to ensure that aluminum frames were set in a continuous bead of silicone caulk to provide a tight weather seal. This was made easier by the absence of decorative casing on all of the windows; storms were simply screwed fast to the flat, three-inch weight pocket covers (see figure 9). A new beveled 1" wooden strip was applied around the outside perimeter of the weight pocket covers and the heads, and caulked forming an uninterrupted seal with the brick masonry wall. Weight pockets were not insulated since the counterweights remained operable.

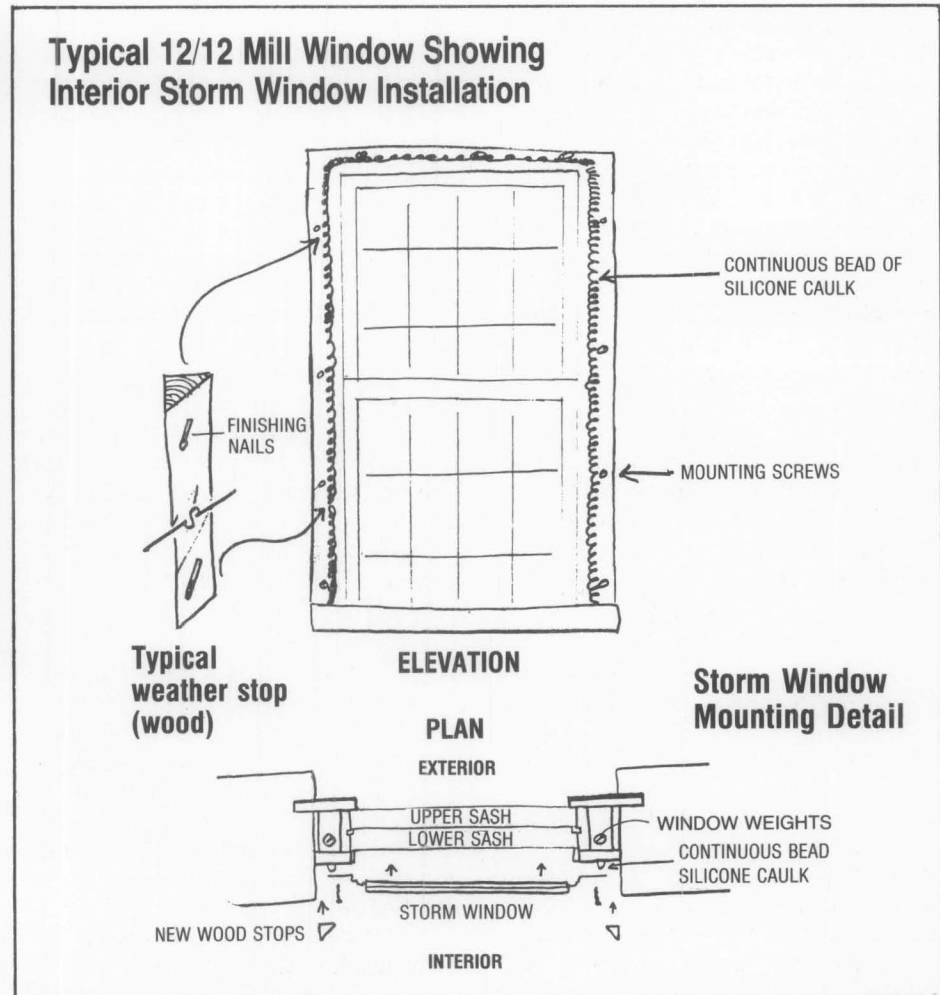
Figure 9. Drawing showing installation of the interior storm window. Drawing: Christopher Closs
