9 ROXBURY ROAD SCARSDALE, NEW YORK

Tech Notes

NUMBER 19

Repairing Steel Casement Windows

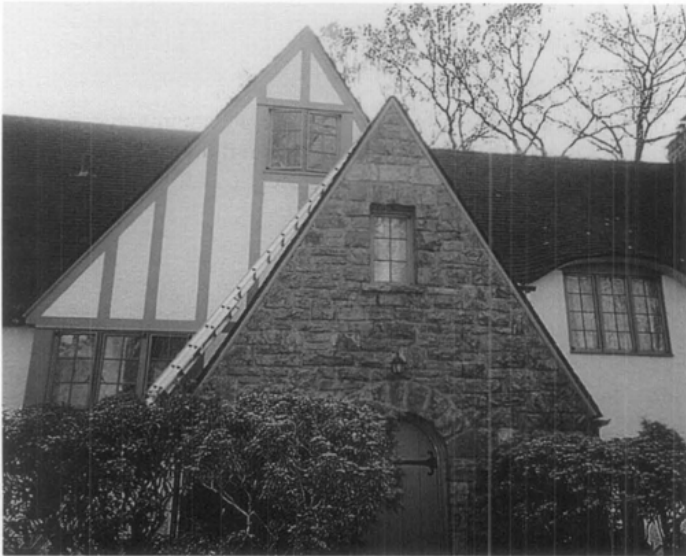
Figure 1. Steel casement windows were placed in various configurations throughout the house. Grouped windows open in opposite directions from each other, assuring that breezes can be captured, and a sash opened during rainy weather, regardless of the wind direction.

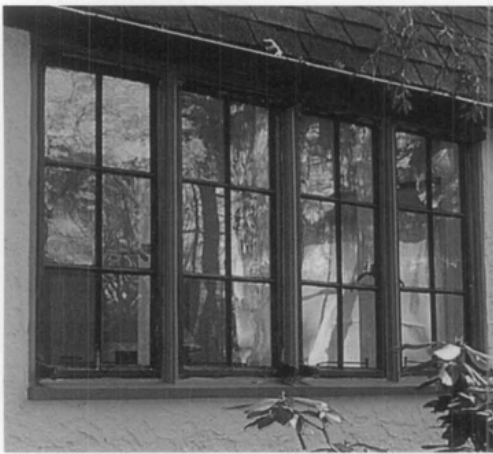
Figure 2. Each casement sash had six lights with projecting hinges that allowed the unit to open outward. Note the variation among glass panes as seen in the reflections. Caused by small differences in the positioning of panes within the sash and minor imperfections in the glass itself, this appearance is an important characteristic of historic windows.

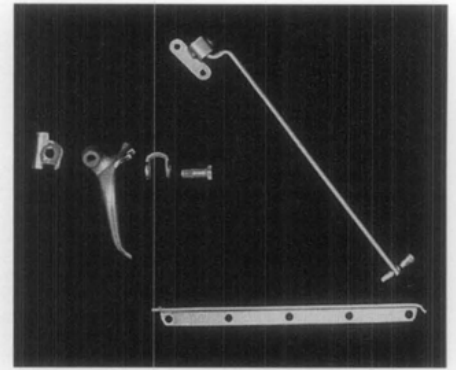
Figure 3. The window hardware at 9 Roxbury Road included a two-part "lift and stay" operator (right) and a common locking handle (disassembled at left). The hinged portion of the lift and stay (upper right) is attached to the sash while the perforated length is connected to the frame. To open the window, the pin is lifted from the hole on the far right, the sash is pushed open and the pin reset in one of the adjacent holes.

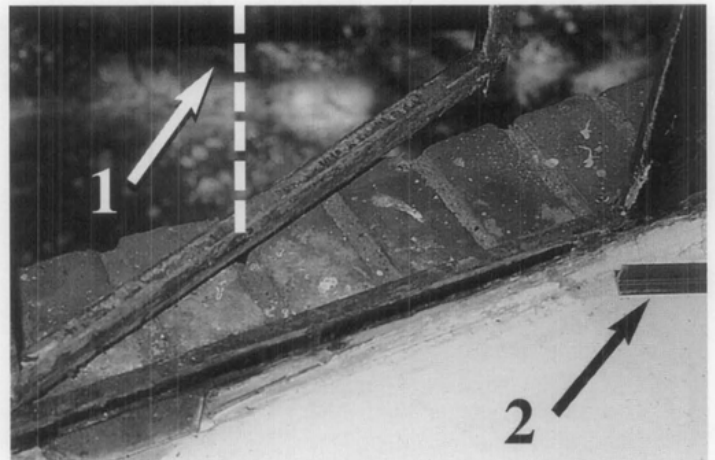
The windows on 9 Roxbury Road showed deterioration and damage typical of historic steel casements. In the course of over seventy-five years, corrosion, wear and some distortion of the sash and frame had occurred. Rust was particularly prevalent along the lower parts of the sash and frame where water had penetrated the distorted opening and the cracked perimeter

caulk (see figure 4). Originally tight fitting, all of the sash were bent out of alignment with resulting gaps from 1/16" inch to 3/4" inch between sash and frame. Hardware was corroded, stiff, and in some windows, seized shut. Prior attempts to force the distorted windows closed had also bent some of the locking handles and other hardware.

Figure 4. The sash and frame were most severely corroded along lower, horizontal members. A vertical glazing bar had previously been removed from the sash above to fit a window air conditioning unit (1). A replacement "T"-shaped length of steel that will be spliced in can be seen on the right (2).

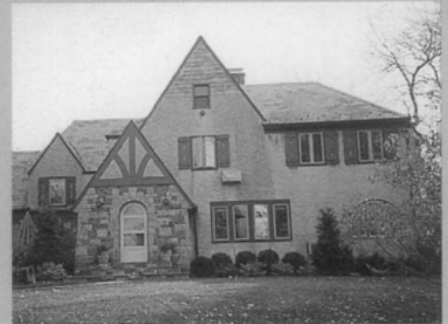
Inappropriate replacement windows dramatically affect the appearance of a historic home that once featured steel casement windows.

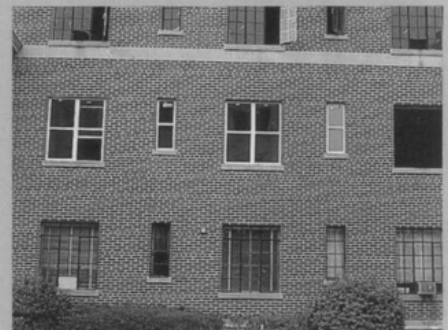
Historic steel casement windows are in the process of being replaced with new units that compromise the character of this building facade.

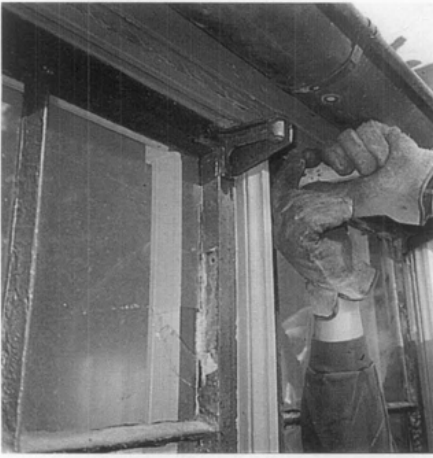
Figure 5. Before realigning the window, paint, caulk, weatherstripping and rust were stripped from all surfaces where the sash and frame were in contact.

After protecting the work area, layers of paint, rust, caulk and weatherstripping were scraped from all contact surfaces where the sash meets the frame and where locking pieces meet (see figure 5). Such extraneous material had to be removed before attempting to realign the window, so that the severity of distortion could be accu-

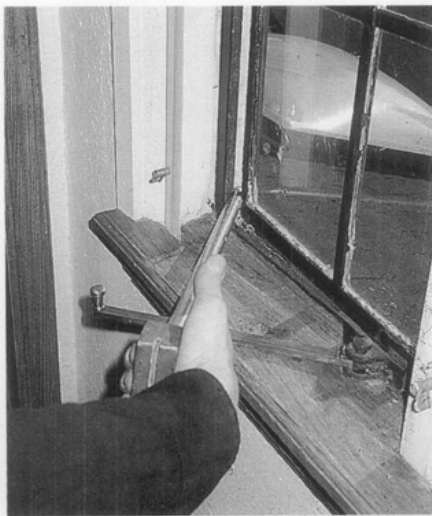
Figure 6. Pull bars were used to realign the sash from the inside. These custom made tools were especially useful on single sash units where the worker was unable to reach through an adjacent opening to apply pressure from the outside.

rately determined and the repairman could tell when a correct fit was achieved. Using metal shims of varying thickness placed between sash and frame, the worker then began the realignment process by gently applying pressure to the sash. With the shims acting as levers, one location was pushed in while another was pulled, to bring racked corners and warped planes back into alignment. Where the sash was bent outward on either the top or bottom, it was gently twisted back into shape. On single windows, where there was little room to reach out and manipulate the sash from the inside, various pull bars custom-made of notched aluminum rods were used (see figure 6). When the sash was aligned, bent locking pieces and other hardware were similarly returned to their original shape or, where broken, replaced with identical pieces.

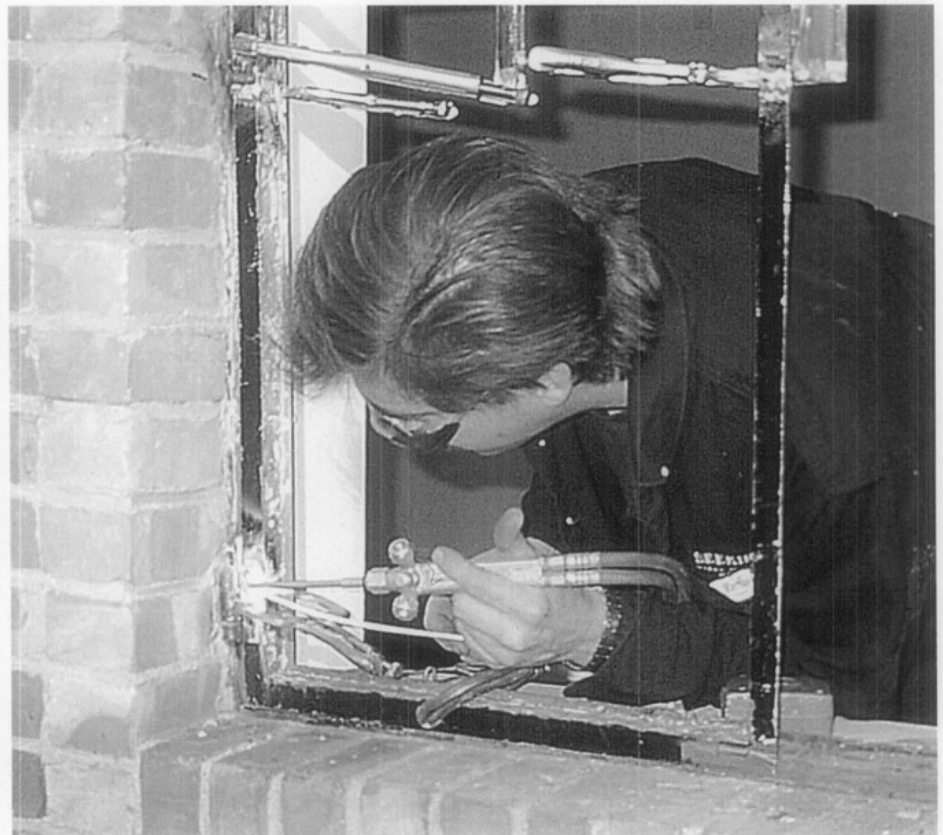
Figure 7. New steel sections were brazed into the historic sash and frame where the windows had previously been altered to fit air conditioning units. Because the replacement pieces came from a stock of salvaged window materials, they matched perfectly the profiles and dimensions of the missing sections.

In order to repair the four windows previously altered for air conditioning at 9 Roxbury Road, it was necessary to replace missing metal sections along the lower third of the sash and frame. Lengths of replacement steel with the typical "Z" and "T"-shaped profiles were obtained from a stock of salvage material maintained by the repair company. Exact matches were easily achieved because replacement pieces came from identical Fenestra casement windows of the same period. To rebuild the sash, replacement steel bars were held to the existing sash with clamps and brazed together with an oxygen-acetylene torch (see figure 7). After

cooling, the brass seam was ground down with a sander so that it was flush with the existing surface. Though not necessary in this project, a similar treatment can be used when portions of the frame or sash are corroded beyond repair. In such a case, damage is usually limited to the frame, sill and lower portions of the sash, where unattended water problems lead to severe oxidization. The deteriorated section can usually be cut out and new pieces from salvaged stock brazed into place.

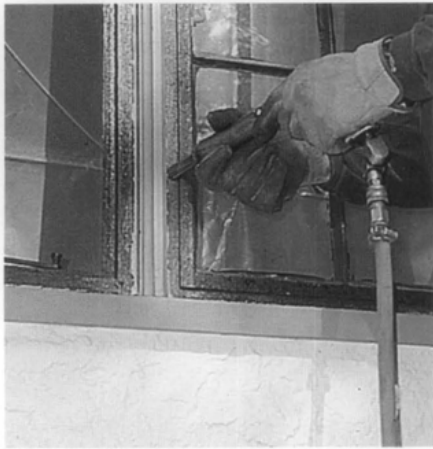
Figure 8. A pneumatic needle gun was used to strip much of the paint from the steel frame and sash. It was followed by wire wheel and small disk sanders and hand chisels. The blunt tipped needles did not damage the steel or adjacent glass.

Initial paint and rust removal was done with a pneumatic needlegun. When set to a standard air pressure, the needlegun neither pitted the steel, nor damaged adjacent glass (see figure 8). Occasionally an air hammer with a blunt end attachment was also used. The needlegun was followed by a sander with wire wheel attachments. Run the length of each steel member, this tool removed almost all of the remaining paint and most of the rust. It was especially useful in clearing pockets of rust from crevices and gently grinding down the more severely pitted surfaces. Removing rust with a sander was preferred over sandblasting because a sander is less messy, does not require shielding the glass and masonry surround, and is less likely to damage the steel. Finally, a small hand chisel and sandpaper were used in corners, on the inside edges of the hinges and in other tight locations not reachable with larger tools. Because they were used as guides for the application of the new putty bevel, it was essential that the edges of the muntins were free from nicks or bumps that would have resulted in an uneven profile.

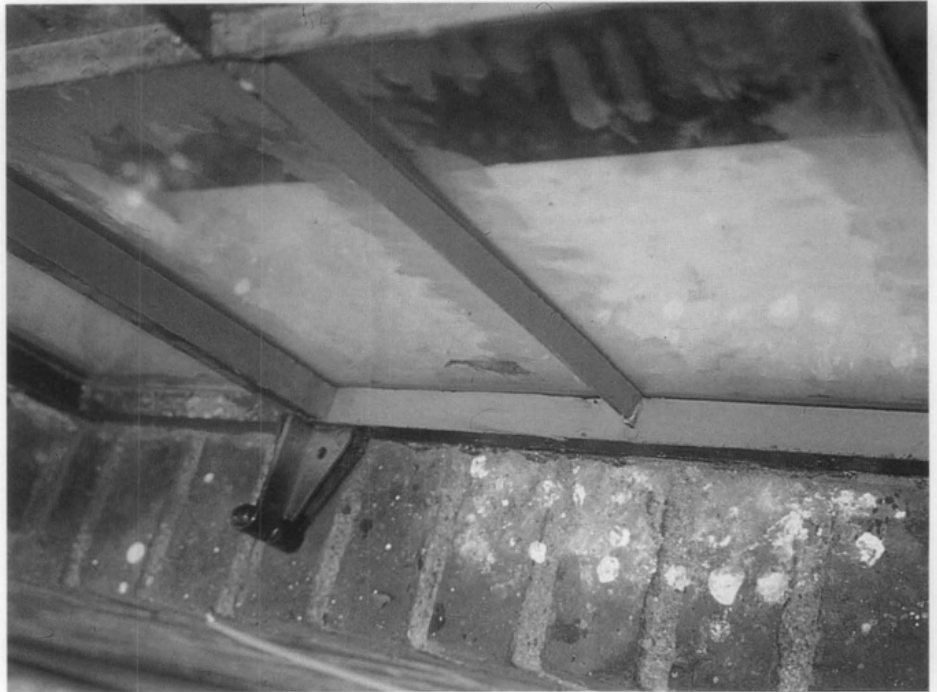
Figure 9. An oil-based putty was used to reglaze the historic casement windows. Painting was undertaken two weeks after reglazing.

The glazing contractor used natural, oil-based (linseed or soybean) putty that remains relatively soft. Putty was repacked along the interior face first. In keeping with the historic appearance of the windows, all putty lines on the inside were run flush with the muntin, so that no bevel profile was present. This brought sightlines back to the narrow appearance that is so characteristic of historic steel windows, while creating a watertight seal that keeps condensation from entering the joint. Putty was then applied along the exterior in a beveled profile that helps shed water (see figure 9). Finally, the glass was carefully cleaned with a four-inch razor blade followed by a standard glass cleaner.

Although the manufacturer states that the putty can be painted the day after application, the painting contractor preferred to allow two weeks for the putty to cure sufficiently. Two finish coats were applied to the frame, sash and glazing putty. The industrial paint, a brand commonly used on steel bridges, was custom mixed a taupe color to match the exterior wood trim. To form a moisture resistant seal, paint was extended a small amount beyond the putty and onto the glass face – a standard practice, both past and present.

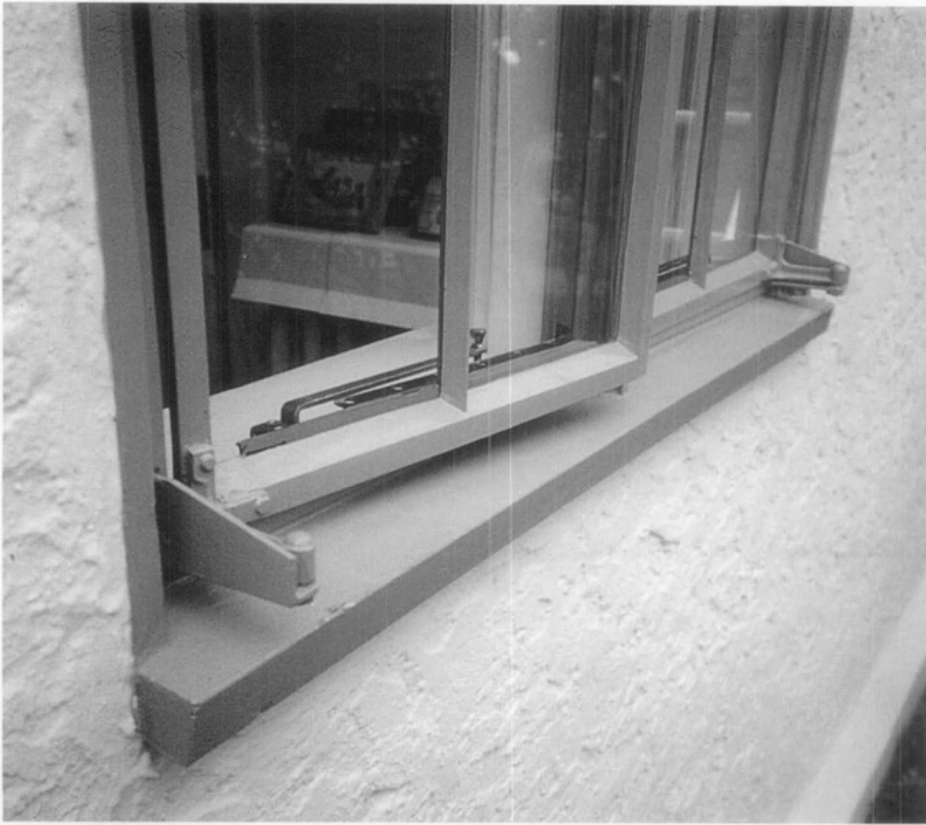
Figure 10. Detail of complete windows, repaired, serviced, reglazed and repainted.

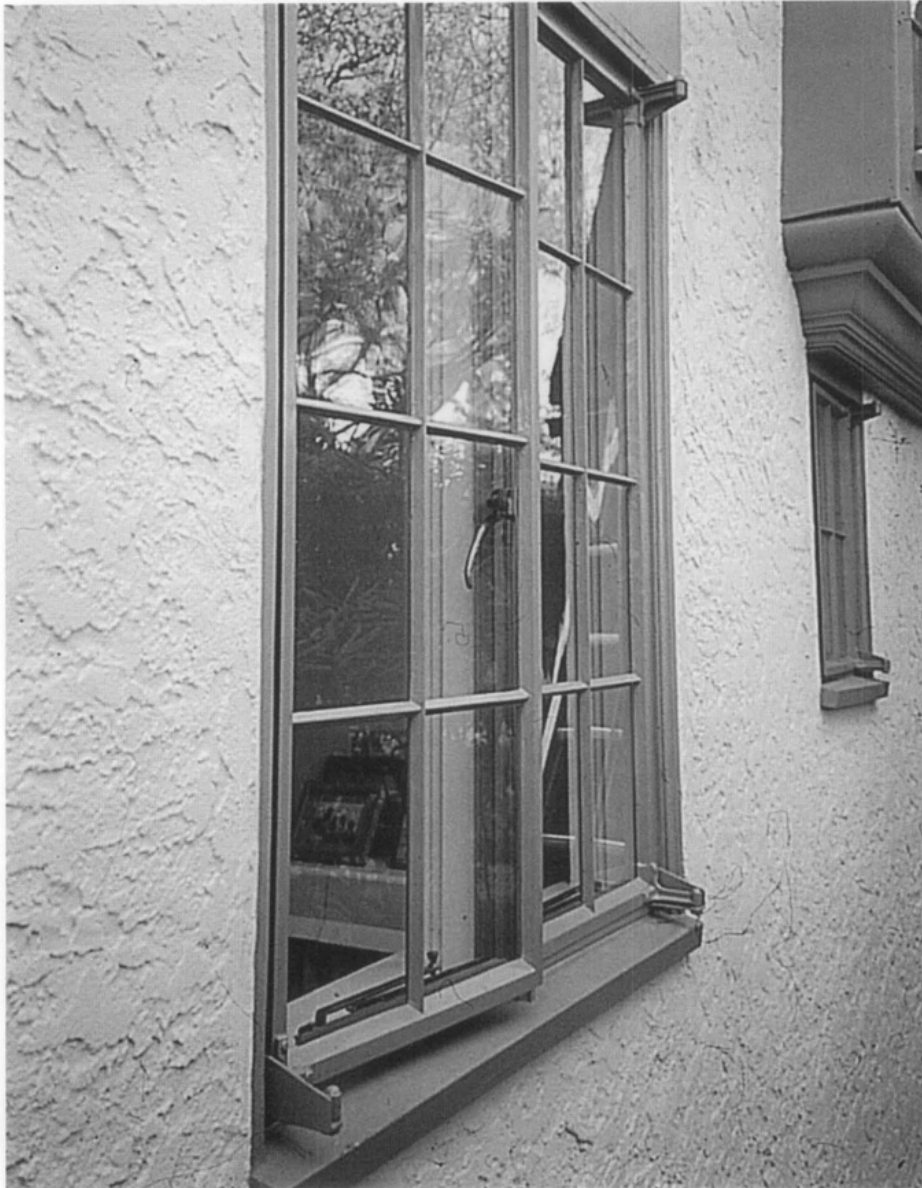
Figure 11. The completed work reveals the aesthetic appeal of the historic casement window – qualities appreciated both past and present.
