7 SE 97th Ave | Portland, OR 97216
503.256.3852 | 503.252.7806 (FAX)
www.talbottassociates.com

December 21, 2023

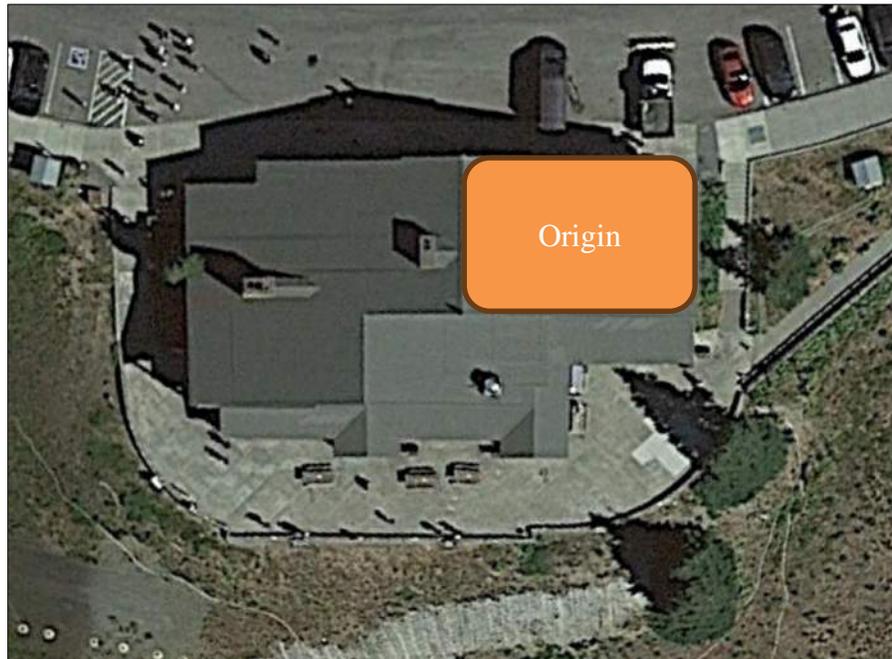
Figure 1 – Area of Fire Origin – Pre-fire image.

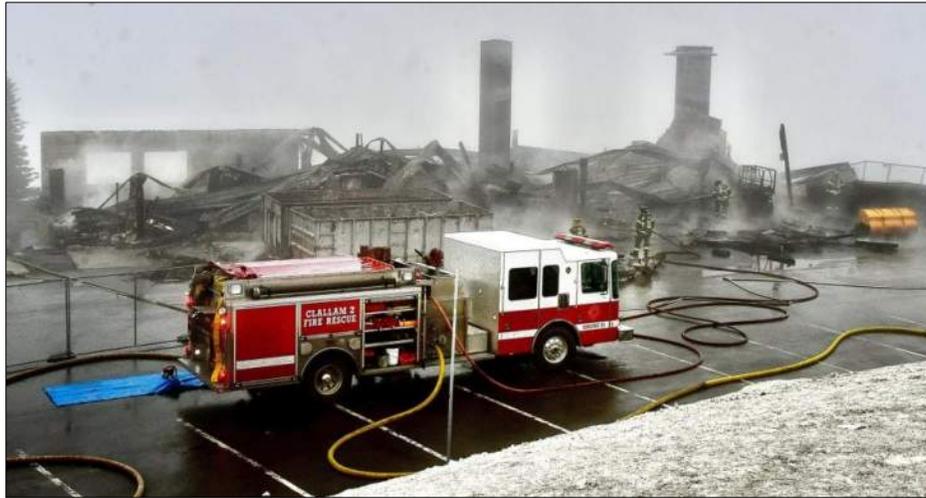
Figure 4 - Fire Fighters at HRDL on May 7, 2023.

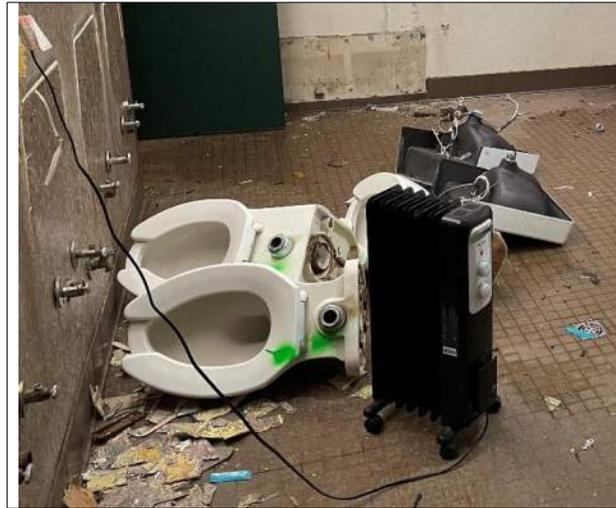
Figure 5 - Radiant Heaters utilized at HRDL. (April 19, 2023)

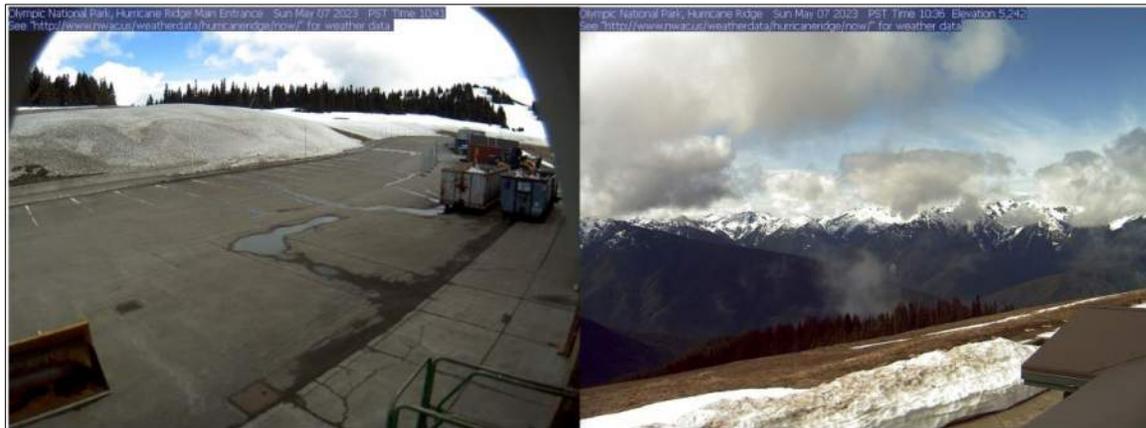
Figure 7 - Final HRDL Webcam Images. 10:41 a.m. (left) and 10:36 a.m. (right).

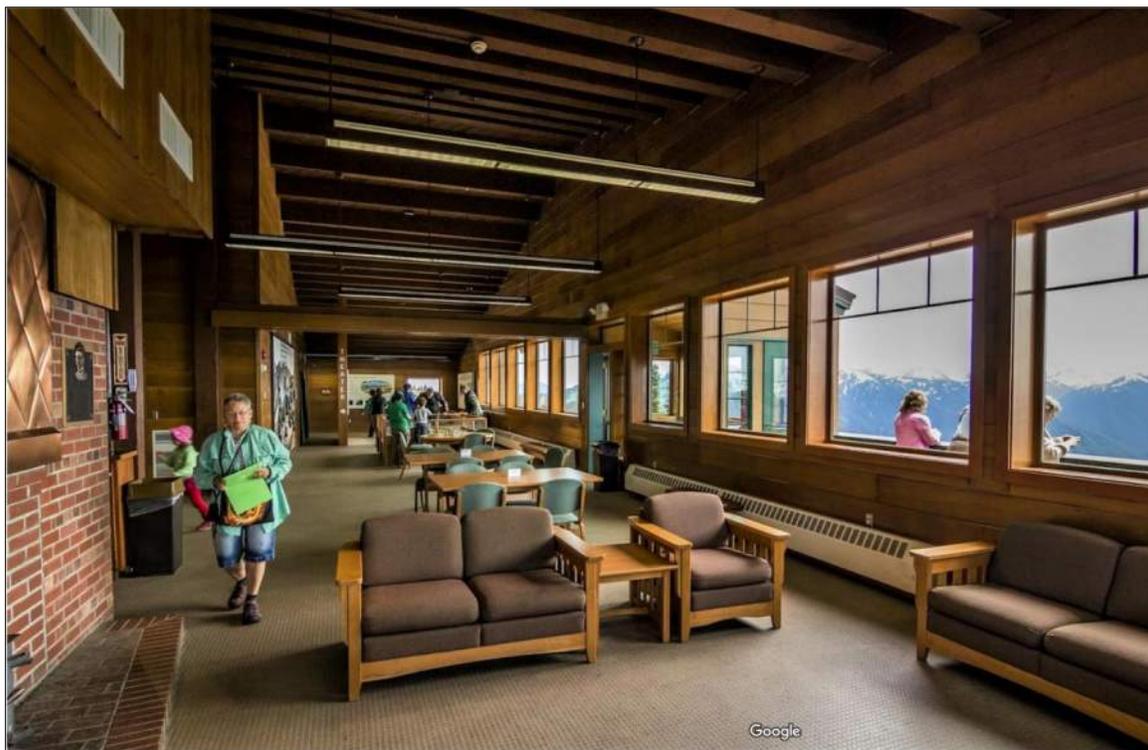
Figure 8 - Prefire photograph of the lounge and exhibits area (Google Maps).

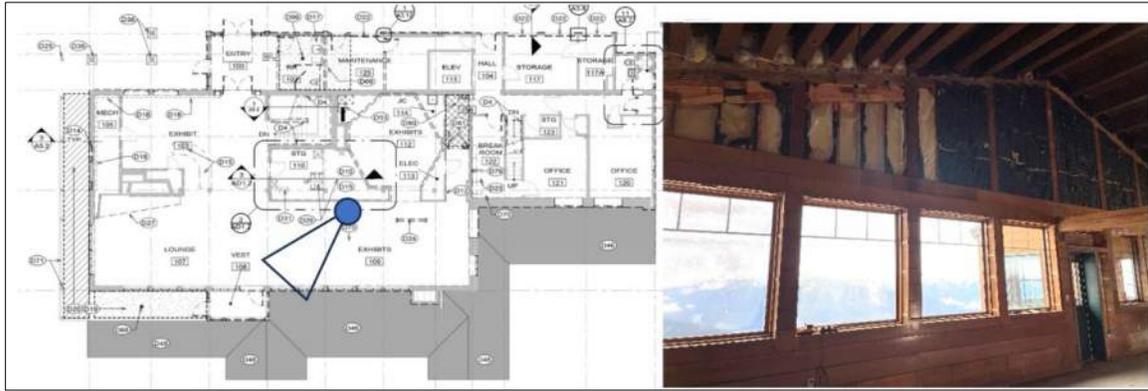
Figure 12 - Exposed wood structure in the Lounge Area (Main level, facing southwest, May 4, 2023).

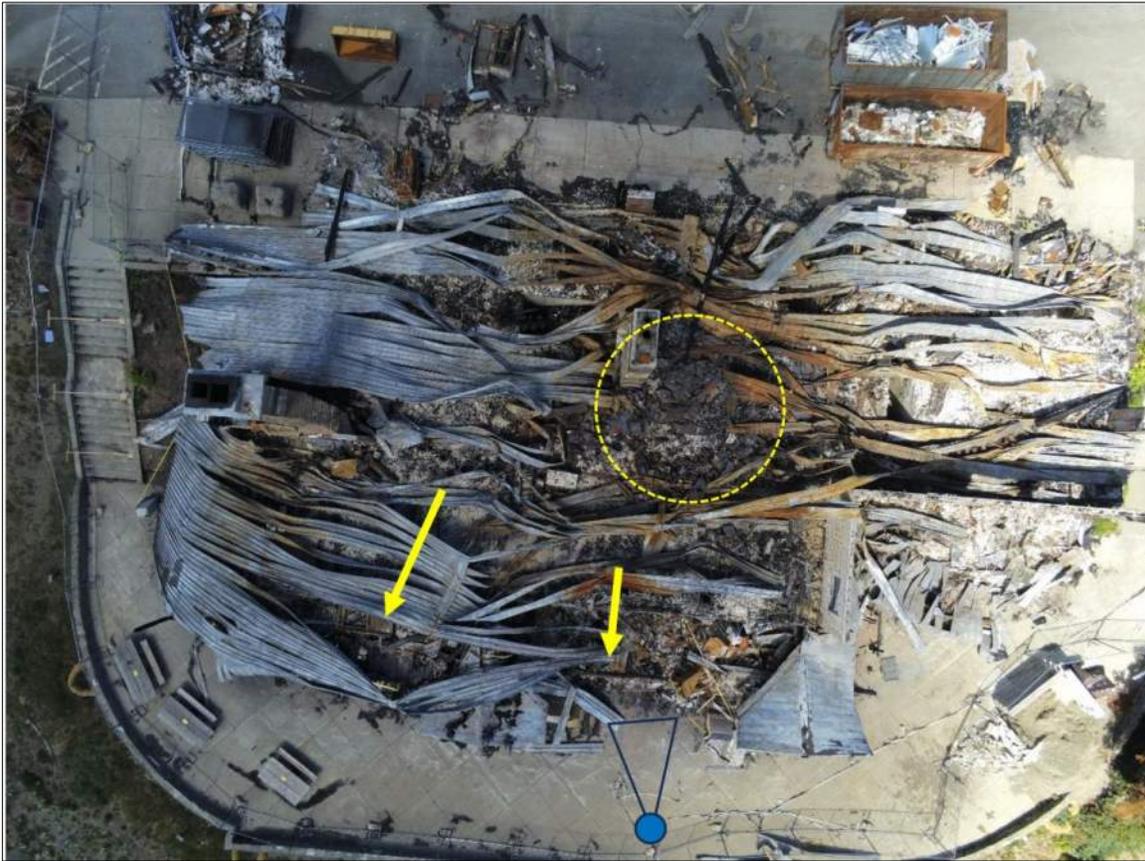
Figure 13 – NPS Drone Image – Roof Details - August 8, 2023.

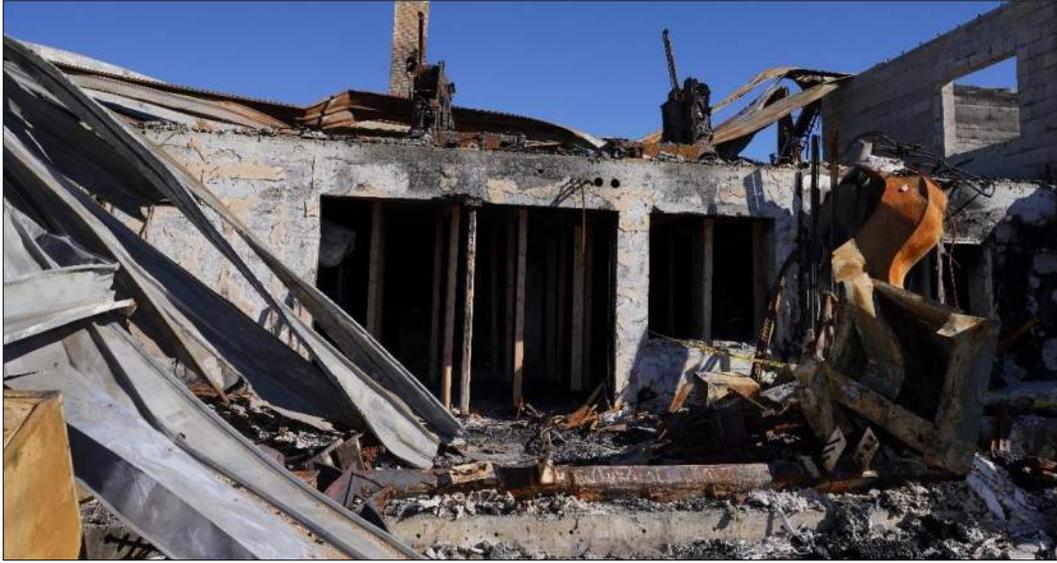
Figure 14 - South side of the concrete structure (looking north, August 17, 2023, TJB).

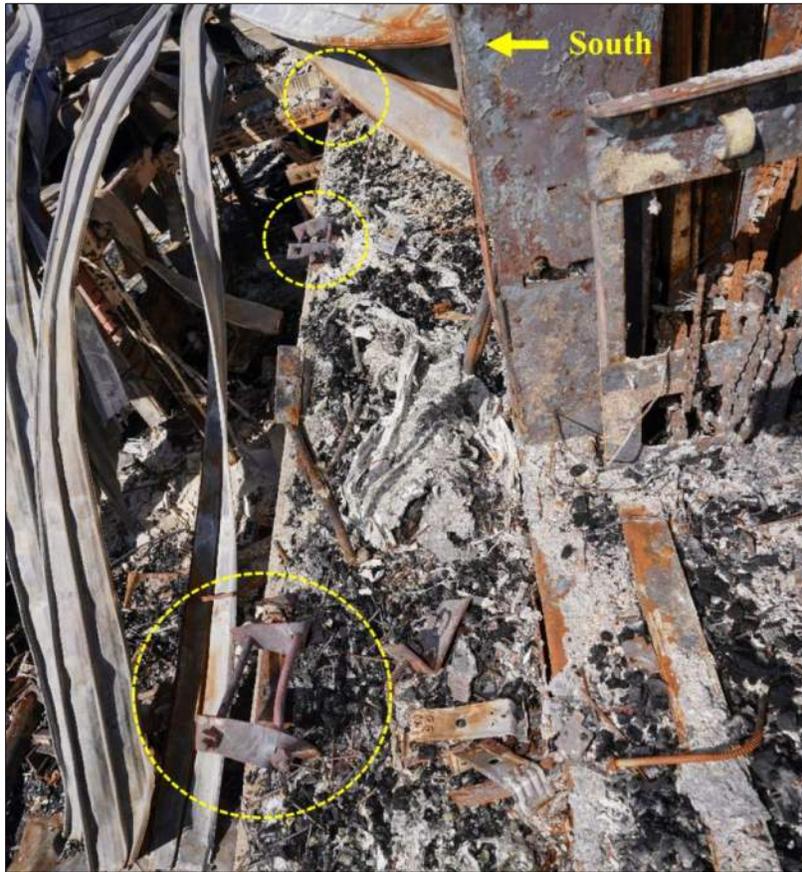
Figure 15 - Column brackets bent toward the southern exterior of the structure. (August 16, 2023, TJB)

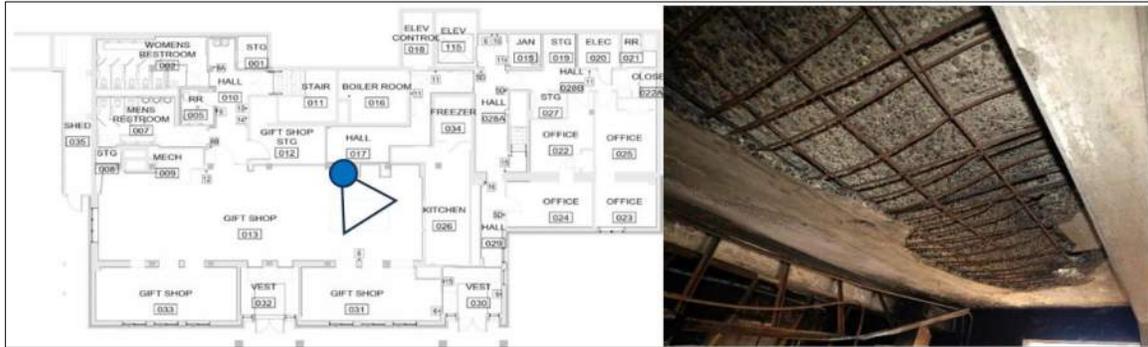
Figure 16 - Concession area spalling (Lower level - South end, August 15, 2023, TJB).

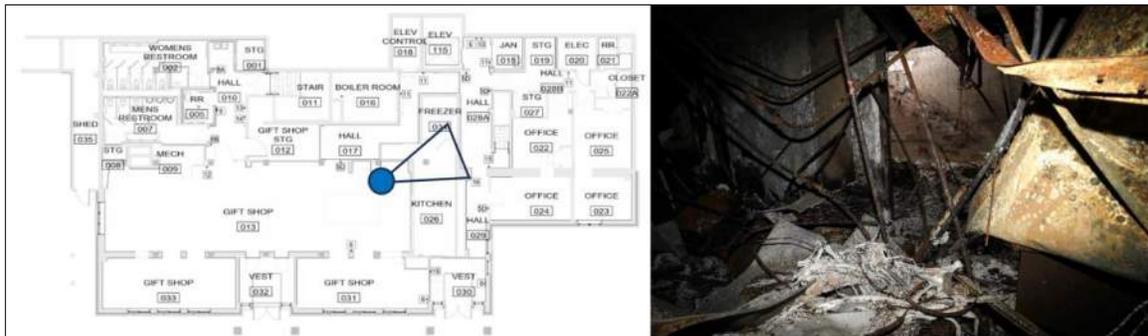
Figure 17 - Damage to kitchen and stairwell (Lower Level, July 12, 2023, TJB).

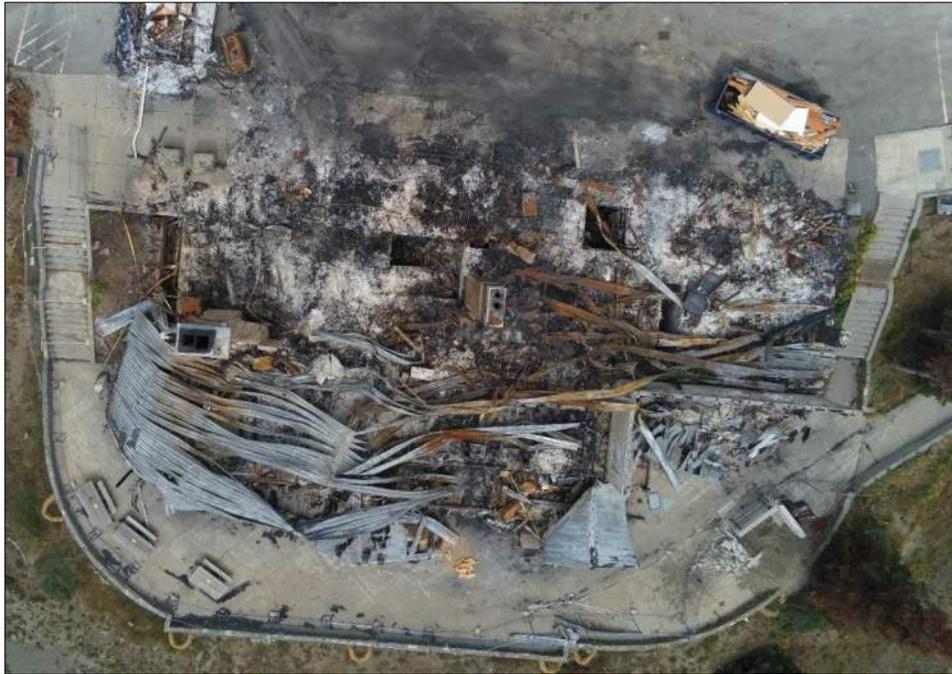
Figure 20 – NPS Drone Image - August 22, 2023.

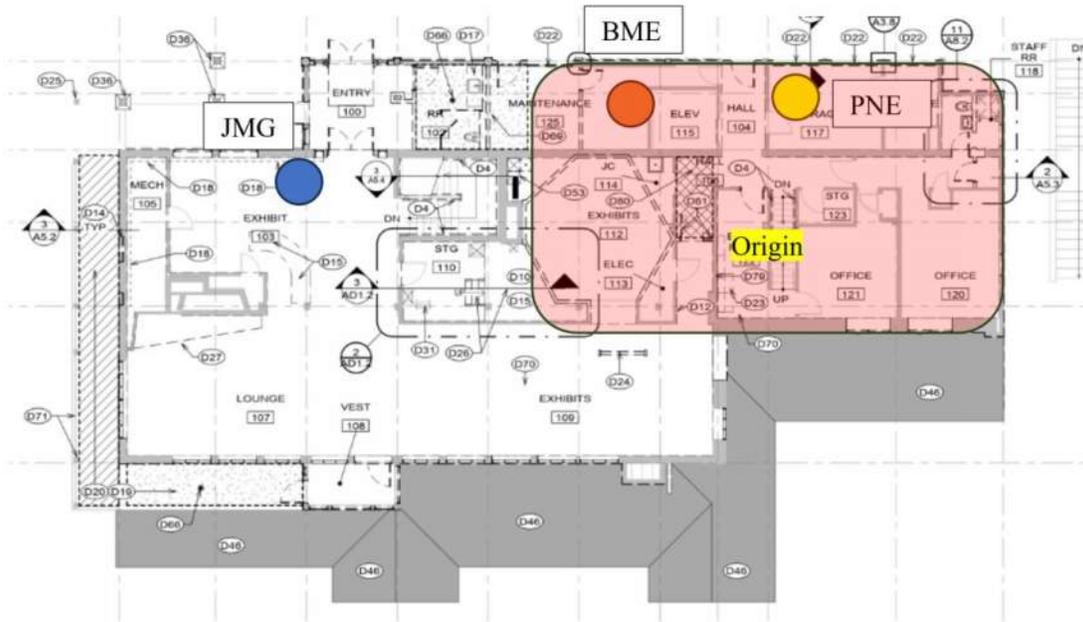
Figure 21 - Approximate tool battery locations.

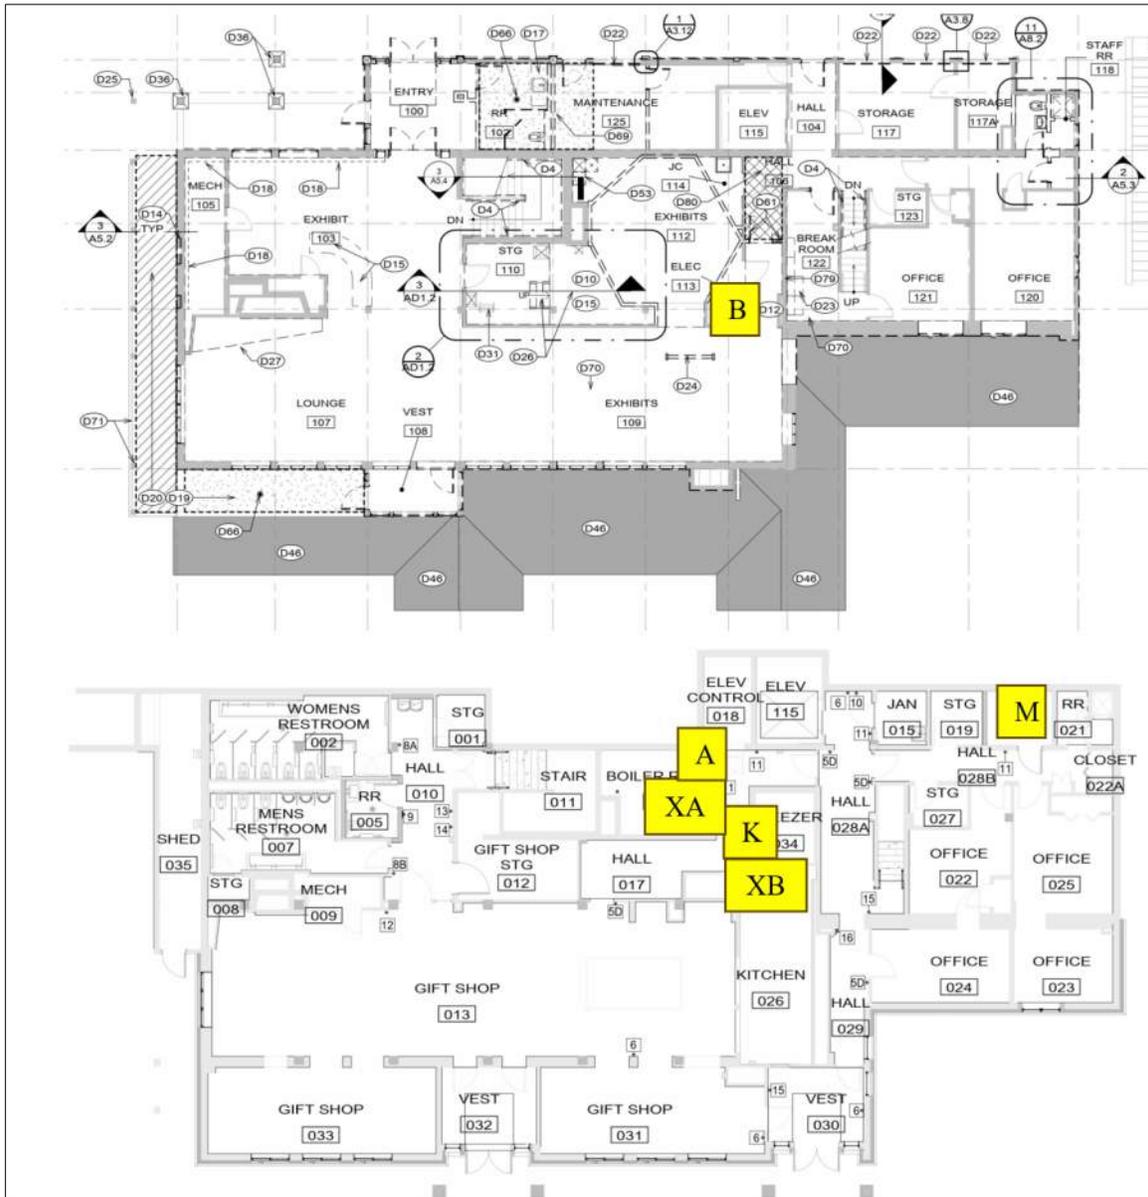
Figure 26 - Panel locations (Main and Lower Levels).

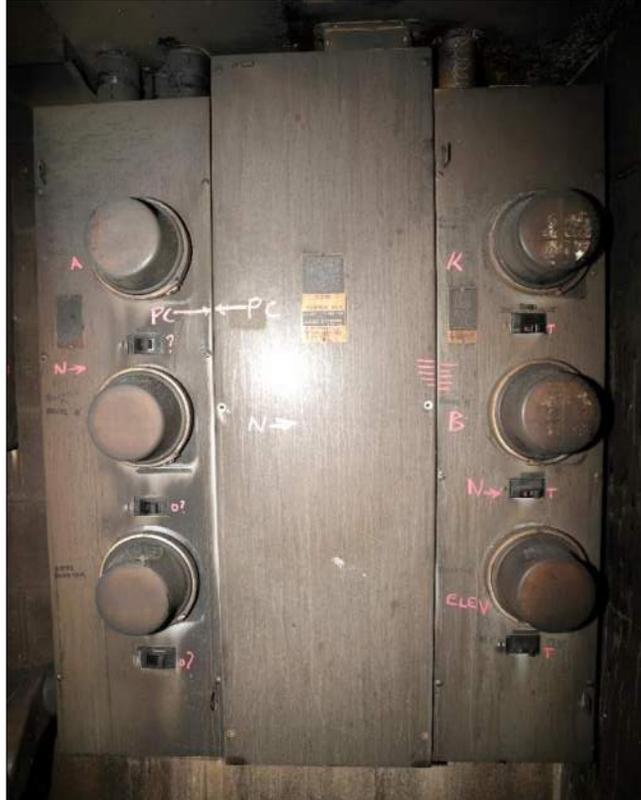
Figure 27 - Service entrance metering gear. (August 15, 2023, TJB)

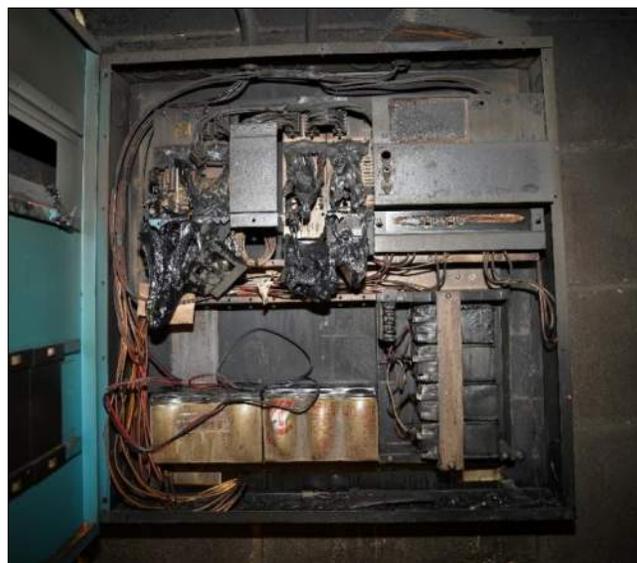
Figure 28 - Pyrotronics System-3 Fire Alarm Panel. (August 15, 2023, TJB)

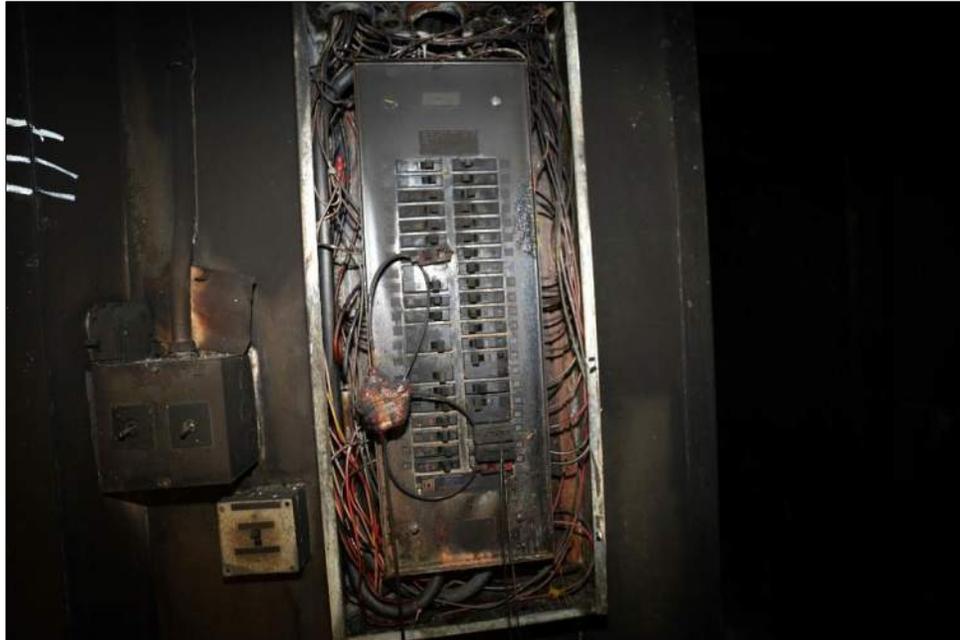
Figure 29 - Panel A (August 15, 2023, TJB)

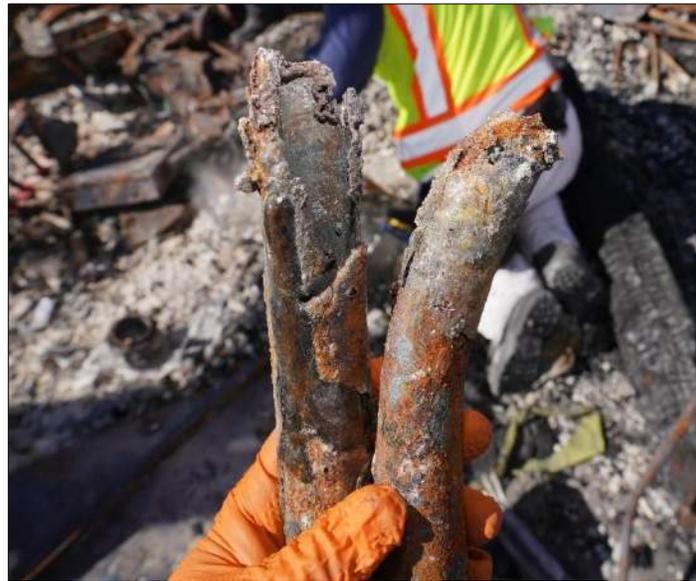
Figure 31 - Arced conduits from the main level (Fed from XB). (August 16, 2023, TJB)

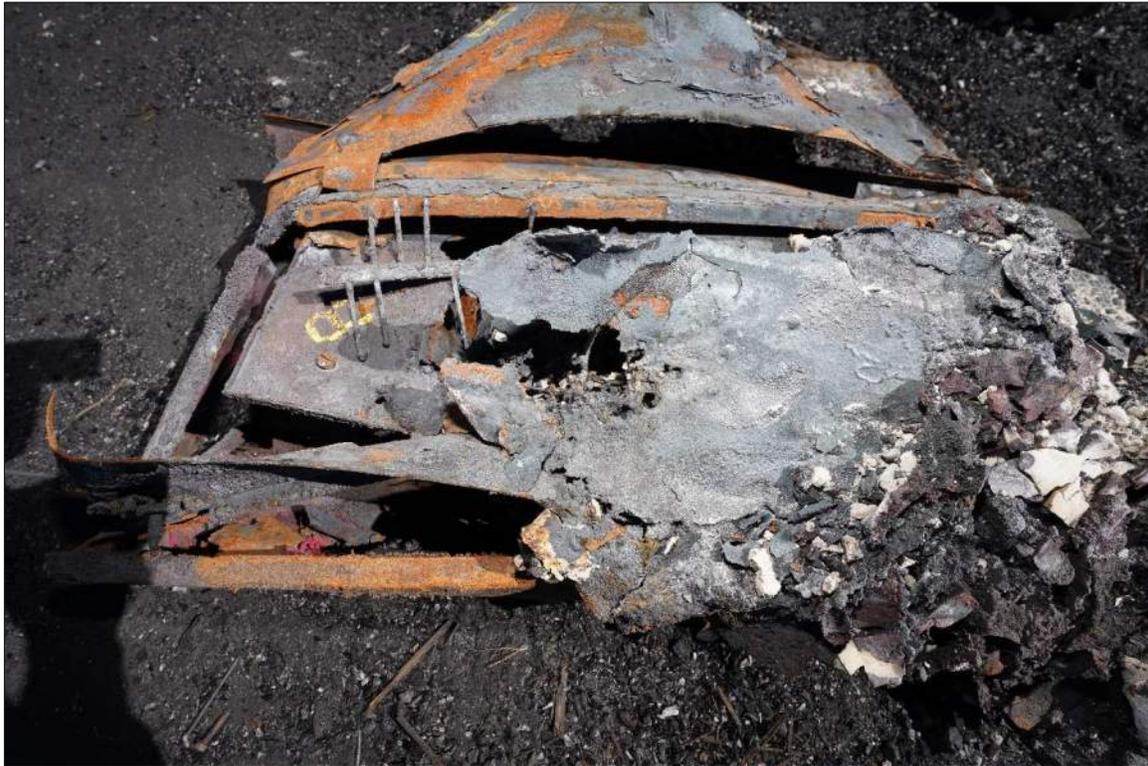
Figure 32 - Panel B (August 16, 2023, TJB)

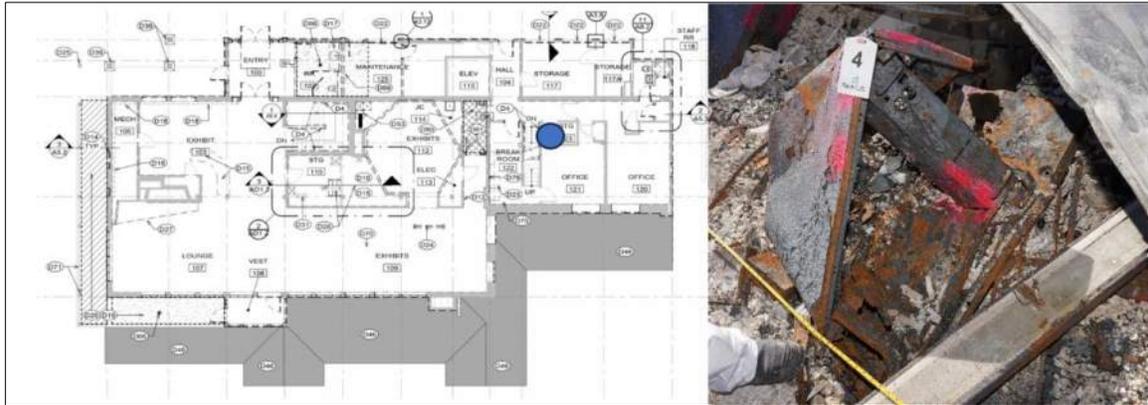
Figure 33 - IT/Network Cabinet. (August 16, 2023, TJB)

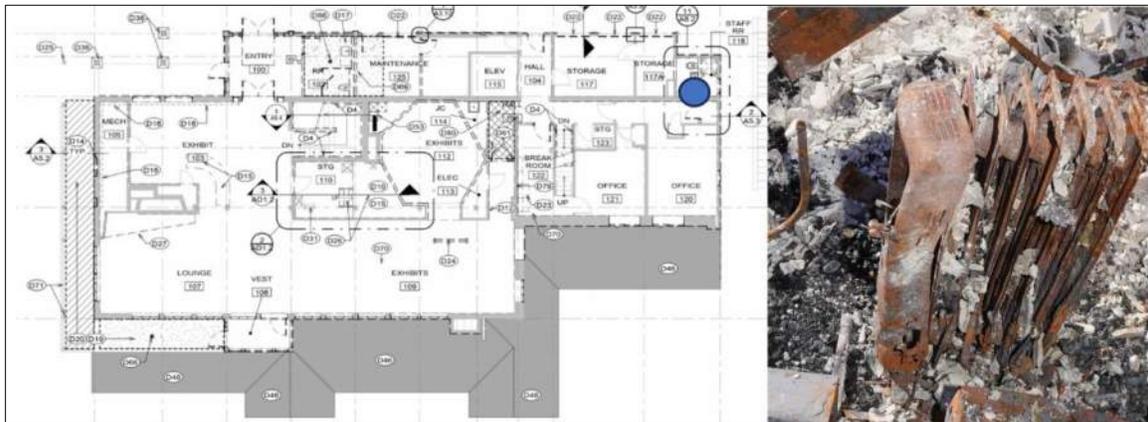
Figure 34 - Radiant heater observed along the northeast area on the main level. (August 16, 2023, TJB)

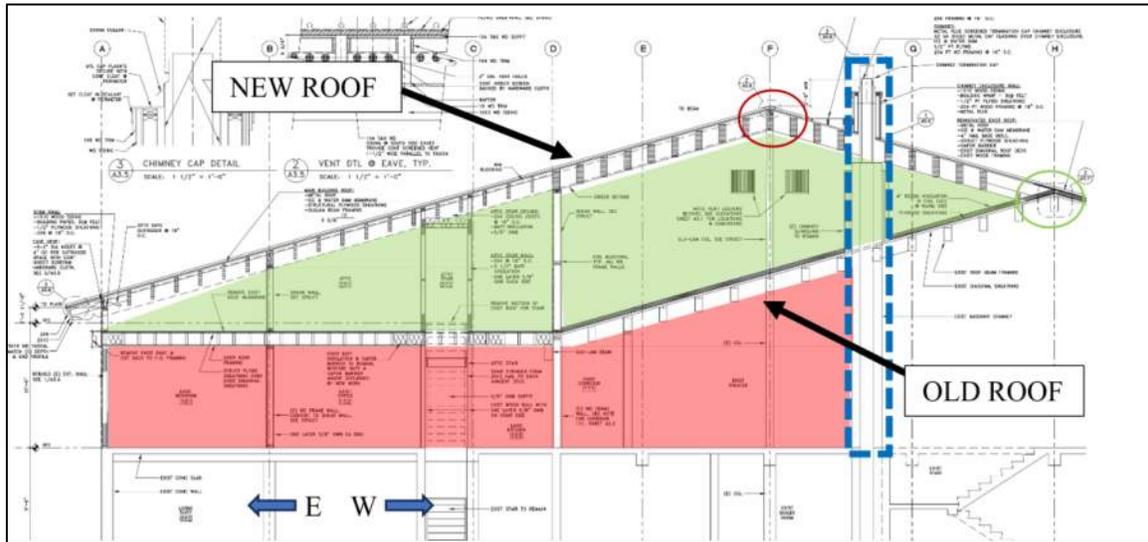
Figure 35 - Profile view - roof structure from 1999 submittal.
