Cape Lookout National Seashore  
**GASKILL - GUTHRIE HOUSE**

# **HISTORIC STRUCTURE REPORT**

**August 2003**  
**Historical Architecture, Cultural Resources Division**  
**Southeast Regional Office**  
**National Park Service**

2002  
Historic Structure Report  
Gaskill- Guthrie House  
Cape Lookout Village  
CAPE LOOKOUT NATIONAL SEASHORE  
Harker's Island, NC  
LCS#: 272049

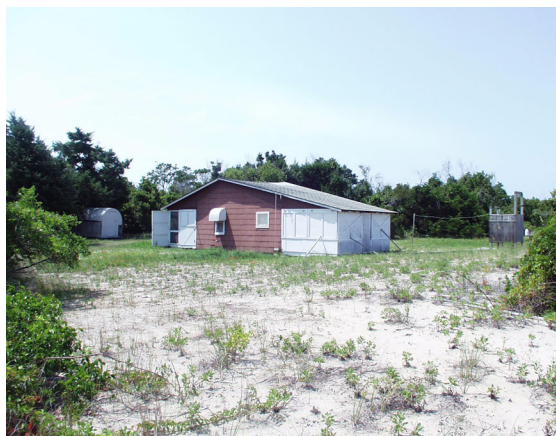
**Figure 1** View to south of Gaskill-Guthrie House. Modern metal building is at left, in front of the house; modern shower enclosure is at right, behind the house. (NPS-SERO-CRS,2002)

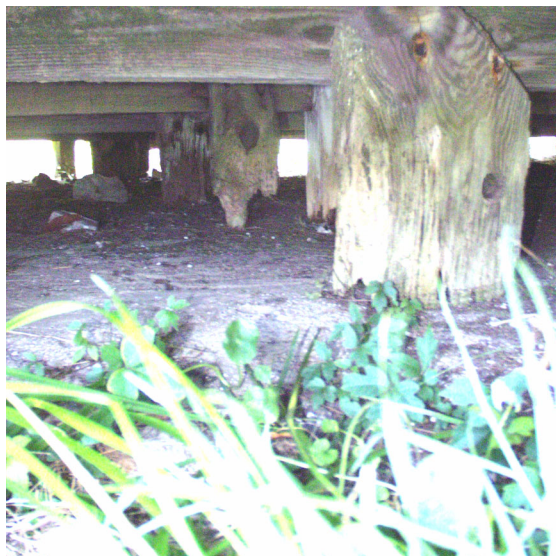
**Figure 2** View of rotted wooden piers that formerly supported floor joists at mid-span. (NPS-SERO-CRS, 2002)

The wood frame of the main body of the house is within inches of the ground, with the sills set on a series of wooden piers, 8" - 12" in diameter, sunk to some indeterminate depth into the ground. Most are, at best, in fair condition, and concrete block have been inserted at some locations to provide additional support.

- Replace all piers, replicating size and placement of originals.

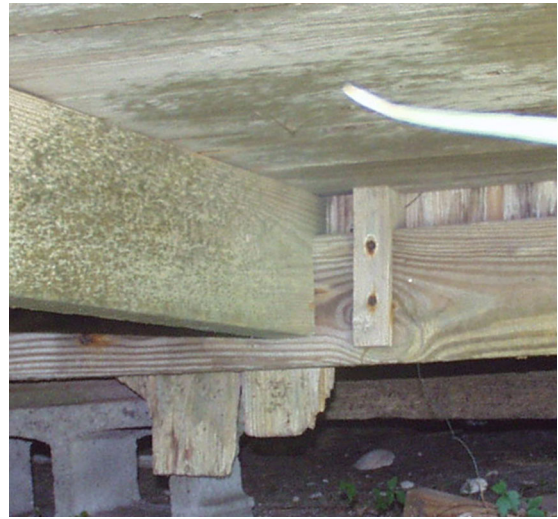
*Floors:* Original floor joists are generally 2" by 6- 1/2" (actual dimension), set on 32" centers. Single 2" by 6- 1/2" boards form the perimeter sills of the original house. As noted above, the mid- span supports for these joists have rotted, which has left the floor system unstable. In addition there has been severe sill damage at several locations, especially on the northeast side of the house.

**Figure 3** View of front sill of house and typical joist and stud connections. (NPS-SERO-CRS, 2002)

- Reduce span of joists and rafters by adding intermediate members.
- Repair termite- damaged and/or rotted sills and other framing elements as necessary.
- Reconstruct original porches.
- Restore original roof line.

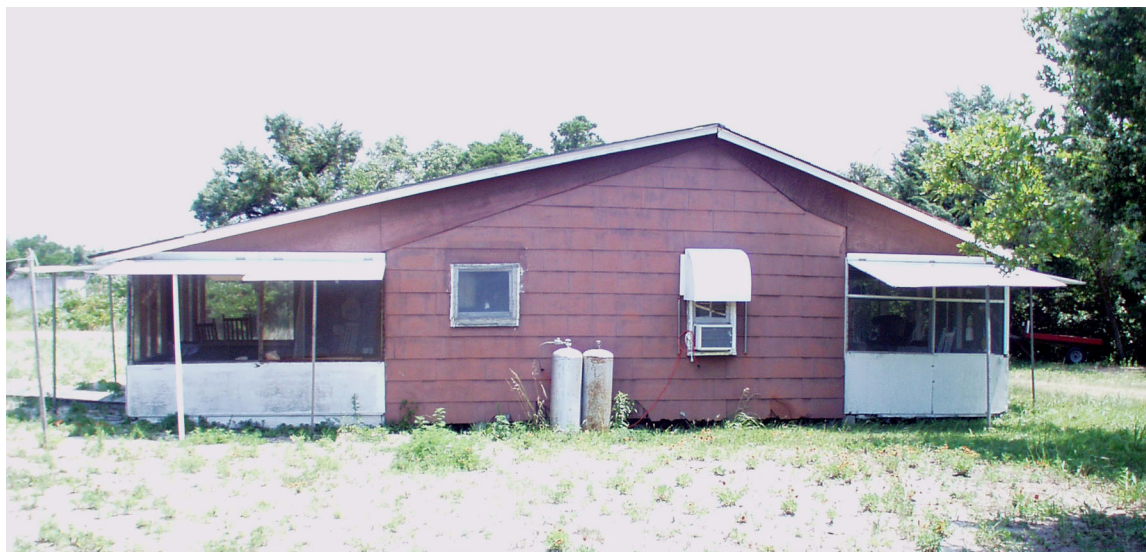
**Figure 5** View of southwest side of house, showing line of original roof prior to installation of present roof after 1976. (NPS-SERO-CRS, 2002)

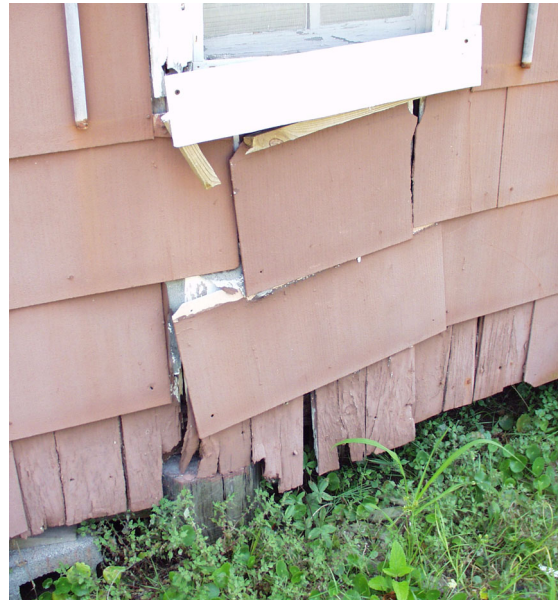
The building was originally finished with vertical siding, 3/4" thick and 5" wide, tongue and groove. It is not clear if battens were used originally. If battens were present, they were removed when the present asbestos-cement siding was installed, probably in the 1950s. This siding, originally white but now painted pink, is installed over "tar paper" sheeting nailed to the original vertical board siding. Most of the asbestos siding is in good condition, although there are isolated areas where shingles are broken and/or partially missing.

**Figure 6** View of damaged siding on northeast side of house, the result of major sill damage in this location. Original board siding is exposed across bottom of wall. (NPS-SERO-CRS, 2002)

- Remove asbestos siding, reusing or stockpiling the shingles.
- Repair and preserve underlying tongue- and- groove siding.
