East Feed Lot/Warren Hereford Ranch

Introduction

EXISTING CONDITIONS INVENTORY
WARREN HEREFORD RANCH
 OBJECTS, SMALL-SCALE & MISSING FEATURES
 GRANT-KOHRNS RANCH NATIONAL HISTORIC SITE

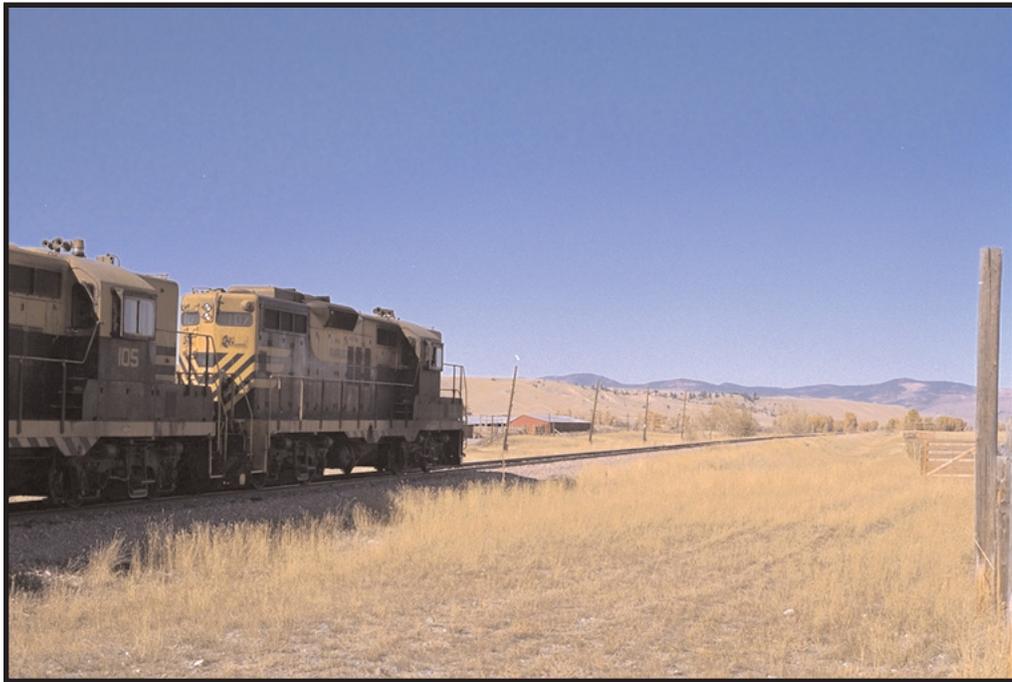
Photo 3-2-1 : (RQ-23) The topography within the Warren-Hereford Ranch is generally flat. The dominant grade changes occur to the west of the corrals, where a drainage swale occurs along the railroad corridor.

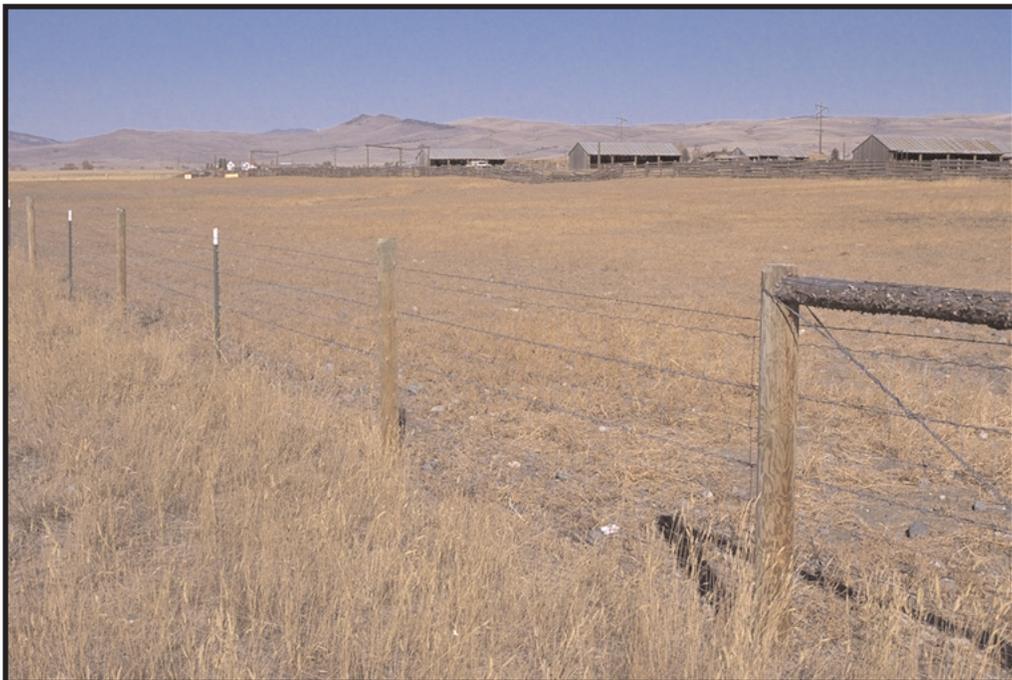
Pasture grasses comprise all the vegetation within this complex (see Photo 3-2-2), and provide food for the grazing livestock contained there. Because these corrals have been so heavily impacted by livestock, the species composition is a mix of native and non-native grasses and forbs. A detailed breakdown of vegetation species is not available for this area.

Photo 3-2-2 : (RQ-22) Pasture grasses comprise all the vegetation within this complex, and provide food for grazing livestock.

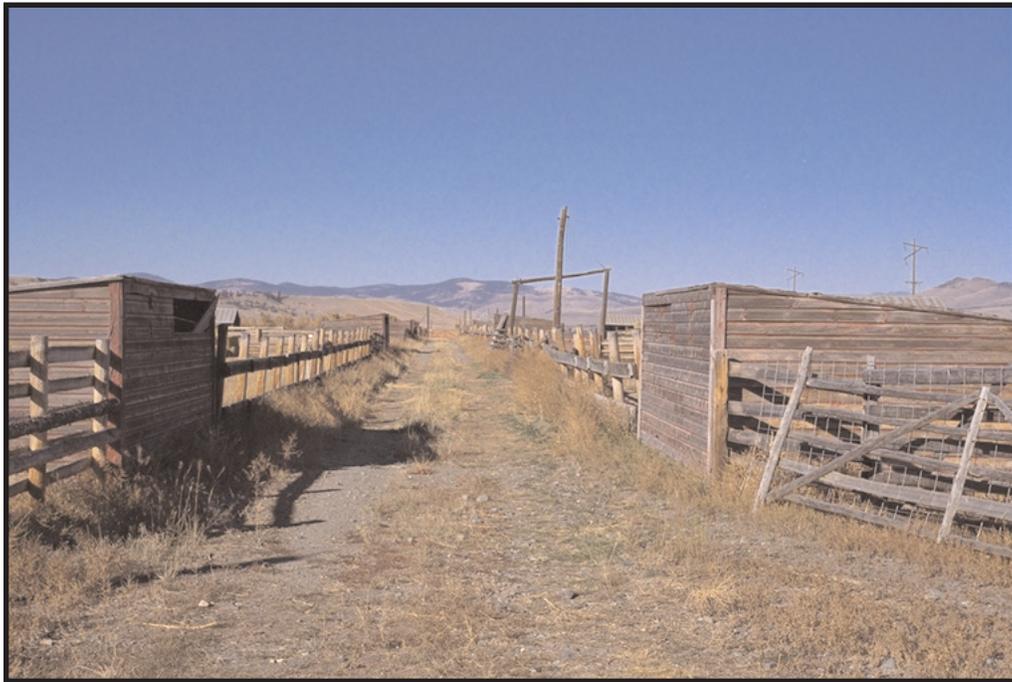
Photo 3-2-3 : (RL-07) The feed lot corral complex is organized by two alleys; the one shown here is located along the central axis.

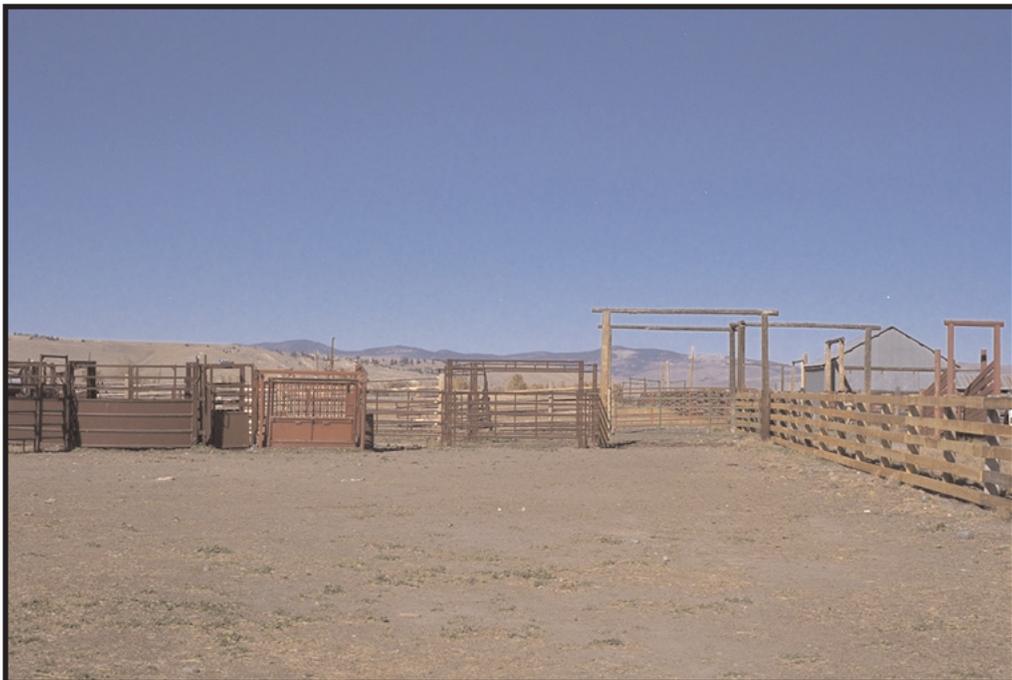
Photo 3-2-4 : (RR-22) One corral contains a squeeze chute and feed rack, and serves as staging area for moving cattle from the feedlots onto trucks or trailers, and vice versa.

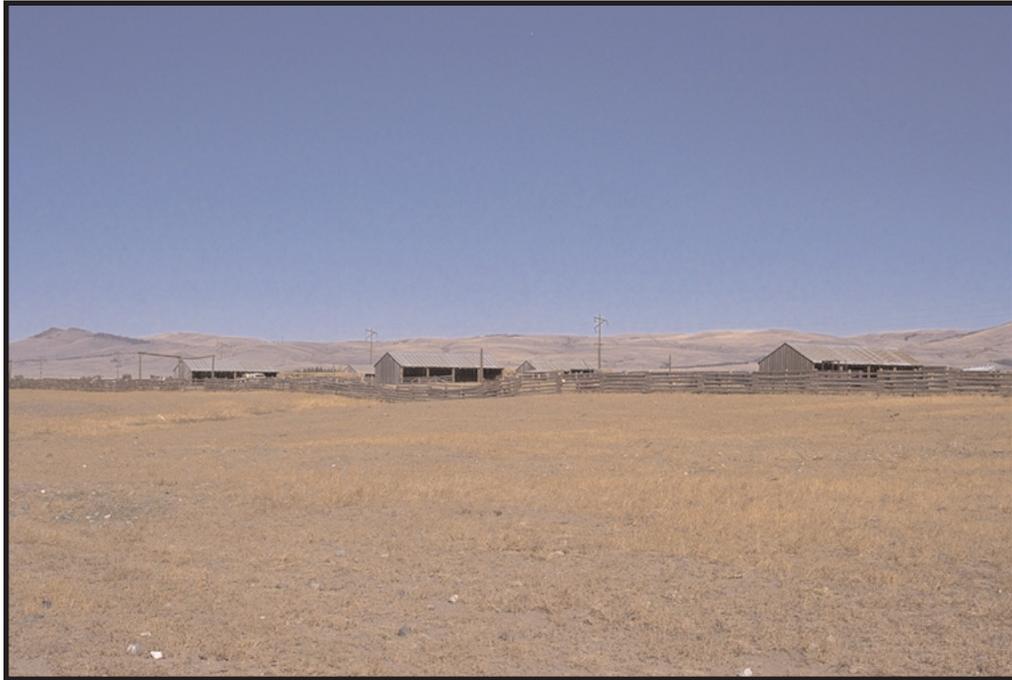
Photo 3-2-5 : (RQ-19) Northwest corral in feed lot complex.

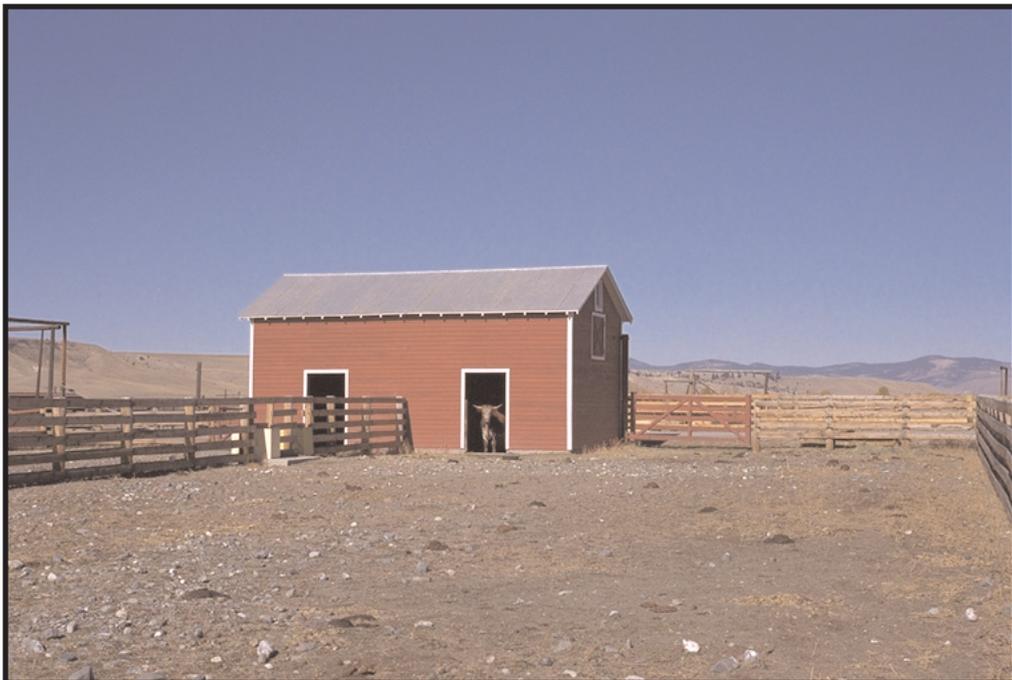
Two identical **Bull Barns** (HS-62 and 63), (see Photo 3-2-6) are located directly east of the railroad grade and northwest of the Warren home. The barns used to house Warren's prize Hereford bulls. They are two-story, rectangular, wood-frame structures constructed on poured concrete foundations, each approximately 32 feet long, 16 feet wide and 20 feet high. Corrugated metal panels cover the gable roofs and rafter ends are exposed. Red, originally white, 5 1/4" horizontal wood siding sheaths the walls. Each gable-end contains a square, side-hinged hay door with cross bracing and painted metal hardware. A four-light window is centered above each hay door. A central, side-hinged door, flanked by two small windows, is on the north elevation of each barn.

Photo 3-2-6 : (RT-19) Four smaller corrals, each measuring 40' x 15', share access to two bull barns located along the road.

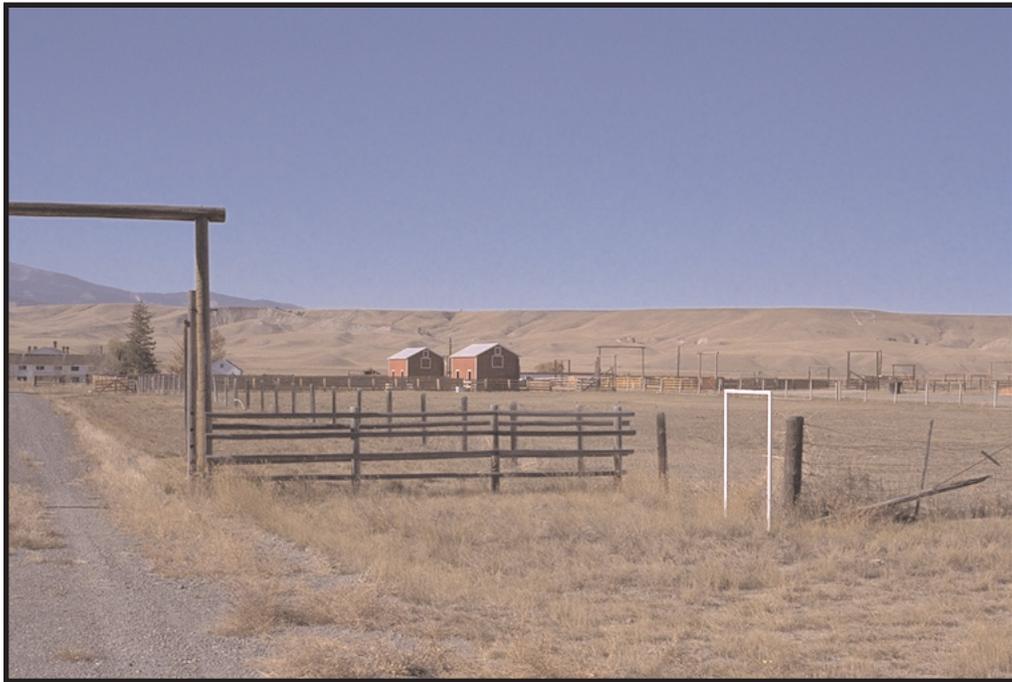
Photo 3-2-7 : (RS-07) The "Whiskey" pasture, named after Con Warren's last horse, is now used for NPS parking, with the west end filled with gravel.

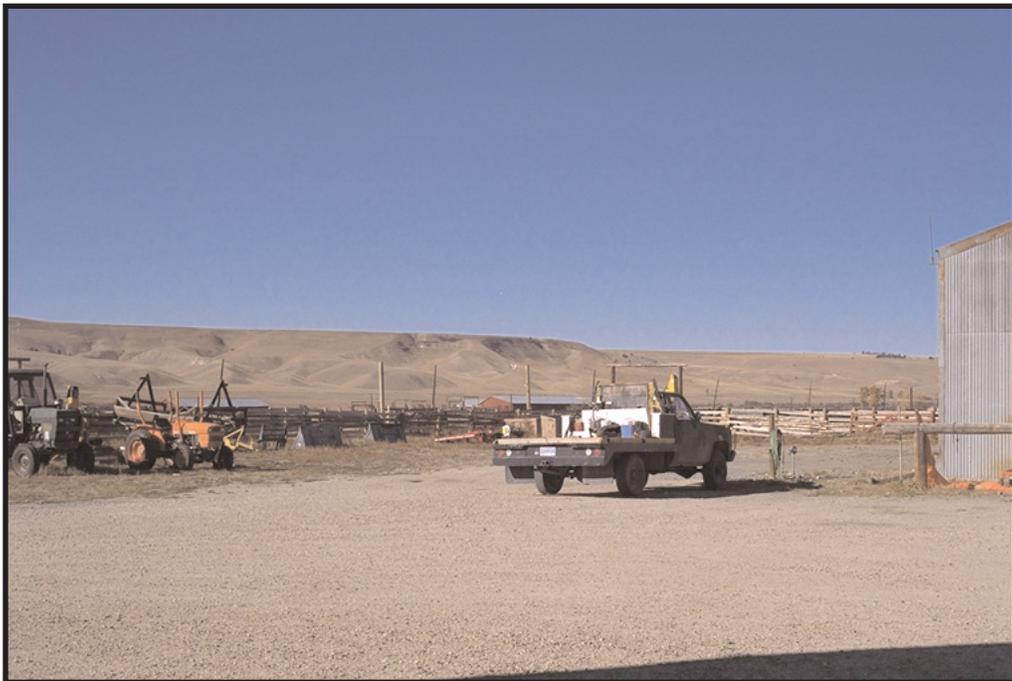
Photo 3-2-8 : (RP-19) The area immediately surrounding the Sales Barn and resource building/office also contains a variety of NPS farm and earthmoving equipment and materials, such as a horse trailer, tractor, backhoes, trucks, wood posts and planks for fencing, and several other pieces of machinery associated with working ranch operations.

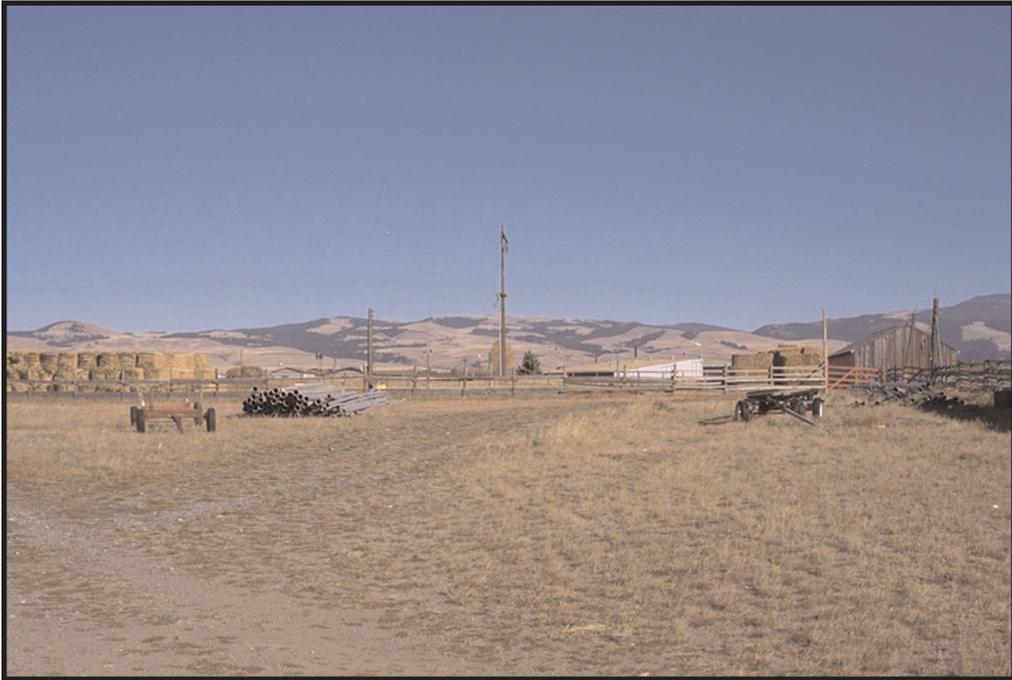
Photo 3-2-9 : (RN-24) The "boneyard," currently serves as a storage area for surplus materials, such as old wood palates, wood and metal fencing materials, a dolly, a chassis, and metal watering troughs. It also contains the hand-irrigation pipes that are assembled to irrigate the fields with water from the effluent ponds.

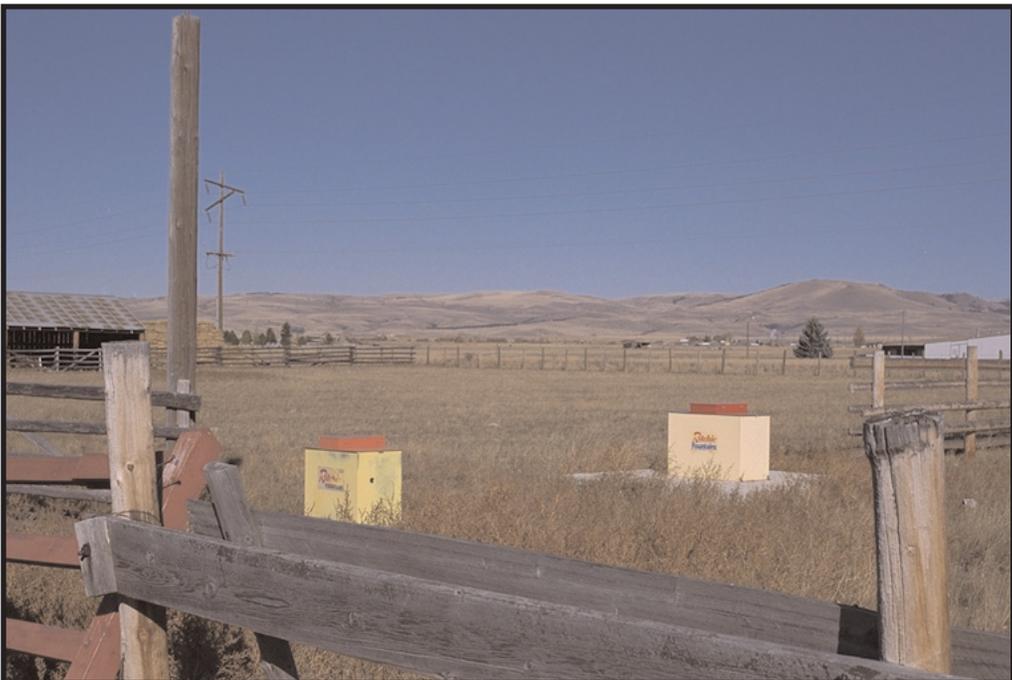
Heated water troughs are located in each of the corrals (see Photo 3-2-10). These “Ritchie Fountains” can be found along shared fence lines between corrals, the shared fence lines of the two bull barns, and in the northeast corner of the west corral. These fountains are approximately 18 inches wide, four feet long, and three feet deep, and each derives its energy source from an underground electrical line. They were added sometime before 1956. In some corrals, the NPS has added a second fountain ca. 1999. Fire hydrants were added ca. 1999, around the same time as the city water connections. There is also enough hand line to irrigate the West Corral with water from the effluent ponds, if necessary. This system was installed by the NPS in 1999 and is described in more detail in the Pasture/Hay Fields section.

Photo 3-2-10 : (RM-15) Heated water troughs, "Ritchie Fountains," are located in each of the corrals.

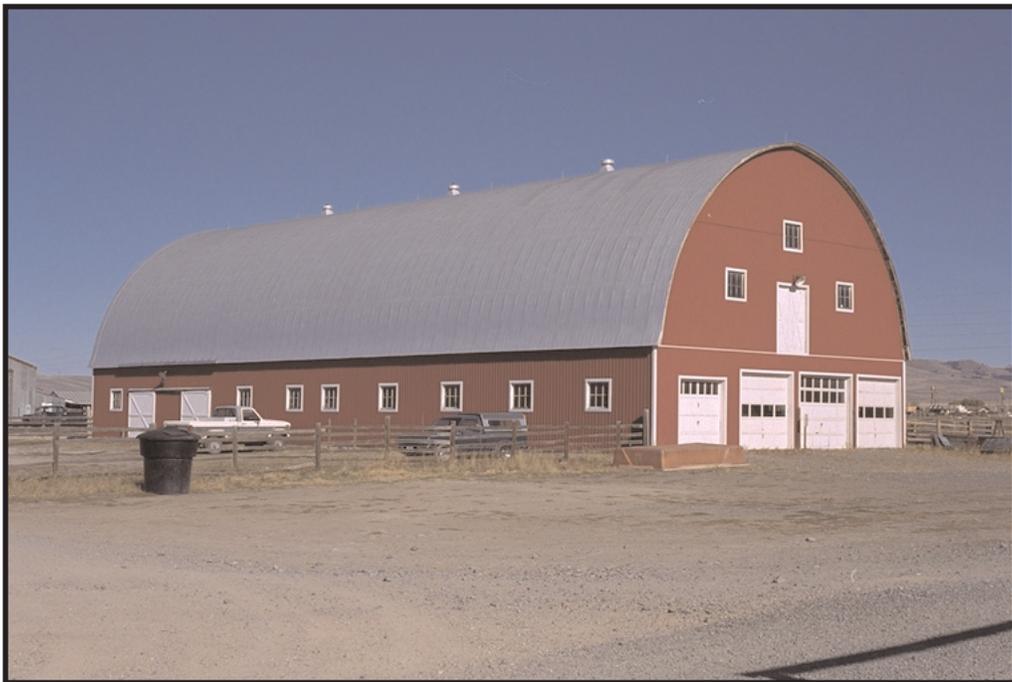
The functional center of Warren's purebred breeding operation lay within the **Warren Barn** (HS-64), (see Photo 3-2-14). This large, two and one-half story, post-and-beam, rectangular barn has a barrel-vault roof formed by large, glue-laminated beams. The roof features 1" by 10" sheathing, corrugated metal roofing, and three metal ventilators. The building is constructed on a concrete slab foundation. In 1972, the original white-painted shiplap siding was covered with red, vertical, anodized, corrugated steel siding. Four multi-light, multi-panel overhead garage doors, three added in 1972, dominate the lower level of the south elevation. At the loft level, the south elevation contains one set of centered, cross-braced, wood-frame double doors. Three hopper windows surround the double-doors: one on either side and one centered above. The north side of the west elevation has two wooden cross-braced sliding doors suspended from a metal rail. Eight multi-light hopper windows are spaced evenly across the west elevation. A multi-light, multi-panel overhead garage door, on the north elevation, is off-center to the east. A pair of wood-frame, cross-braced double doors are off-center to the east at the loft level. Multi-light hopper windows surround the hay doors. Ten multi-light hopper windows are spaced across the east elevation. A centered, wood-frame, side-hinged, cross-braced door provides access to the stall area.

Photo 3-2-14 : (RR-14) Warren Barn (HS-64).

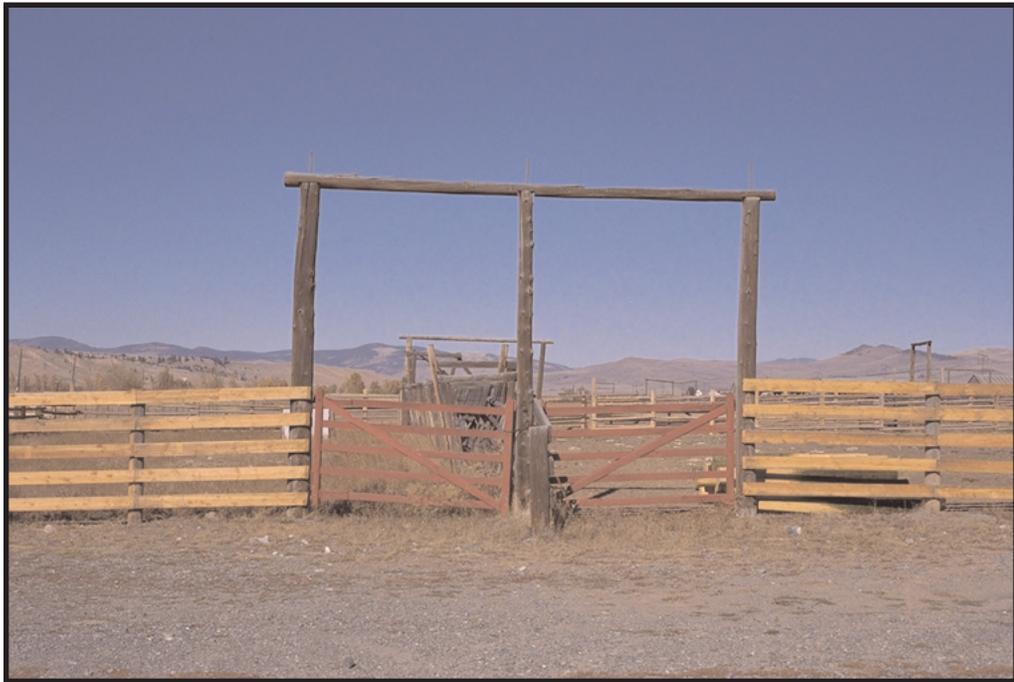
A **Squeeze Chute** (HS-67), (see Photo 3-2-15) and **Feed Rack** (HS-68), (see Photo 3-2-16) are located in the corral north of the Bull Barns and west of the Warren Barn. The squeeze chute is approximately 110' long and is constructed of wood. It was rehabilitated in the 1990s. The feed rack consists of several narrow wood beams crossed close to the bottom of the beams to form a large V pattern at the top while the rack rests on the smaller V. A long wood plank rests in the crux of the larger V to support fodder. As this structure was completely deteriorated, it was reconstructed in 1998.

Photo 3-2-15 : (RQ-01) Squeeze chute behind double gates (HS-67).

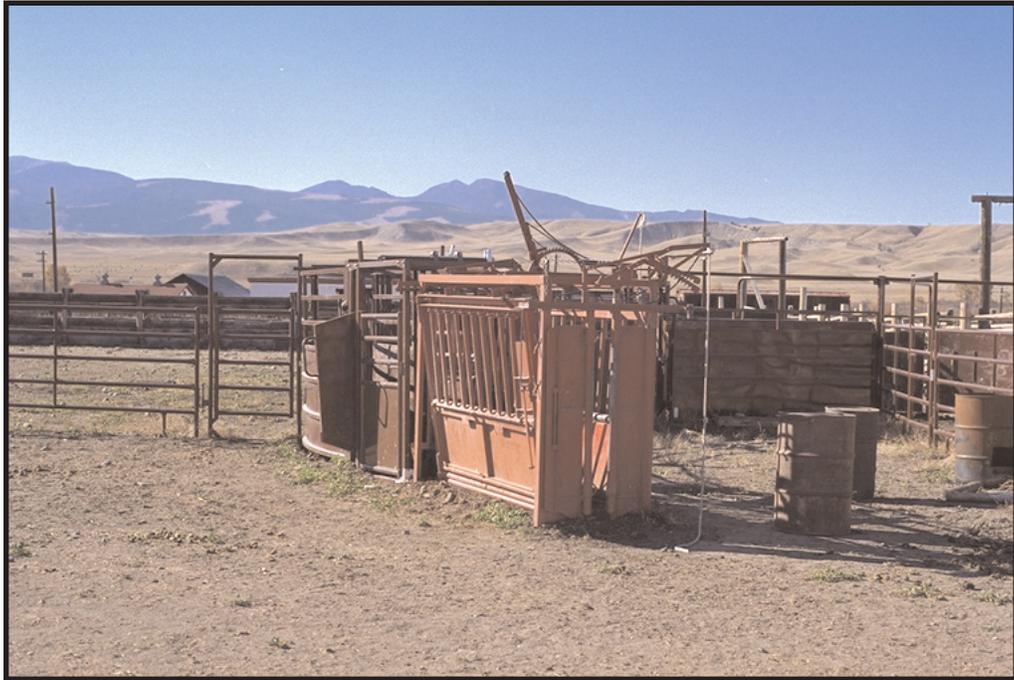
A **Portable Chute System** (see Photo 3-2-17), constructed of sheet metal, square tubing, and round pipe was added by the NPS in 2000 to more safely and efficiently control the movements of animals. It is dark brown in color and is a completely portable structure. The chute ends consist of sliding metal doors. Each side consists of a row of vertical metal posts resting on a metal wall. The animals enter one end from a corral and are released through the other into a narrow passageway leading to a second corral. This portable chute is used instead of the existing historic squeeze chute (HS-67) for animal and staff safety.²

Photo 3-2-17 : (RP-03) Metal squeeze chute.

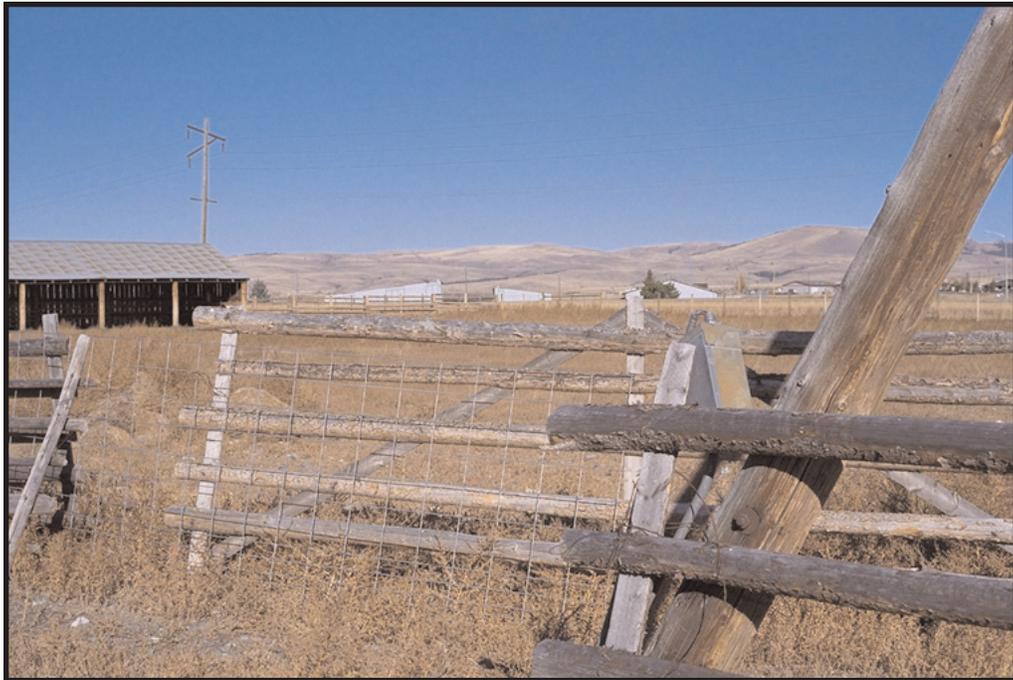
While Hog Wire fence is also made of woven wire, it is never referred to as such. Hog wire fencing is comprised of individual “panels” and is occasionally used as a quick fix around the ranch. All the wire is of the same size and stands up by itself with the help of a few wire ties to hold the posts in place.

Photo 3-2-27 : (RL-9) Hogwire panel (NPS quick fencing fix).

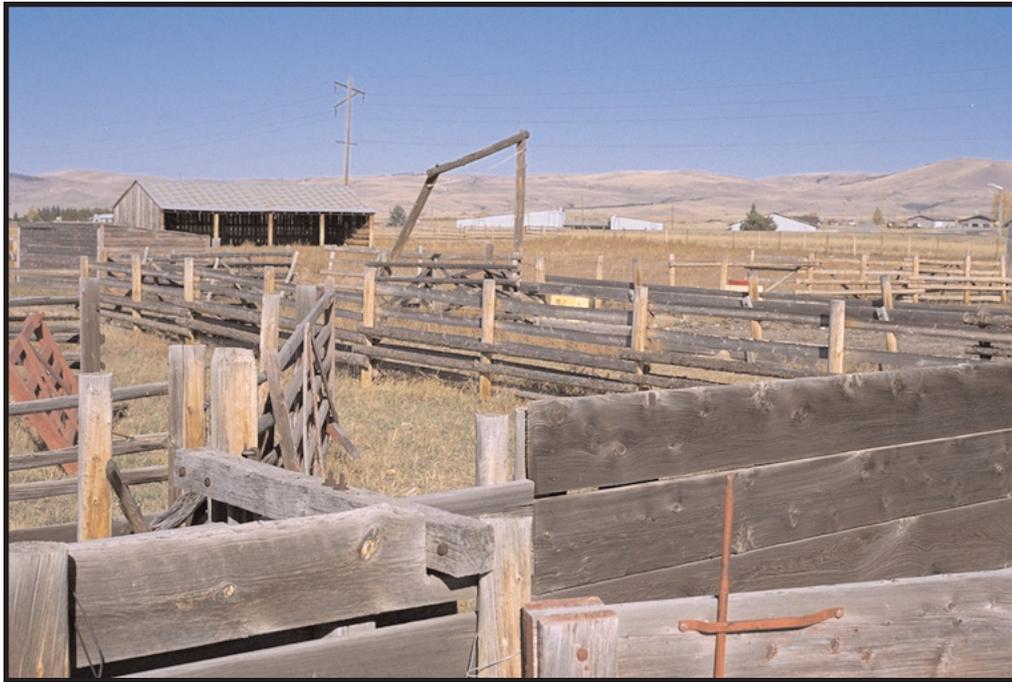
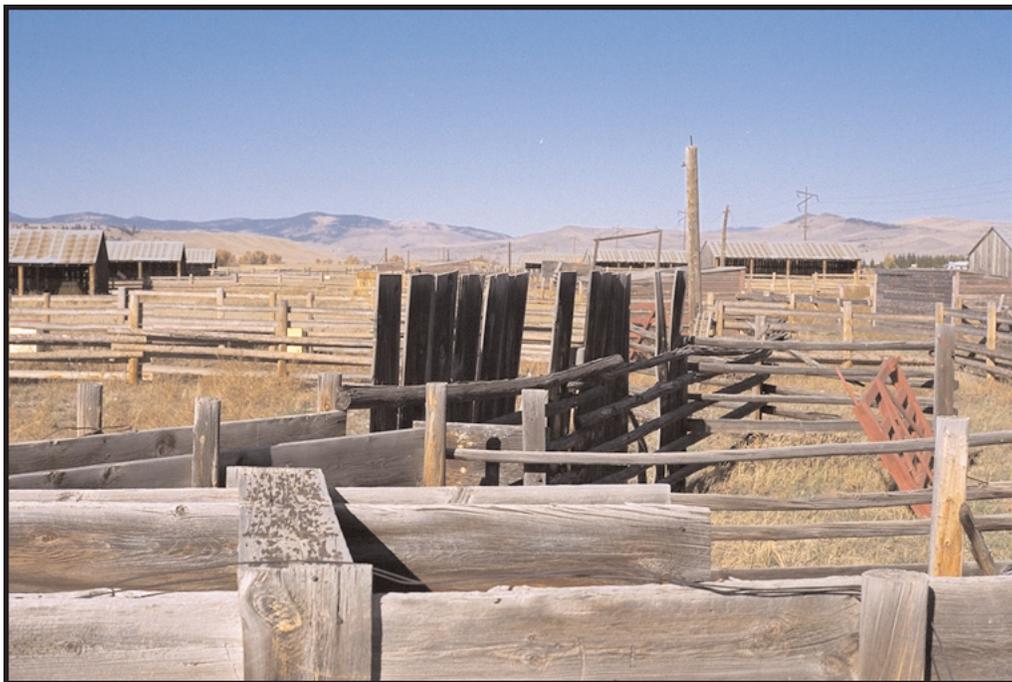
East of the Sales Barn is a complex **system of wood chutes and gates** that were used during the auctions (see Photos 3-2-29 and 3-2-30). This system contains a wide variety of different fence types, to include plank and post fence, 5-rail locked end fence, 5-rail stacked end fence, and a unique chute structure that consists of flat rails stacked horizontally to the inside of a pair of round wood posts. In some areas, the sides of this structure are braced by a wooden plank that spans the approximate three foot space in between the rails. These chutes and gates were observed to be in poor condition at the time of the field visit.

Photo 3-2-29 : (RO-4) Complex system of fences and gates once used for auction.

Photo 3-2-30 : (RO-3) Complex system of fences and gates once used for auction.

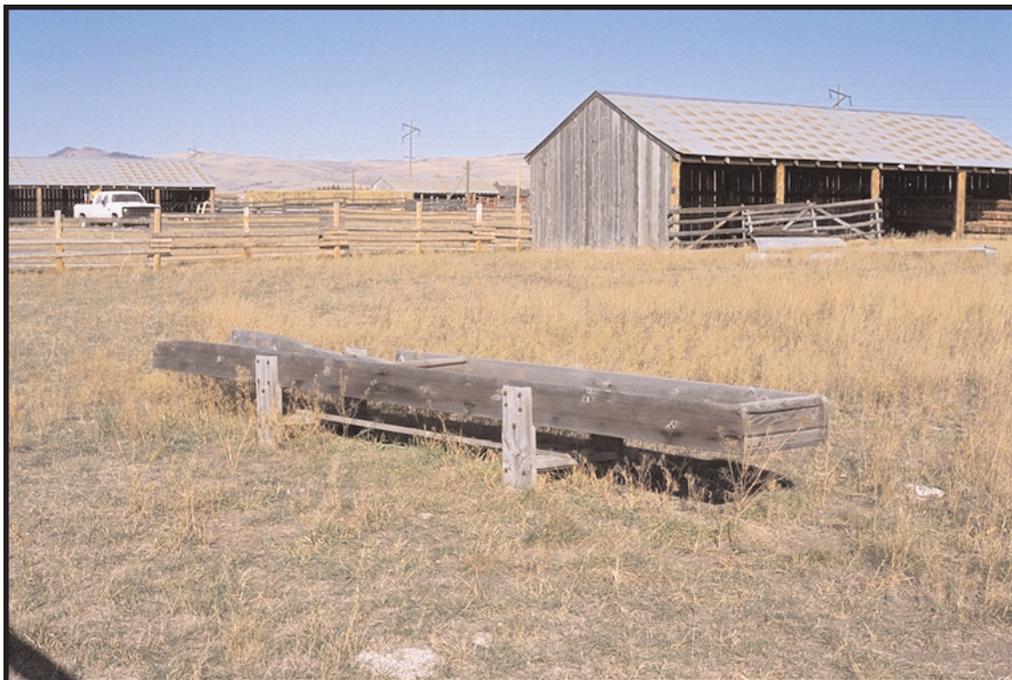
A **wooden trough** is located in one of the feed lots, south of B-75 (see Photo 3-2-34). This small structure is constructed of wood planks on three sides (with some metal components), and is open on one end. Approximately six inches deep, it is supported by four wooden posts, braced on the bottom with a horizontal plank. A small piece of wood appears to divide the trough in half. This trough is typical of those built and used by Warren in the feed lot area. There used to be one in each corral.³

Photo 3-2-34 : (RN-12) Wooden Trough.
