Completion Report

Tusayan Museum, Grand Canyon N P

The project consisted of replacing or repairing all of the viga ends on the Tusayan Museum.

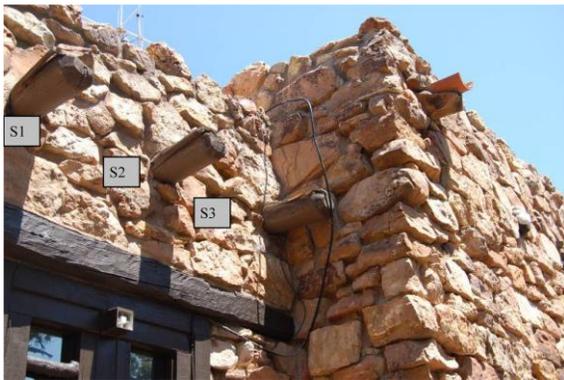
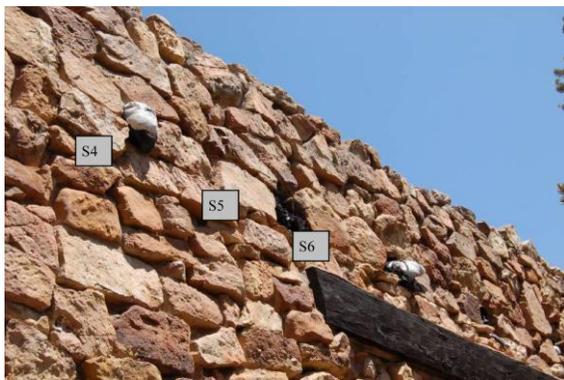
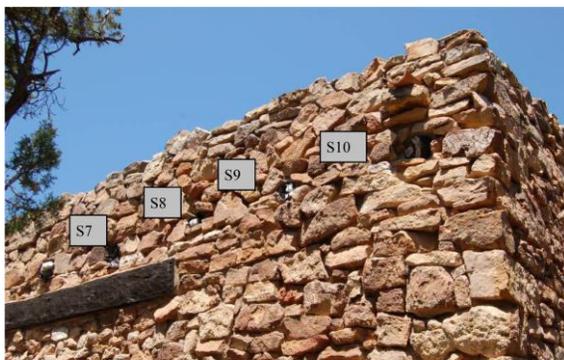
In order to identify the viga ends, the viga ends were numbered from left to right facing the building and labeled with an N for north (the front) and S for south (the back) (See key below).

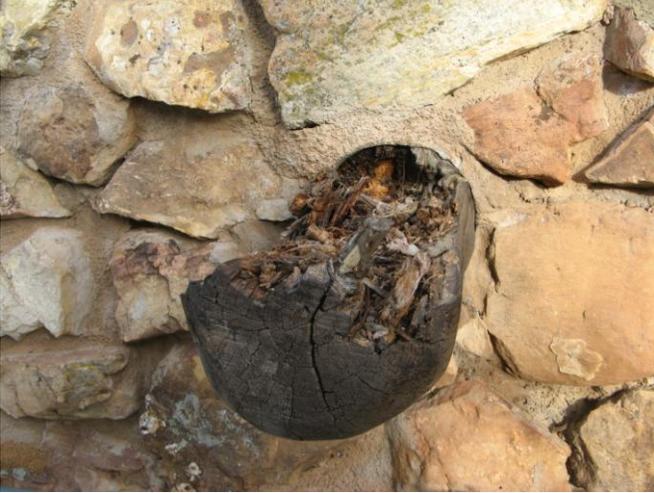
Typical of derivatives of the Spanish Colonial style in the American Southwest, the viga roof supports on the structure protrude beyond the exterior wall, exposing the viga ends to the elements. Replacing the viga ends has been necessary several times throughout the buildings life. A majority of the viga ends were replaced in 1987, however three original viga ends, number N1, N4 and N7, still remain. All viga ends required treatment, whether replacement, Dutchman repairs or consolidation.

Viga ends prior to preservation

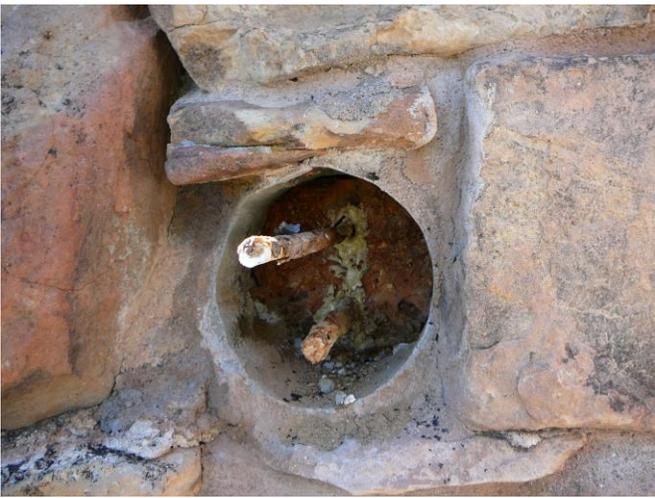
Borate impel rods

Vigas S3, S4 and S11 were approached in the same manner. For vigas S3 and S4, the remaining log was cut off flush with the outside of the building. The wood for all three vigas was then removed to a depth of around 6 inches inside the wall using large drill bits and an angle grinder with a special grinding wheel. Once the wood was removed, the end inside the wall was stabilized with an epoxe consolidant to protect the rest of the viga. Holes were drilled and Borate impel rods were installed at 11 and 2 o'clock one inch in from the outside surface of the log end. A hole was drilled and the impel rod inserted into the hole, which was then plugged. Finally, two pieces of fibertglass rebar were situated vertically two inches in from the top and bottom of the logs, drilled twelve inches into the remaining log and twelve inches into the viga end. The new viga ends were then epoxied in place. This technique of inserting Borate impel rods and fiberglass was used on all viga end replacements as a precautinary measure to protect the log

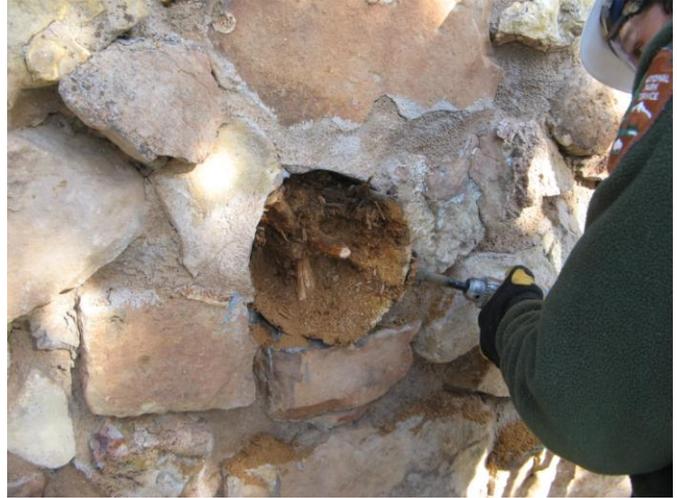
Removing rotted viga end

Vigas S1 and S4 had their rotten 1987 replacement ends removed, and the old fiberglass rebar was cut off and new ends were glued on using the above mentioned technique. The hole for vigas S5 through S10, which had been removed earlier, were cleaned out and the old fiberglass rebar was cut off. New viga ends were attached using the fiberglass rebar and epoxy method. Viga S1 through S4 were finished with the "Beaver Cut" finish using an ax, and vigas S5 through S11 were sized to the holes left and cut at random lengths to match the front. They were finished with a round profile also using an ax.

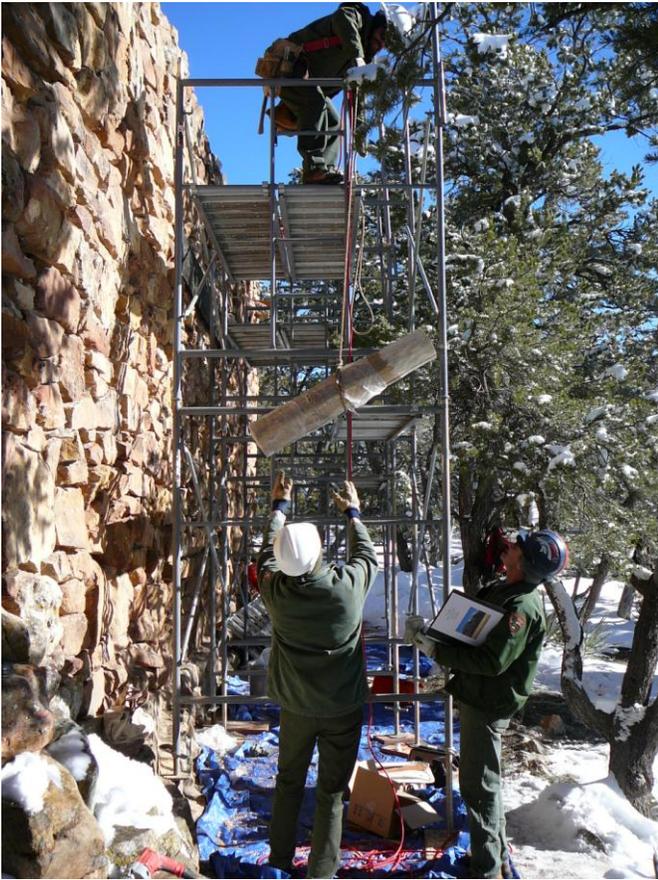
Raising viga end replacements

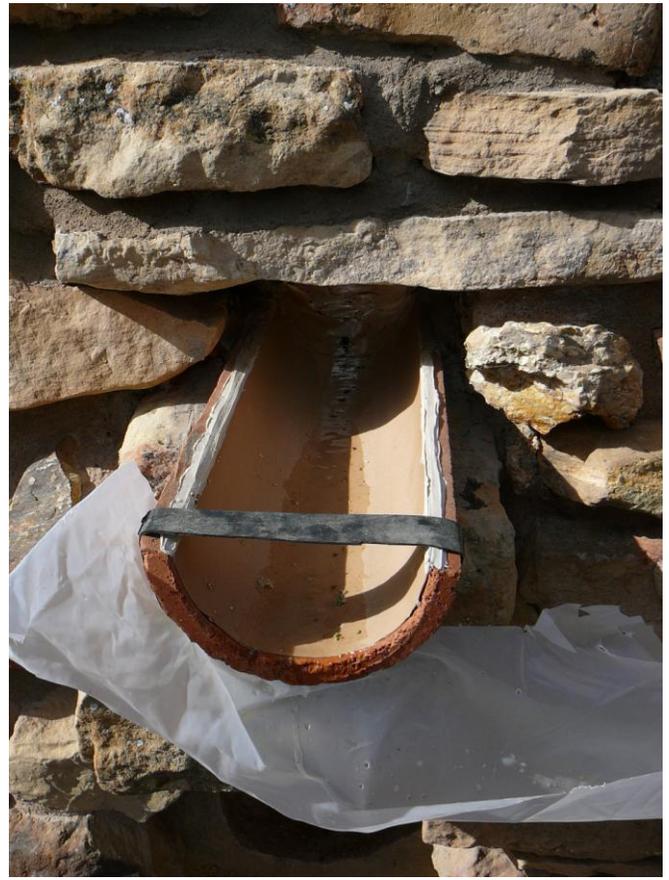
On the south side of the building, vigas S1 and S4 were rotting more than half way through the log, despite having been replaced in 1987. Dutchman half log repairs done in 1987 on vigas S2 and S3 were failing, rotten and split, exposing the rest of the log to further deterioration. Vigas S5 through S10, which were also replaced in 1987, had been removed some time later in an attempt to mitigate a leaking roof. The holes had been plugged with sandbags, hardware, cloth and plastic, and the roof was repaired and a vinyl membrane installed. When the roof was repaired, the canales were extended with clay half pipe, which directed water over S11 and near S5. Viga end S11, not replaced in 1987, was rotten three inches inside the wall. At some point S11 was cut flush with the outside wall, and the canale was directing dripping water directly on it, expediting deterioration.

Canaly at east SE

In order to address the rotting viga ends, a number of approaches were utilized. On the south side of the building, extension flashing was installed to redirect water past viga S5 and S11. The flashing was constructed of heavy gauge copper and glued in under the vinyl using PL400 construction adhesive.

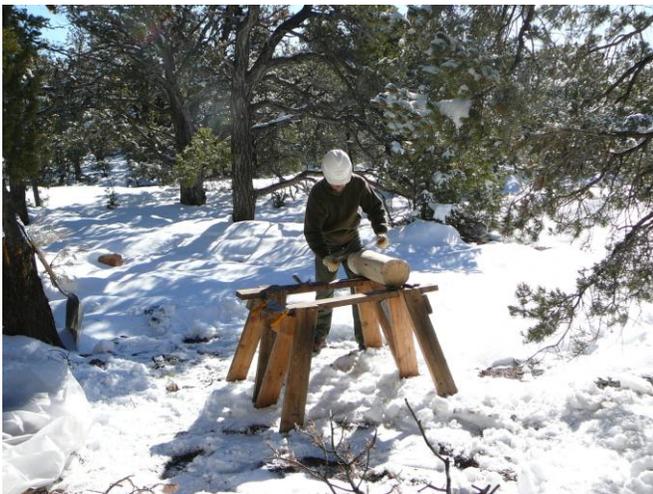
Shaping viga ends

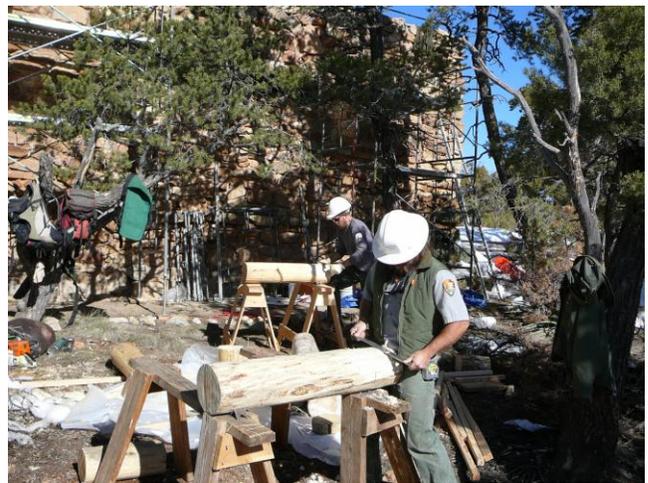
Shaping viga ends

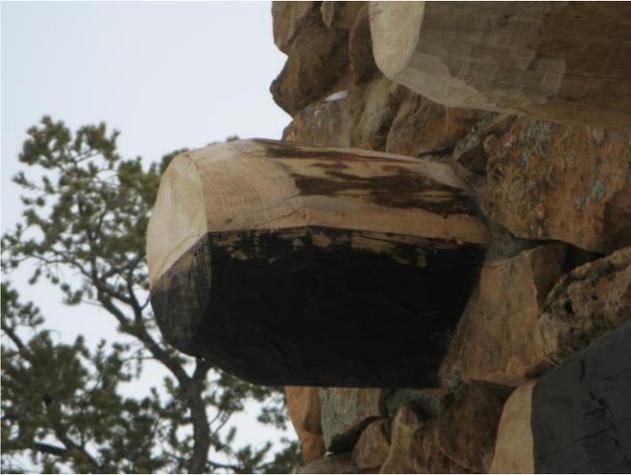
Dutchman half log repair, rounded end

replacement was appropriate. The Dutchman repair consisted of cutting away the top half of the log and removing the wood to 4 inches inside the wall. A new top half to the log was fitted, and the log half was fitted to a hair line glue joint on the horizontal plane. The Dutchman half log repairs allowed the vertical seam to be hidden inside of the wall. The log replacement top was then glued in place using epoxy and fiberglass rebar located in the ends of the wood and one in the flat plane.

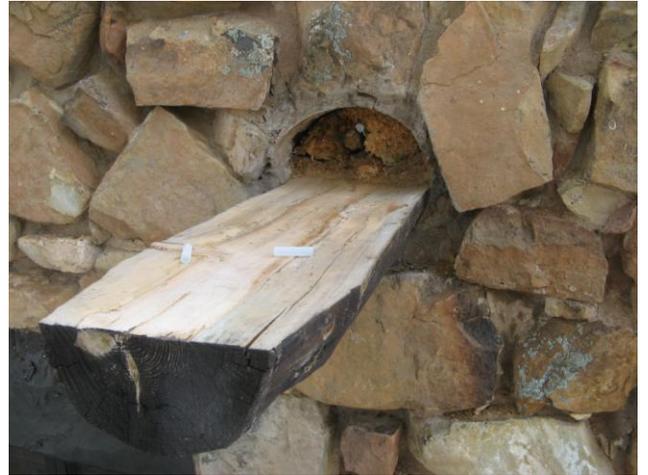
Dutchman half log repair in progress

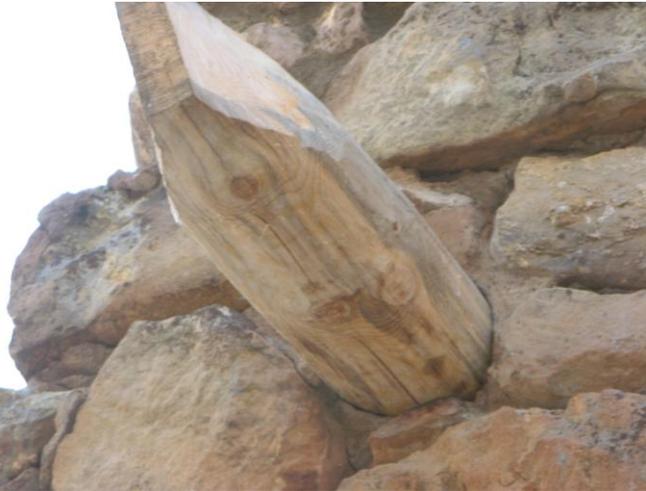
Complete replacement, "beaver cut" end

The ends of the vigas on the north side were finished to replicate the existing viga ends. Vigas N1 through N6 were rounded using an ax, and vigas N7 through N10 were cut using the "Beaver Cut" style, also done with an ax.

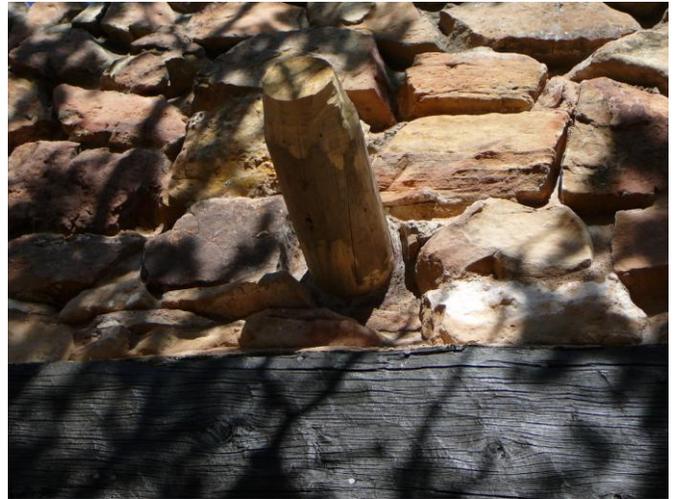
Complete replacement, rounded end

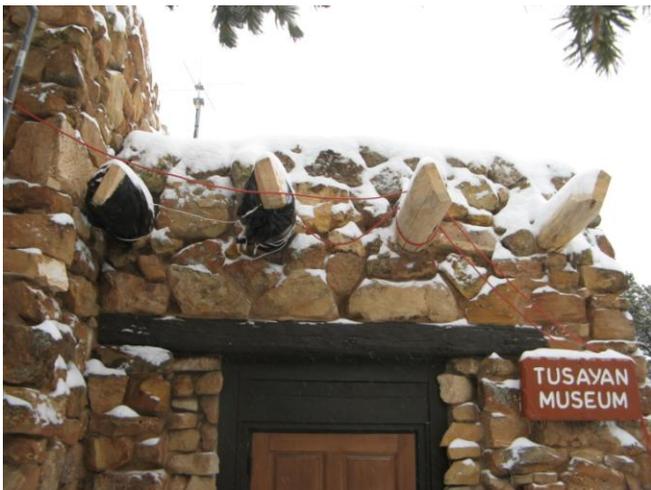
Heating pads over the viga ends

GRCA supplied the heating pads that were used each night to heat the viga ends, allowing them to set up.

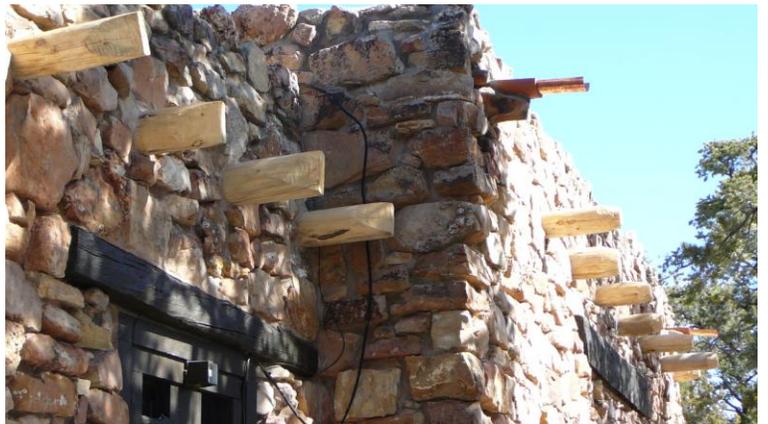
Completed preservation

All of the new vigas were left untreated in order to allow the viga ends to weather for a season or two before any preservative is added, allowing the wood to darken to match the originals that were left. The staff at GRCA will determine what preservative and finish will be applied in the future, but the Western Center for Historic Preservation recommends X100 wood preservative.
