# **Summary Report on Hydrologic-Related Issues for Lyndon B. Johnson National Historical Park**

**June 2008**

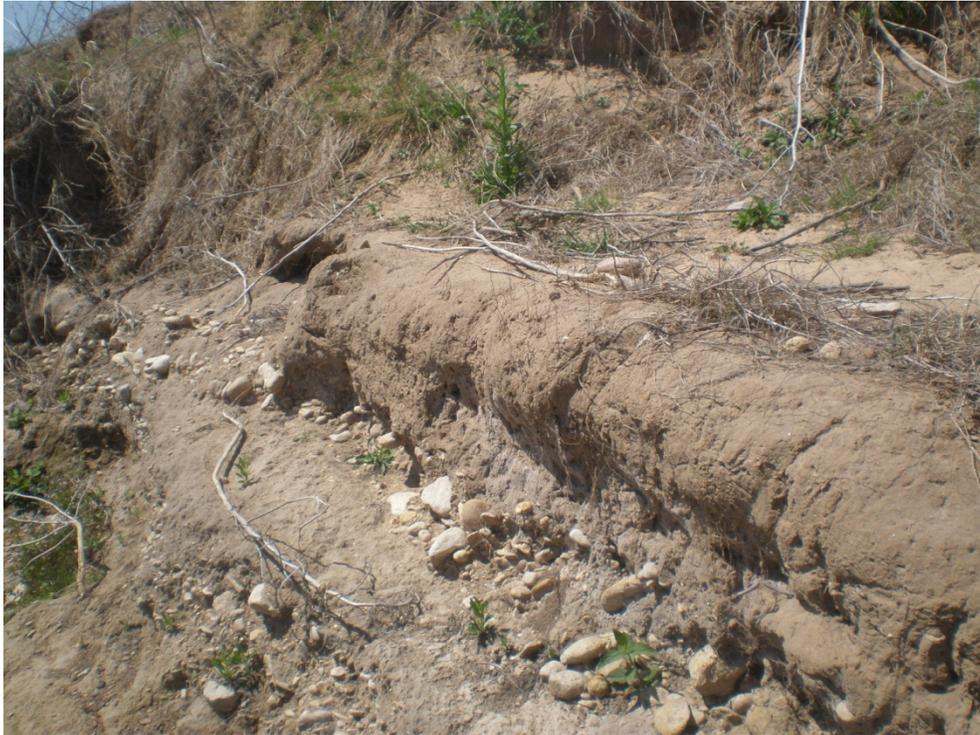
fine sand in the upper profile with some pebbles and cobbles in a sandy matrix at depth (**Figure 1**). Overall, the exposed soil profile appeared to be very non-cohesive and, therefore, susceptible to erosion. Both upstream and downstream of the park, the topsoil has been eroded from the underlying bedrock on the left (north) bank of the river.

**Figure 1** – Exposed bank of river showing general composition of alluvial material

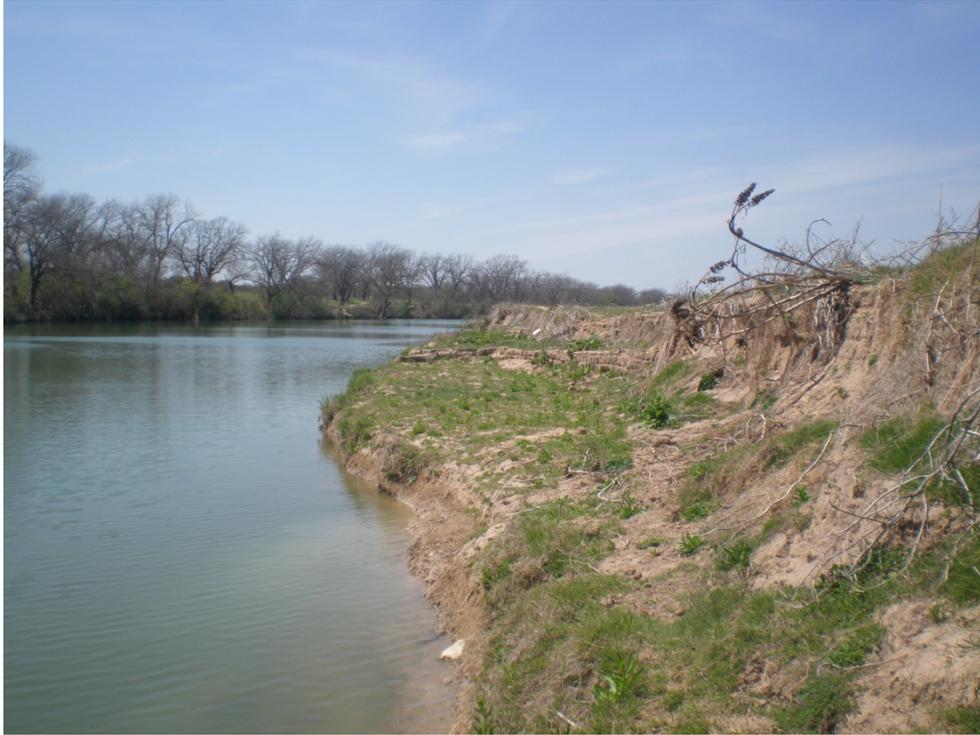
The whole suite of riparian benefits would not be achieved with the restoration of only a thin strip; however, the very important benefit of bank stabilization may be accomplished or at least increased. Presently, long reaches of the north bank of the river within LYJO are unvegetated and near vertical, periodically experiencing erosion during high flows (**Figure 2**). Because even a thin corridor of woody and herbaceous riparian vegetation could realize benefits of streambank stabilization and improve the overall appearance of the bank, we recommend considering restoring the riparian corridor, at least within the context of the Core Period.

**Figure 2** – View of the Pedernales River looking upstream and contrasting the north bank (foreground) and the south bank (upper left). Note the thin yet well developed riparian corridor on the south bank and the almost total lack of vegetation on the north bank.

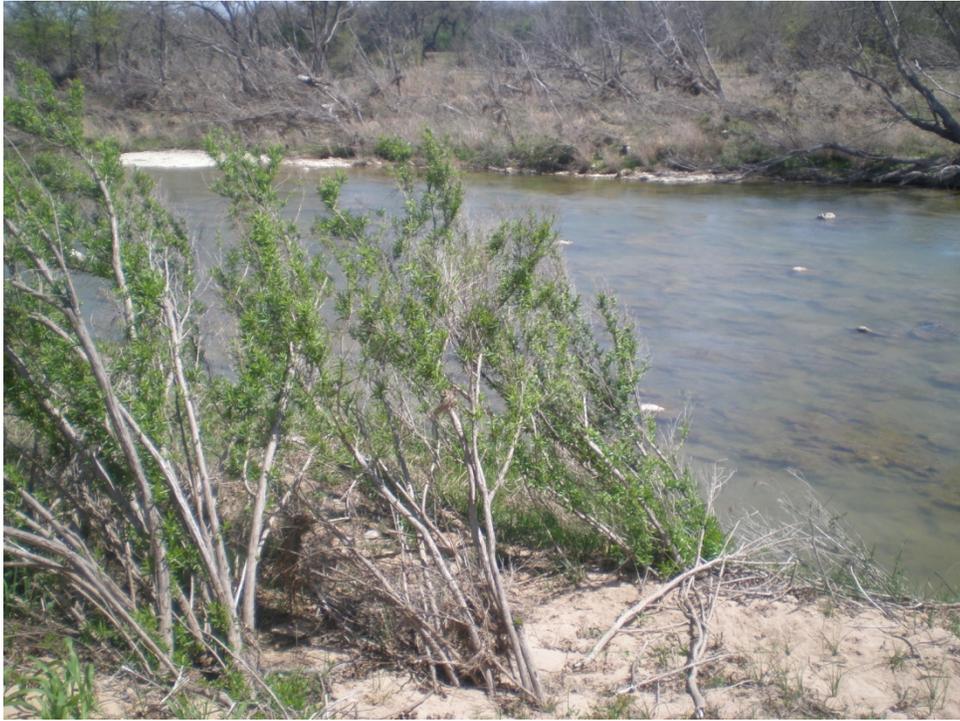
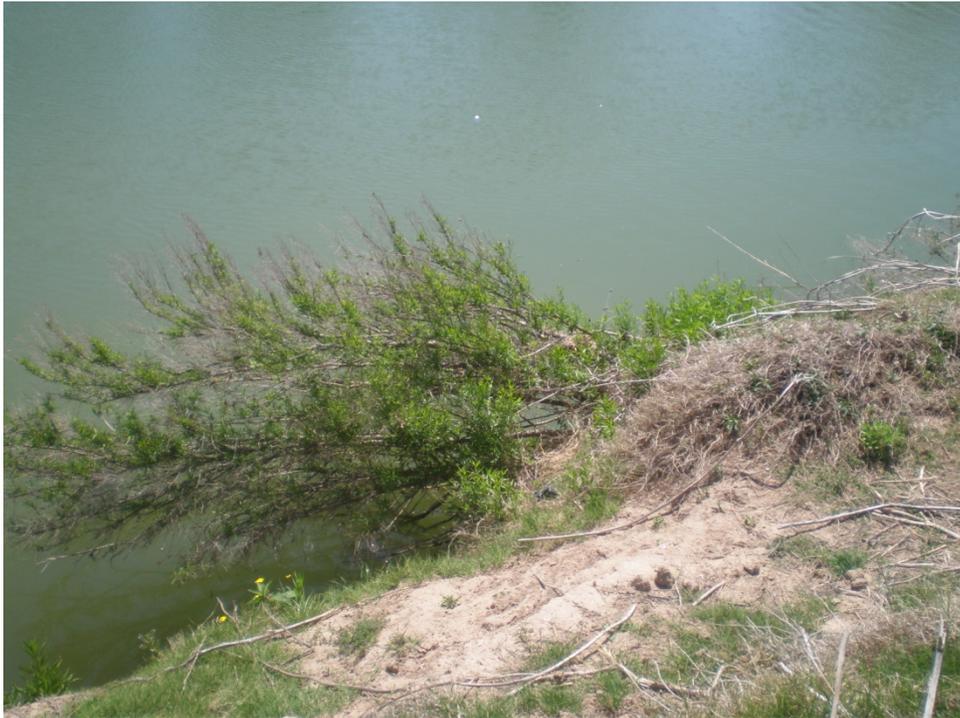
**Figure 3** – Two views of some of the sparse woody vegetation present on the north bank. The presence of these naturally occurring stands suggests restoration of a more extensive corridor is possible.

Several approaches to restoring the riparian could be considered. The most simple would be to encourage natural re-vegetation by eliminating any activities that could inhibit growth, such as mowing, grazing, and/or herbicide application. Of course, exotic species, like the castor bean, would need to be managed. During the site visit, we observed some woody species on the river bank, suggesting natural re-establishment may be possible (**Figure 3**).

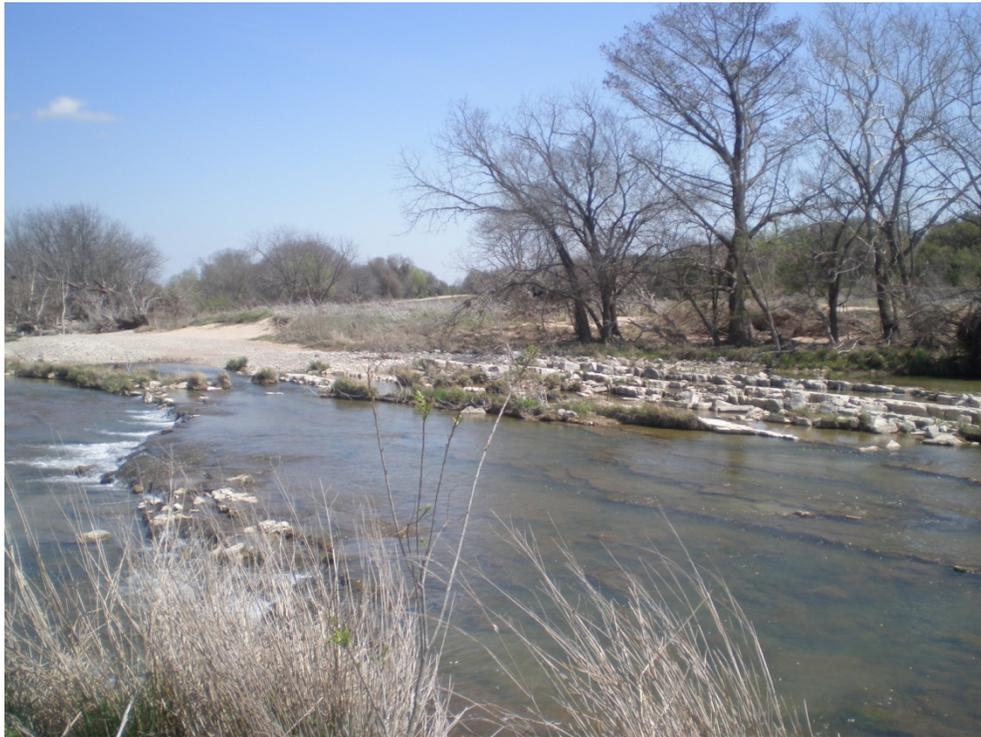
Another issue related to floodflows and riparian management that has been considered in the past is the removal of trees and sediment on the right (south) bank, across from the Junction School. The idea is that “opening up” the entire channel to floodflows would reduce the velocity in the vicinity of the Junction School. This short reach of the river is fairly complex from a hydraulic standpoint. Not only is there a well developed stand of trees, which serves as a substantial resistance to flow, but there is a dipping bedrock outcrop in the channel, which creates a channel slope in the direction of the school (**Figure 4**). Additionally complicating the hydraulics is a highway bridge downstream of the school that likely creates a substantial backwater effect during larger flows. We would suggest that prior to endorsing the removal of relatively rare

**Figure 4** – Bedrock outcrops in the channel just upstream from the Junction School. Note how the configuration of the bedrock creates a “cross-channel” slope towards the left bank, the one supporting the school.

riparian habitat, a more comprehensive hydraulic analyses be conducted. If this is ever seriously considered, WRD would be able to undertake such an analysis on behalf of the park.
