THE CAPTAIN WILLIAM SMITH HOUSE

HISTORIC STRUCTURE REPORT

Minute Man National Historical Park
Lincoln, Massachusetts

December 2007

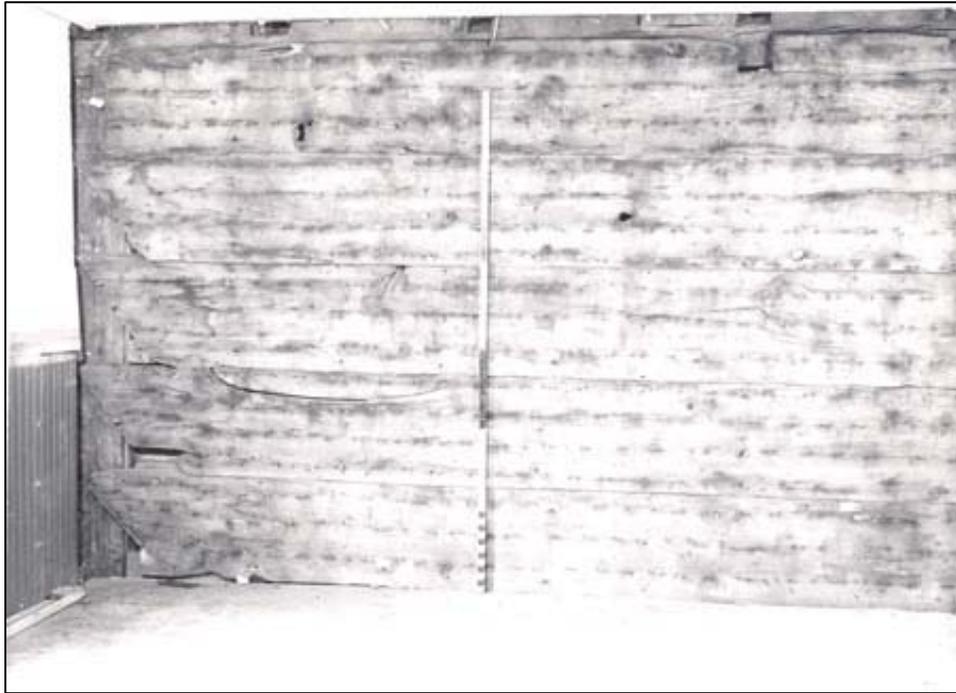
Figure 43. Ca.- 1900 Addition: Second- story east room, looking south at north (formerly exterior) wall of main house, showing original wall boards removed ca. 1900 and replaced in 1980.

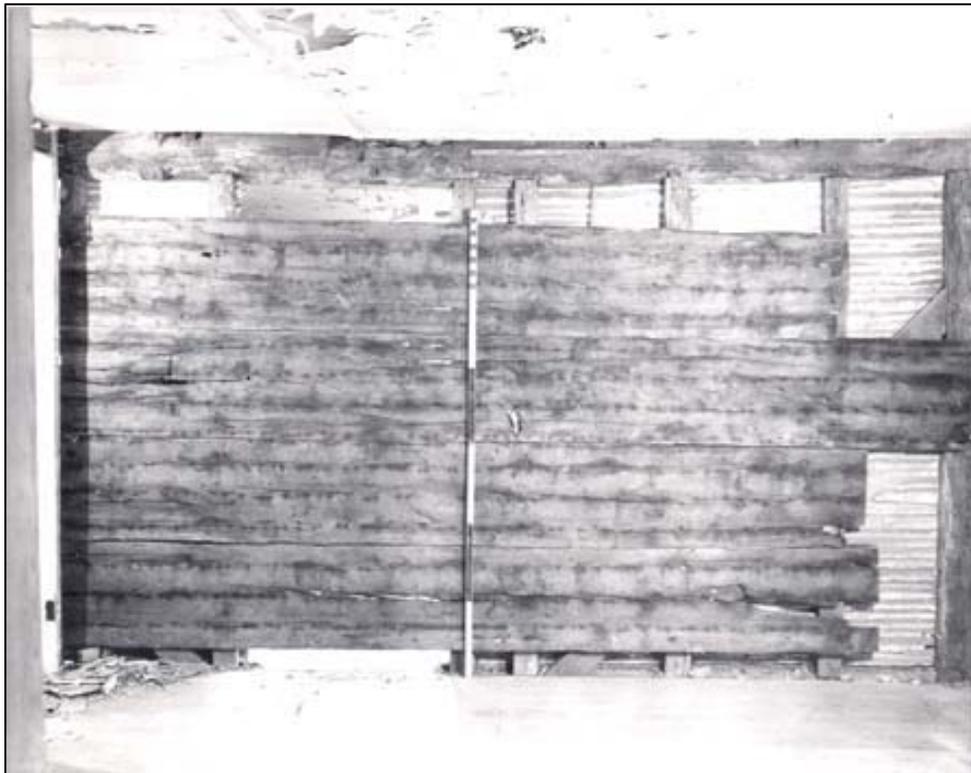
Figure 44. Ca.- 1900 Addition: Second- story west room, looking south at north (formerly exterior) wall of main house, showing original wall boards removed ca. 1900 and replaced in 1980.

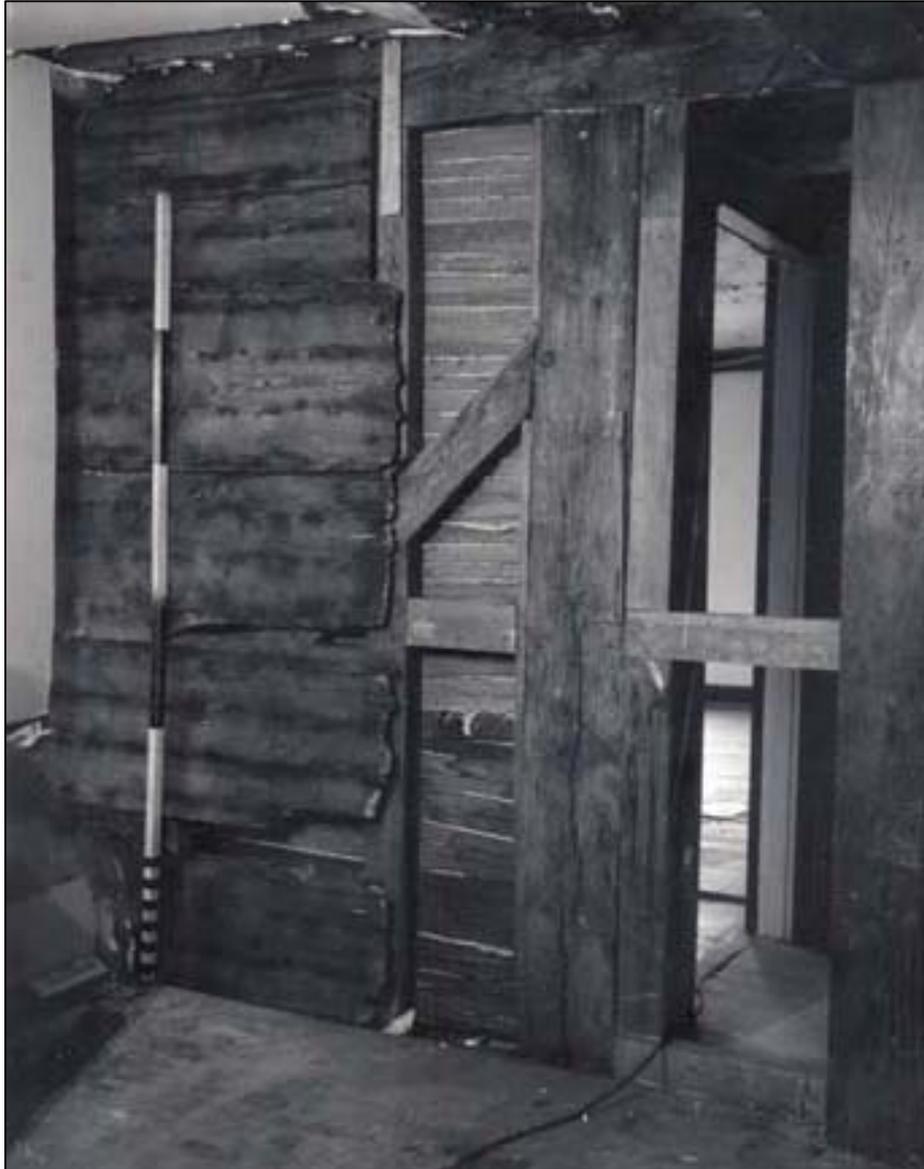
Figure 45. Ca.- 1900 Addition: Second- story center room, looking south at north (formerly exterior) wall of main house, showing original wall boards with lapped ends, removed ca. 1900 and replaced in 1980.

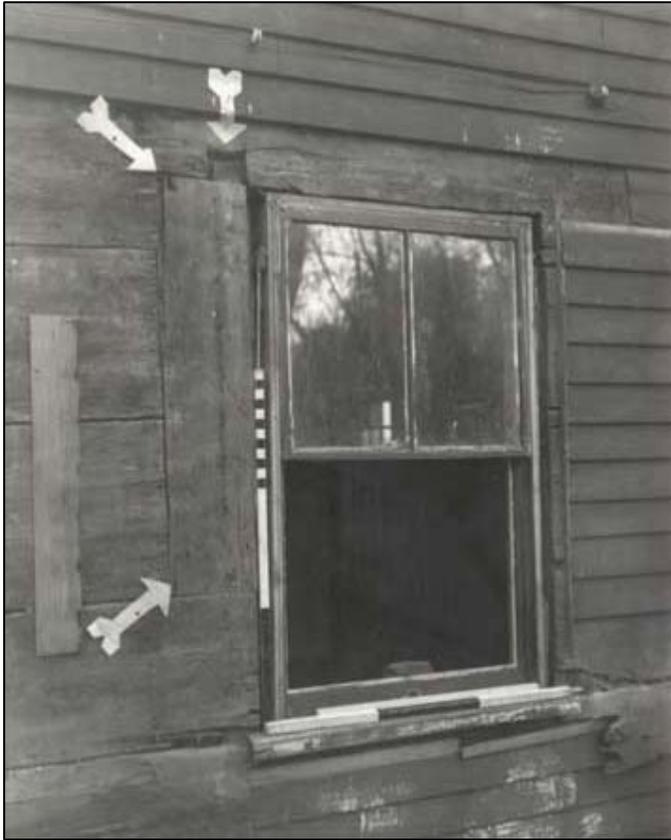
Figure 46. Main House:
West exterior wall, showing
West Parlor window; arrows
point to head and sill of ca.-
1692 window opening.

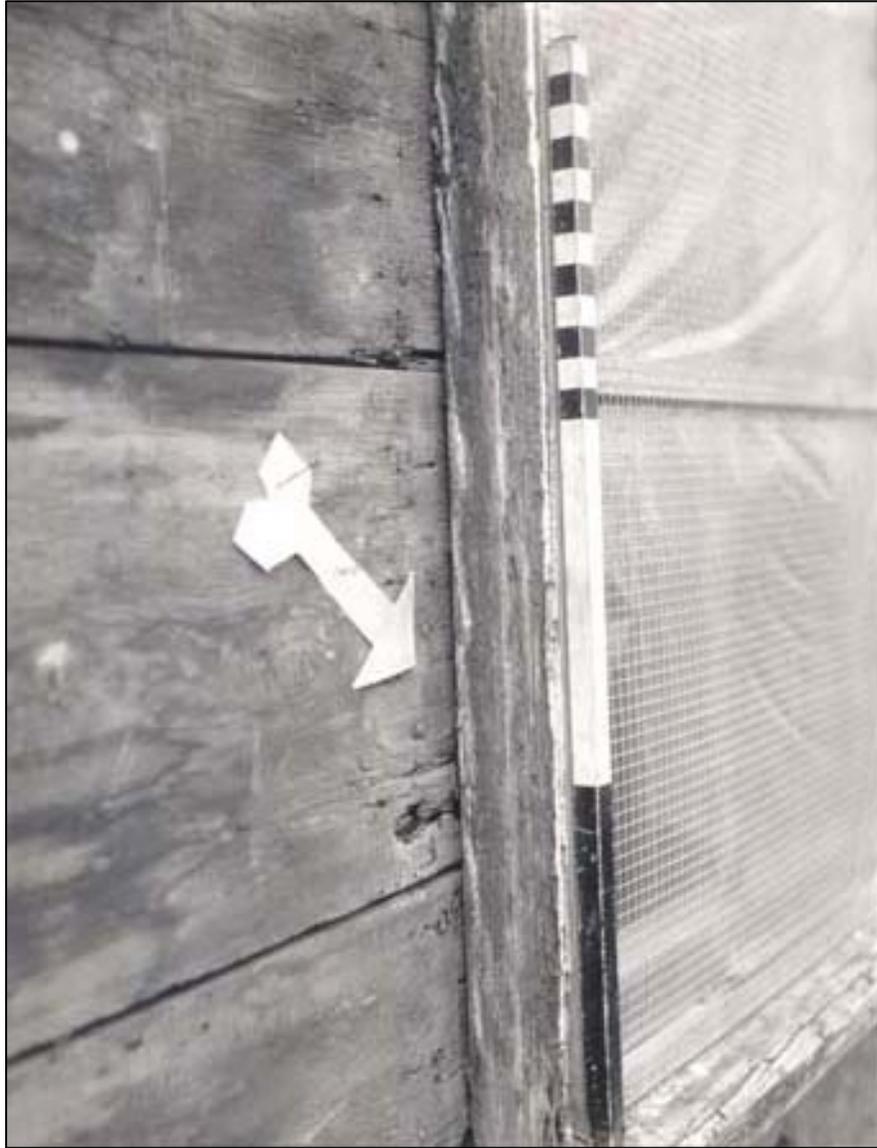
Figure 50. Main House: East exterior wall, showing East Chamber window; arrow points to outline of ca.- 1692 window sill, jamb.

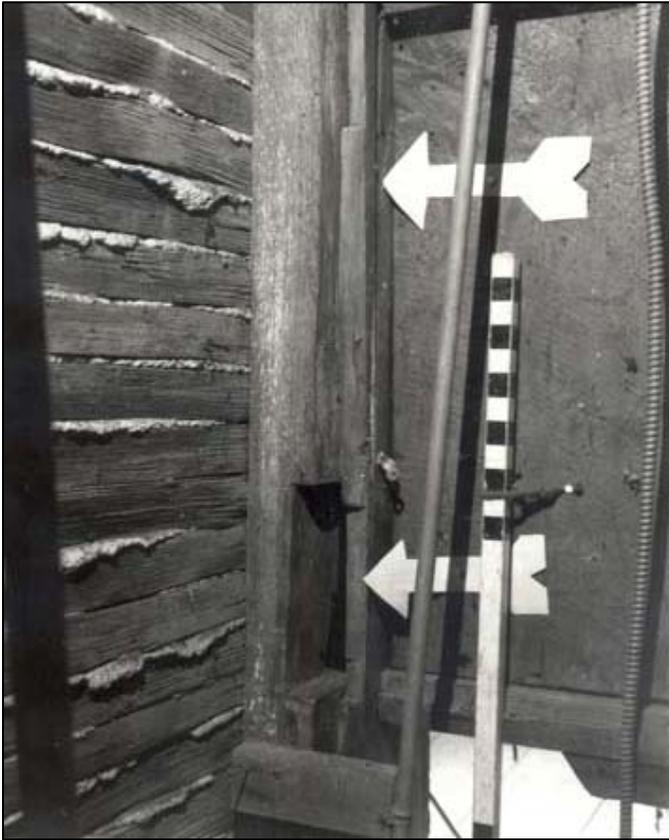
Figure 60. Main House: Former central chimney area, looking east at backside of fireplace wall of West Chamber; arrows point to evidence of missing, possibly original cove soffit (top) and mantelshelf (bottom).

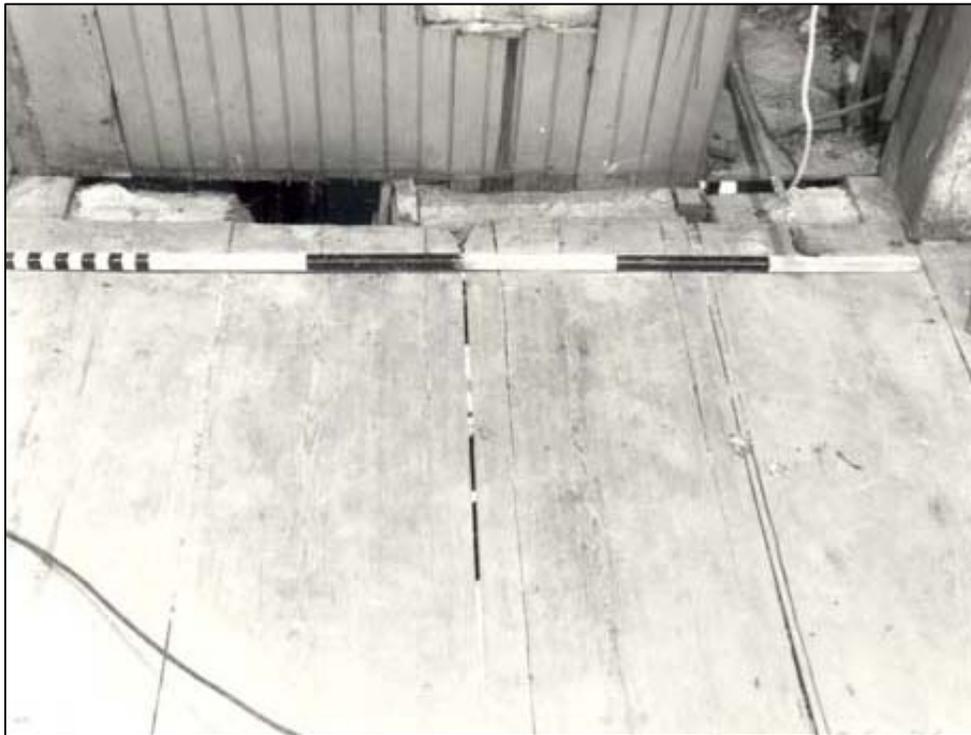
Figure 61. Main House: West Chamber, east wall, evidence of the ca.- 1692 hearth.

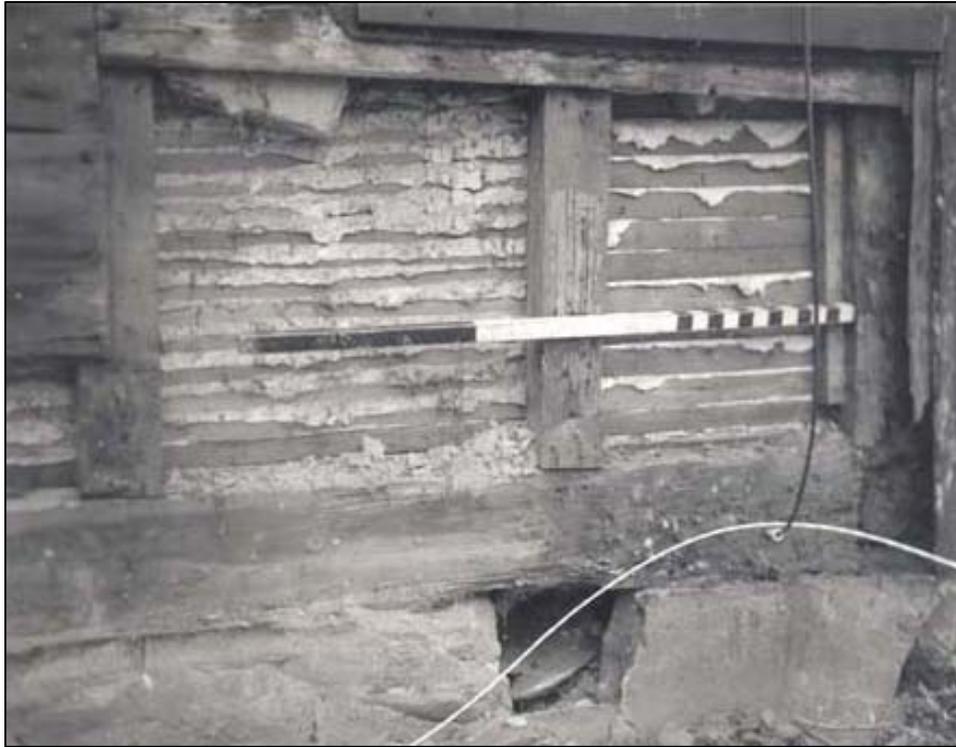
Figure 78. Main House: West wall, south corner, showing west sill replaced ca. 1825.

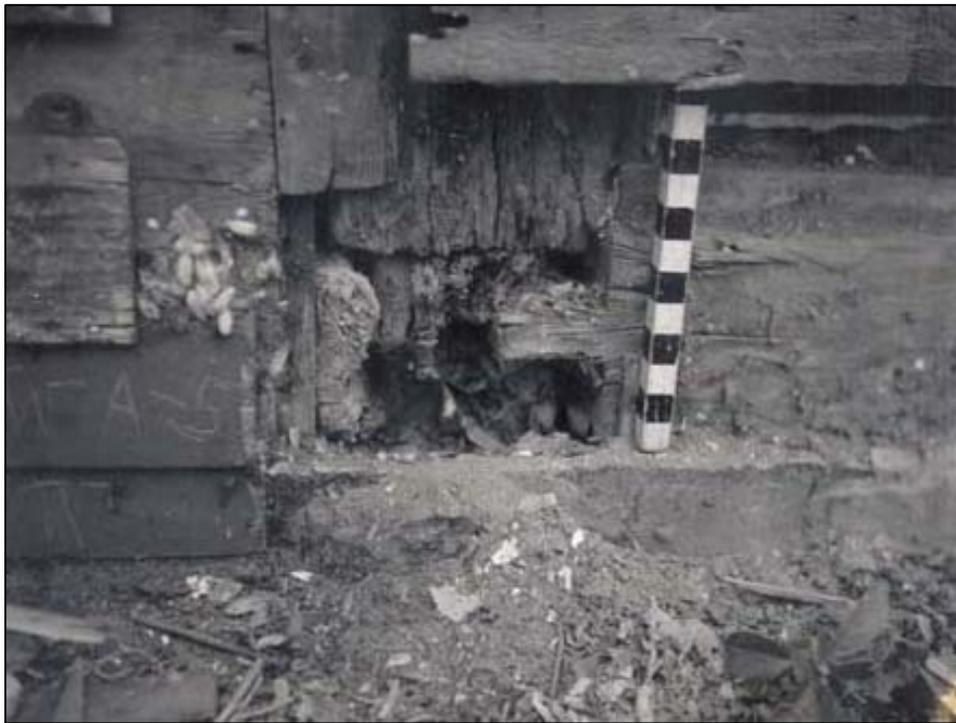
Figure 79. Main House: West wall, north corner, showing west sill tenoned into north sill.

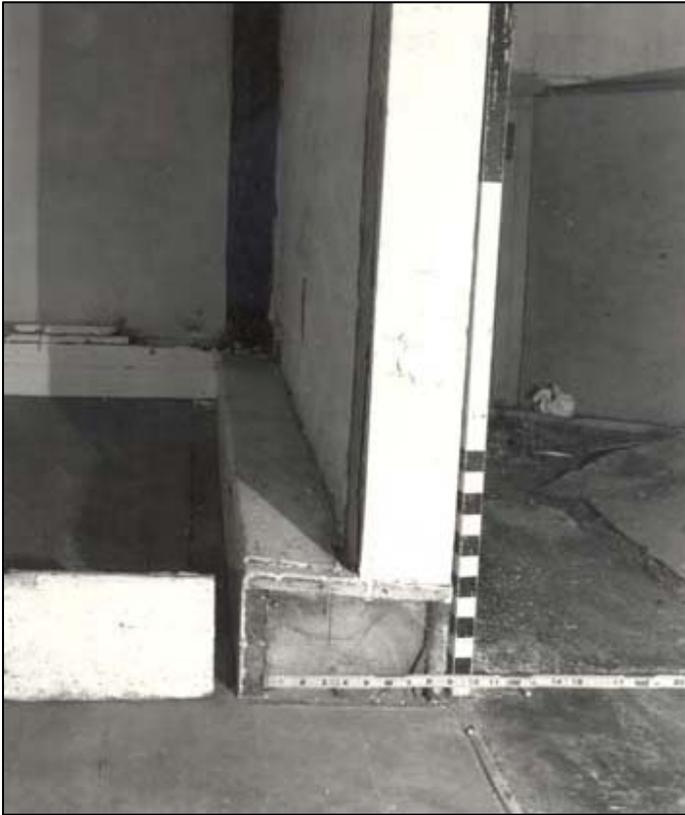
Figure 82. Main House: West Parlor, north wall, foundation sill cut out for ca.- 1910 doorway to ca.- 1900 addition.

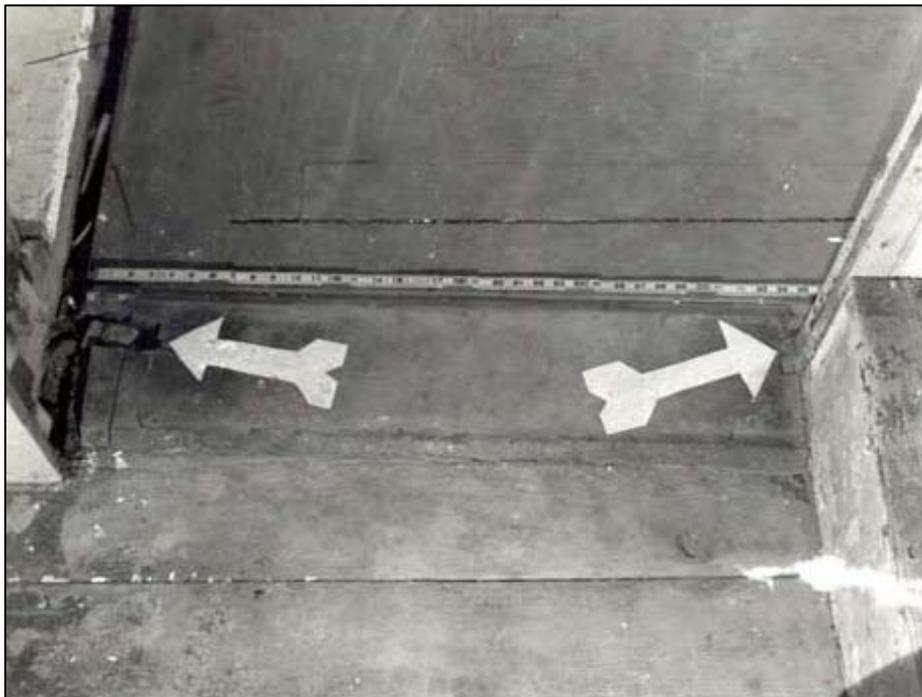
Figure 83. Main House: Entry Hall, threshold of ca.- 1910 doorway to West Parlor, showing probable location of original doorway; arrows point to locations of former vertical boards forming doorway jambs and stops.
