# BUILDING 24

## HISTORIC STRUCTURES REPORT

*Charlestown Navy Yard • Boston National Historical Park*

PREPARED BY GOODY, CLANCY & ASSOCIATES

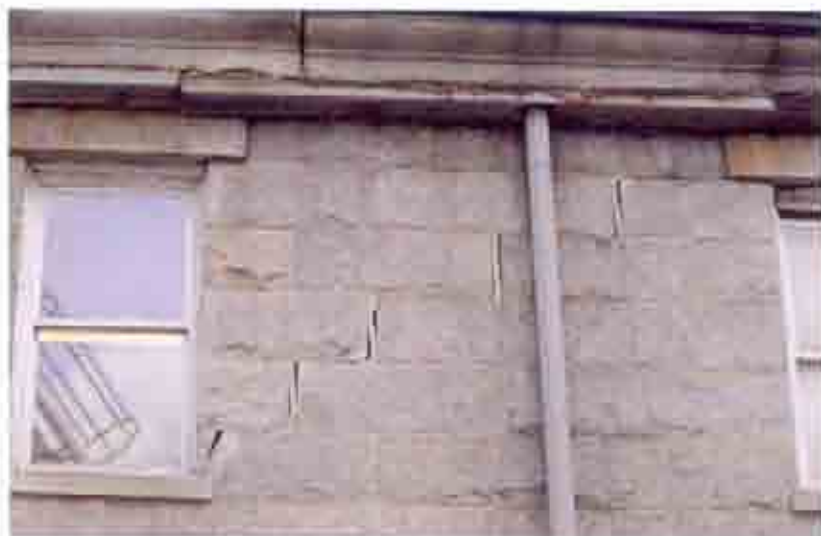
**Fig. 7** Step cracks have formed along some mortar joints due to structural movement of the building.

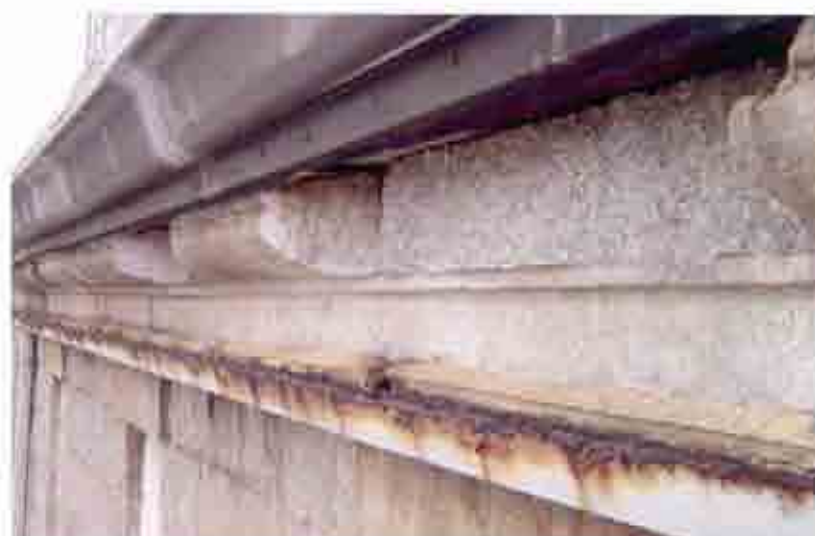
**Fig. 8** West elevation cornice stone with spalled stone, rusted gutter fasteners, and rusted Z channel.

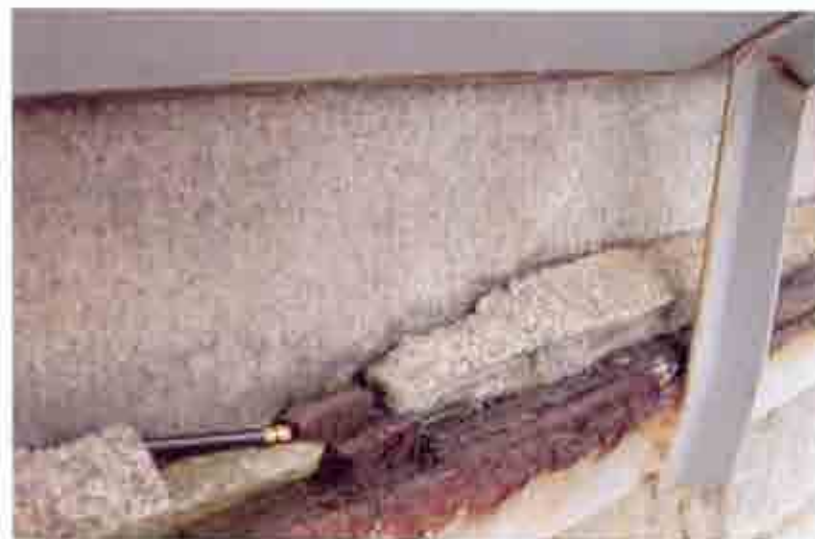
**Fig. 9** West elevation cornice stone. Note mortar filler in gap created at Z channel.

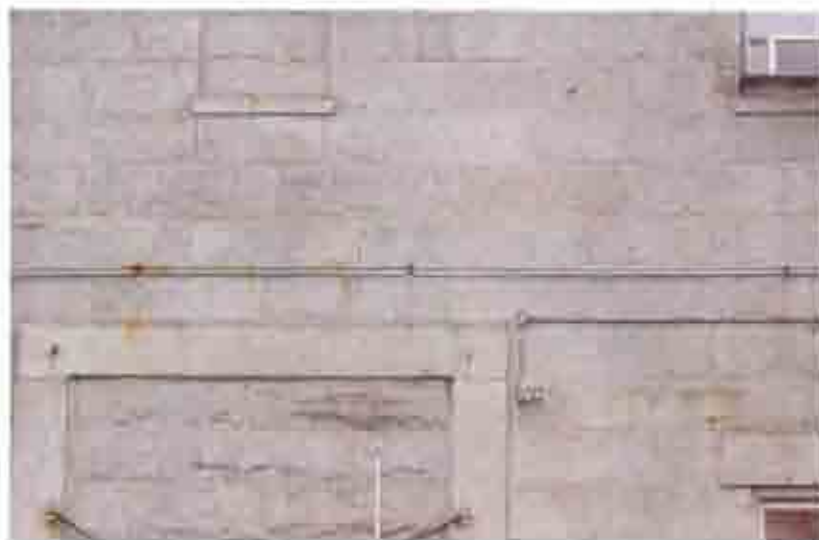
Fig. 10. Old fasteners for surface elements long since removed remain in the granite, leading to staining of the surrounding stone.

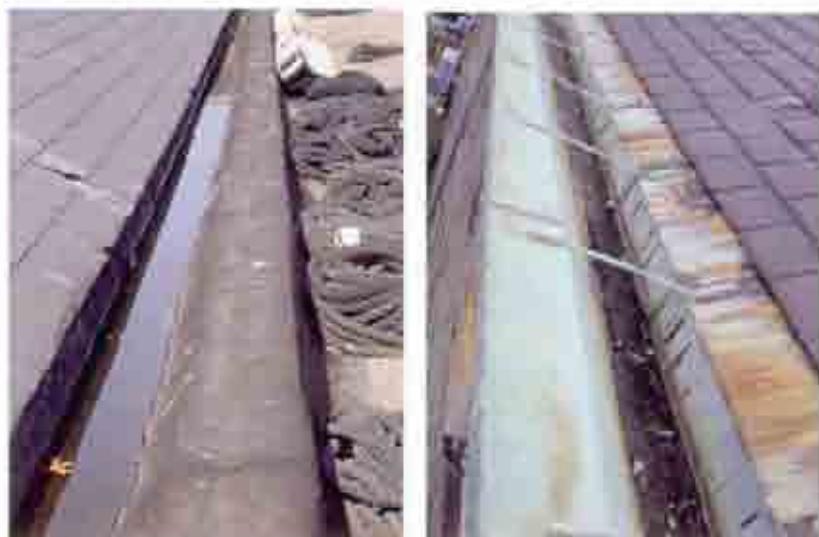
**Fig. 12 & 13** East roof slope (left) with original copper gutter coated to meet fast roof of addition. Copper gutter of west roof slope (right) shows streaking, indicating advanced deterioration of material.

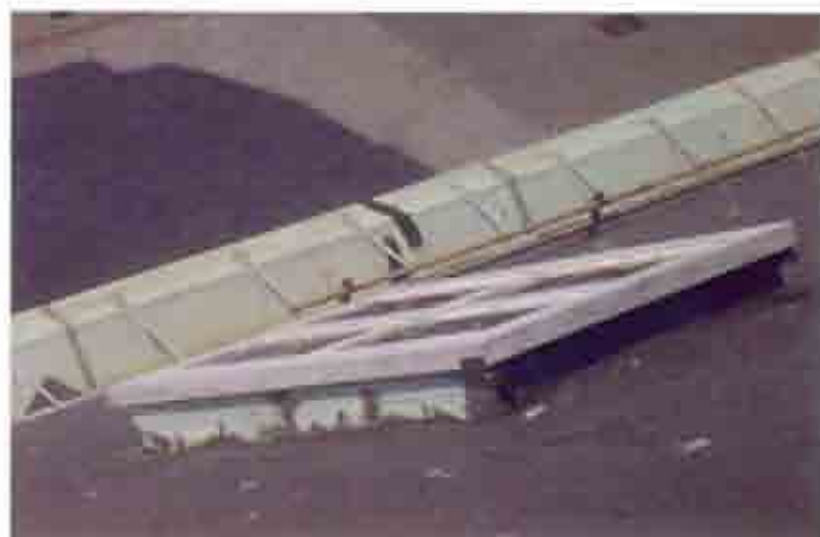
**Fig. 14** Many of the wood framed skylights are actively leaking. Note the loss of paint and patched metal flashing.

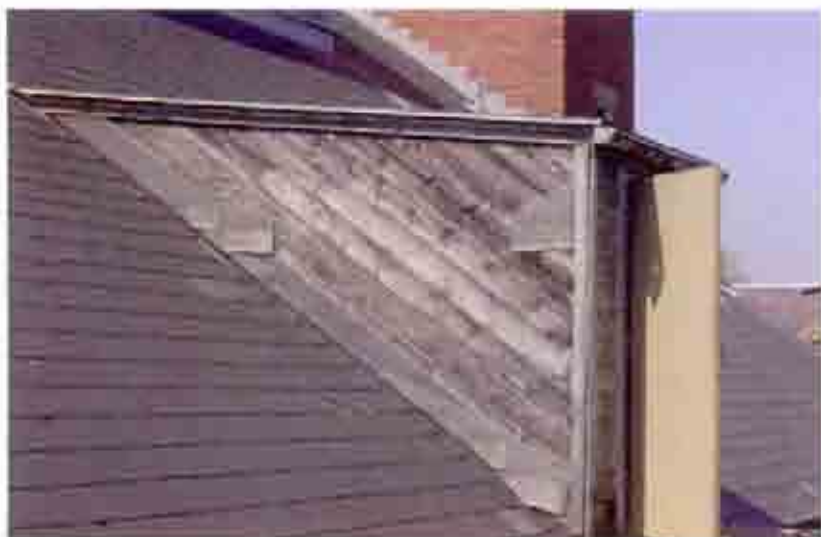
**(g) Dormers.** The dormer on the east elevation is in fair condition (Fig. 15). Most of the asbestos shingles are gone from the diagonal sheathing,

Fig. 15 The east elevation dormer is in fair condition.

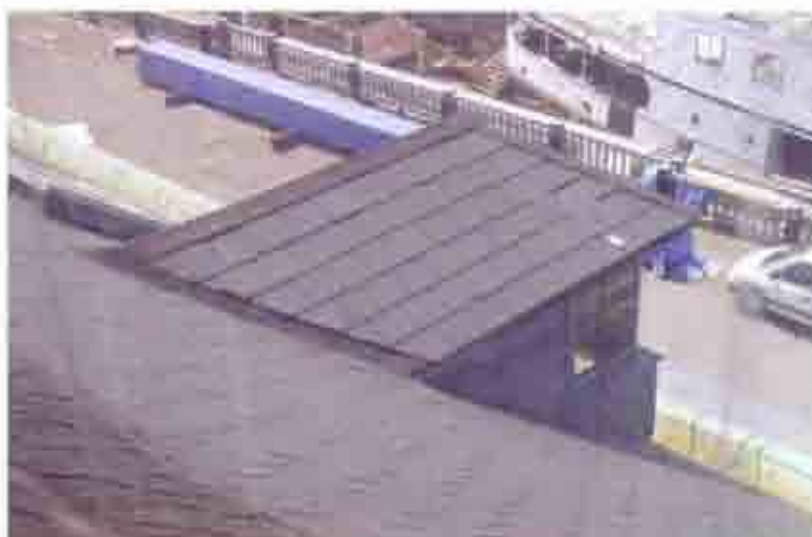
Fig. 16 West elevation dormer. Note temporary repairs made to metal flashing.

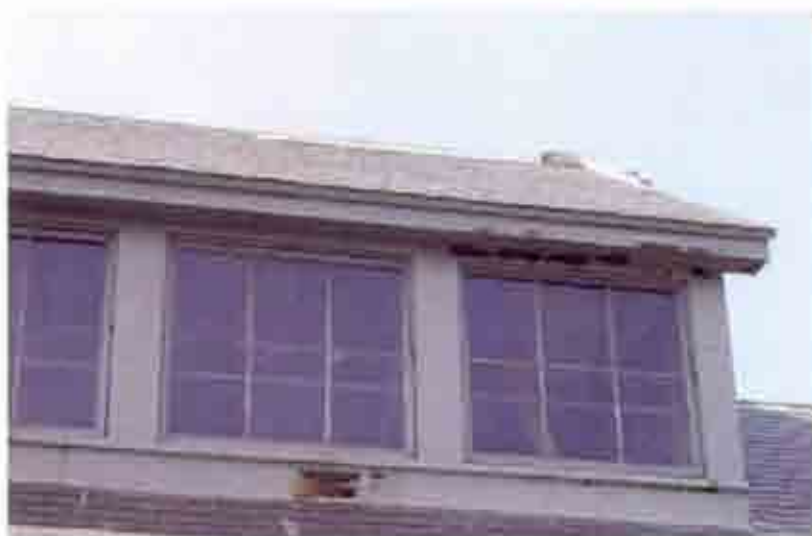
*(i) Monitor Windows.* The monitor window sash were replaced in the 1970s. The windows are in poor condition and are currently fixed in place. The original operating mechanism, which consists of a gear mechanism that operates a series of bars and levers to open the pivot windows, is still in place. (Figs. 18 & 19)

Fig. 17 Monitor. Detail of wood windows and metal trim. Note rusting of galvanized metal and loss of paint on wood and metal.

*(i) Monitor Windows.* The windows should be replaced to match the 1913 drawings. The operating mechanism should be restored to make the pivot windows operational to provide ventilation to the upper portions of the space.

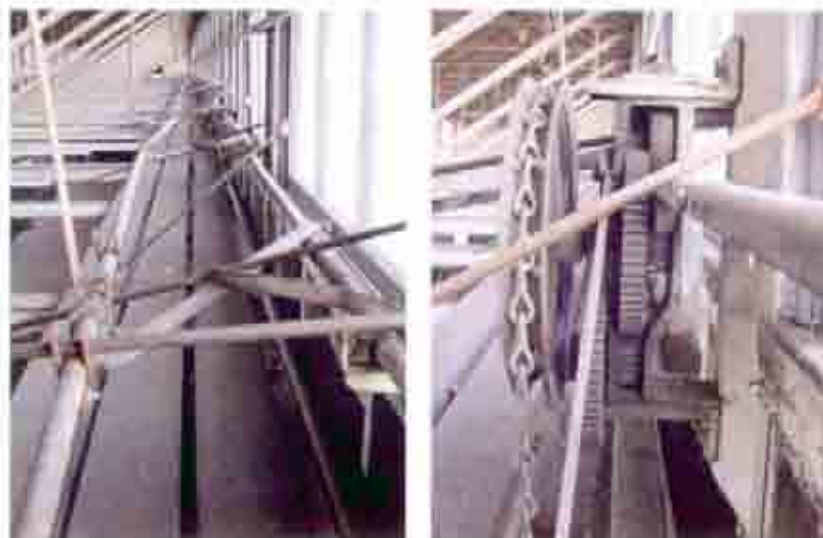
Fig. 18 & 19 Monitor interior. Operating mechanism for window sash.

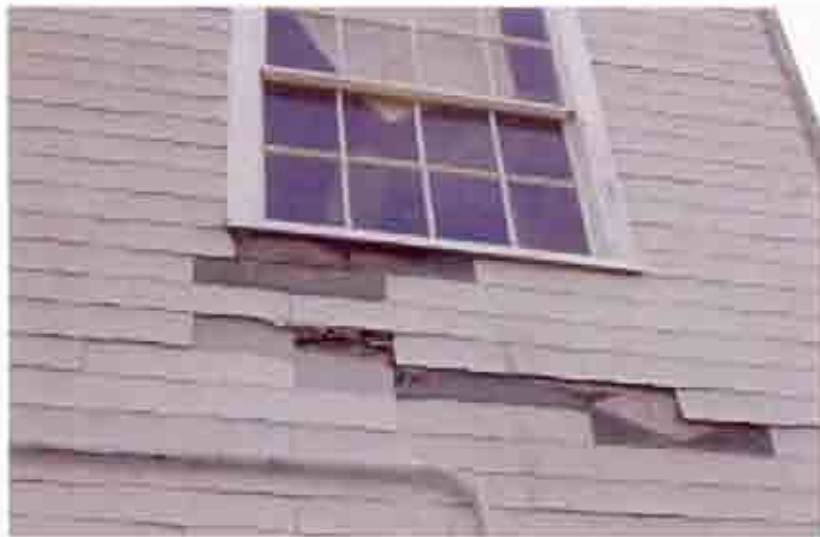
Fig. 20 Detail of asbestos shingle siding and window condition

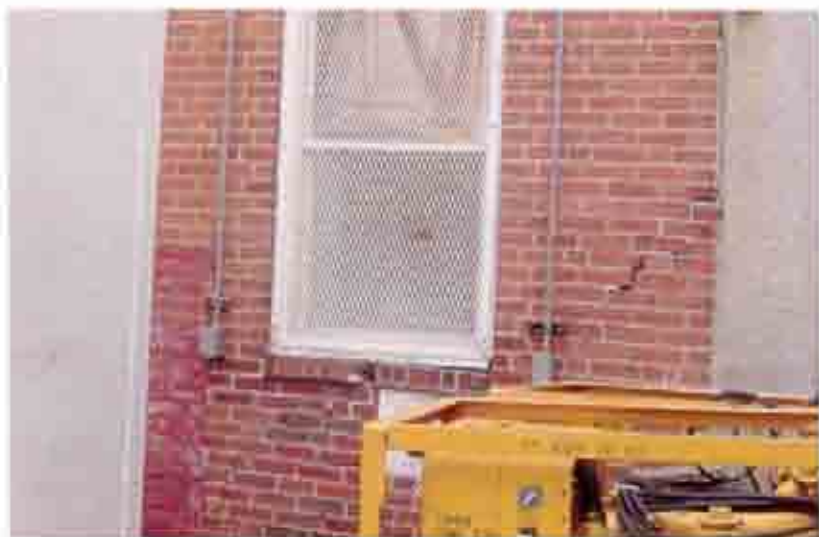
Fig. 28 West elevation, step crack detail. Continuation of crack into brick infill panel.

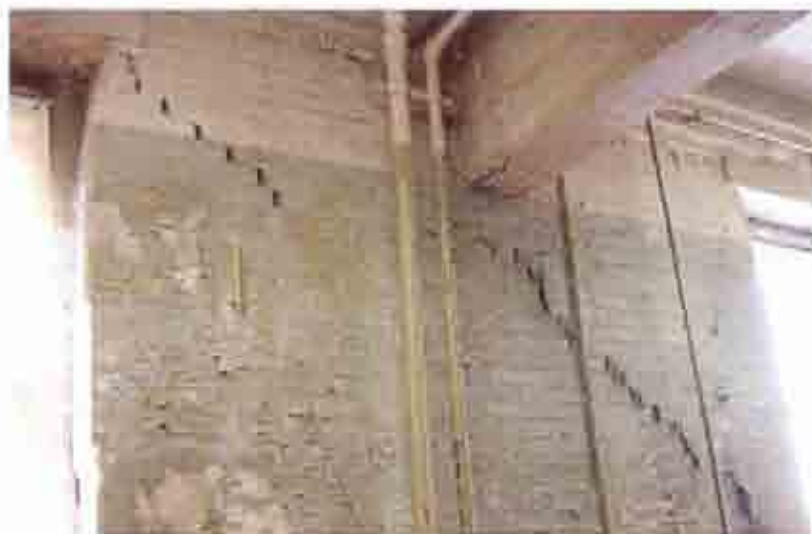
Fig. 29 Step crack at west exterior wall. Interior location of Fig. 20.

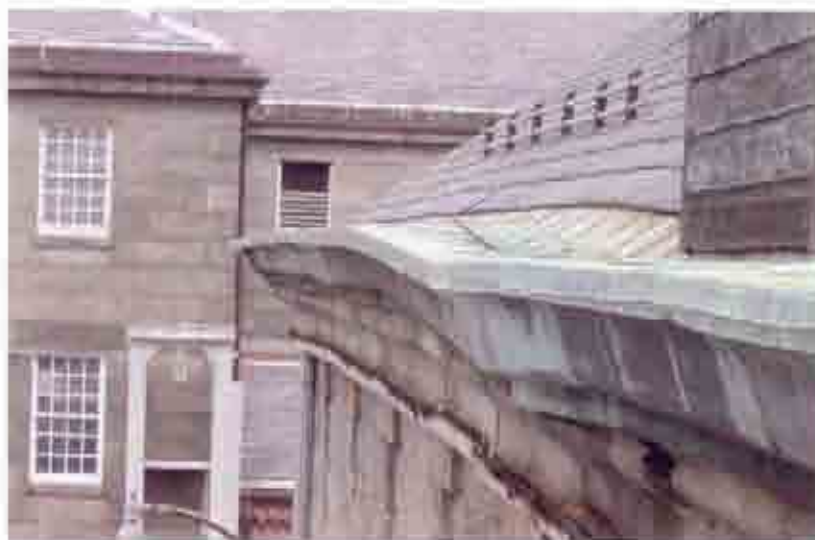
Fig. 30 West elevation cornice, looking north. Note dip in gutter level and rusted Z channel.

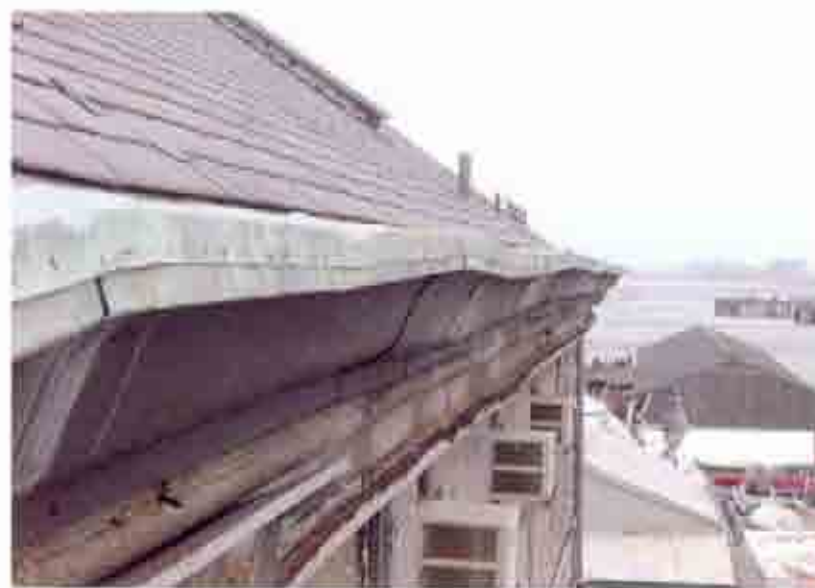
Fig. 31 West elevation cornice, looking south. Note dip in cornice stone and rusted Z channel.

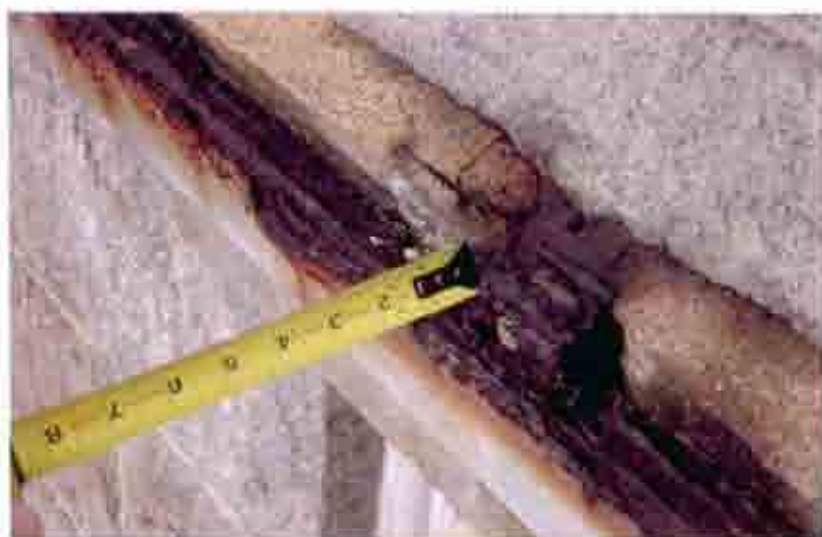
Fig. 32. West elevation cornice stone. Note rust jacking at Z channel.

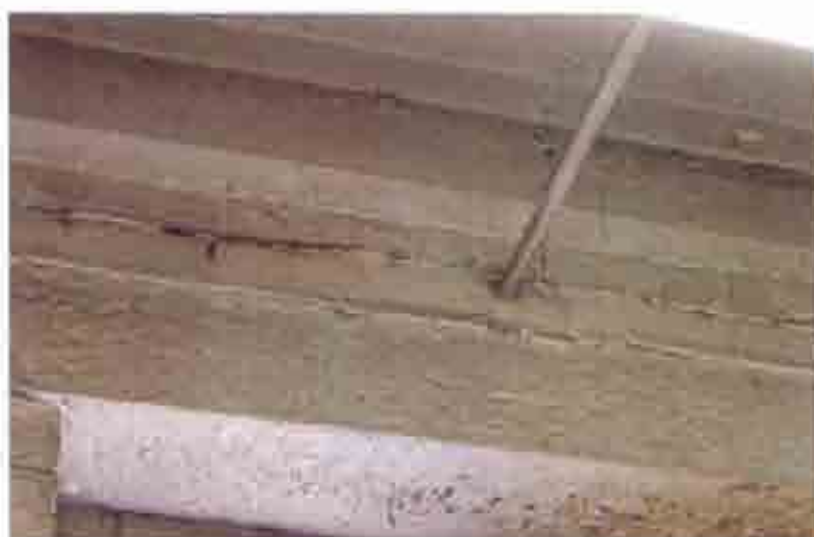
Fig. 33. Typical condition where Z channel tie rods pass through exterior wall.

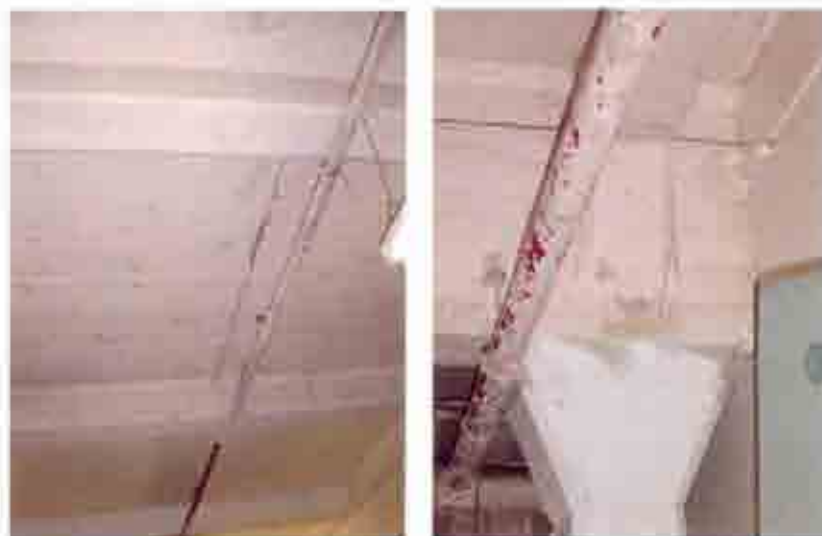
Fig. 34& 35 Typical construction shrinkage crack in concrete slabs (left), and vertical crack at beam-to-column intersection (right).

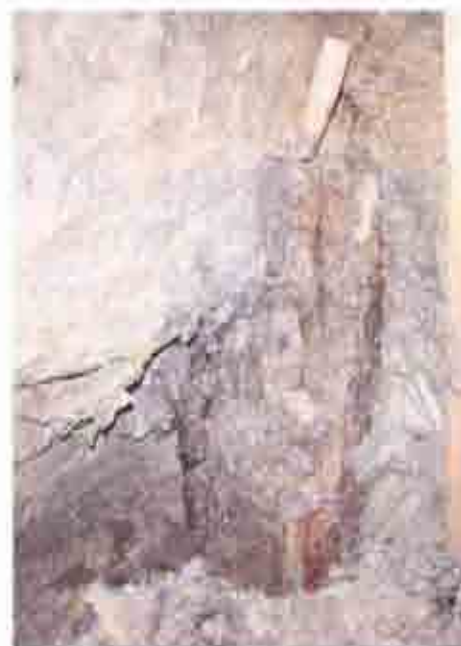
**Fig. 37** Granite footing stones were discovered to have crushed the tops of each of the two wood piles discovered in Test Pit No. 1 during excavation in June 2002.

The most urgent recommendation for treatment is to make the necessary structural repairs to stabilize the building. The repair to the deteriorated wooden piles is first priority. When these repairs are made, the repairs to the roof and the masonry walls to make the building weather tight should occur.

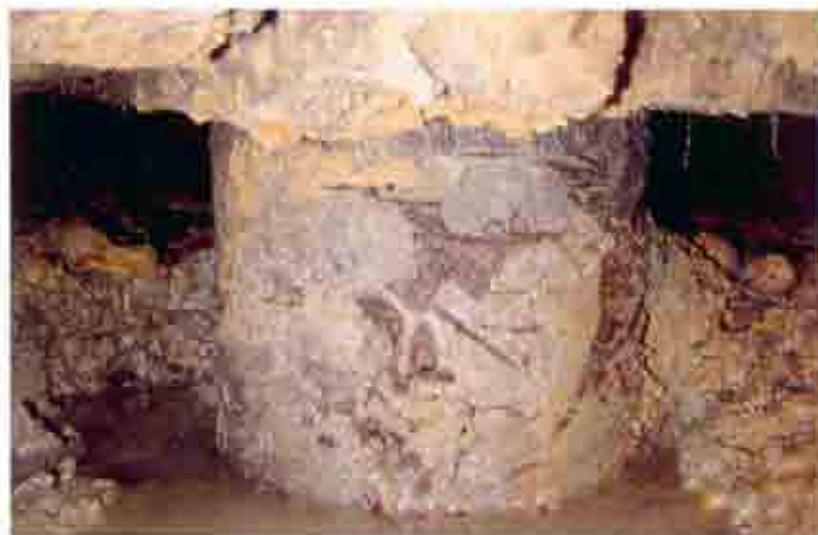
Fig. 38 Groundwater was observed entering Test Pit No. 2 at a depth of about five and a half feet.

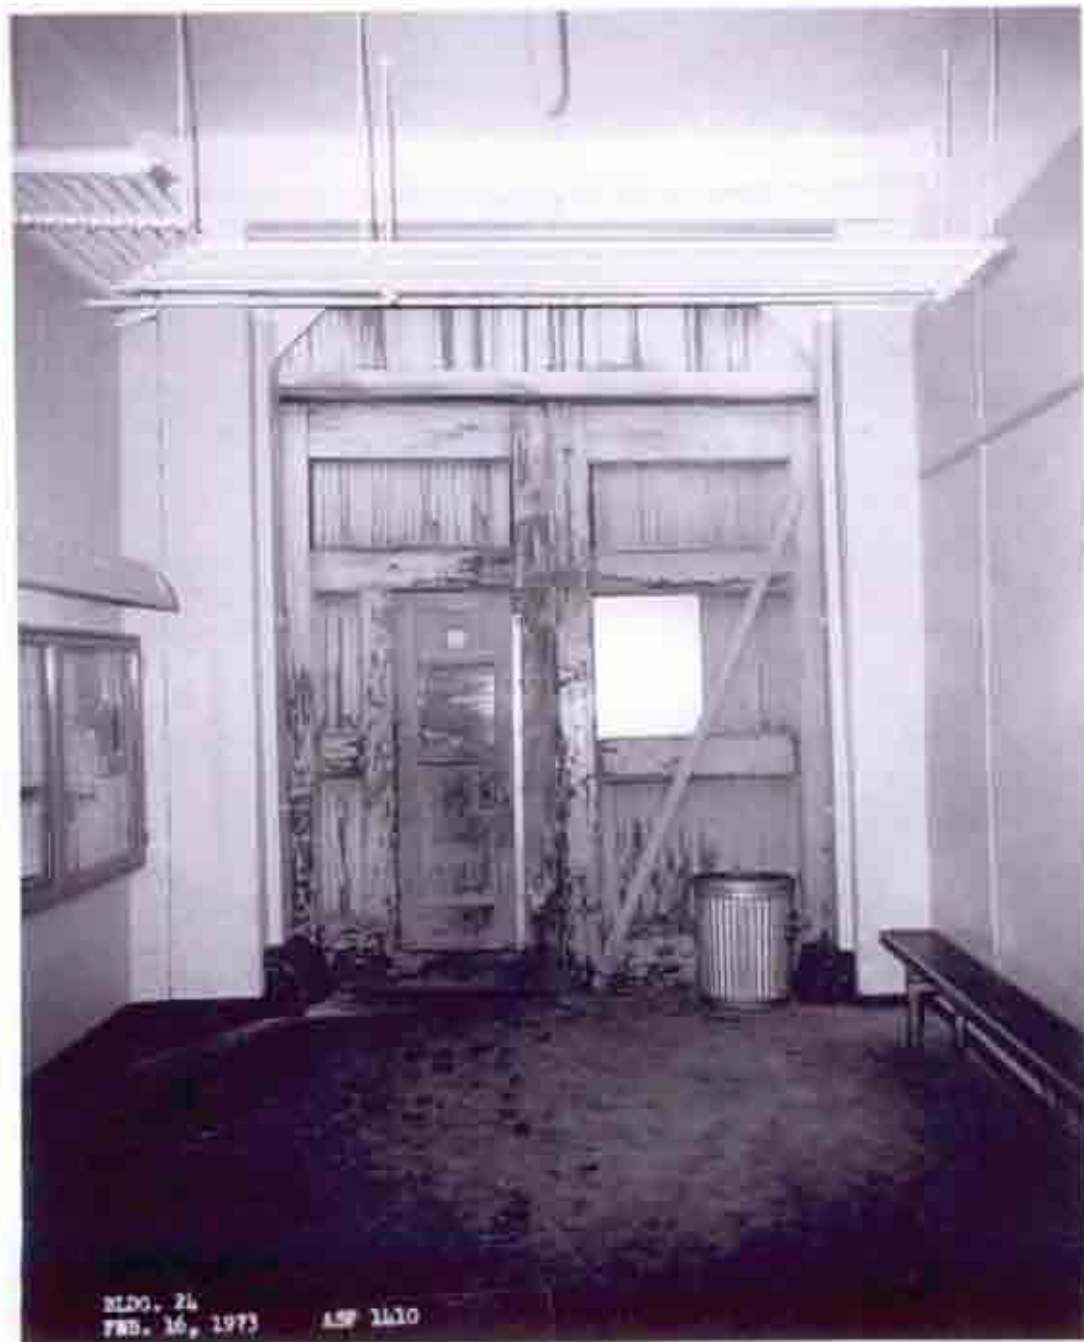
BS4 Fig. B-54 Photo "BLDG. 24 FEB. 16, 1973 ASF 1410". 1973 photo showing cracked lintel over door.

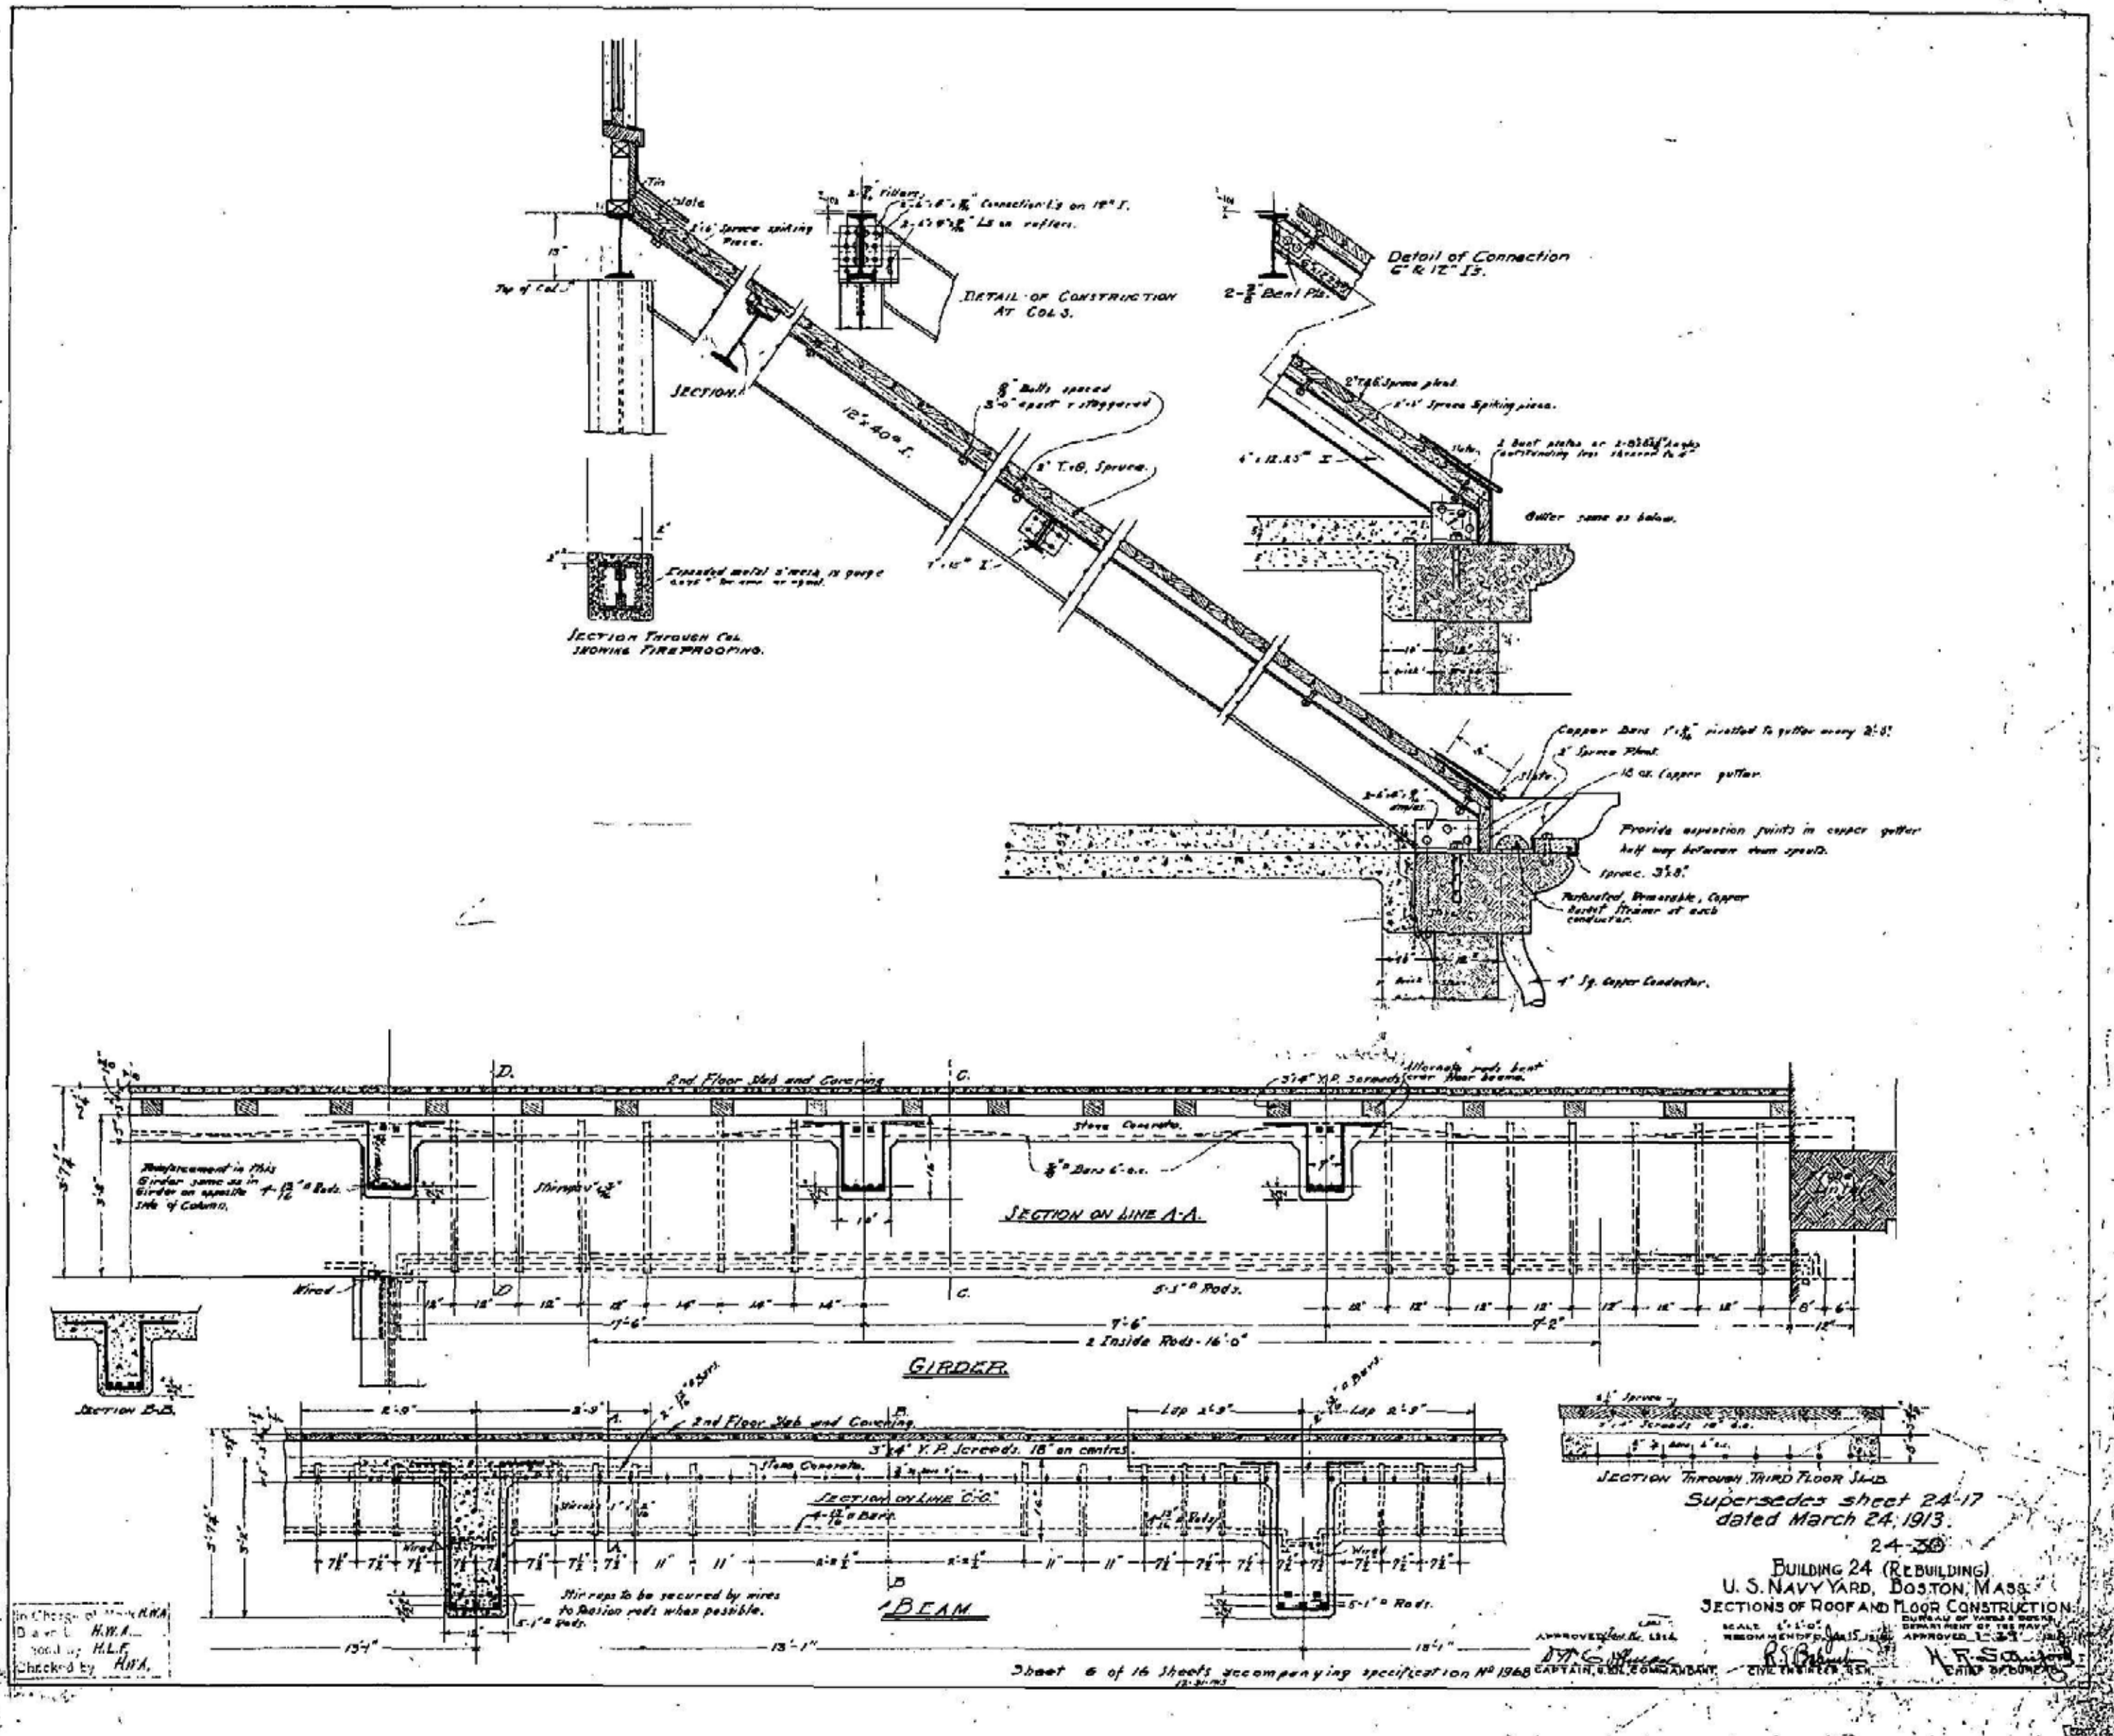
Fig. C10 24-30 "Sections of Roof and Floor Construction". Dated 1914 (rebuilding). Note the bolt used to fasten the gutter nailer to the cornice stone. This is the element that is rusting and causing the cornice stones to spall.
