# DRY DOCK 1

## HISTORIC STRUCTURE REPORT

*Charlestown Navy Yard • Boston National Historical Park*

PREPARED BY MCGINLEY KALSOW & ASSOCIATES

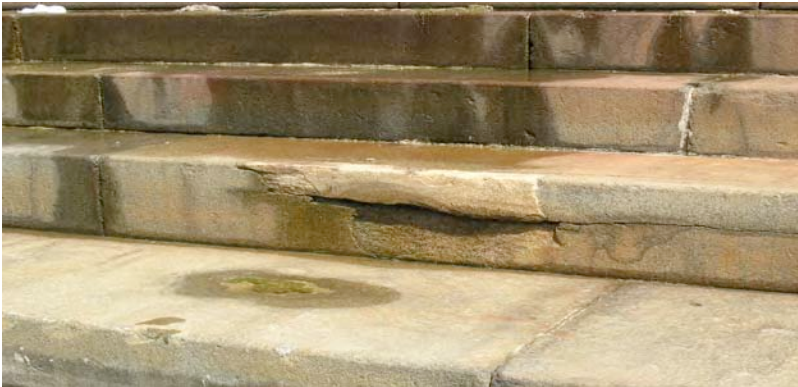
**Fig. 10** Detail of cracked and broken granite block in step-back along the west wall that has been repaired with concrete.

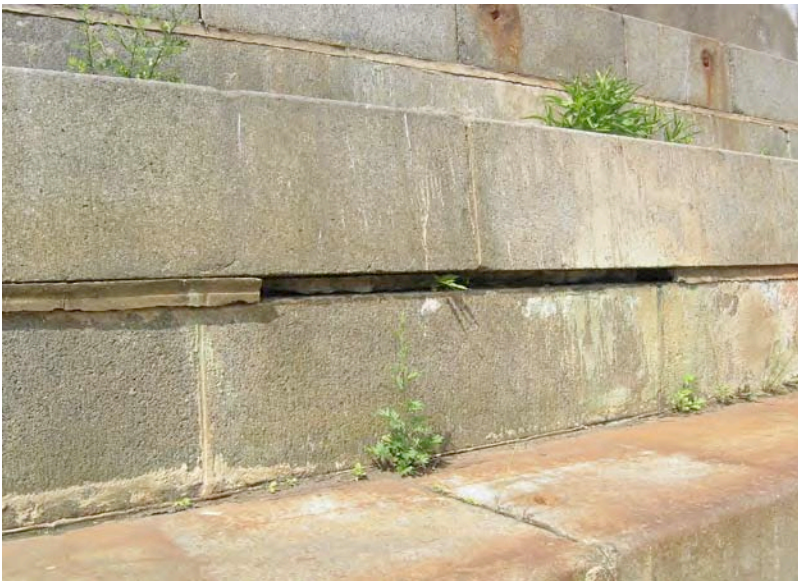
**Fig. 11** Detail of vegetation, missing grout, and deteriorated mortar in joints of the lower altars on the west side of the chamber. This condition is prevalent throughout the dry dock.

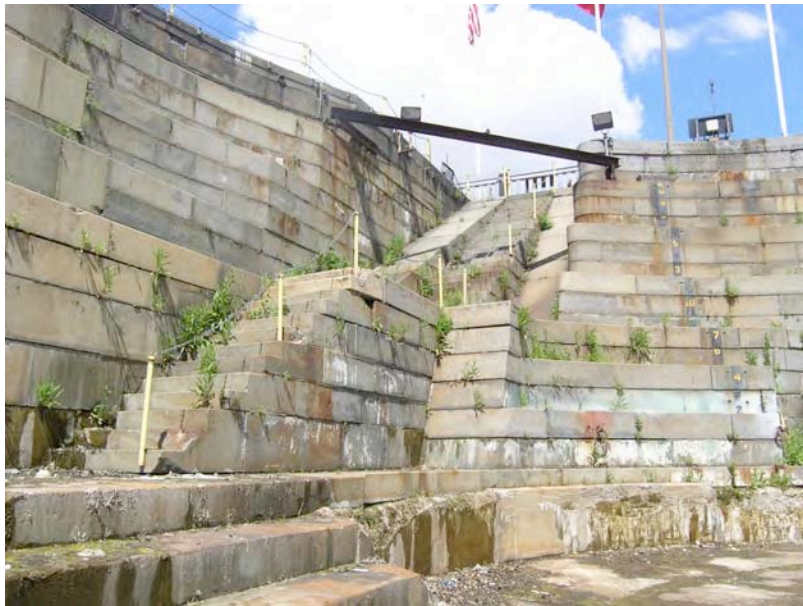
**Fig. 13** Lower flight of Stair 3, on west side near the head of dock. Note that the three step-backs of the arc at the head of dock have been removed and replaced with a concrete wall that is now deteriorated.

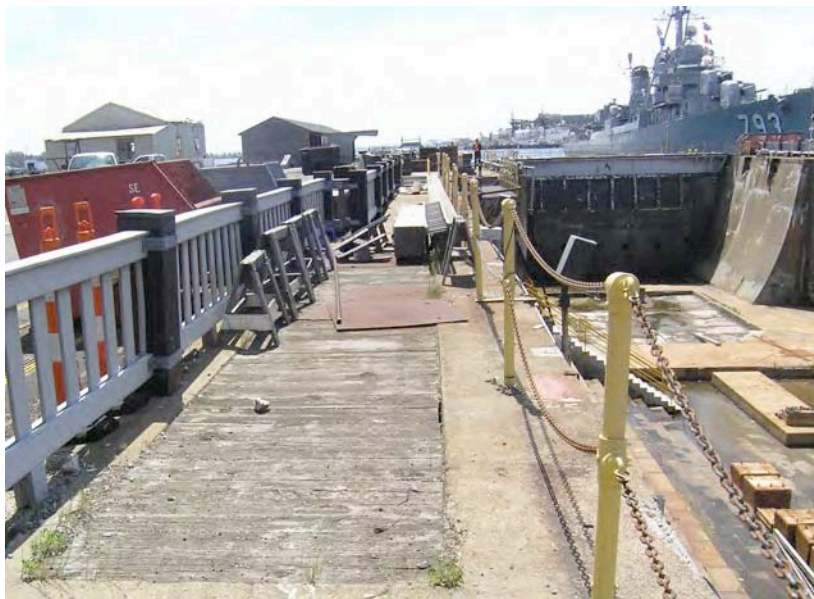
**Fig. 15** Detail of blocked entrance to the chamber of Stair 6, near the middle of the dock.

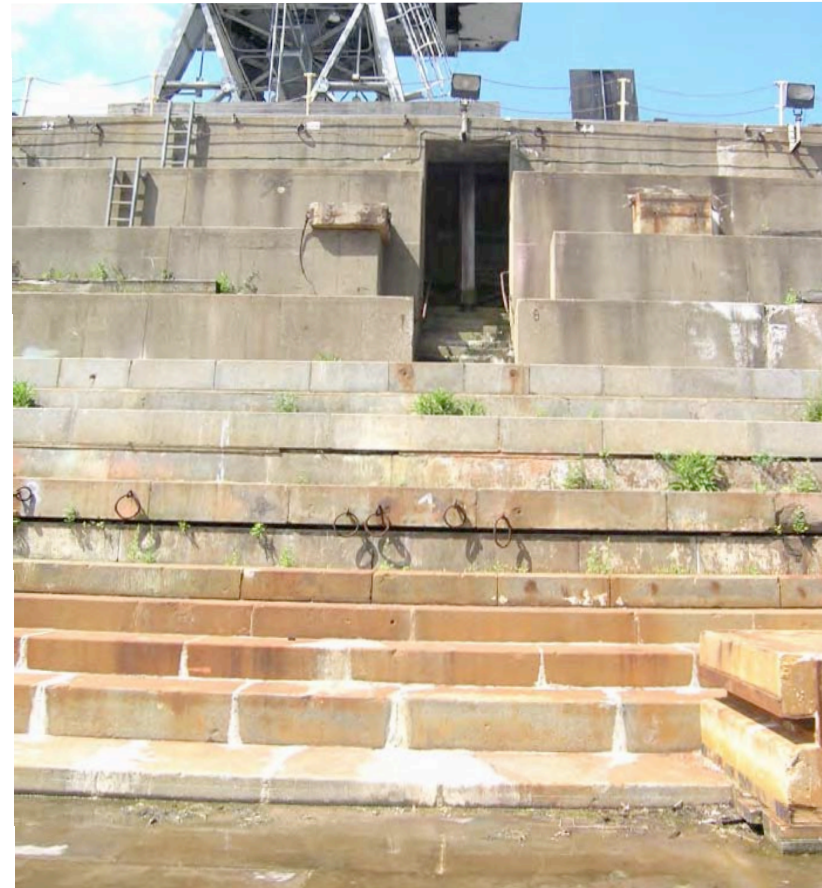
**Fig. 16** Detail of entrance to the chamber of Stair 6, near the middle of the dock on the west side. One of the timber posts that supports the timber planking, which blocks off the ground-level entrance to the stairway, is visible in the center.

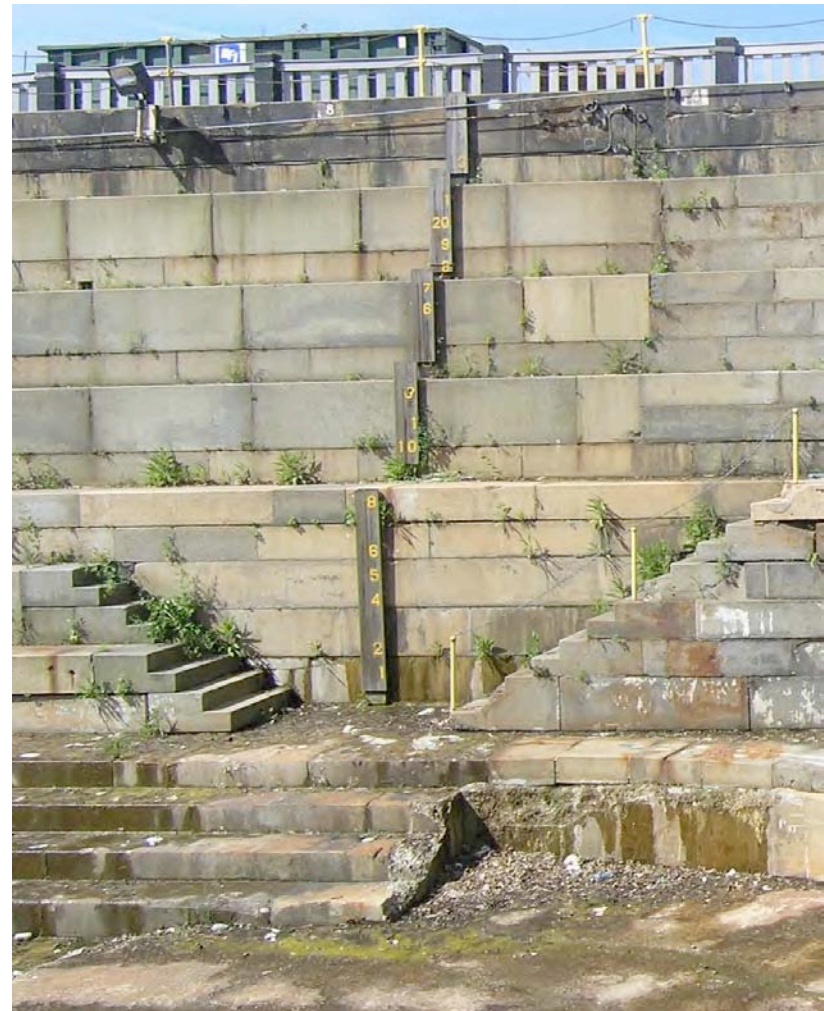
**Fig. 17** Granite stairs at lower altars, west side of the chamber. Note that some deterioration has occurred in the lower steps (at lower right) where a section of the lower steps, extending around the arc of the dock's head, were removed and replaced with a low concrete wall that is now in poor condition.

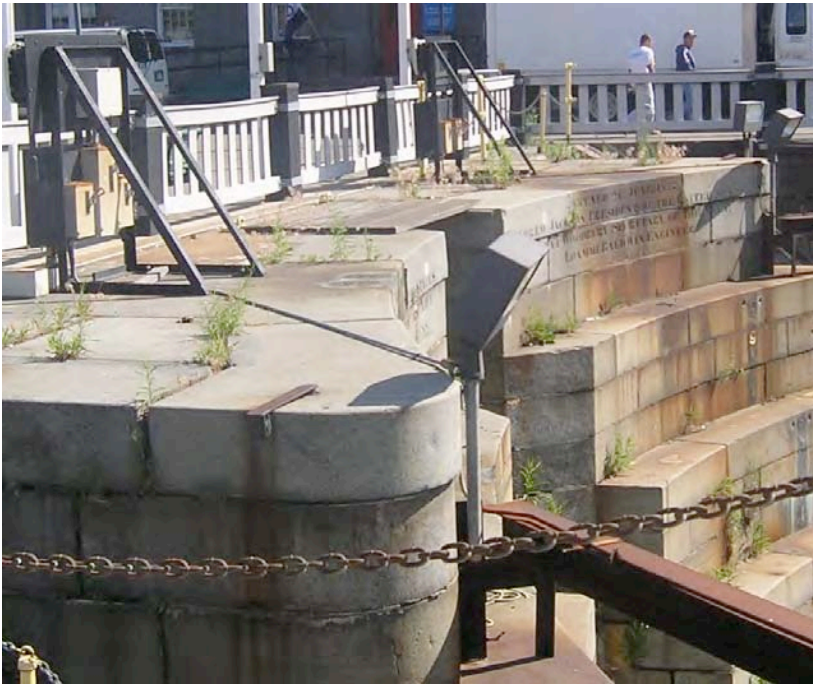
**Fig. 21** On top of the head of dock are visually intrusive, non-historic utility boxes (mounted on steel frames) and electrical lines. The timber planks spanning the removed center slide are deteriorated and unsafe. Two iron rings from the 19th century remain in place, as do two small steel pulleys mounted to steel bars.

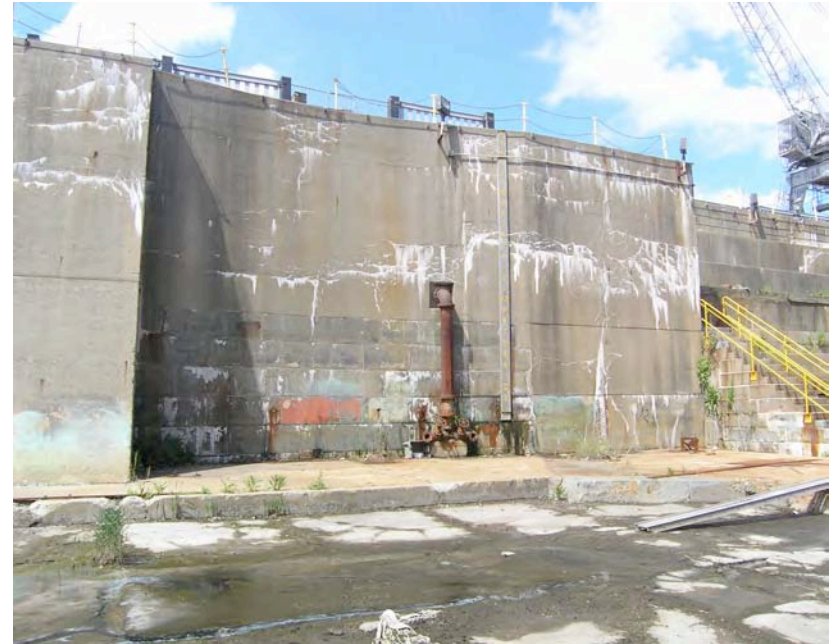
**Fig. 25** View of the west wall, showing the condition of the concrete. This was part of the work carried out for the seaward extension in 1947-1948. Note that some of the lower courses of granite, which date from the original construction of Dry Dock 1, that were retained. The rusting steel pipe and valve structure in the center was part of the improved hydraulic system installed at the time of the seaward extension.

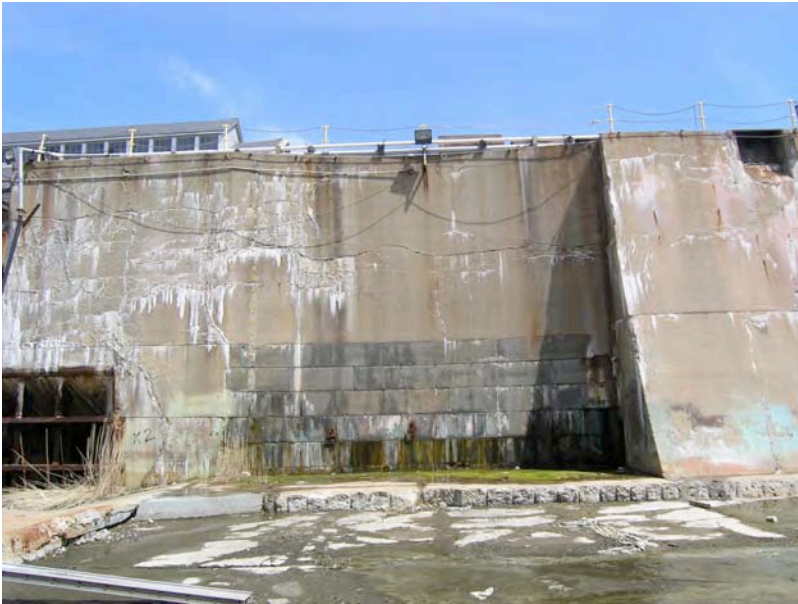
**Fig. 26** View of east wall of the 1947-1948 seaward extension, showing deteriorated concrete work. The lower courses of granite that were part of the original turning basin were retained.

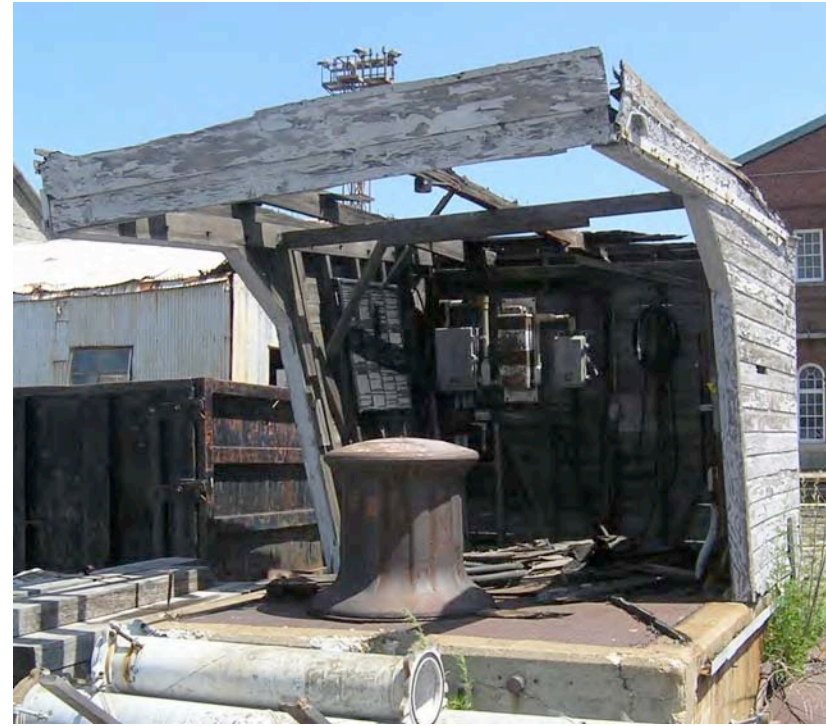
**Fig. 30** Capstan No. 3 on the dock's east side near the caisson gate, looking east. The dilapidated wood-frame structure, which contains electrical panels, partially encloses this capstan.

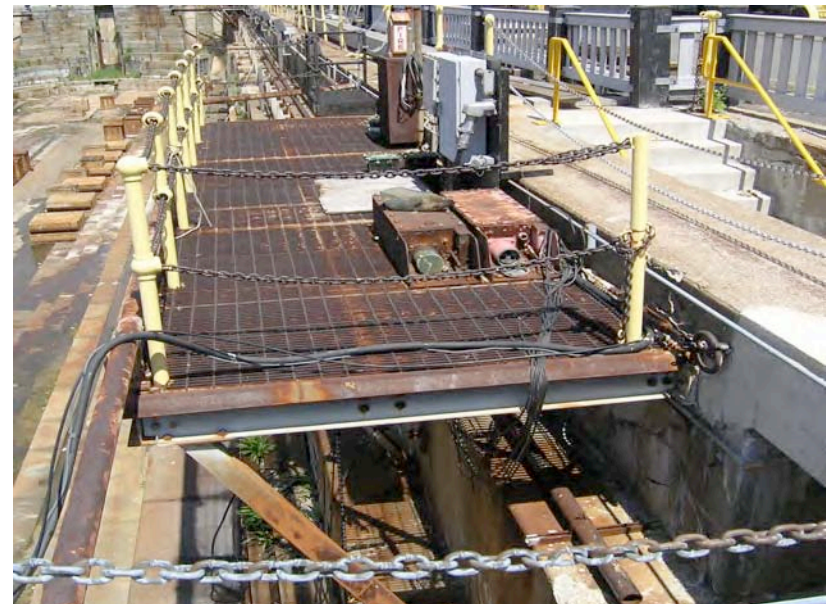
**Fig. 33** Work platform, east wall, near seaward end. Note the abandoned utility lines and boxes on the platform.
