# Bodie Island Lighthouse Historic Structure Report

PLEASE RETURN TO:

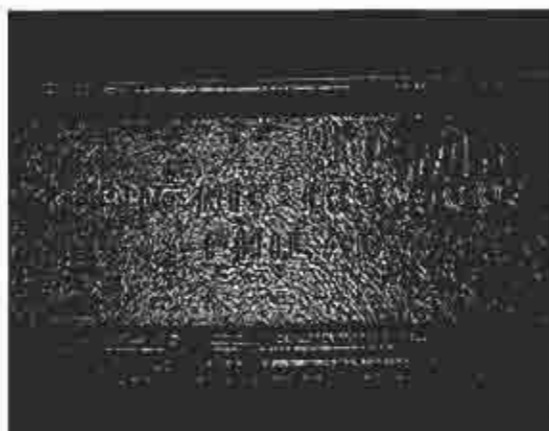
**Figure 4** Landing support beams in Tower. Beams were actually installed with manufacturer's stamp upside down. Photo courtesy of Jack McCombs.

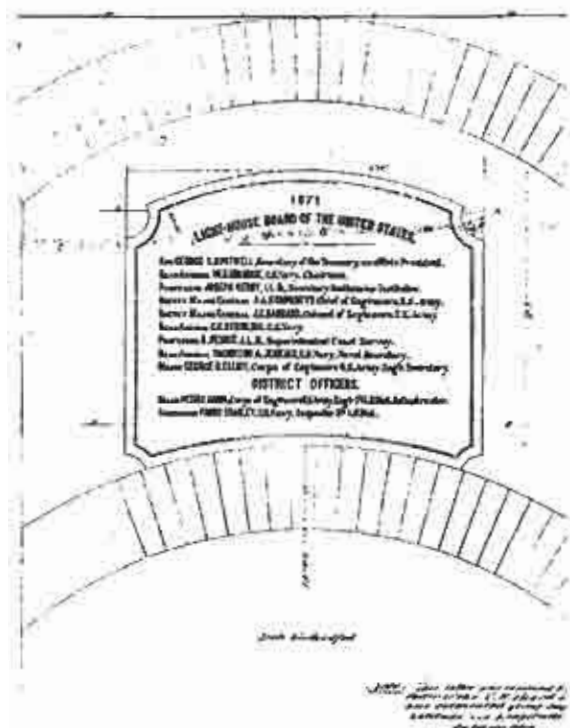
Figure 5 Drawing of original Bodie Island plaque.

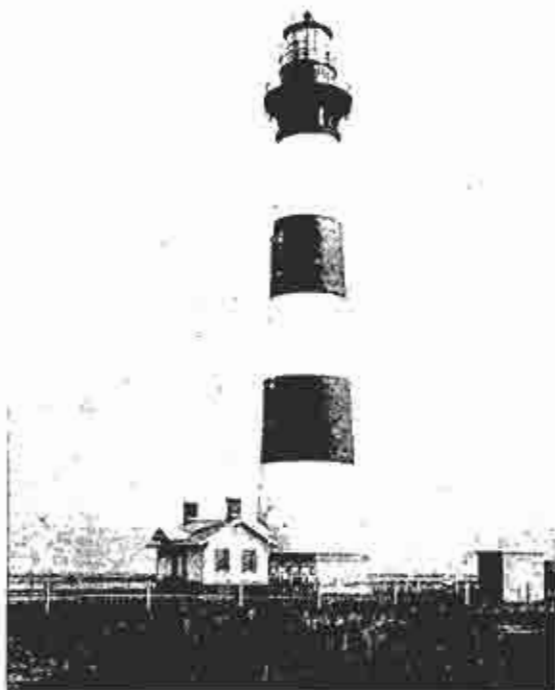
**Figure 6** Bodie Island Lighthouse, 1920s. Photograph courtesy of Cheryl Shelton-Roberts. Original in possession of John Gaskill.

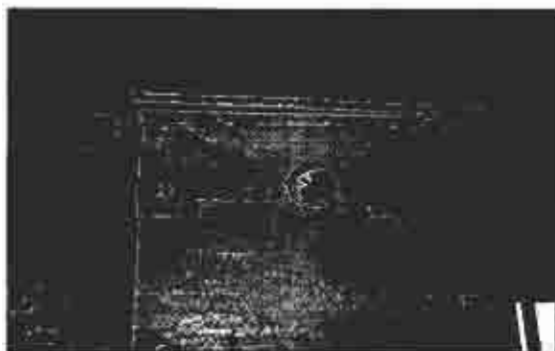
**Figure 8** 1989 USCOE photo showing cracked masonry in Oil Room interior chimney.

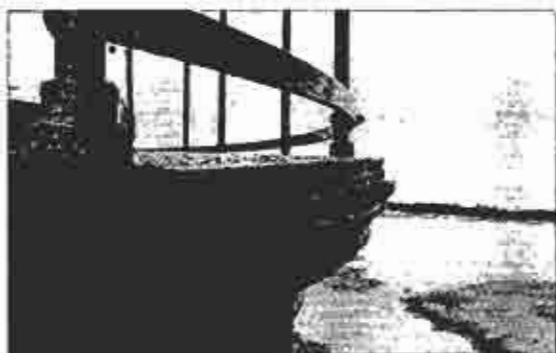
**Figure 9** 1989 USCOE photo showing deterioration of exterior edge of lantern gallery.

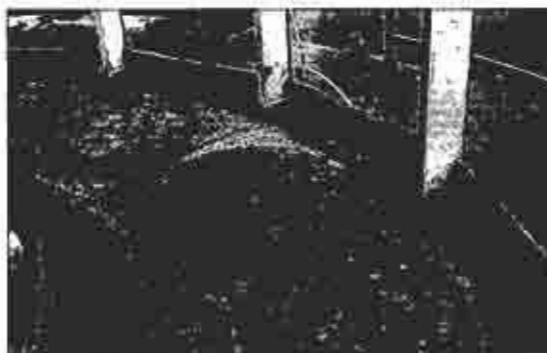
**Figure 10** 1989 USCOE photo showing missing lantern deck prisms.

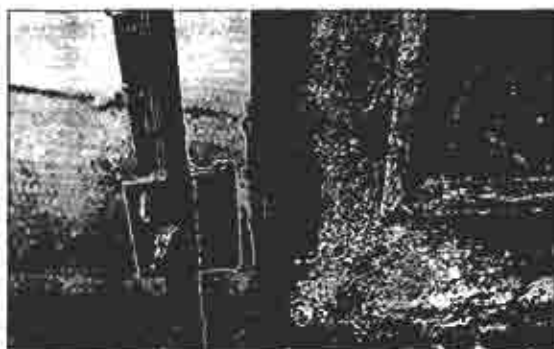
**Figure 11** 1989 USCOE photo showing detached hinge on door to gallery.

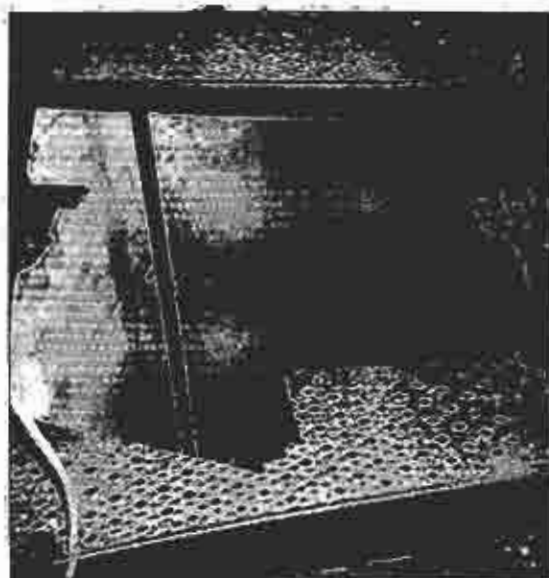
**Figure 12** USCG close-up photograph of damage to stair treads, 1992.

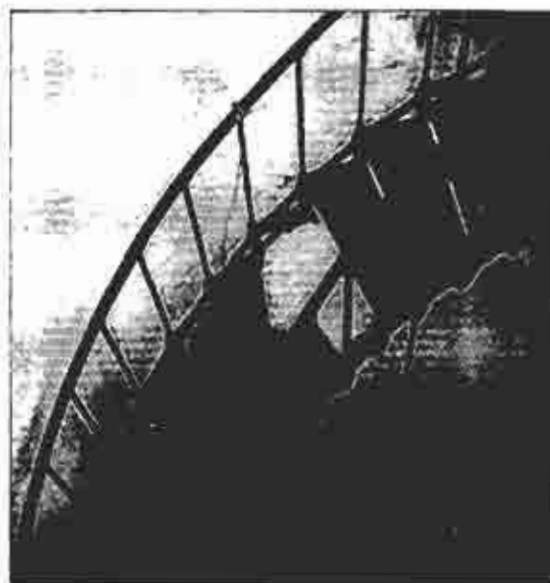
**Figure 13** USCG photograph of damage to stair treads, 1992.

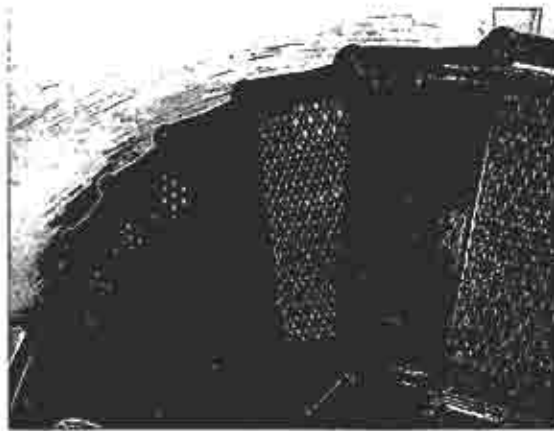
Figure 14 Existing repairs to stair treads.

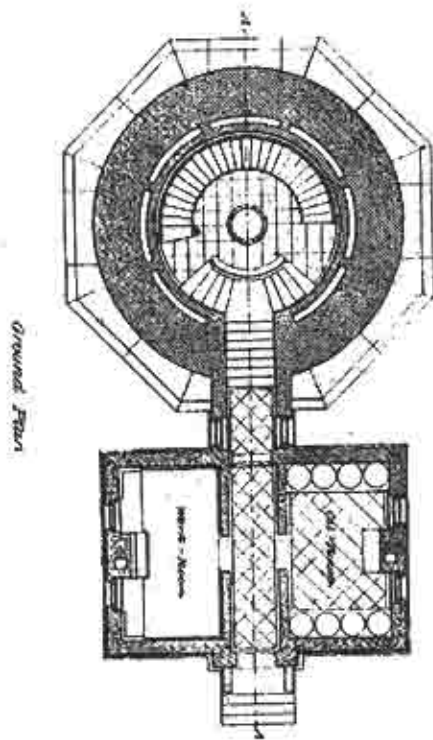
**Figure 15** Historic plan of ground floor.

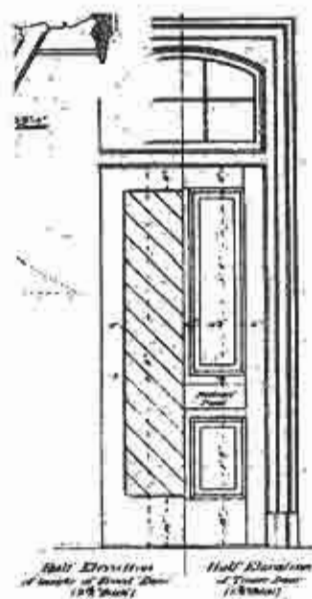
**Figure 17** Original drawing of front door details.

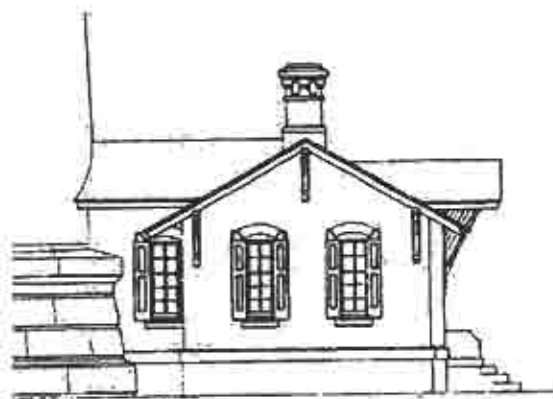
Overall, the north elevation is in sound condition. However, there are signs of past stress in the cracks over the west window in the elevation. This crack has been patched and painted, is sealed, and appears to be inactive.

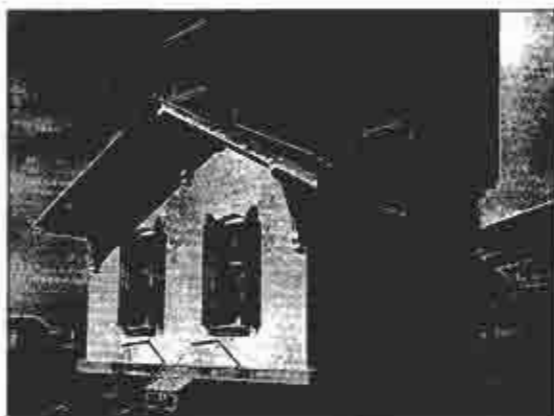
**Figure 19** Photo of south elevation by U.S. Coast Guard, 1948.

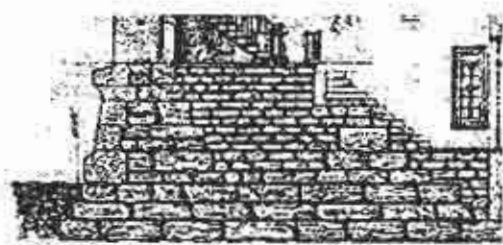
**Figure 20** Drawing detail of Lighthouse base.

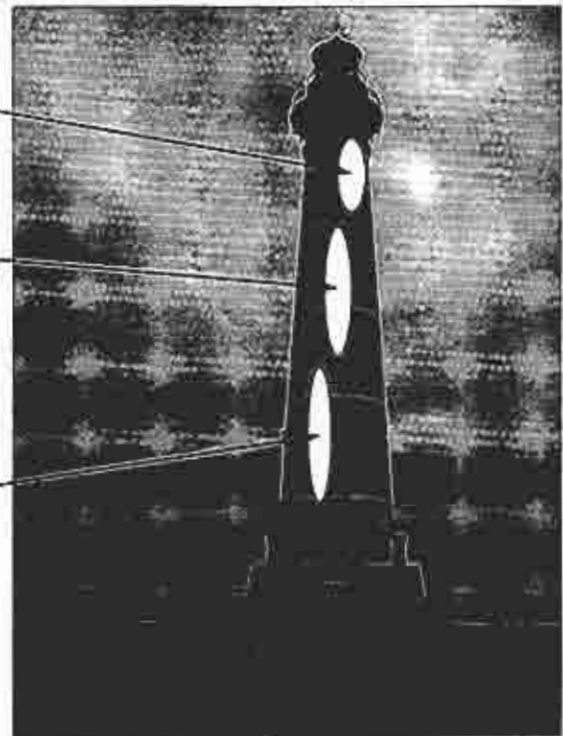
- Black at the watch level and above with the exception of the white window muntins at the lantern level.

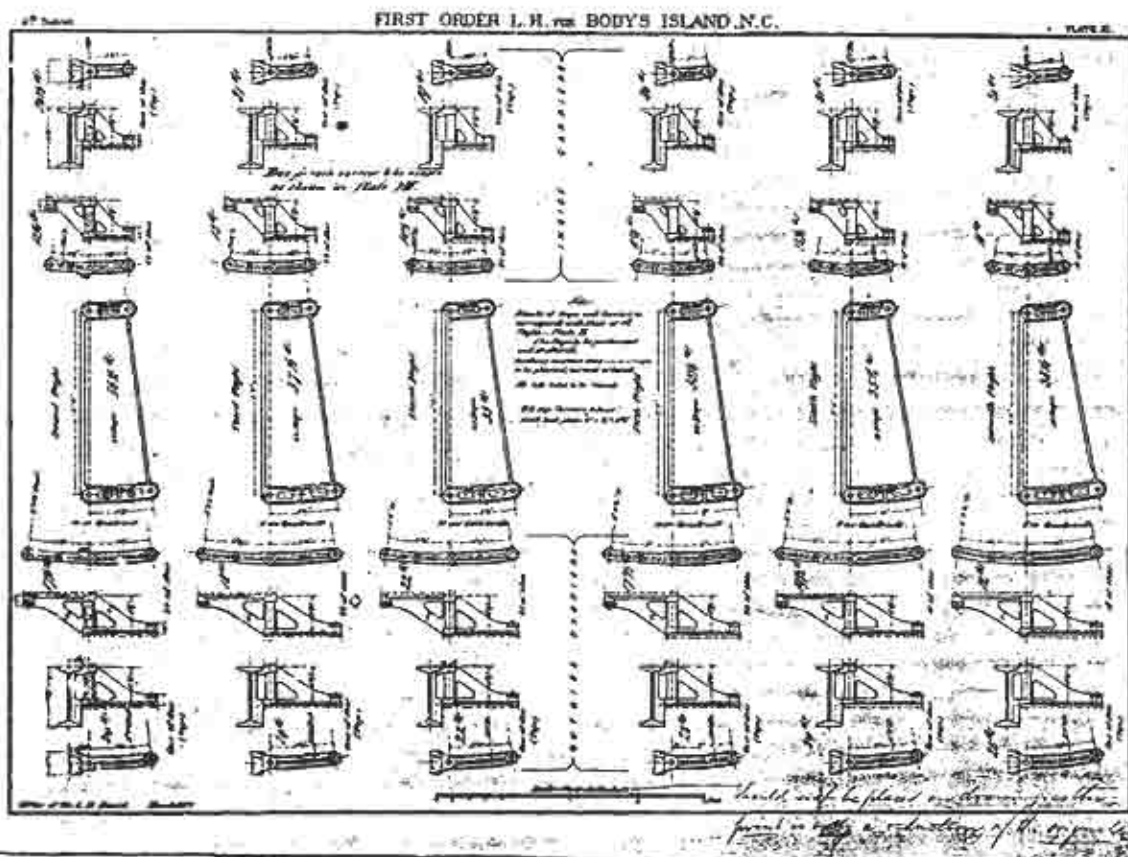
Figure 22 Plate XI, 1871 Drawings.

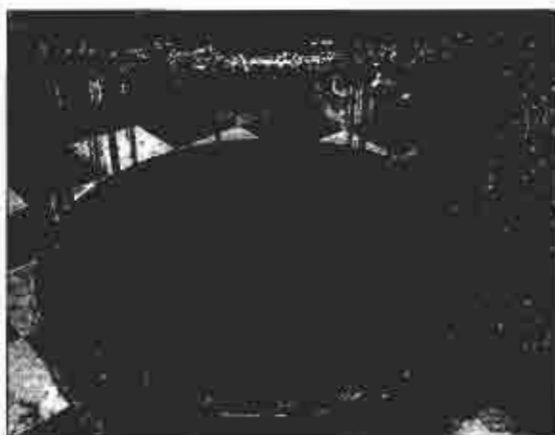
*Well:* In the center of the ground level is a depressed well approximately 30" deep protected by an original cast iron railing 38" high. The well is constructed of cast iron, with a cast iron wall and cast iron floor, the entire assembly being painted black. The well and railing are in sound condition. The well was reportedly constructed to receive weights used in the operation of a mechanism that would allow the

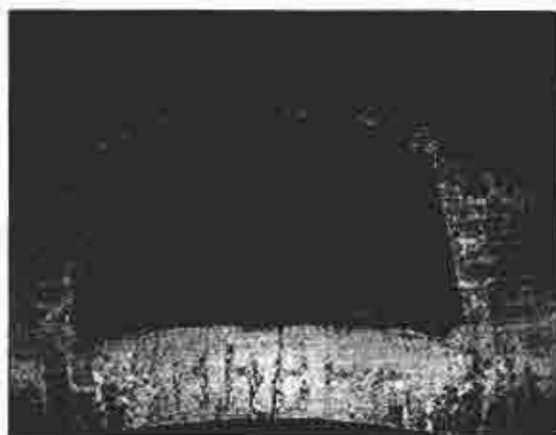
**Figure 24** Dedication Plaque.

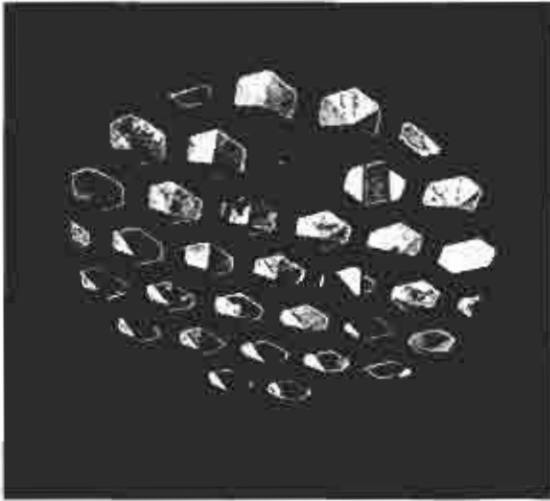
**Figure 25** Watch Room ceiling insert made of prismatic glass.

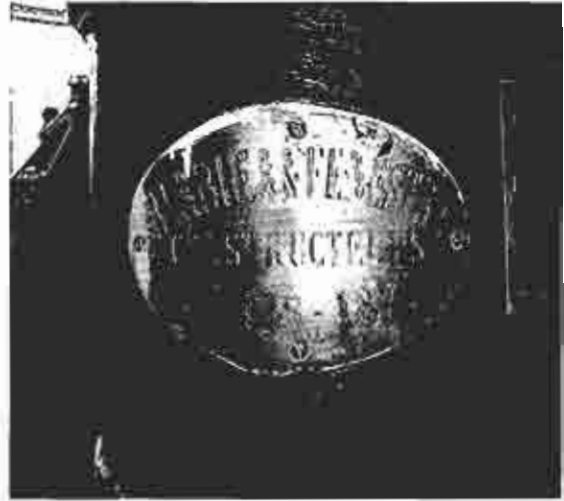
**Figure 26** Lens pedestal, original manufacturer's brass plaque.

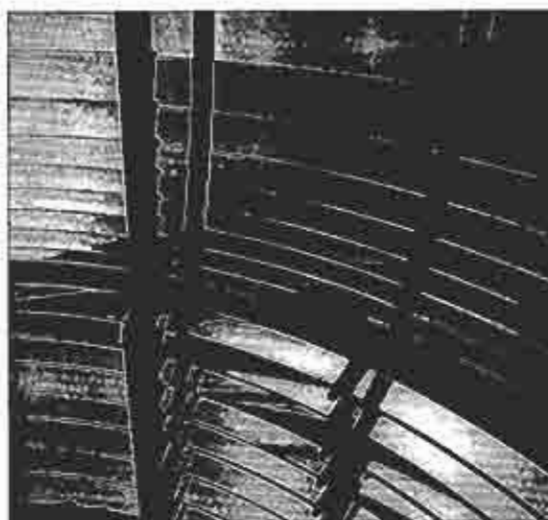
**Figure 27** First order Fresnel lens.

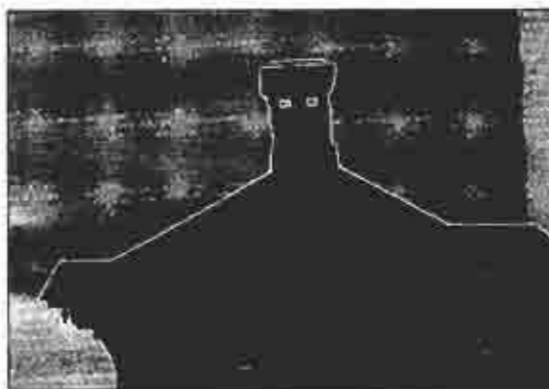
**Figure 28** South chimney above the Oil Room.

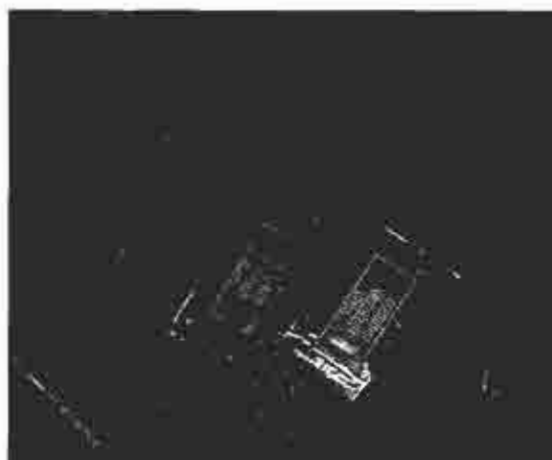
**Figure 29** Three treads with notable cracks, below Landing #1.

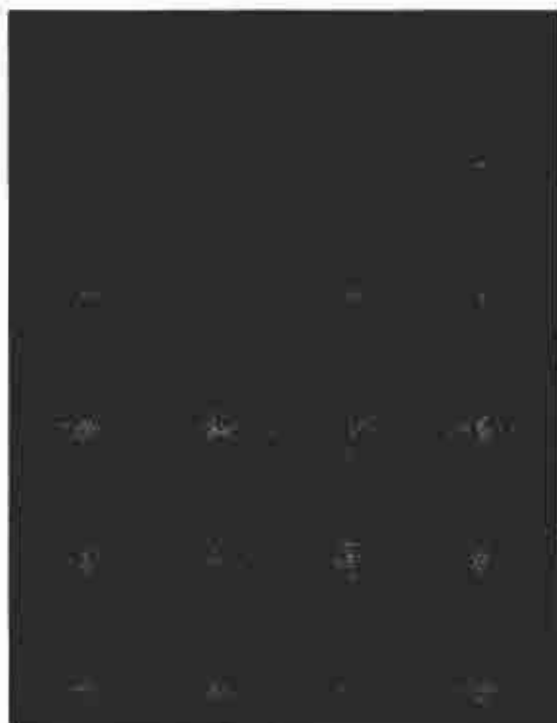
**Figure 30** Detail of vertical crack on south side of masonry wall.

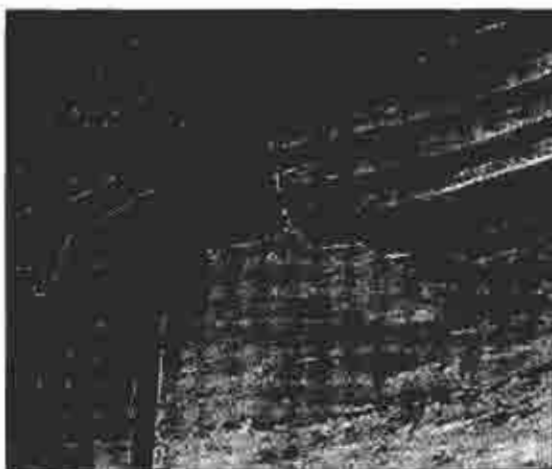
**Figure 31** Detail of masonry repair located above landing support beam.

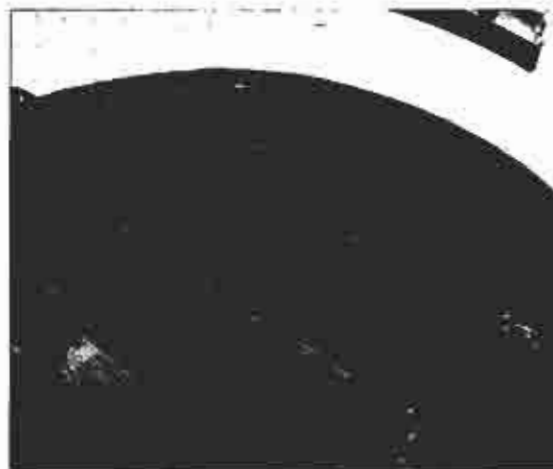
**Figure 32** Detail of water collecting on landing that accesses Service Room.

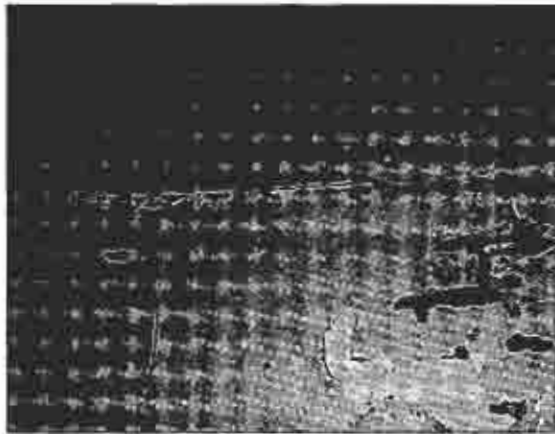
**Figure 33** Detail of peeling paint in Watch Room.

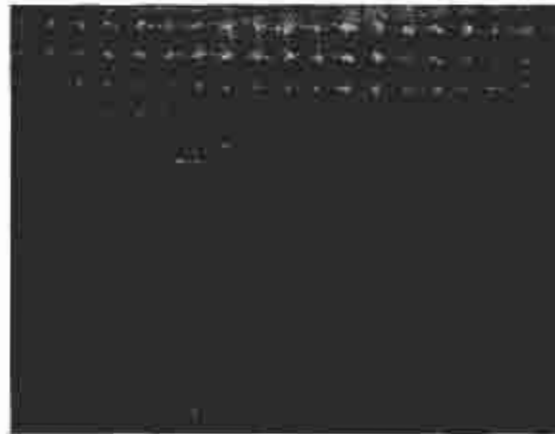
**Figure 34** View from Lantern Gallery.

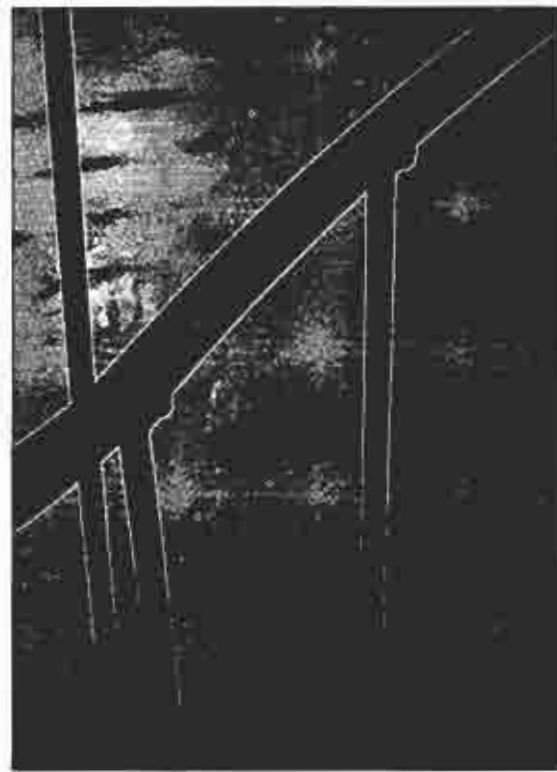
Figure 35 Detail of handrail.

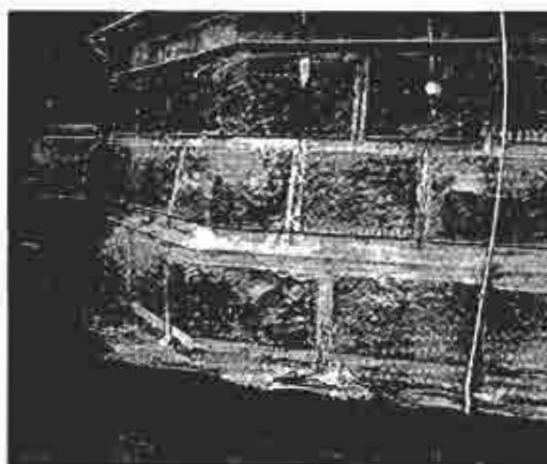
**Figure 42** Conduit for lightning protection, located at tower base.

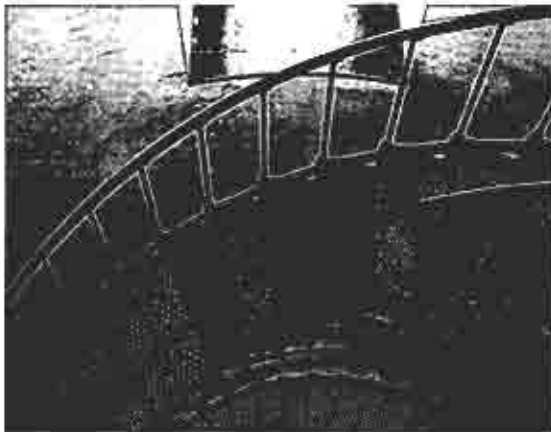
**Figure 43** Detail of stair showing tread repair.

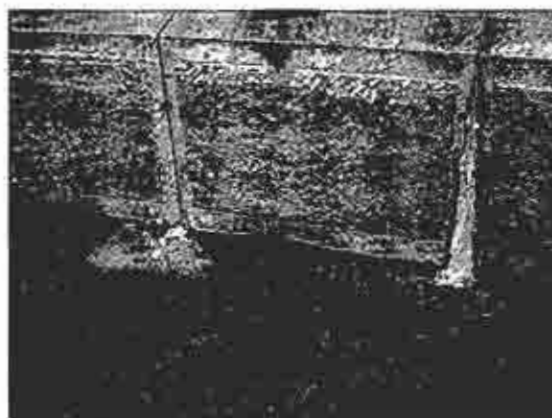
**Figure 44** Detail of foundation showing mortar leaching.

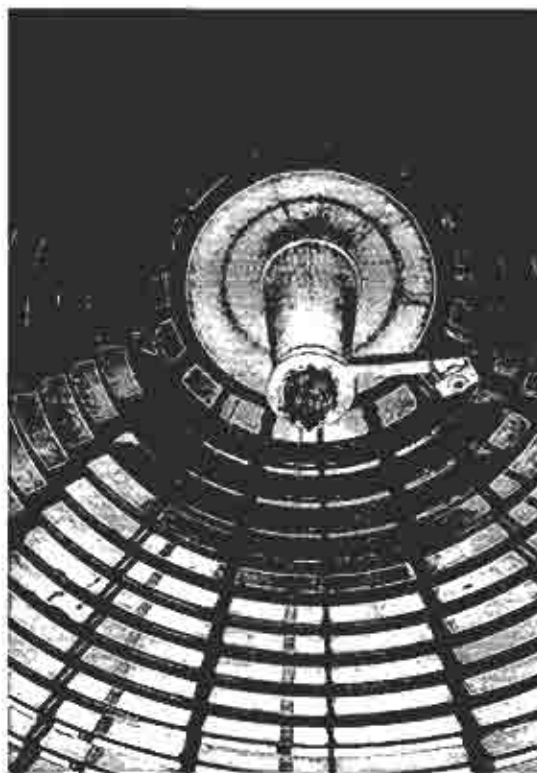
**Figure 45** Detail of Fresnel lens.

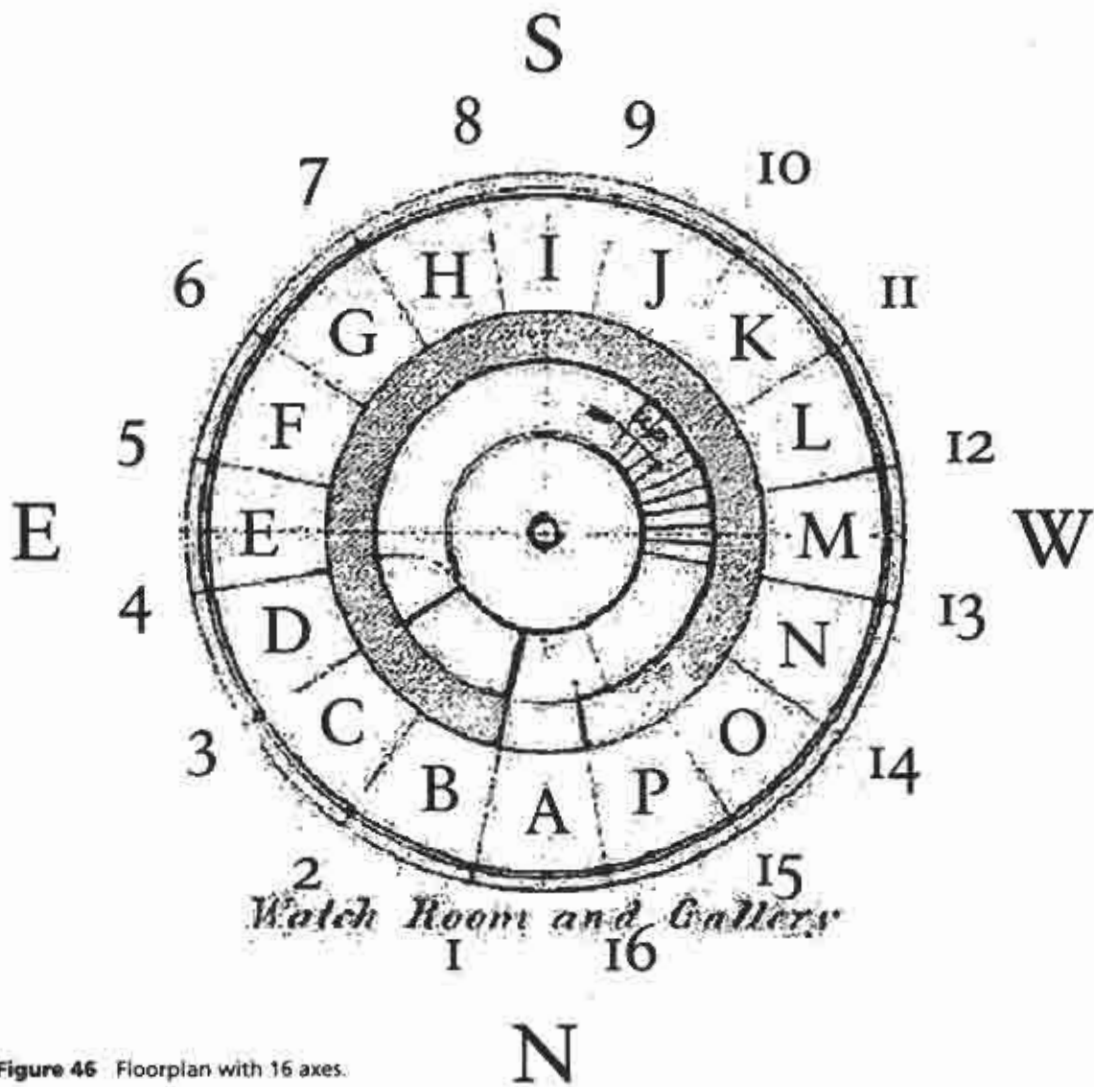
Figure 46 Floorplan with 16 axes.

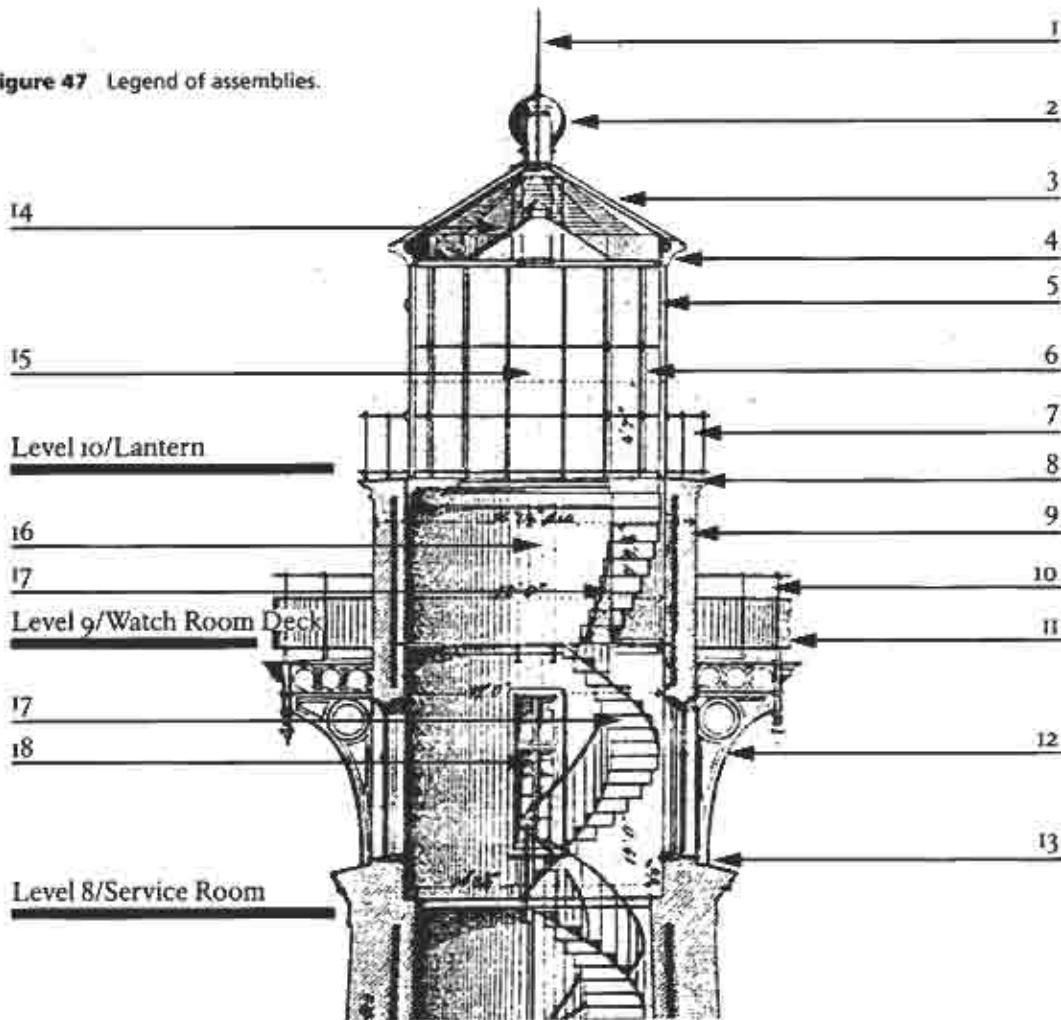
### Overview of Findings
