Cape Hatteras National Seashore
Bodie Island Light Station
Double Keepers Quarters
Historic Structure Report

Joseph K. Oppermann - Architect, P.A.

2009
Historic Structure Report
Bodie Island Light Station
Double Keepers Quarters
Historic Structure Report

Building Investigation/
Building Condition Assessment

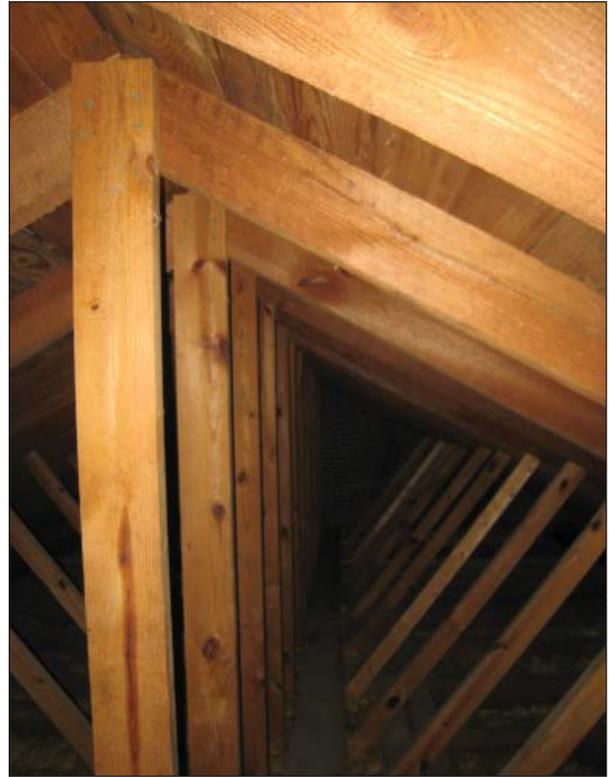
Also at some point, perhaps in 1954, a modern, 1⅝" by 5½" pine board was added as a vertical brace at the connection of each rafter pair and joist. Though not on the 1954 as-built plans these vertical boards were already installed by commencement of the 1990 repairs.

Figure 9, Vertical brace added at unknown date to apparently help support the 1954 oil heater.

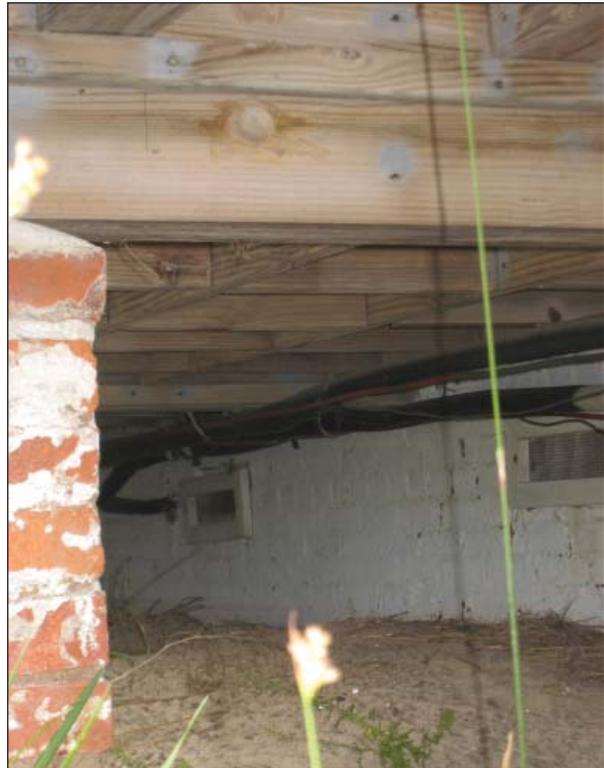
Figure 18, Replacement floor joists at West Porch.

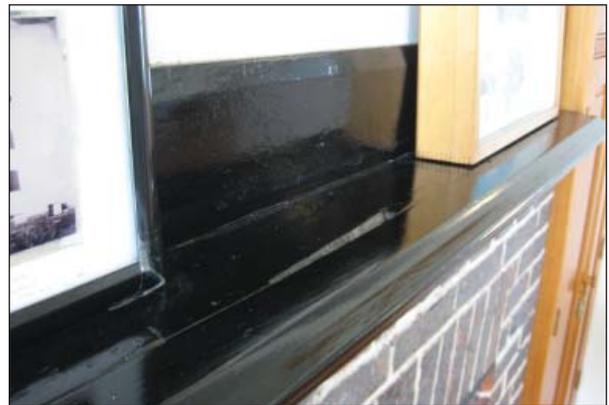
Figure 43, Dutchman repair (1990s) to mantel shelf, Room 101.

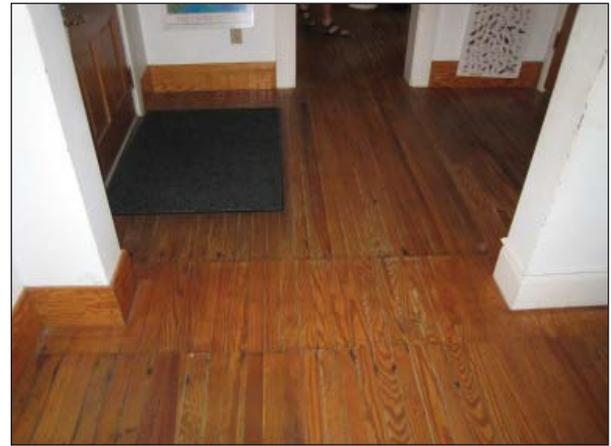
Figure 56, Floor patch at original dividing wall between Room 109 (foreground) and Room 108.
