CAPE LOOKOUT NATIONAL SEASHORE
Cape Lookout Village
FISHING COTTAGE #2
**HISTORIC STRUCTURE
REPORT**

**Historical Architecture, Cultural Resources Division
Southeastern Regional Office
National Park Service**

2004
Historic Structure Report
Fishing Cottage #2
Cape Lookout National Seashore
Cape Lookout Village
LCS#: 091833

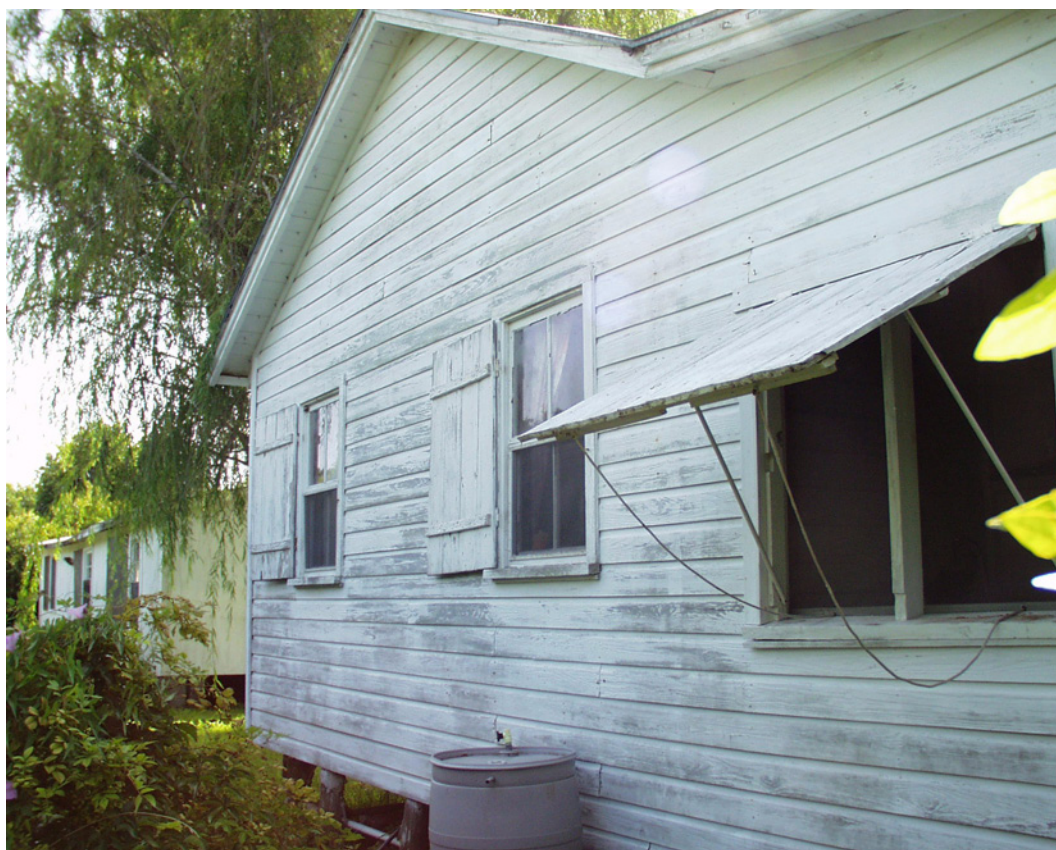
Figure 14 View east showing typical exterior finishes. (NPS-SERO-CR, 2002)

Exterior siding, window and door casing, and trim are intact and in good condition. Except for the porch, where more- extensive repairs may be needed, maintenance of painted finishes is all that is necessary.

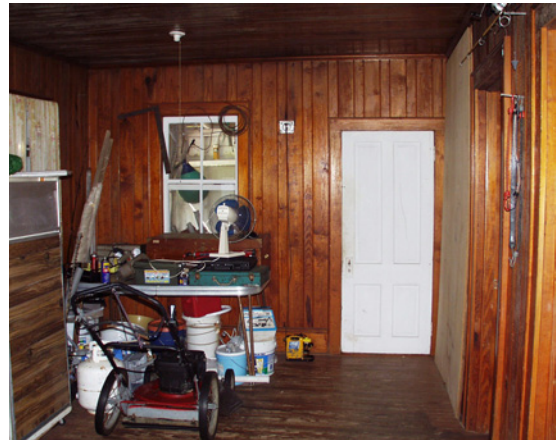
At the northeast end of the main room is a pine counter 6'- 11" long and 25" deep with a porcelain- enameled sink. Although the formica counter top is modern, the base cabinet, which is constructed of the same tongue- and- groove boards used on the walls and ceilings, appears to be original.

Figure 15 View to southwest in Room 100. (NPS-SERO-CR, 2002)

The existing kitchen arrangement should be rehabilitated. Cabinet, sink, and pump can be preserved, but the formica counter top, which is a modern replacement of the original can be replaced. The wall-mounted shelves and cabinet should be preserved.

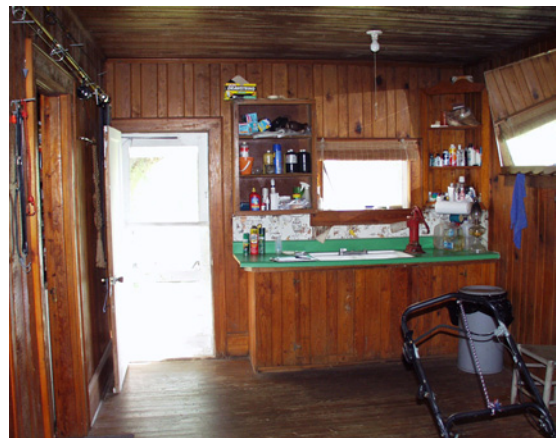
Figure 16 View to northeast in Room 100. (NPS-SERO-CR, 2002)

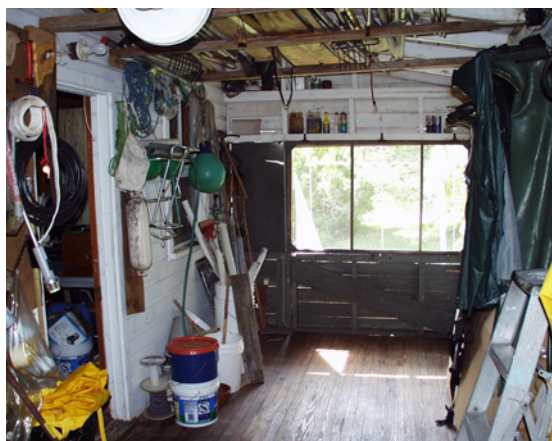
Figure 18 View to southeast on porch. (NPS-SERO-CR, 2002)

The northwest end of the porch has been partially enclosed in recent years to allow installation of a shower and toilet. At the southeast end, the knee wall has been cut and hinged to swing open and part of the wall above the screening has been removed to increase vertical clearance. These alterations are associated with the ramp that allows small vehicles to be stored on the porch.

- Reconstruct missing portions of southeast porch wall
- Remove plywood shutter at southeast end and replicate board- and- batten shutters to match original shutters elsewhere on the building

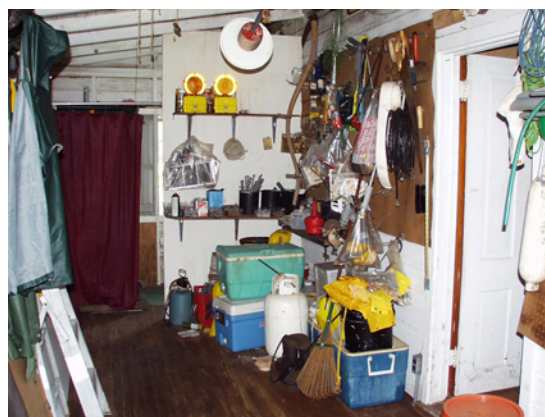
Figure 19 View to northwest on porch, showing enclosure for bath room at center rear. (NPS-SERO-CR, 2002)

Plumbing: The entire plumbing system should be rehabilitated. The existing bath area, which does not include a lavatory, should be replaced by a conventional bathroom in the same location. A framed wall, with a door opening, should be constructed approximately six feet from the northwest end of the back porch to create the space. The exposed back wall of the house and the outside knee walls and screening that form the other walls of the space can be repaired and preserved. The top-hinged exterior shutters are currently raised for light and air in the bath area, and they can continue to be

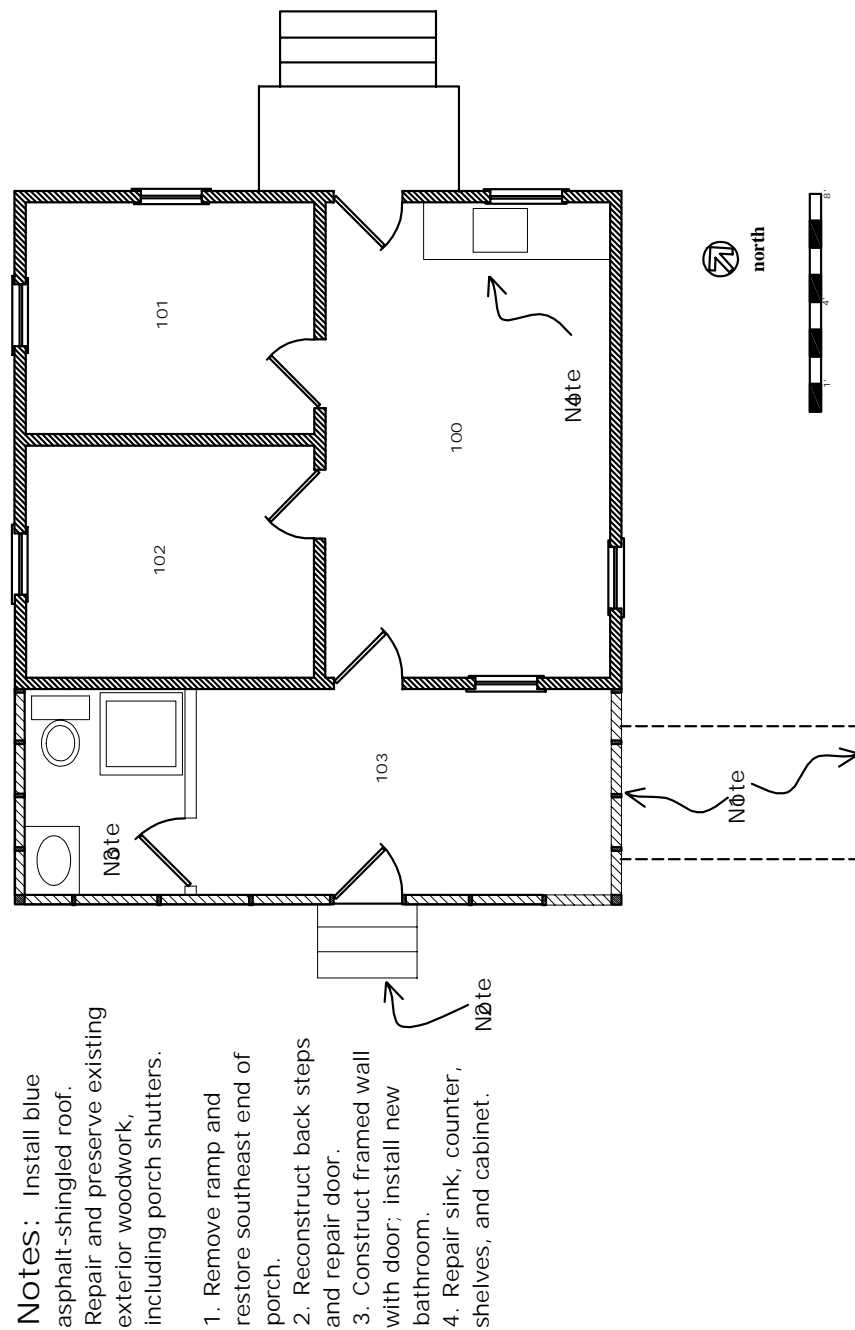
Figure 21 Proposed plan for treatment and use. (T. Jones, NPS-SERO-CR, 2003)
