CAPE LOOKOUT NATIONAL SEASHORE  
PORTSMOUTH  
ED STYRON HOUSE

# HISTORIC STRUCTURE REPORT

**Cultural Resources, Southeast Region  
National Park Service**

2004  
Historic Structure Report  
Ed Styron House  
Cape Lookout National Seashore (CALO)  
Portsmouth Village  
LCS#: 12516

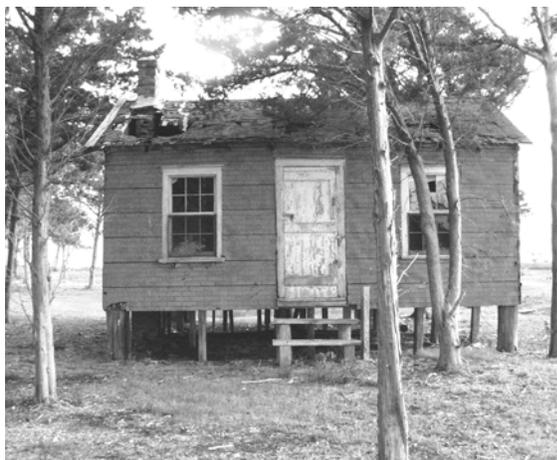
**Figure 2** Left, view southeast of front of Styron House. (NPS-SERO-CRS, 2001)

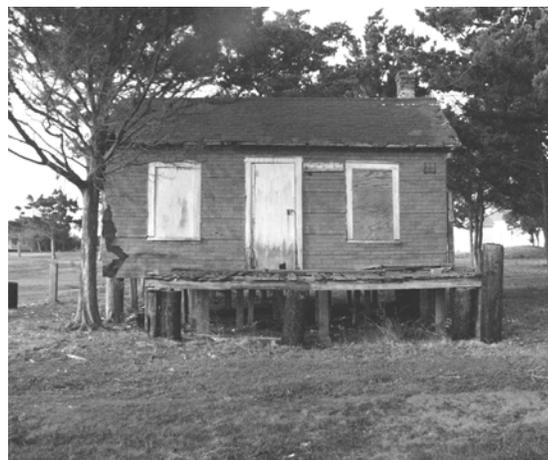
**Figure 4** Right, view northwest of rear of Styron House. (NPS-SERO-CRS, 2001)

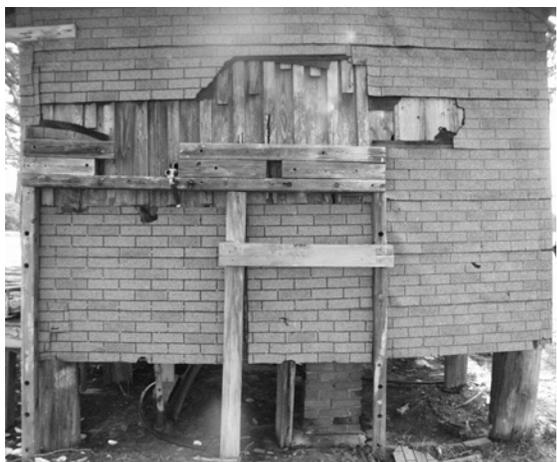
**Figure 3** View of remains of wooden frame for cistern at northeast end of house. Parts of a brick foundation remain in the ground below. (NPS-SERO-CRS)

through a gutter from the southeast (rear) shed of the roof. The gutter and tank are now missing, but part of the wooden frame that supported the tank remains attached to the northeast end of the house.

- Preserve brick pad associated with the cistern at north-east end of house.
- Preserve wooden piers associated with missing addition at southwest end of house.

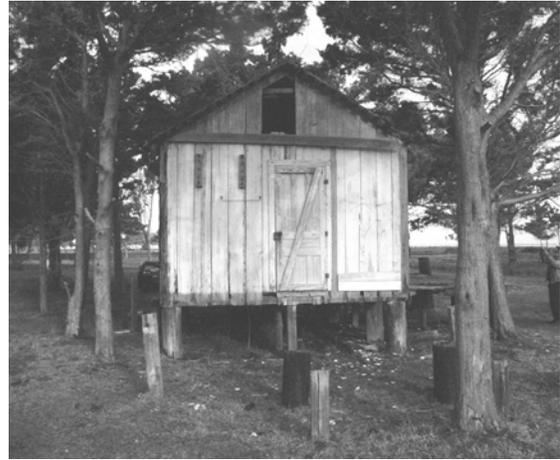
**Figure 5** View of southwest end of house; note piers in foreground which supported the modern addition that was removed after 1984. (NPS-SERO-CRS, 2001)

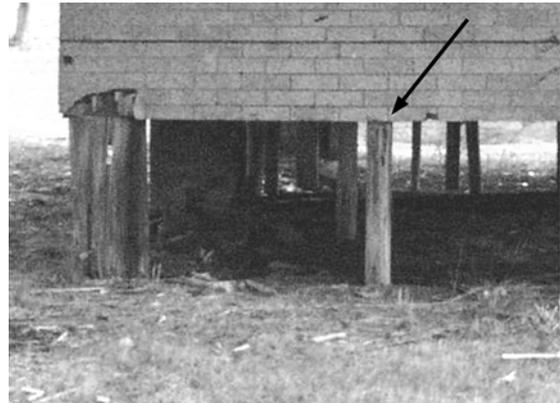
depth into the ground. The original piers appear to be the three 4" by 8" piers on the front of the house, a similar pier at the northwest end, and two 3" by 12" piers under the rear sill of the house. The remainder of the piers appear to have been added or replaced. The most recent piers include the sections of creosoted telephone poles that underpin the four corners of the house.

**Figure 6** View of north end of front of house; arrow marks one of several original wooden piers. (NPS-SERO-CRS, 2001)

- Repair and repoint chimney as necessary.
- Replace modern wooden piers with wooden piers that more closely match the original.

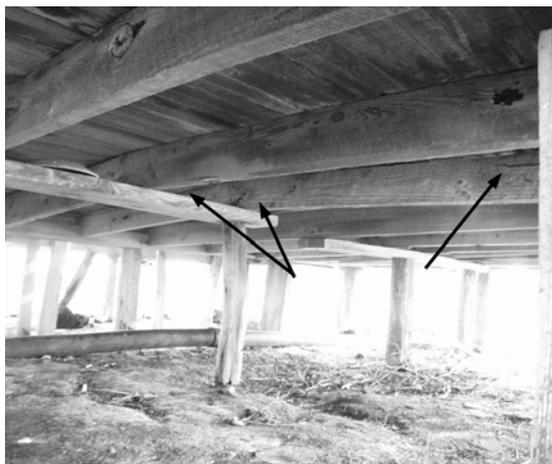
Floor joists are generally 1- 3/4" to 2" by 5- 3/4" to 6", running from the front to the back of the house and set on centers ranging from 22" to 24". Joists are lapped and nailed to the sills. An added support girder made up with 2 x 6s laid flat on wooden posts runs the length of the building and supports the joists at mid- span. Joists are in good condition except for two under the southwest side of the main room (101) which have split where they lap the sills and are broken where they cross the support girder. This damage is due to the deteriorated sill at the rear of the house which, along with settlement of the piers along that side of the house, especially at the northeast end, has allowed the

framing to settle several inches. In addition to allowing the entire house to sink, the sagging joists have pulled away from the flooring above in several areas. Wall framing could not be examined but appears to be composed of standard 2 by 4s on about 24" centers. Ceiling joists

**Figure 7** View of floor framing; arrow at right indicates where joist has split; arrows at center show location of two joists that have broken where they cross the added support beam. (NPS-SERO-CRS, 2001)

- Repair roof structure, preserving existing rafters and reconstructing exposed rafter ends wherever possible.
- Repair or replace rear sill; raise and level building structure.
- "Sister" new floor joists to broken joists.

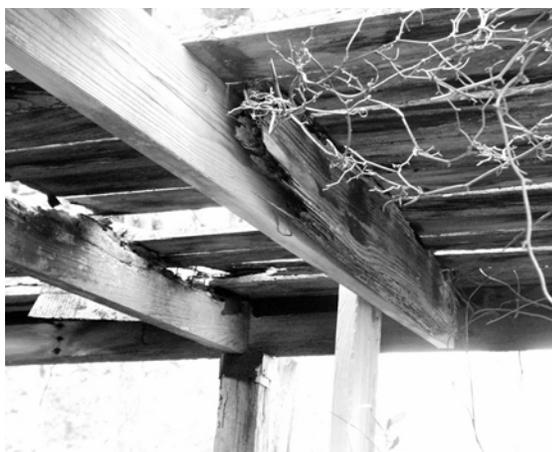
**Figure 8** View under north end of rear deck, showing remains of original floor framing. (NPS-SERO-CRS, 2001)

five now- missing wooden steps on open stringers at the north end of the deck. Set on a variety of posts (none of which are readily identifiable as being original) the deck is framed with modern 1- 1/2" by 5- 1/2" joists running the length of the deck and is floored with 1" - thick boards, 4- 1/2" to 4- 3/4" wide. Remnants of two older joists, about 1- 3/4" by 5- 3/4", survive at the north end of the deck and are an indication that the deck is a feature of the original house.

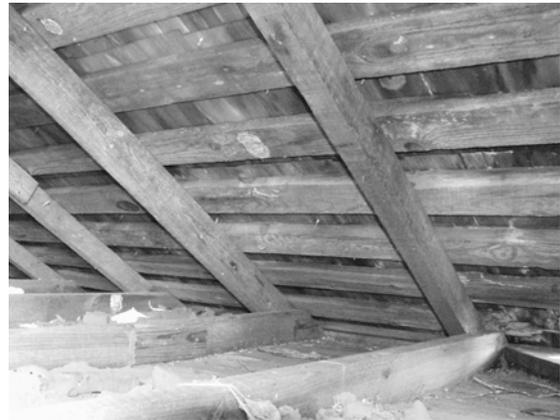
The roof is framed with a mixture of 2" by 3" and 1- 1/4" by 3" rafters set on approximately 24" centers. Rafters are nailed at the ridge without a ridge board. Roof decking is composed of 1" by 4" boards spaced about 3" apart. The roof was originally covered with wood shingles, many of which remain in place. The last roof covering, which probably dates to the 1950s, is a distinctive asphalt composition roof, much of which survives but in very poor condition. Shingles have a green mineral coating, embossed with a wood- grain texture. Failure of the roof covering has caused major damage to the roof decking and a few joists and has also exposed the interior of the house to major damage, particularly around the north corner of the house and on the northwest side of Room 102.

**Figure 9** View of southeast shed of roof; note wood shingles still in place. (NPS-SERO-CRS, 2001)

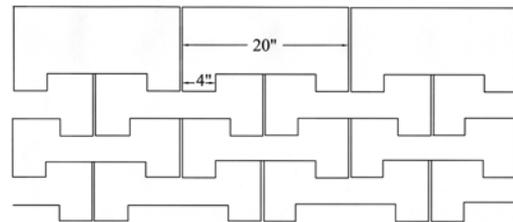
The house has been re-roofed only once, after 1939 when the present textured asphalt composition roofing was first offered for sale by the Rubberoid Company.<sup>10</sup> Textured shingles were widely-used into the 1950s, which is when the present roof was probably installed. This assumption is based on the facts that the original wood-shingled roof would have probably remained serviceable for at least twenty years and that the asphalt roof remained in reasonably sound condition when it was first photographed in 1984.

**Figure 10** Pattern of mid-twentieth century asphalt shingles on Styron House. (NPS-SERO-CRS, 2001)

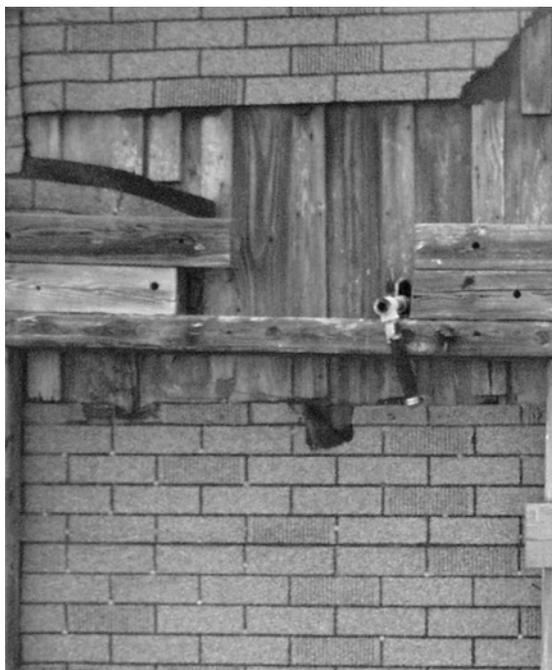
The exterior finishes were considerably altered for installation of the brown, asphalt- composition "brick" panels that now cover most of the exterior. The panels may have been installed around the same time as the asphalt- shingle roof. In order to provide a flat surface for this "brick," battens were removed from the entire house except for a few which remain on the northeast end (see Figure 2, above). In addition, the vertical board siding on the rear (or southeast) side of the house appears to have been relaid horizontally. The lower 12" - 24" of all (or nearly all) of the surviving vertically-placed boards have suffered severe deterioration and rot. It is possible that the boards on the rear were especially deteriorated due to their proximity to the porch deck. To repair the damage, the boards may have been removed, the damaged portion sawn off, and the remainder of the board re- laid horizontally.

**Figure 11** View of “brick” asphalt-composition siding over original board-and-batten siding at northeast end of house. (NPS-SERO-CRS, 2001)

- Remove existing "brick" siding, archiving as much material as practical for possible later re-use.
- Repair board and batten siding, replacing damaged and missing elements as necessary.
- Paint siding red, trim white.

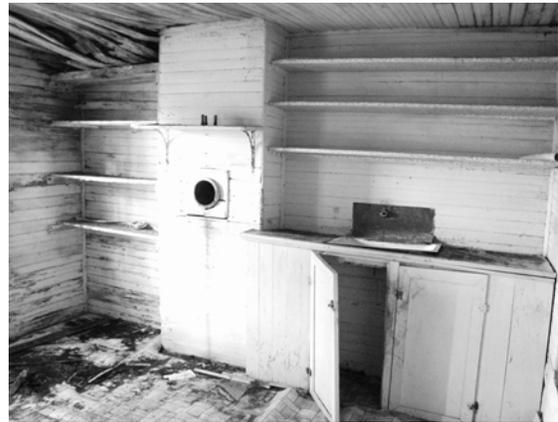
**Figure 12** View north in main room (101). Sink is to right of chimney. (NPS-SERO-CRS, 2001)

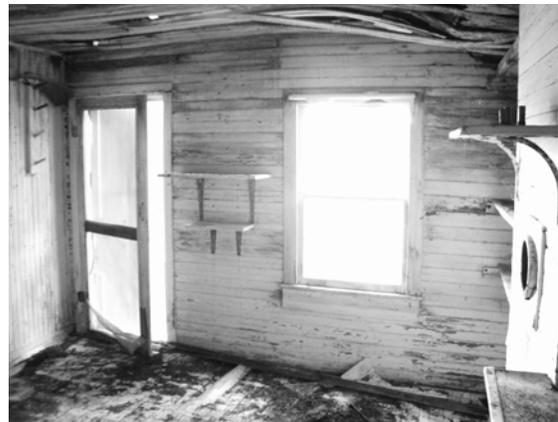
**Figure 13** View west in main room. (NPS-SERO-CRS, 2001)

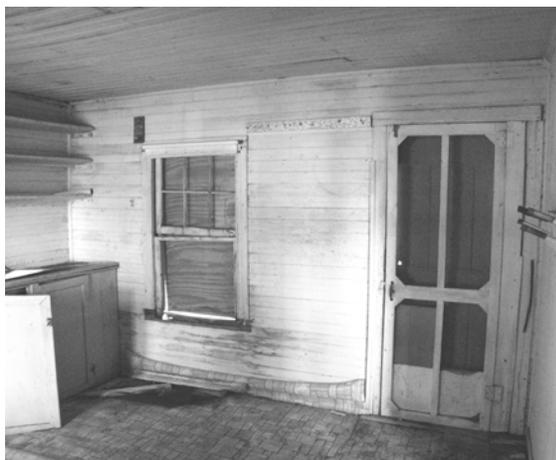
**Figure 14** View east in main room. (NPS-SERO-CRS, 2001)

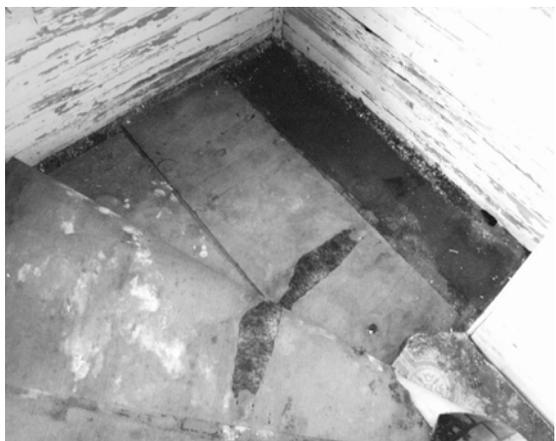
*Floor:* Flooring is narrow tongue- and- groove with a face 2- 1/2" wide. It appears to have always been painted gray and remains in excellent condition, having been covered by linoleum at an early date. The floor has three layers of floor coverings, none of them in good condition. The top layer is a modern, sheet- vinyl floor covering, probably installed in the 1970s. Beneath it is a green- and- gold patterned, sheet- vinyl floor covering that may date to the 1960s. The earliest layer probably dates to the 1930s or 1940s and is one of the felt- based imitators of linoleum that were widely used before the mass- marketing of modern vinyl floor coverings in the 1950s.

**Figure 15** View of floor in northwest corner of main room, showing early felt-based, imitation linoleum under two later floor coverings. (NPS-SERO-CRS, 2001)

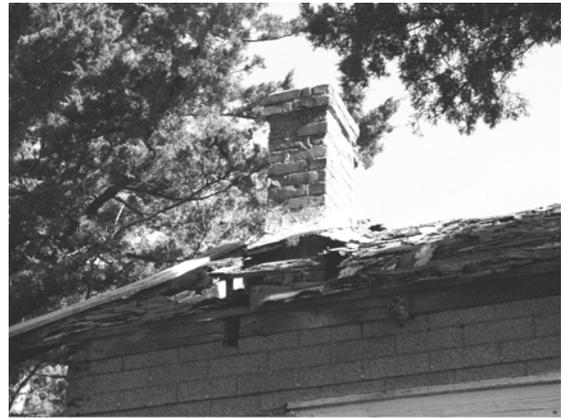
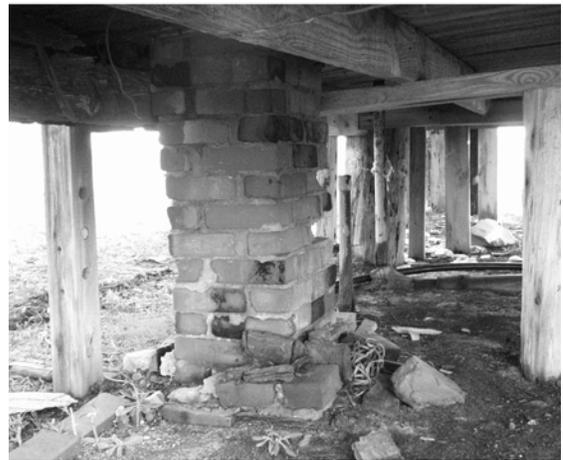
chimney with its 7-1/2", terra-cotta, stove flue. The foundation of the chimney has deteriorated, mostly due to rising damp. The chimney stack above the roof also has some spalling brick; where it rises through the roof, the brick has been disfigured by repeated applications of tar and other sealants.

**Figure 16** Top, view of chimney stack; below, view of chimney foundation. (NPS-SERO-CRS, 2001)

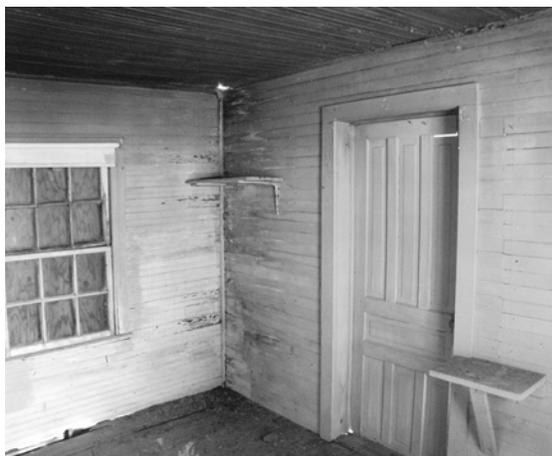
The third exterior door opening is at the southwest end of the house and was installed to replace a window when the now-missing addition was built at that end of the house. The door is 2'-6" by 7'-1" with a single, horizontal, raised panel between four vertical raised panels

**Figure 17** View south in Room 101. Door to right was originally a window opening, converted into a door to the addition in the 1950s. (NPS-SERO-CRS, 2001).

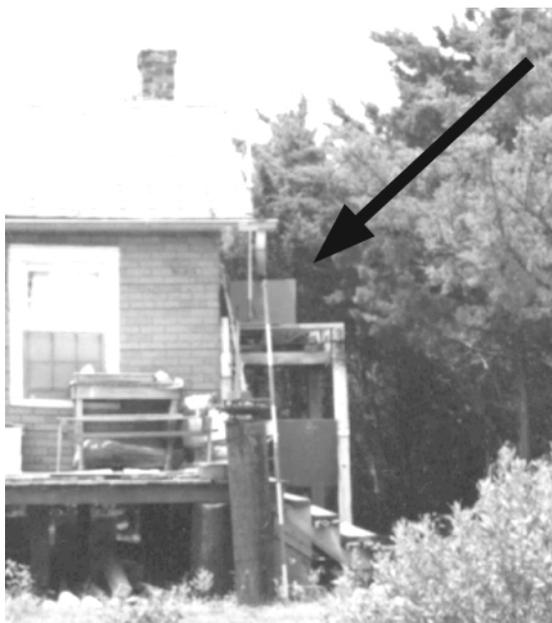
The only water supply was from the cistern at the northeast end of the house. It was supplied by a downspout from the gutter across the rear (southeast) side of the house. Except for part of the support frame and a galvanized iron supply pipe that runs through the wall, all components of this cistern are now missing.

**Figure 18** Detail from 1984 photograph, with arrow indicating now-missing cistern. (NPS-CALO, 1984)
