Cape Lookout Village Lewis-Davis House Historic Structure Report

HISTORIC STRUCTURE REPORT

**Historical Architecture, Cultural Resources Division
Southeast Regional Office
National Park Service**

2004

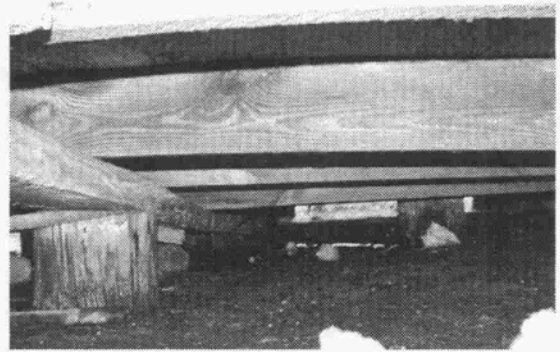
The wood frame of the main body of the house is set on a series of wooden piers, 8"- 12" in diameter, sunk to some indeterminate depth into the ground. Piers are so low that the house's frame is only a few inches above grade. Most are, at best, in fair condition, and concrete block have been inserted at some locations to provide additional support. Water is standing under large areas of the house, contributing to its ongoing deterioration.

Figure 23 View of crawl space and piers. (NPS-SERO-CR, 2002)

- Raise house and replace all wood piles, replicating the existing size and placement of piles.
- Design and install storm-resistant mechanism to tie the house's wood frame to the foundation piles.

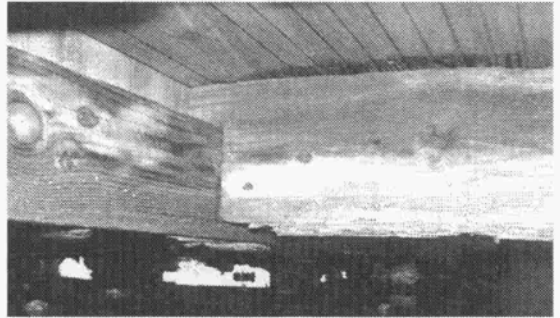
Floor: Floor joists appear to be a mix of 2" by 4" and 2" by 6" (actual dimensions could not be ascertained), set on 30"- 36" centers. Deterioration is widespread. Sills appear to be mostly single 2" by 8". Along the northwest side of Room 104, floor joists and sill have collapsed and there is major structural damage in Room

Figure 24 View of typical joist sill connection. (NPS-SERO-CR, 2002)

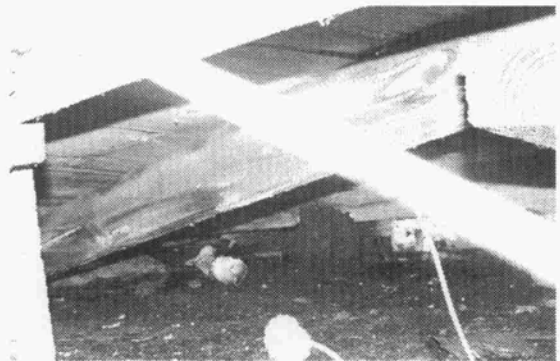
The structure has suffered major damage from termites and a leaking roof. Floors are collapsing in Rooms 101, 104 and 105, and there appears to have been major damage to the sills throughout the house. The roof, too, is in extremely poor condition, with large areas of rotten and termite-ridden rafters and decking. Although most of the historic finishes remain in place, the house as a whole is in very poor condition.

Figure 25 View of collapsing floor under Room 104. (NPS-SERO-CR, 2002)

- Stabilize structure before repairs proceed.
- Remove 1950s roof structure and restore original roofs.
- Repair floor, wall, and ceiling framing as necessary and make improvements in connections of framing members to reduce the possibility of significant damage from high winds.
- Remove porch additions and restore porches to their appearance in the 1940s photographs.
- If entire house cannot be salvaged, repair and preserve original structure encompassing Rooms 100 and 101.

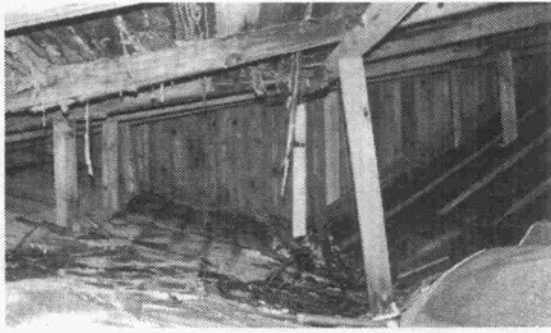
The valley at the junction of the two gabled roofs on the house must have been an ongoing maintenance problem, and after World War II the present roof line was created. The rear shed of the roof was removed entirely and a new roof structure was built over both roofs, eliminating the valley between the two sections of the house. At the same time, the front shed of the roof was extended to fully engage the roof of the front porch. Given the time period in which this occurred, it is likely that the covering for the new roof was asphalt shingles, which seemed to have generally replaced wood

Figure 26 View of junction of roofs of two original structures; note severe termite damage in rafters and decking at left. (NPS-SERO-CR, 2002)

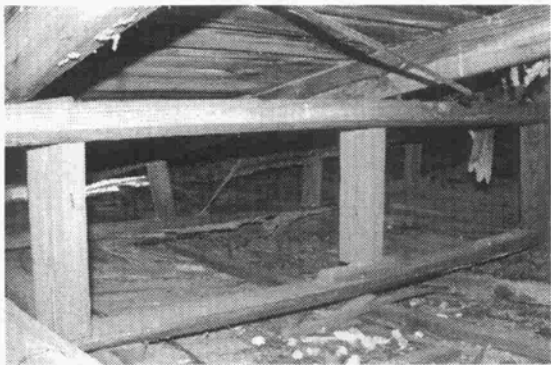
Figure 28 View of heavily-damaged roof and ceiling structure over Room 104. (NPS-SERO-CR, 2002)

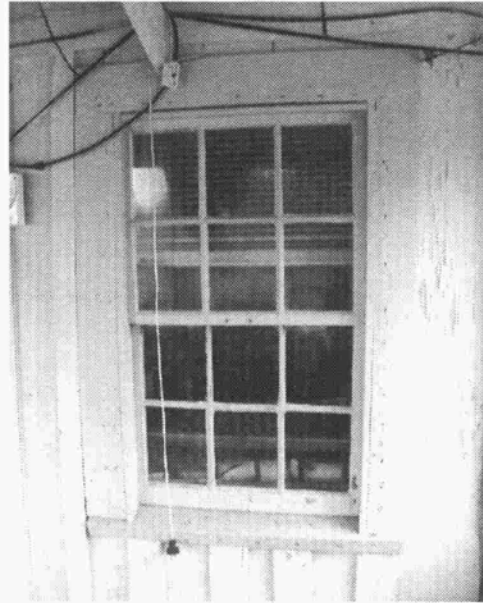
Figure 29 View of window W-2 on southeast (front) side of house, with exterior siding and trim typical of the original building. (NPS-SERO-CR, 2002)

- Preserve historic sash (W-1, W-2, W-4).
- Restore altered opening (W-3) in Room 100.
- Replace missing sash (W-8) at rear porch.
- Repair or replace remaining sash as necessary.

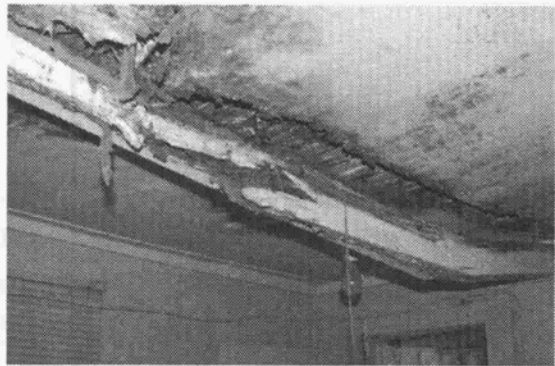
Ceiling: The ceiling, like the floor, is on the verge of total collapse due to severe termite and water damage. It was originally finished with double- V- joint, tongue- and- groove boards, 3-1/2" wide.

Figure 41 View to east of ceiling in Room 104. (NPS-SERO-CR, 2002)
