Cane River Creole National Historical Park
Oakland Plantation
Gin Complex
Historic Structures Report

Hartrampf, Inc.

2004
Historic Structures Report
Gin Complex
Oakland Plantation
Cane River Creole National Historical Park
Natchitoches, LA
LCS#: 100635

Historic Structures Report

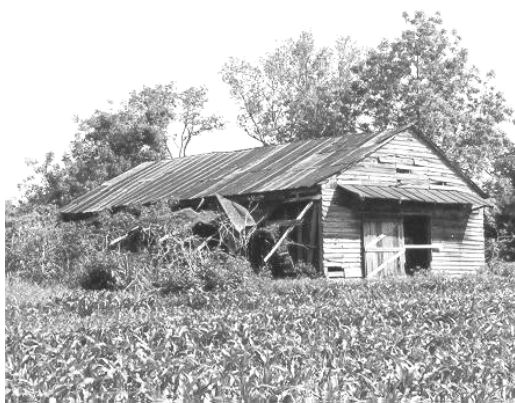
Figure 11. Seed house. c. 1999.

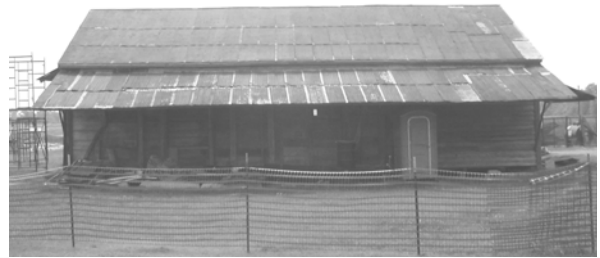
Figure 13. Seed House, north elevation.

Reconstruction and modification of exterior walls.

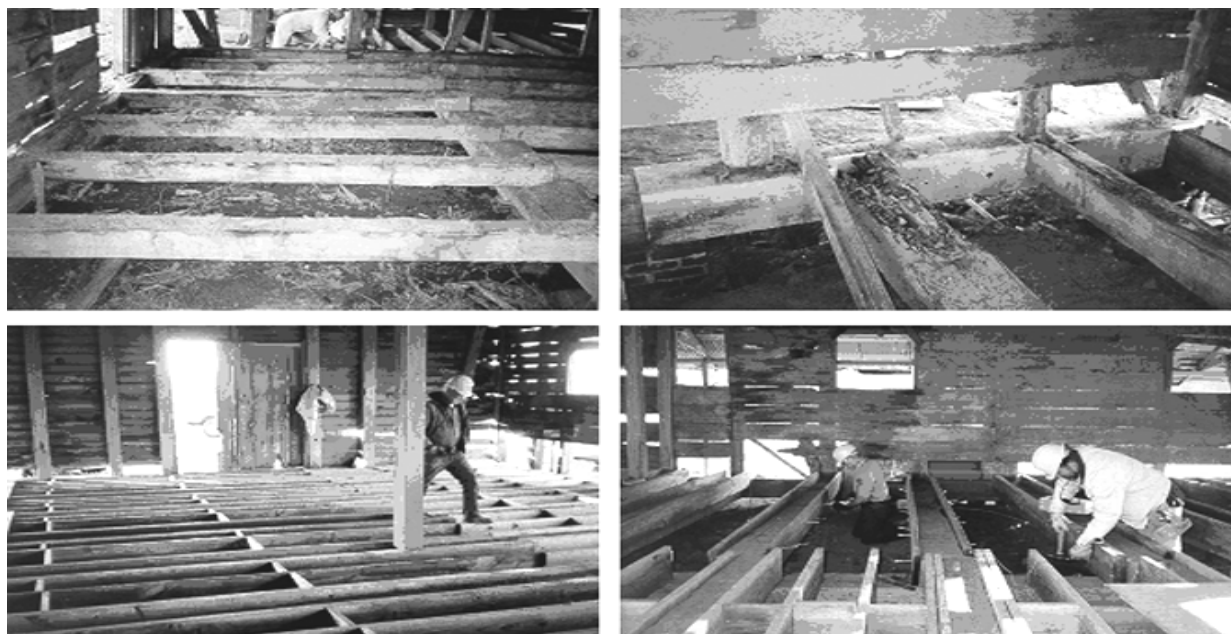
Figure 14. NPS rehabilitative work on the floor framing system of the Seed House, 1999. Note sistering of historically sloped floor beams to achieve level floor surface.

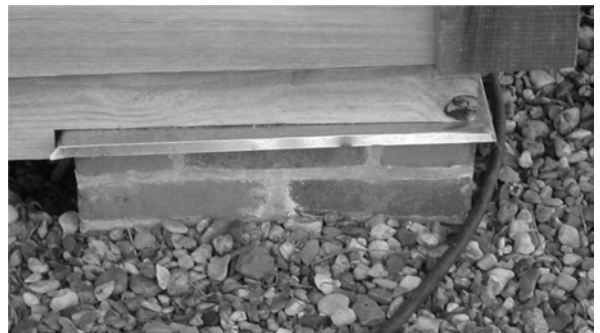
Figure 24. Typical perimeter Pier/ Post 1999.

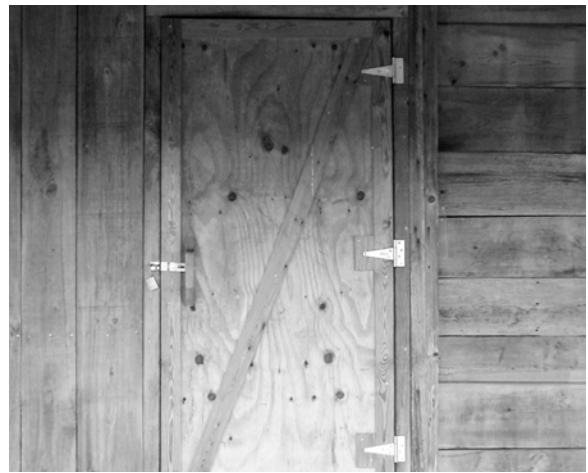
Figure 42. Detail of exterior siding, south elevation. Note the differing materials on either side of the door.

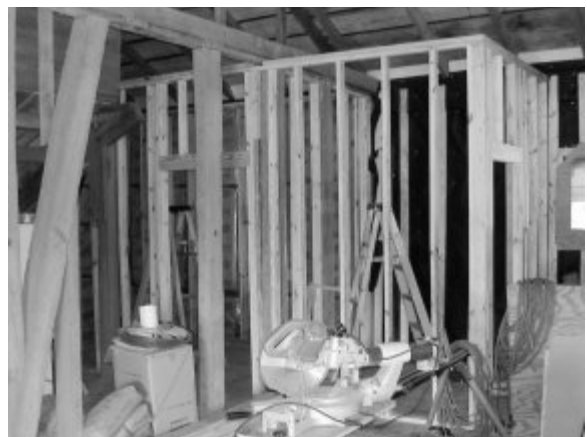
Figure 52. Framing for restroom and storage room in Seed House.
