Cane River Creole National Historical Park
Oakland Plantation
The Cottage
Historic Structure Report

Historic Structure Report

Cottage

Cane River Creole National Historical Park

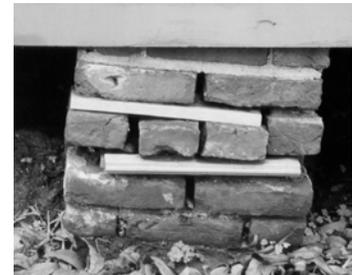
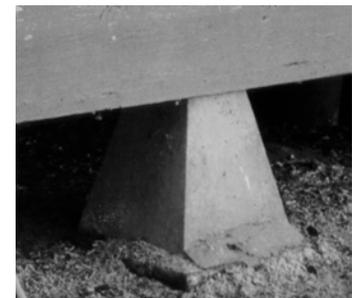
Brick piers and concrete pylons support the structure. Piers are generally about 17" x 14". Precast concrete pylons were used to replace deteriorated brick piers and/or supplement earlier foundation support in certain areas, most notably on the northwest corner of the building, the area of the 1880 addition. The concrete pylons were installed in 1998 and 1999.

Many of the remaining brick piers are in various stages of deterioration, specifically in the mortar joints. It is likely that the earlier piers have no sub-grade foundation component to their assembly. In some cases, wood blocking has been inserted into exposed masonry joints to help stabilize the piers. Wood blocking between the wood beams and the brick piers were noted at some piers. This type of blocking is typical of construction at the plantation and in the region. Cedar blocking, generally the thickness of a masonry unit, was inserted between the brick and the beams to prevent

wicking of moisture from the ground through the bricks and into the beams. The small wood blocks were more easily replaced when deteriorated than the large framing beams holding up the house.

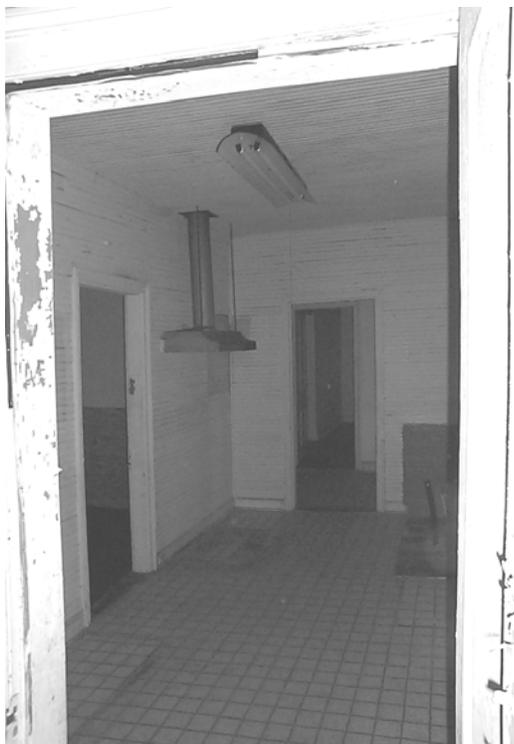
Utilities: There are two duplex outlets in the east wall. The room has a light fixture in the center of the room (Fixture Type 3). An electrical panel box is located on the north end of the room.

Miscellaneous Features: There is a fire extinguisher hanging on the west wall. It is expected that the extinguisher was placed there by the National Park Service as a fire protection measure.
