Carl Sandburg Home National Historic Site

Chicken House/Wash House

Historic Structure Report

September 2007

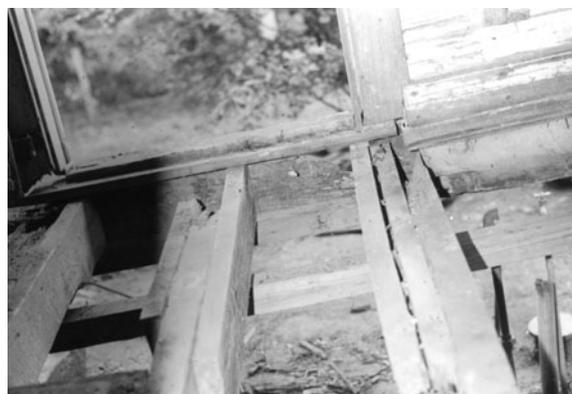
Figure B-10 Flooring removed in Kid room to facilitate joist repairs, Haynes, 1977 (CARL4007/35/09P)

Photographic documentation of the repair work begins in late 1977 and continues into the following summer. It shows that flooring was removed to facilitate repairs to framing. Dutchman repairs were made to the sills and studs, and many floor joists were sistered.

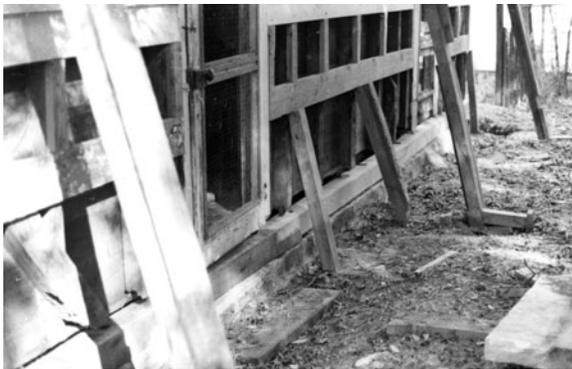
*Figure B-12 Sill repairs on east elevation,
summer 1978 (CARL4008/05/59P)*

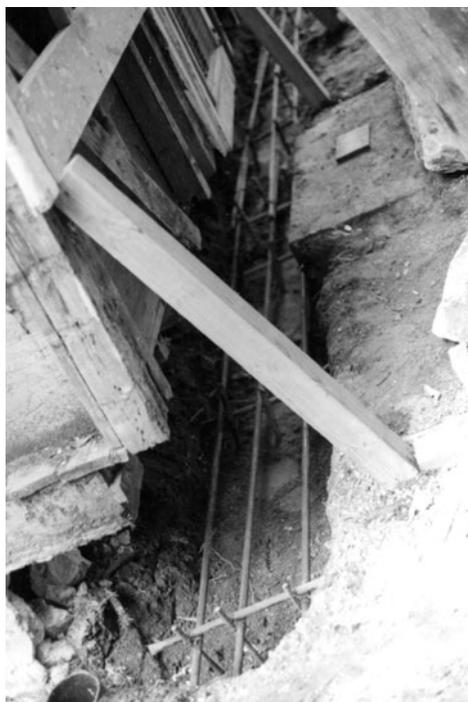
Figure B-13 New reinforced concrete footings, November 10, 1977 (CARL4008/05/35P)

Some siding was removed as well, and it is not known whether any of the removed siding was reinstalled or if new siding was used in its place. The building was shored up and the stone foundation completely removed. A reinforced concrete spread footing was poured, and the foundation rebuilt. It is not known if the original foundation stones were re-used, but it seems likely.

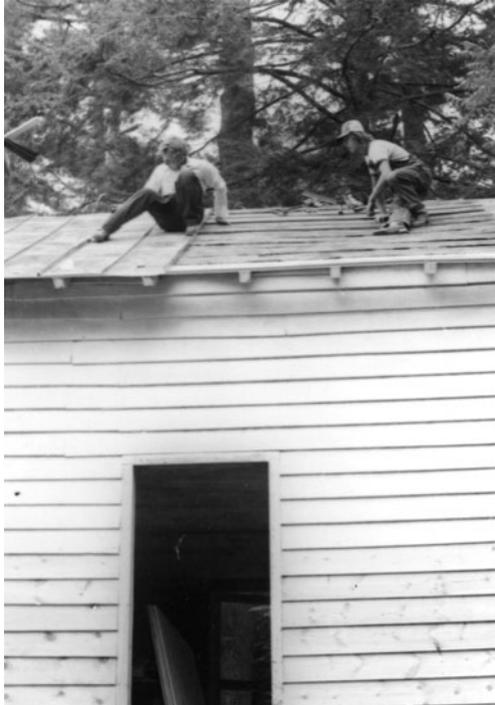
*Figure B-15 Roof repairs in progress, May 1978
(CARL4008/05/46P)*

A purchase order for roof replacement dated September 23, 1977, indicates that McCall Sheet Metal & Roofing, Inc., was awarded a contract for \$965 for installation of a new standing-seam tin-coated metal roof and flashing of the chimney. An amendment to the contract for roofing metal, dated May 26, 1978, added \$207.90 to McCall's contract. CARL records state that the building was painted by John Tulen in 1978.

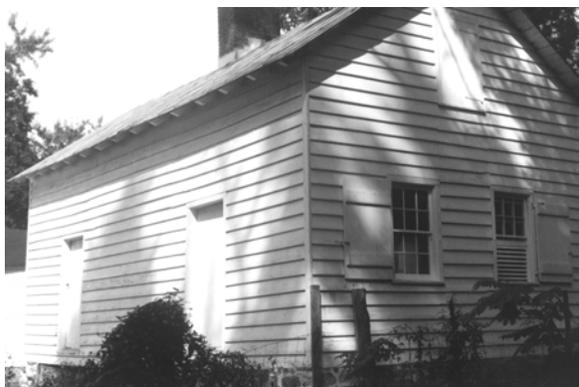
Figure B-18 Southwest oblique of Chicken House, presumably showing completed repairs, 1985 (CARL4004/21-02P)

special consideration to the original, replace only what is necessary and restore to original appearance; vent foundation by leaving cracks between underpin boards and screen behind boards to keep out pests.” It is assumed that this work was carried out, though photo-documentation of the repairs is sparse.

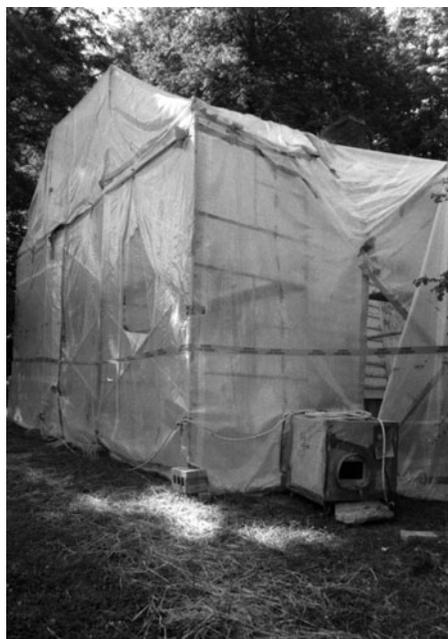
Figure B-19 Northwest oblique, showing tent for lead abatement, 2001 (CARL4018/2-116P)

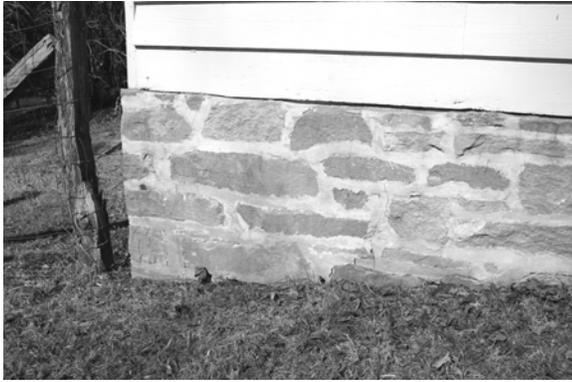
Figure C-3 Stone foundation near west corner of south elevation

Foundations & Cross Walls: The perimeter foundation walls are made of randomly-coursed blocks of granite, and they were rebuilt in the 1970s work. It is not known if the original stones were reused, though it is likely. Photo-documentation indicates that poured-in-place concrete footings were installed at that time.

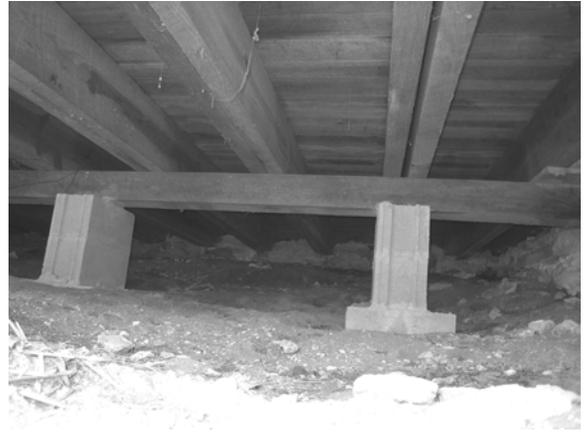
Figure C-6 Floor framing with modern sistered joists and CMU supports

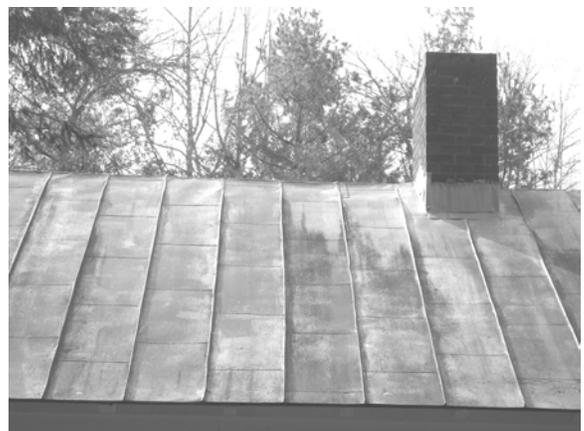
Roof and Rainwater Collection/Dispersal: The roofing material consists of standing-seam terne-coated metal roofing, installed in 1978. It replaced a previous metal roof seen in the earliest clear photo of the building, dated c. 1946 in the early years of

Figure C-8. Terne-coated metal roofing and stepped chimney flashing.

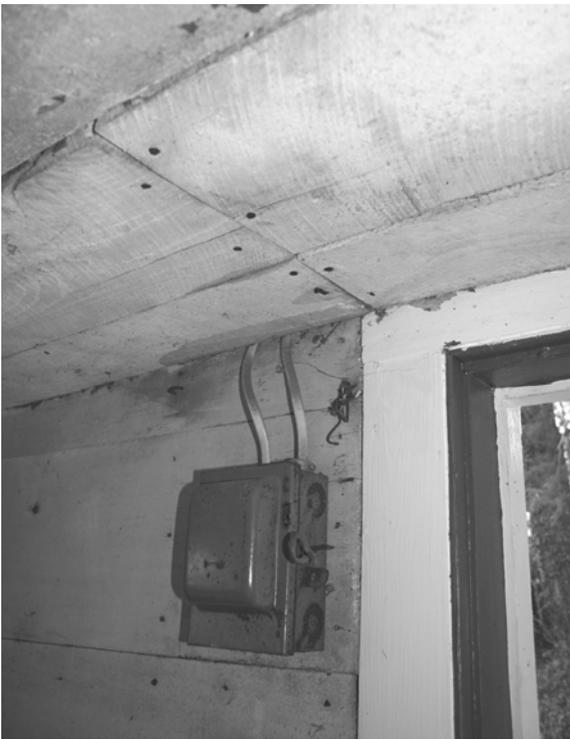
Ceiling: The ceiling is sheathed in what is probably the original tongue-and-groove boards measuring 3/4" thick by 10 3/4" wide, with some 11" wide boards. Two ceiling boards nearest to the east wall are newer circular-sawn boards measuring 6" and 9 1/2" wide by 7/8" thick. It is assumed that these ceiling boards were replaced when the adjacent electrical disconnect box was added in 1976.

Figure C-49 Disconnect box on east wall of Room 102B, with adjacent replacement ceiling boards

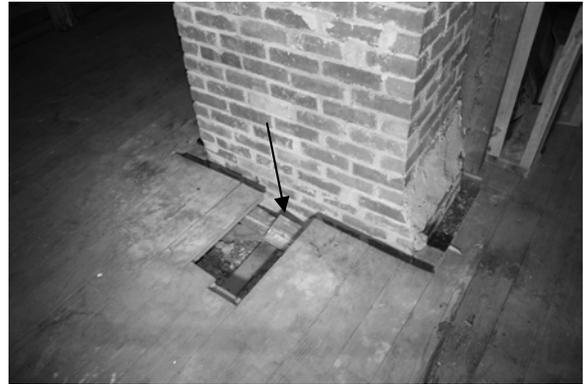
Figure C-63 Painted sections of baseboard discarded in floor cavity
