# HISTORIC STRUCTURE REPORT

## Hoover Block

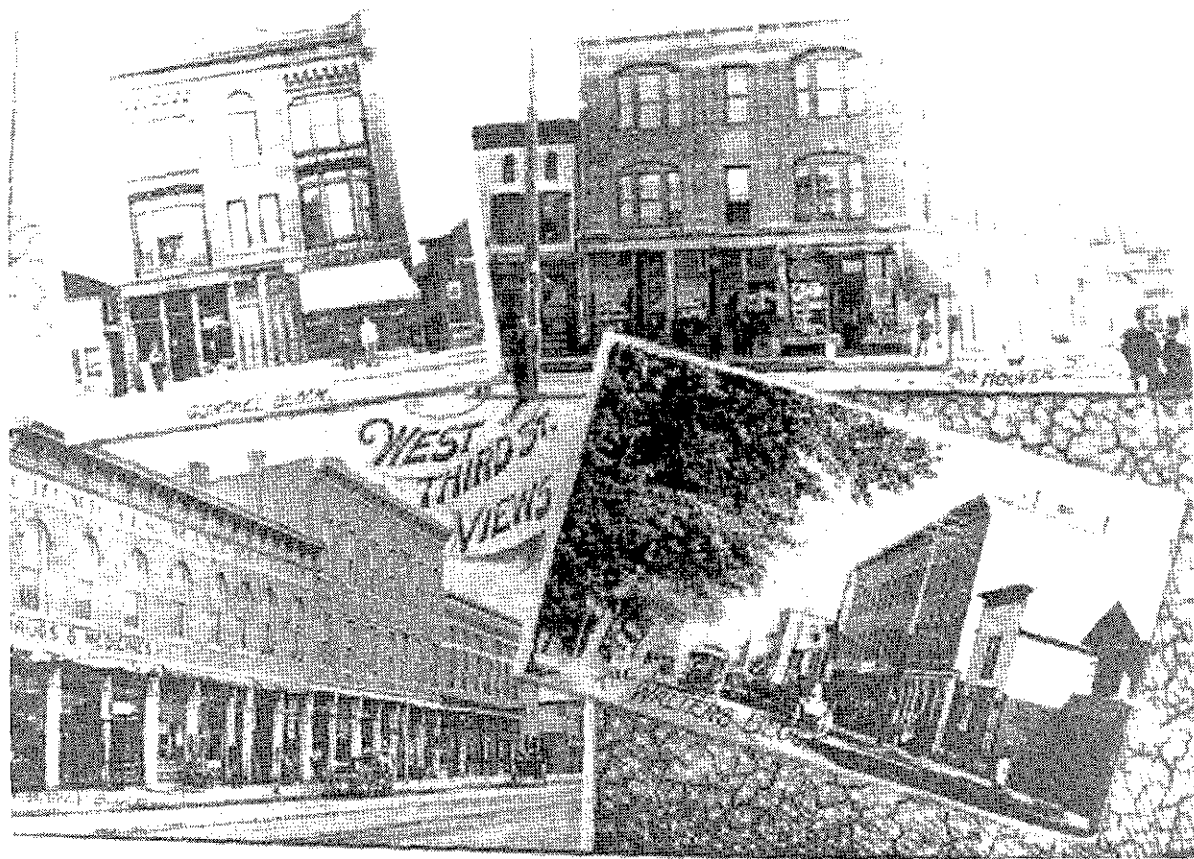
Figure 2 This composite photograph, ca. 1893, features several of the commercial buildings on West Third Street. *New Dayton Illustrated* (Dayton: National Coupon Publishing Company, 1893).

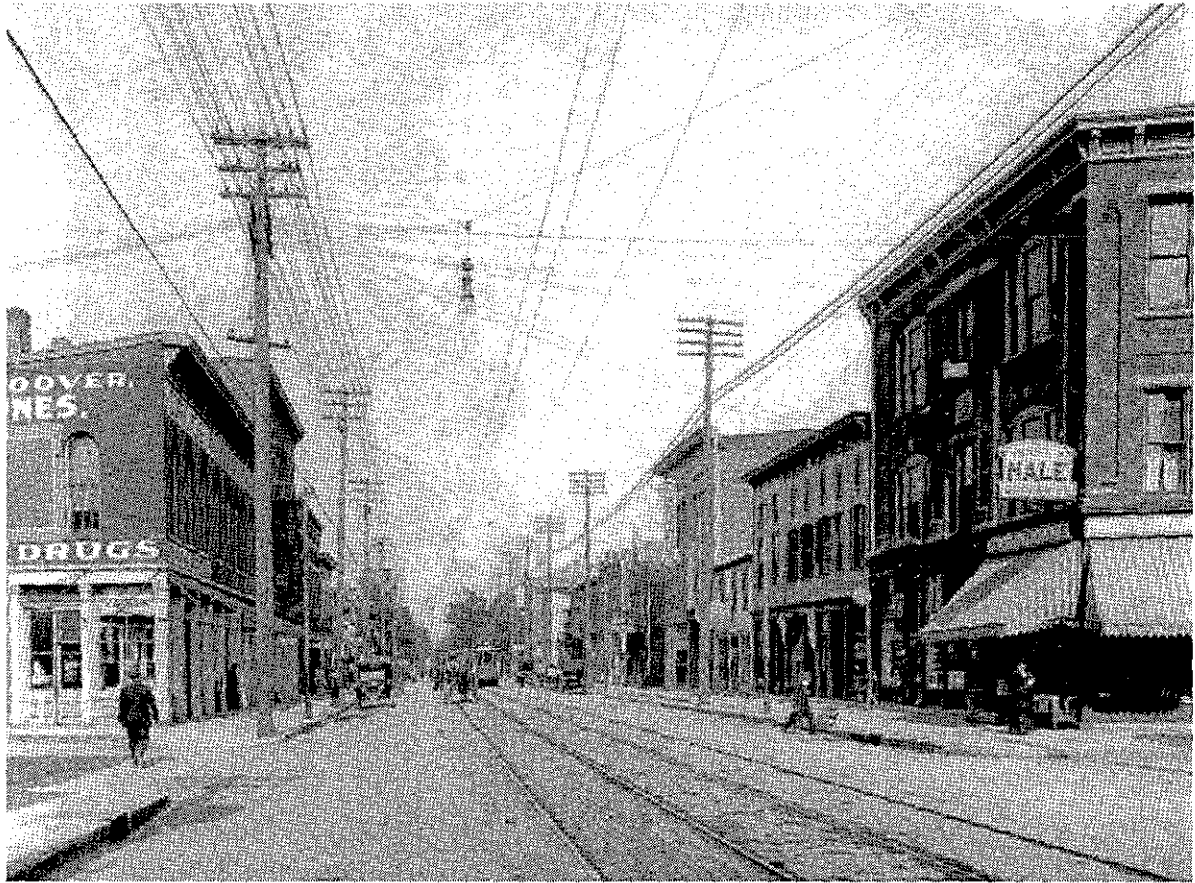
Figure 3 View looking east on West Third Street, ca. 1912. The Hoover Block is the first building on the right with the Frank B. Hale sign. (Marvin Christian Collection, William Preston Mayfield Photos)

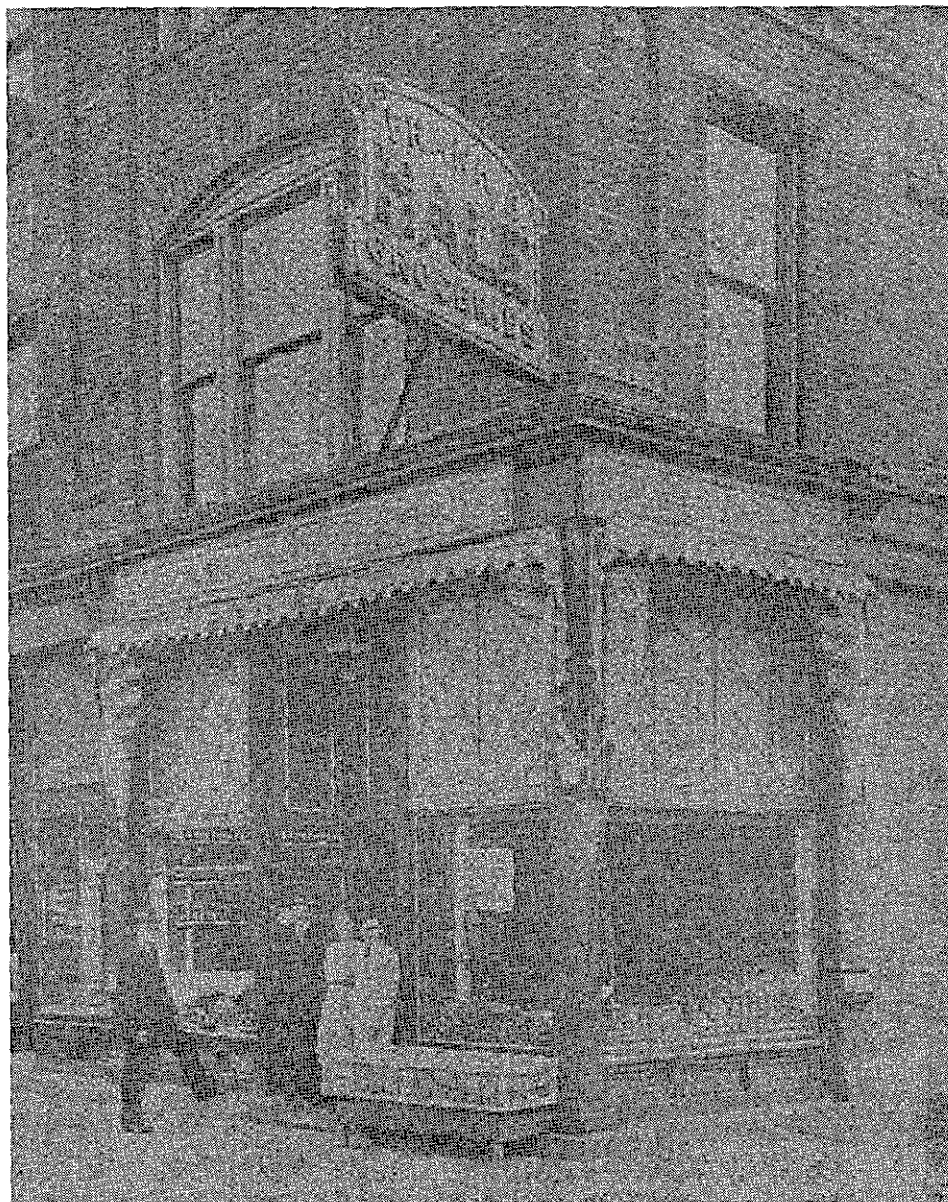
*Figure 4* View of the northeast corner of the Hoover Block, 1915. Note the curb cut, and the ramped entrance into Frank B. Hale's store. (*Dayton Daily News*, May 16, 1915).

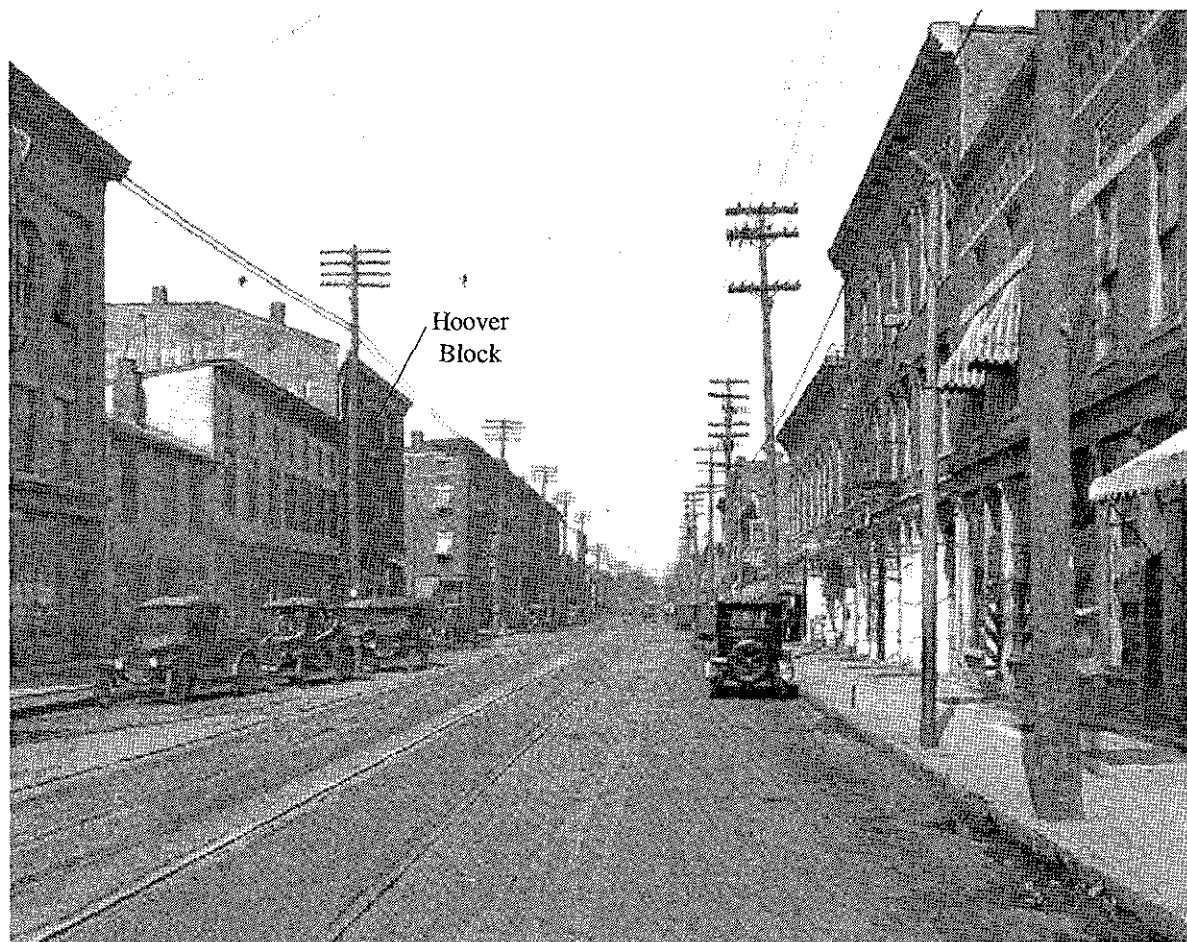
Figure 5 View looking west down West Third Street, ca. 1921. Note the two chimneys and partially painted sign on the east elevation of the Hoover Block. (Marvin Christian Collection, William Preston Mayfield Photos)

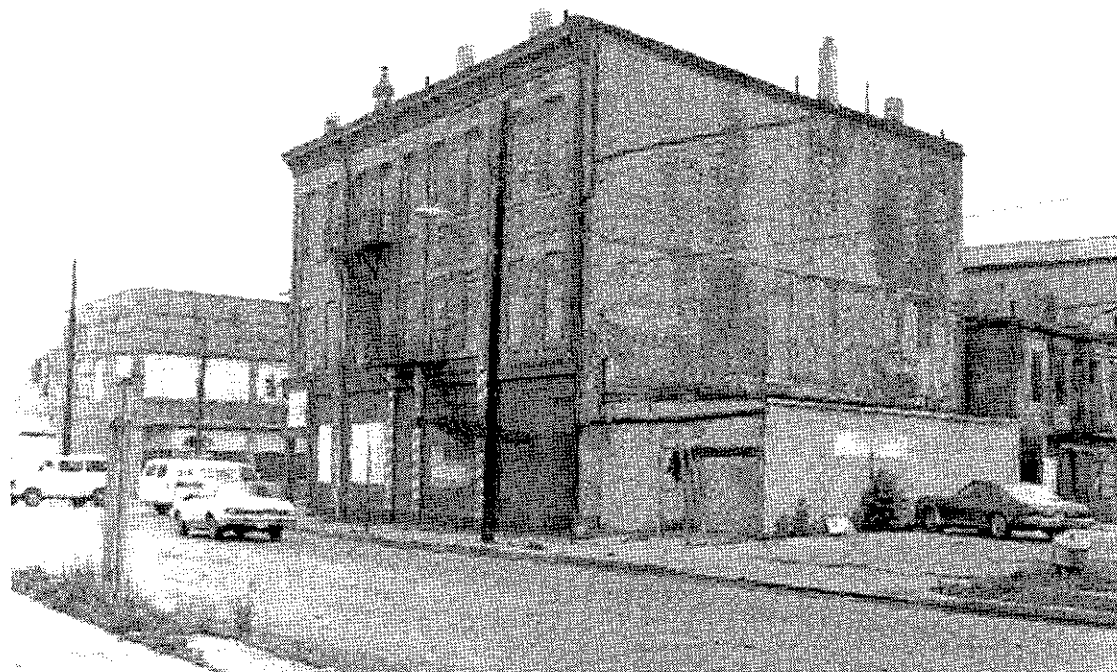
*Figure 9 View of the southwest elevation of the Hoover Block, 1986. Note that almost all of the building's openings have been infilled with masonry. Also, the brick face of the upper stories seems to have several large areas of spalling and erosion. (Aviation Trail, Inc.)*

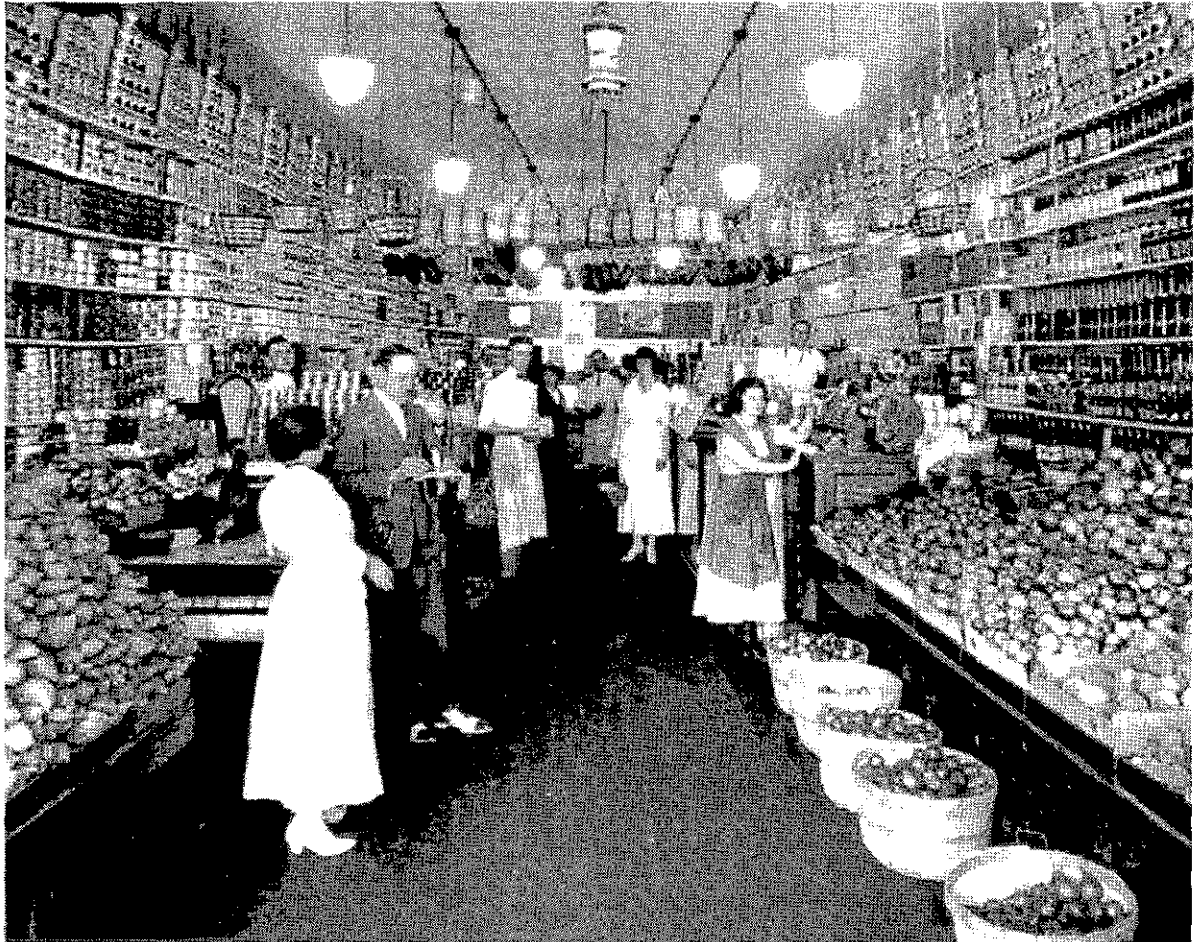
*Figure 12 Interior, grocery at 1046 West Third Street, Hoover Block. (NCR Archives, September 17, 1920)*

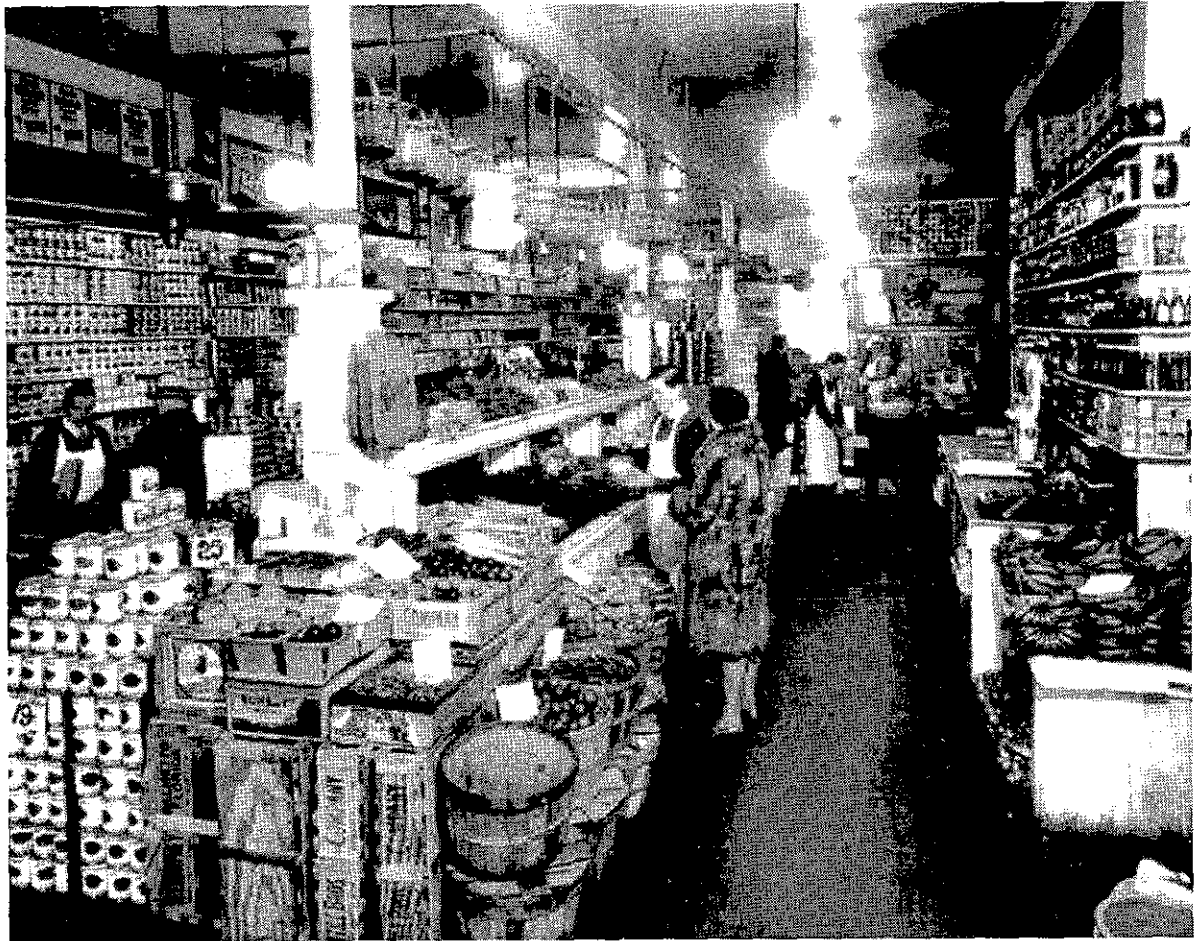
*Figure 13 Interior, A&P Grocery at 1046 West Third Street, Hoover Block. (NCR Archives, February 6, 1931)*

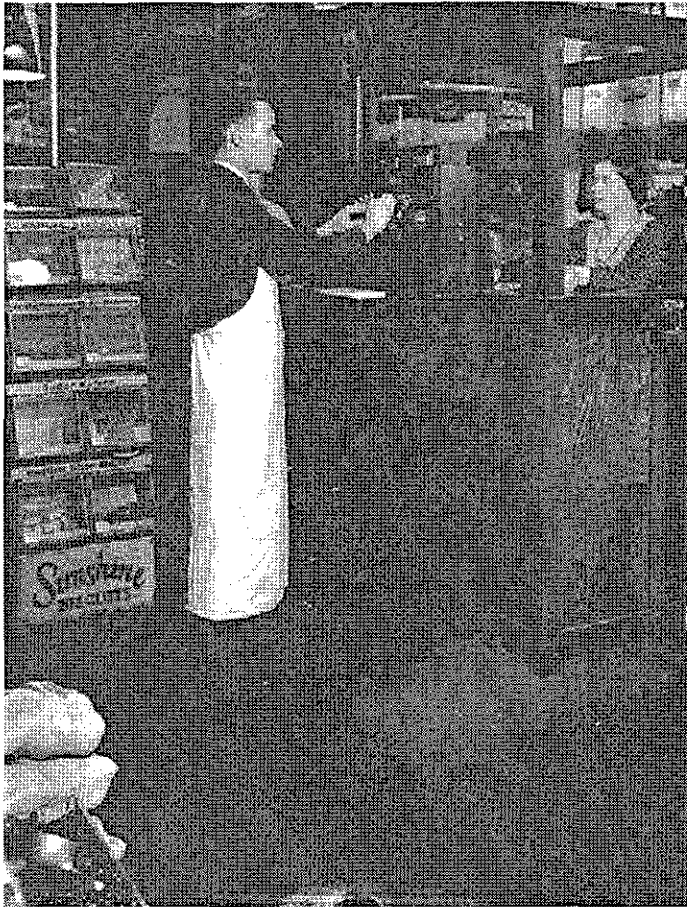
*Figure 14 Cashier's Window, A&P Grocery at 1046 West Third Street, Hoover Block. (NCR Archives, February 6, 1931)*

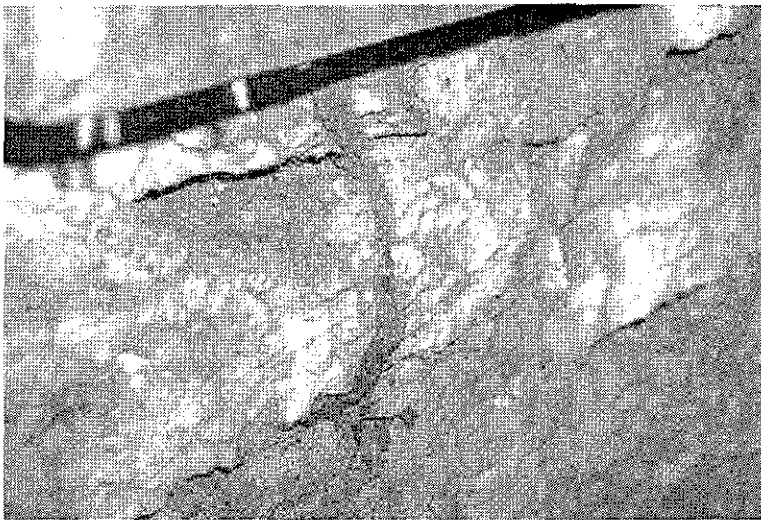
*Figure 1 Termite tunnel on east exterior wall, east basement, south end, below wood panel; tunnel cut by Tom Fitzpatrick at mid-height (photo 1:35, Fitzpatrick Structural Engineering, P.C., October, 1996)*

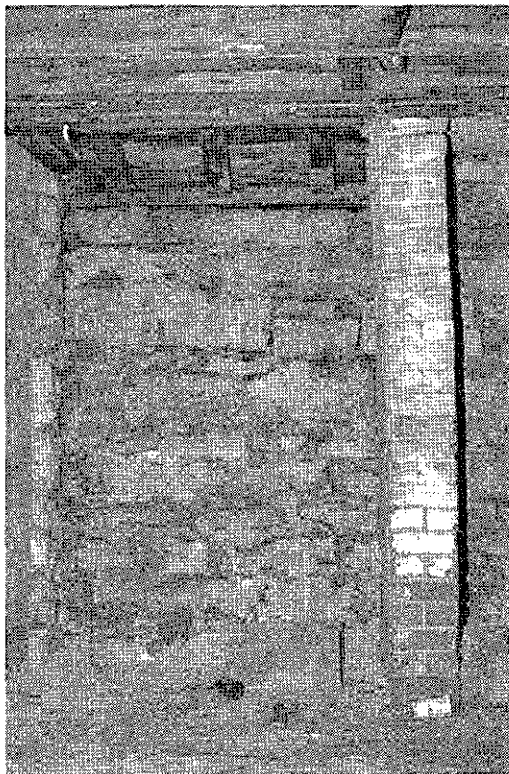
**Figure 2** Bowed brick pier, middle basement at north end (photo 2:10, Fitzpatrick Structural Engineering, P.C., October, 1996)

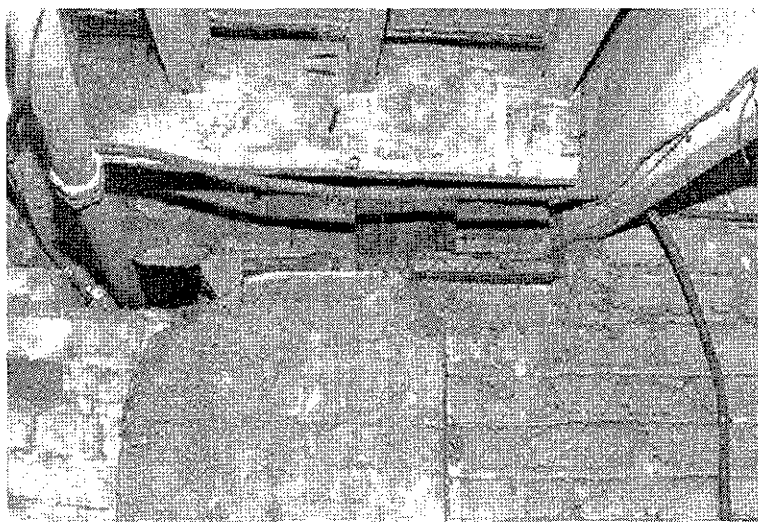
**Figure 4** West interior basement wall, third concrete column from the north supporting steel column above; note steel column aligns on edge of pier, not centered (photo 2:14, Fitzpatrick Structural Engineering, P.C., October, 1996)

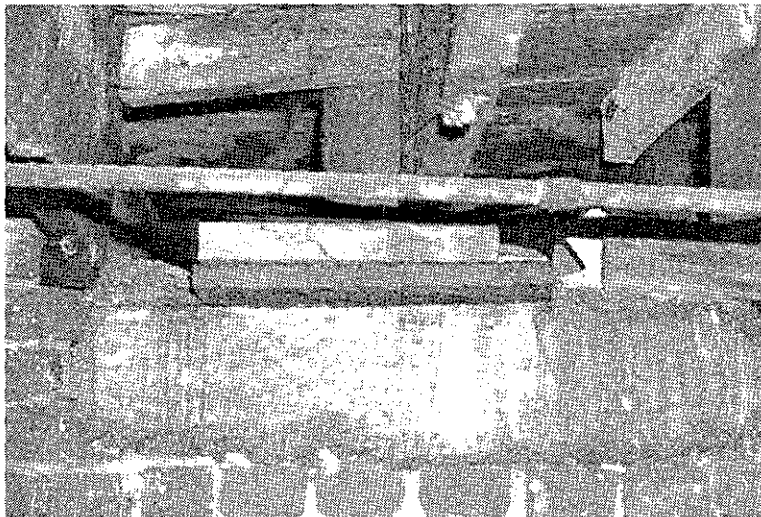
Figure 5 East interior basement wall, first floor column concrete bearing block, third column from north; note base plate overhangs (photo 1:24, Fitzpatrick Structural Engineering, P.C., October, 1996)

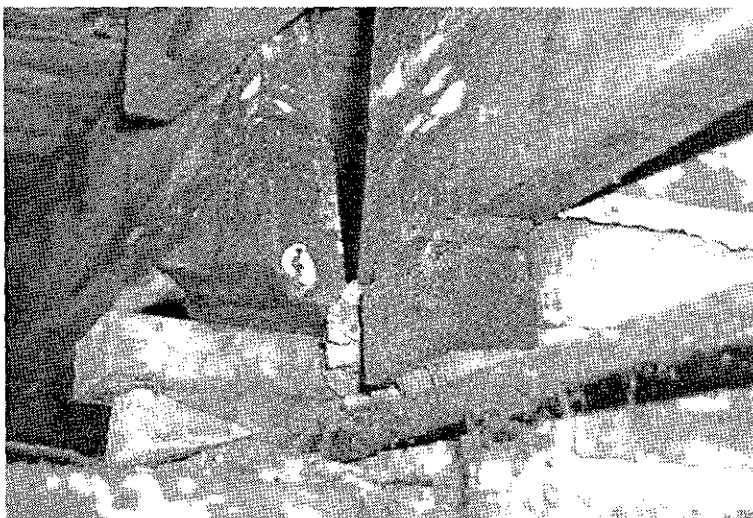
*Figure 6 Joist bearing at east wall mechanical opening just south of the first column bearing block from the north; note that the exposed joist ends are 'fire cut', and joists are not headered (photo 1:18, Fitzpatrick Structural Engineering, P.C., October, 1996)*

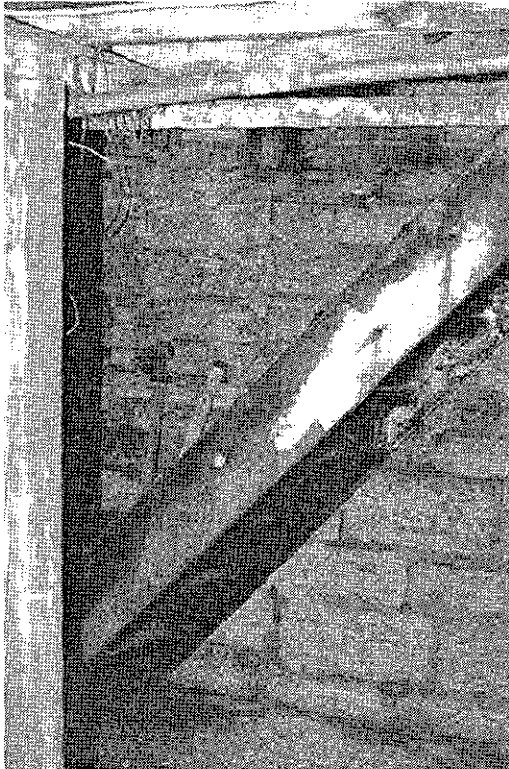
Figure 7 Stair remnant at middle basement south wall (photo 2:19, Fitzpatrick Structural Engineering, P.C., October, 1996)

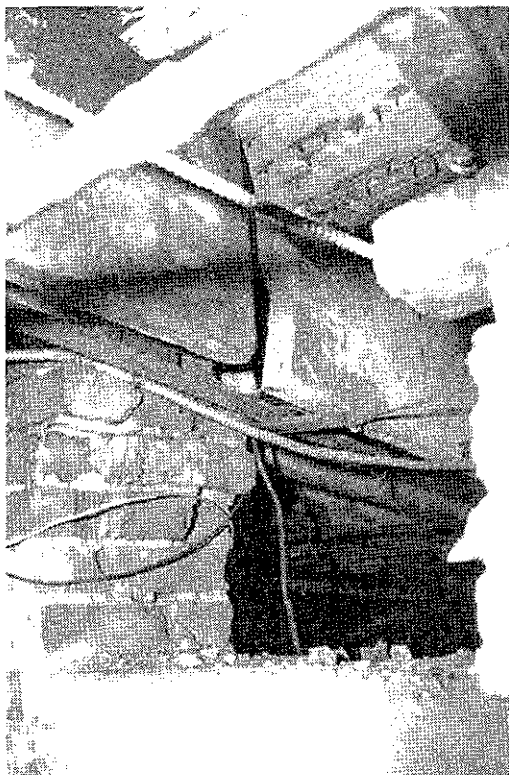
*Figure 8 Unheadered joist at east wall mechanical opening just south of the fourth column; no apparent joist support (photo 1:30, Fitzpatrick Structural Engineering, P.C., October, 1996)*

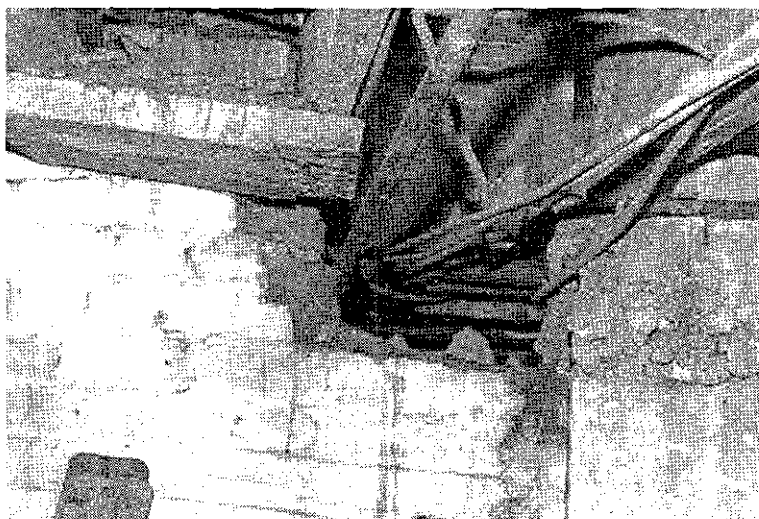
*Figure 9 Joist bearing at west wall mechanical opening just south of the fourth pier from the north; no headers (photo 2:16, Fitzpatrick Structural Engineering, P.C., October, 1996)*

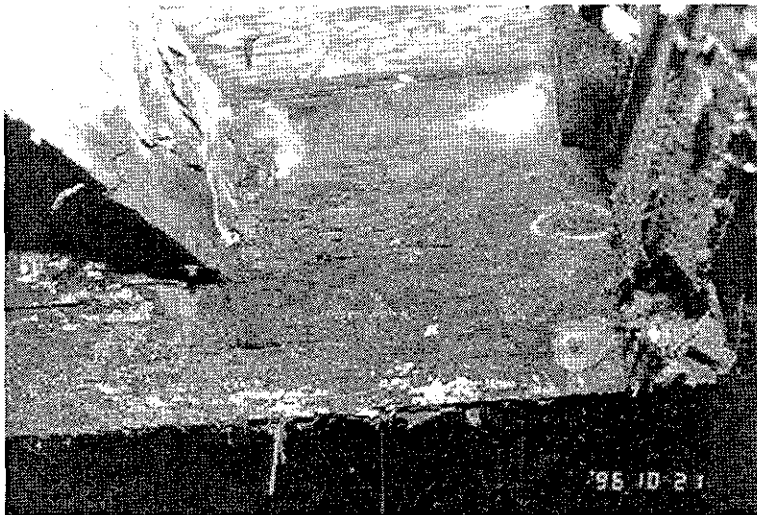
Figure 10 Stair header at east basement south end; extensive water stain, wood rot, and insect damage (photo 2:4, Fitzpatrick Structural Engineering, P.C., October, 1996)

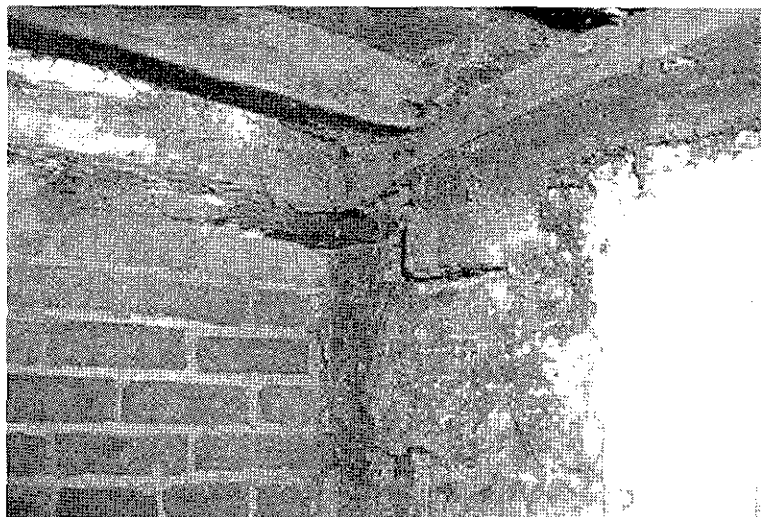
*Figure 11 Floor framing at north end of east basement; water stains and wood rot; note limestone threshold at upper left (photo 1:12, Fitzpatrick Structural Engineering, P.C., October, 1996)*

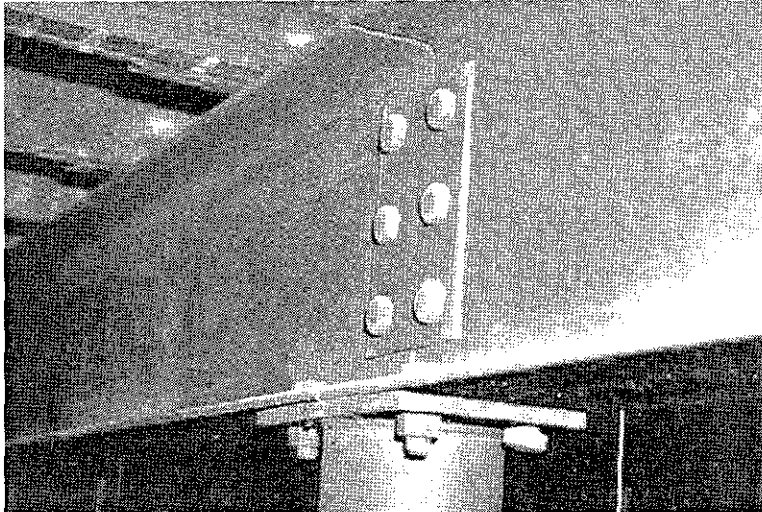
Figure 12 Steel beam to column connection at east column row, third column from the north (photo 3:3, Fitzpatrick Structural Engineering, P.C., October, 1996)

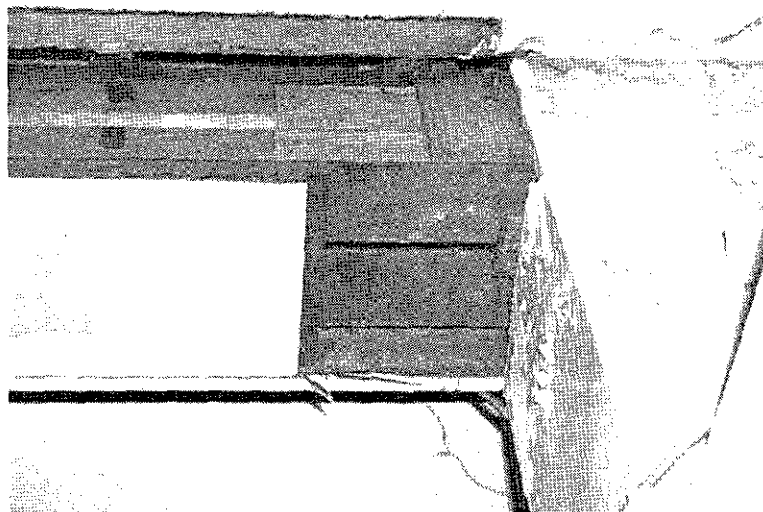
Figure 13 Steel beam bearing at west column row, north end bearing on brick pier (photo 3:7, Fitzpatrick Structural Engineering, P.C., October, 1996)

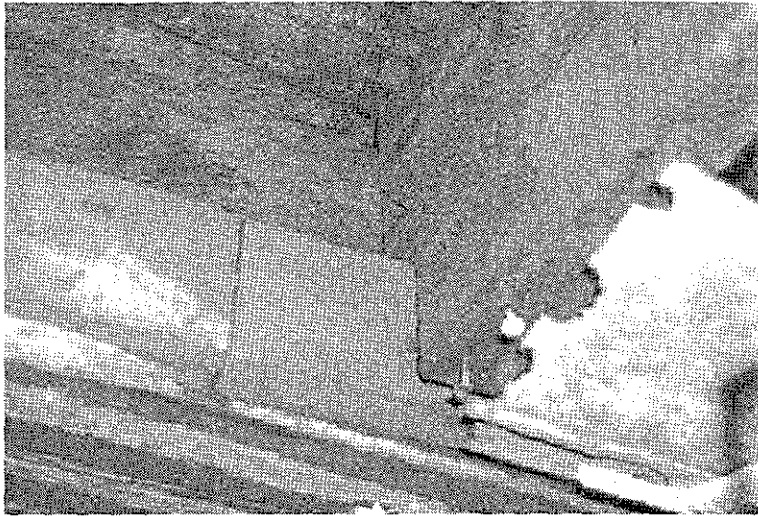
Figure 14 Third floor beam joist connection, east beam row toward south end (photo 3:23, Fitzpatrick Structural Engineering, P.C., October, 1996)

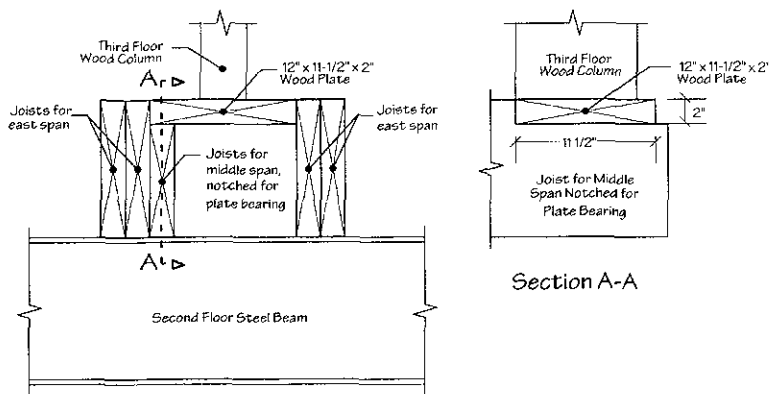
Figure 17 Sketch illustrating middle column in the west bearing. (Drawn by Cheryl Kryscynski, Fitzpatrick Structural Engineering, P.C., April 2, 1998)

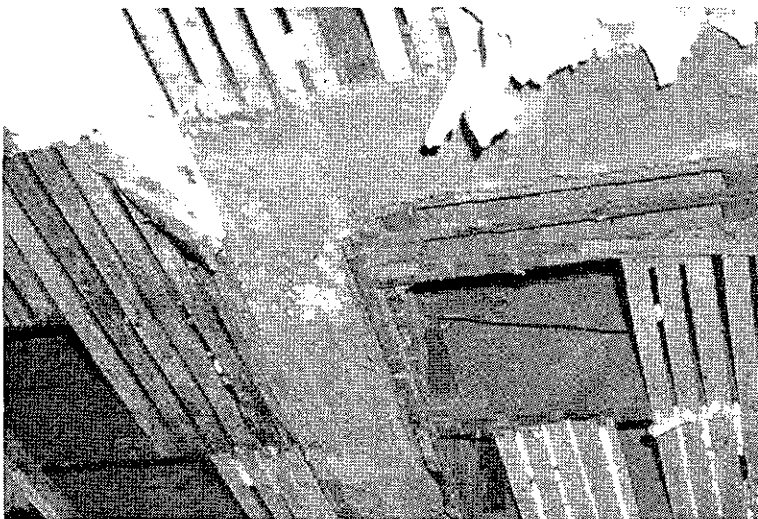
Figure 18 Apparent concrete infill at west side of third floor structure; note that concrete cuts across joist spans with no obvious support (photo 3:16, Fitzpatrick Structural Engineering, P.C., October, 1996)

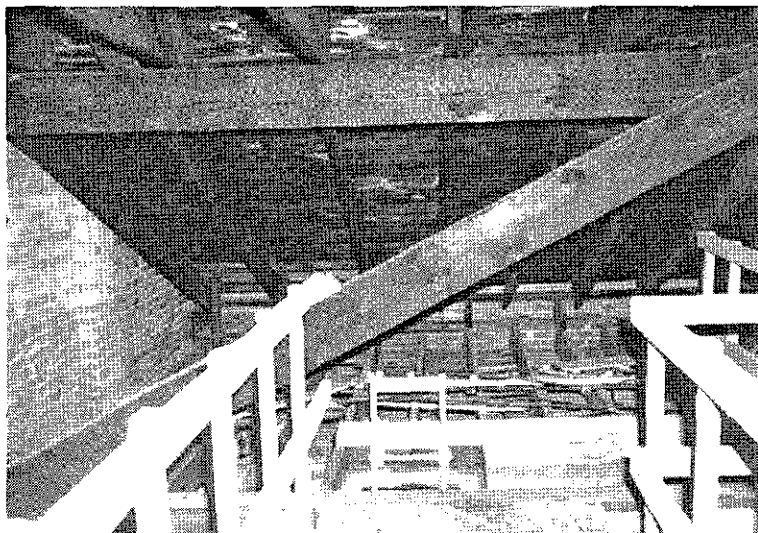
*Figure 19 East end of Truss 3; note charring fire damage on top member; fire damage and water staining at joists and sheathing (photo 3:27, Fitzpatrick Structural Engineering, P.C., October, 1996)*

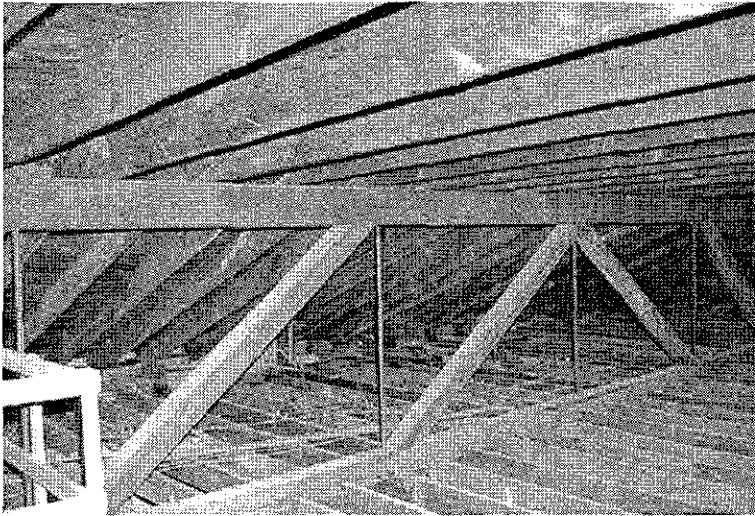
*Figure 20 Truss 3 looking toward the west end; roof rafters supported on top chord; ceiling joists supported on ledger (photo 3:29, Fitzpatrick Structural Engineering, P.C., October, 1996)*

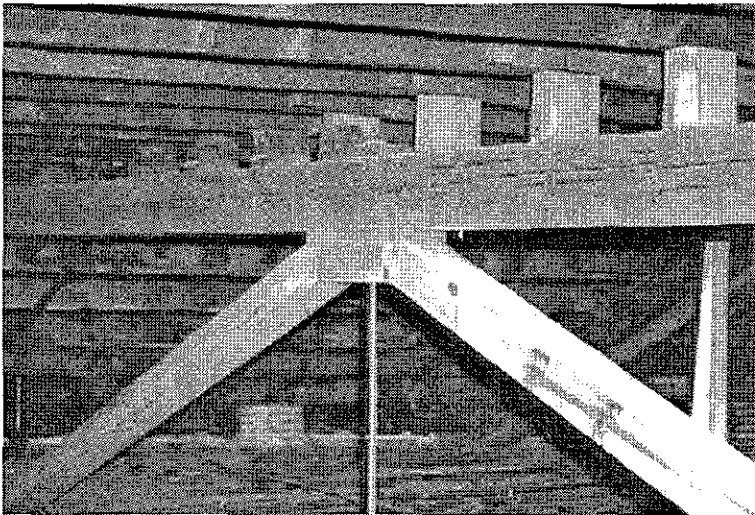
*Figure 21 Truss 2 at middle panel point looking to the northwest; roof rafters raised with blocking to create slight slope (photo 3:33, Fitzpatrick Structural Engineering, P.C., October, 1996)*

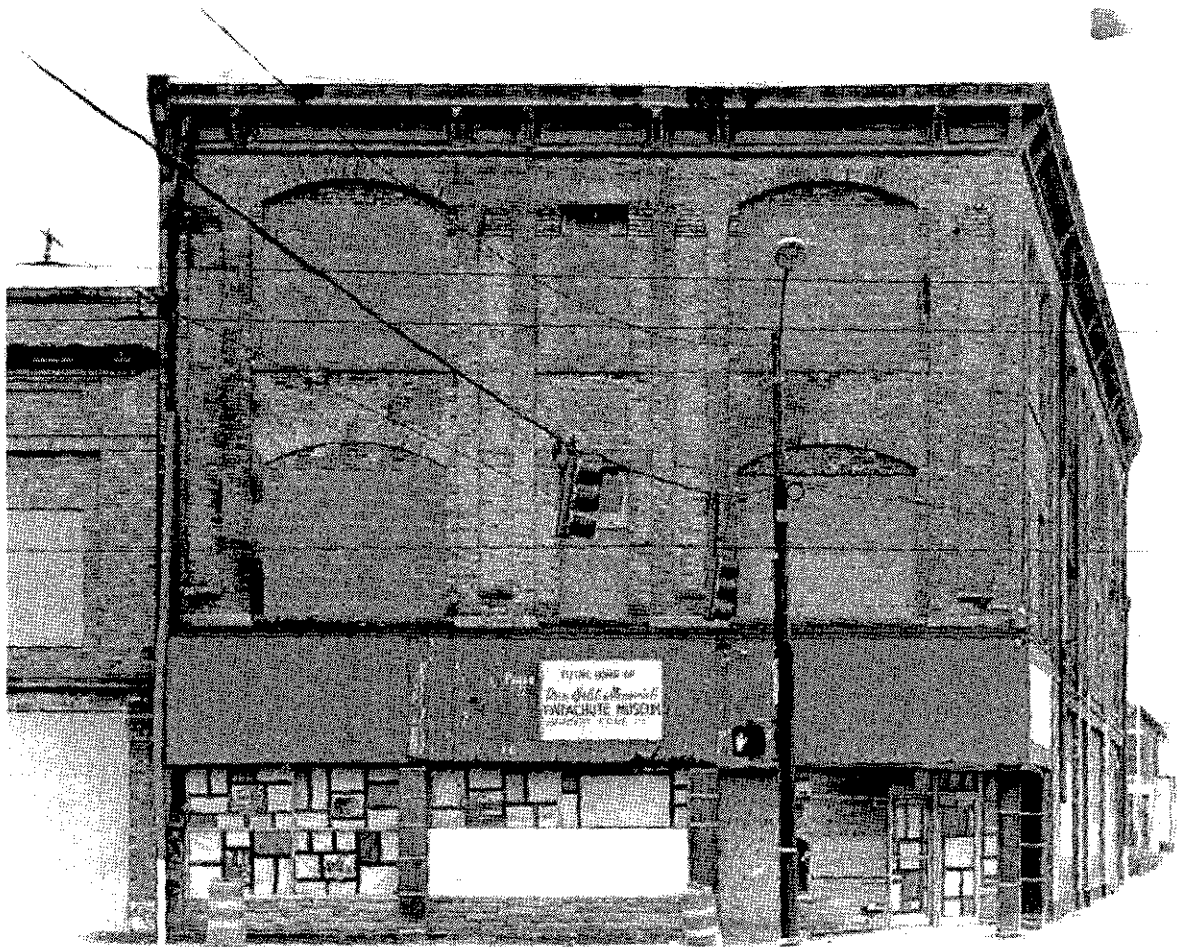
Figure 22 View of the north elevation of the Hoover Block (J. Miles Wolf, 1995).

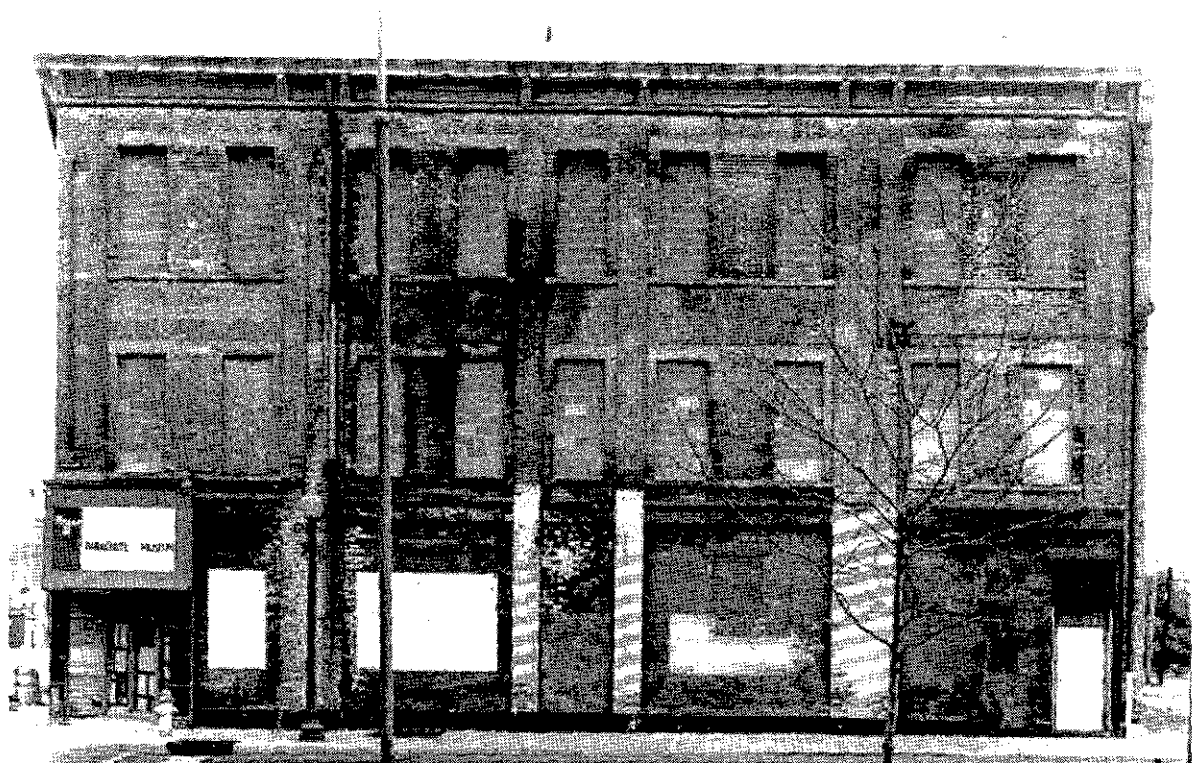
*Figure 23 View of the west elevation of the Hoover Block (J. Miles Wolf, 1995).*

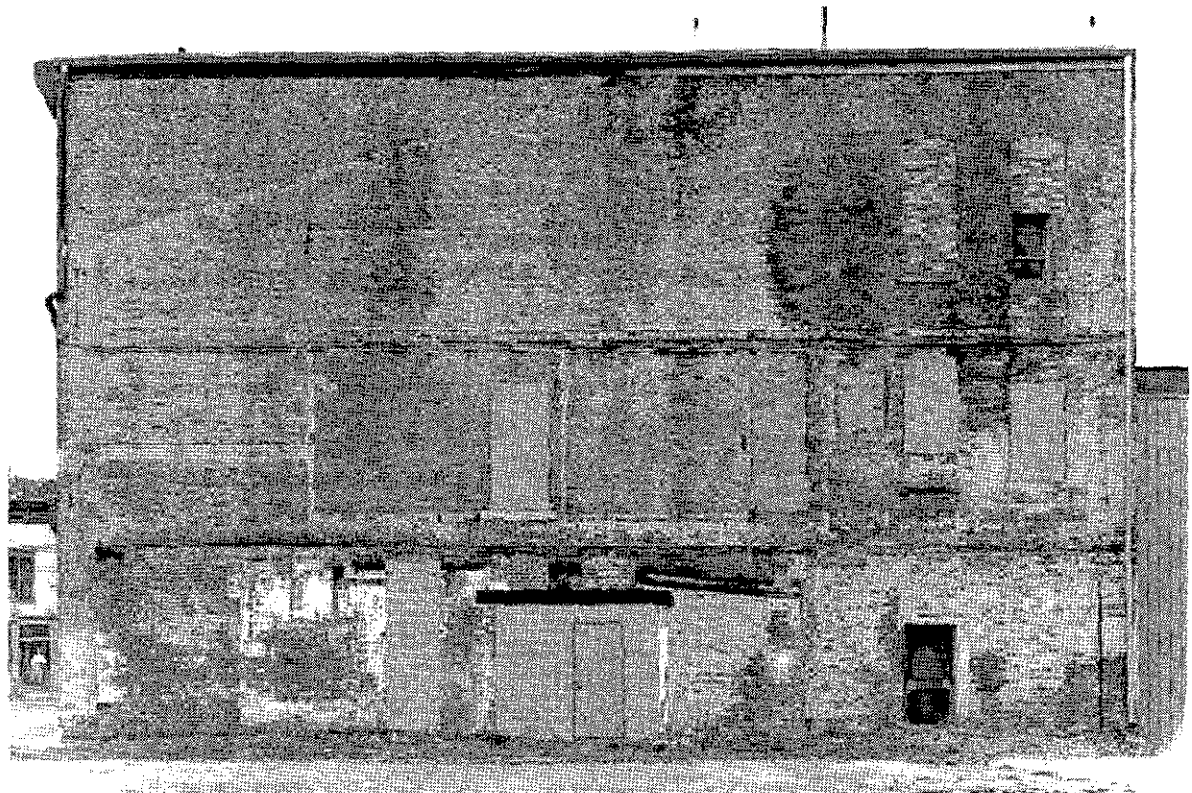
*Figure 24* View of the south elevation of the Hoover Block (J. Miles Wolf, 1995).

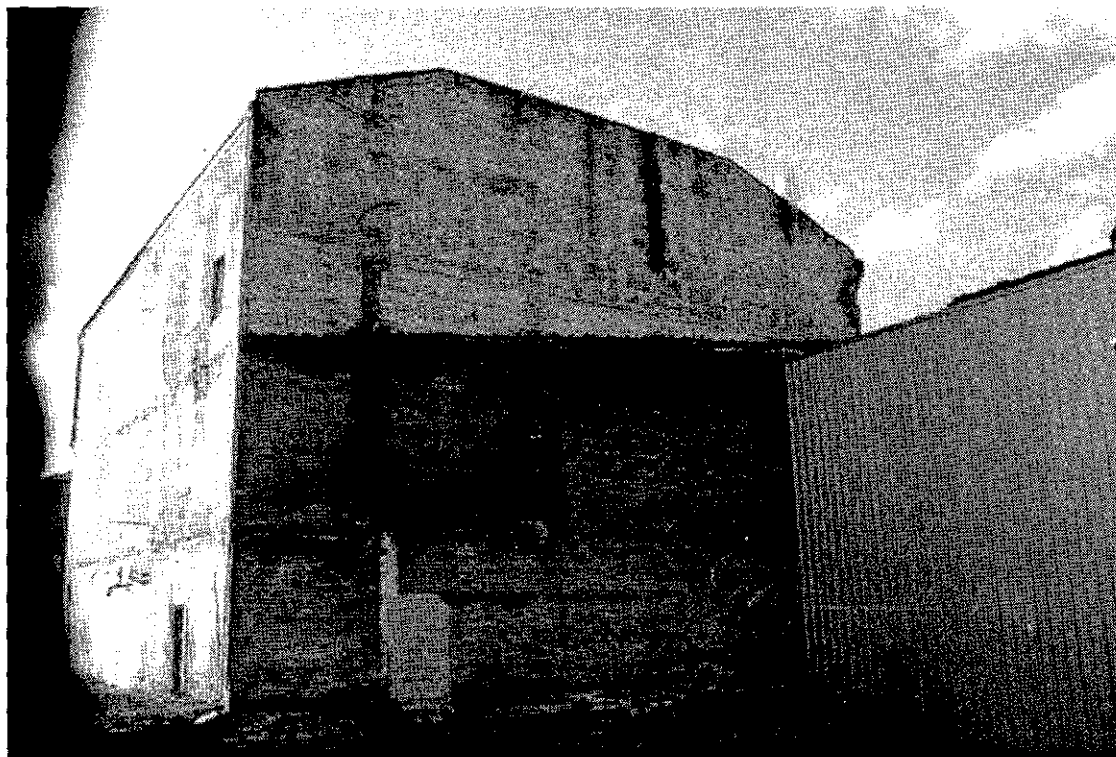
Figure 25 View of the east elevation of the Hoover Block (Quinn Evans/Architects, 1995).

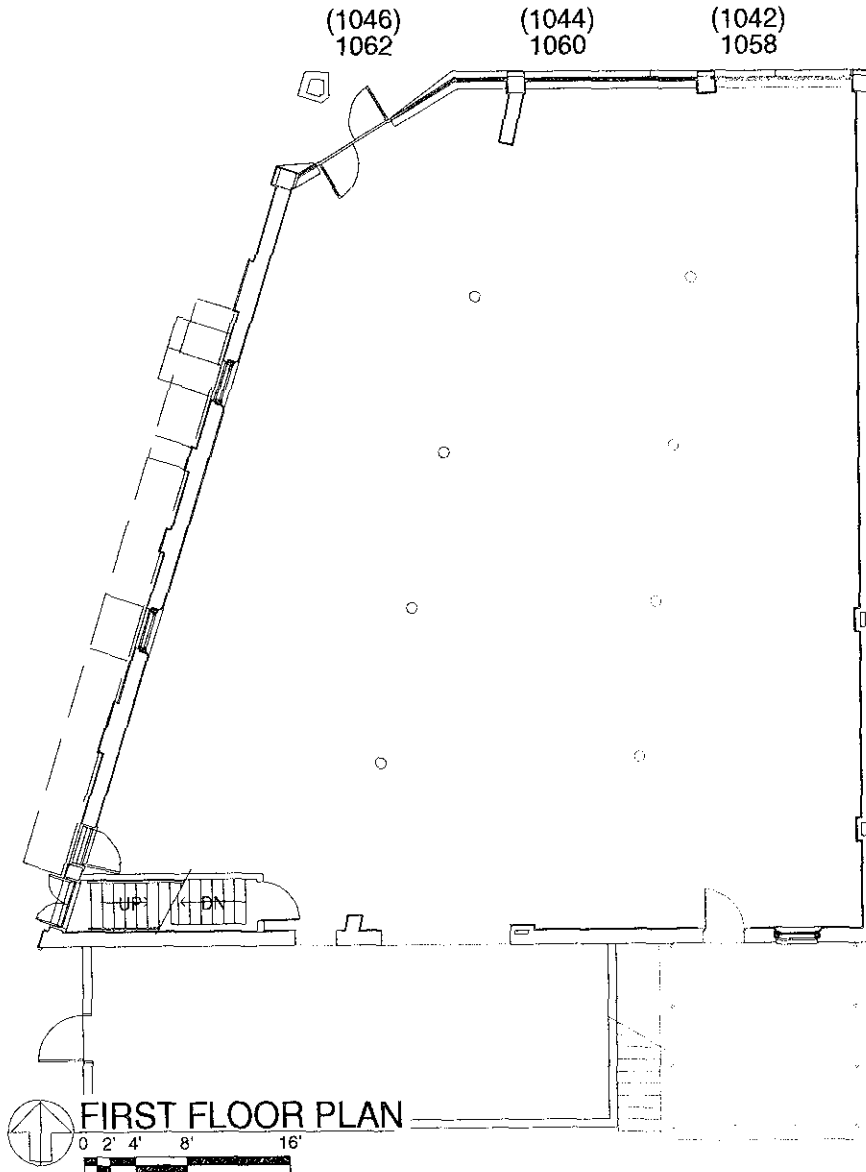
### **Episode 6: 1993 - 1997 [Existing Condition]**
