# HISTORIC STRUCTURE REPORT

## Hoover Block

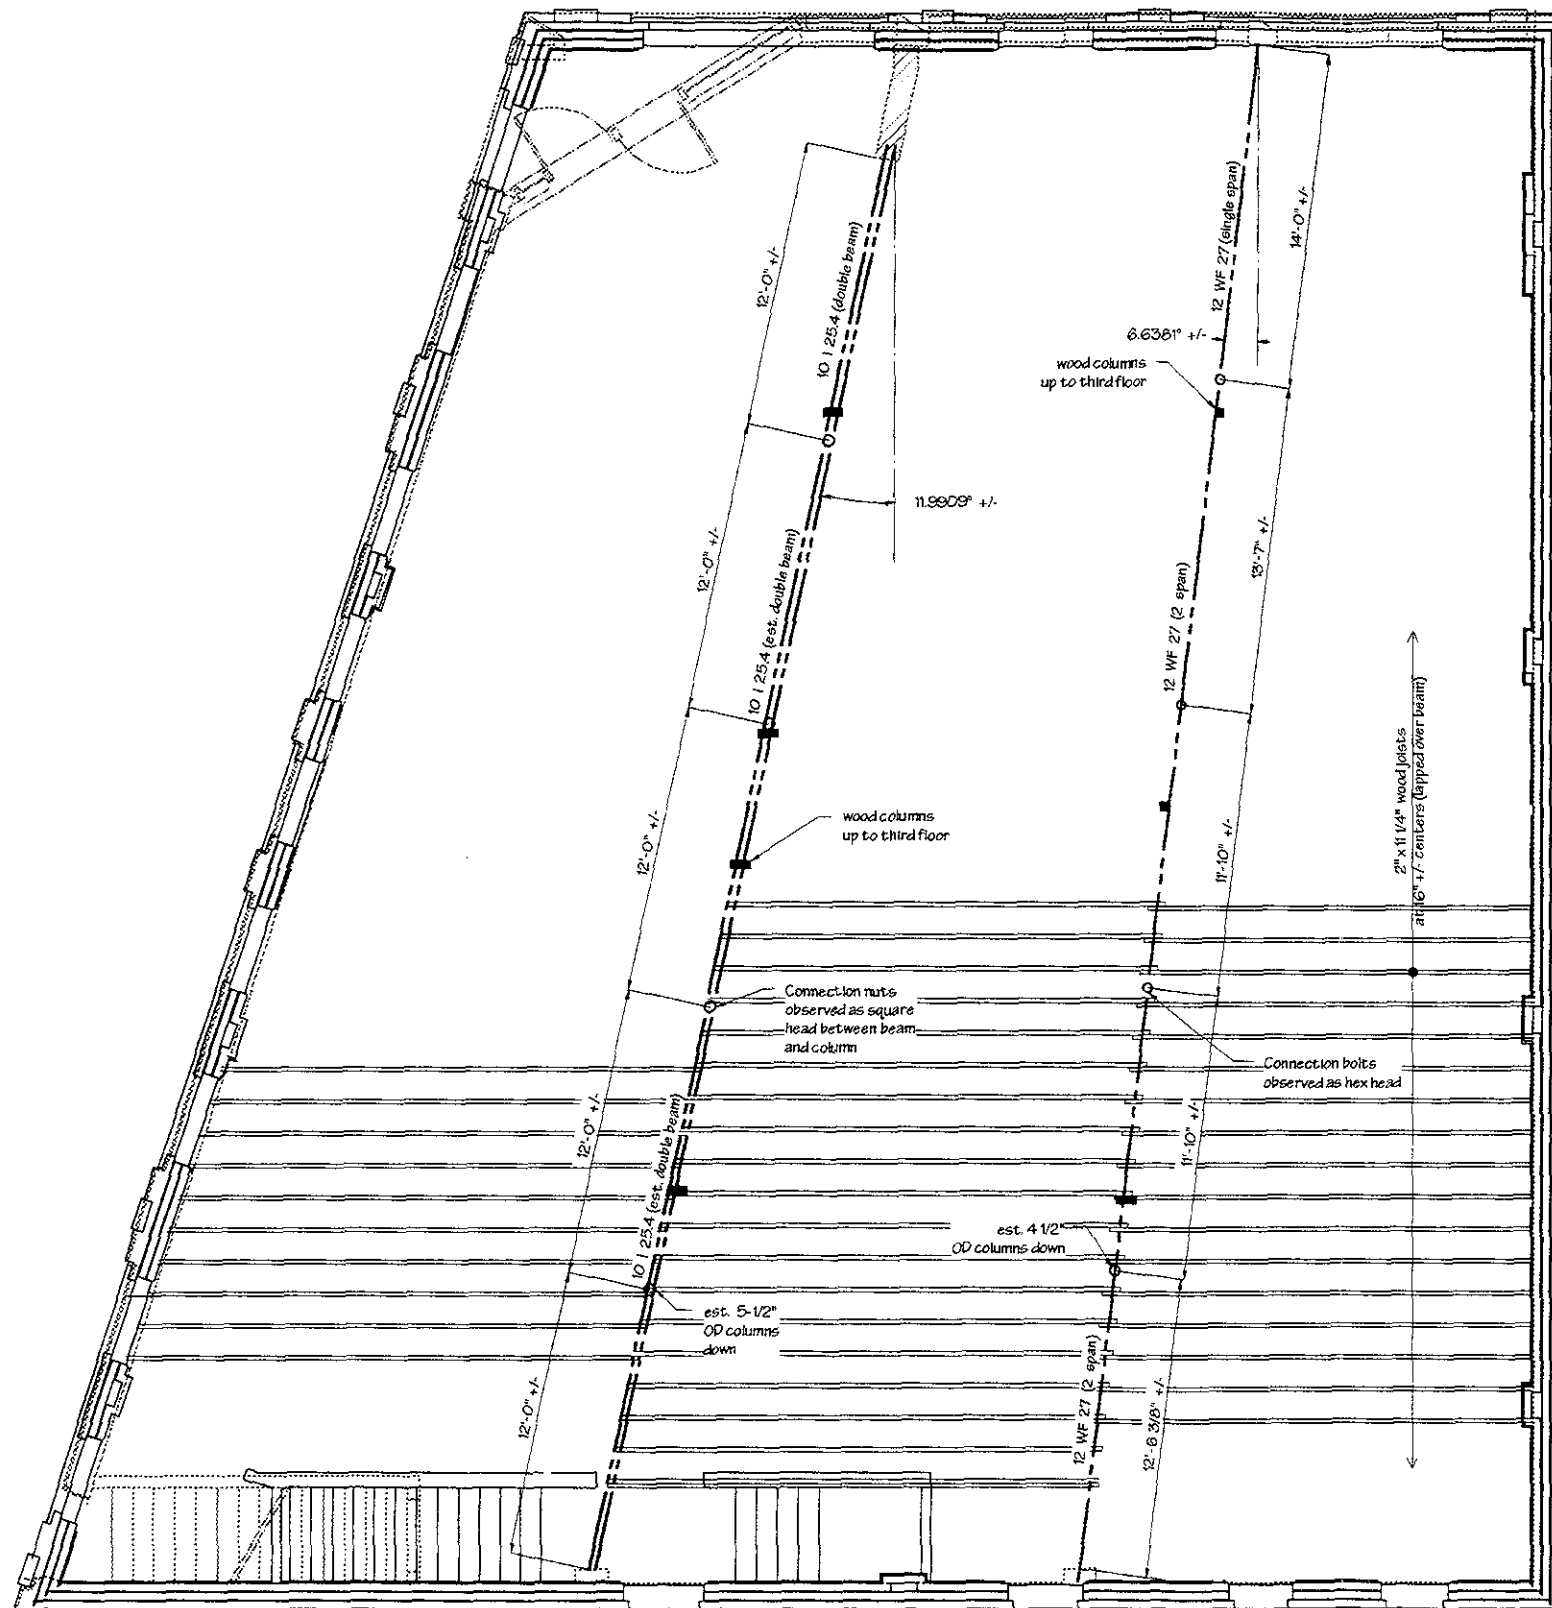
**Steel Beam Notes:**

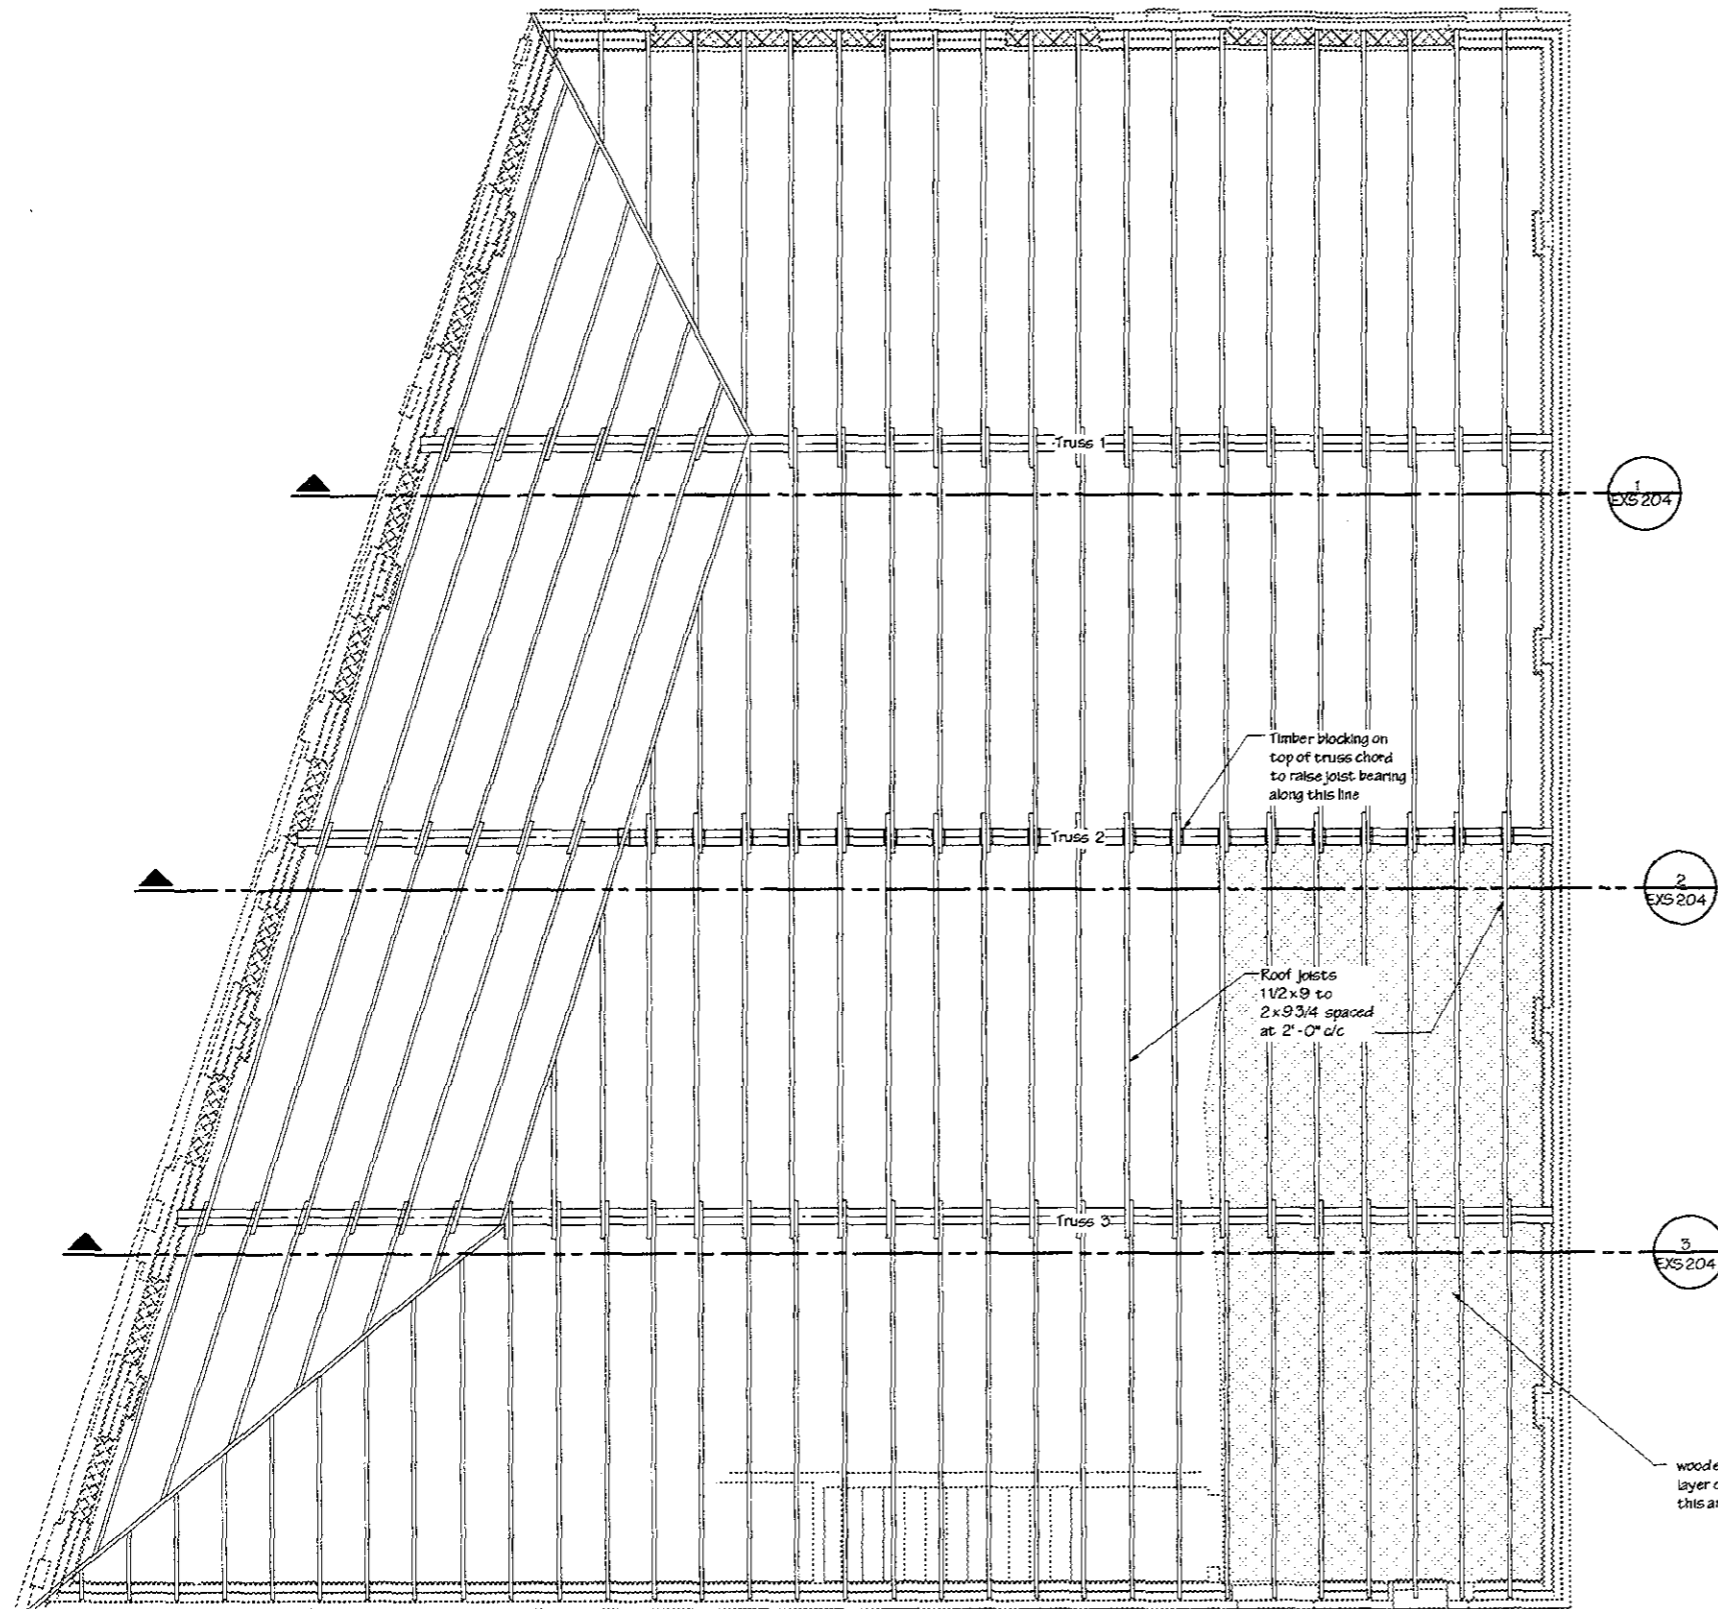
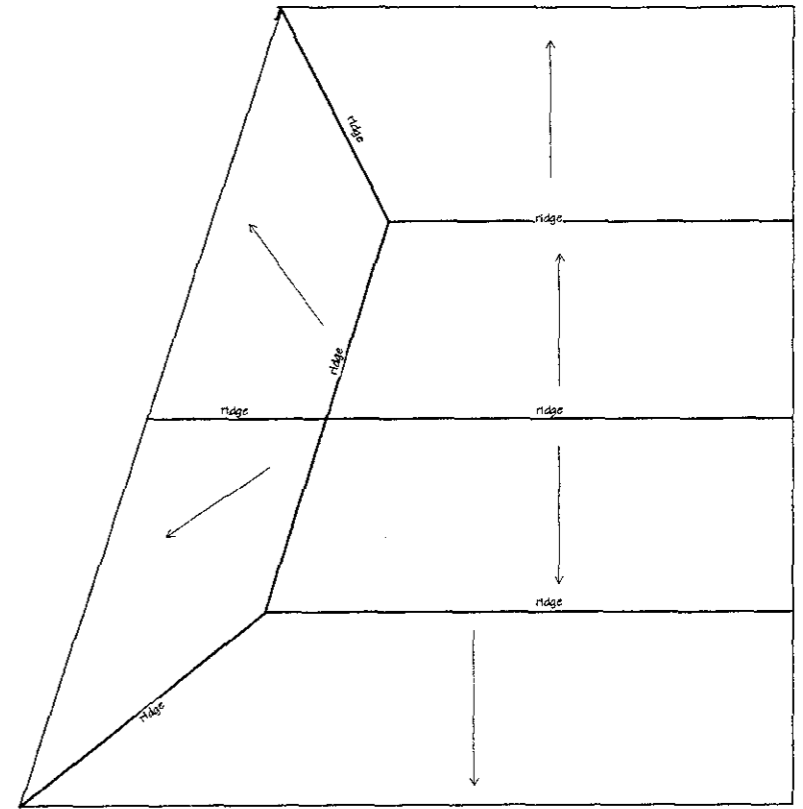
Schematic Roof Slope Plan

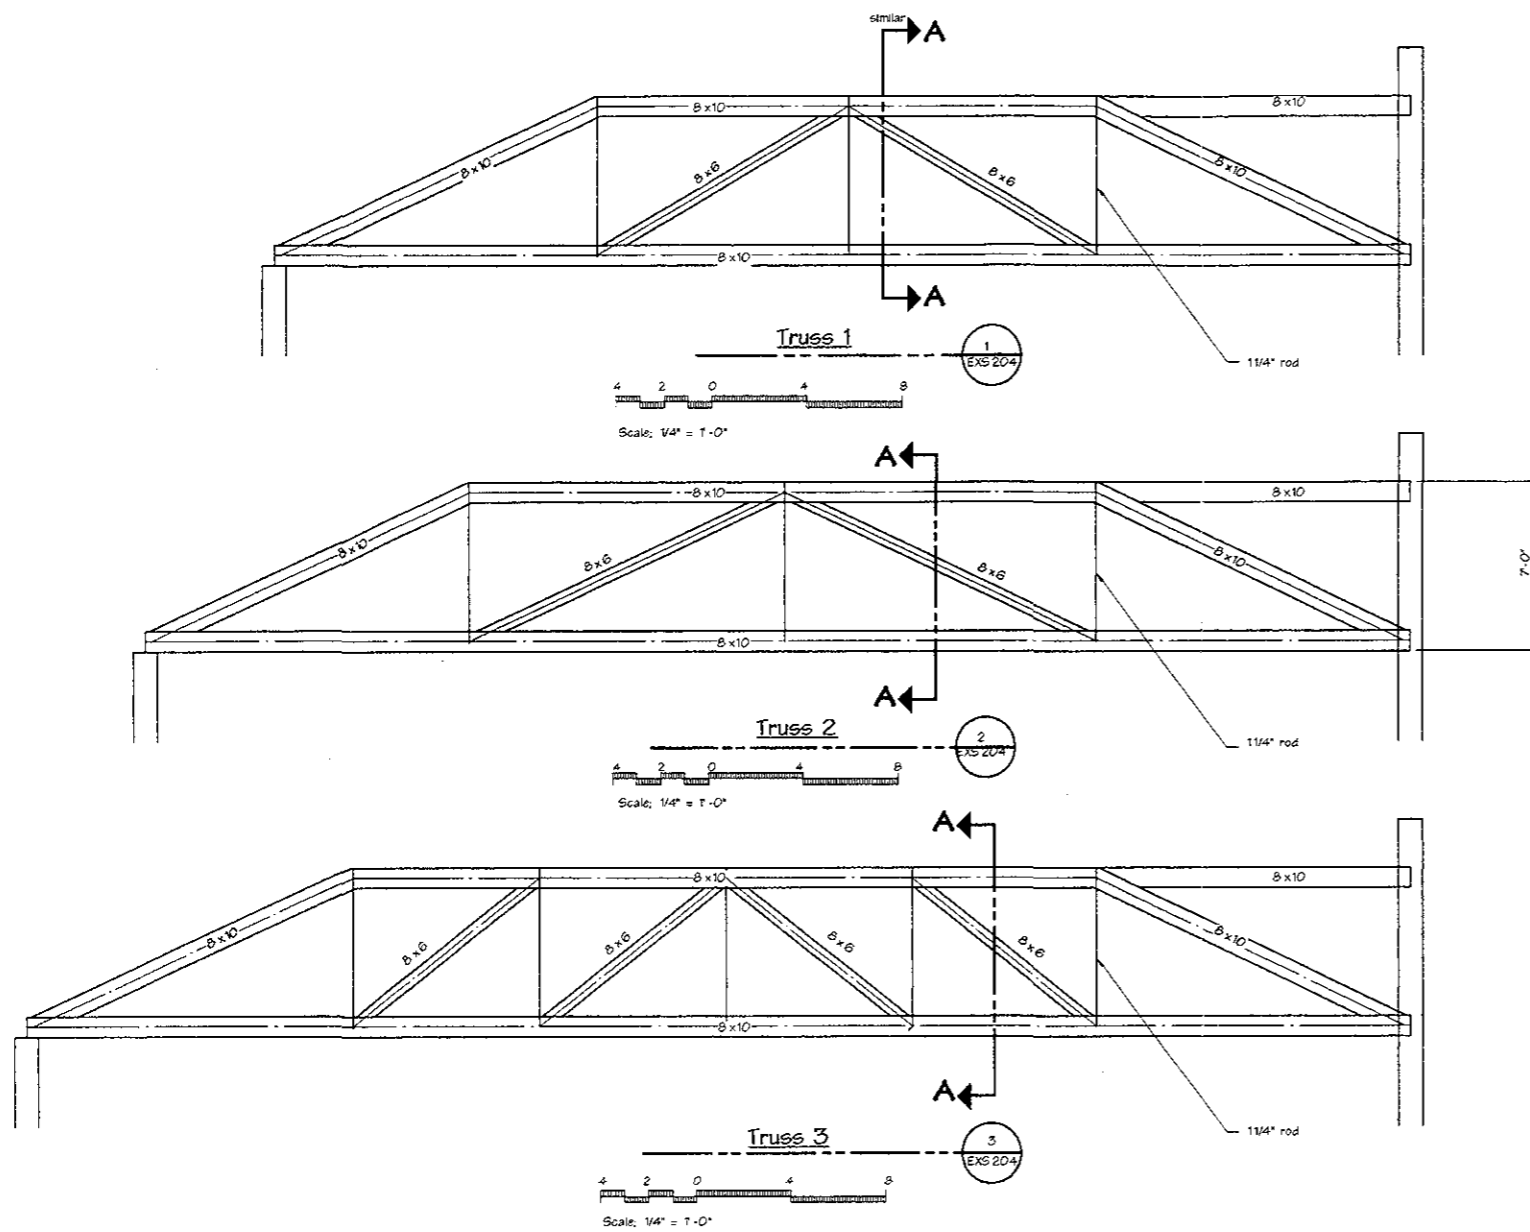
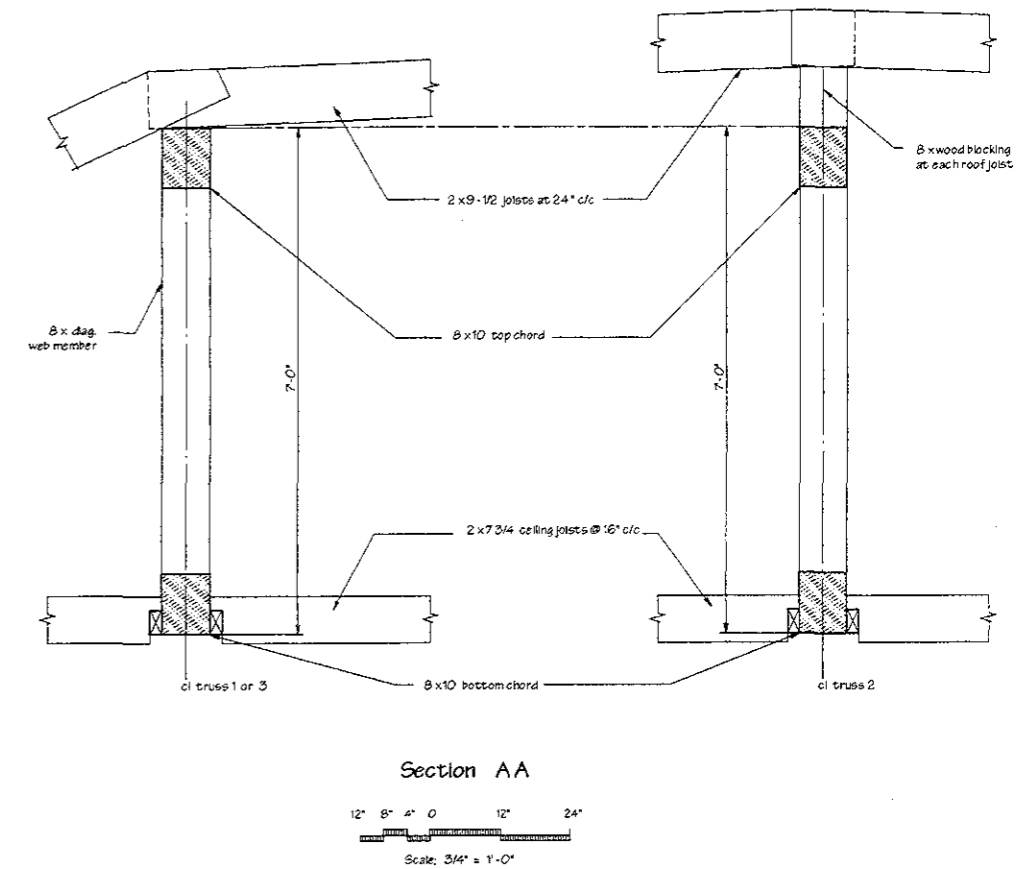
<p>Fitzpatrick Structural Engineering, P.C. 219-1/2 N. Main • Ann Arbor • MI • 48104 313-769-0320 Fax 313-769-3015</p>	<p>QUINN EVANS ARCHITECTS 219 1/2 N. Main Street Ann Arbor, Michigan 48104 313 663 8888</p>	REVISED DATE: _____ BY: _____	PREPARED TRF DESIGNED TRF/CLK DRAWN TRF/CLK CHECKED Q2-26-97 DATE	TITLE OF SHEET <b>Roof Truss Sections</b>	Existing Conditions of Hoover Block Dayton Aviation Heritage National Historic Park Dayton, Ohio United States of America Department of the Interior National Park Service	AUTOCAD FILE NO. _____ SUBSHEET NO. _____	DRAWING NO. 362 SHEET NO. 20013 OF 6
		EXS-204

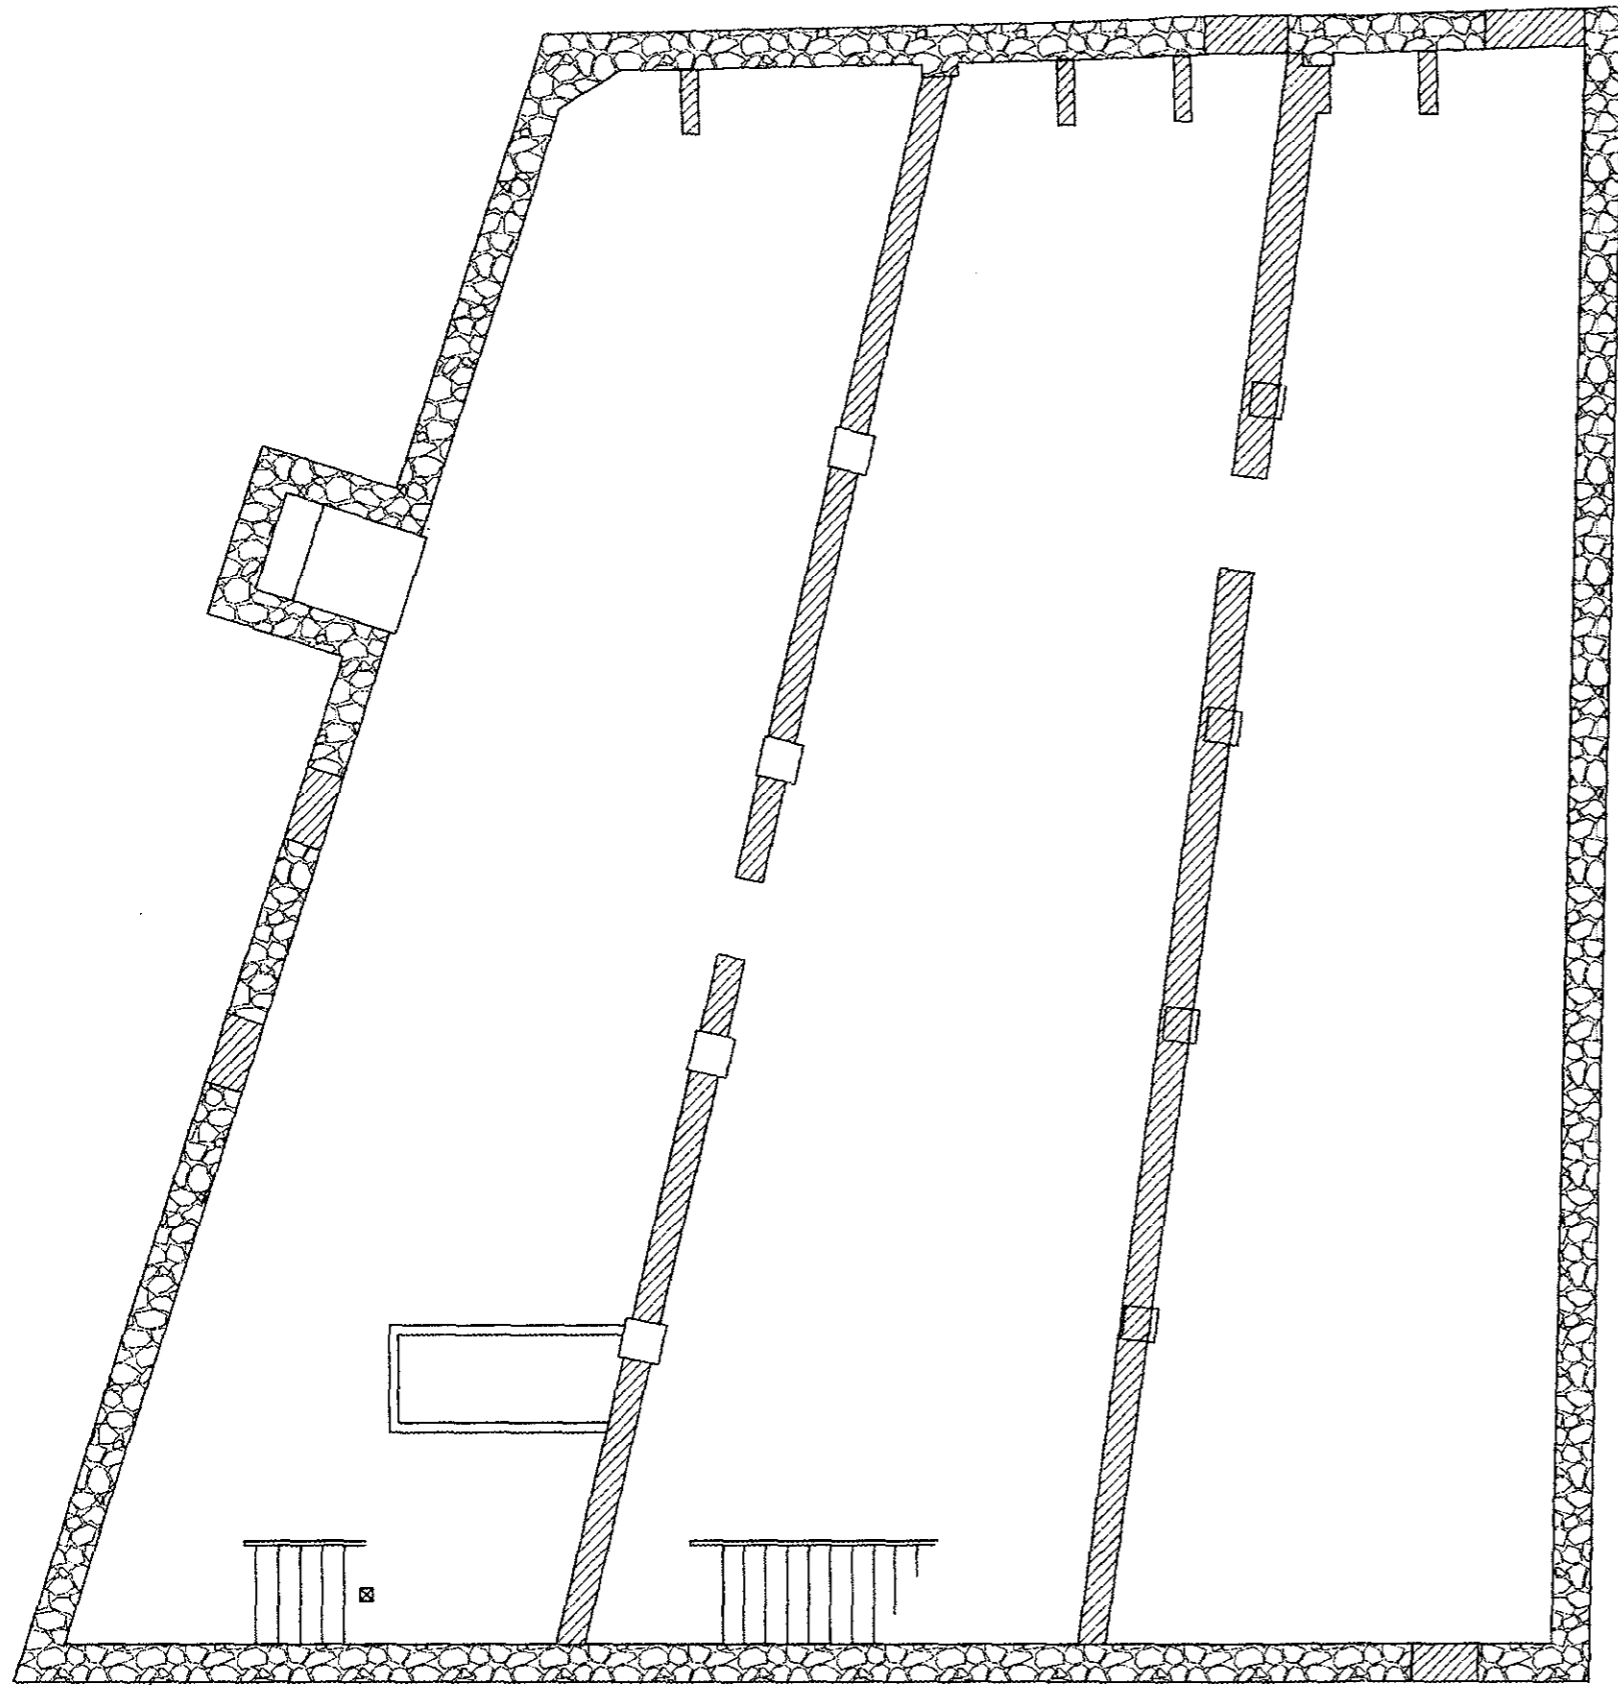
**Appendix D**  
*Existing Condition Drawings*

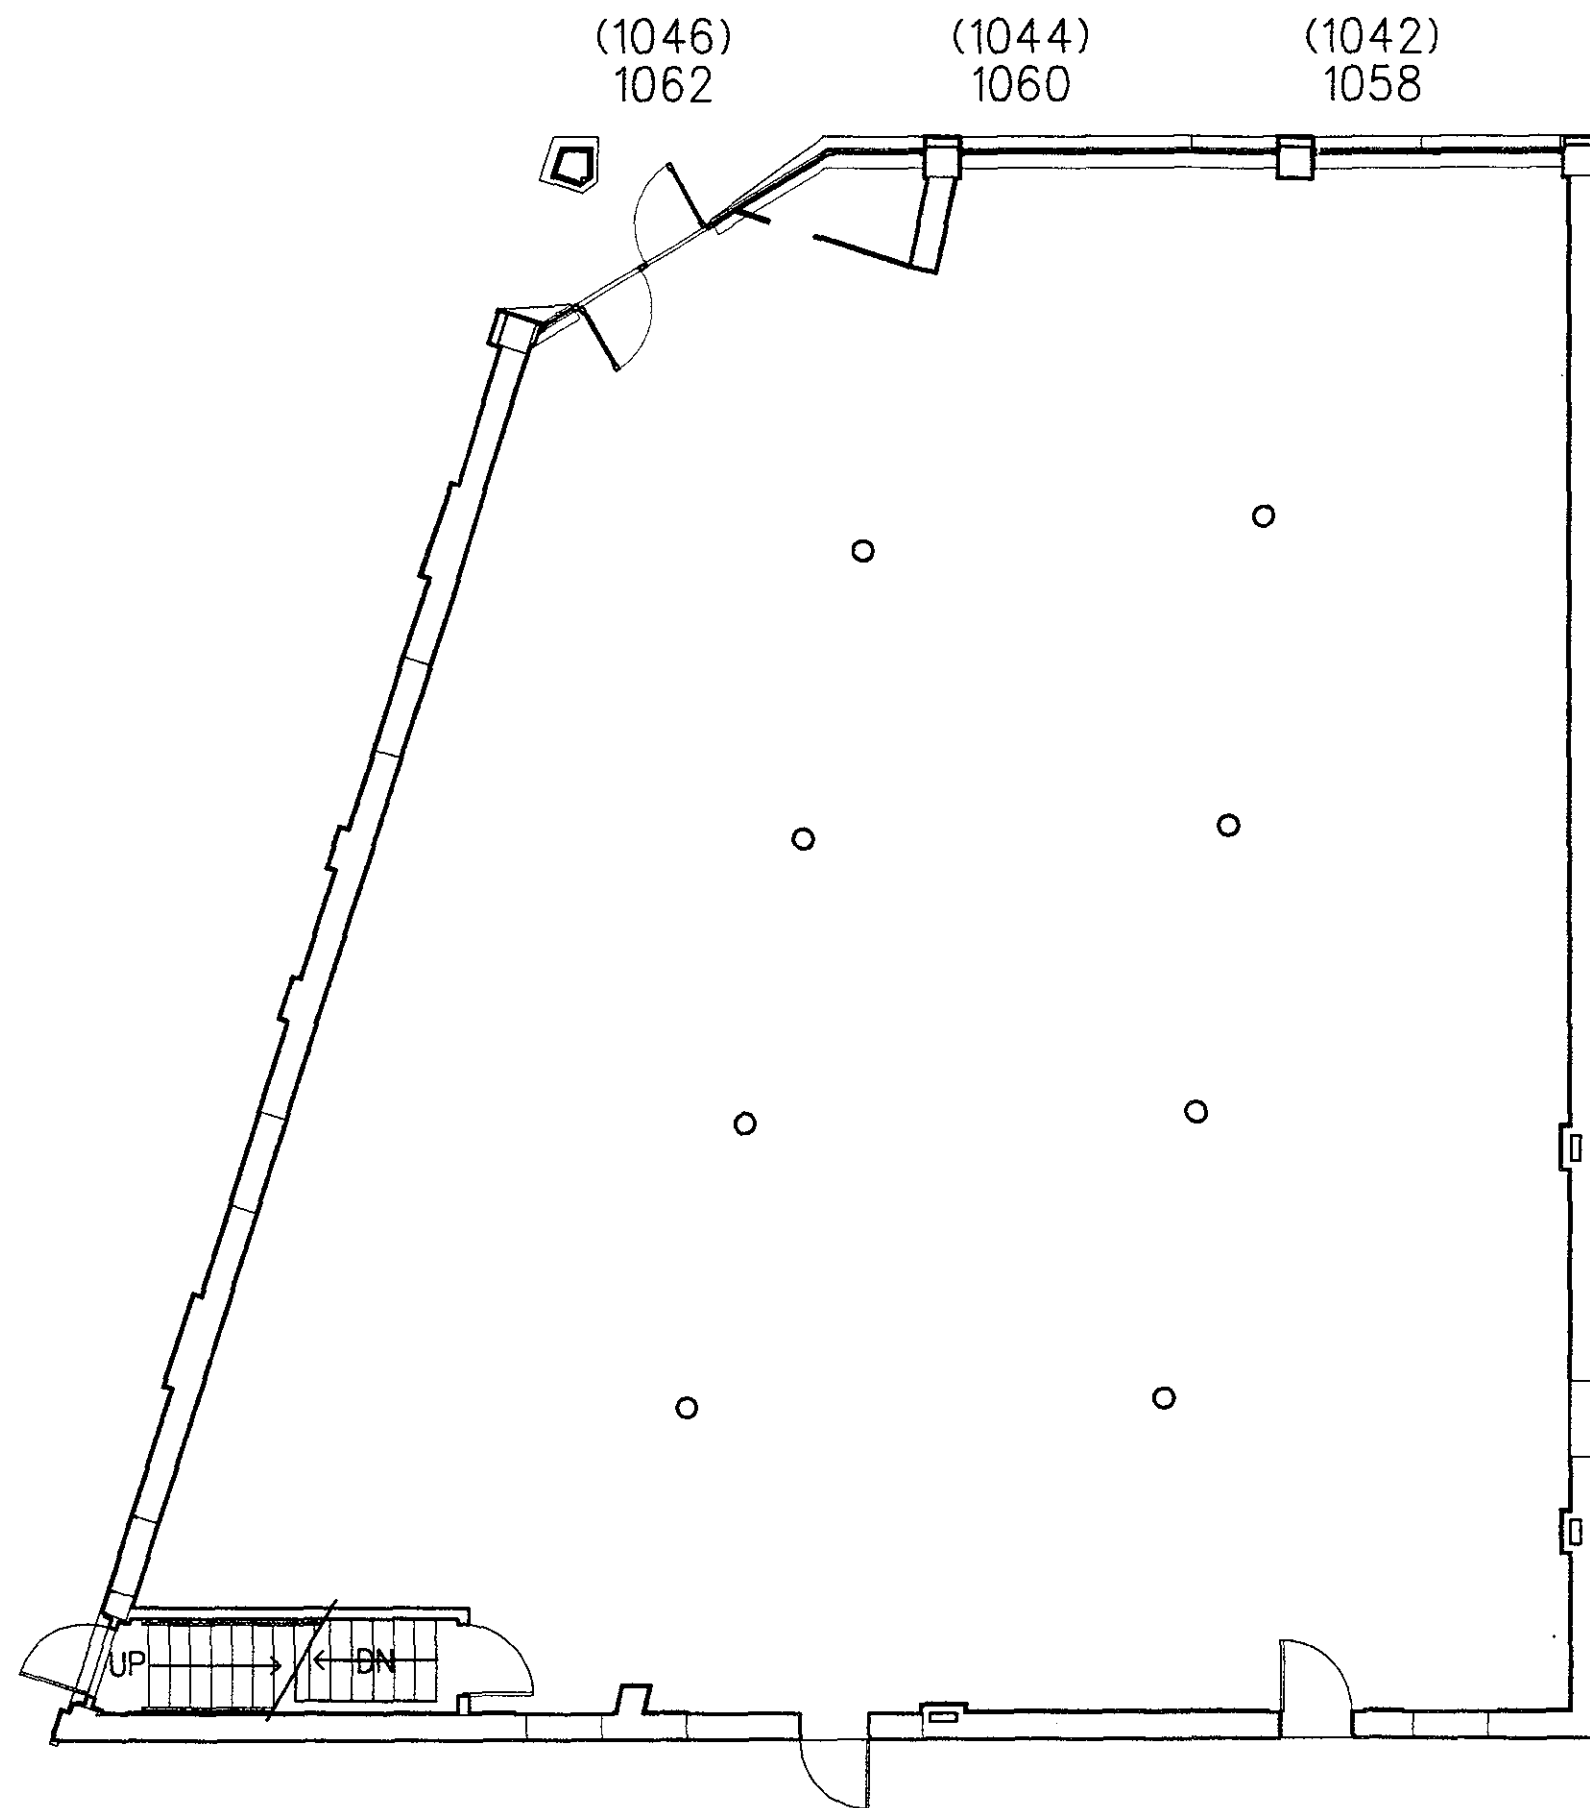
<b>QUINN EVANS</b> ■ ■ ■ ■ <b>ARCHITECTS</b> 219 1/2 N. Main Street Ann Arbor, Michigan 48104 313 663 5888	DESIGNED:	SUB SHEET NO.	TITLE OF SHEET	DRAWING NO.
	DRAWN:		<b>EXISTING CONDITIONS FIRST FLOOR PLAN</b>	362
	TECH REVIEW:			30074
	DATE:			HOOPER BLOCK DAYTON AVIATION HERITAGE NATIONAL HISTORIC PARK

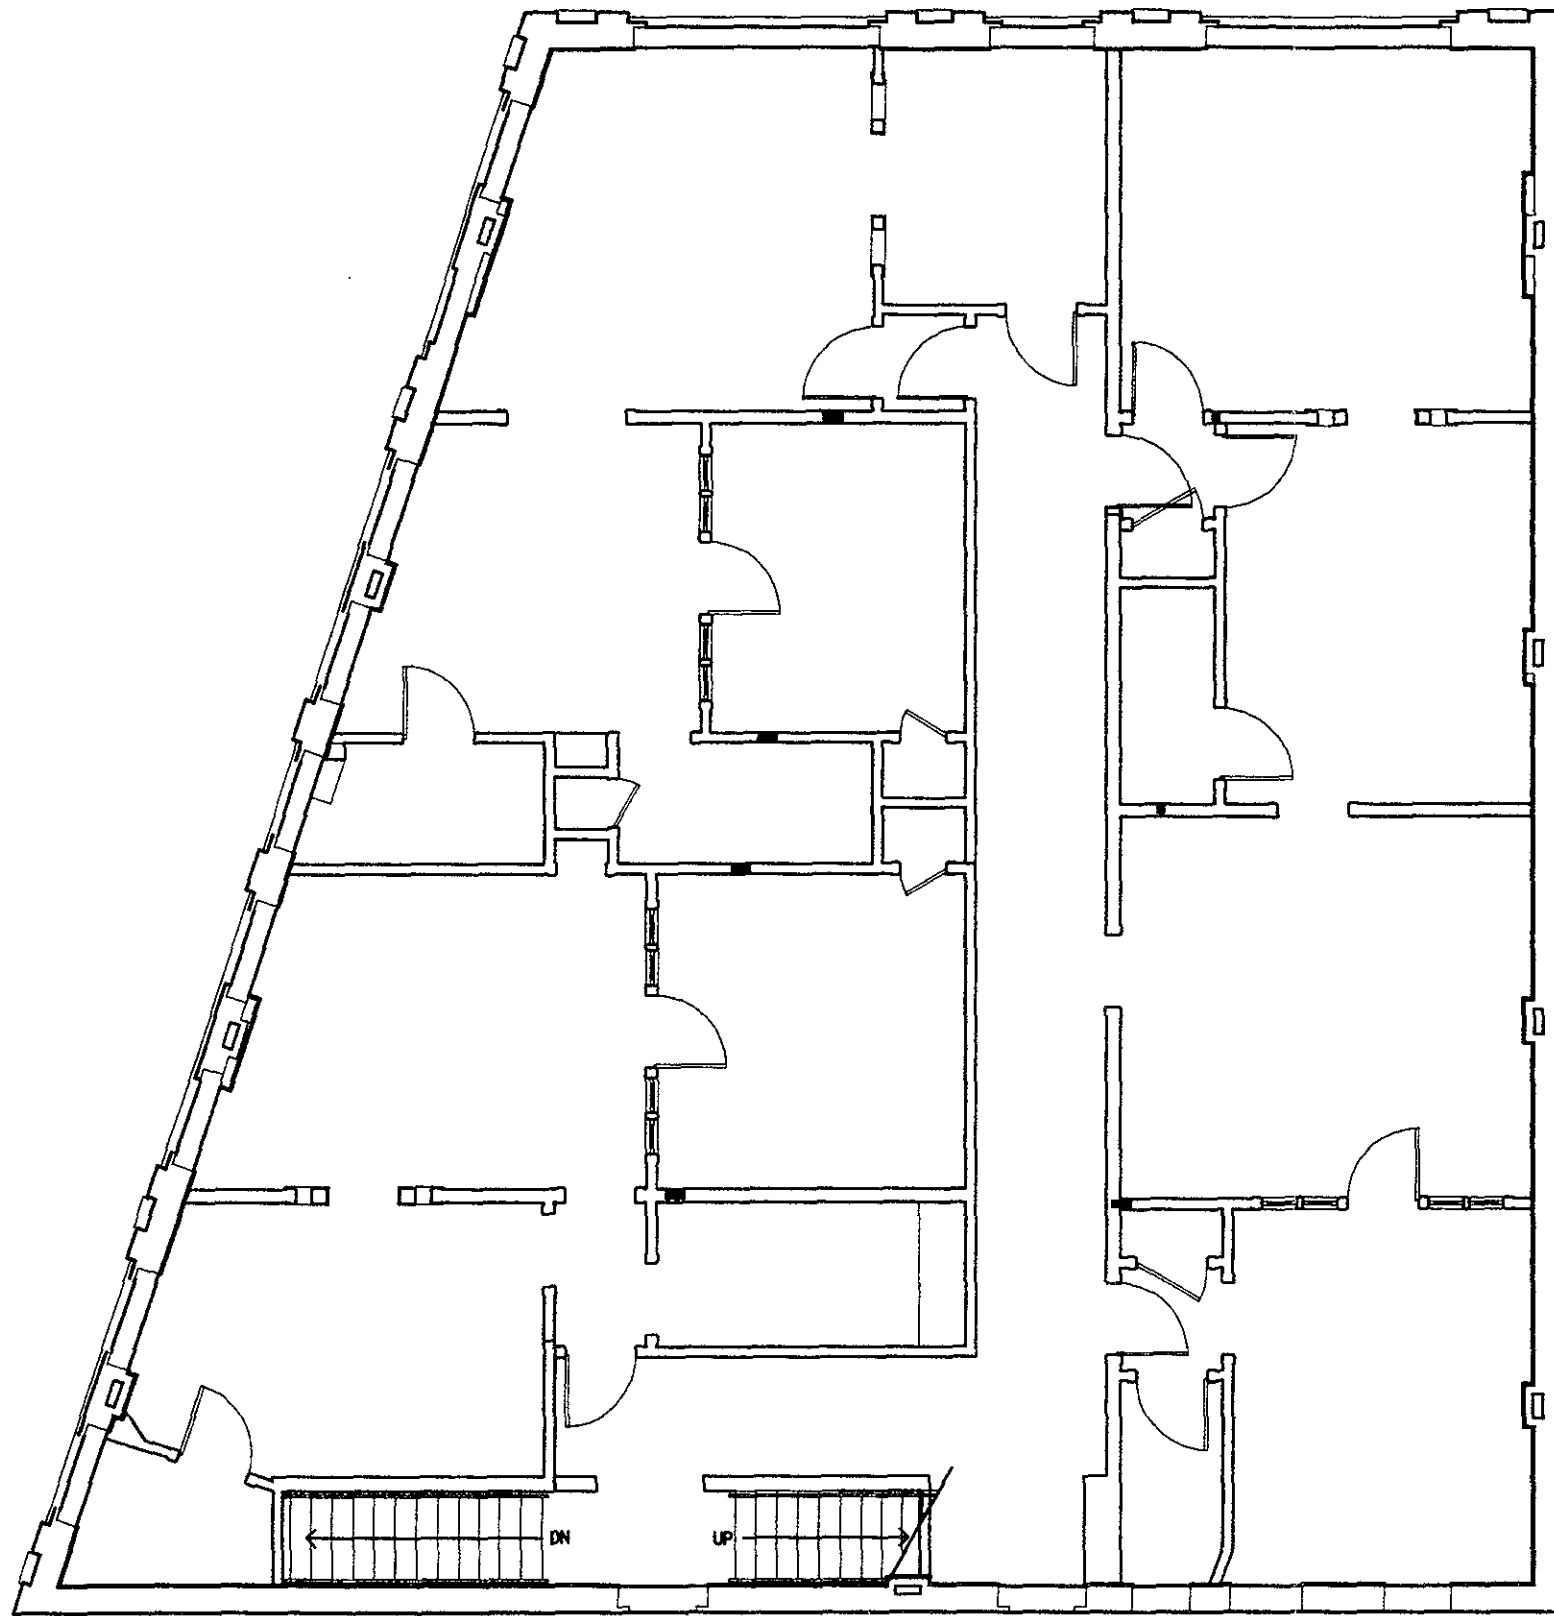
<b>QUINN EVANS</b> ■ ■ ■ ■ <b>ARCHITECTS</b> 219 1/2 N. Main Street Ann Arbor, Michigan 48104 313 663 5888	DESIGNED:	SUB SHEET NO.	TITLE OF SHEET	DRAWING NO.
	DRAWN:		<b>EXISTING CONDITIONS SECOND FLOOR PLAN</b>  HOOVER BLOCK DAYTON AVIATION HERITAGE NATIONAL HISTORIC PARK	302
	TECH REVIEW:			PKG. NO.
	DATE:			SHEET
				3
				8

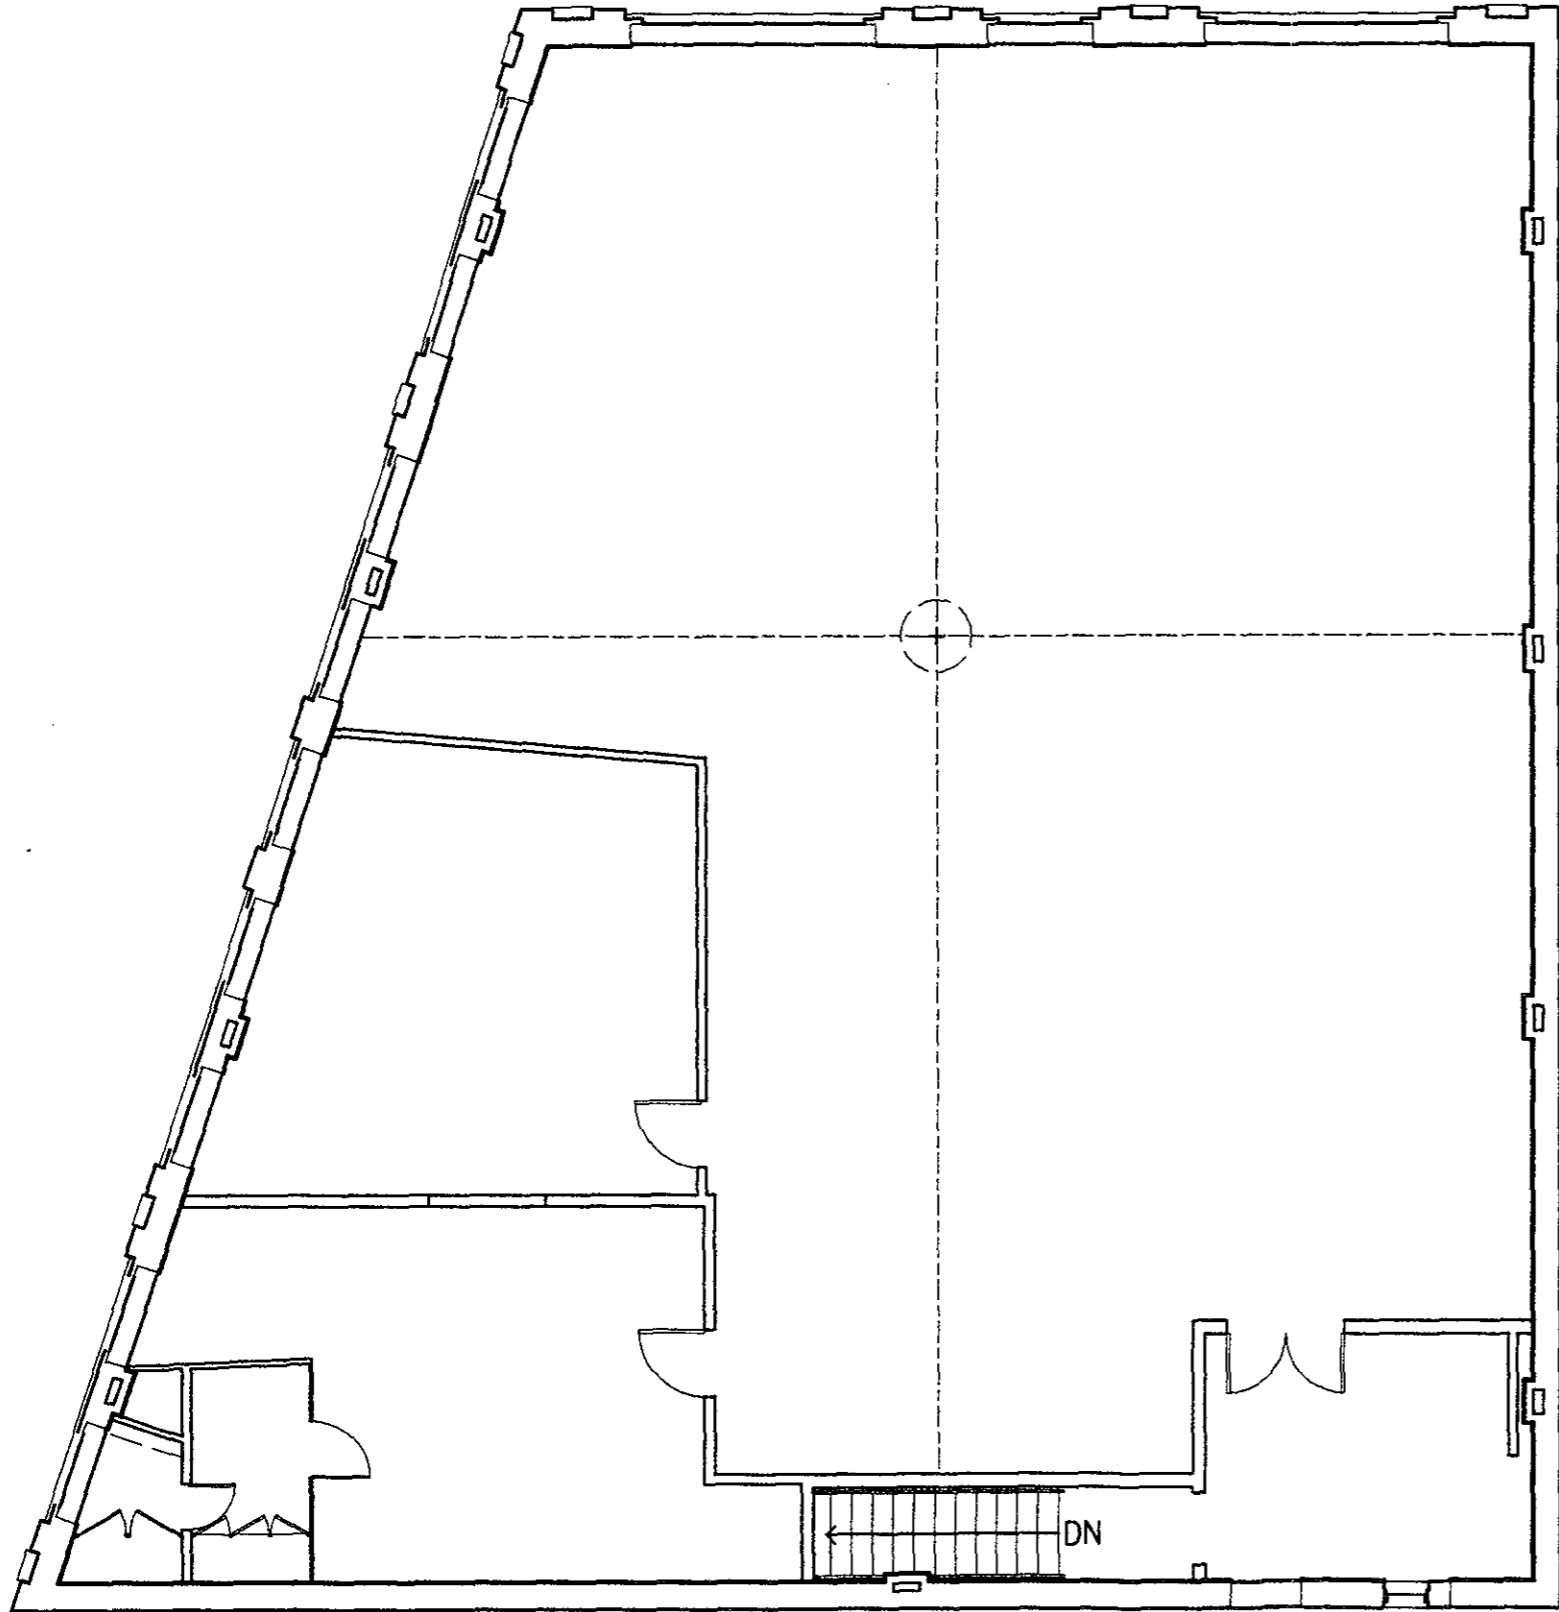
<b>QUINN EVANS</b> ■ ■ ■ ■ <b>ARCHITECTS</b> 219 1/2 N. Main Street Ann Arbor, Michigan 48104 313 663 5888	DESIGNED:	SUB SHEET NO.    	TITLE OF SHEET	DRAWING NO.
	DRAWN:		<b>EXISTING CONDITIONS THIRD FLOOR PLAN</b>  HOOVER BLOCK DAYTON AVIATION HERITAGE NATIONAL HISTORIC PARK	362
	TECH REVIEW:			20074
	DATE:			PKG. NO. SHEET <b>4</b> OF <b>8</b>

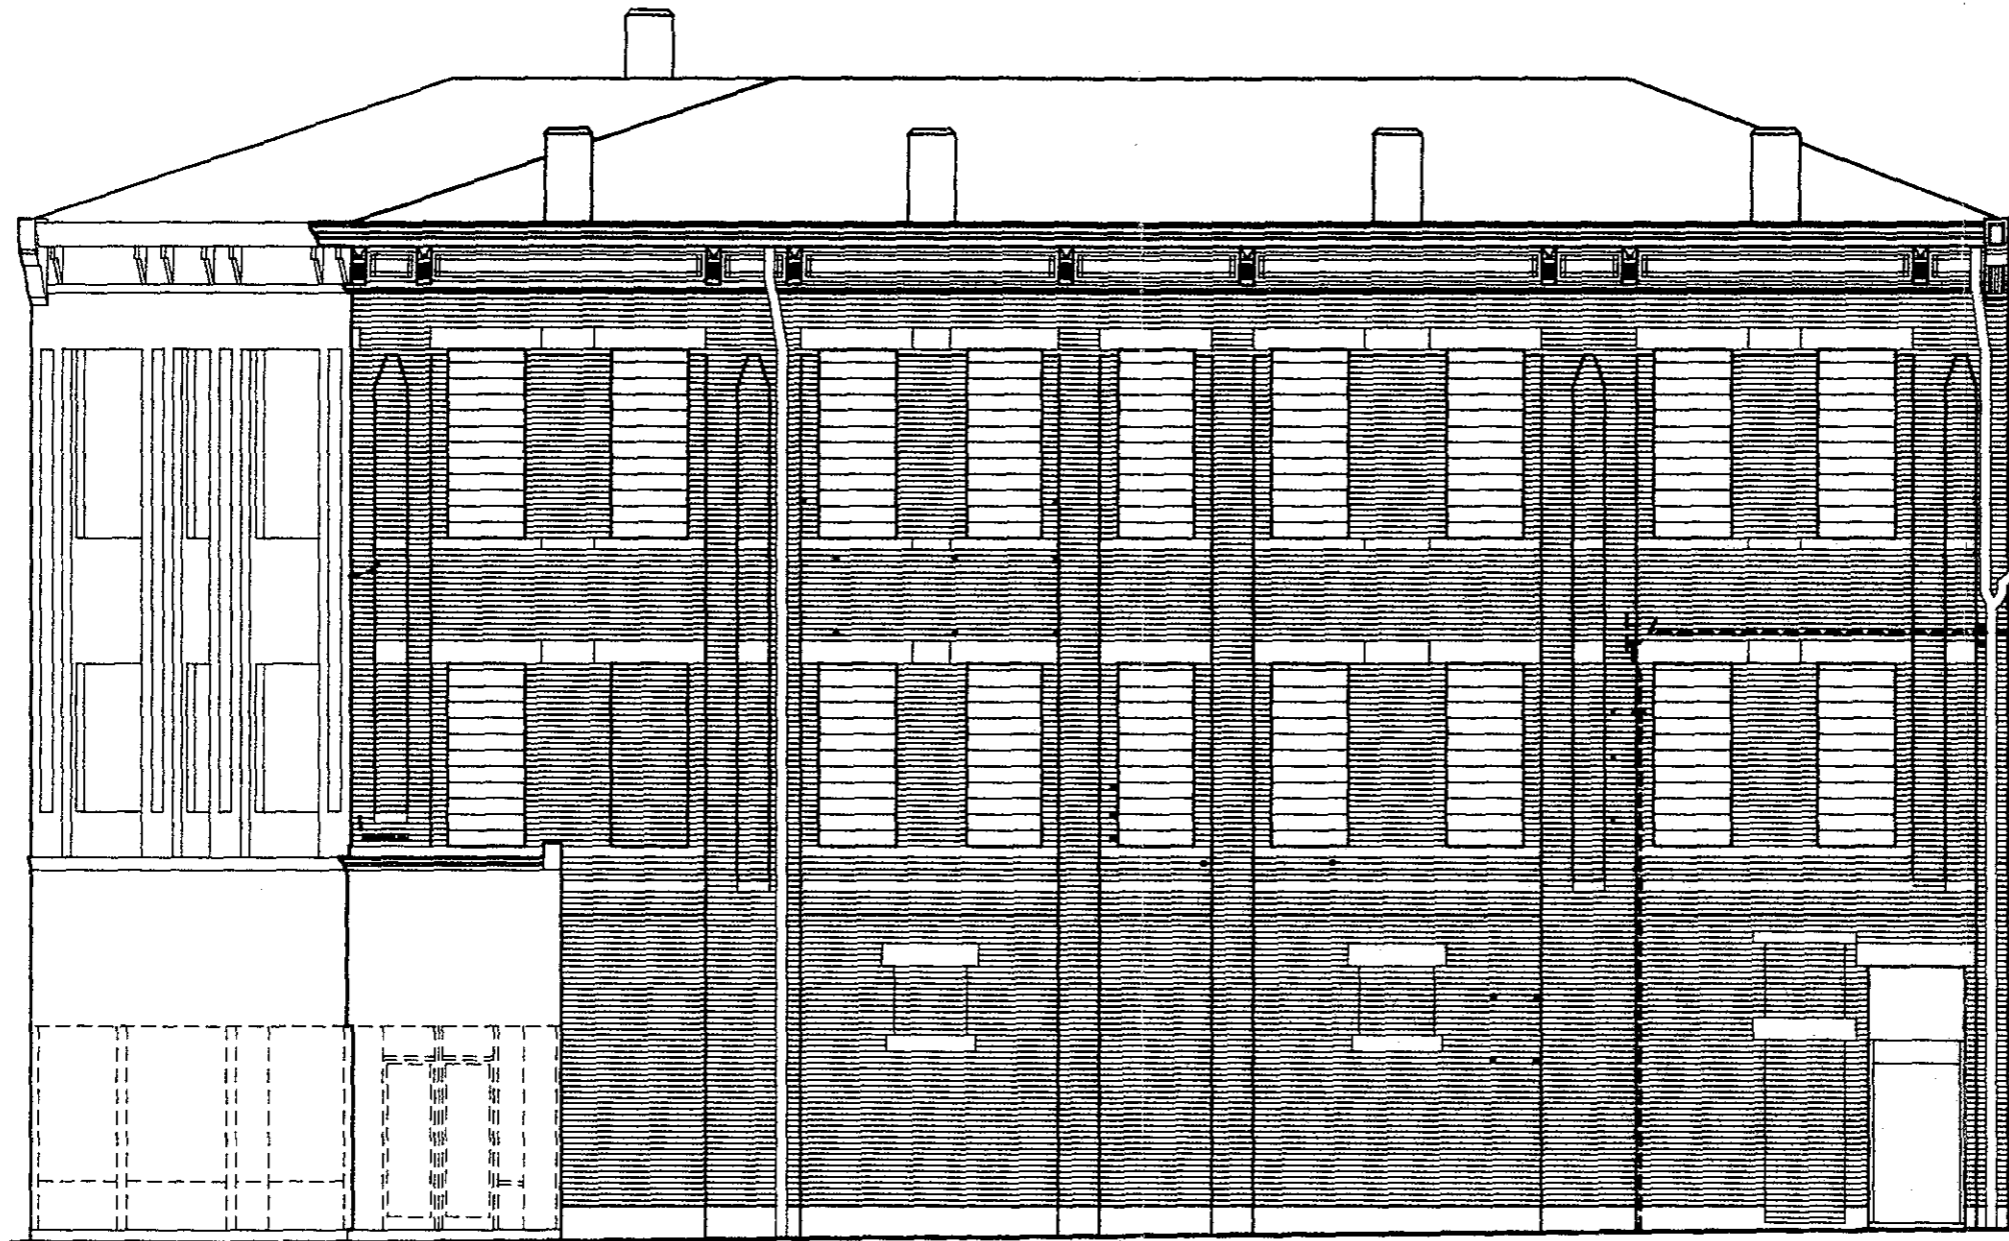
**WEST ELEVATION**  
SCALE: 1/4" = 1'-0"
