# HISTORIC STRUCTURE REPORT

## Hoover Block

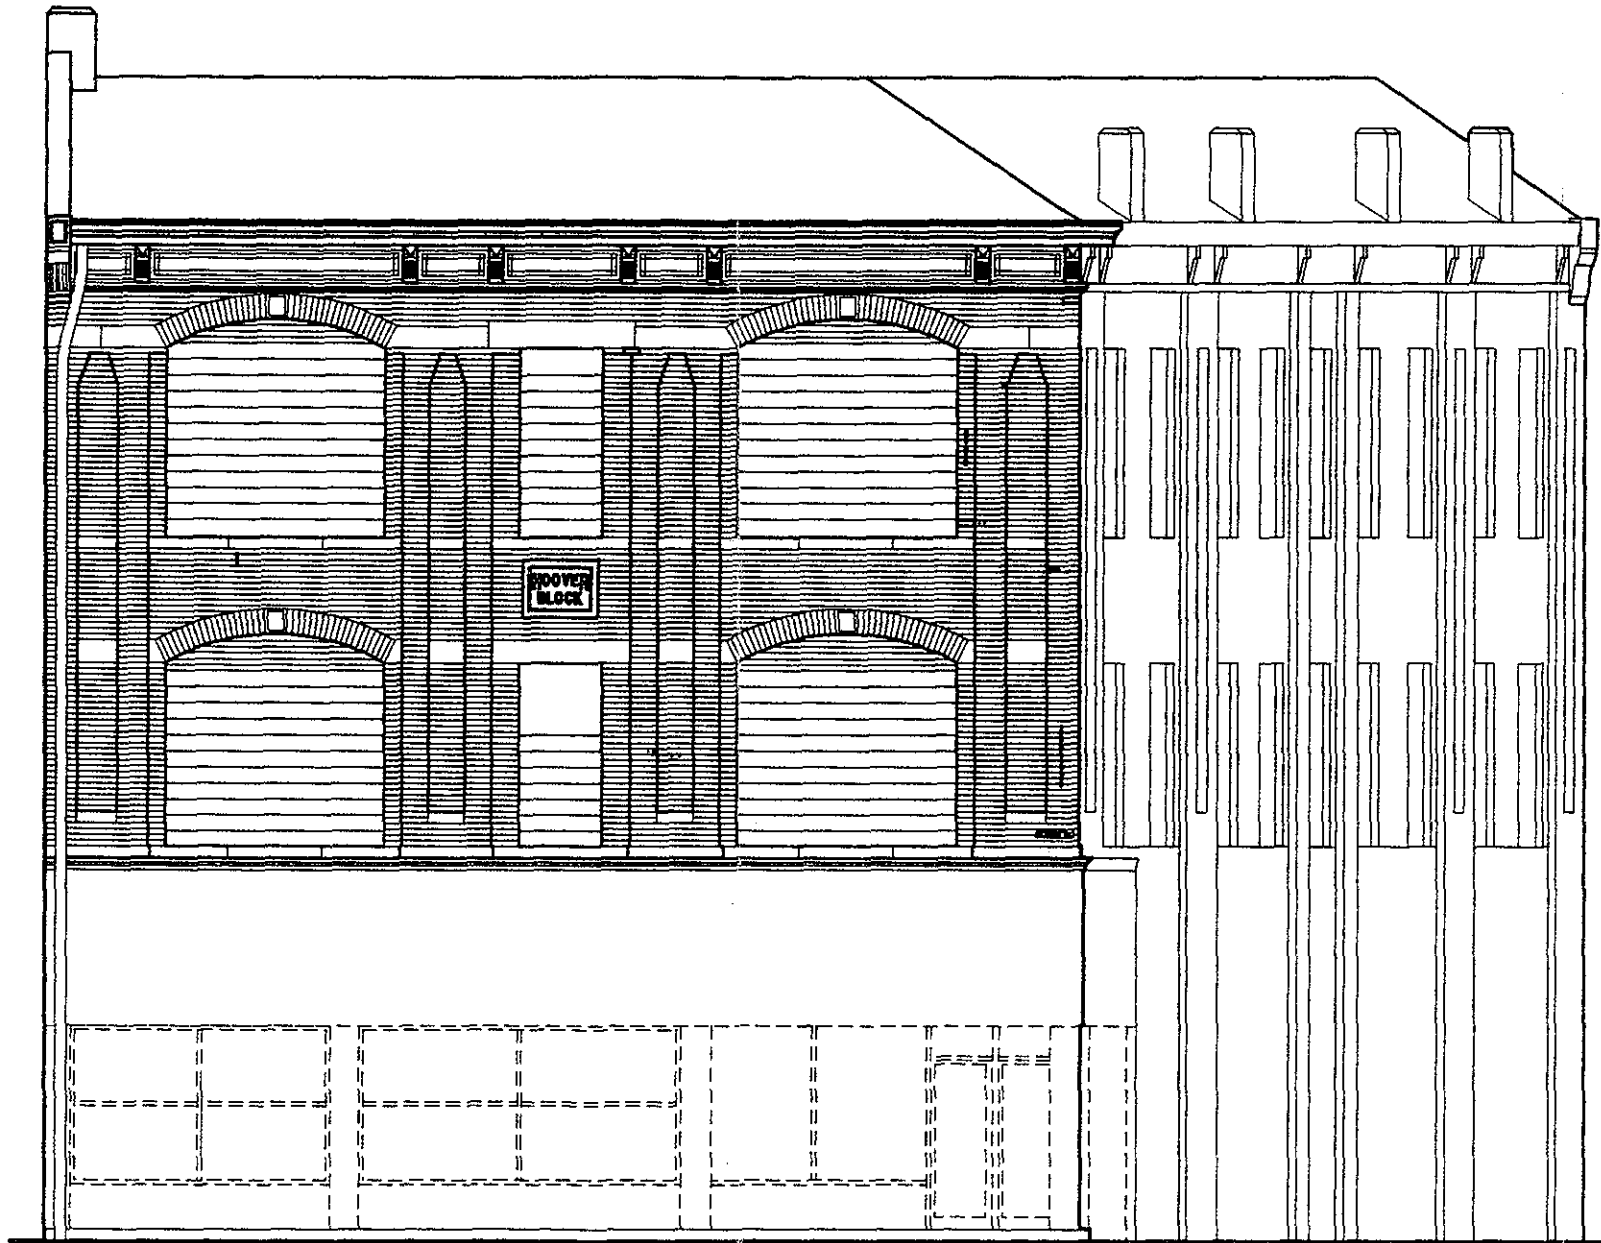
**NORTH ELEVATION**  
SCALE: 1/4" = 1'-0"

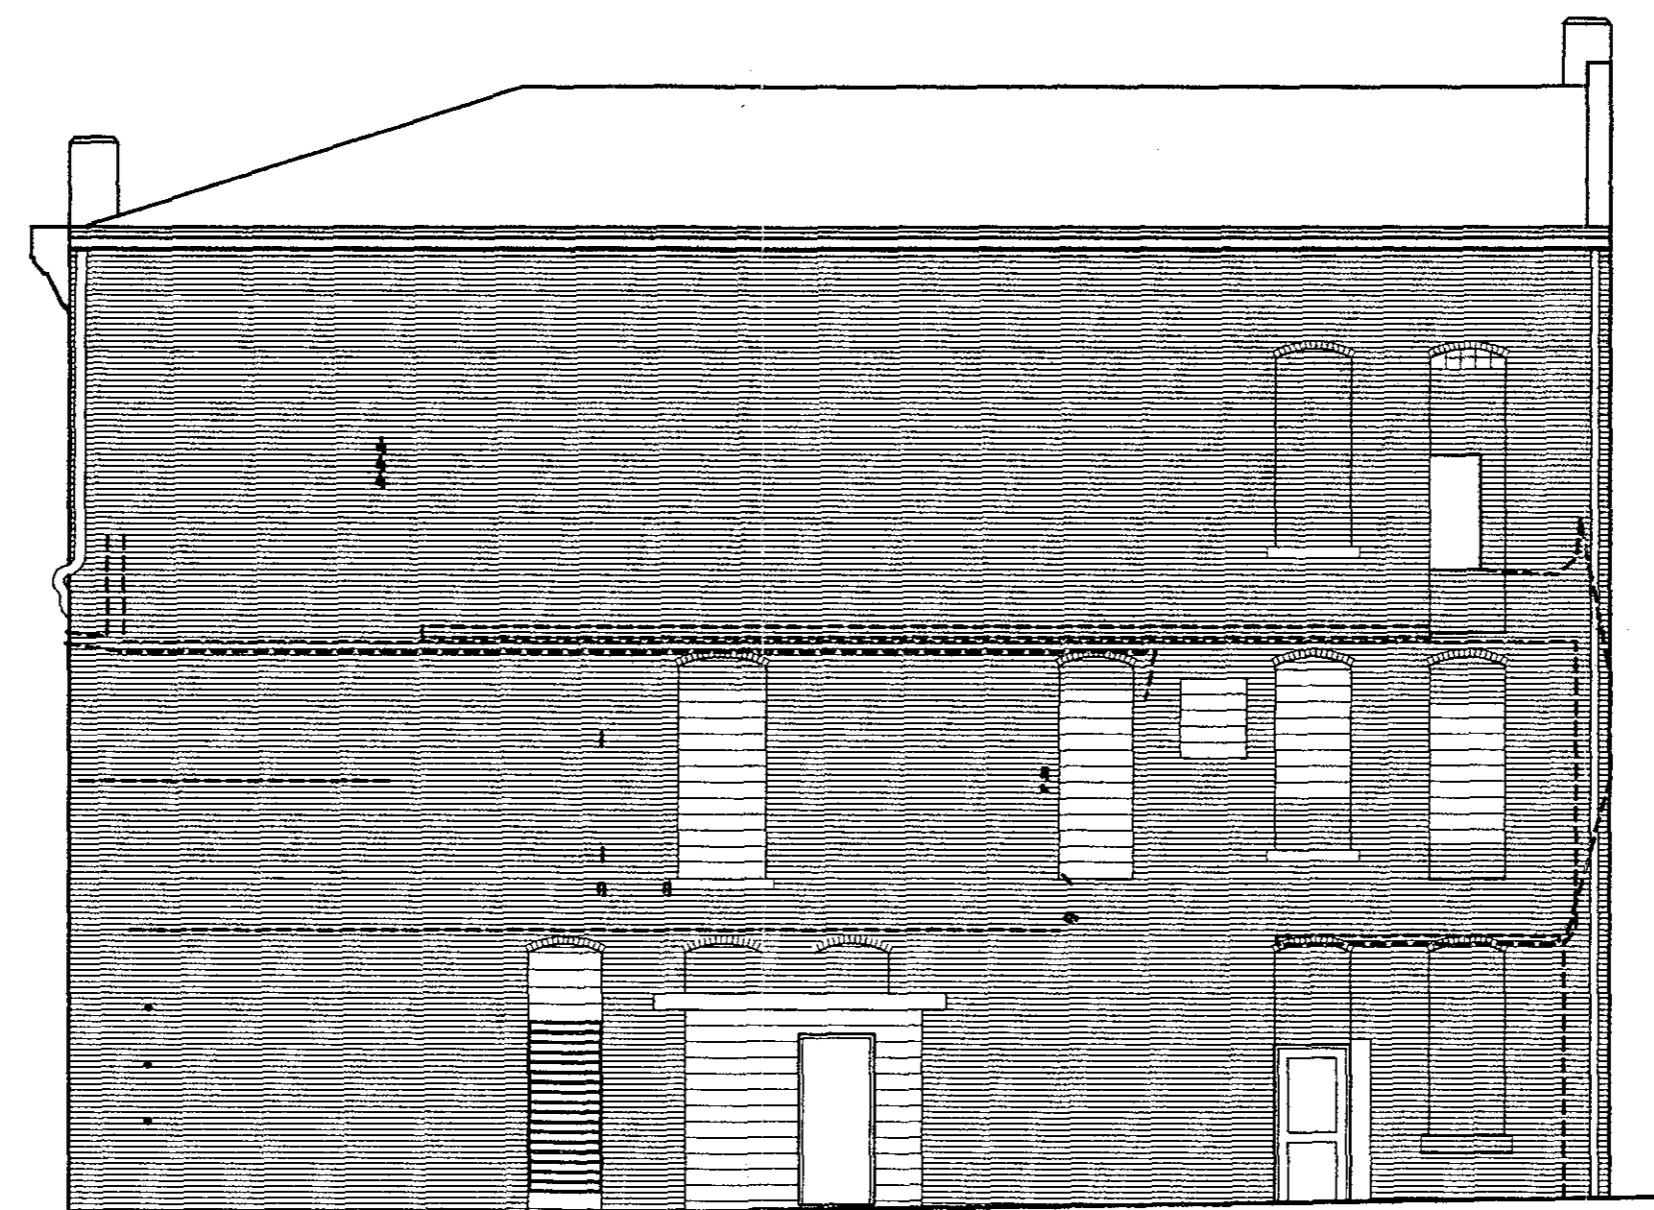
**SOUTH ELEVATION**  
SCALE: 1/4" = 1'-0"

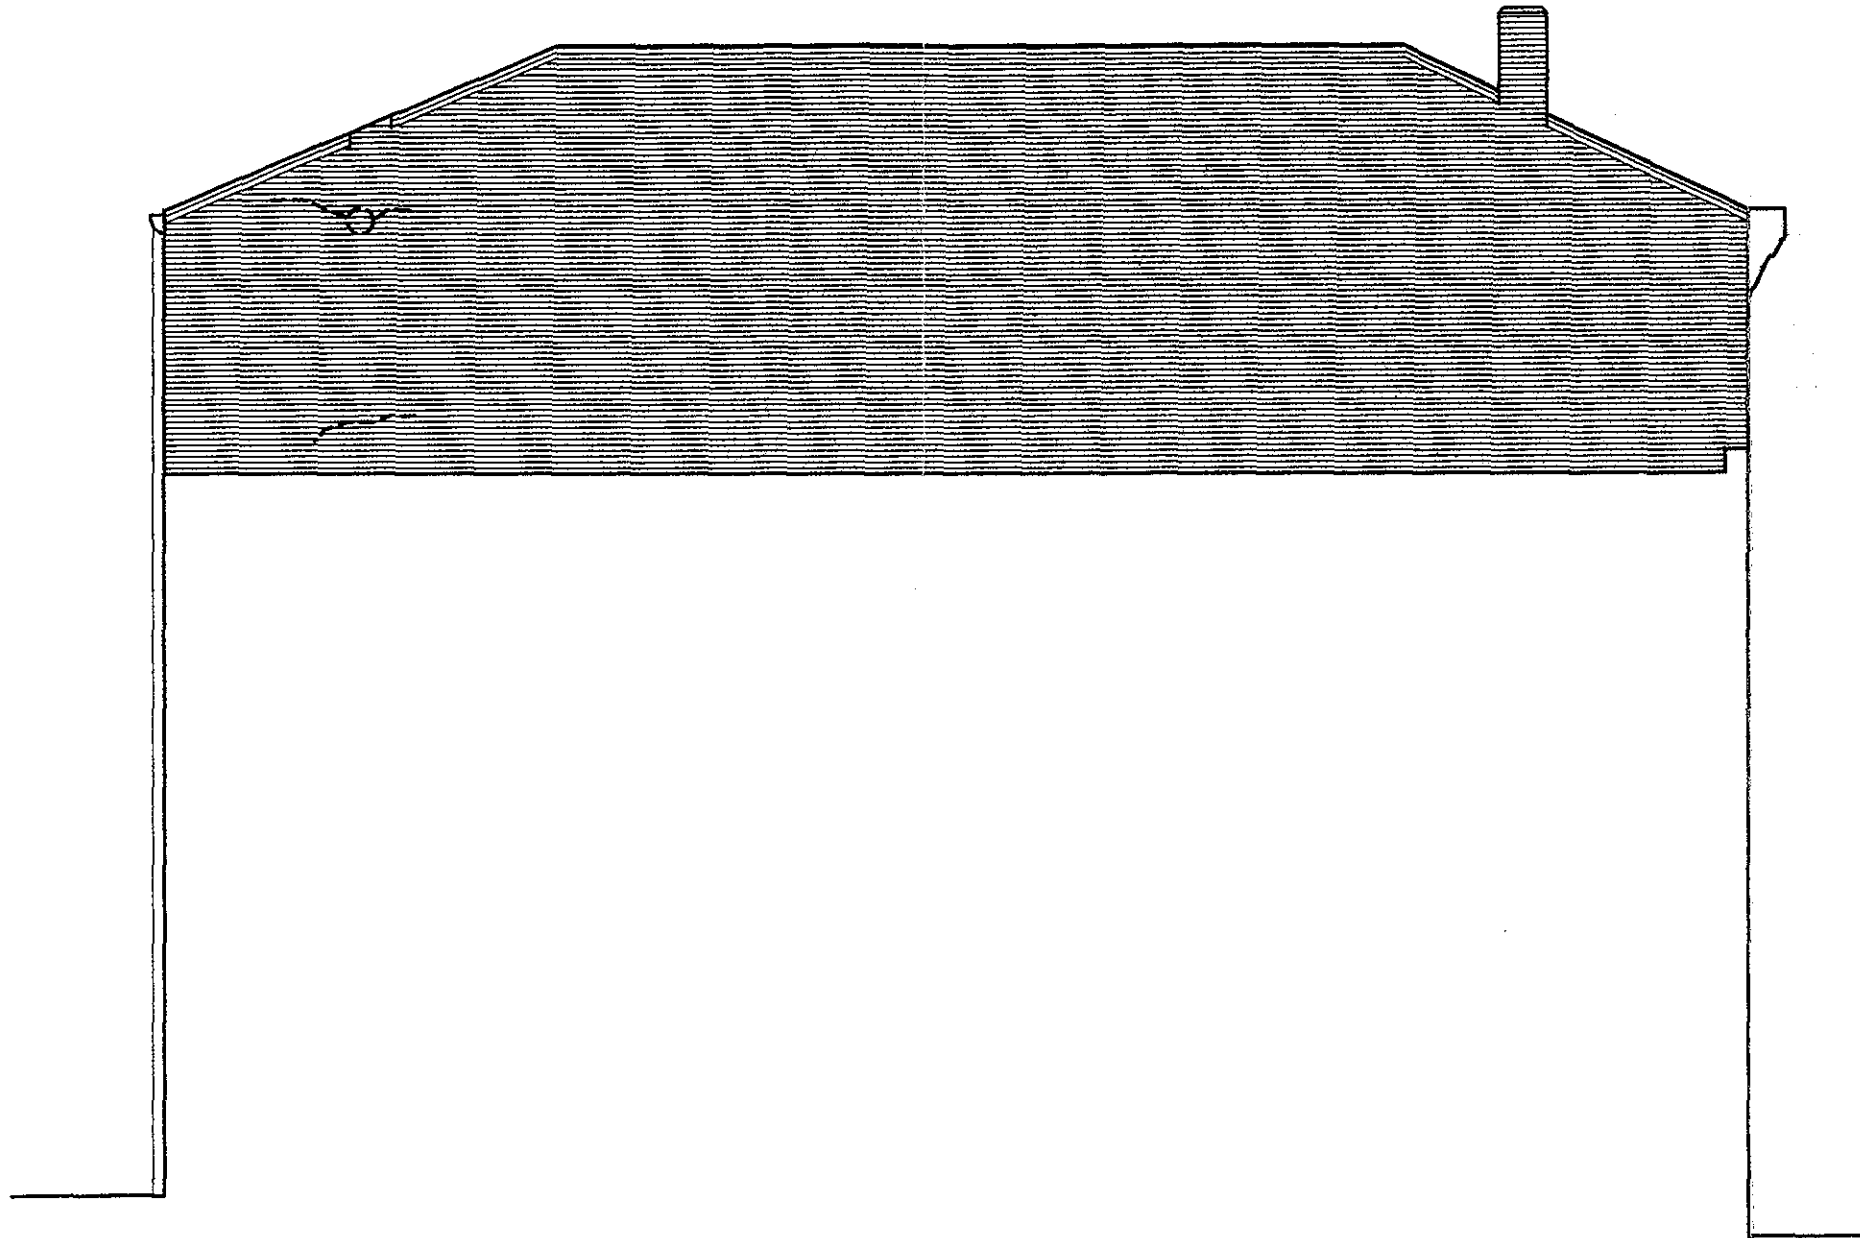
**EAST ELEVATION**  
SCALE: 1/4" = 1'-0"

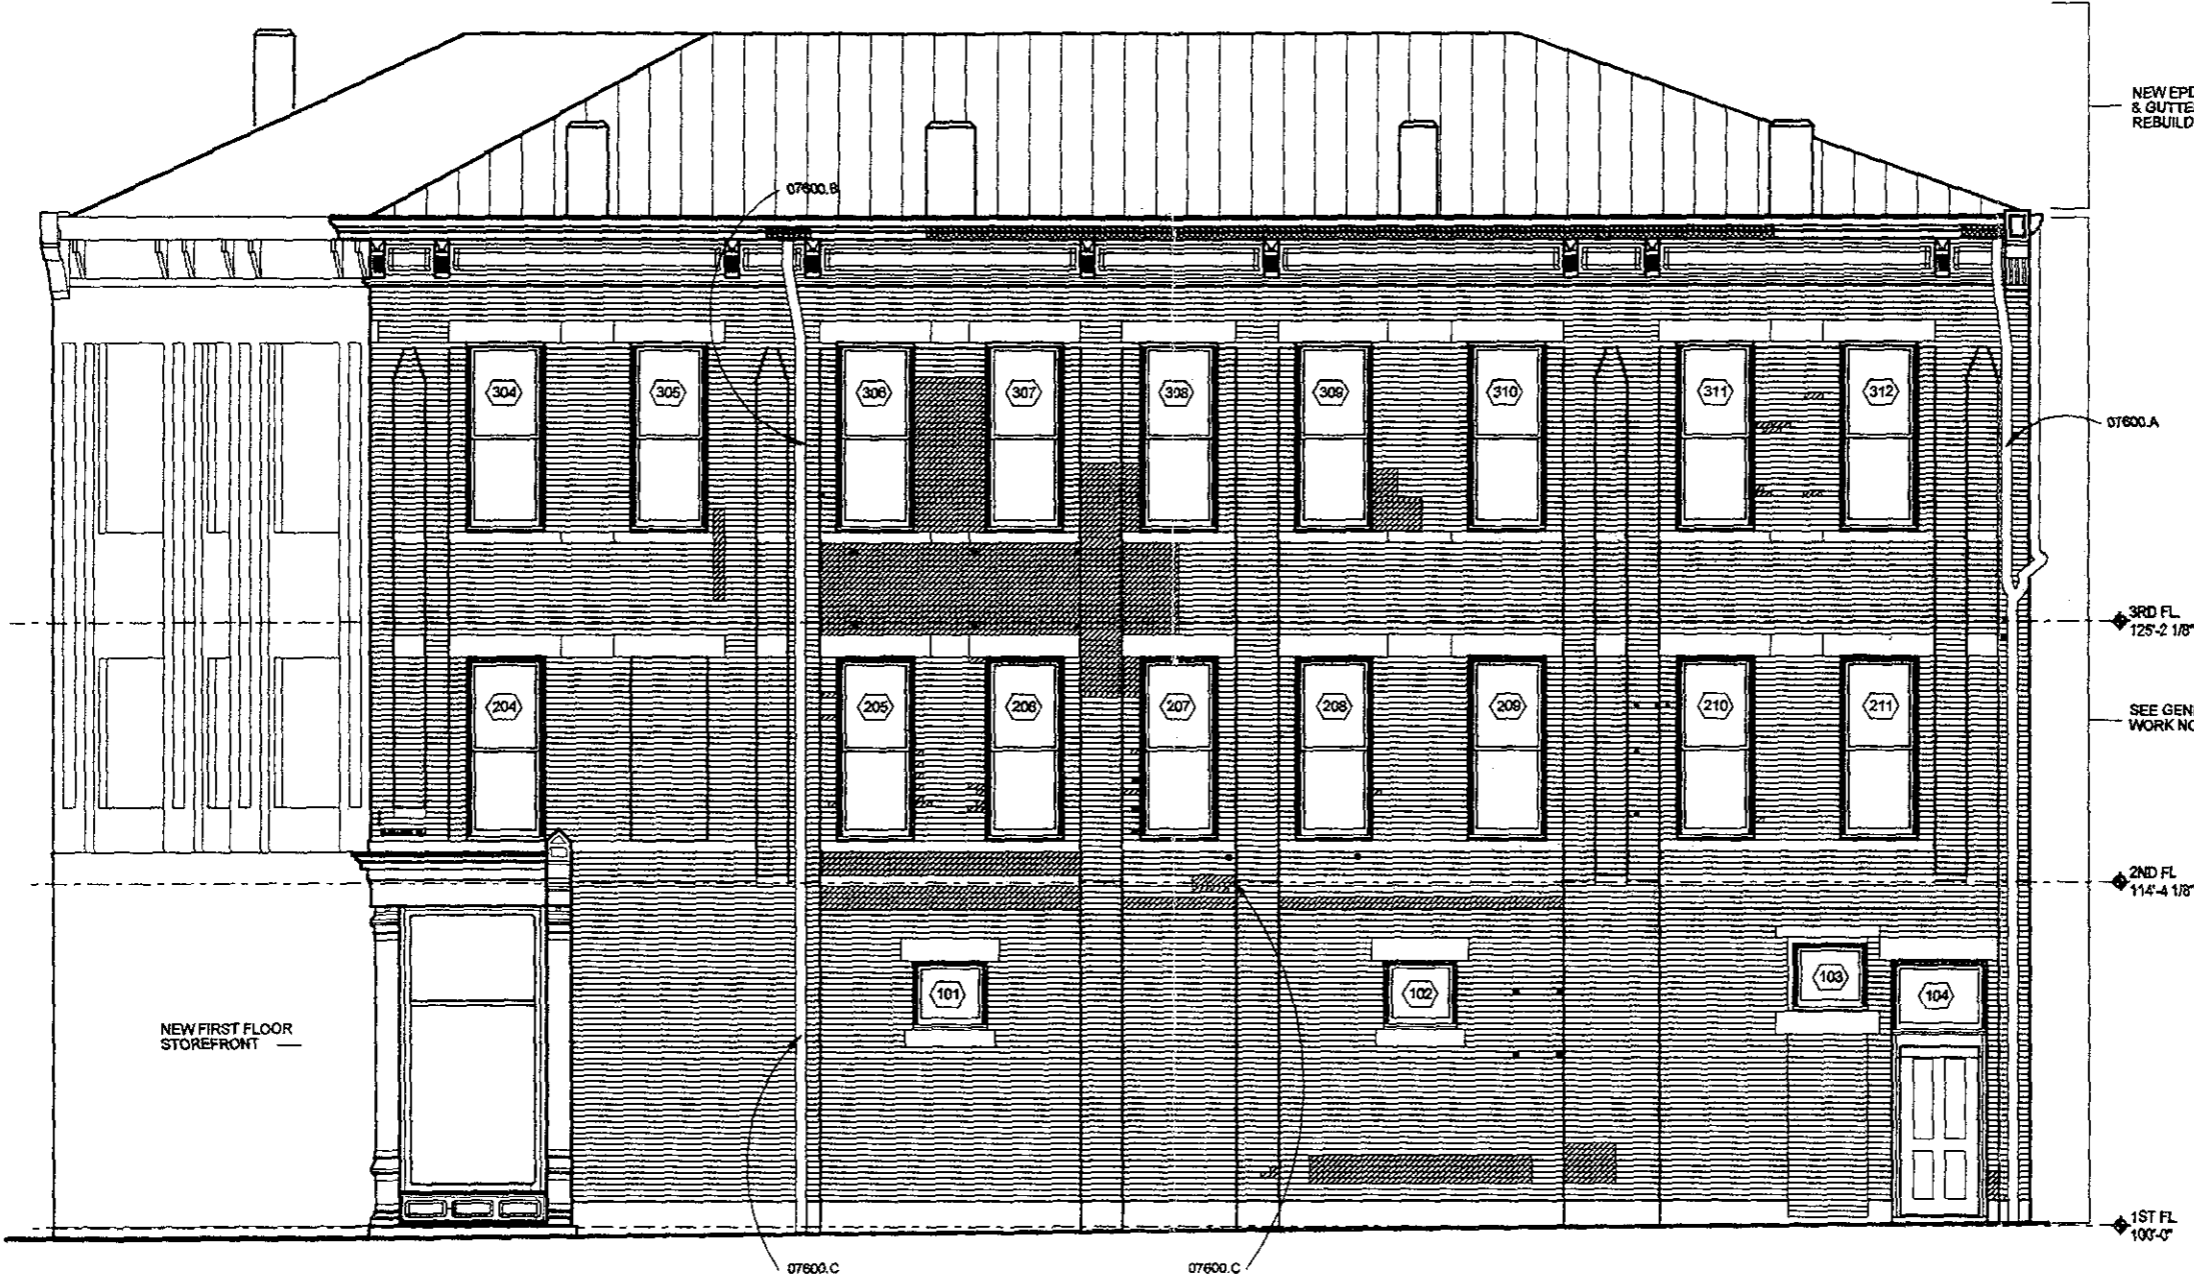
**WEST ELEVATION**  
SCALE: 1/8"=1'-0"

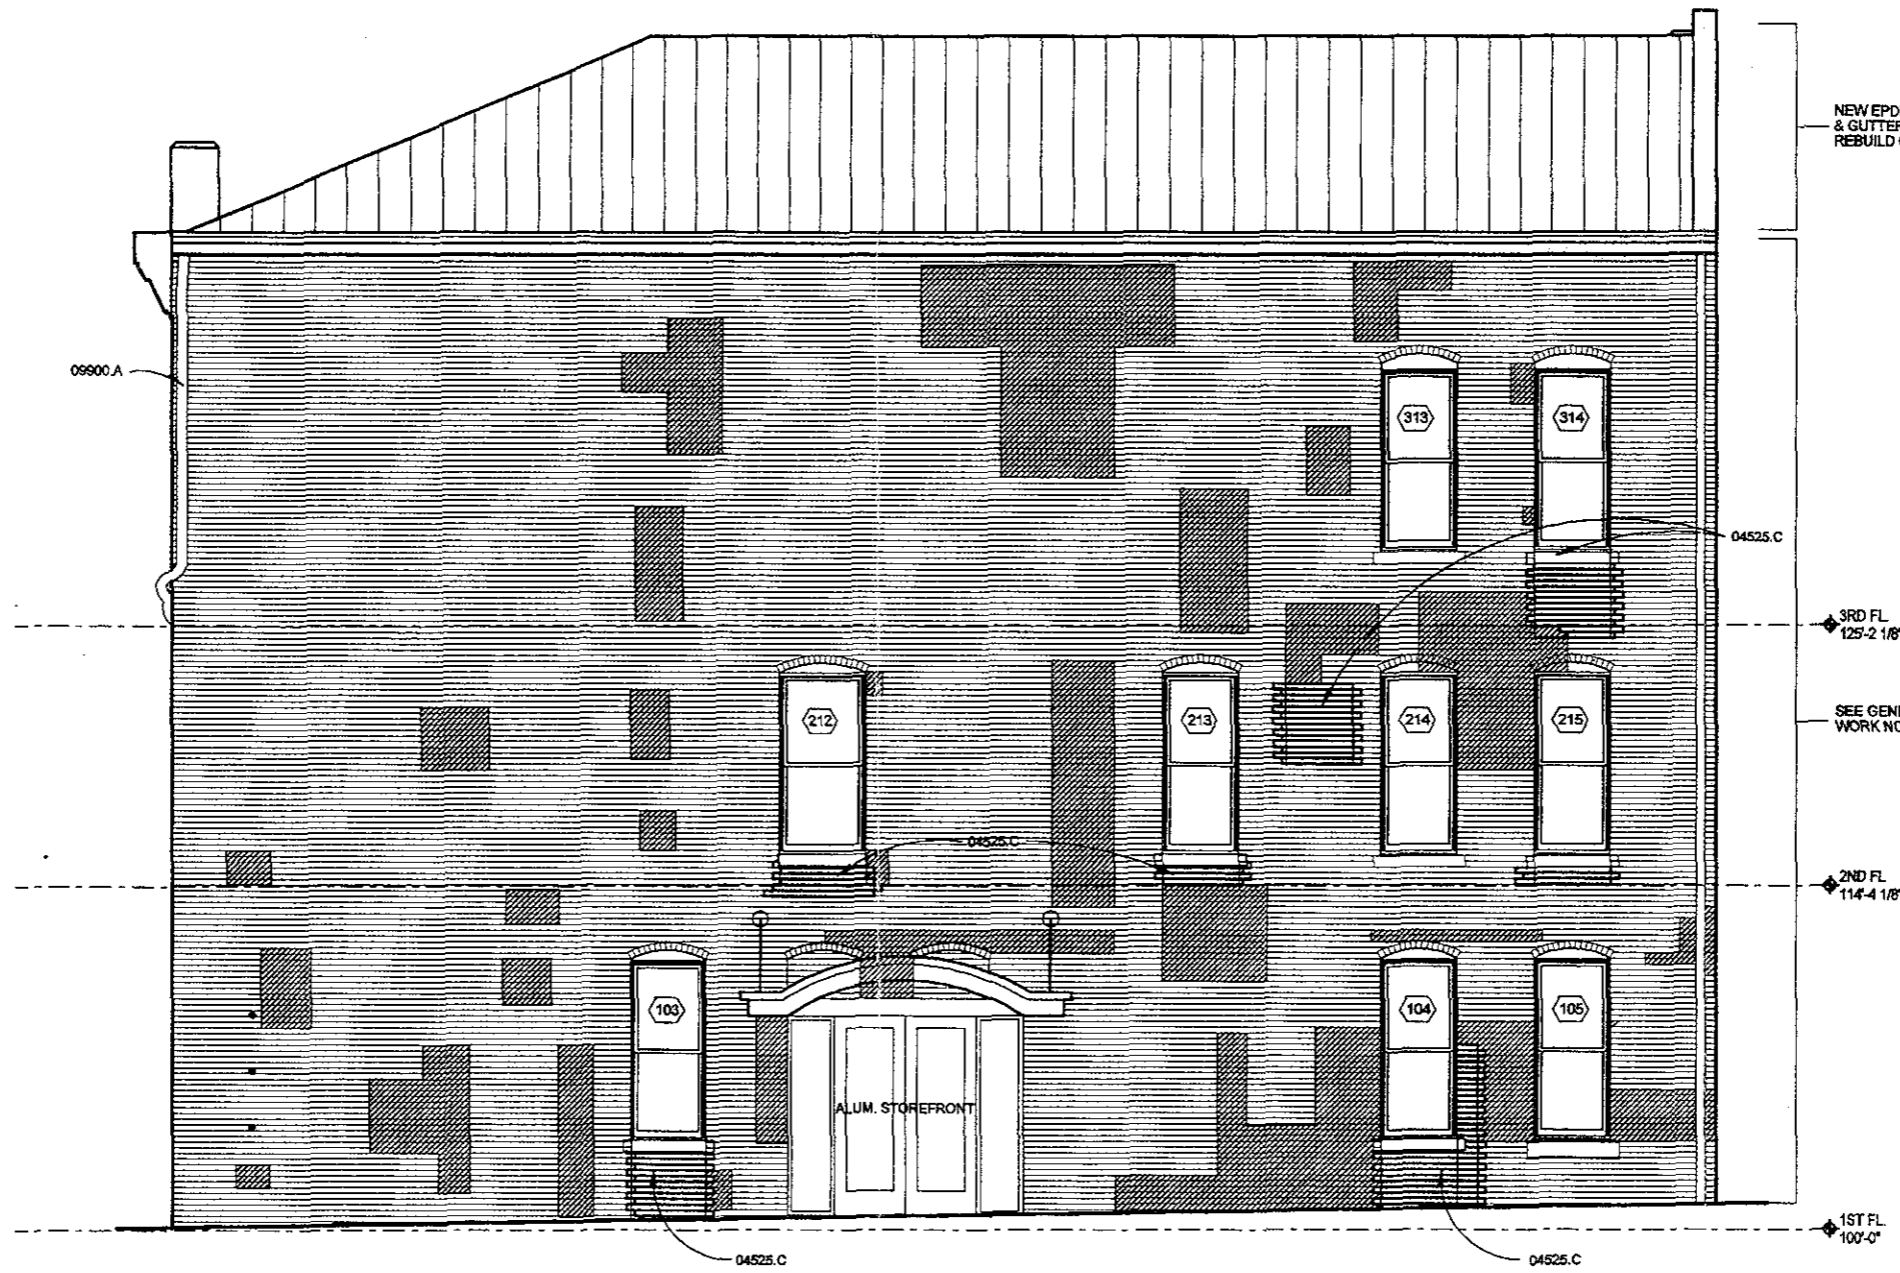
**SOUTH ELEVATION**  
SCALE: 1/8"=1'-0"
