HISTORIC STRUCTURE REPORT

Wright Hall

Carillon Historical Park

March 30, 2006
Final Submission

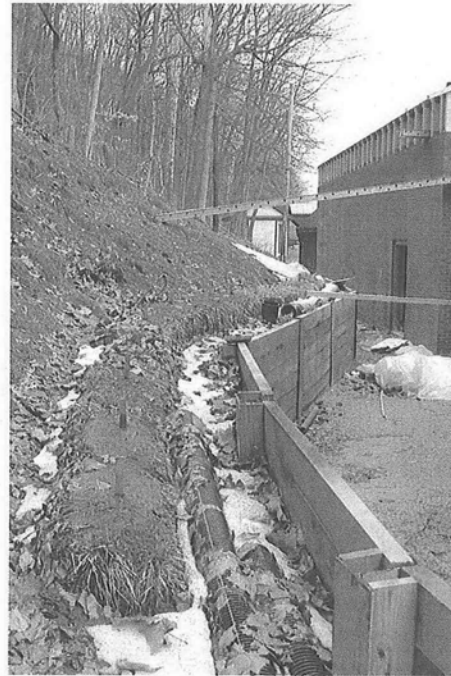
All of these systems remain intact. At the time of survey, the gutters on the south, west and east elevations were not complete, with missing leaders and leader straps. Modifications were made for drainage into an underground system on the south side of the building in an effort to eliminate the water penetration into the building (figure 24).

Figure 24: Moraine siting, south side of Wright Hall

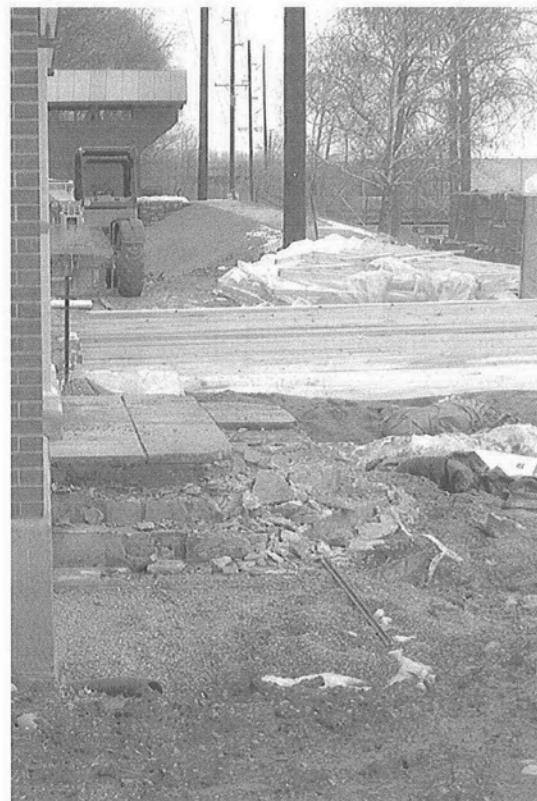
Figure 27: Dismantled front steps.

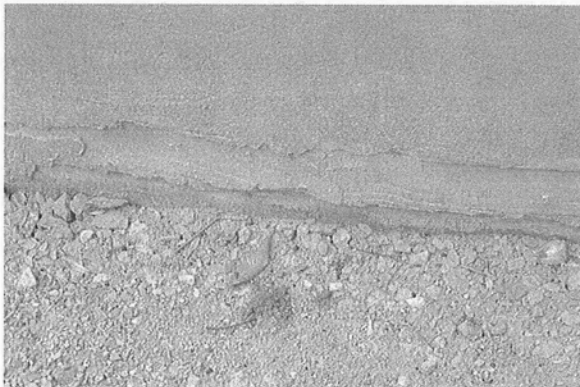
The foundation shows evidence of spalling of a recent parging repair adjacent to the ground. Foundation cracking and the repair of earlier foundation cracking is evident along the entire south elevation (figure 28).

Figure 28: Foundation condition at grade.

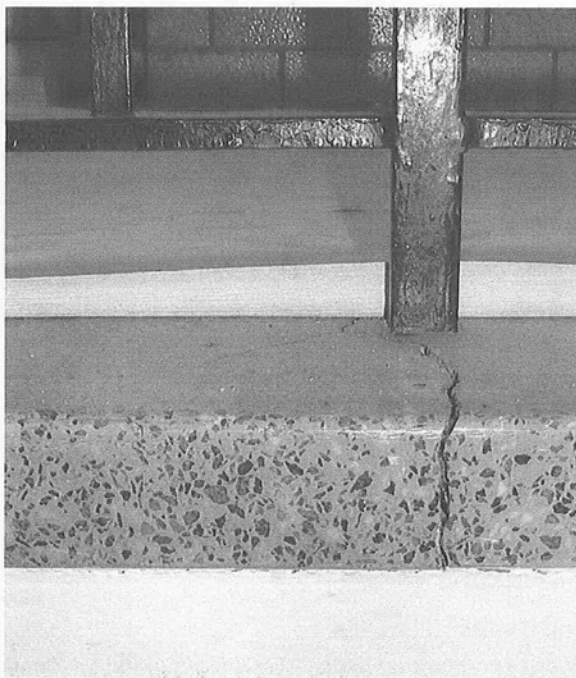
Figure 29: Crack in terrazzo floor.

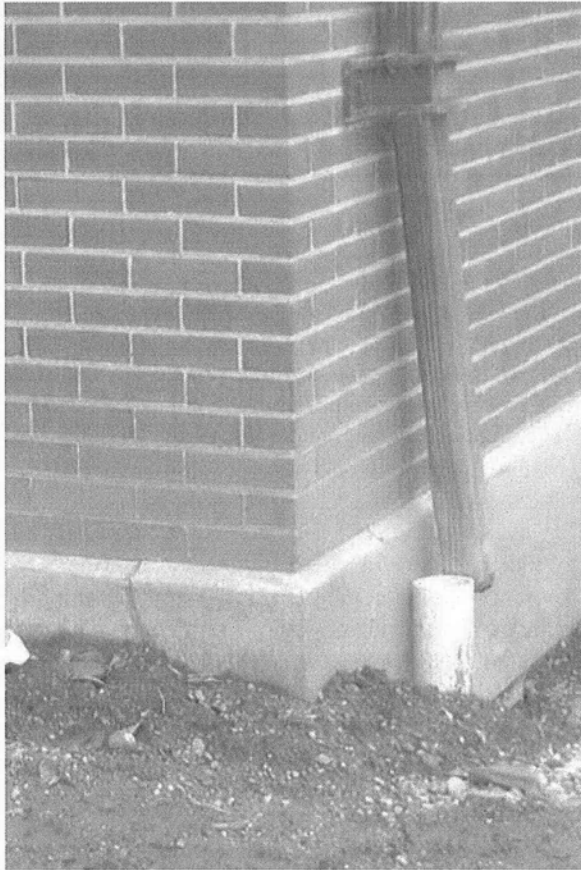
Figure 30: Evidence of cracking at floor on exterior

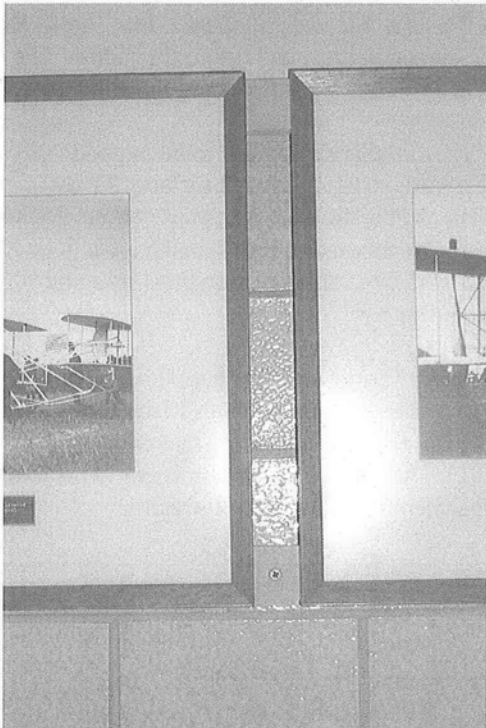
Glazed Brick: The glazed brick is generally in good condition, with some penetrations at the locations where the lower wood trim mounting rail is in place (figure 32). There is some mortar missing at the joints below the sills of each window corner.

Figure 32: Glazed brick at mounting rail.

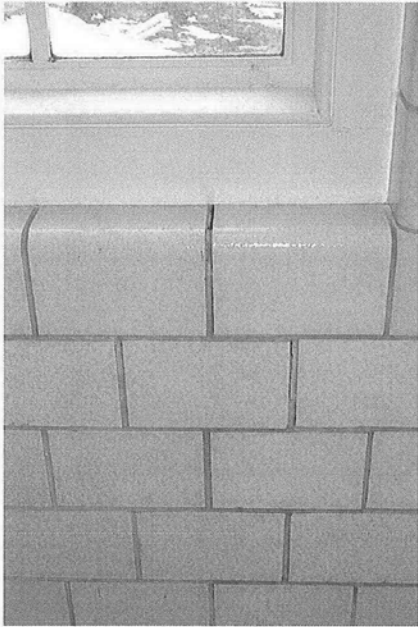
Figure 36: Glazed brick at window sill.

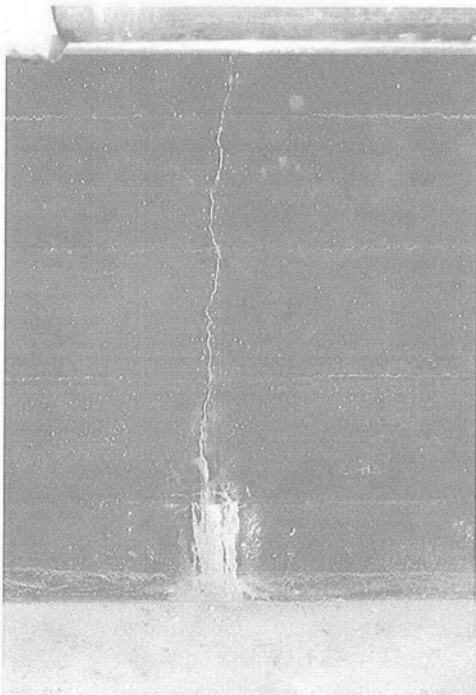
Figure 46: Interior wall foundation crack (QE|A 2000)

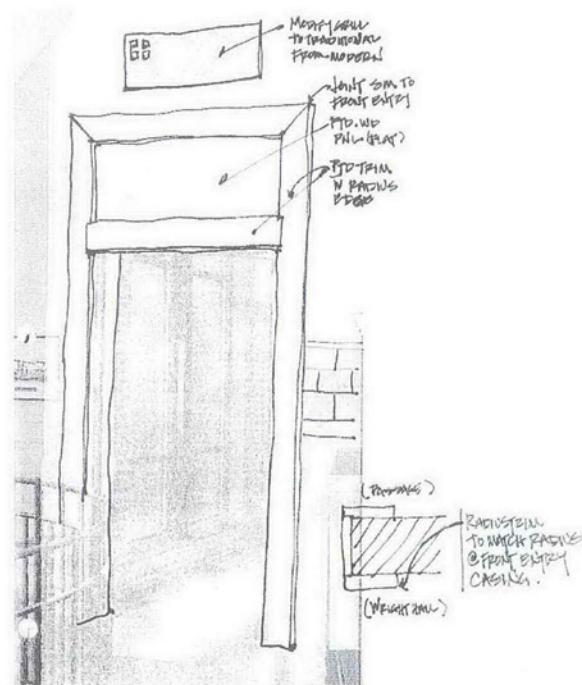
Figure 47: Proposed door trim simplification (QE\A 2000)

The recommendation is to maintain the east and west wing openings as doors and to modify the trim. In doing so, the trim should be simplified so that it is flat with a radius profile. The faux transom also should be trimmed out and the new opening replicated.

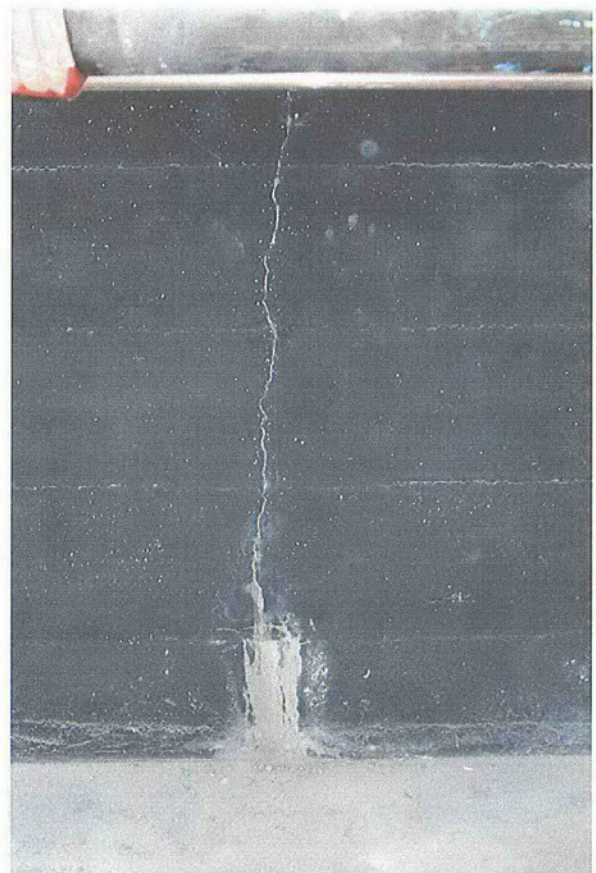
Wright Hall east plenum, thru-wall crack (QE\A 2000)
