HISTORIC STRUCTURE REPORT

FORT POINT LIGHT

└ FORT POINT NATIONAL HISTORIC SITE

May, 1972

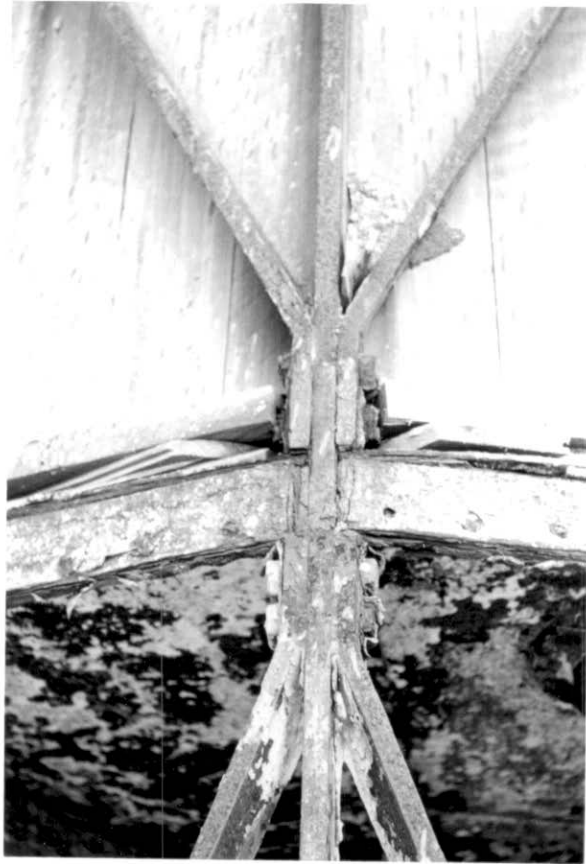
Illustration 5

Detail of framing at level "B". Note T&G decking and wall lining at level "B". Also, note that the iron forming the structural frame is in sound condition.

14. Repair interior T&G wall lining and decking and construct new hinged trap door at level "B".
15. Repair T&G decking at level "C".
16. Enclosed spaces shall be made weather-tight.

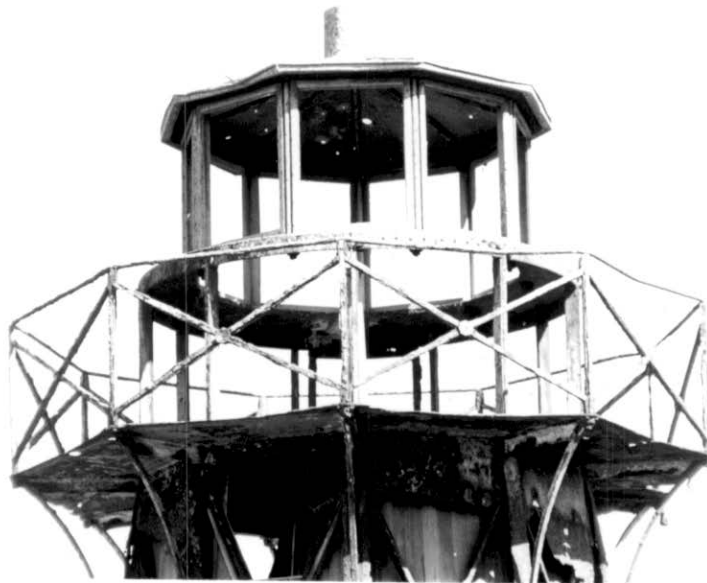
Illustration 6

Detail of lantern and gallery.

9. Replace spiral iron stairway and railing at level "A" and ladder at level "B" with new to match original.
10. Replace gallery including railing and exterior brackets that support it with like material.

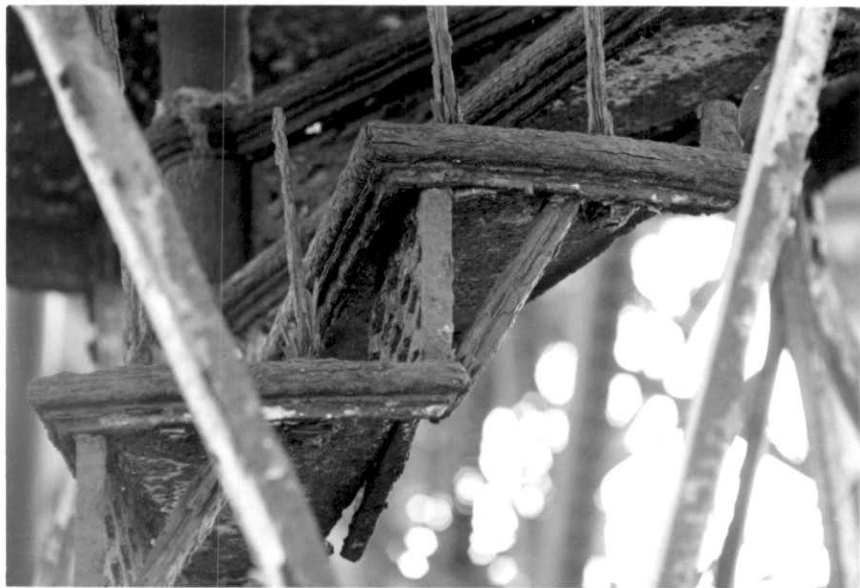
Illustration 7

Detail of cast iron spiral stairs. Note deterioration of iron beyond salvaging.

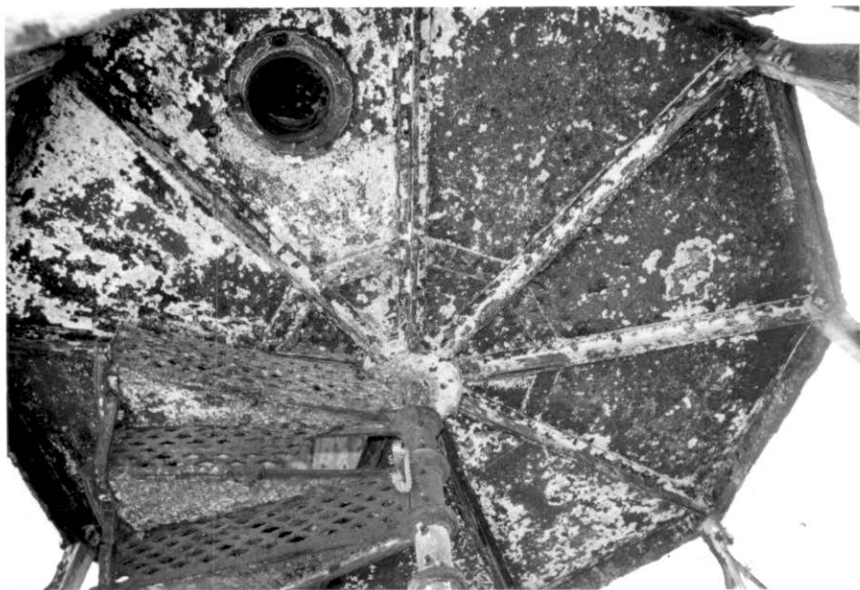
Illustration 8

Detail of underside of deck at level "B" and at gallery.

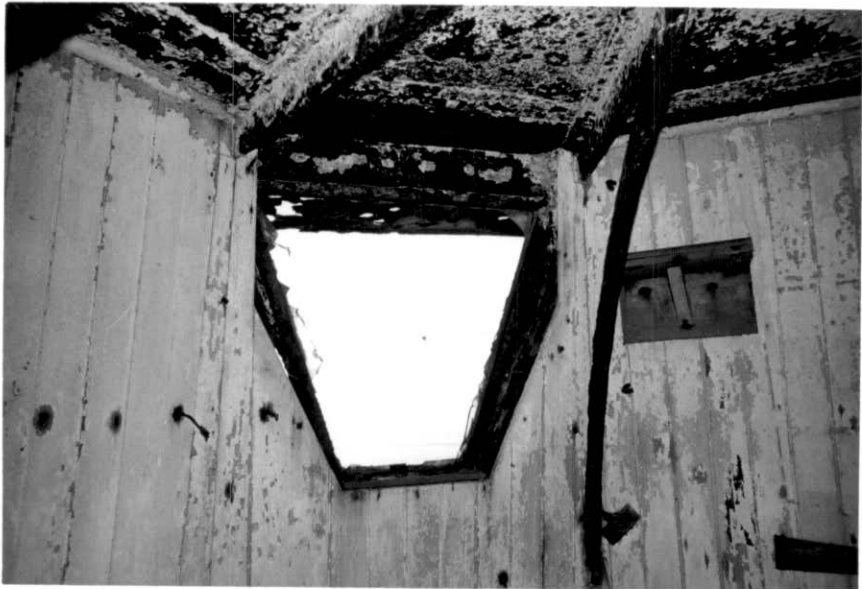
Illustration 10

At approximately 12 feet above the base an iron plate, over which is constructed a T&G wood floor, is supported by 4" T bars framed into a central ring. The space above to the gallery level, about 8 feet, is enclosed with iron plate on the exterior; and the interior is lined with beaded 1" x 4" T&G. This enclosed space was the Watch Room, and was reached by a spiral cast iron stairway and a trap door. Trapezoidal windows, of iron frame and 5/16" thick plate glass, fit between the "X" bracing in three panels below the gallery. The windows are rusted beyond salvage.

Detail of windows and interior T&G wall lining at level "B".
Note iron knee bracing.

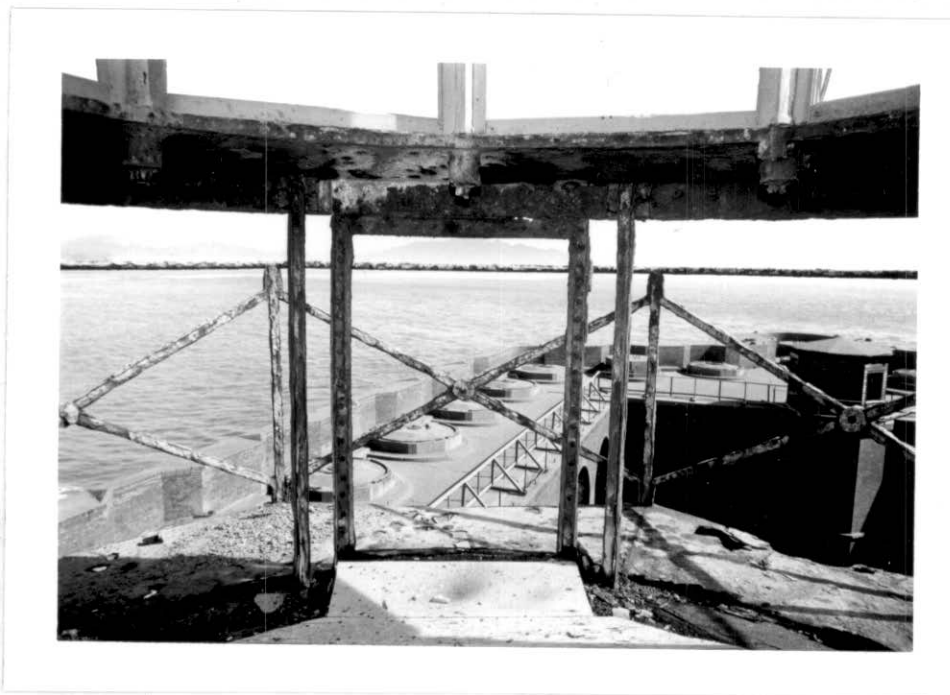
Illustration 12

Detail of framing and assemblage of access door at parapet, level "C".
