National Park Service
U.S. Department of the Interior

Fort Point National Historic Site
Golden Gate National Recreation Area

Abbreviated Fort Point Historic Structure Report

September 2006

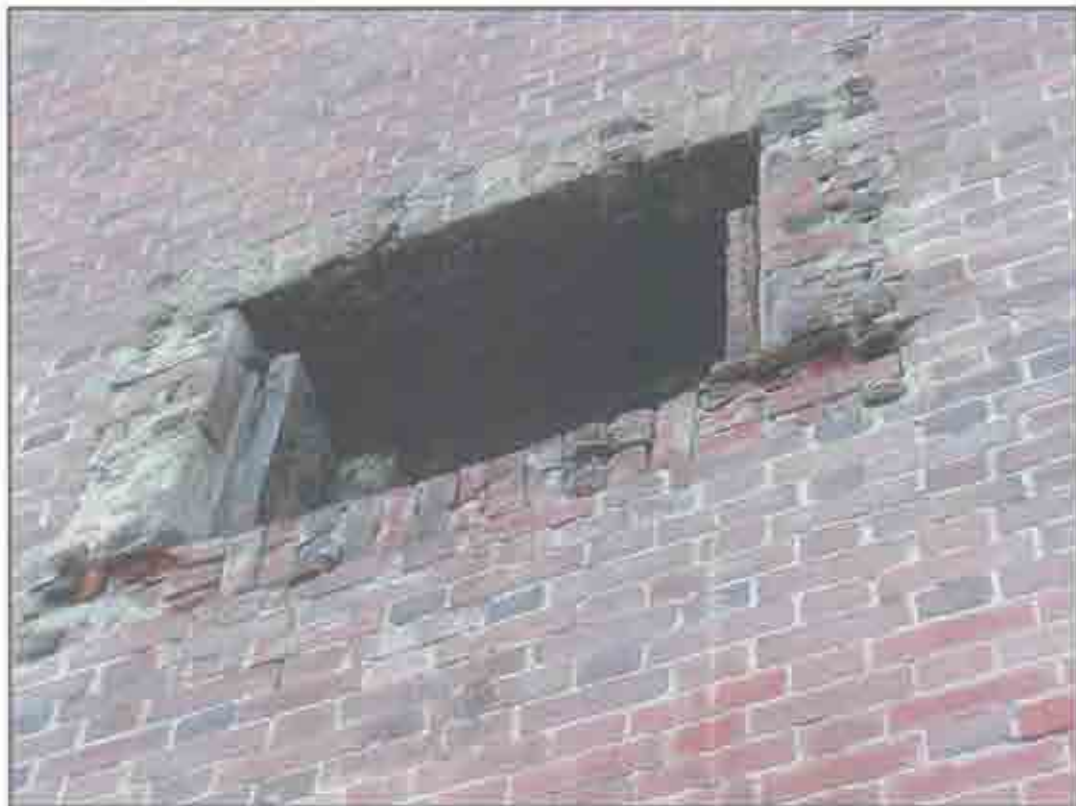
The quoins in the path of the wind and saltwater spray have lost their smooth quarried finish. (Jane Lehman, 2005)

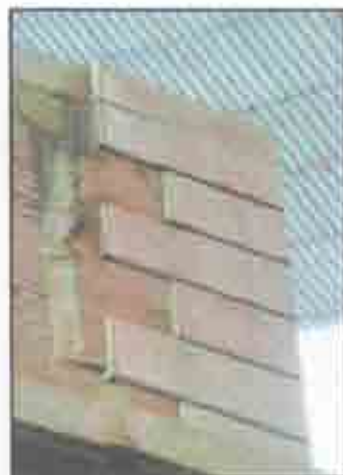
Lateral displacement is evident in the south flank parapet. (Jane Lehman, 2005)

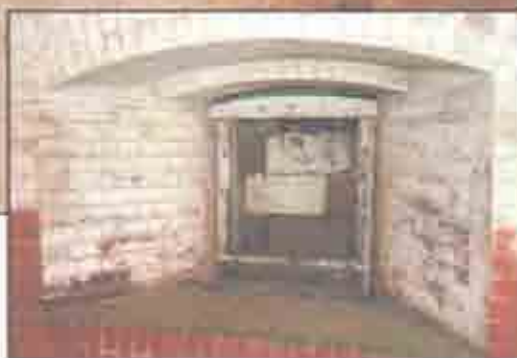
Most of the iron embrasures have deteriorated over the years and the openings have been infilled with brick and block for security purposes. (John Martini, 2005)

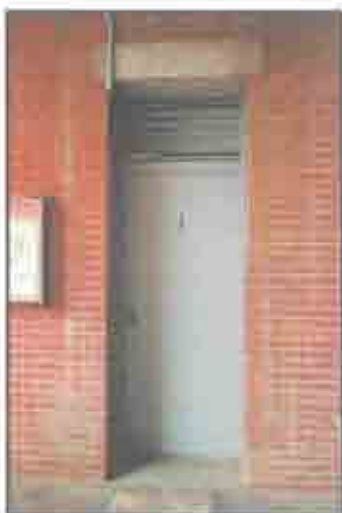
The transom windows above the 3rd tier gallery doors were replaced with wood louvers. These louvers need to be replaced because they are all installed backwards. (John Martini, 2005)

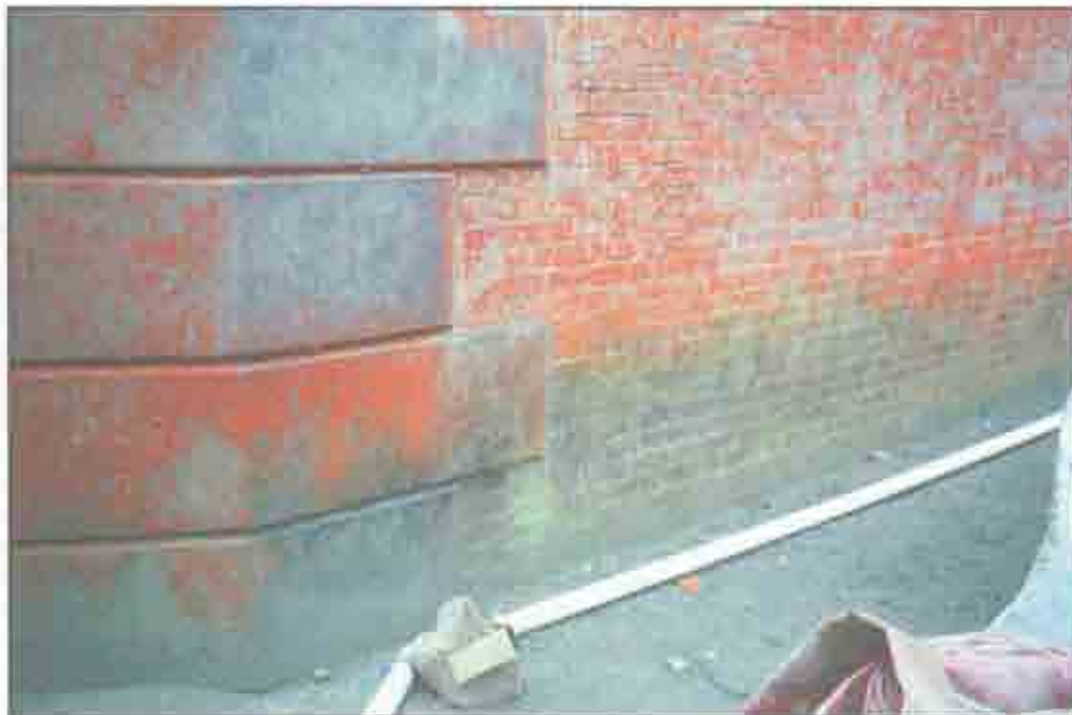
Condition Photo 2:
Intersecting Arch of Casements
98 and 99; Biological growth and
efflorescence settle on masonry
surfaces. (Courtesy of ARG, 2003)

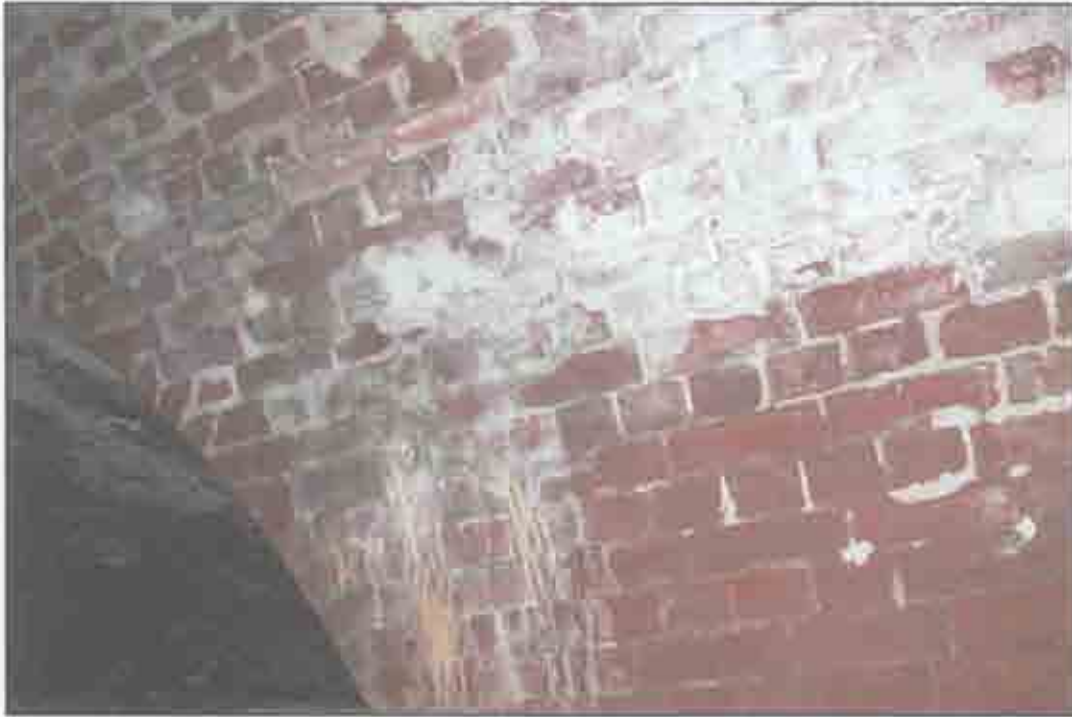
Condition Photo 3:
Casemate 101; Calcium deposits
are draining from open joints
and coating is no longer extant.
(Courtesy of ARG, 2003)

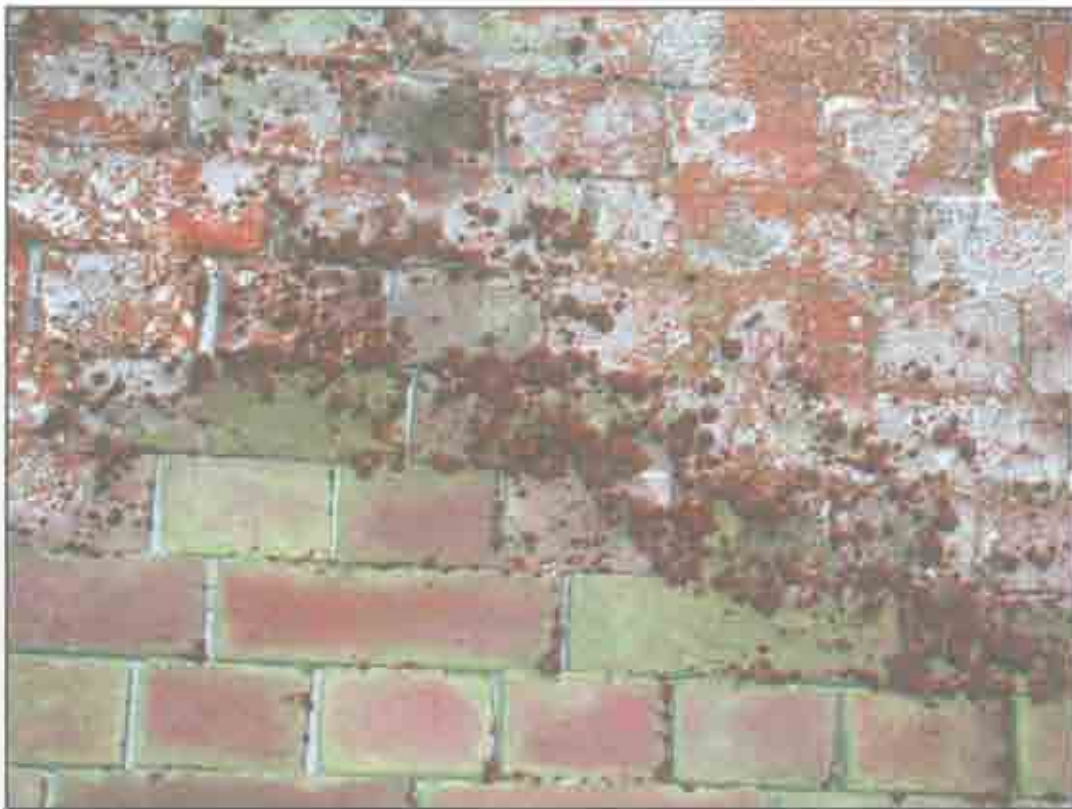
Condition Photo 4:
Casemate 100; Biological growth and
salts on masonry surface.
(Courtesy of ARG, 2003)

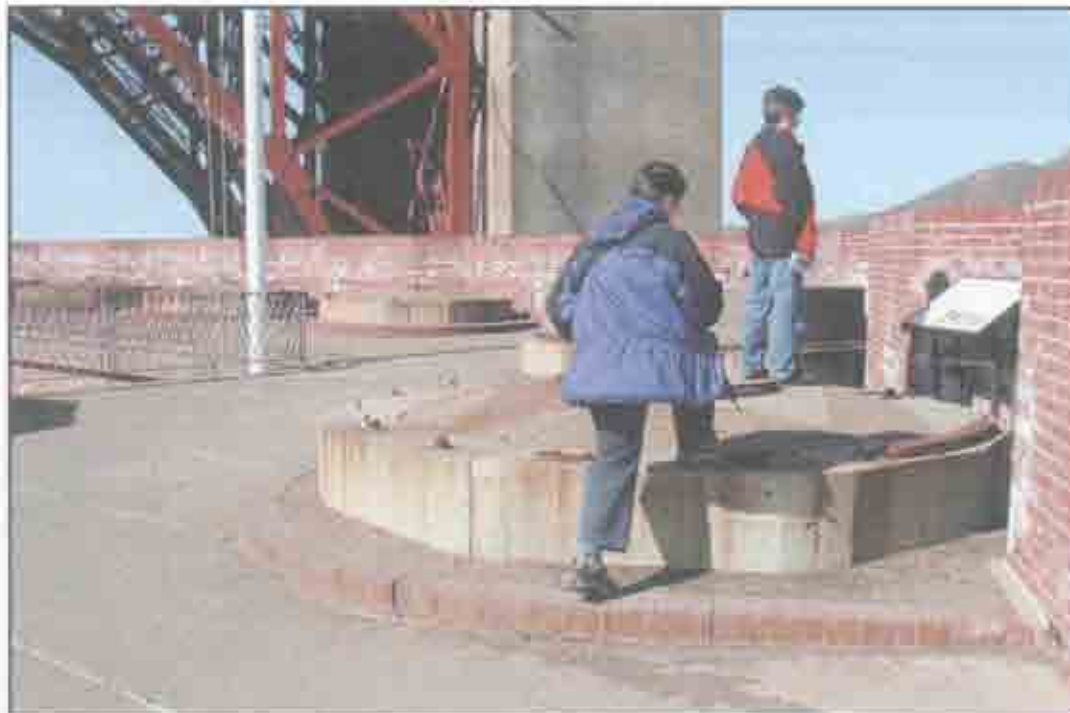
Condition Photo 6:
Top Landing at Barbetta Tier; Crack
in granite. (Courtesy of ARG, 2003)

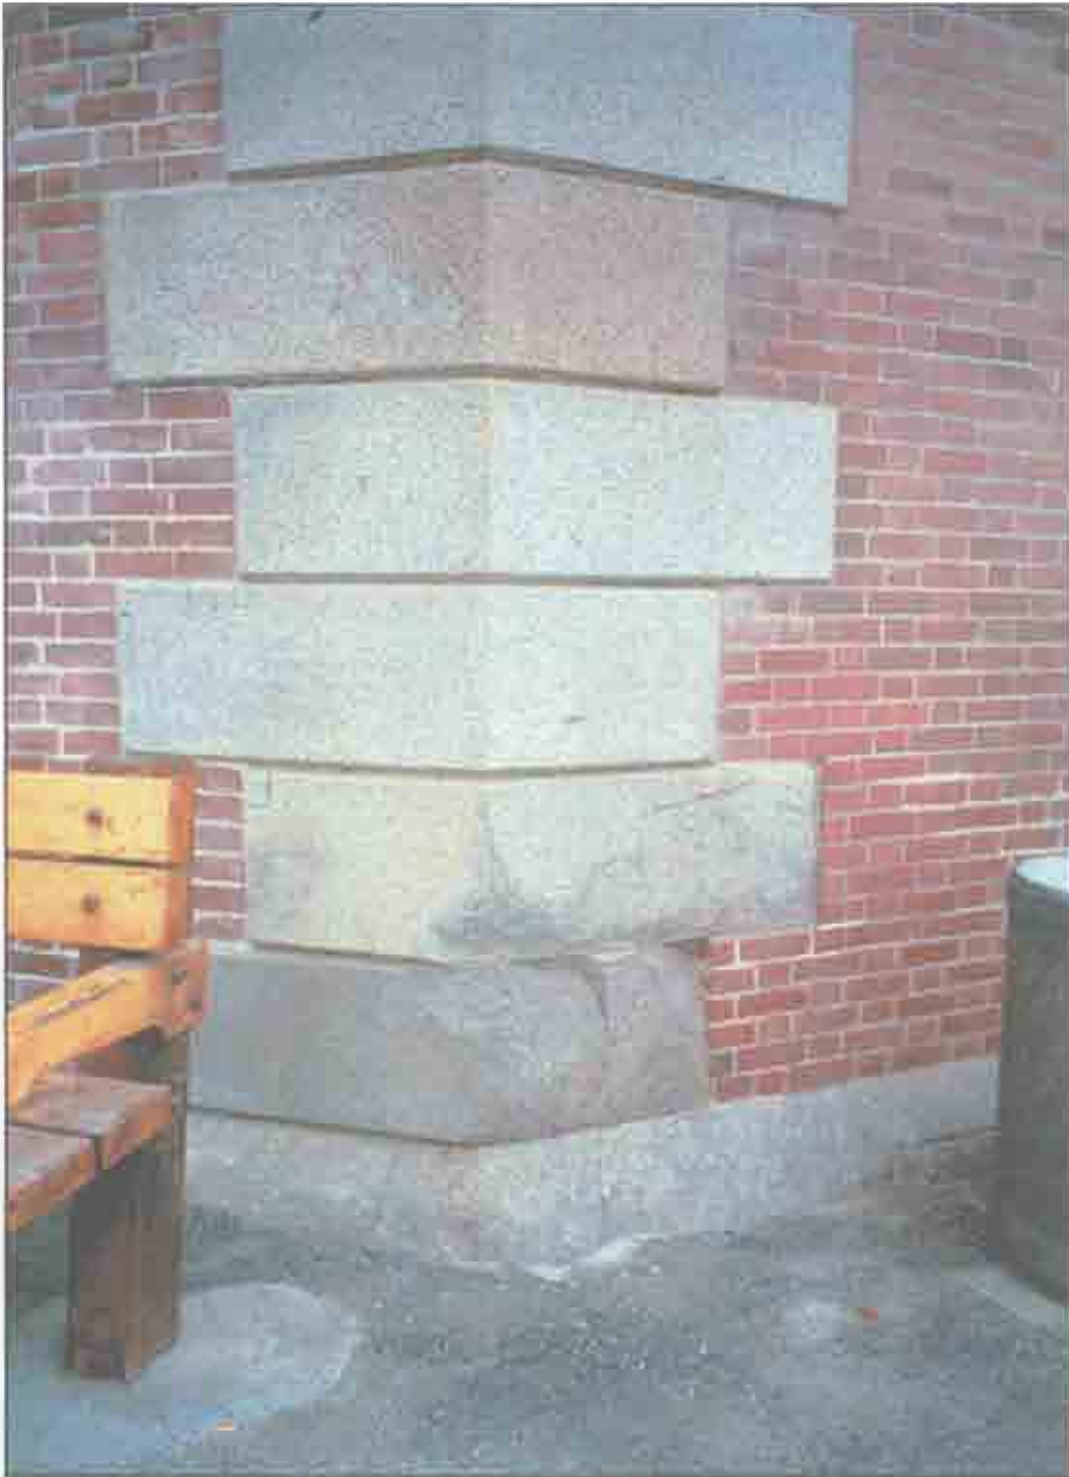
Condition Photo 2:
East Bastion—East Flank, impact
damage at granite quoins and base.
(Courtesy of ARG, 2003)

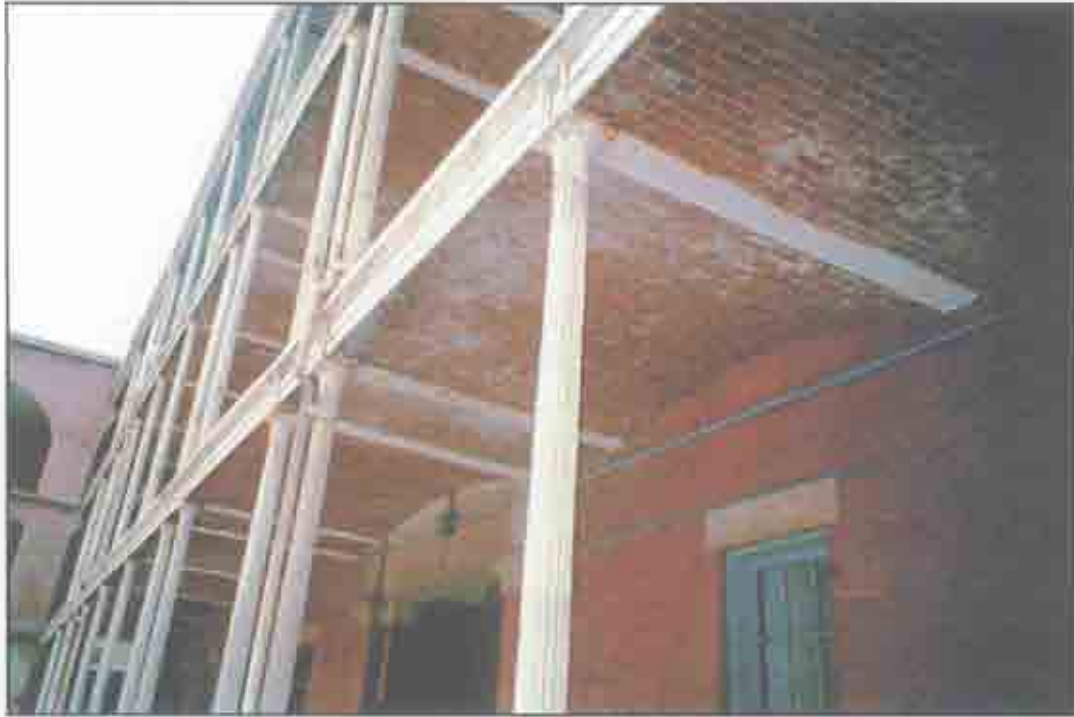
Condition Photo 10:
Southeast Face Courtyard; Corroding
metal columns and walkway
supports. Missing metal railings in
this photo have been reinstalled.
(Courtesy of ARG, 2003)

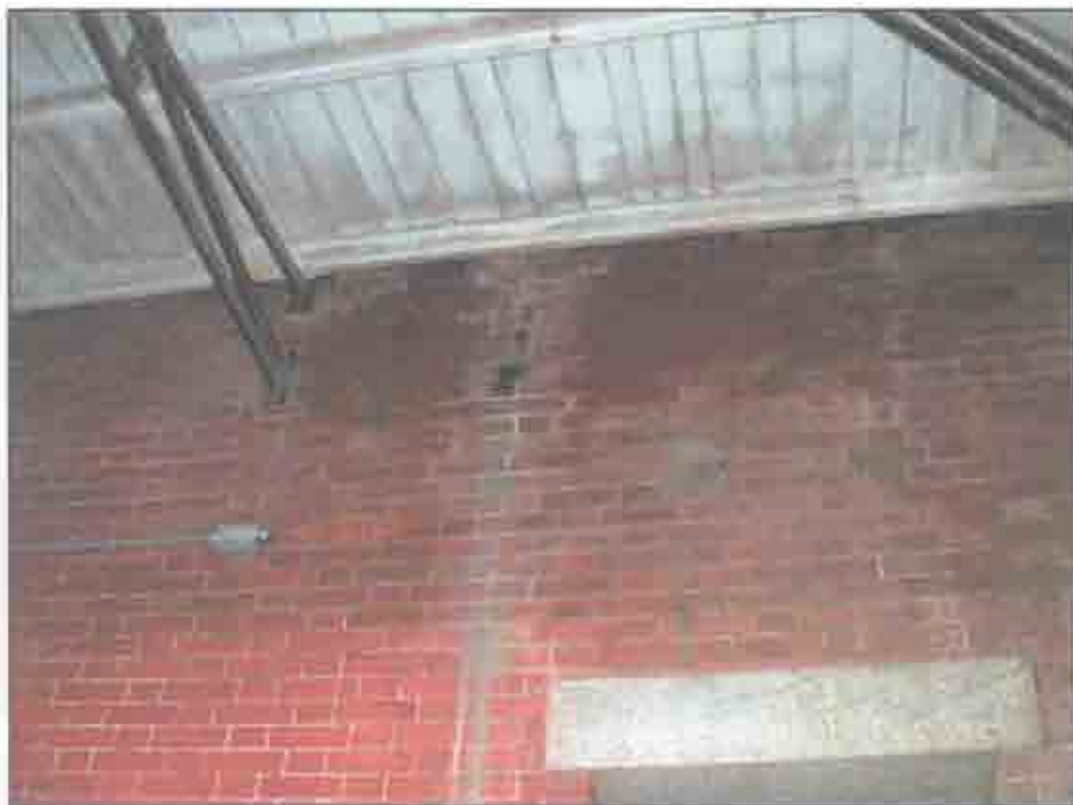
Condition Photo 13:
Stair 3; Missing siding exposes the
structural framing. (Courtesy of ARG,
2003)

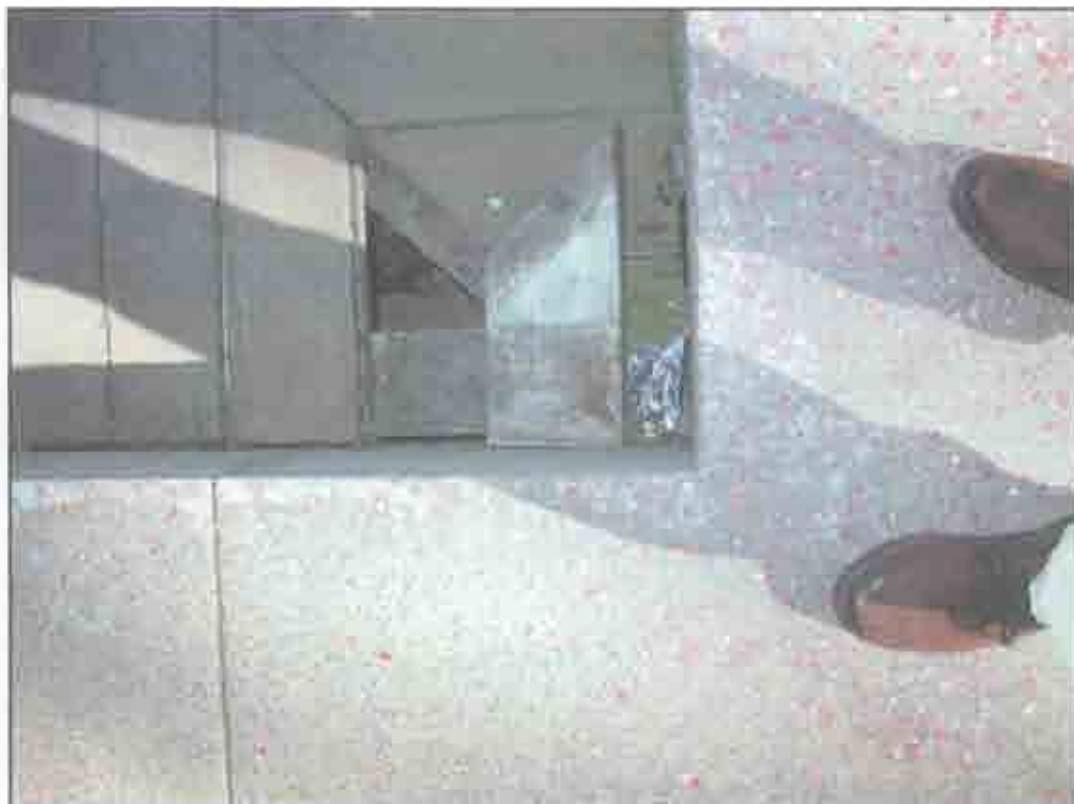
Condition Photo 14:
Wood Walkway – Barrette Tier
by Stair 1; Components are not
properly fastened at wood walkway.
(Courtesy of ARG, 2003)

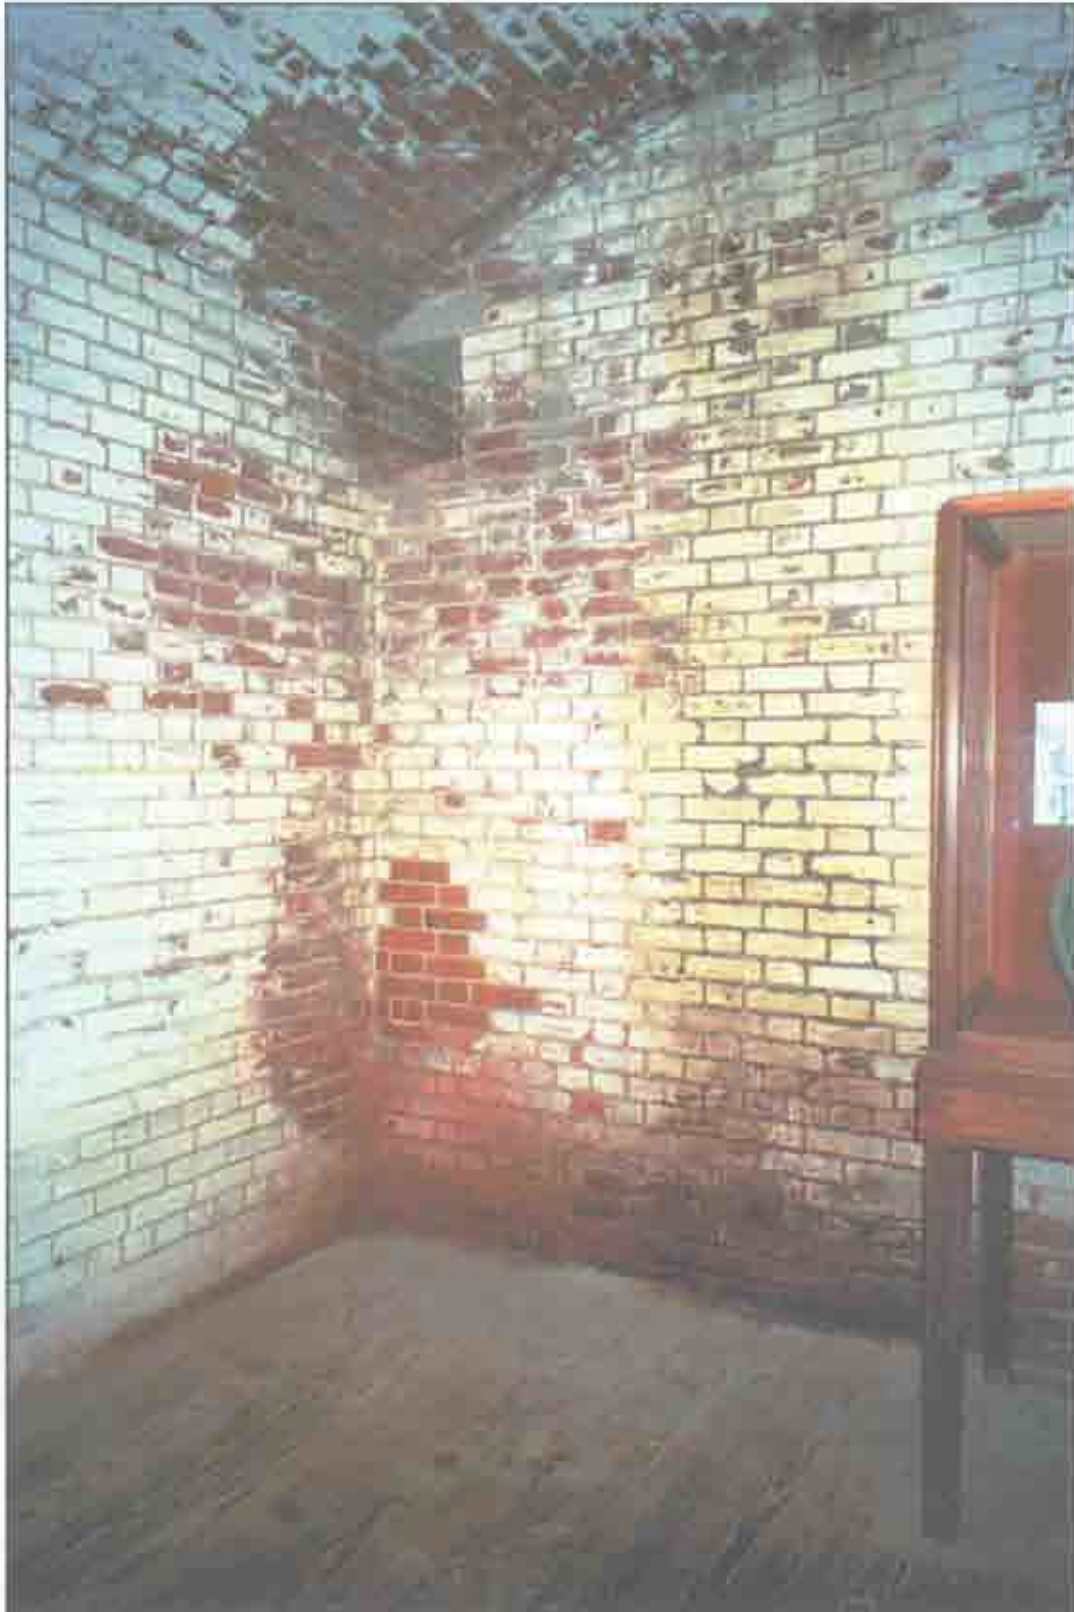
Condition Photo 16:
Casemate 11; Open joints at the
brick masonry and heavy water
infiltration. Biological growth on
the interior brick. (Courtesy of ARG,
2003).

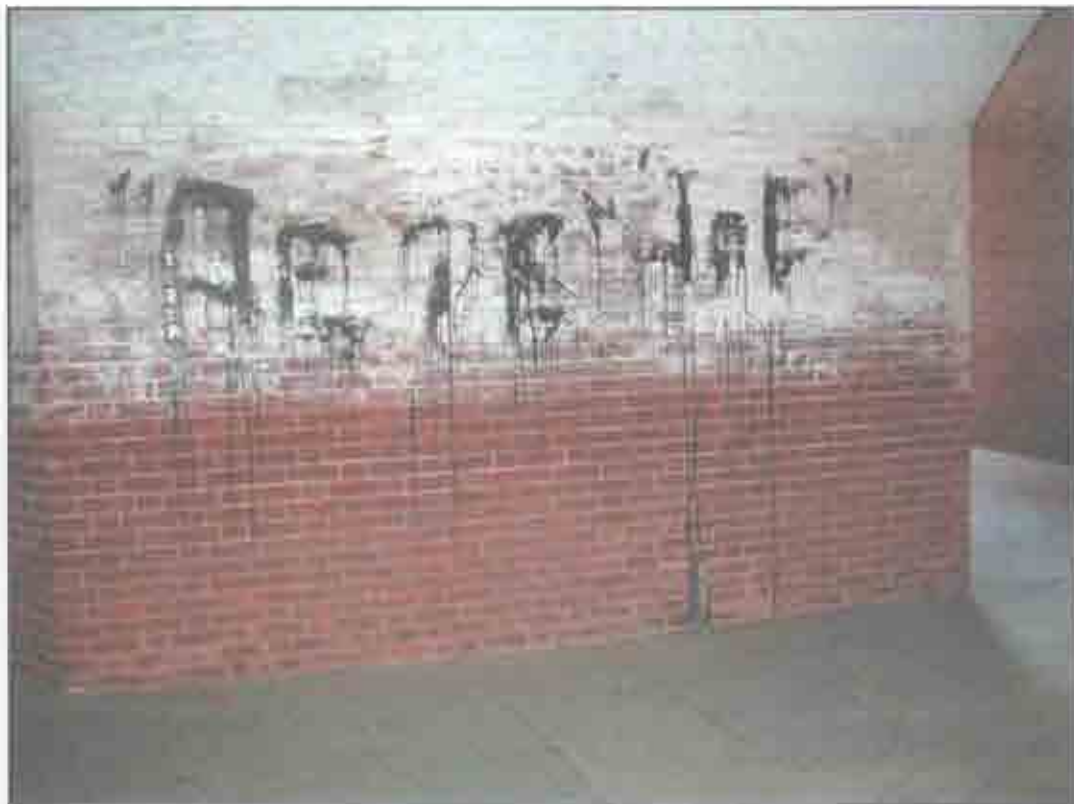
Condition Photo 18:
Casemate 68A—Second Tier: Graffiti
noted on masonry wall.
(Courtesy of ARG, 2003)

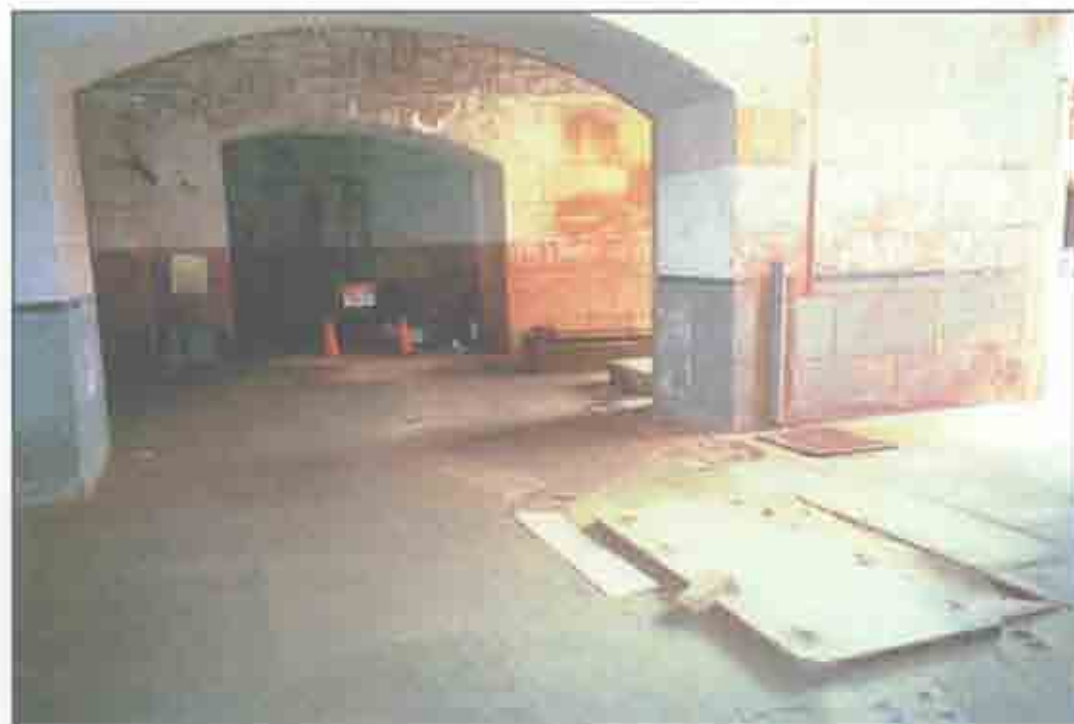
Condition Photo 19:
Casemate 34: Uneven surfaces, open
holes and potential tripping hazards.
(Courtesy of ARG, 2003)

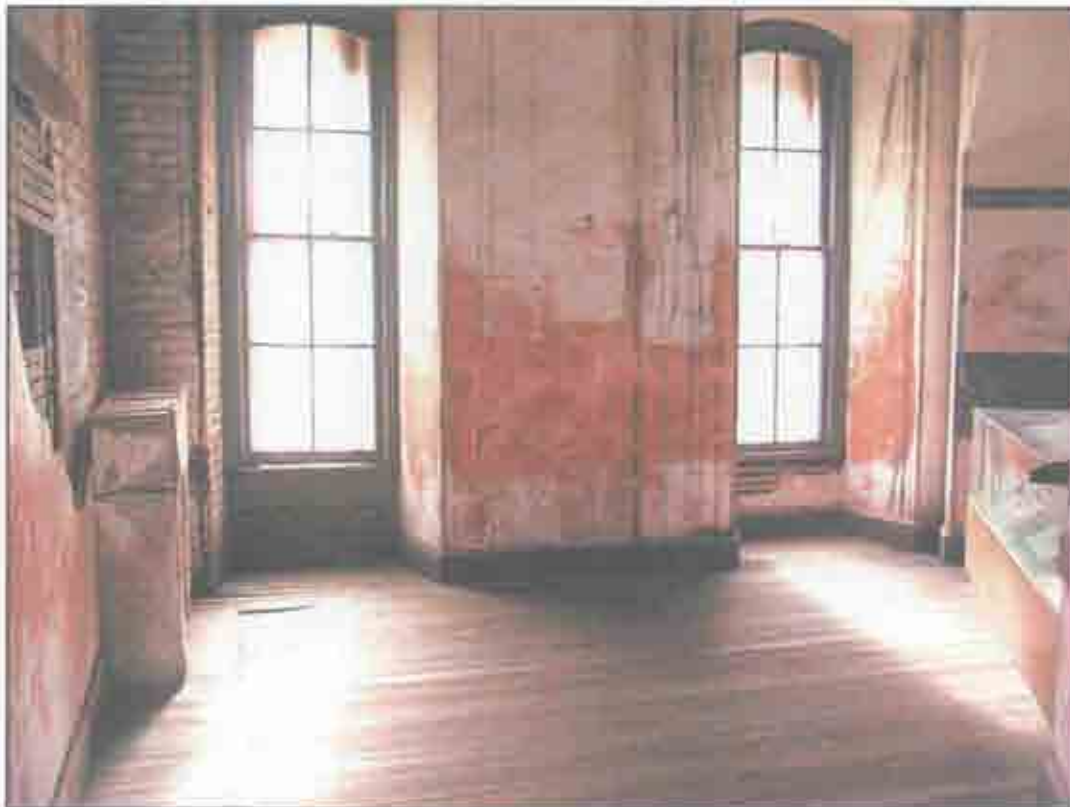
Condition Photo 23:
Stained plaster at Casemate 81.
(Courtesy of ARG, 2003)
