**Fort Pulaski National Monument  
Quarantine Attendants' Quarters**

**Historic  
Structure  
Report**

March 2004

2004  
Historic Structure Report  
Quarantine Attendants' Residence  
Fort Pulaski National Monument  
Savannah, GA  
LCS#: 12172

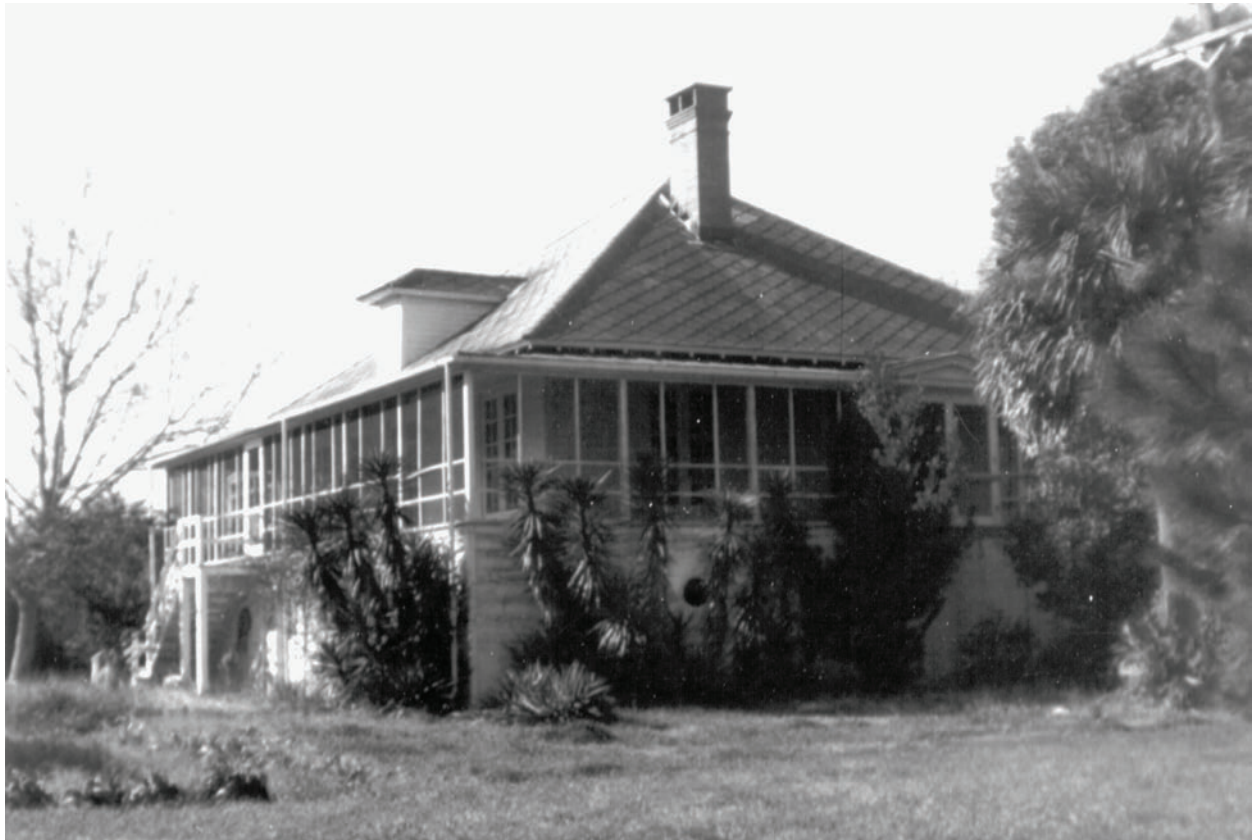
FIGURE 18. View of house from northeast, January 1960. Note unusual porthole windows and missing front stairs. (FOPU Coll.)

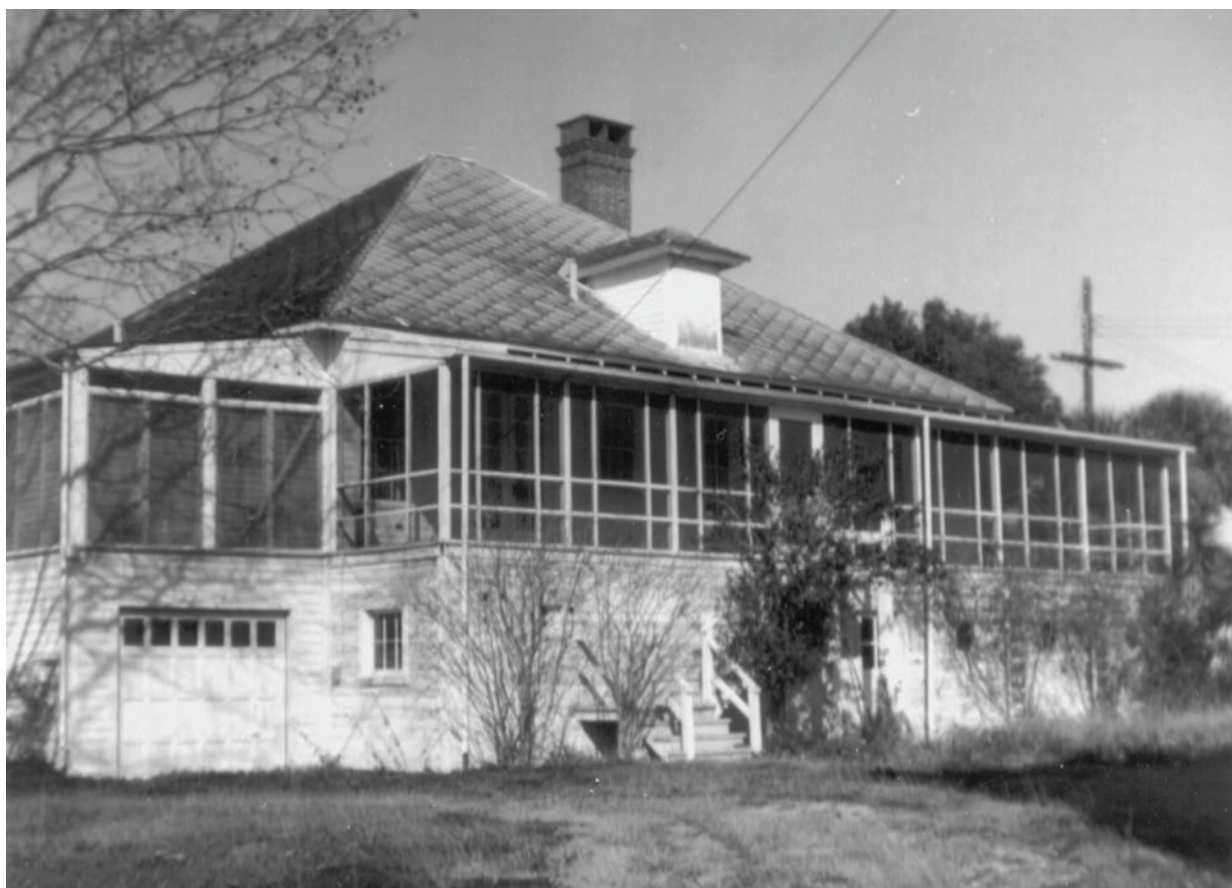
FIGURE 19. View of house from southeast, January 1960. Note jalousie windows installed in 1953 and the closed dormer window. (FOPU Coll.)

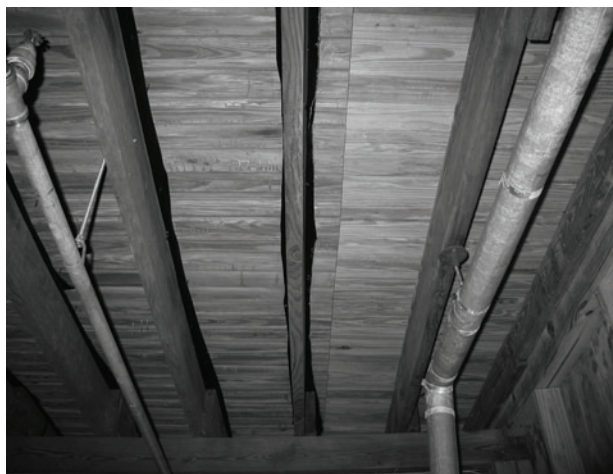
FIGURE 30. View of underside of east porch, with new flooring visible at right where older flooring has been removed. (NPS-SERO-CR, 2003)

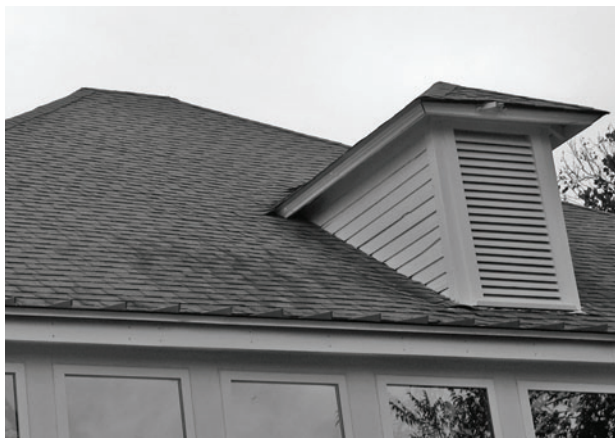
FIGURE 34. View east, showing original dormer. Note that modern fascia replaces original crown molding. (NPS-SERO-CR, 2003)

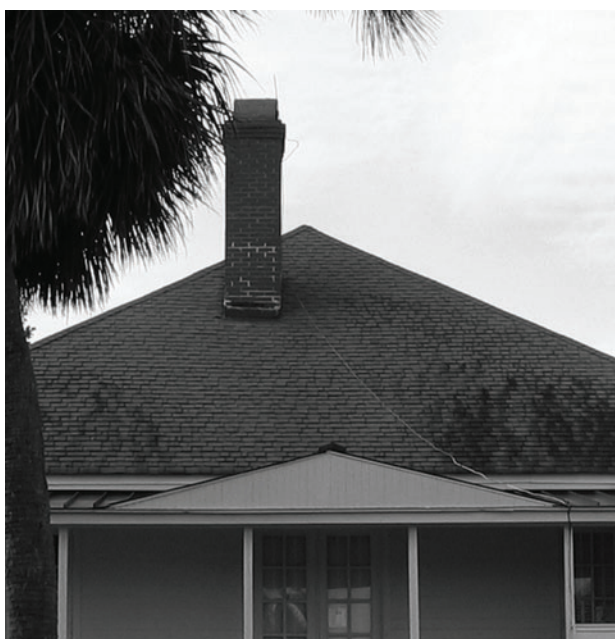
FIGURE 35. View south, showing modern gable over porch entrance. Note that modern fascia replaces original crown molding. (NPS-SERO-CR, 2003)

- Restore small gable over north entrance.
- Recreate openings at basement level and replace plastic lattice with lap siding.
- If necessary, preserve window wall that created Room 110; otherwise remove and restore west porch.

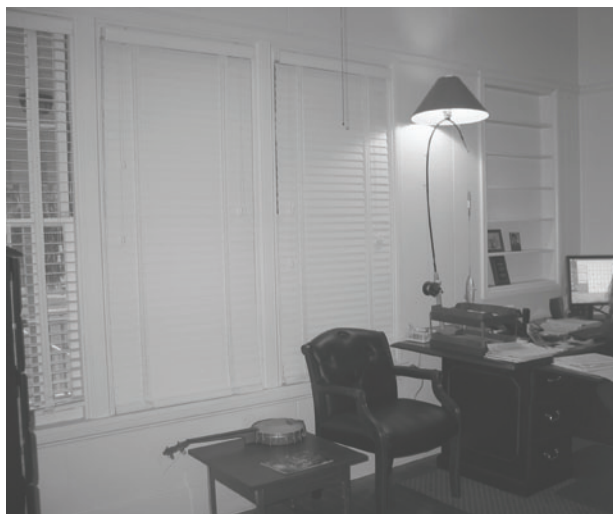
FIGURE 60. View southwest in Room 106. Bookcase at right marks location of old bathroom window. (NPS-SERO-CR, 2003)

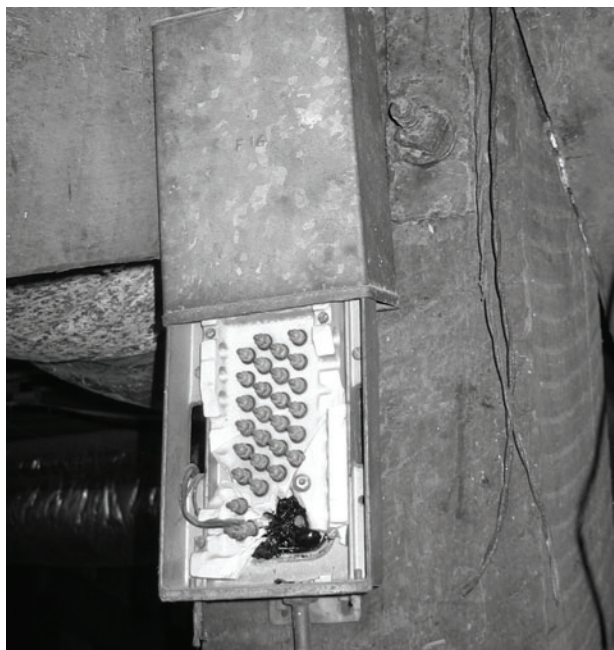
FIGURE 73. View of abandoned telephone junction box in basement. (NPS-SERO-CR, 2003)
