Historic Structures Report:

Lee's Ferry and Lonely Dell Ranch

Glen Canyon National Recreation Area,
Arizona

**AA Project No. 1084
September 2000**

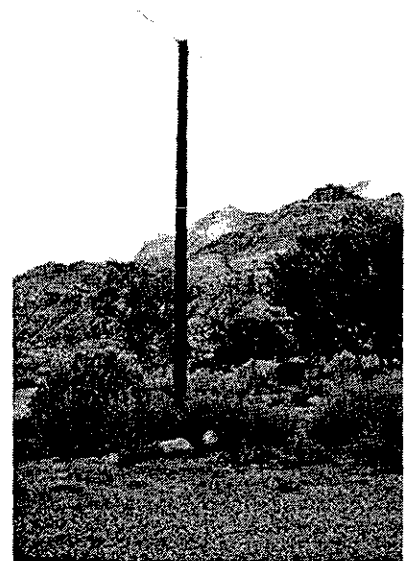
Photograph 61: Power pole within foundation area

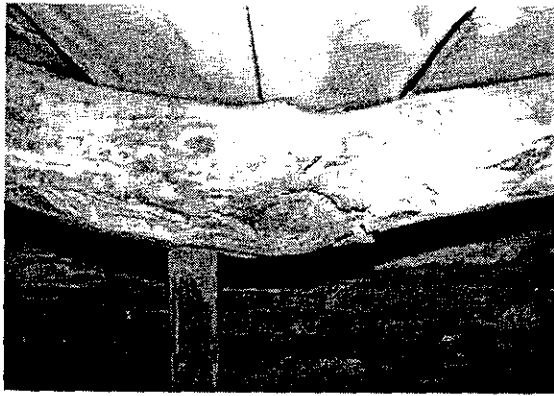
Photograph 73: Broken roof timber.

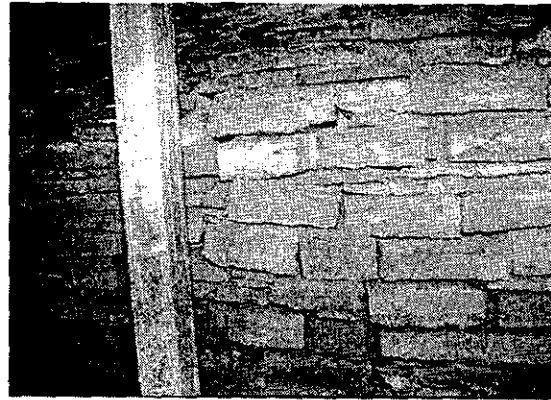
Photograph 74: Interior wall condition.

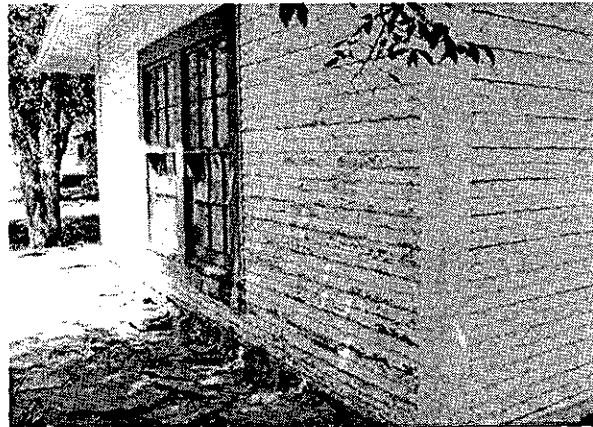
Photograph 92: Detail of wood siding condition at east wing.

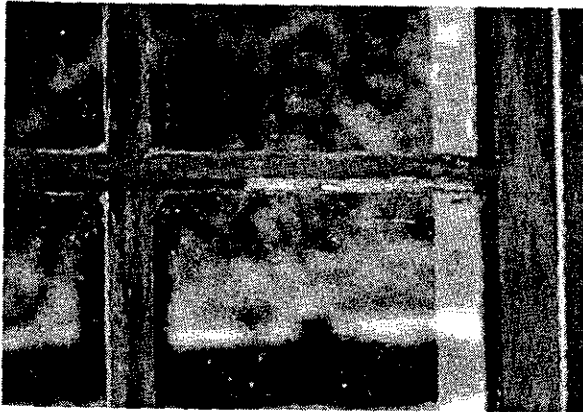
Photograph 93: Detail of glazing putty.

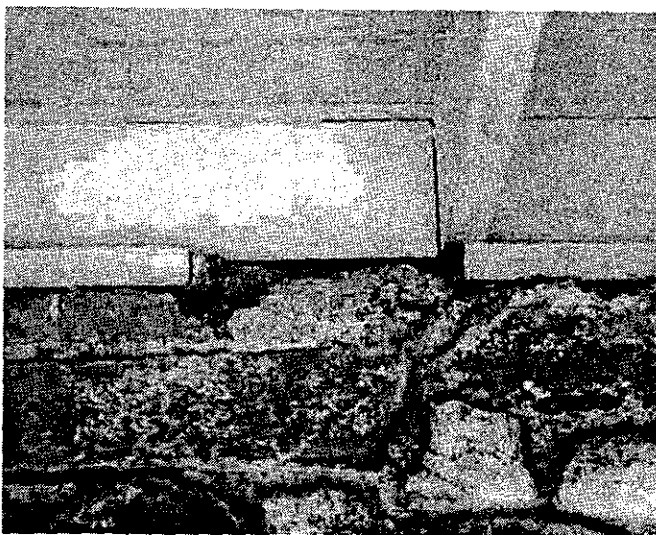
Photograph 97: Gaps in blocking at eaves.

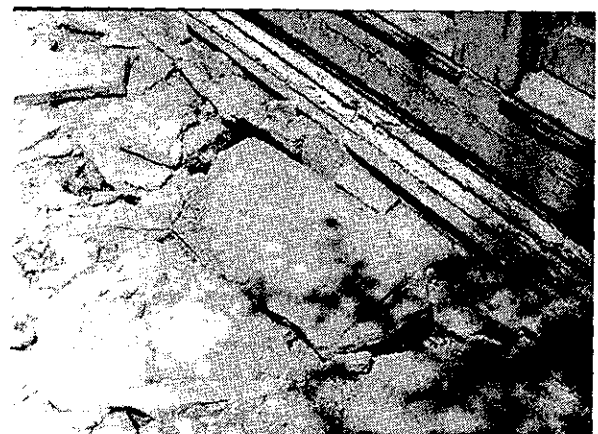
Photograph 98: Deterioration at terrace floor.

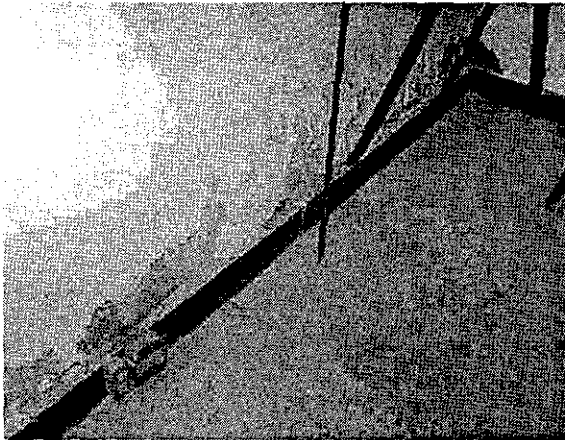
Photograph 101: Moisture damage of wall at storage room.

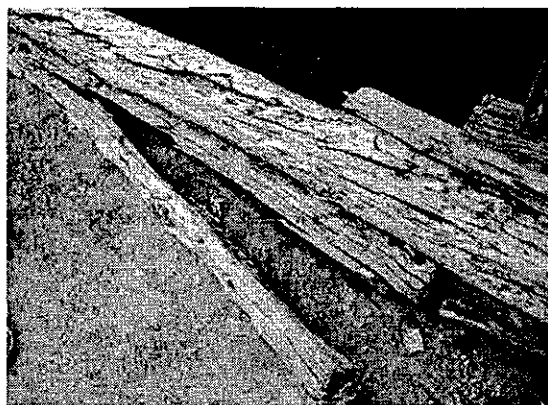
Photograph 119: Detail of sill damage below window.

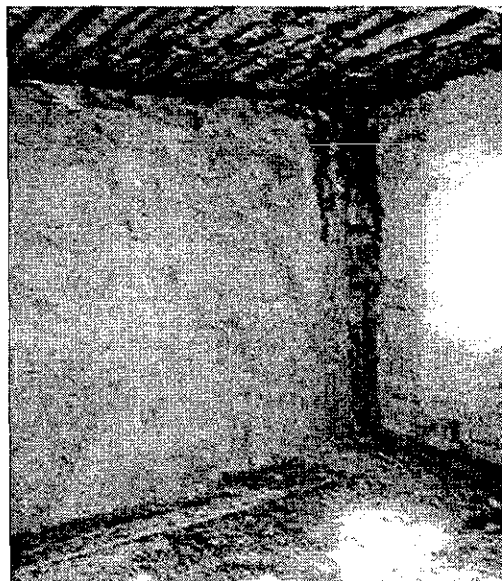
Photograph 208: Interior water damage, northwest corner.

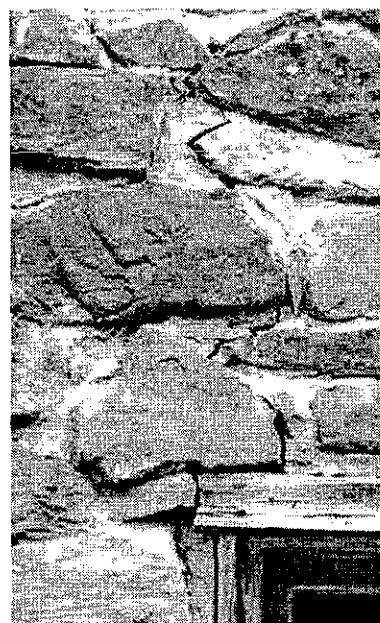
Photograph 209: Crack above south window.

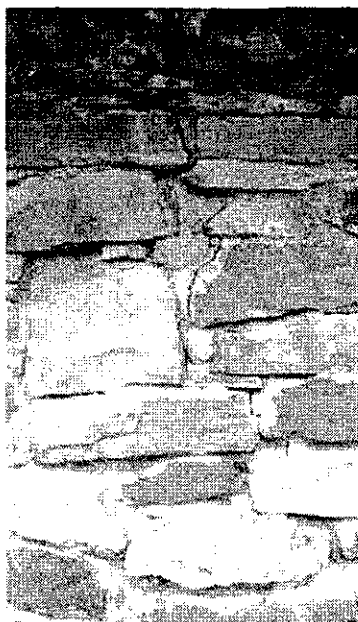
Photograph 210: Crack in west wall.

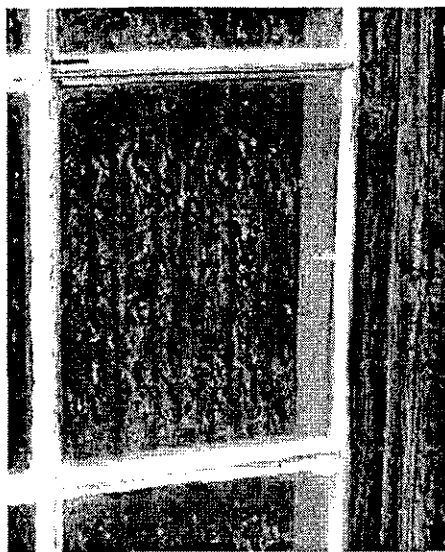
Photograph 211: Failure of glazing putty at window.

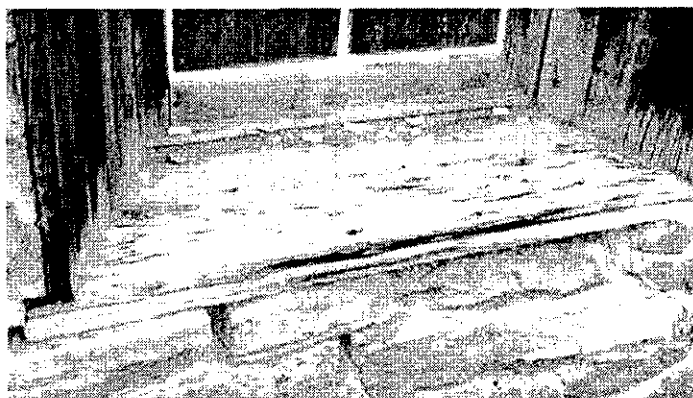
Photograph 213: Deteriorated sill at south window.

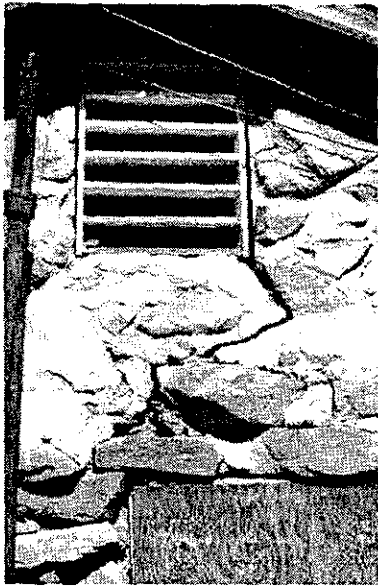
Photograph 234: Crack at east vent.

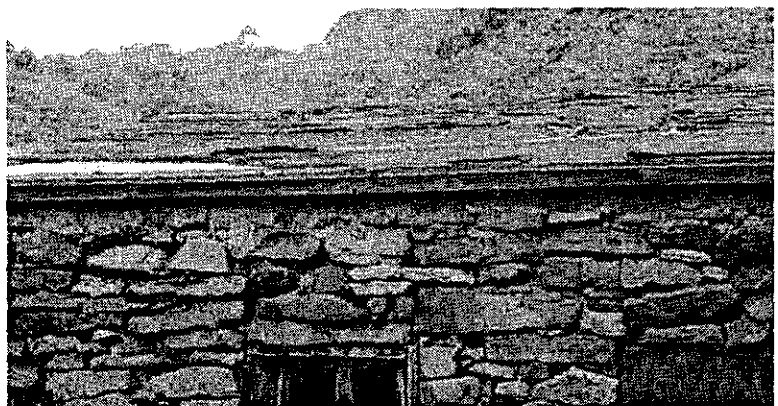
Photograph 240: Roof condition.

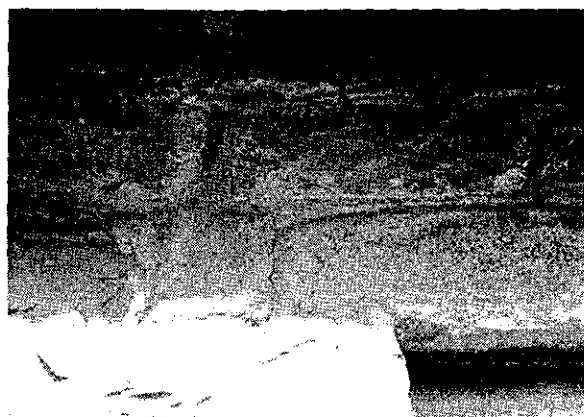
Photograph 252: Crack above east window.

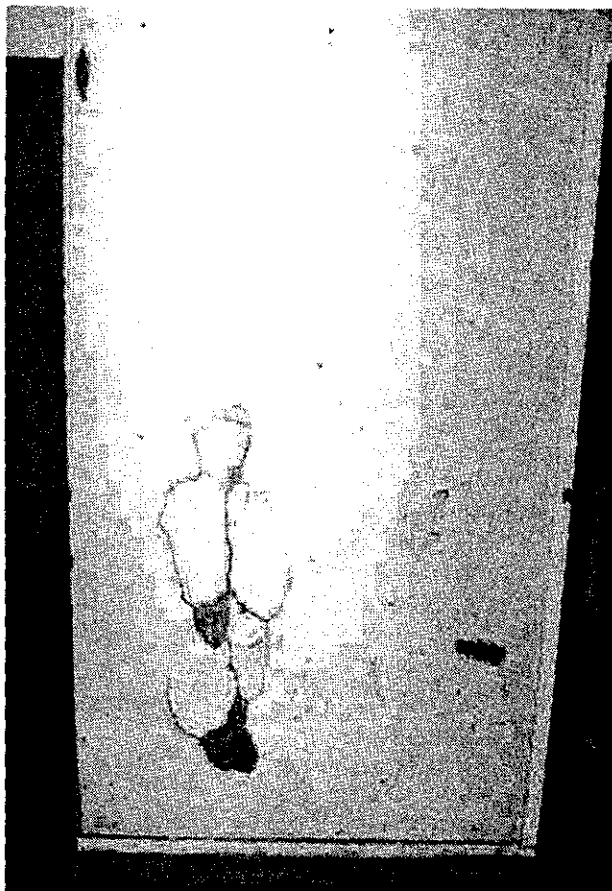
Photograph 258: Interior wall damage.
