## Alcatraz Barracks Building 64

Abbreviated Historic Structure Report

September 2003

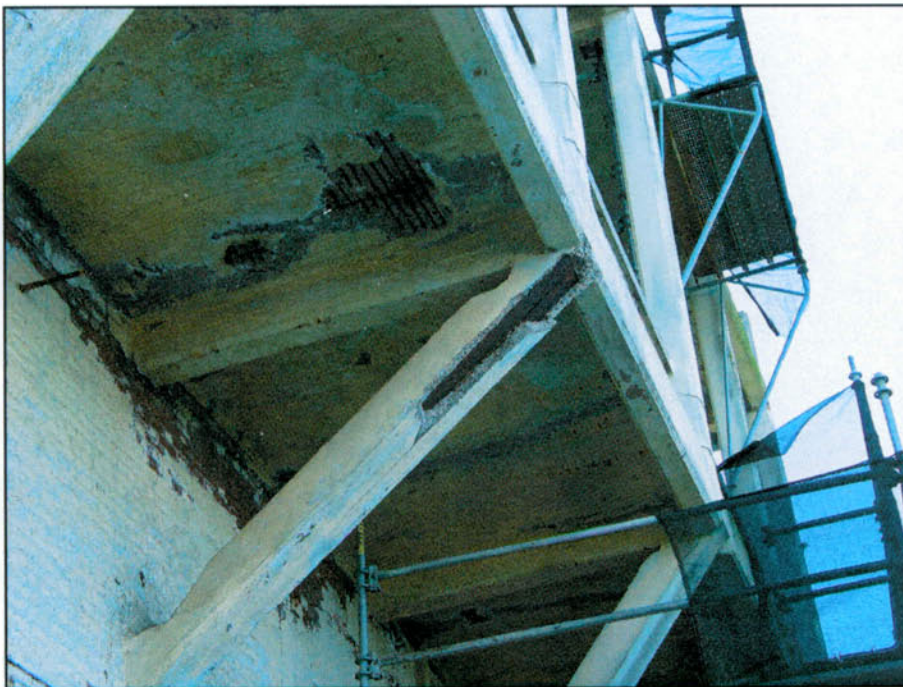
Top: View of underside of concrete balcony under repair, 2003. Photo Credit: John Martini.

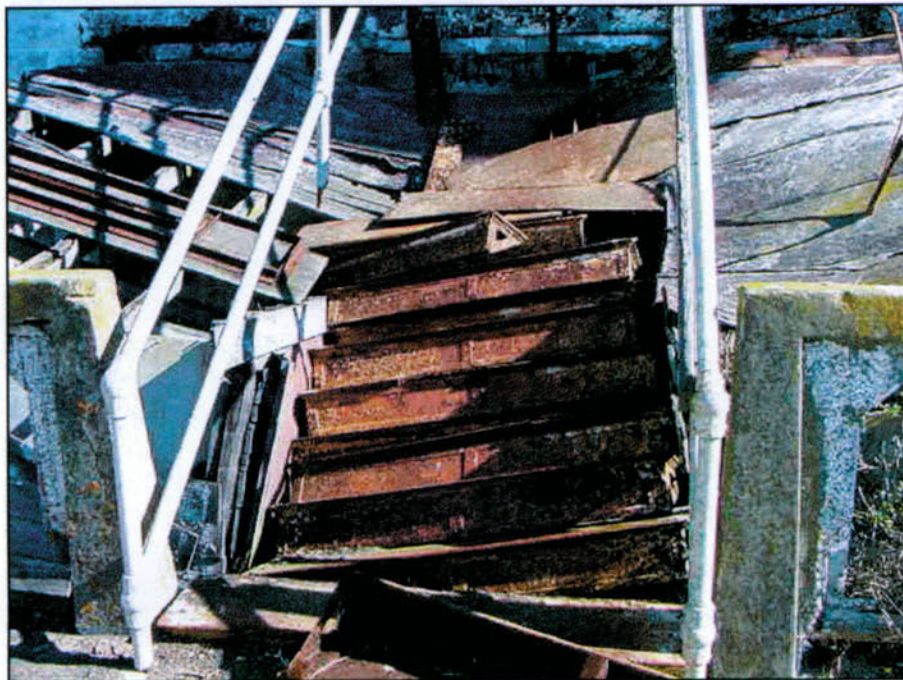
Bottom: Remnants of cast iron stair, south end, prior to wind storm, 2002. Photo Credit: Jane Lehman.

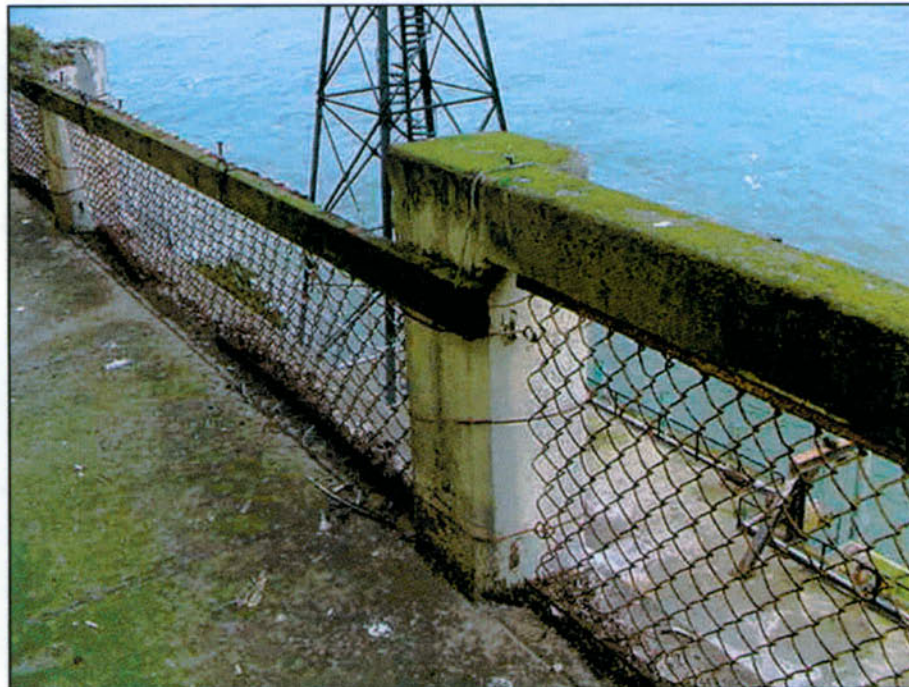
Bottom: Second floor balcony railing before repair, 2003. Photo Credit: Jane Lehman.

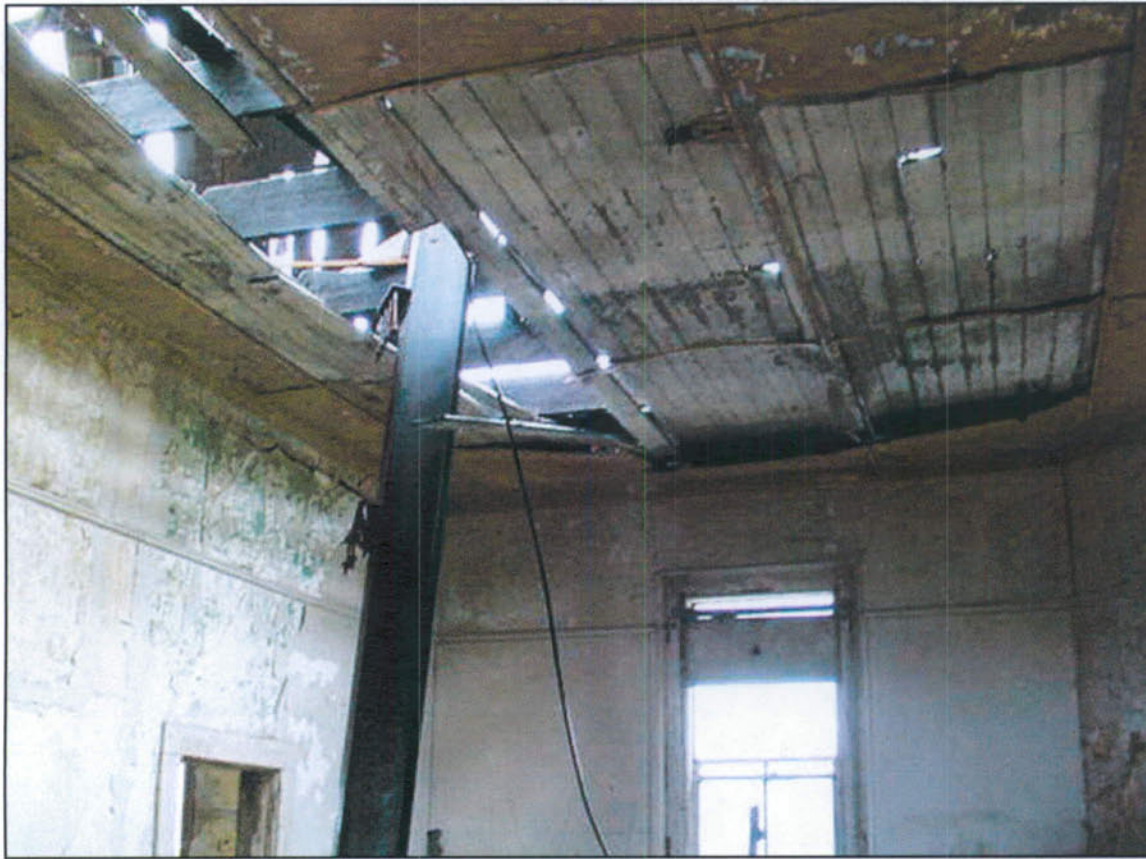
View of extensive ceiling damage at south end of third floor, 2003. Photo Credit: Jane Lehman.
