113/D-555
Grand Canyon

North Rim Entrance Station

Historic Structure Report

North Rim Entrance Station
Historic Structure Report

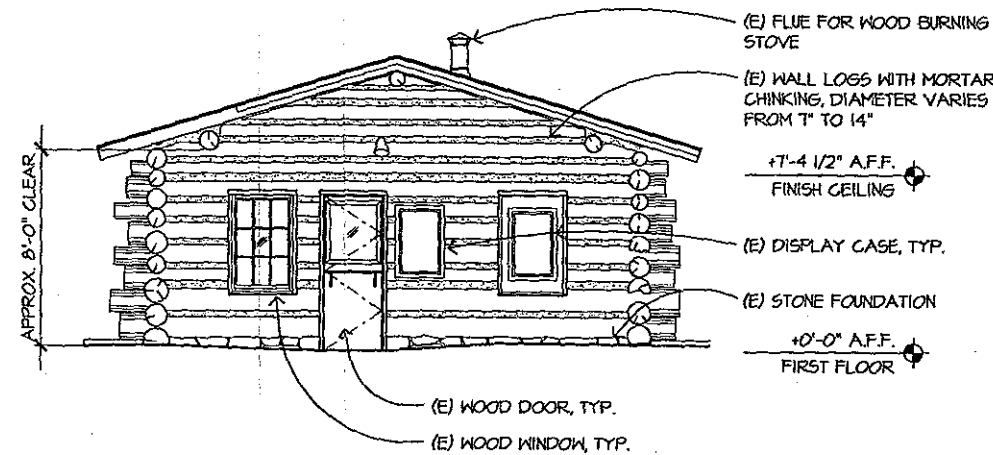
EXISTING CONDITIONS - WEST ELEVATION ③

This elevation receives greater exposure to sun and the elements, consequently, larger amounts of chinking are missing than other elevations; peeling of the painted surface of logs is more severe, particularly at the lower level. On the south side of the west elevation at the upper level, gaps and missing chinking have left three distinct openings around the purlin log into the attic, though this condition does not appear to be problematic. There is no sign of water infiltration and the openings may be beneficial for attic ventilation.

A piece of the roof sheathing and fascia is missing at the northwest corner of the roof where cars have hit the building. The remaining material is damaged; corrugated metal is crumbled.

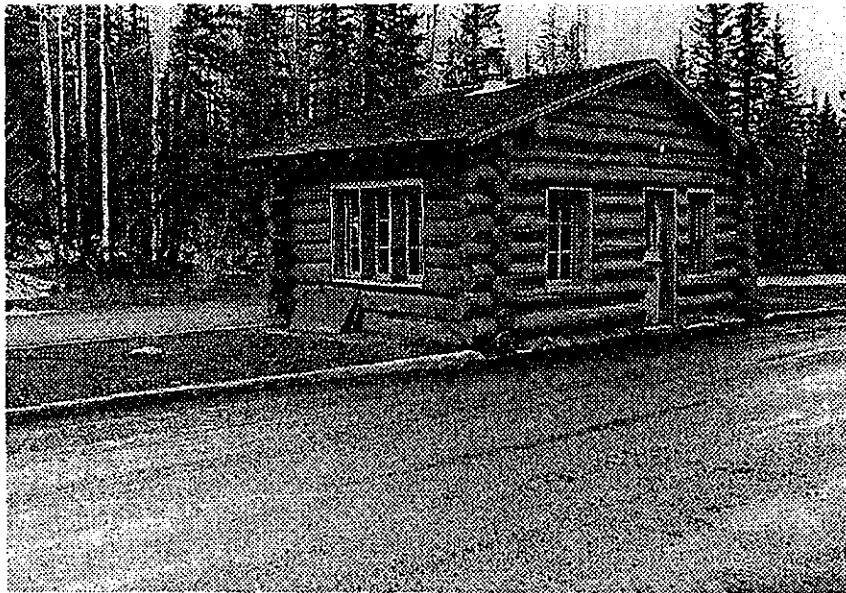
Figure 14. The image illustrates the North Rim Entrance Station after removal of the canopies that covered the roadway. The works significantly altered the architectural expression of the building. Photo is dated 1973. GCNPA Number 10018.

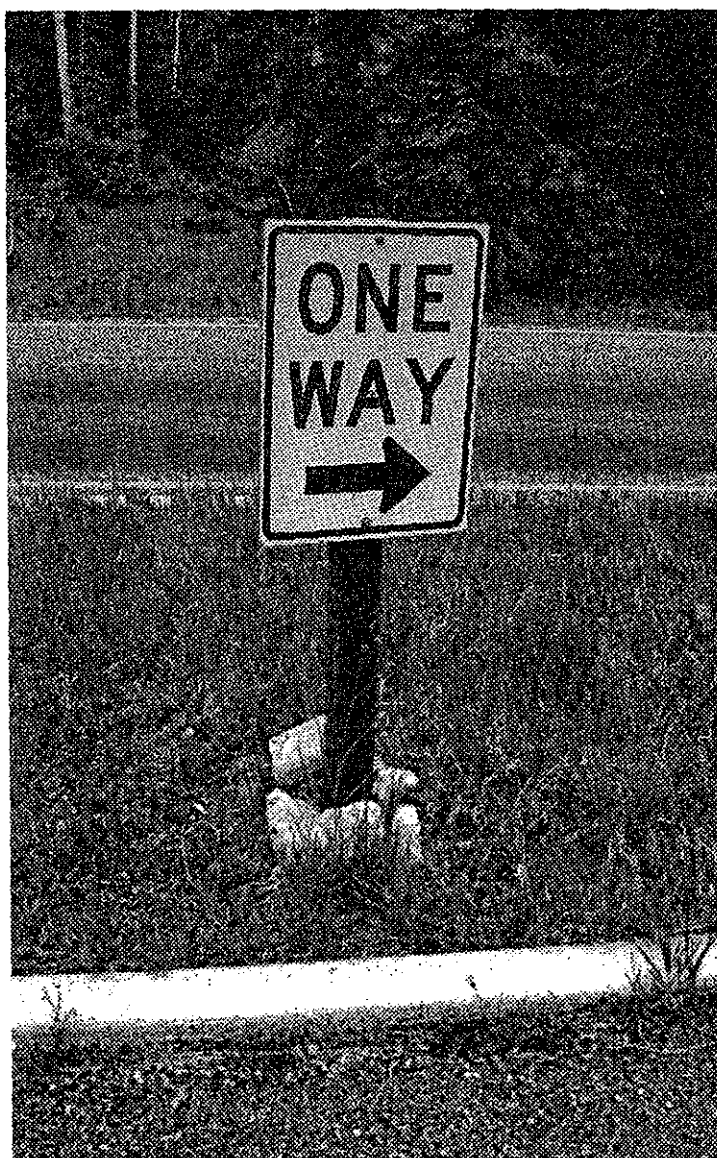
Figure 3. The image illustrates the type of piecemeal signage that clutters the site. ARG Photo dated June, 2000.

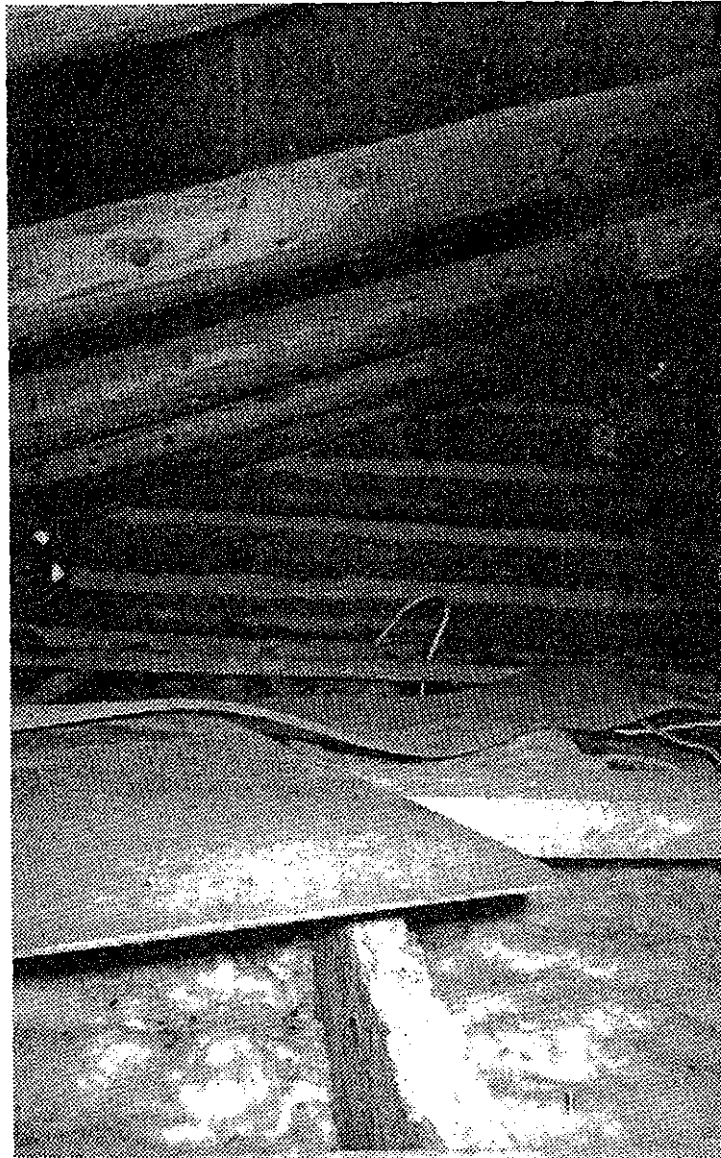
Figure 8. The image illustrates the interior of the attic showing the original color of the chinking and framing members. Note three openings around purlin log on left indicating log shrinkage. ARG Photo dated June, 2000.

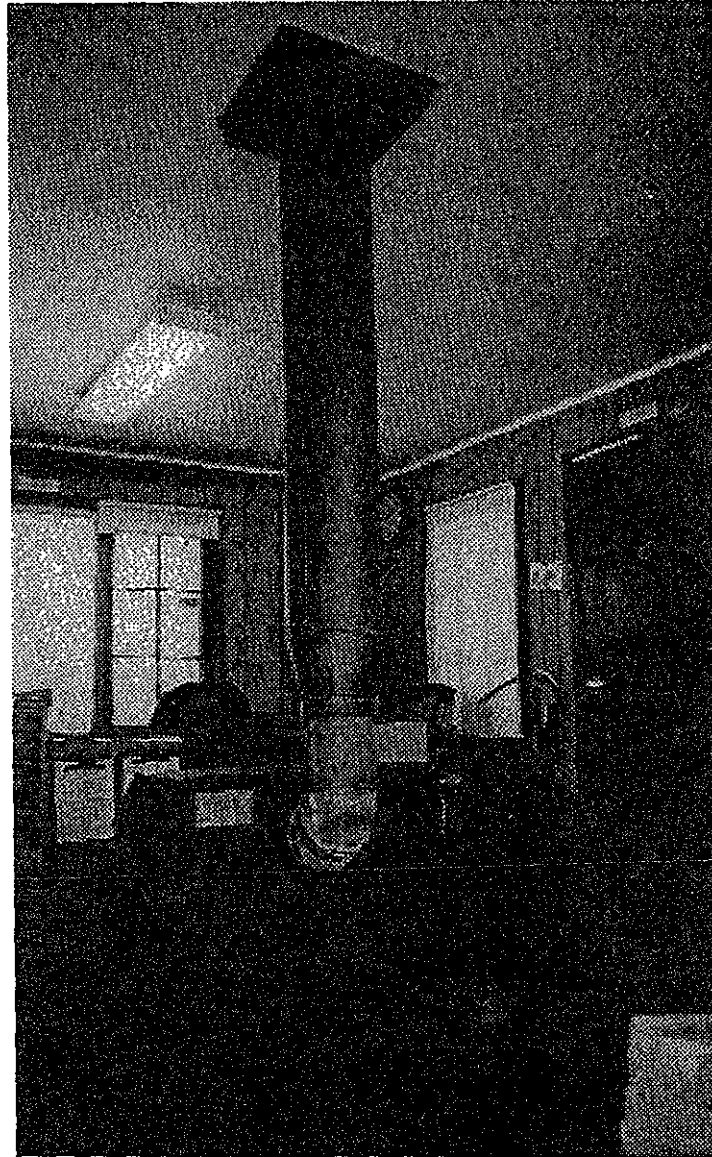
Figure 10. The image illustrates the wood-burning stove in the center of the interior of the North Rim Entrance Station. The stove replaced a stone chimney and fireplace that was removed in the 1950s. ARG Photo dated June, 2000.

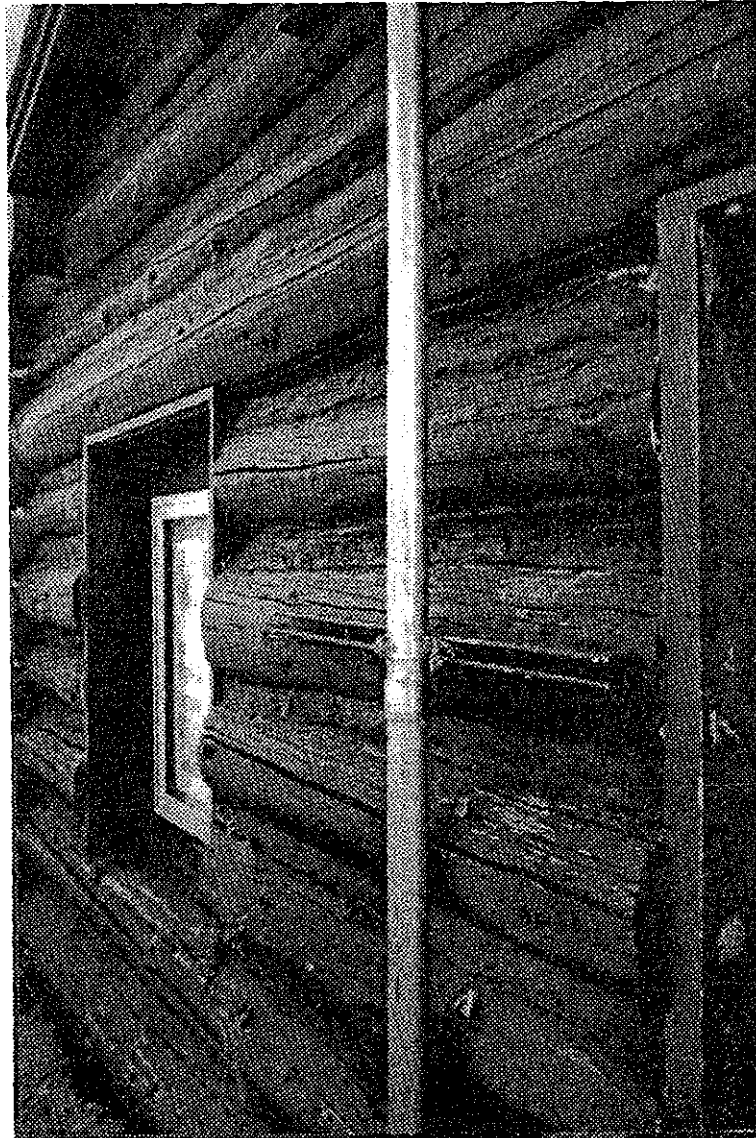
For the most part, the east elevation exhibits standard conditions consistent with the rest of the building. Here the chinking is mostly intact and in somewhat better condition than on other parts of the exterior, though overpainted. Some wood shingles beneath the metal sheathing are exposed where roof material is missing. A severe split in the second log from the bottom on the south side of the door, runs the length of the log and measures an inch in width; however, it is likely that the split has been present since construction. The log is stable and the elevation in good condition. Peeling painted surfaces are consistent with the rest of the building.

Figure 11. The image illustrates the east elevation of the entrance station. Typical conditions are splitting and cracking of the logs, peeling paint on the log surfaces, antenna support pole, and moth cocoons. ARG Photo dated June, 2000.

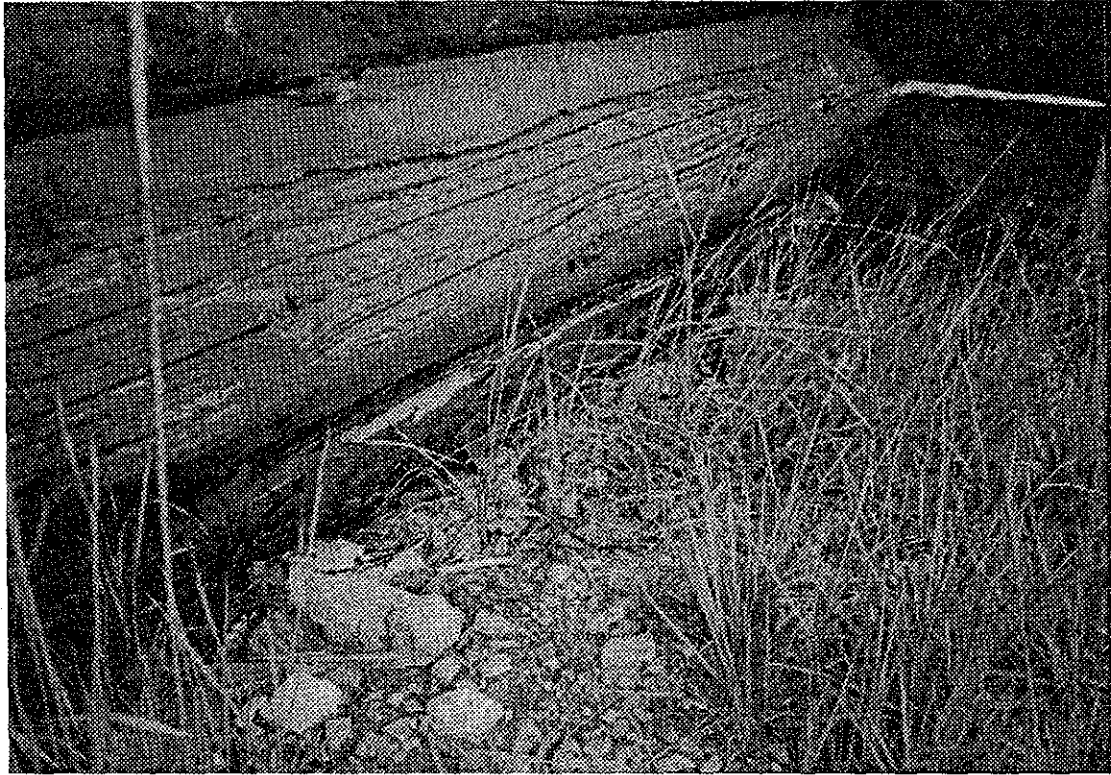
Figure 12. The image illustrates log deterioration at the North Rim Entrance Station. Deterioration on the lower level of the south elevation is particularly severe due to sun exposure and snow drifts in winter. ARG Photo dated June, 2000.

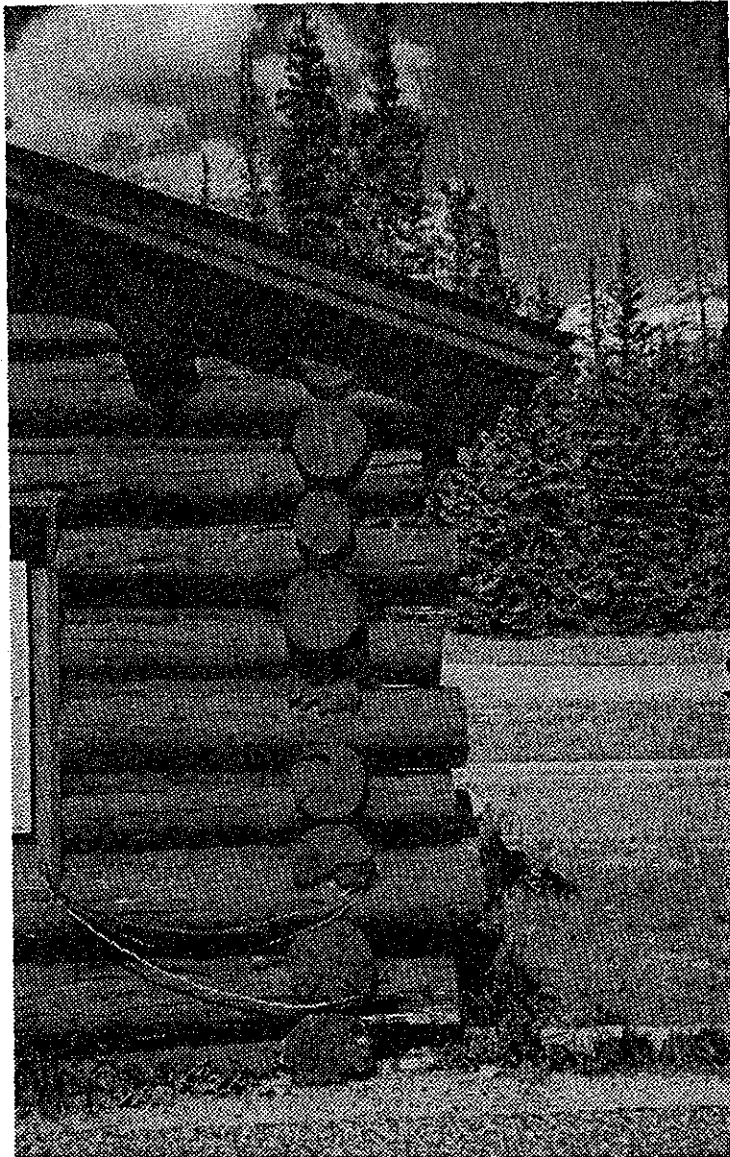
Figure 13. Staggered log ends are a character-defining feature of the North Rim Entrance Station. The north-south running logs retain their original configuration. The east-west running logs (ends facing viewer) have been altered to form an even vertical line to accommodate vehicles that pass closely by the structure. ARG Photo dated June, 2000.

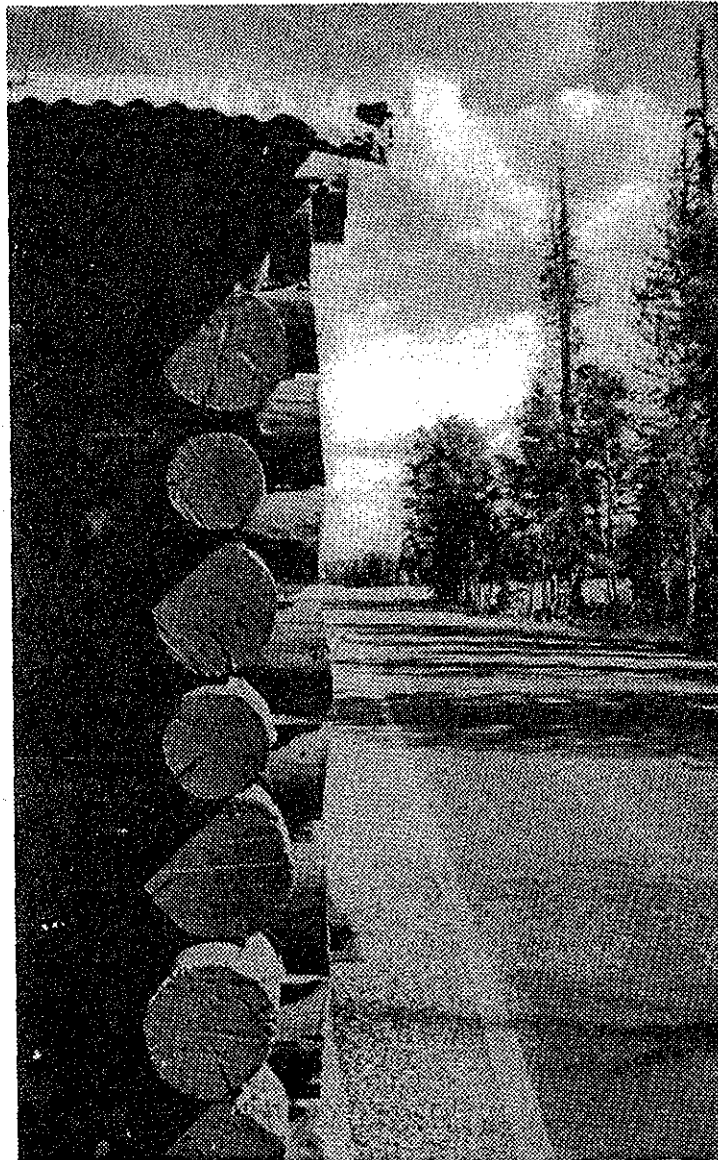
Figure 14. The east-west running logs have been altered to form an even vertical line to pull the log ends back from the roadway to accommodate vehicles. ARG Photo dated June, 2000.

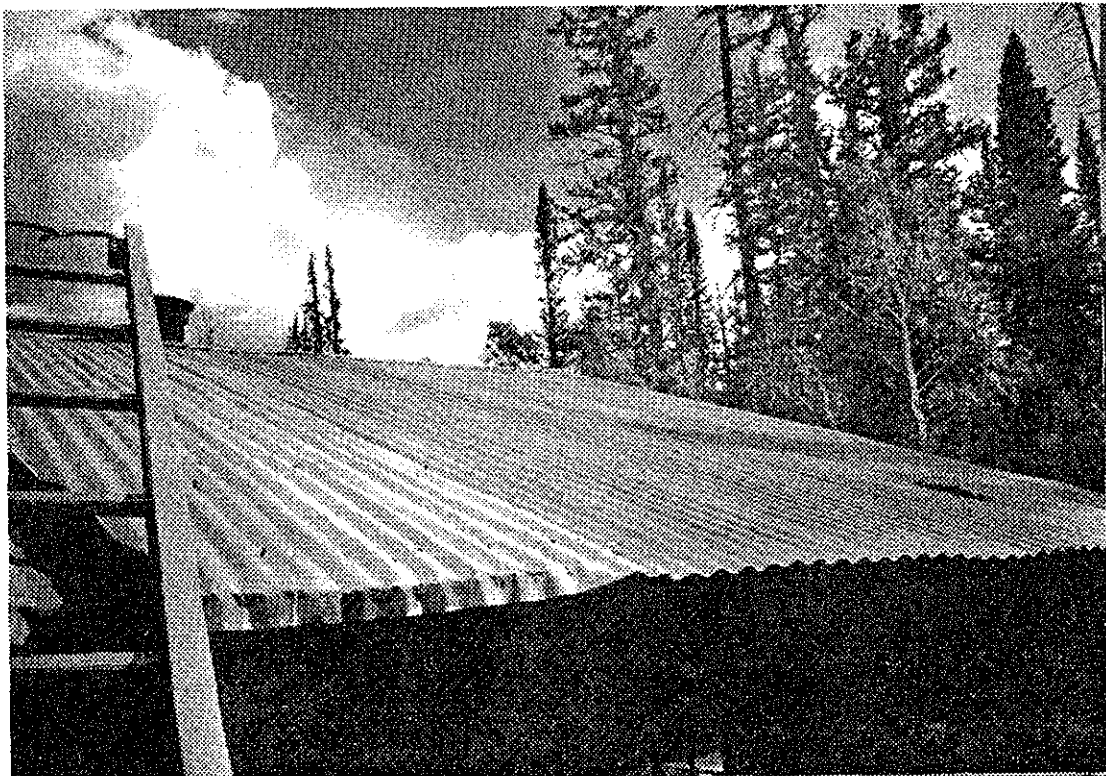
Figure 15. The image illustrates the weathered corrugated metal roof of the building. Characteristics of the roof are: peeling brown paint exposing the metal; curling seams of the sheathing; rusted nails; splitting and curling wood shingle ends of irregular lengths below the metal sheathing; gaps and openings in the seams of the sheathing; and crinkled metal sheathing with holes. ARG Photo dated June, 2000.
