Grand Canyon Railroad Depot

Historic Structure Report

prepared for the
National Park Service

prepared by
Chamberlin Architects, PC
Grand Junction/Lakewood, Colorado

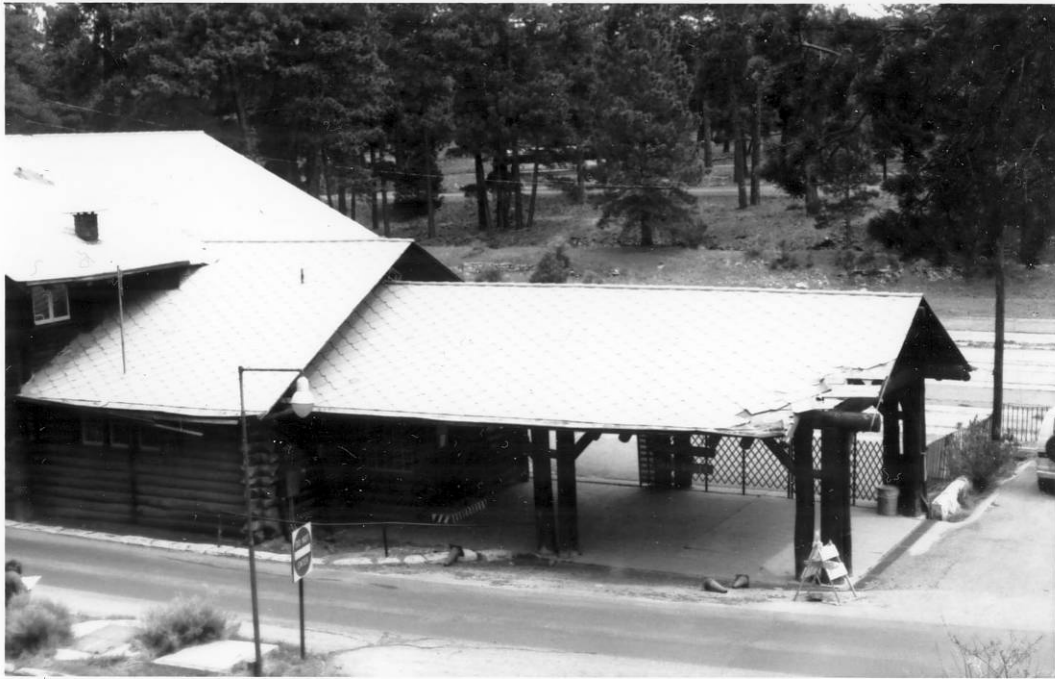
H-63 Grand Canyon Depot, west end and covered waiting area, view from northwest. Note damage to eave. Date May 1984. NPS photo. NPS Catalog # GRCA 59385a

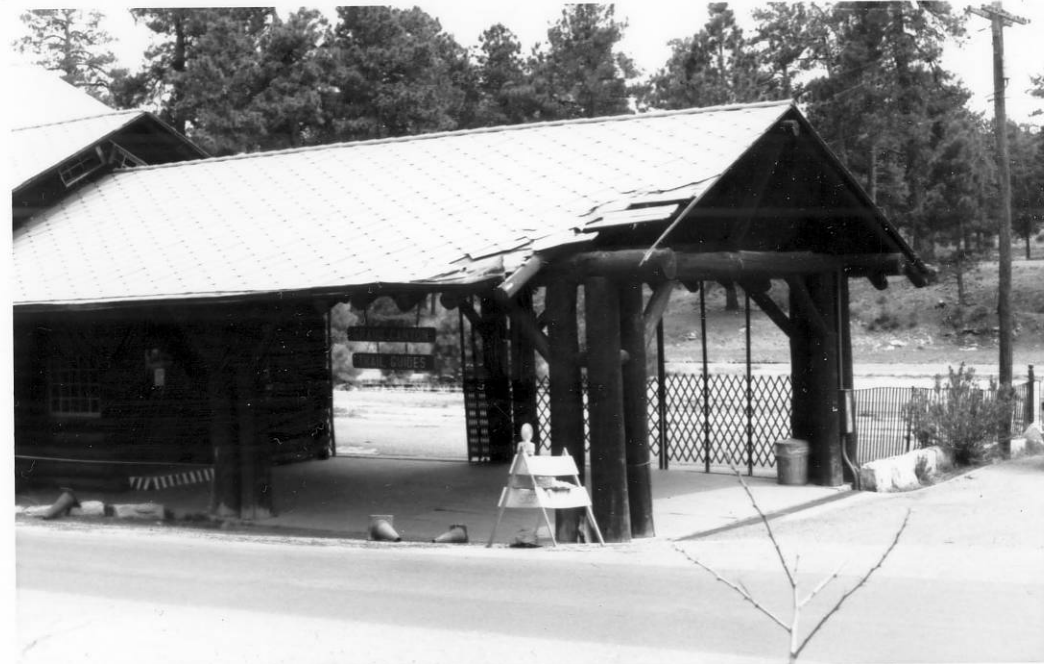
H-64 Grand Canyon Depot, west end and covered waiting area. Note damage to eave. Date May 1984. NPS photo. NPS Catalog # GRCA 59385b

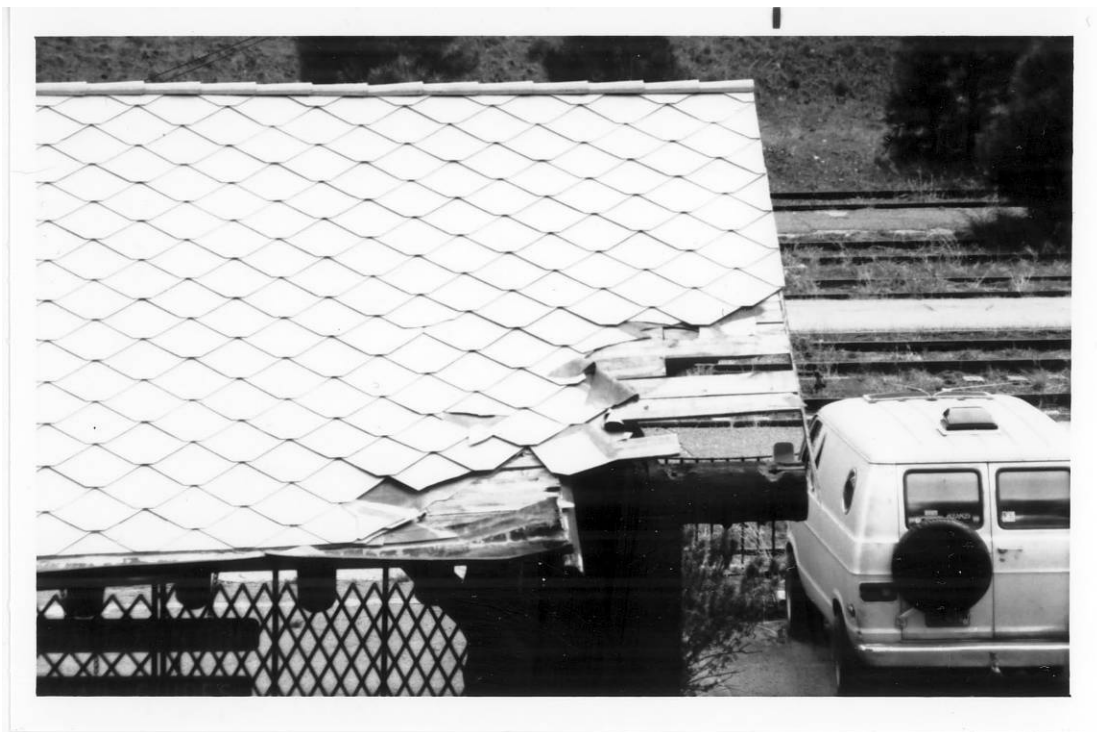
H-65 Grand Canyon Depot, roof of covered waiting area. Note damage. Date May 1984. NPS photo. NPS Catalog # GRCA 59385c

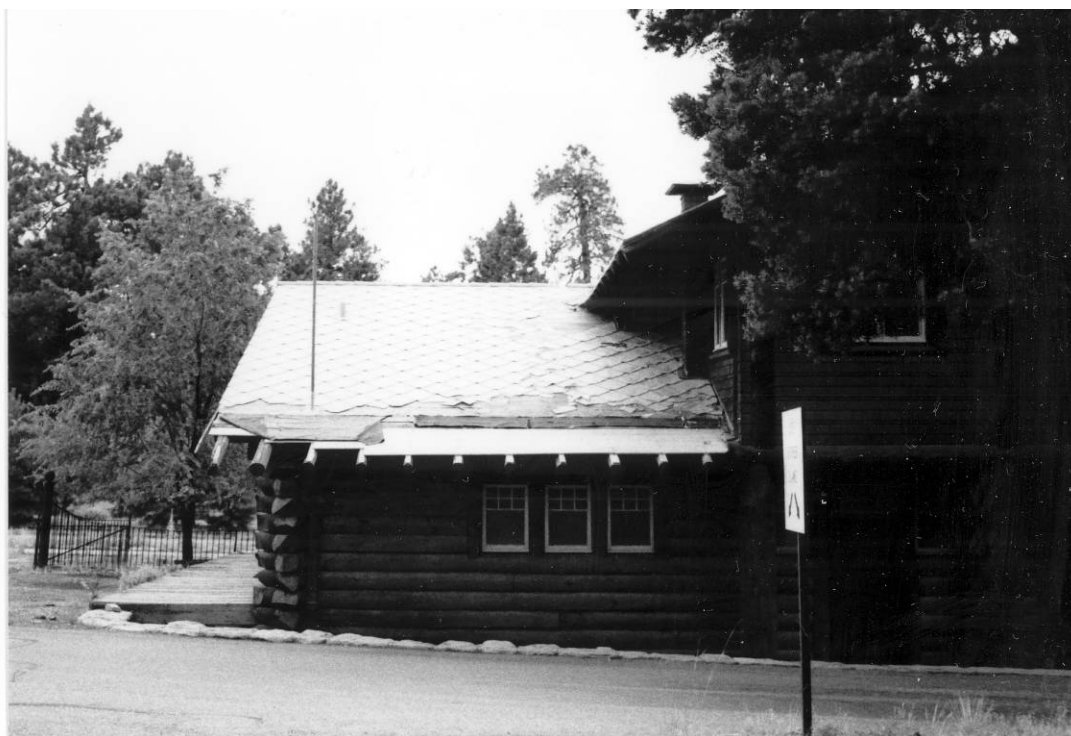
H-88 Grand Canyon Depot north elevation, east end. Note damage to roof eave. This may represent the beginning or roof demo. Date assumed to be July 31, 1986. NPS photos. Scanned from building files.

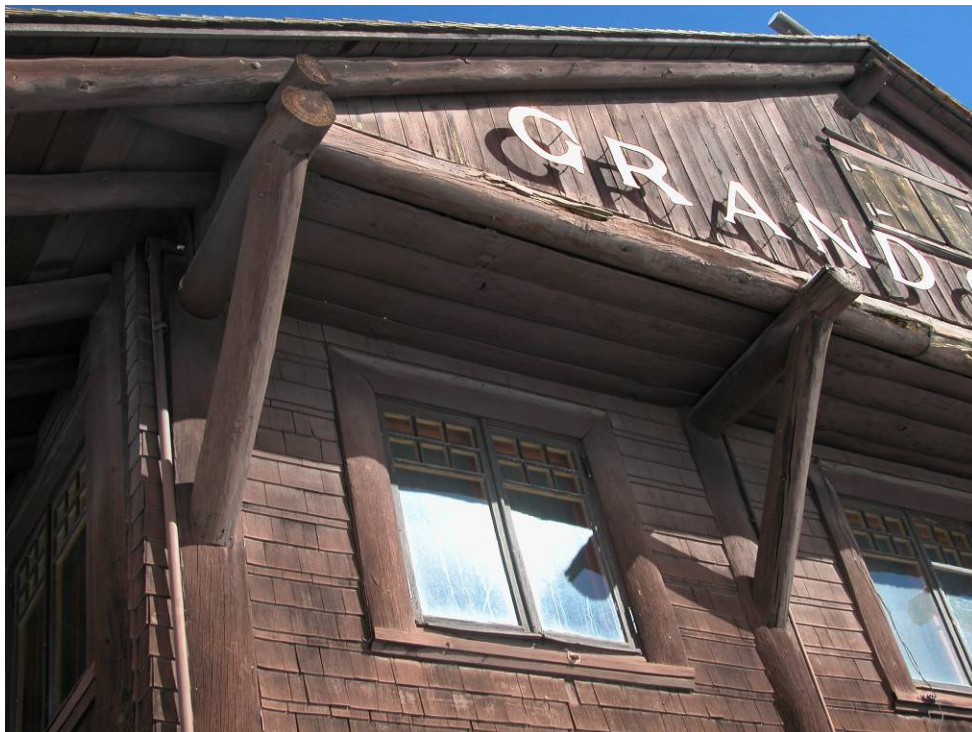
H-139 Grand Canyon Depot prior to rehabilitation. South elevation. Note deterioration of log beam. Date March 3, 2005. Scanned from building files.

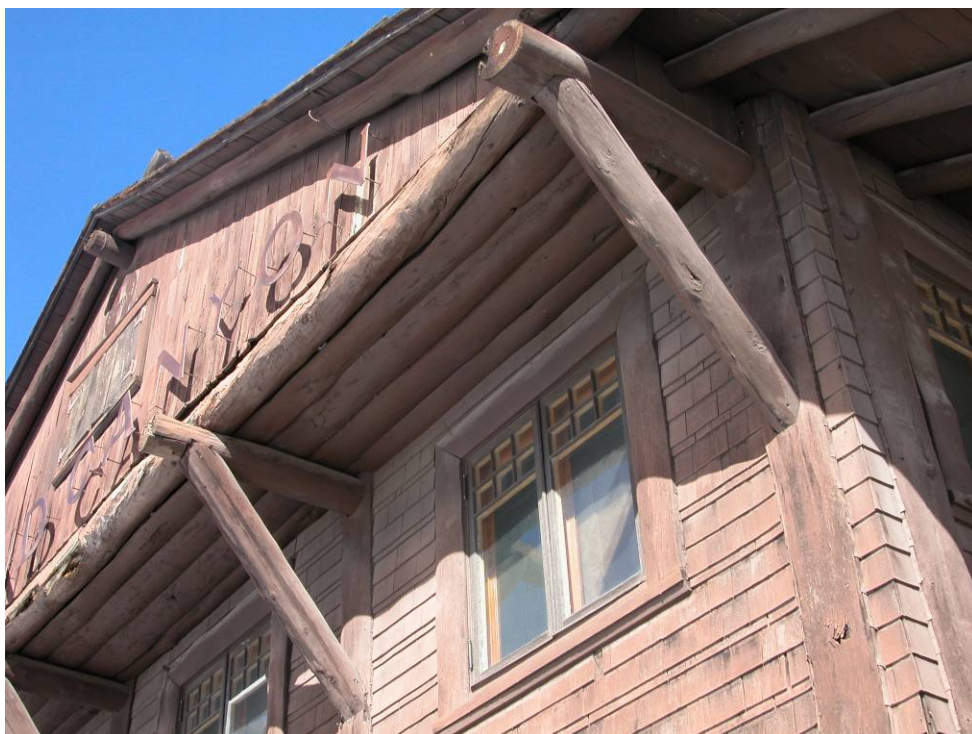
H-140 Grand Canyon Depot prior to rehabilitation. South elevation. Note deterioration of log beam. Date March 3, 2005. Scanned from building files.

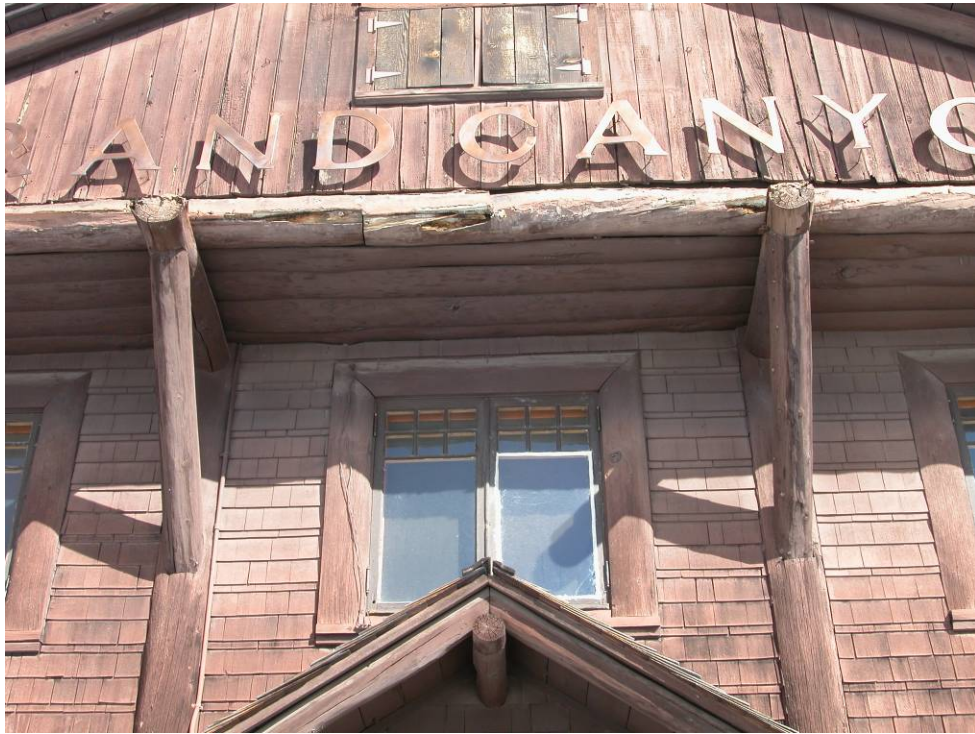
H-141 Grand Canyon Depot prior to rehabilitation. South elevation. Note deterioration of log beam. Date March 3, 2005. Scanned from building files.

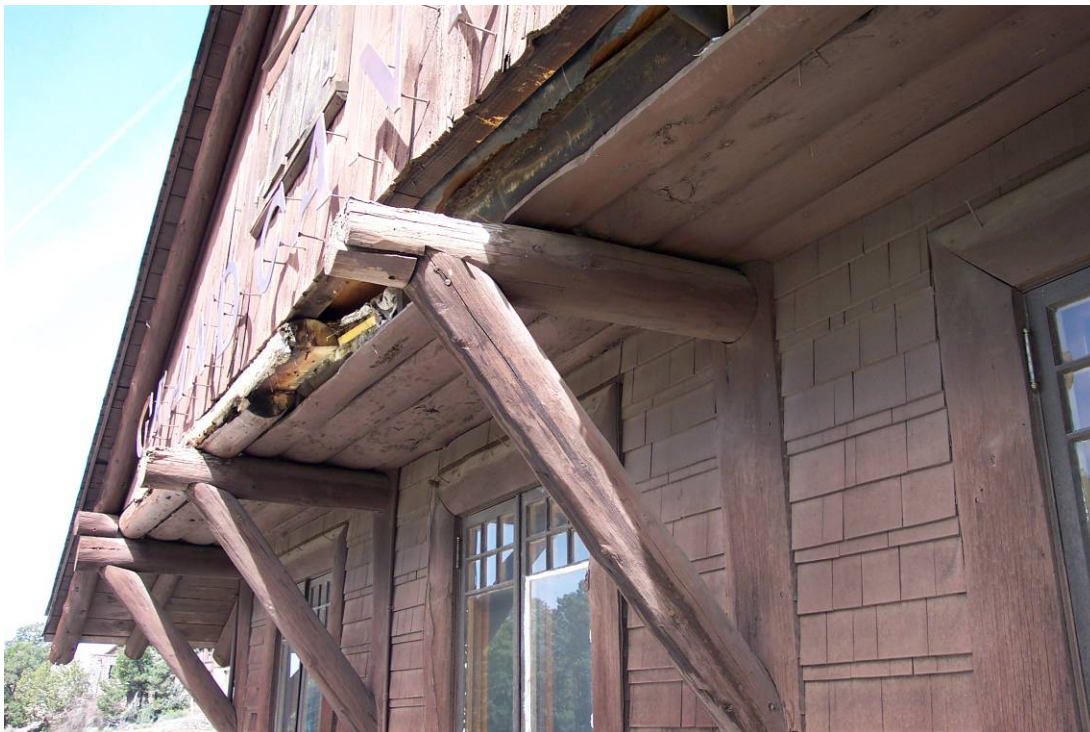
H-149 Grand Canyon Depot during rehabilitation. Deterioration of south gable beam and brackets. Date 2005. From building files. Photo by Craig Struble.

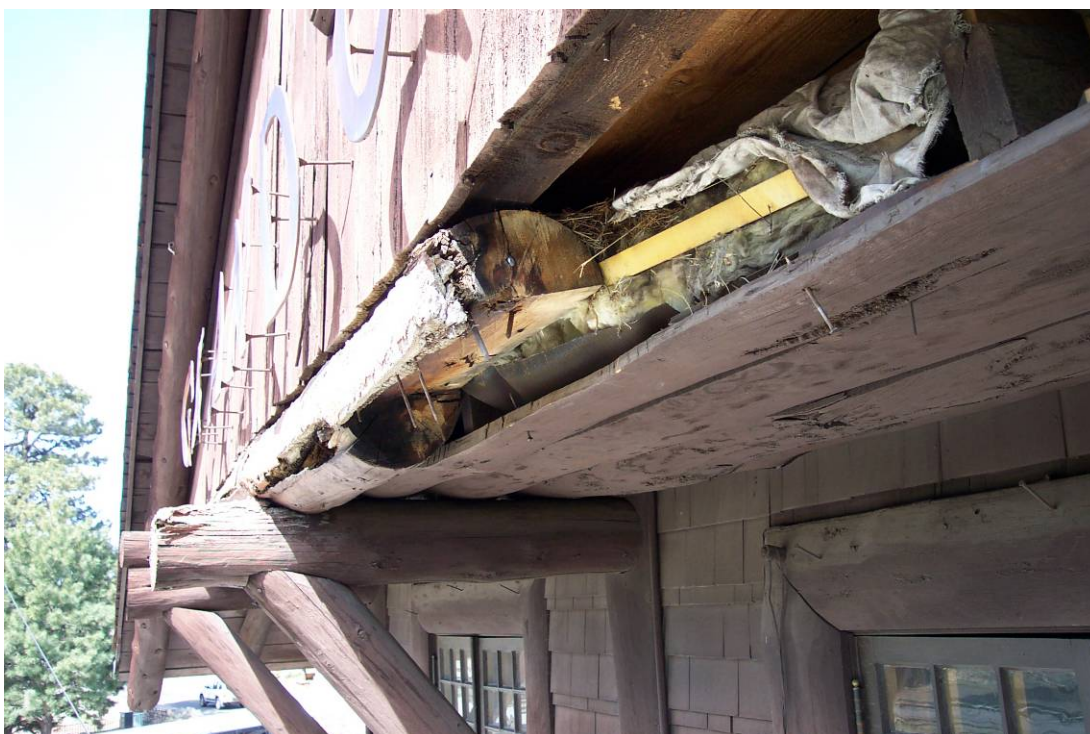
H-150 Grand Canyon Depot during rehabilitation. Deterioration of south gable beam and brackets. Date 2005. From building files. Photo by Craig Struble.

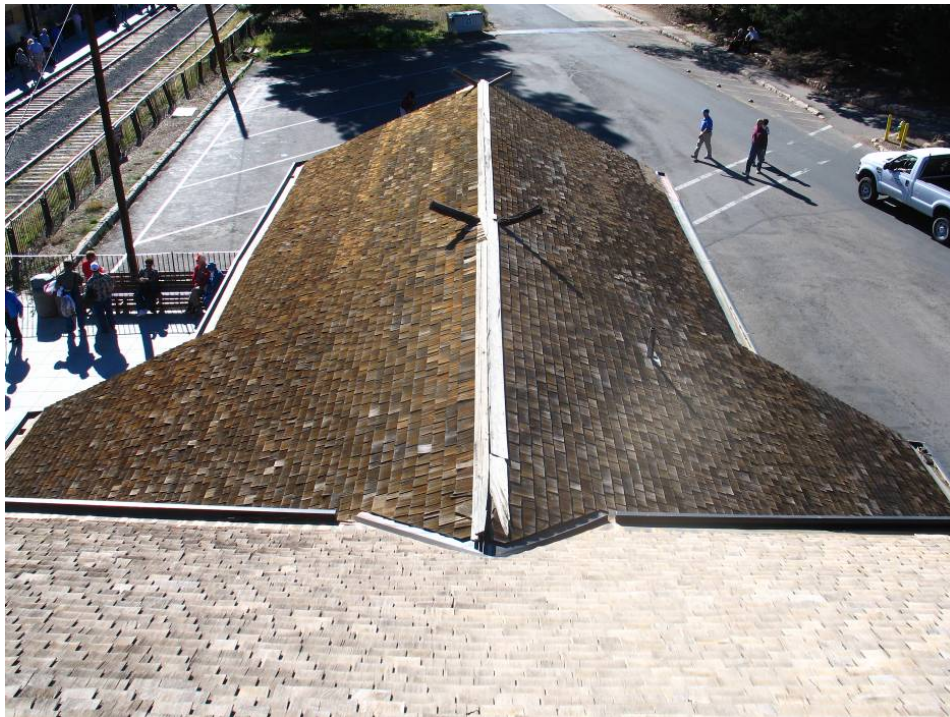
E-78 View of main roof looking west with west bedroom roof and covered waiting area roof beyond. Note damage to ridge boards. October 3, 2007. Photograph by Martin/Martin.

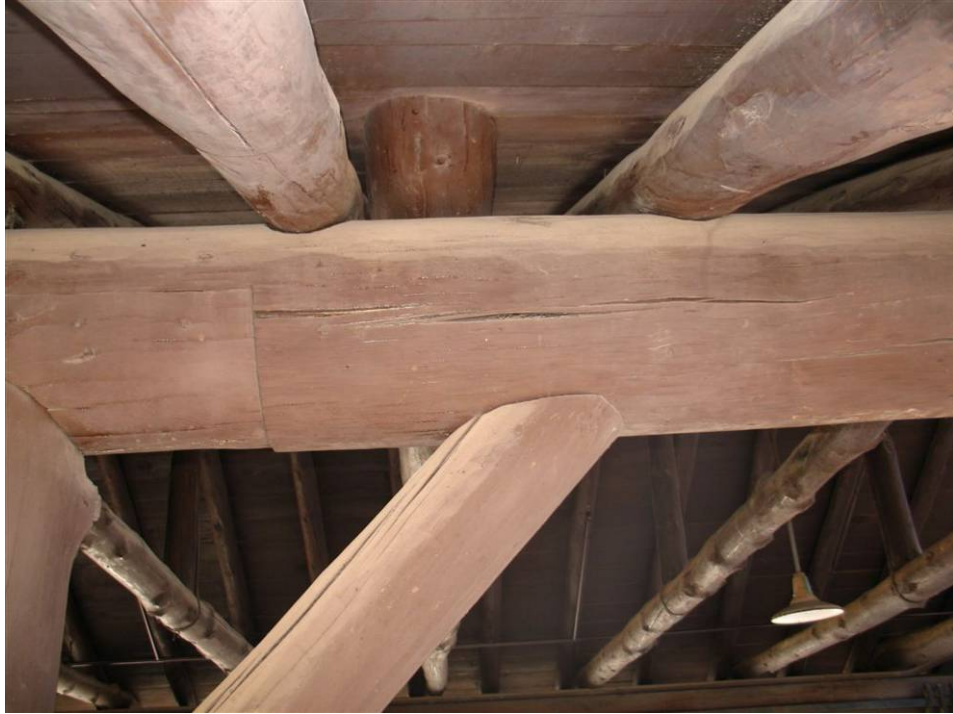
E-79 View of beam in Covered Waiting Area. Note longitudinal cracking. October 3, 2007.
 Photograph by Martin/Martin.

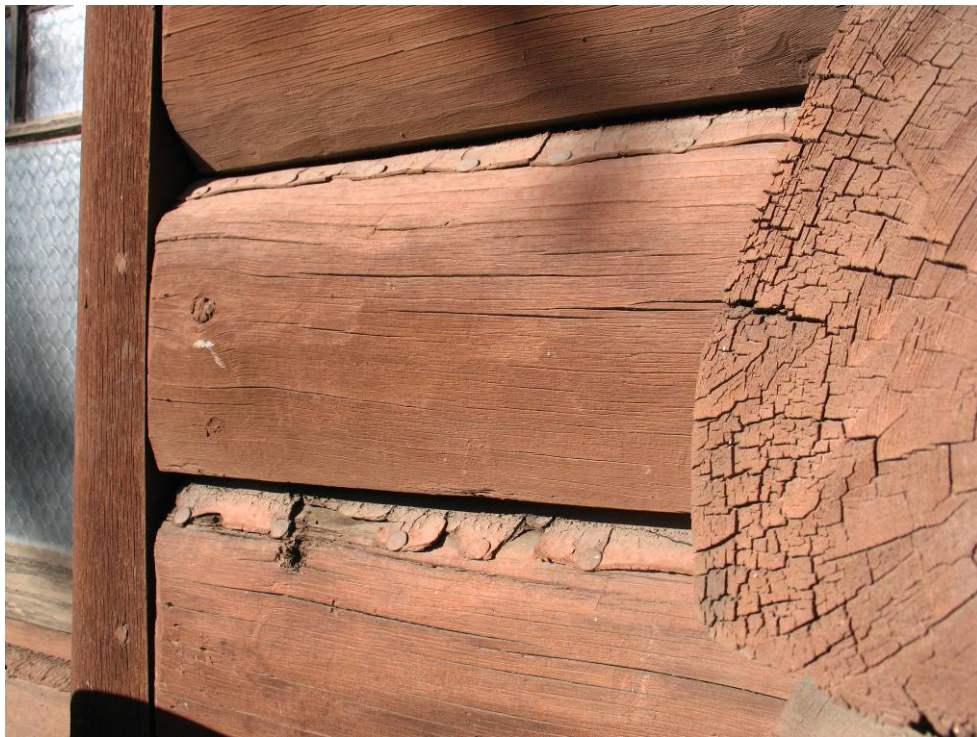
E-80 View of “Rubberoid” flashing. Note deterioration of exposed surface. October 3, 2007.
 Photograph by Chamberlin Architects.

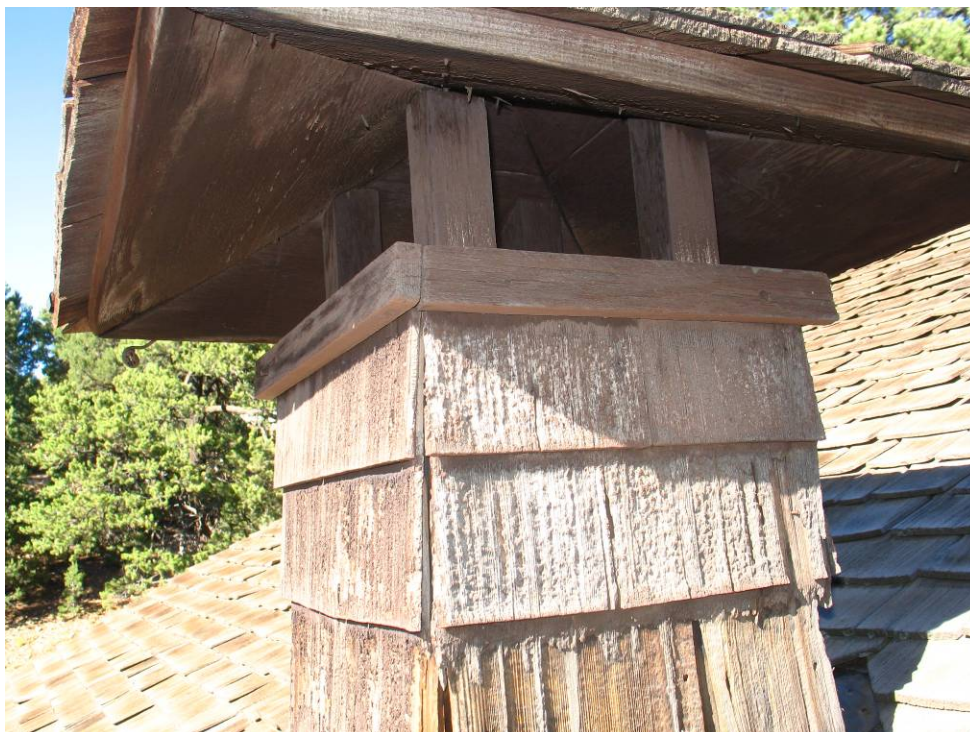
E-81 Close up of restroom vent. Note deterioration of wood shingles October 3, 2007.
Photograph by Martin/Martin.

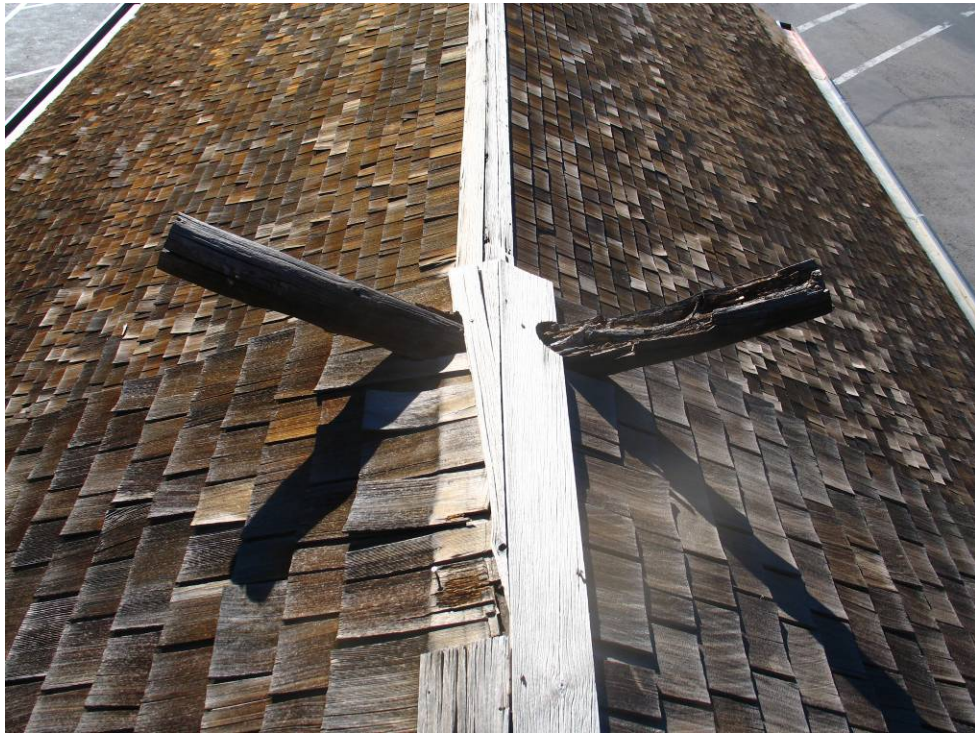
E-83 Close up of false barge rafter extensions at west roof. Note deterioration. October 3, 2007. Photograph by Martin/Martin.

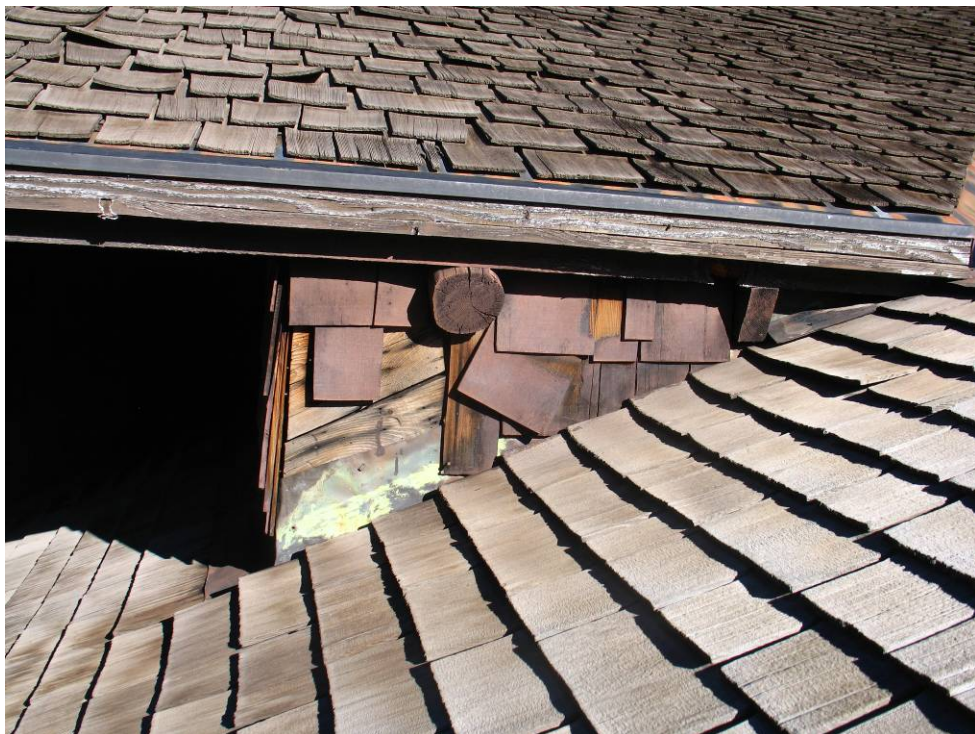
E-84 West side of dormer at Pantry. Note loss of shingles. Also note cupping of roof shingles. October 3, 2007. Photograph by Martin/Martin.

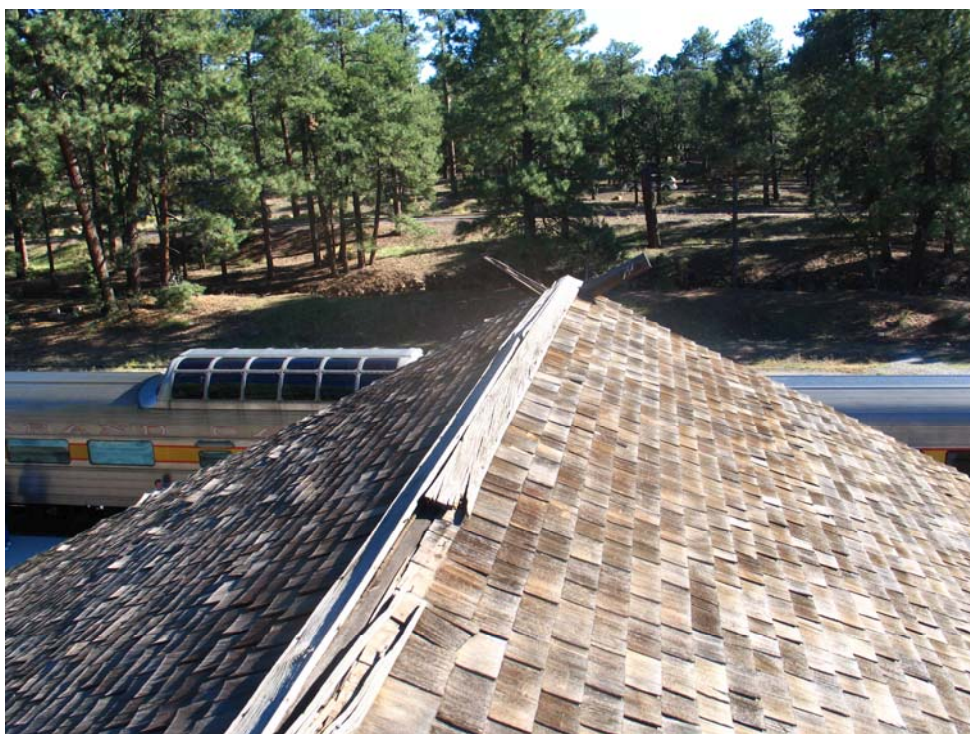
E-86 Main upper roof looking south. Note deterioration of ridge board and cupping of the shingles, particularly on the east side. October 3, 2007. Photograph by Martin/Martin.

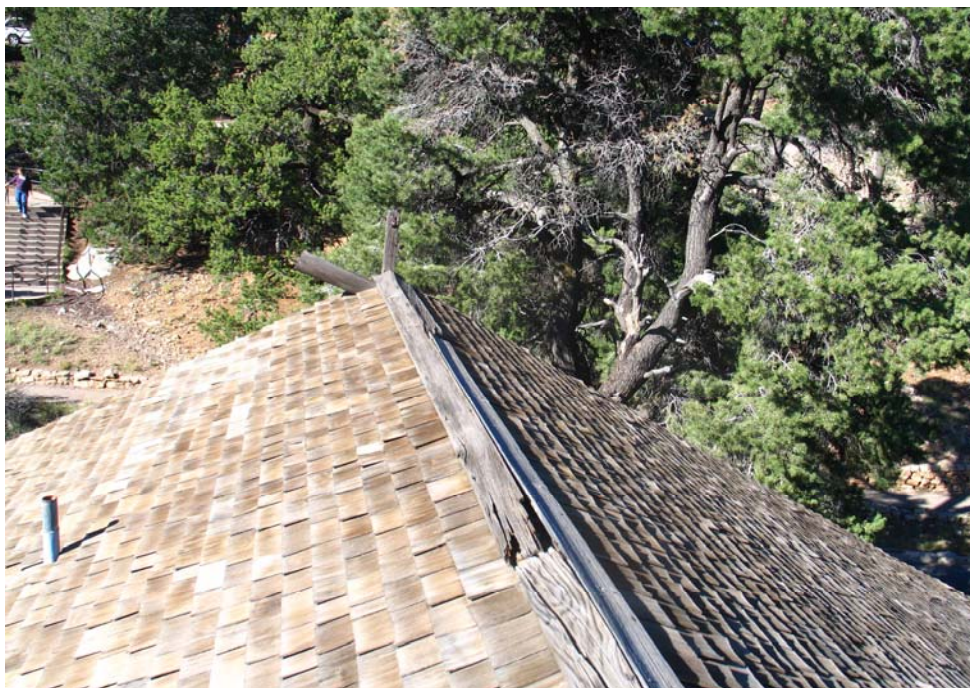
E-87 Main upper roof looking north. Note deterioration of ridge board and missing barge rafter extension. Note vertical board at gable end, possibly for radio antennae. October 3, 2007. Photograph by Martin/Martin.

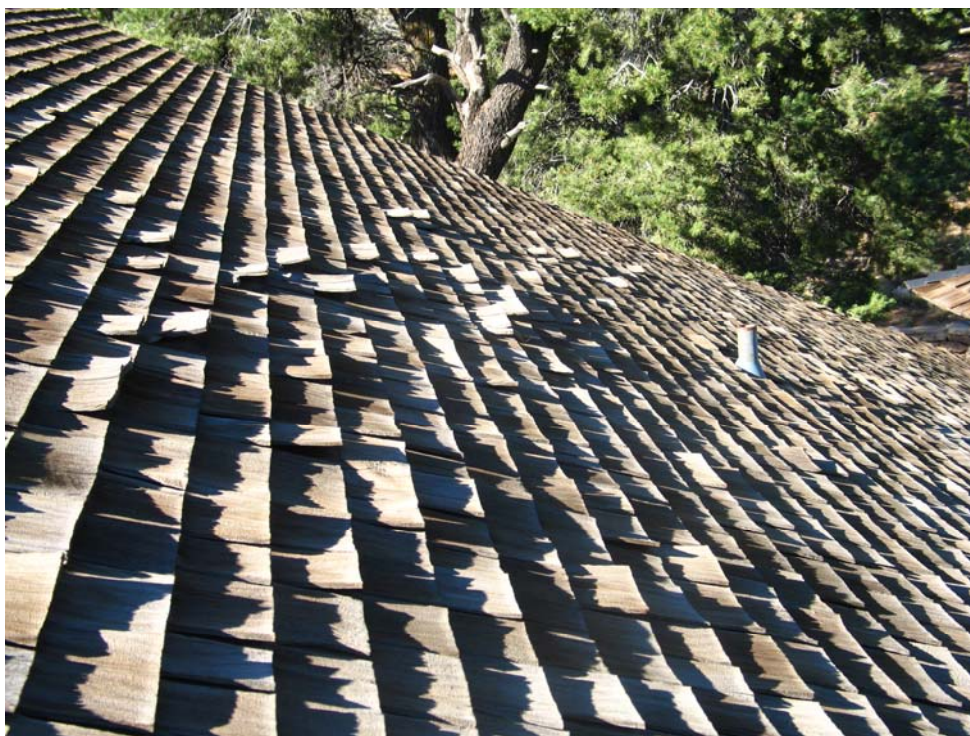
E-88 Main roof, east side, looking north. Note cupping of roof shingles. October 3, 2007. Photograph by Martin/Martin.

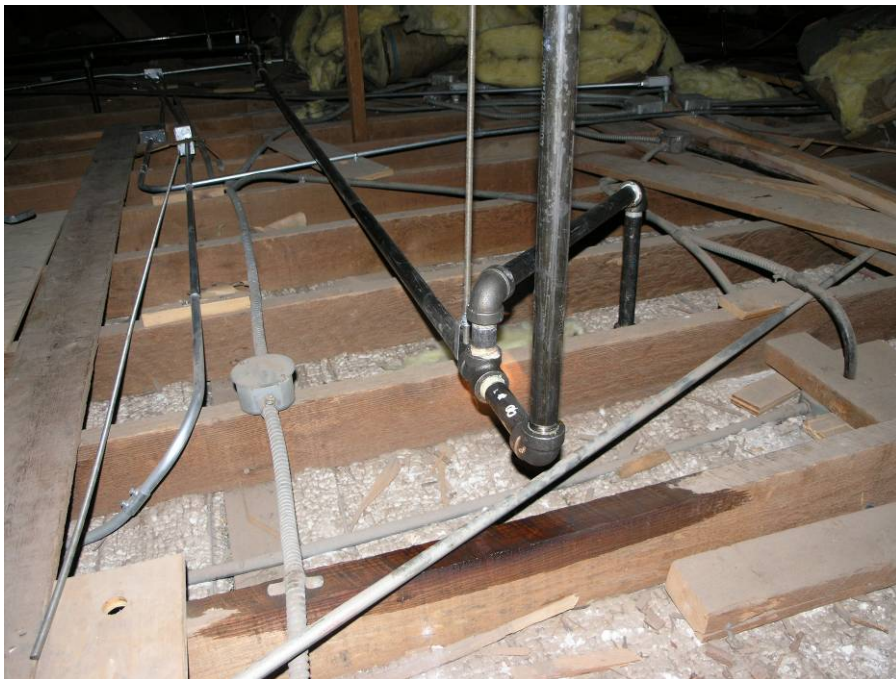
I-108 Attic space looking southwest. Note leak in fire sprinkler line. October 3, 2007. Photograph by Chamberlin Architects.
