South Rim Ranger Operations Building  
Historic Structure Report

Grand Canyon National Park, Arizona

## I. EXECUTIVE SUMMARY

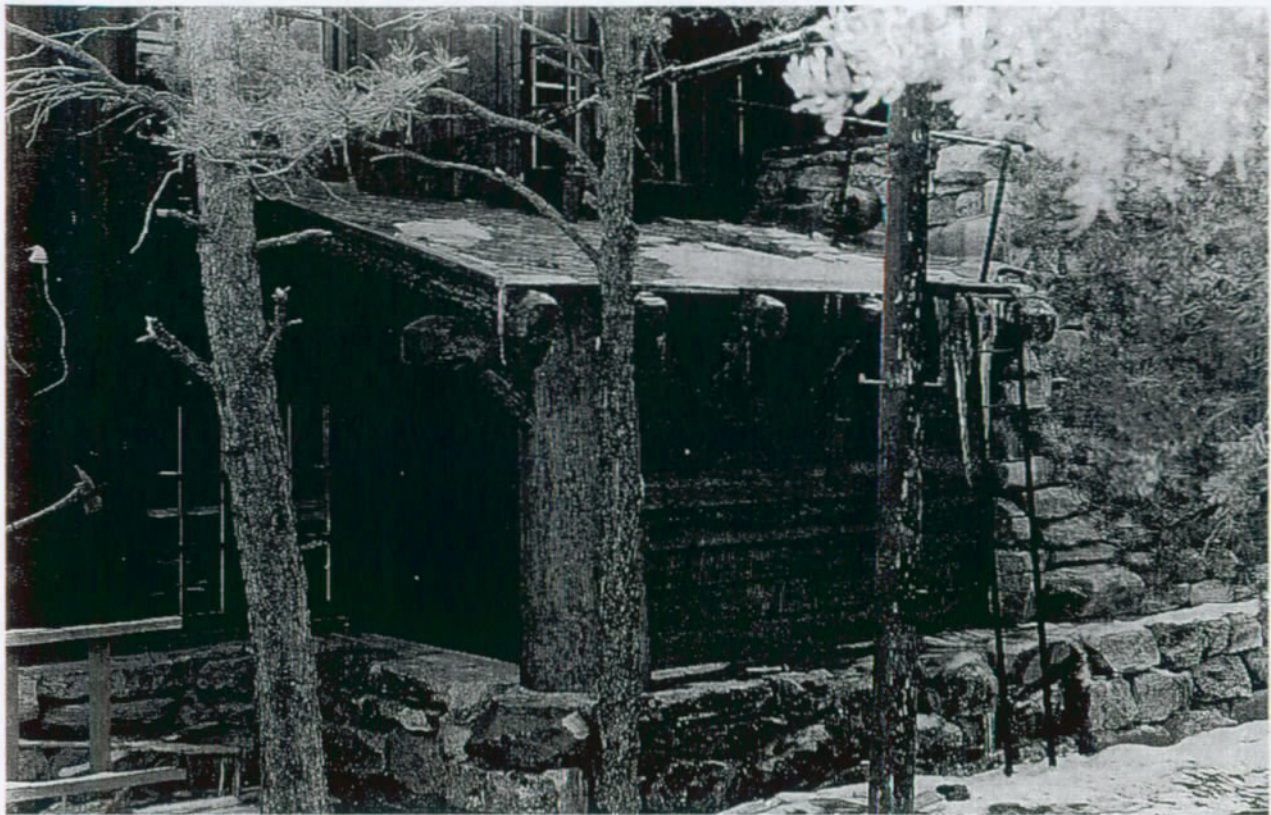
GCNPA Photograph Number 9250.

*Figure 15: Completed vault at east elevation of Headquarters' Building, February 1936. Note stone foundation and emergency exit ladder.*

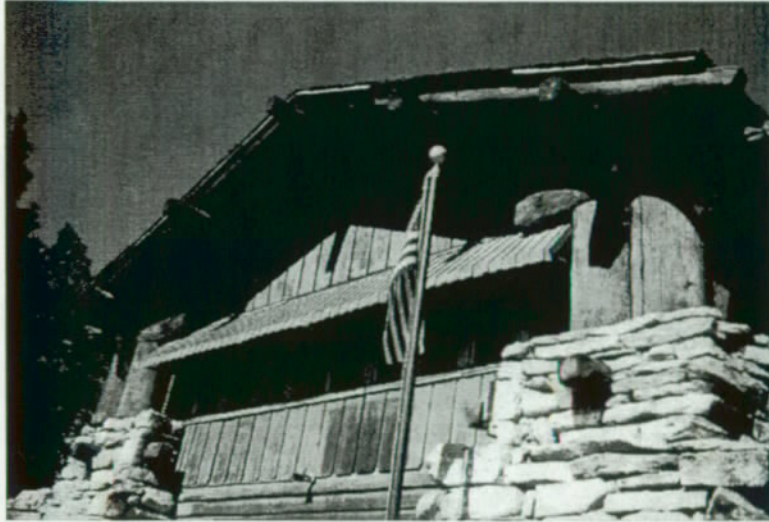
Figure 17: Metal awning at west elevation.

(Figure 17) It is likely that this occurred when the new awning was installed as the original casements would not have been operable with the awning in place. Due to the condition and construction of the double-hung sash, it is assumed that both the awning and double-hung windows were added soon after the building's initial construction date, perhaps when the 1935 alterations occurred to the structure.

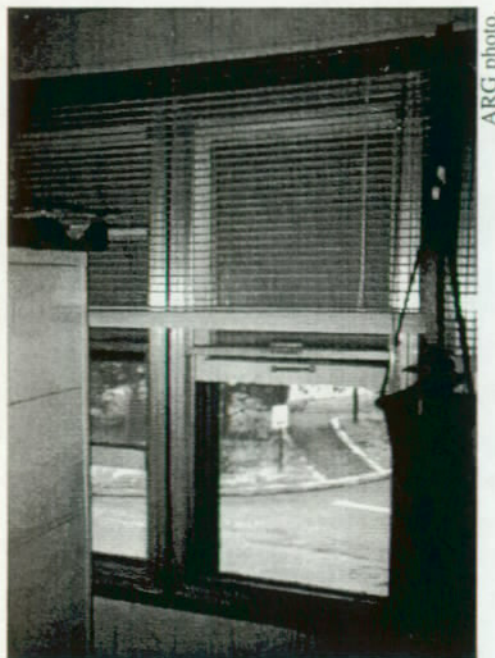
The metal awning at the second floor of the west facade is a non-contributing feature. (Figure 27)

Figure 27: Double-hung wood sash window at Room 201. Note underside of awning outside window.

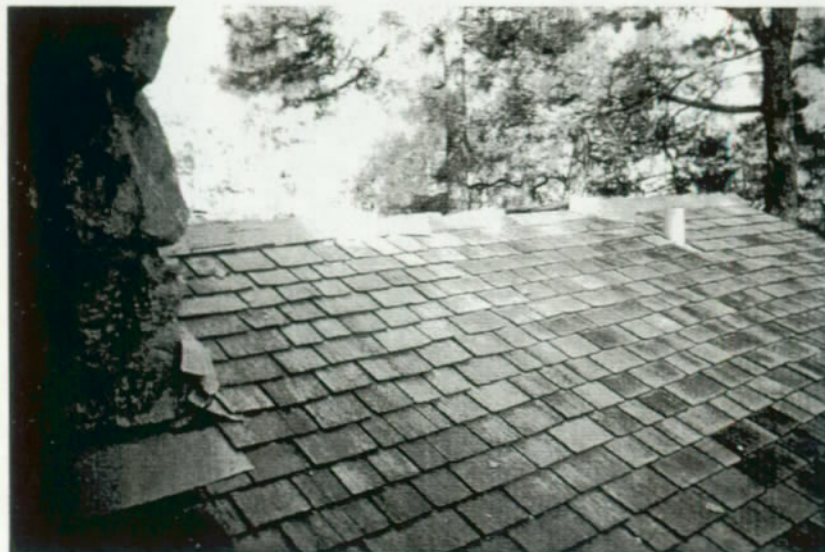
- The original drawings indicate the roof was to be sheathed in wood shakes. However, early photographs of the structure show asphalt shingles laid in a diaper pattern. According to maintenance records, the roof was not re-surfaced with the extant wood shingles until 1983 or 1984. Given that this roofing material is over 15 years old and is exposed to severe winters, it is likely that it will need to be replaced soon. The roofing material over the toilet room addition, in particular, is showing significant biological growth and delamination from the sheathing beneath. (Figure 28) It is recommended that asphalt shingles, laid in a dutch diaper pattern, be used when the building is re-roofed. Though this is not the material specified in the original construction documents, and its

Figure 28: Roofing over toilet room addition. Some wood shingles are slipping at ridge line.
