**HERBERT HOOVER**  
11 CORE AREA BUILDINGS

NATIONAL HISTORIC SITE / IOWA

HISTORIC STRUCTURE REPORT  
ELEVEN CORE AREA BUILDINGS  
HERBERT HOOVER NATIONAL HISTORIC SITE  
WEST BRANCH, CEDAR COUNTY, IOWA

Volume 1: Administrative and Architectural Data

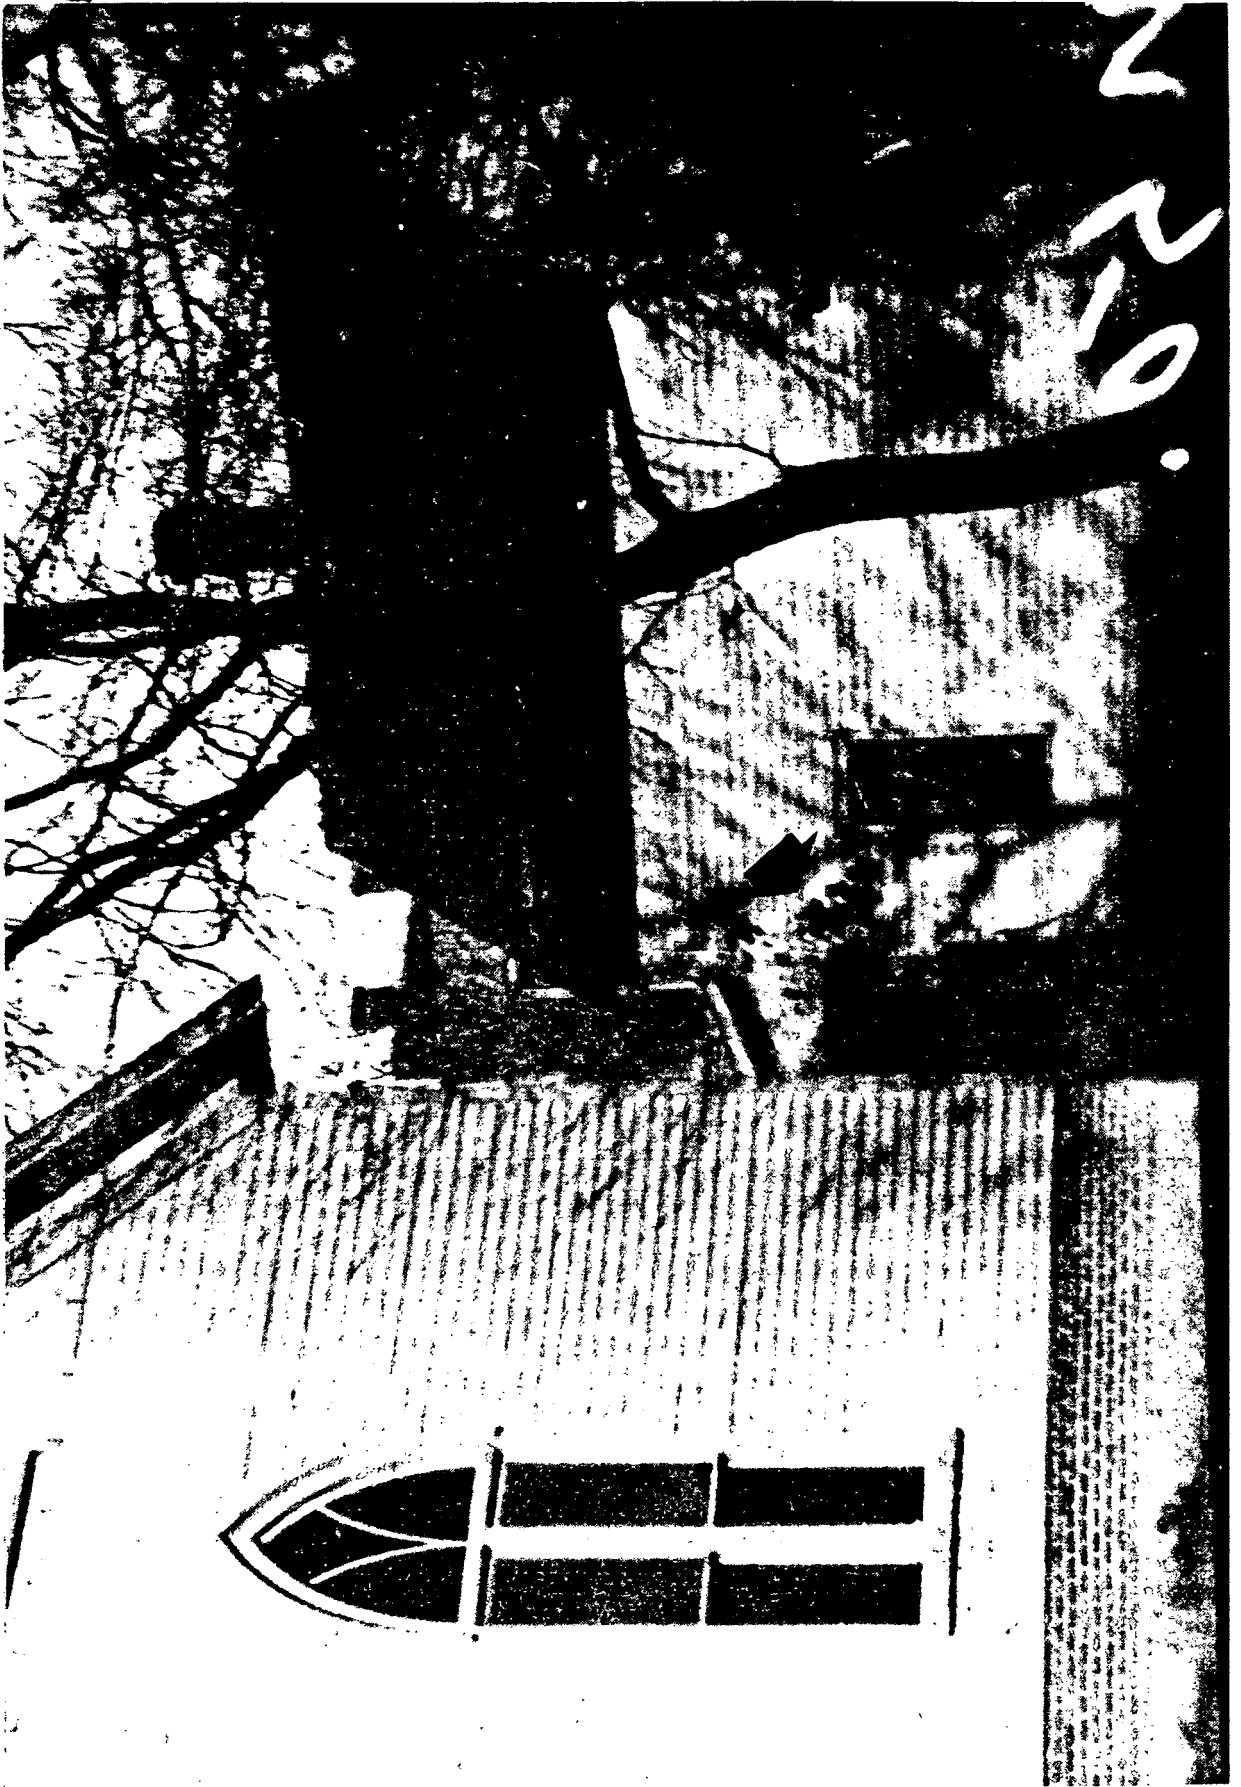
HS-7:6, AMANDA GARVIN HOUSE, 1978. View looking west shows the sill member for the original west window of the house. The original photograph and negative are at Wagner. Marquart. Wetherell. Ericsson. Architects, Des Moines, Iowa.

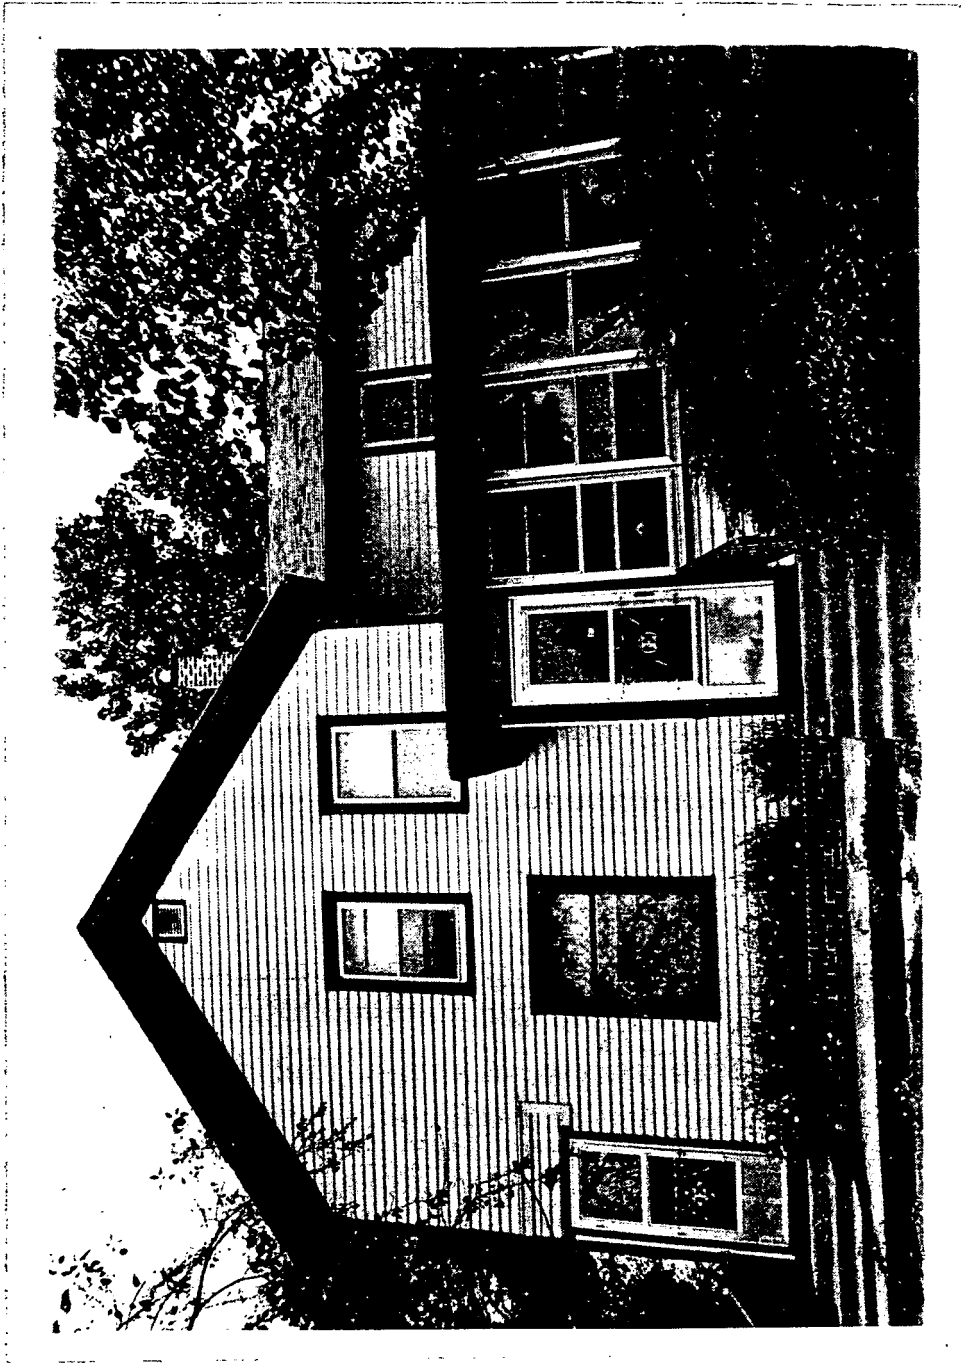
HS-9:4, JAMES STAPLES HOUSE, 1977. Existing view looking south. The original negative is at the Denver Service Center, National Park Service.

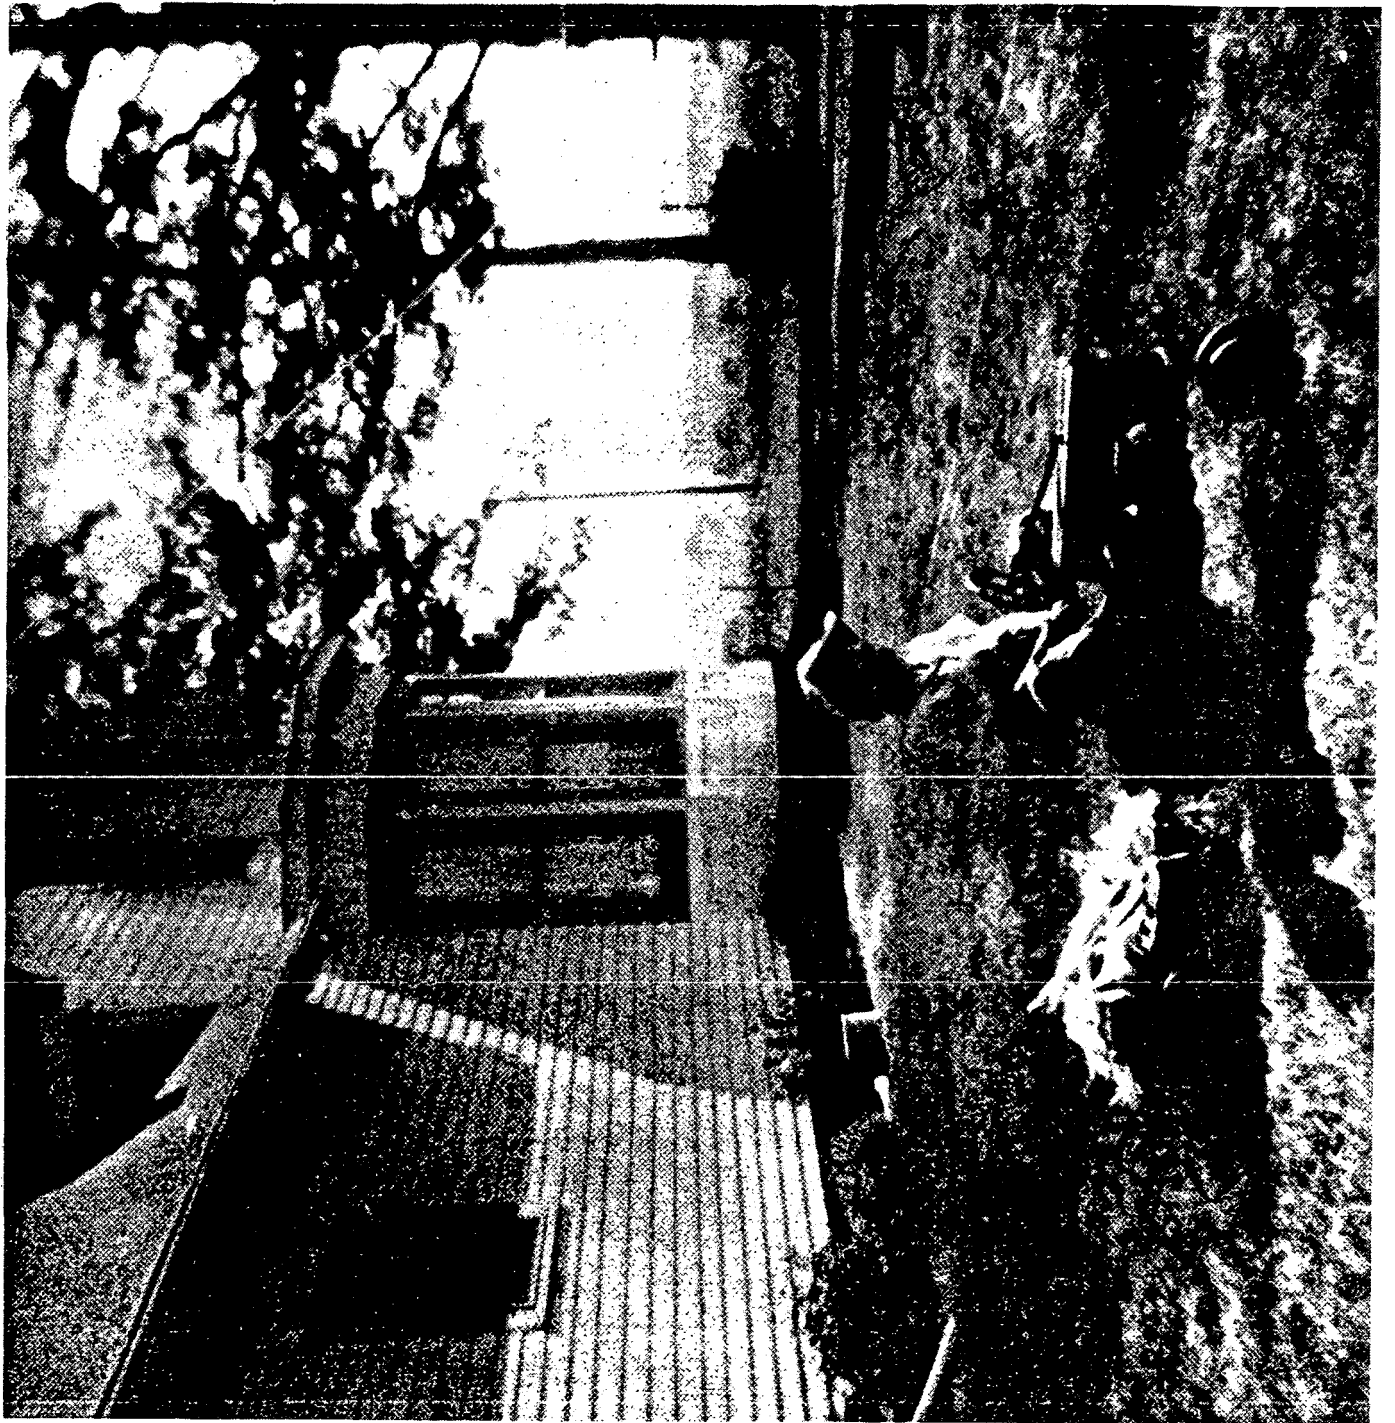
HS-11:5, ISAAC MILES FARMHOUSE, 1978. This photograph shows a portion of the original stone foundation for the east bay window. The original photograph and negative are at Wagner. Marquart. Wetherell. Ericsson. Architects, Des Moines, Iowa.
