INDEPENDENCE  
DESHLER-MORRIS HOUSE

NATIONAL HISTORICAL PARK / PENNSYLVANIA

HISTORIC STRUCTURE REPORT  
ARCHITECTURAL DATA SECTION

DESHLER-MORRIS HOUSE  
INDEPENDENCE NATIONAL HISTORICAL PARK  
GERMANTOWN, PENNSYLVANIA

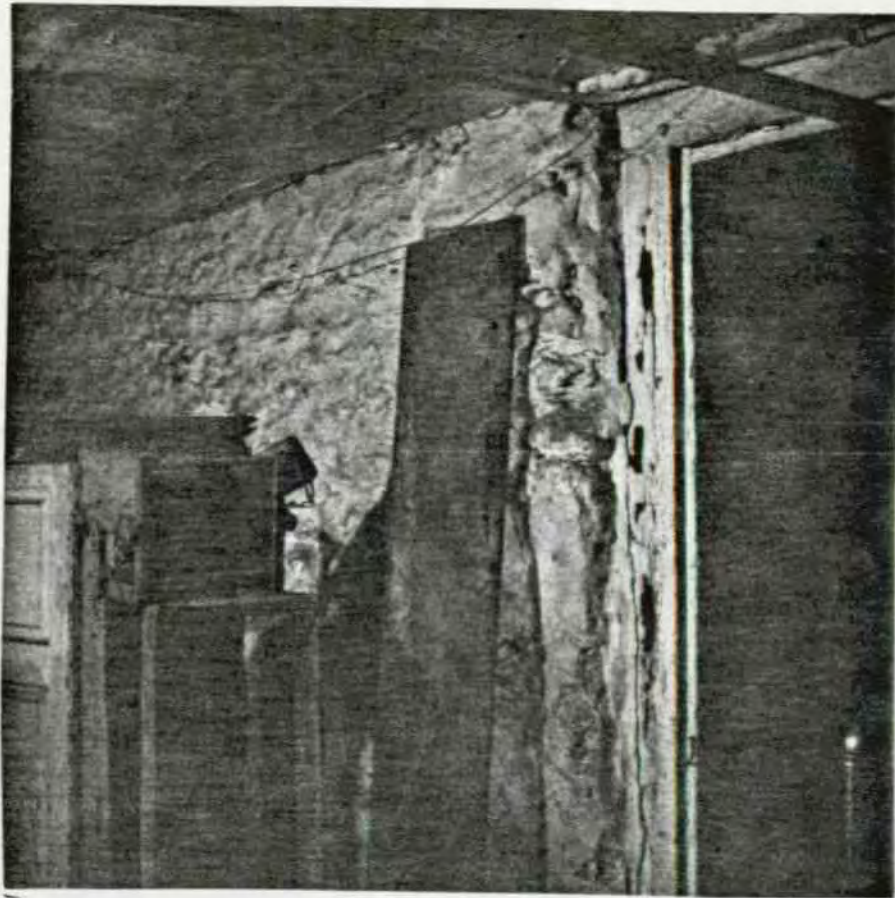
ILLUSTRATION 19 - PHOTOGRAPHED BY NPS.  
1750 Section  
Doorway to 1772 section. Note deteriorated door  
frame and courseness of exterior of foundation  
wall of 1750s section, looking southwest.

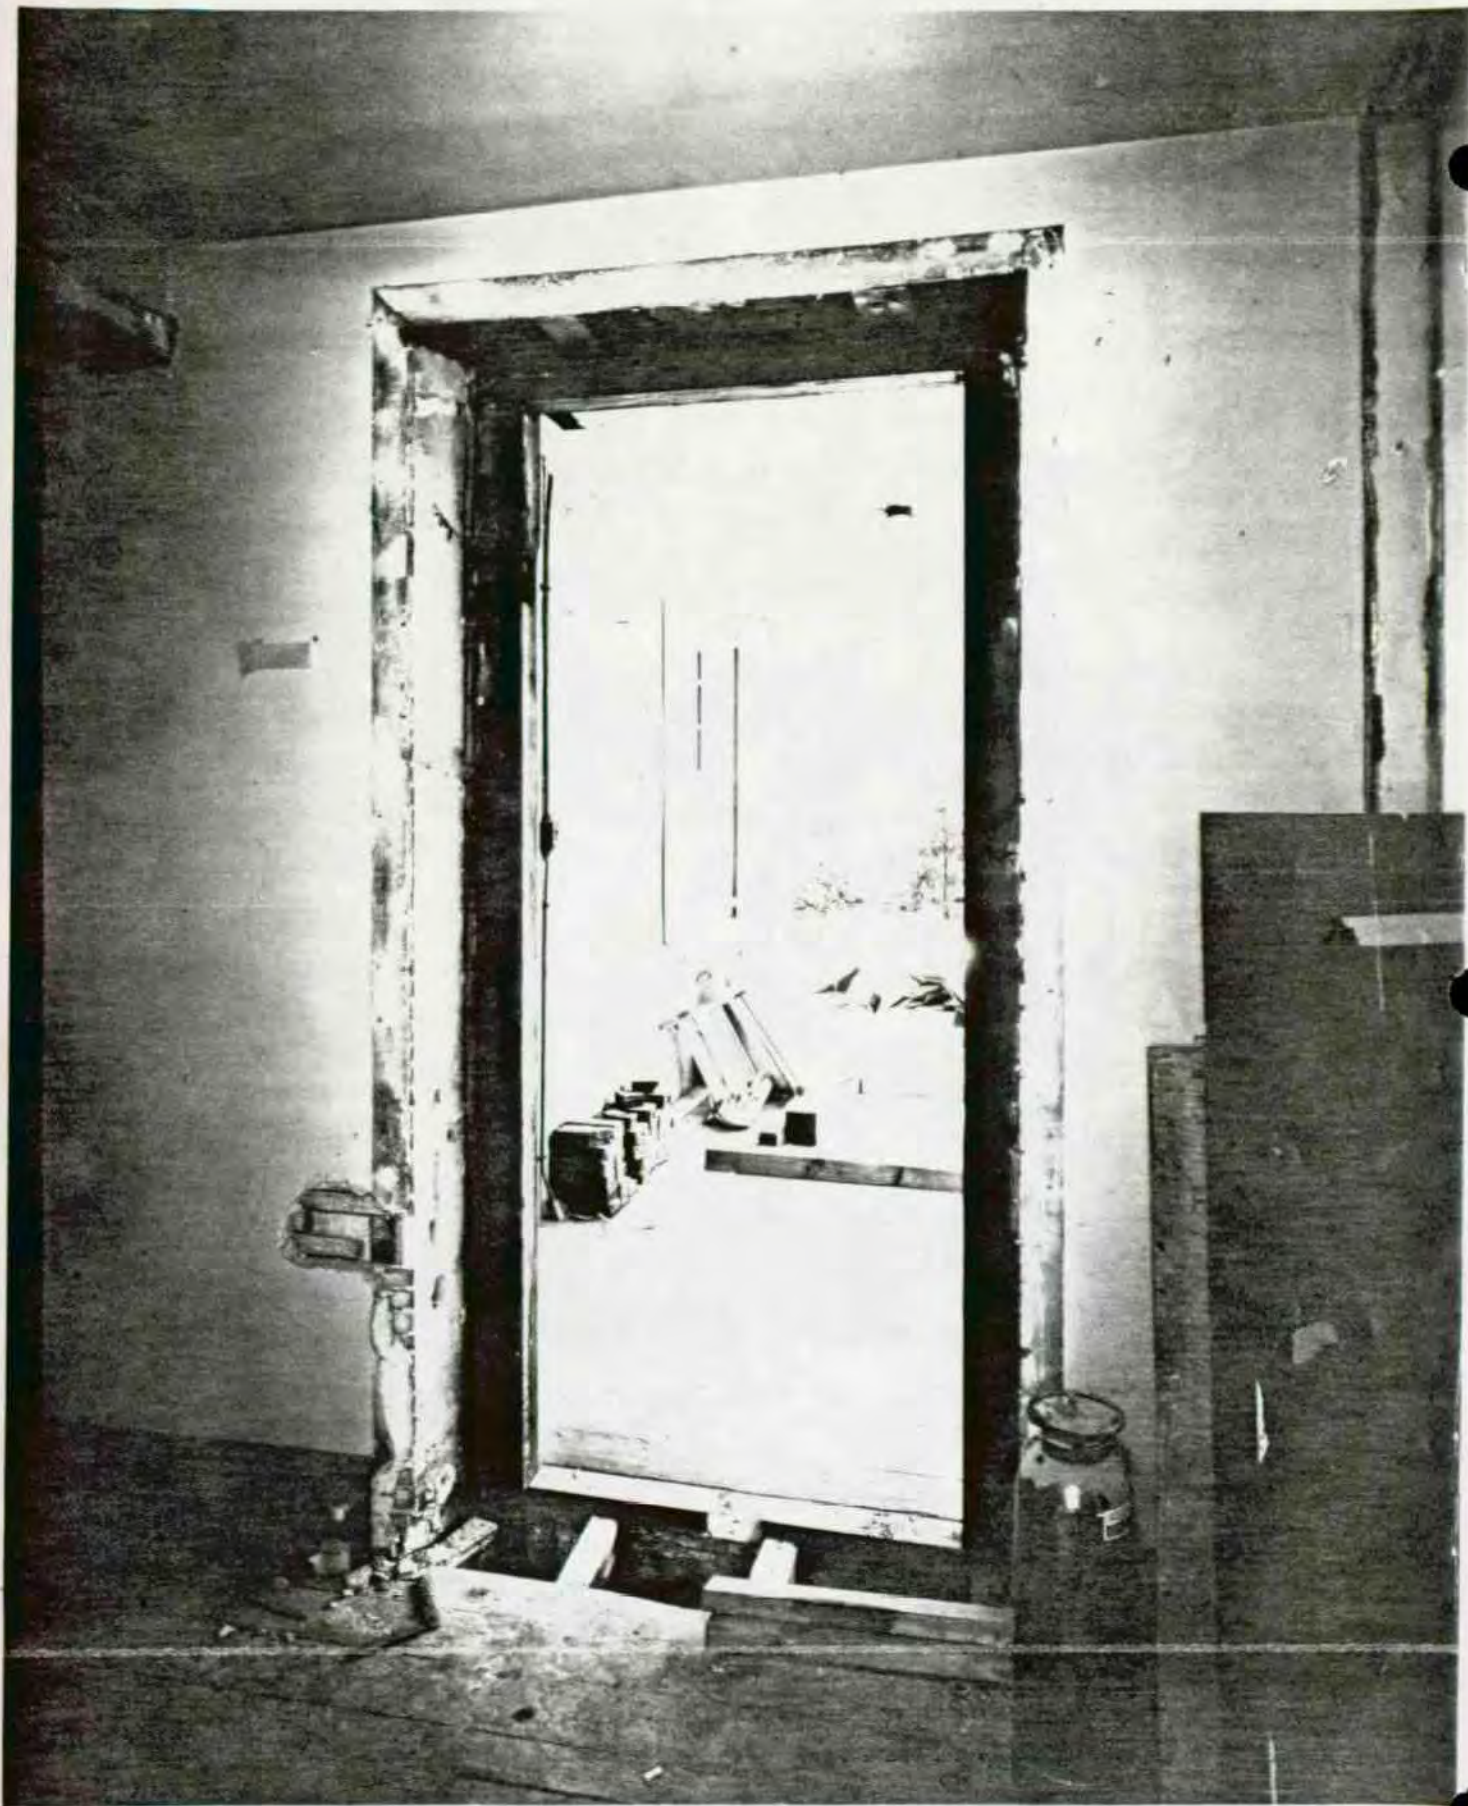
ILLUSTRATION 20 - PHOTOGRAPHED BY JAMES DILLON AND COMPANY.  
1750s Section

Doorway from Room 109 to Porch 108. Note hinge shadows on the right and left of this doorway framing. Note also cut transom at left. Looking south.

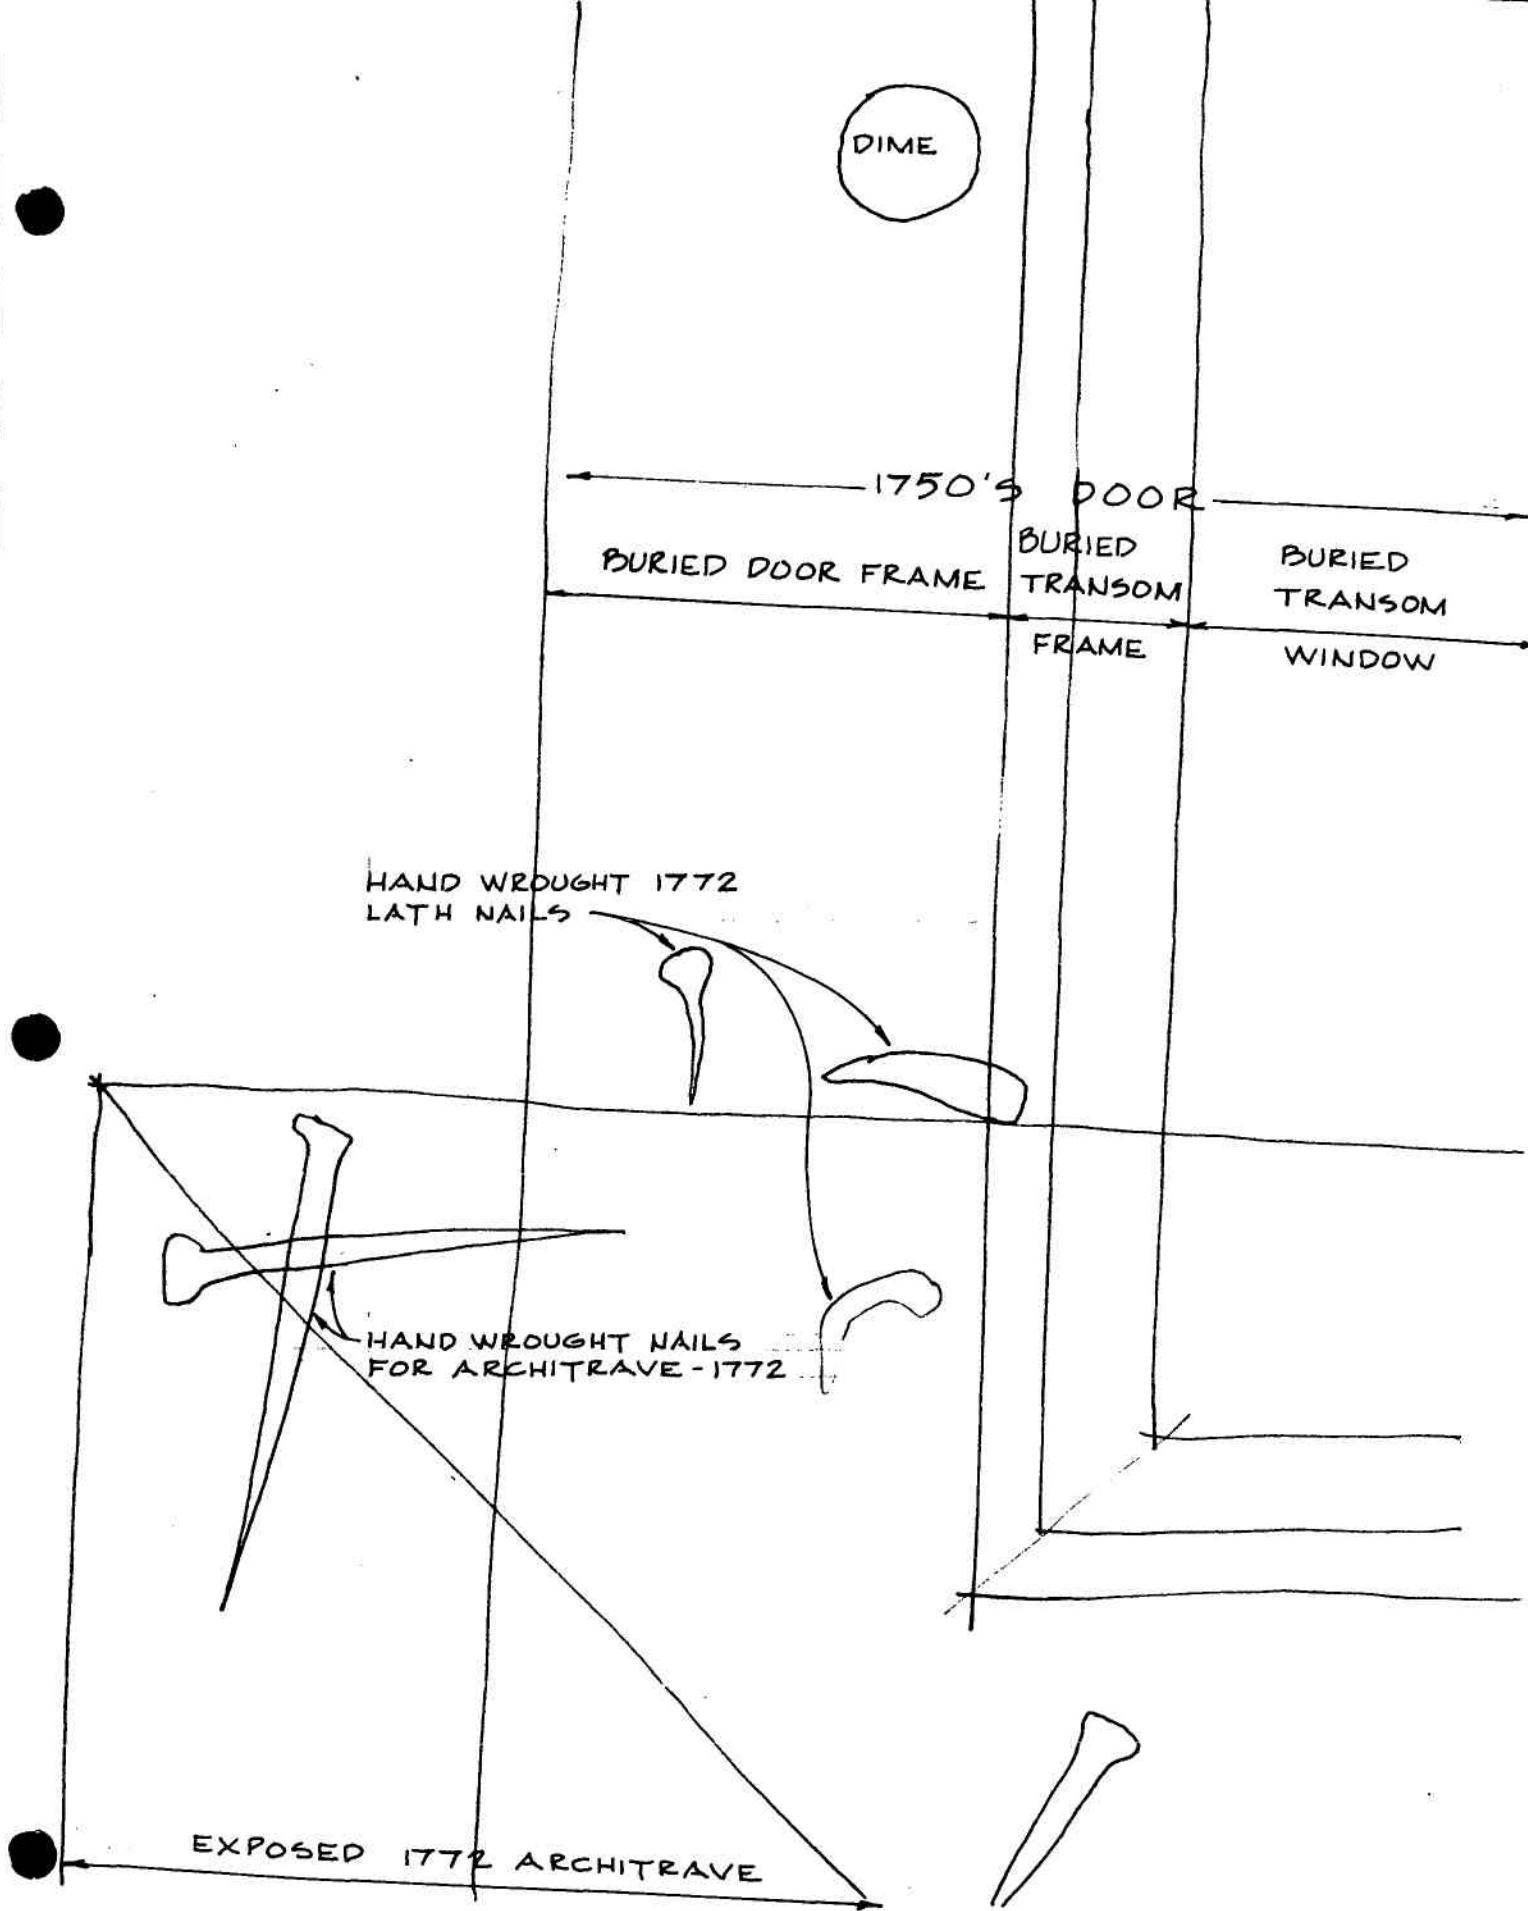
ILLUSTRATION 23

X-Ray Photograph No. 1 and analysis.

Note bottom left corner of transom frame (lower right of page) and upper left corner of door architrave (lower left of page).

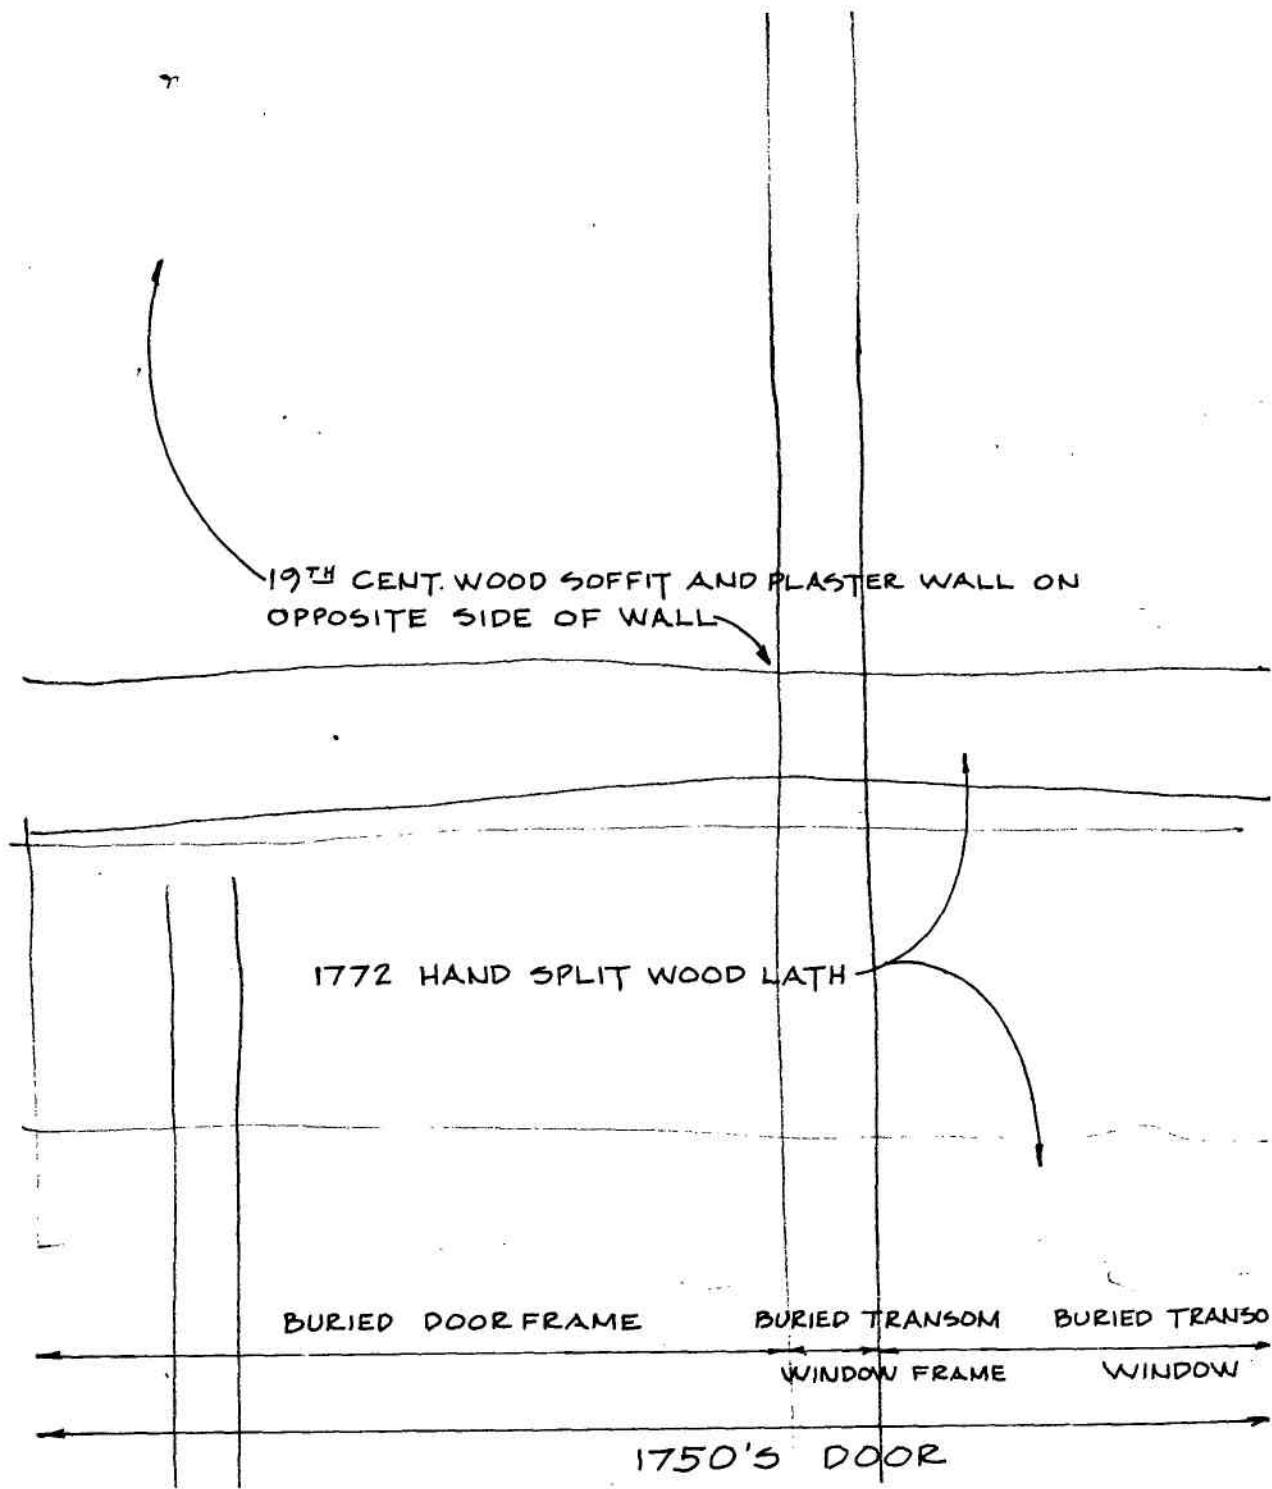
ILLUSTRATION 25

X-Ray Analysis.

Transom window opening and frame continue upward beyond upper edge of photograph.

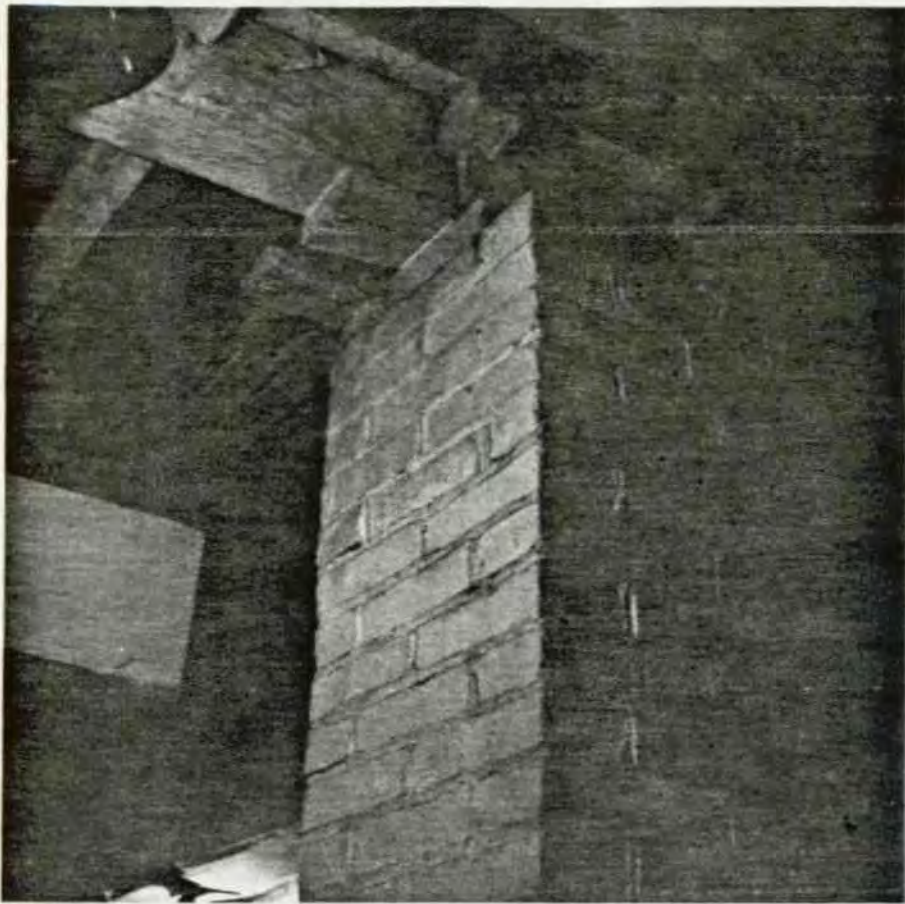
ILLUSTRATION 43  
Photographed by NPS.  
1772 Section  
Cellar-Room 02. Brick pier (1884) with wedges to support joists.

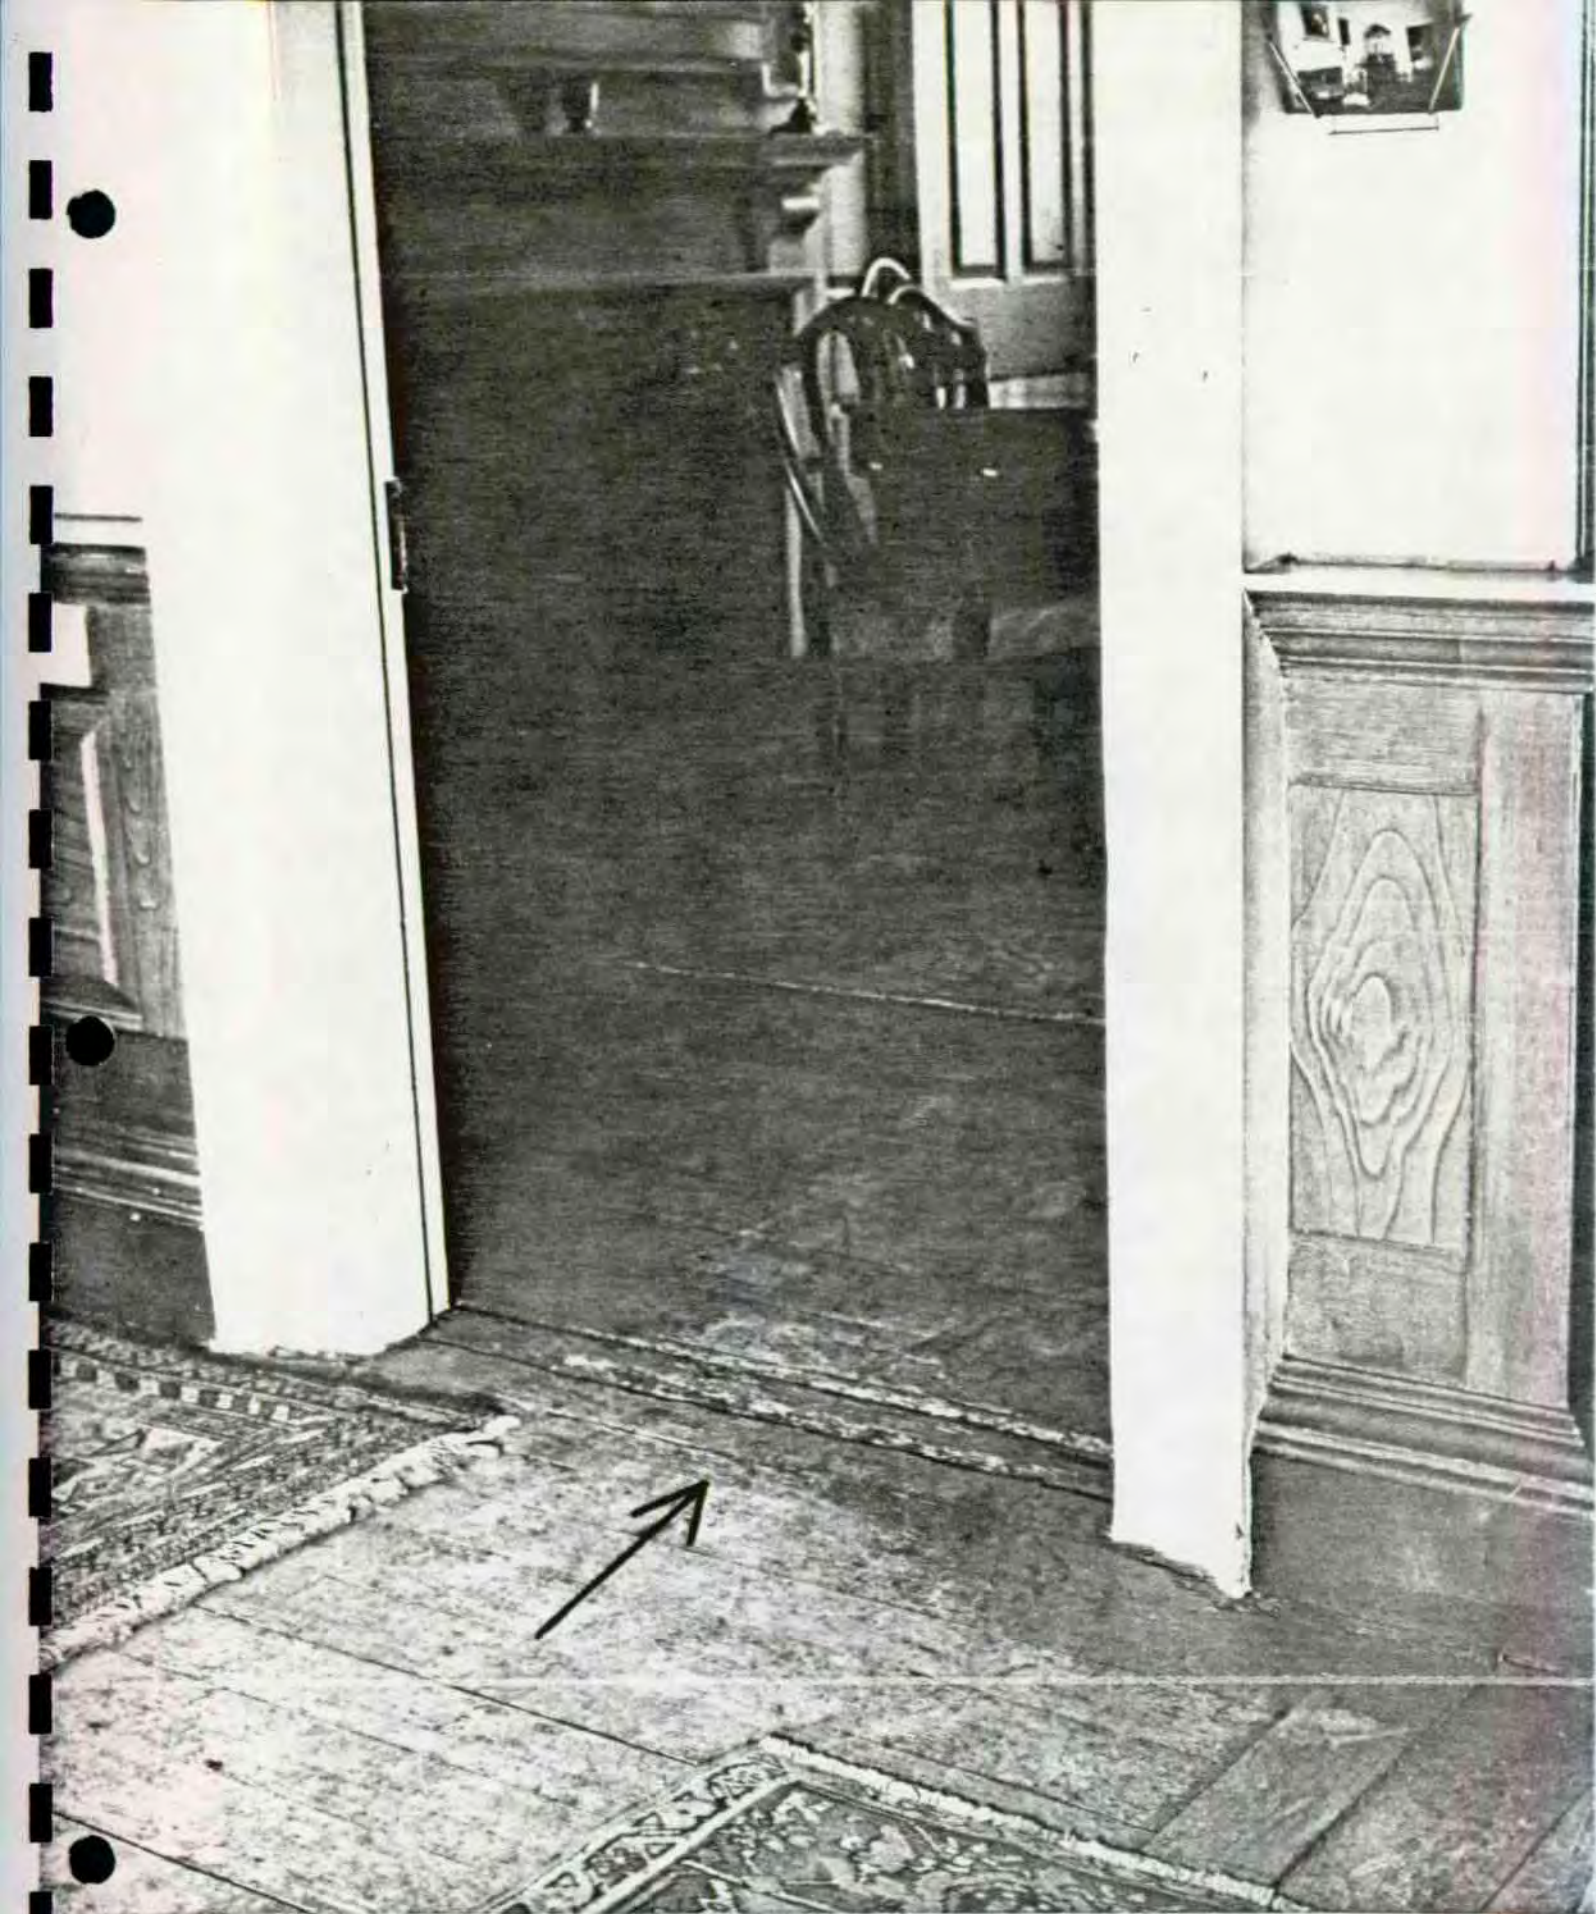
ILLUSTRATION 45 - Photographed by NPS.  
1772 Section

Doorway between Rooms 103 and 107, looking east. Photograph of existing opening and paneling.  
See overlay sketch for analysis of original paneling before opening was cut through wall.

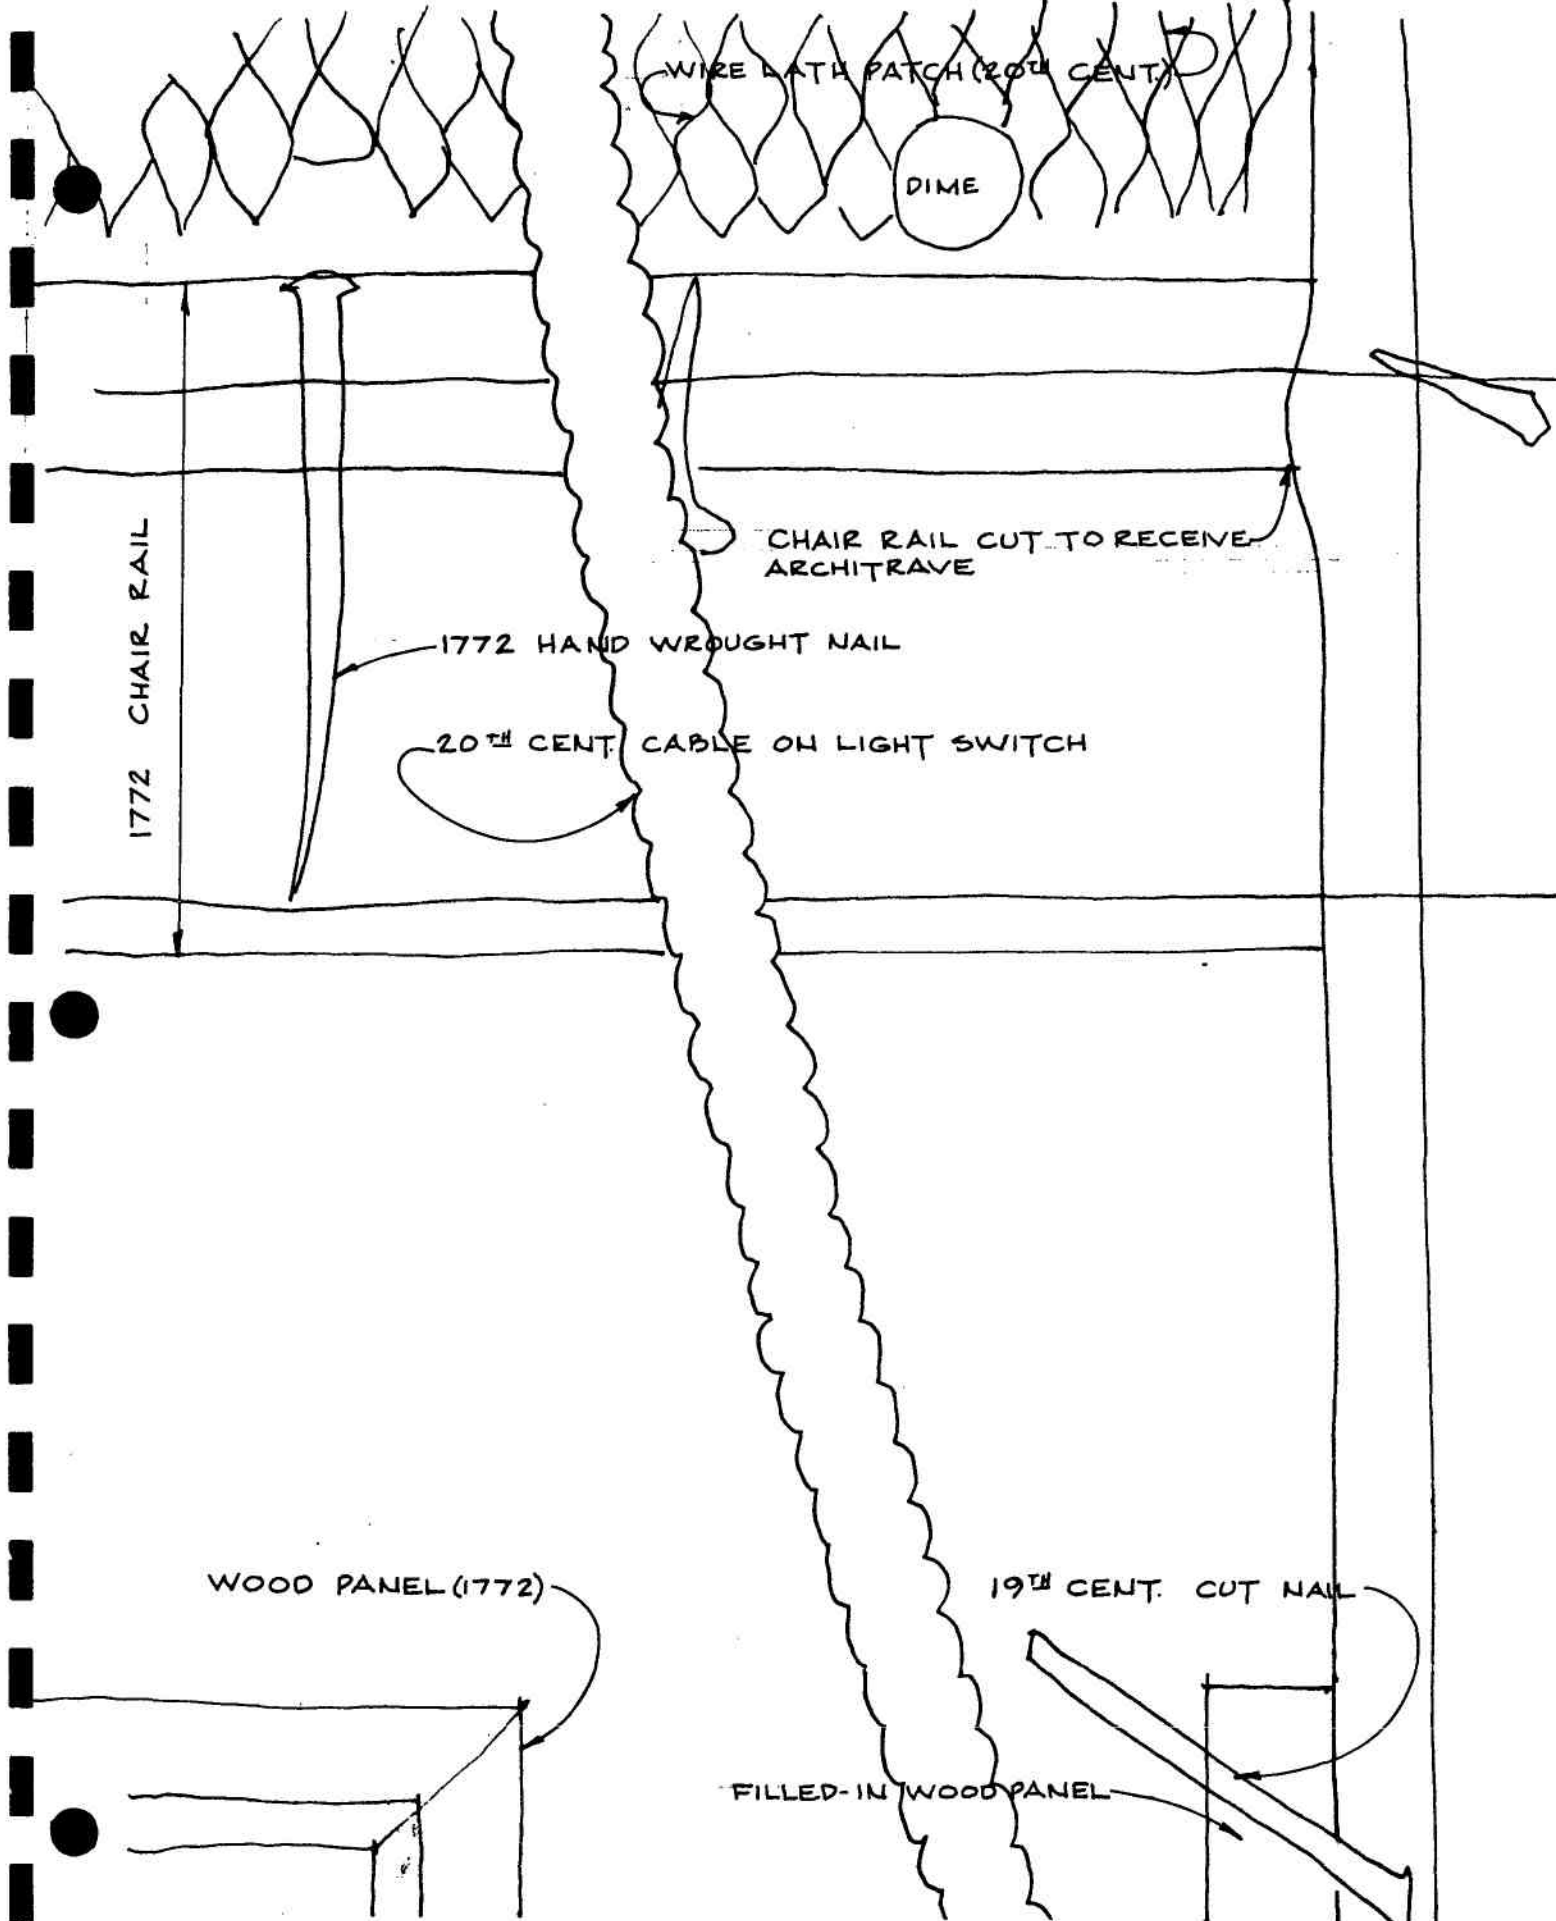
ILLUSTRATION 49  
1772 Section

X-ray analysis, x-ray No. 4. Chair rail and left panel held with 18th century nails. Door architrave on right held with 19th century cut nail.

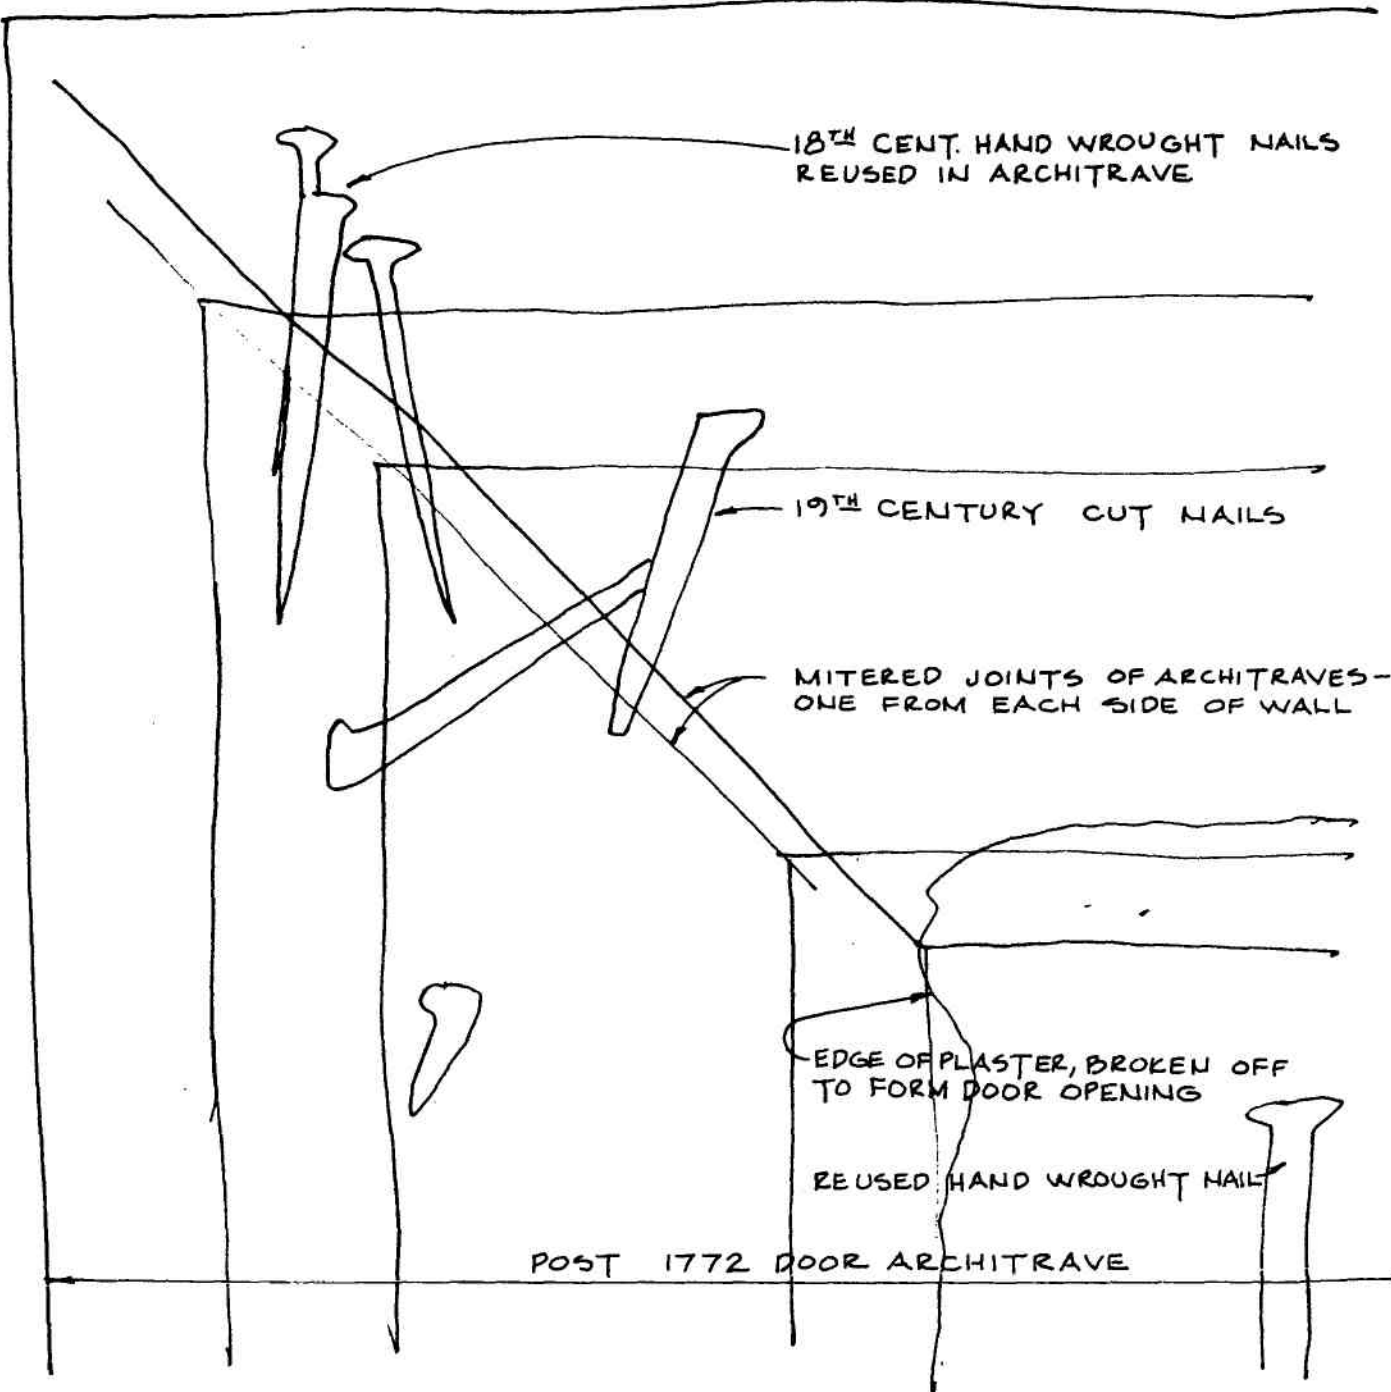
ILLUSTRATION 51  
X-ray analysis Photograph No. 5. Both 18th century and 19th century nails in door architrave. Note rough plaster edge.

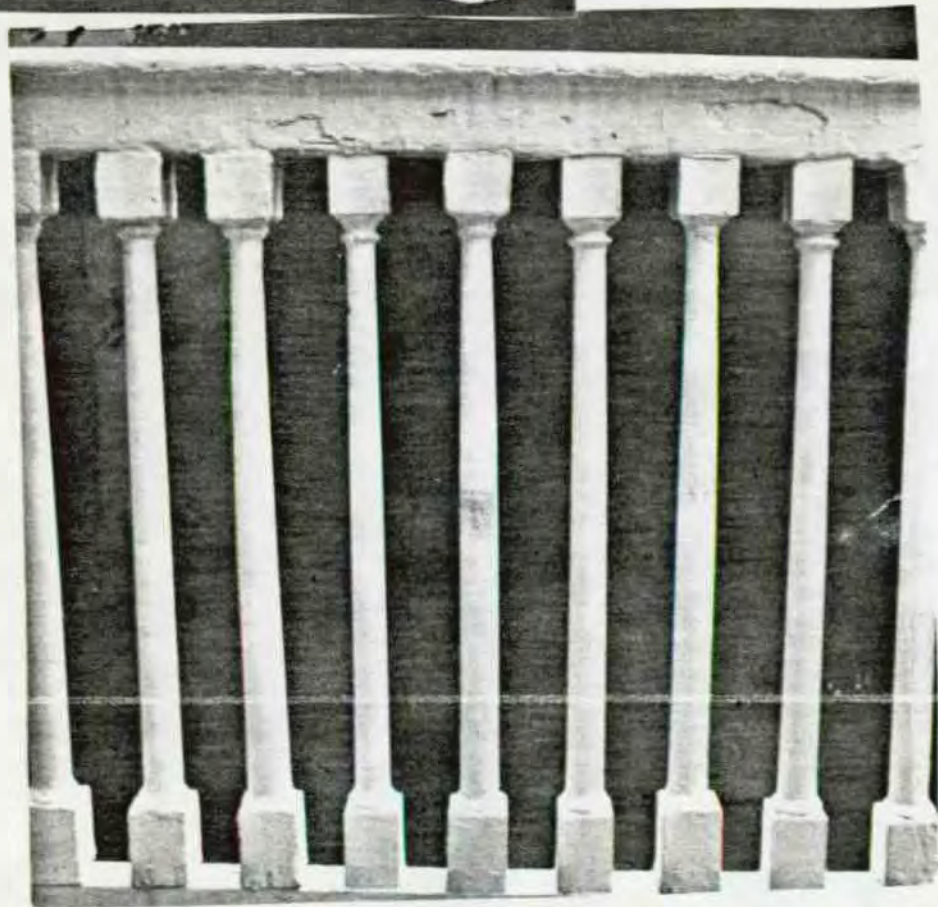
ILLUSTRATION 61  
Photographed by NPS.  
Porch railing, 1772 section. Note replacement balusters  
fourth, sixth, and eighth from left.
