LAWNFIELD  
HISTORIC STRUCTURE REPORT

JAMES A. GARFIELD NATIONAL HISTORIC SITE

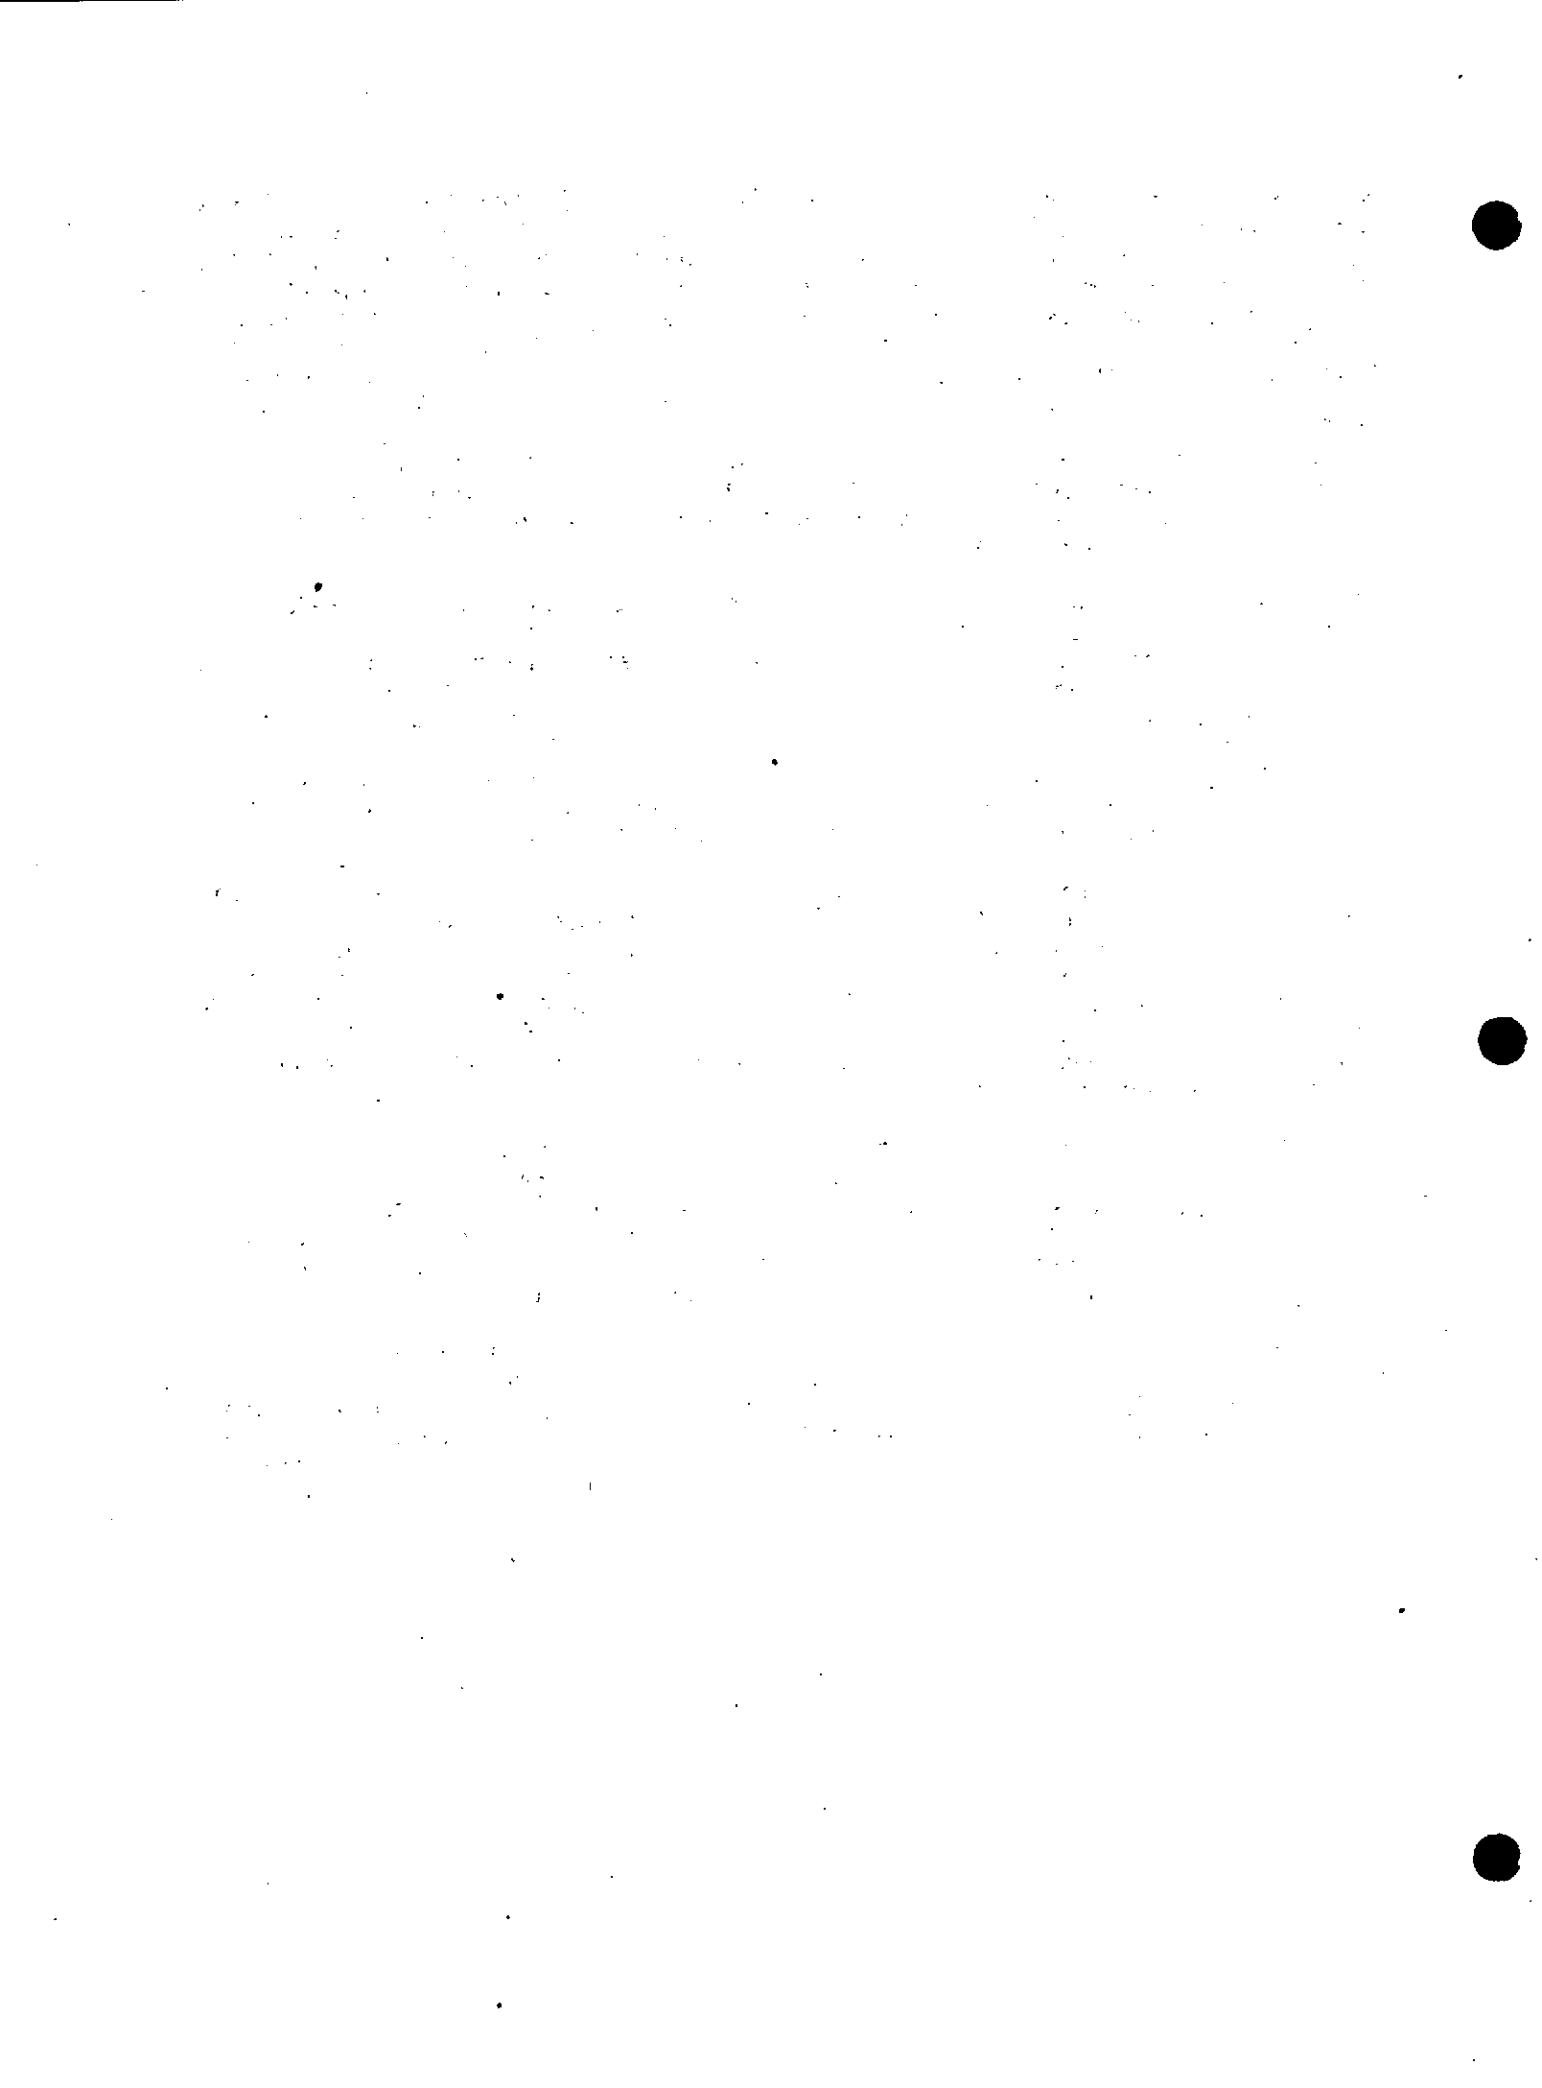
## PHYSICAL DESCRIPTION

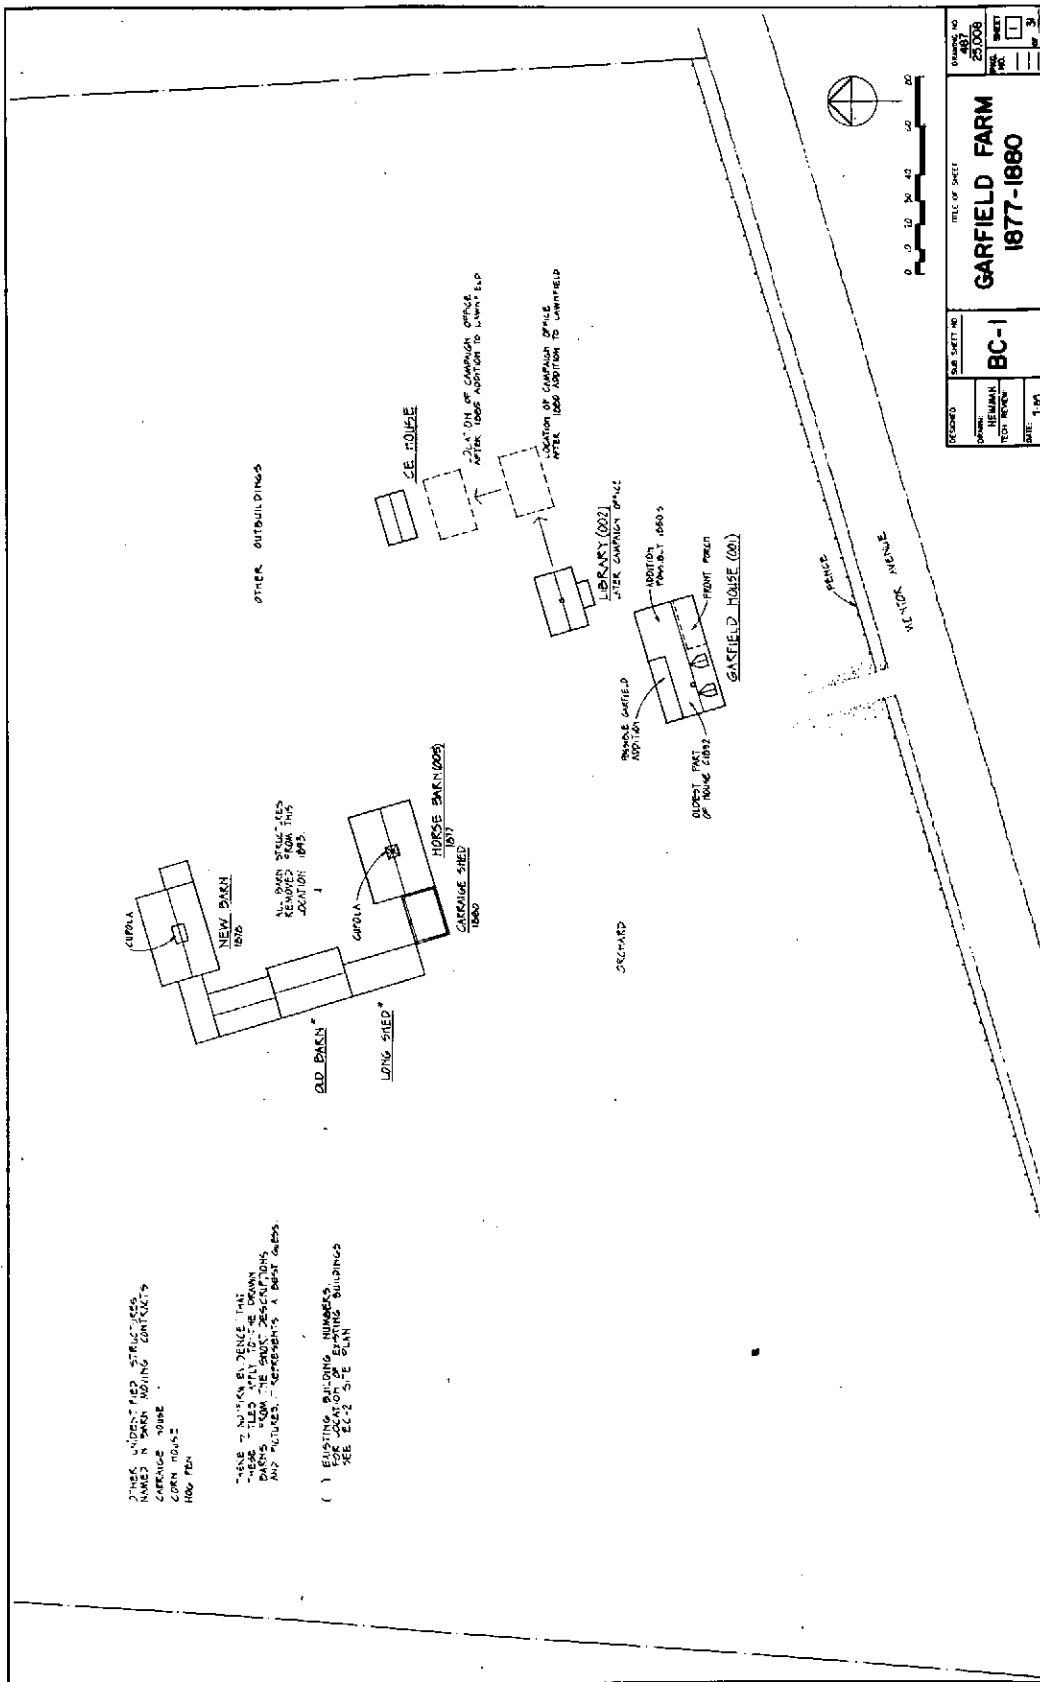
OTHER UNIDENTIFIED STRUCTURES, NAMED IN BARN NOTING CONTIGUOUS CARRIAGE WHEEL CORN HOUSE 1880 PER

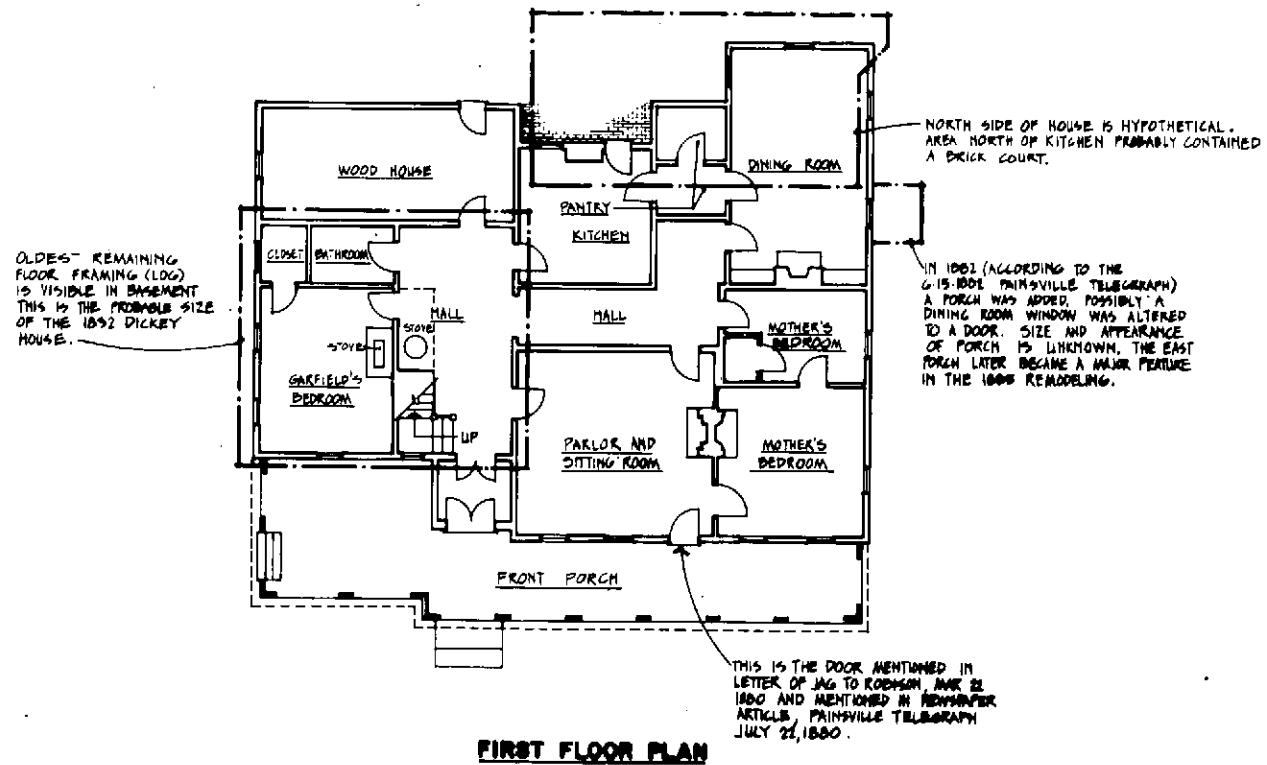
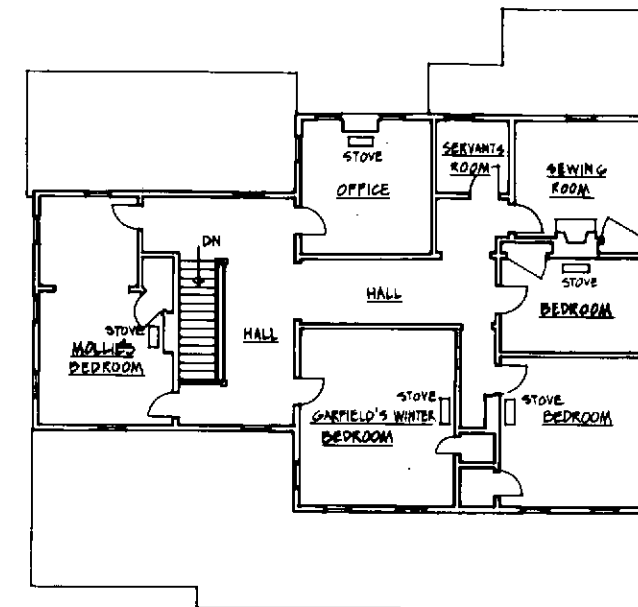
DRAWING BASED UPON INFORMATION CONTAINED ON "LAWNFIELD FLOOR PLAN - THE GARFIELD FARM" NEW YORK HERALD 9-26-1881, VARIOUS HISTORICAL PHOTOGRAPHS AND ILLUSTRATIONS. THIS INFO WAS COMPARED AGAINST THE MEASURED DRAWINGS OF THE EXISTING CONDITIONS AND PHYSICAL EVIDENCE TO DETERMINE THE ACTUAL CONFIGURATION.

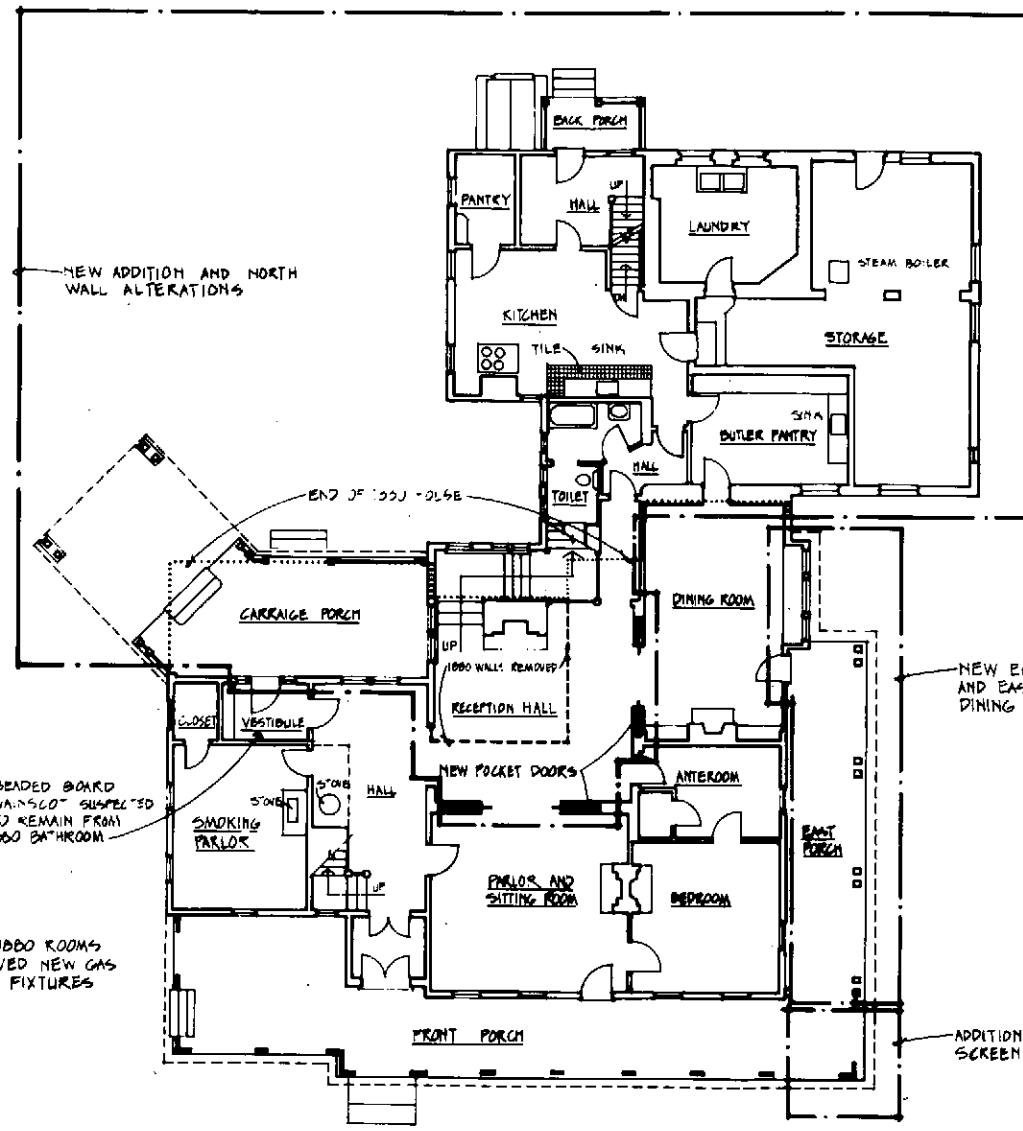
DESIGNED:	SUB SHEET NO.	TITLE OF SHEET	DRAWING NO.
DRAWN:	BC-2	LAWNFIELD 1880	487
TECH. REVIEW:			2
DATE:	10/81		31

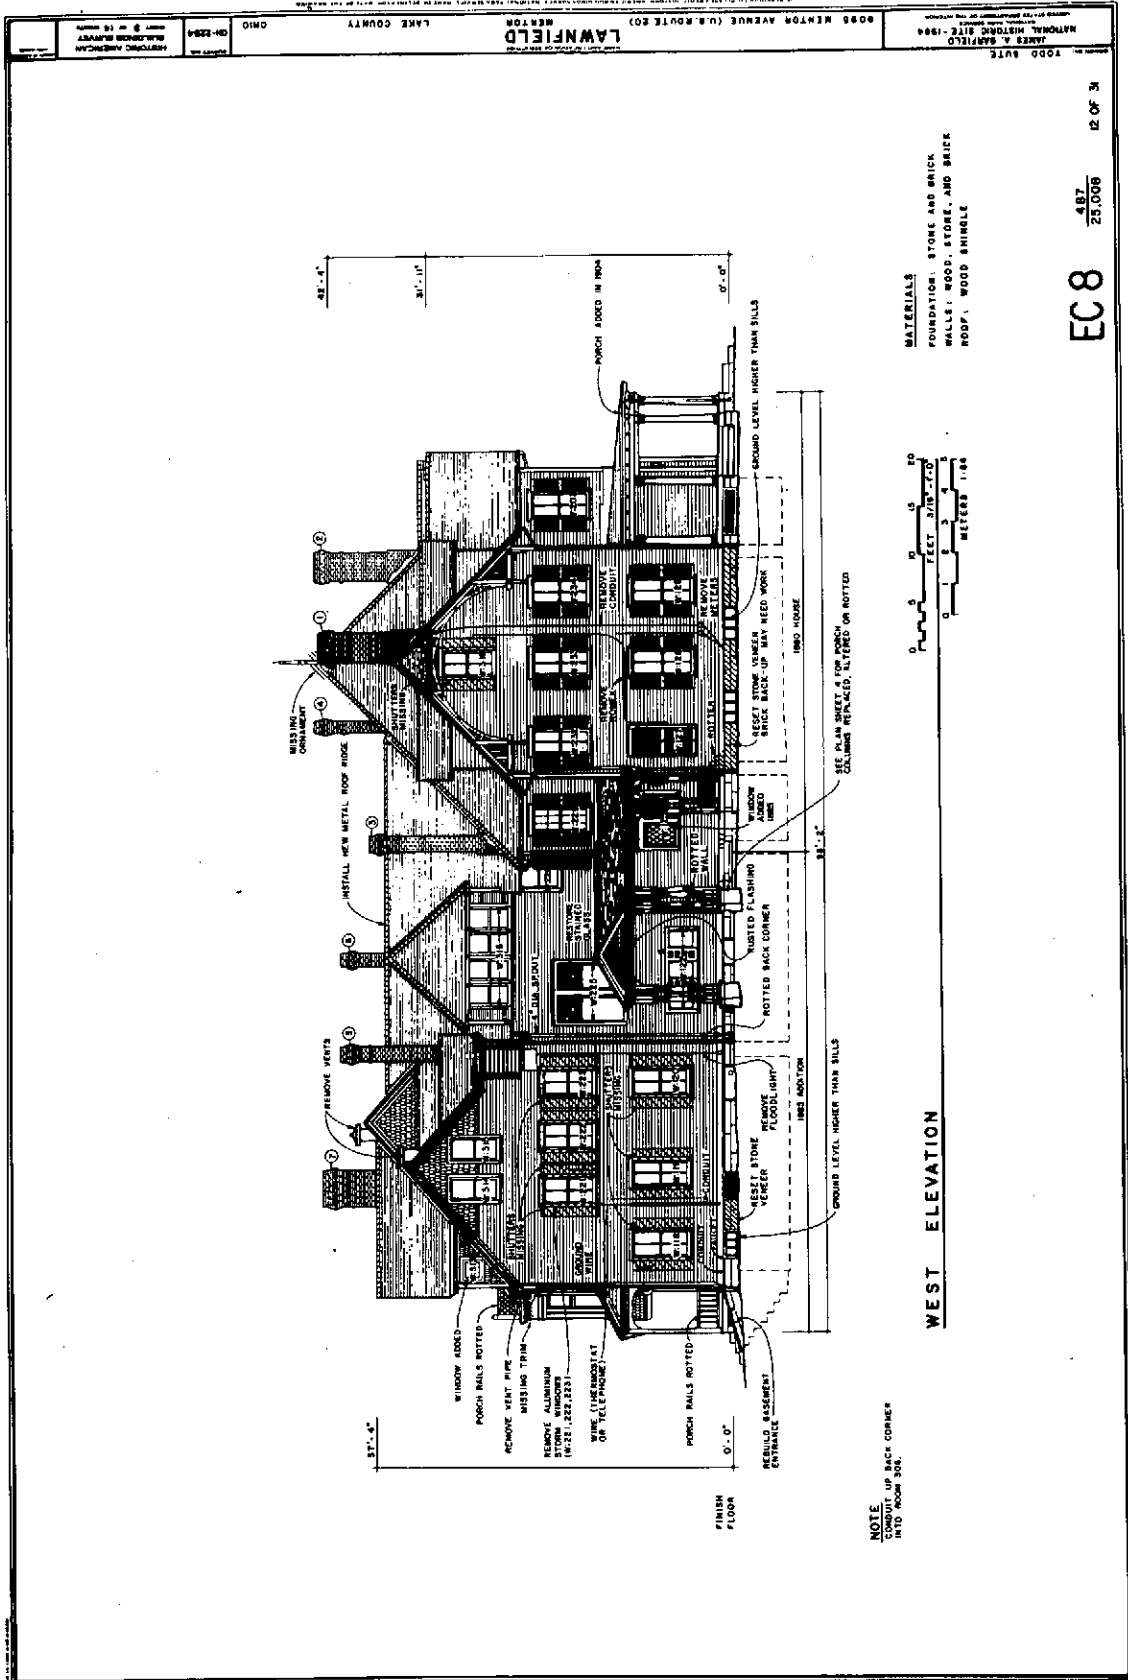
MATERIALS  
 FOUNDATION: STONE AND BRICK  
 WALLS: WOOD, STONE, AND BRICK  
 ROOF: WOOD SHINGLE

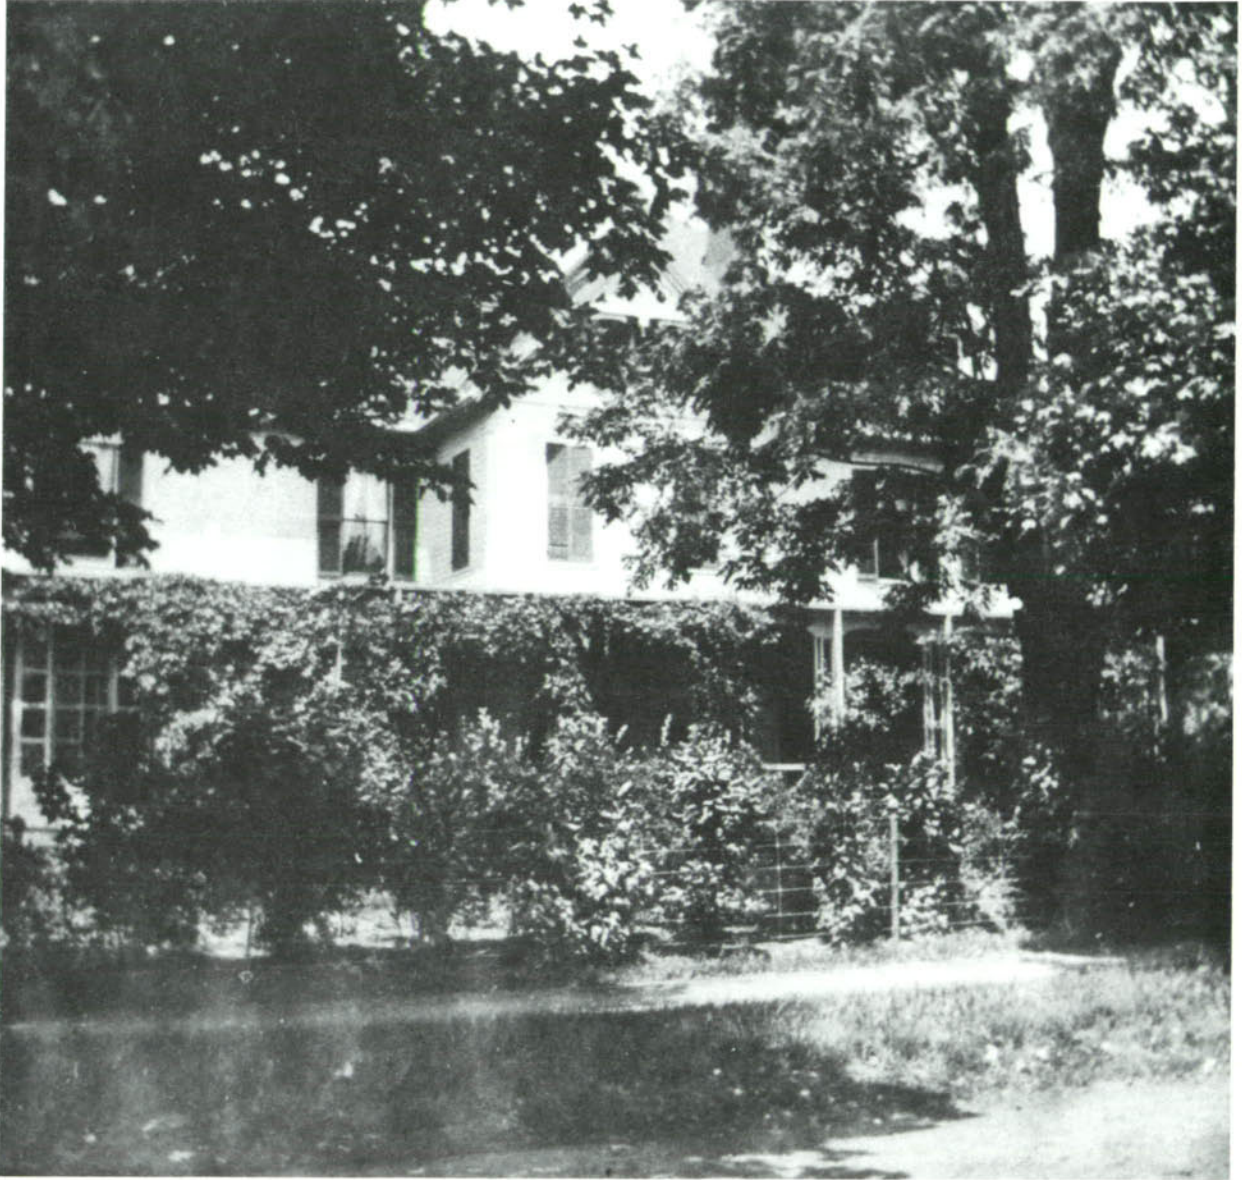
HP-16, Lawnfield, ca. 1903, south side from street. The door at the left side of the front porch is thought to be just leaning against the wall, possibly construction materials for the new 1904 east porch. The picket fence has been replaced by a wire fence.

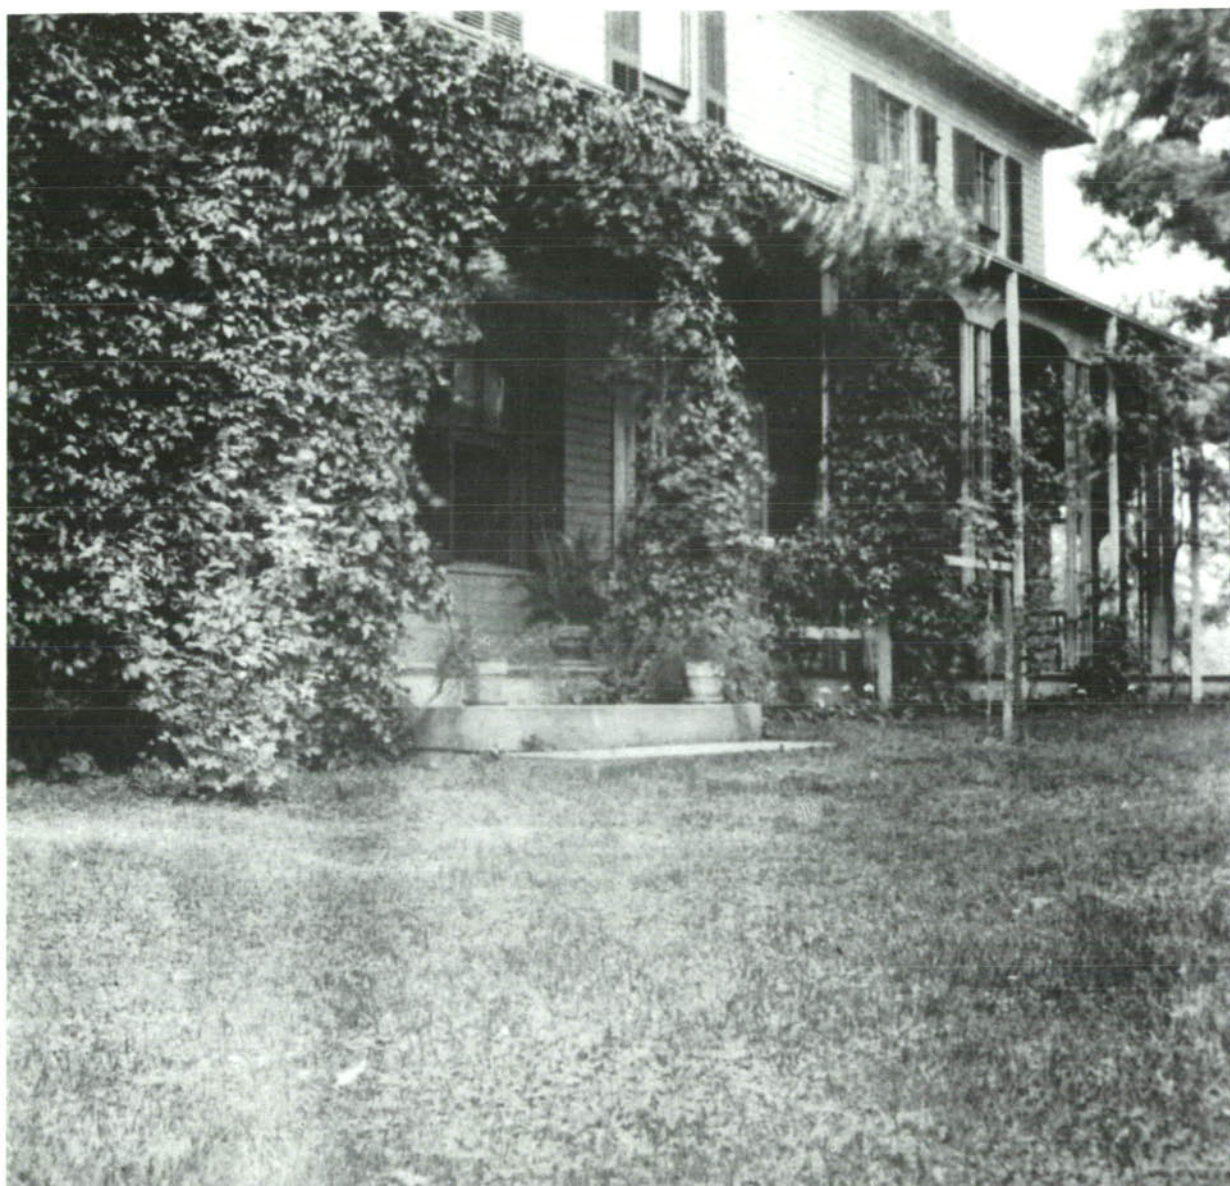
HP-17, Lawnfield, ca. 1903, south side, front porch. LCHS.

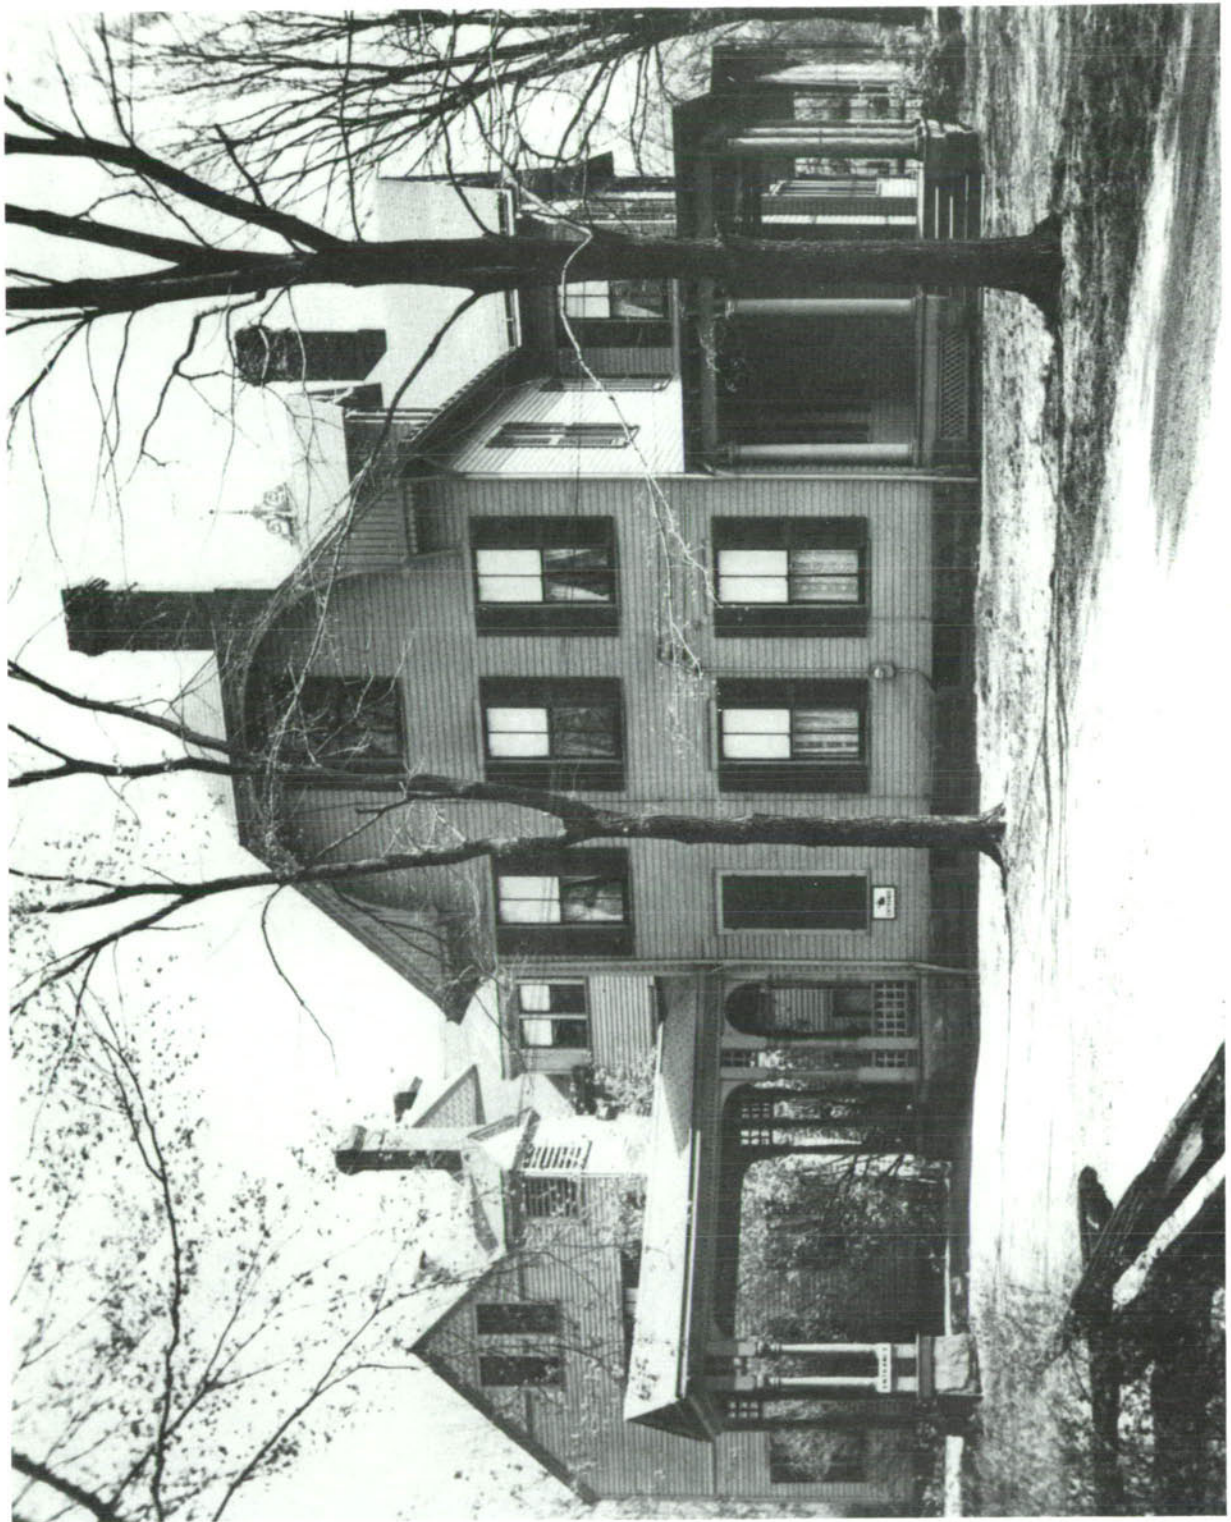
HP-31, Lawnfield, ca. 1936, west and south sides. Shows original woodwork of west porch. Best photo of original roof crest. Roofing replaced with asphalt shingles, lightning protection grounding wire visible, but not air terminals. New overhead electric service, and the bars are still on the basement windows. Shows alteration of third-floor west side rear gable end windows. LCHS.

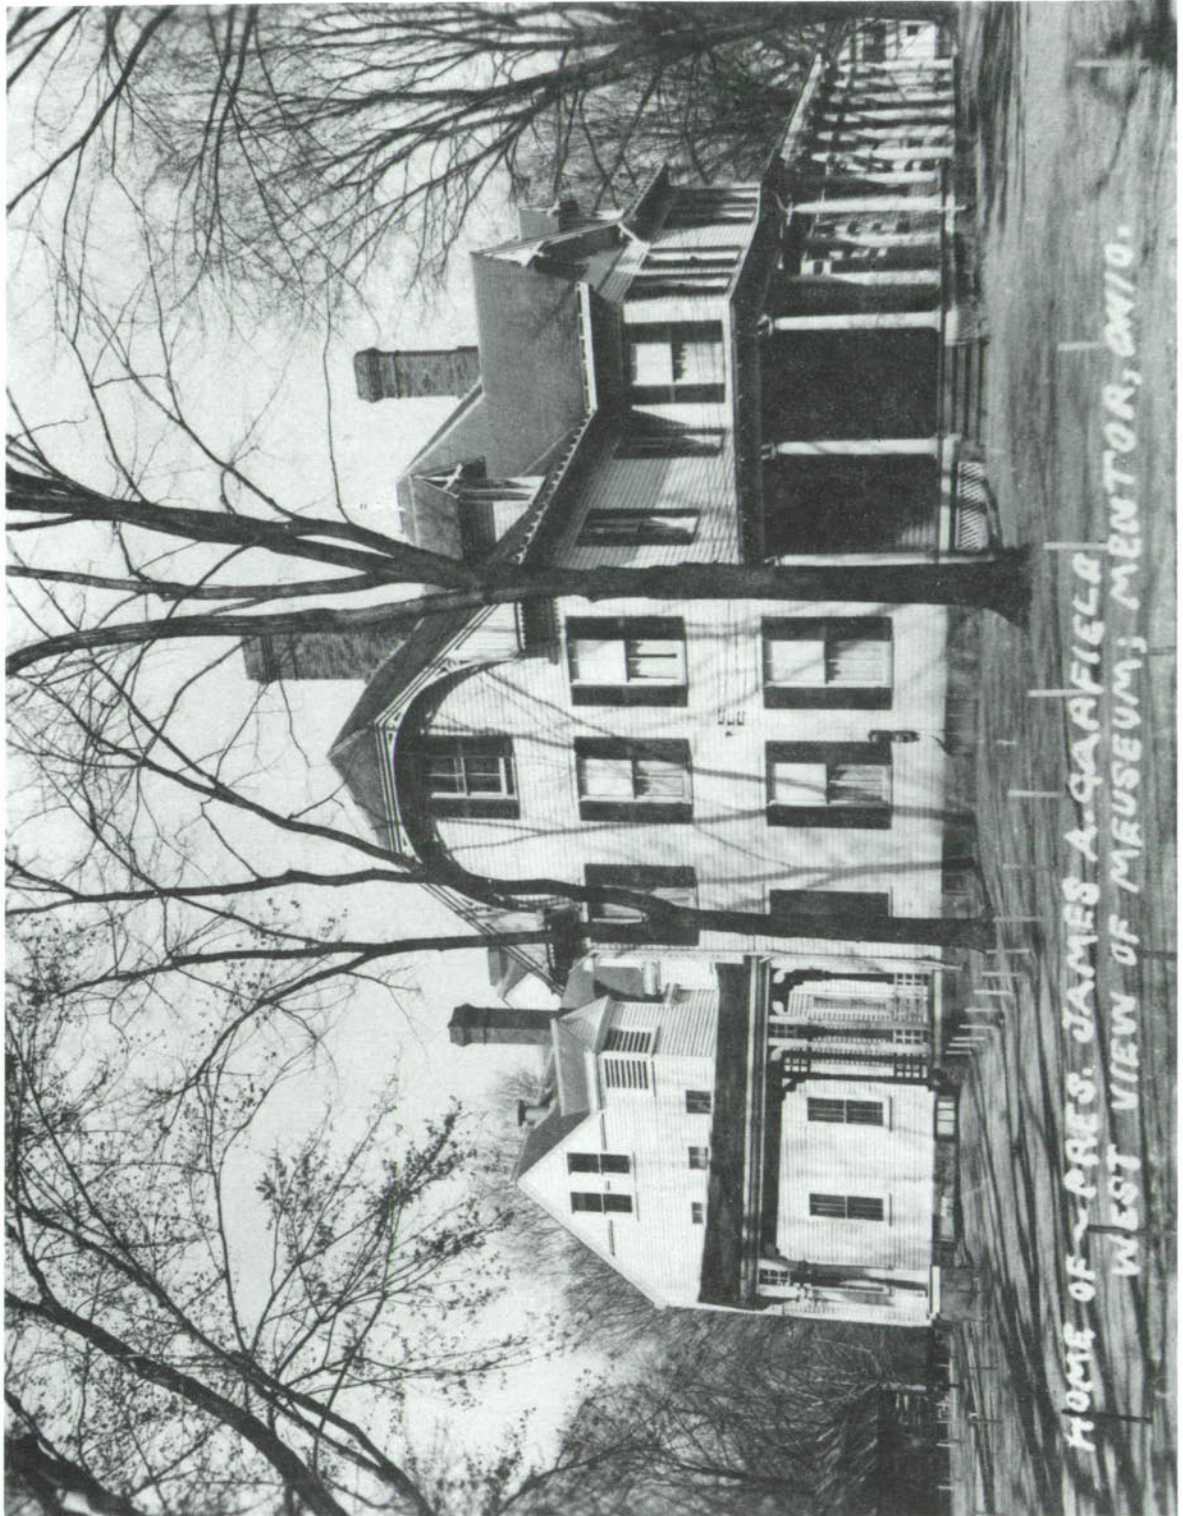
HOME OF PRES. JAMES A. GARFIELD  
WEST VIEW OF MUSEUM; MENTOR, OHIO.

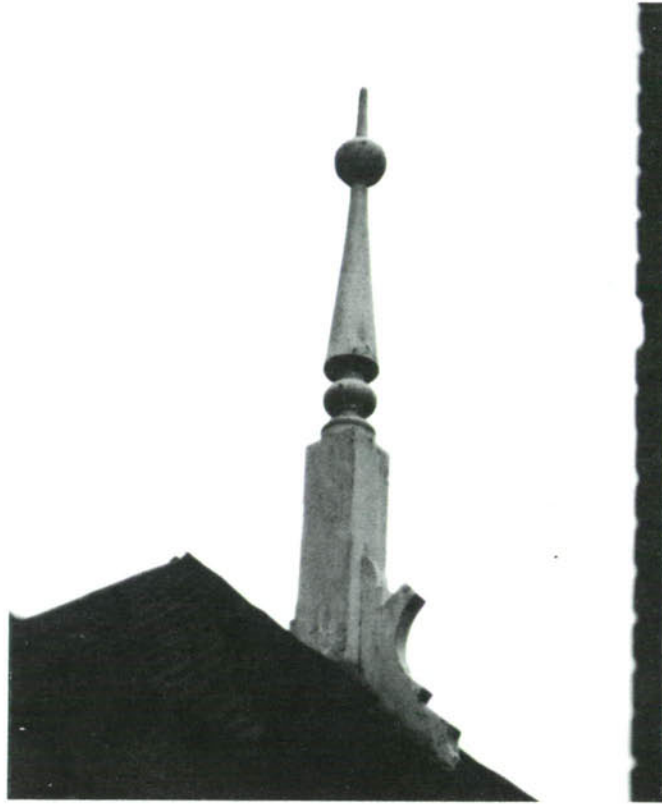
CP-11, Remains of the top crest on the roof. Four side scrolls are missing.

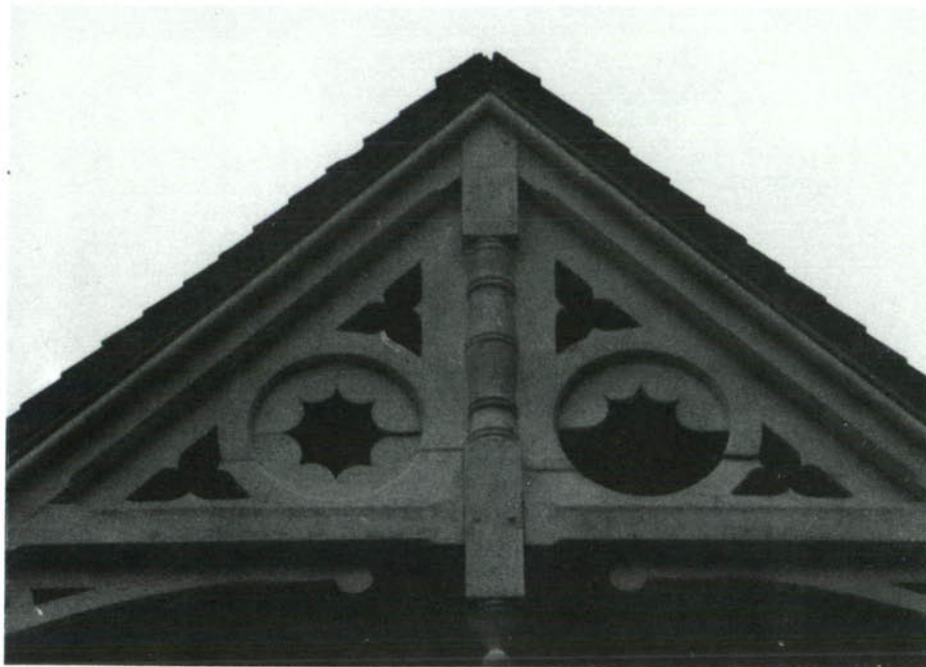
CP-12, Fret detailing of the large gable on the south side. Finial above the roof is missing as well as the lower half of the right hand circle.

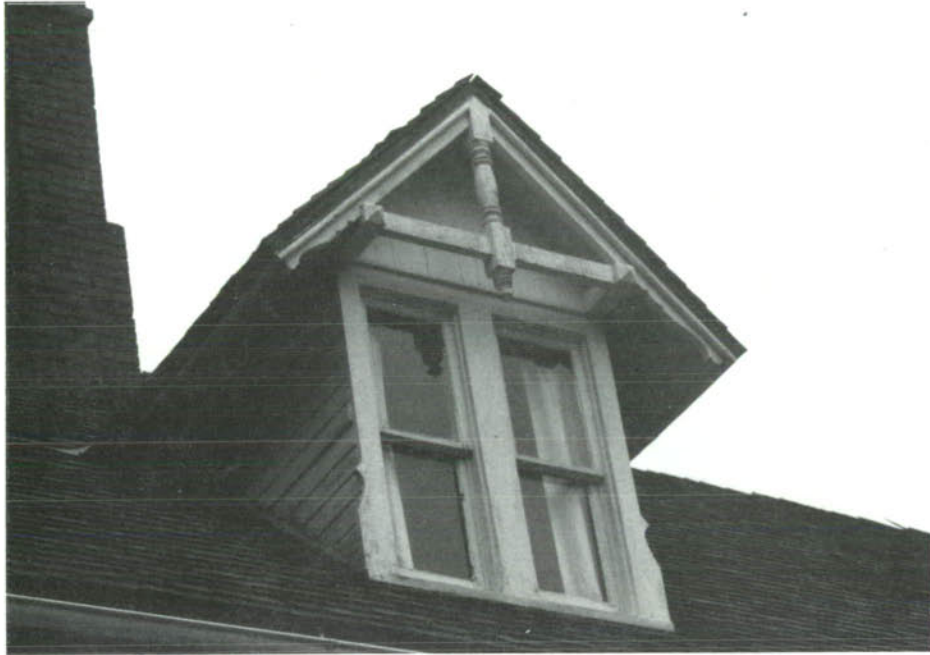
CP-13, Typical dormer on the 1880 portion of the house. Finial above the roof is missing.

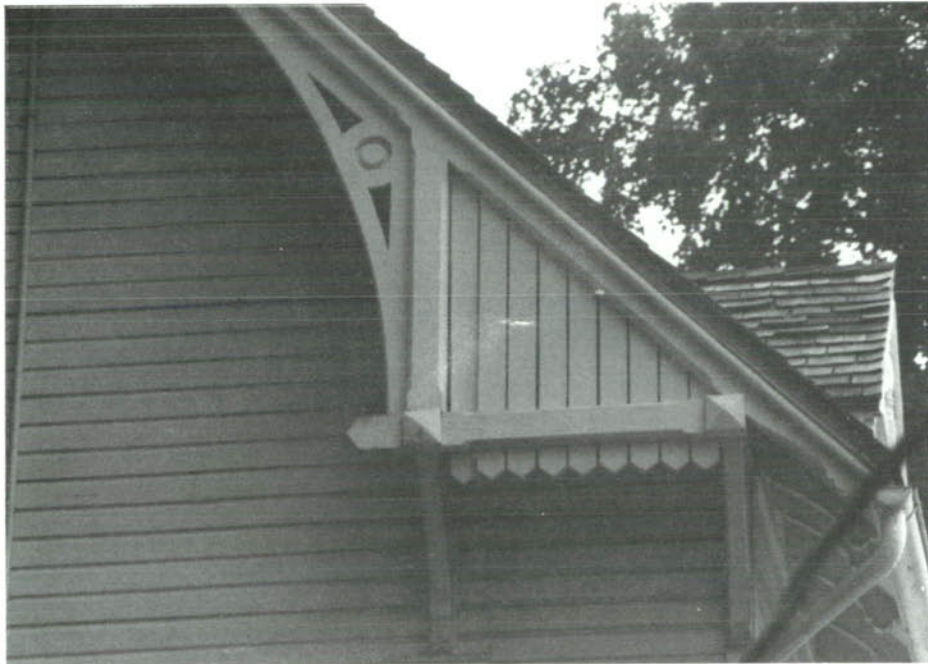
CP-14, Gable detail on the west and east sides of the 1880 part of the house.

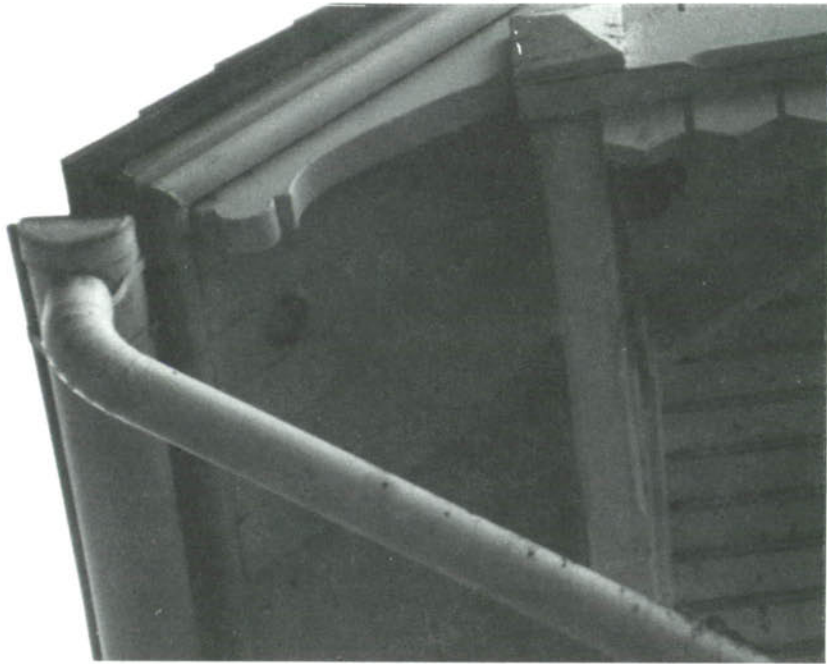
CP-15, Eave detail at the downspout. The hole through the roof sheathing at the right is from the original downspout. Half-round gutter at the left has replaced the original trough gutter system. Pigeons on the bracket soil the building with waste.

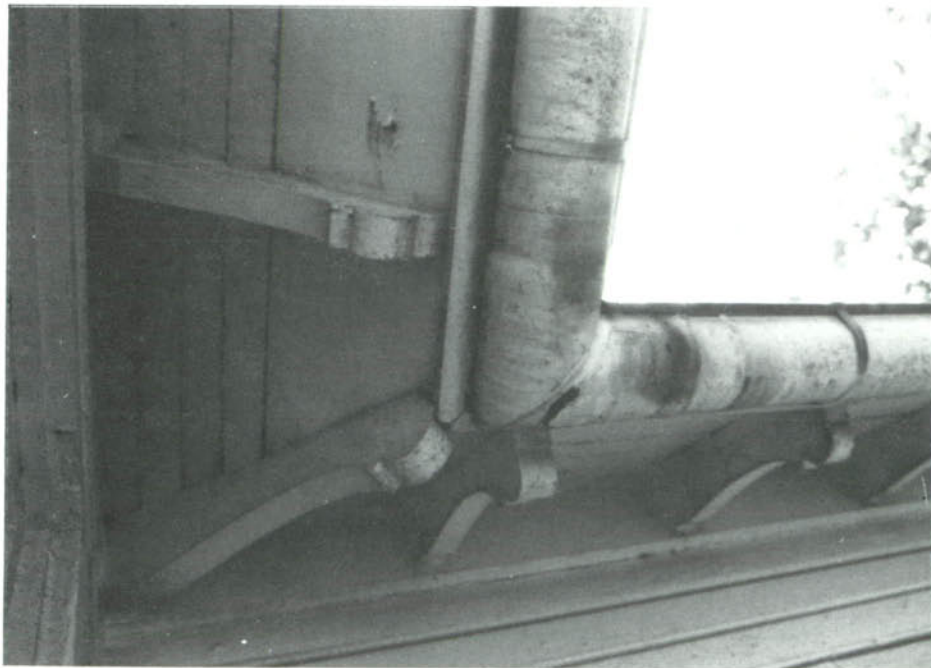
CP-16, Original narrow exposed eave sheathing boards replaced with wide board, probably at the time of gutter replacement. Note the rafter tip splice repairs.

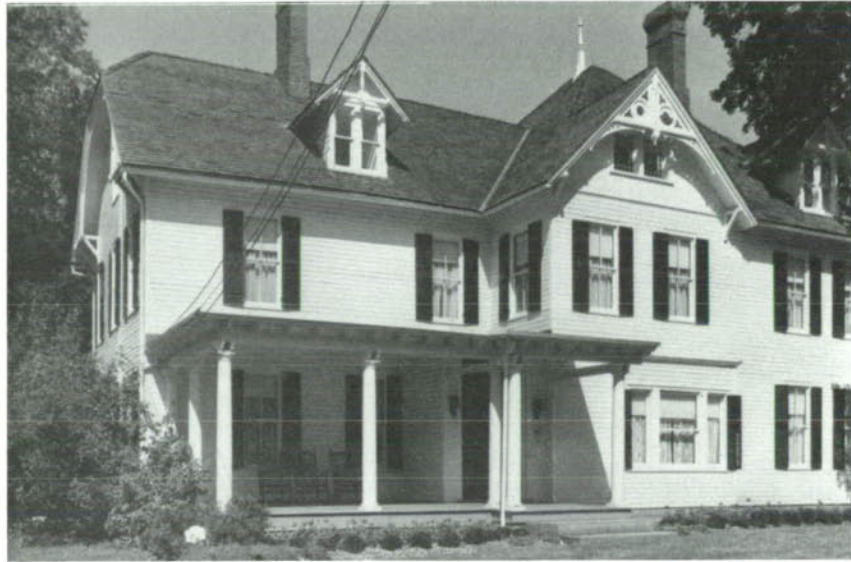
CP-17, South porch was built in 1904. The arbor was removed in 1951.

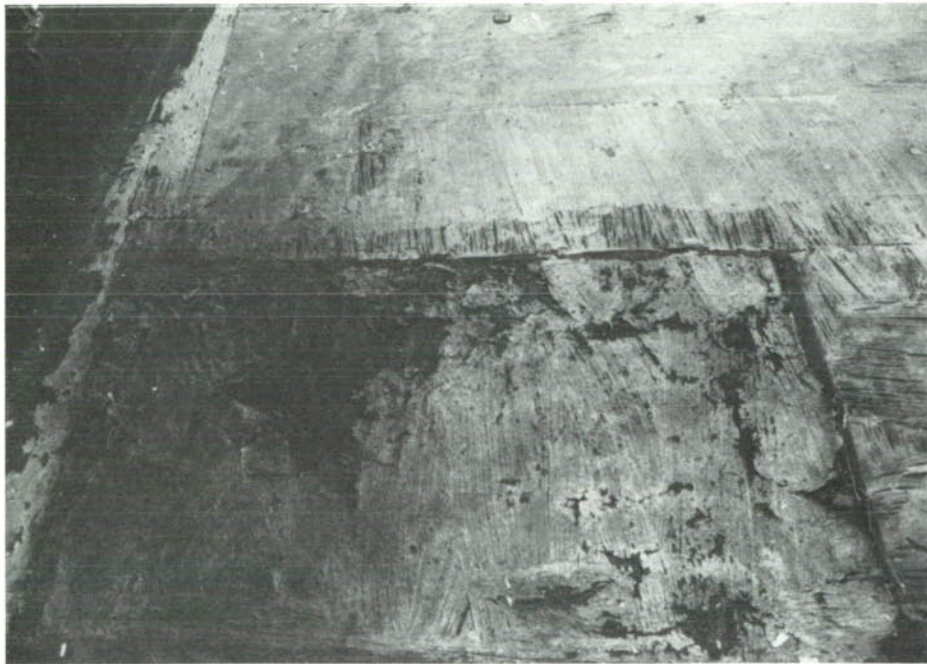
CP-18, Deteriorated roofing of the east porch.

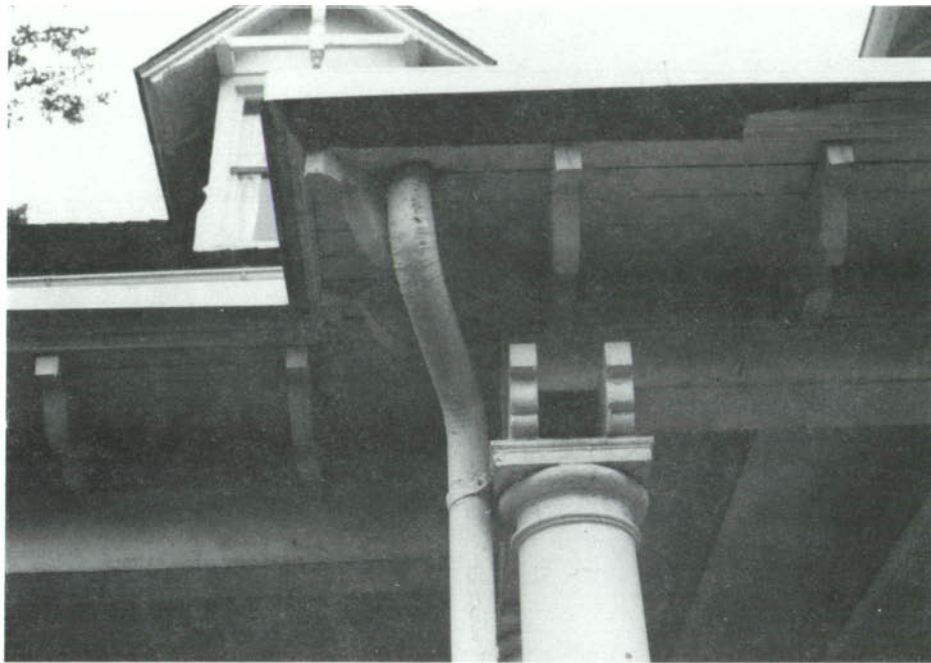
CP-19, Rot and insect infestation in the roof structure of the porch has been caused by roofing deterioration and blocked downspouts.

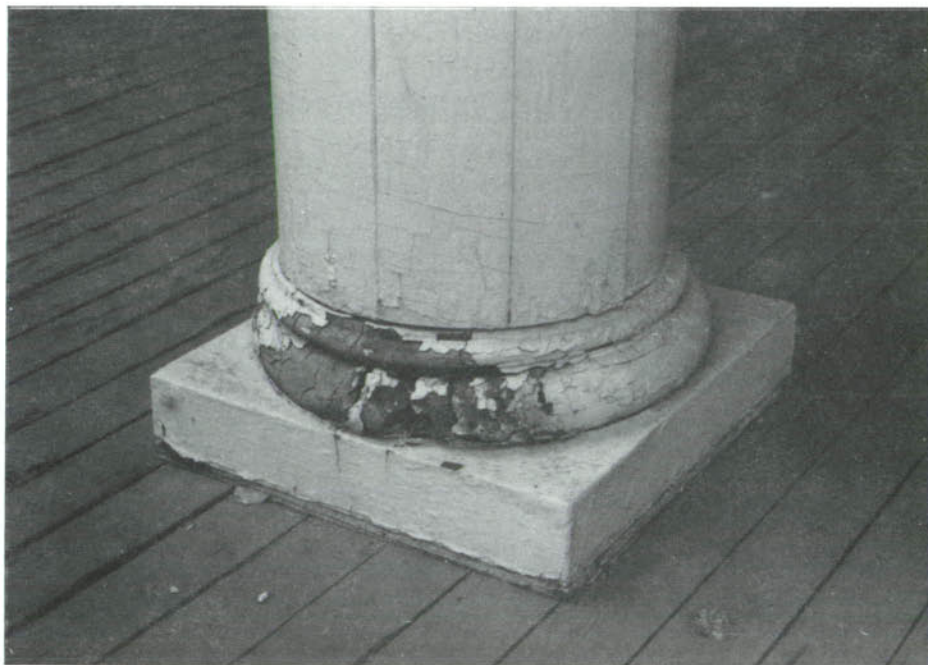
CP-20, Several of the column bases exhibit rot at the bases.

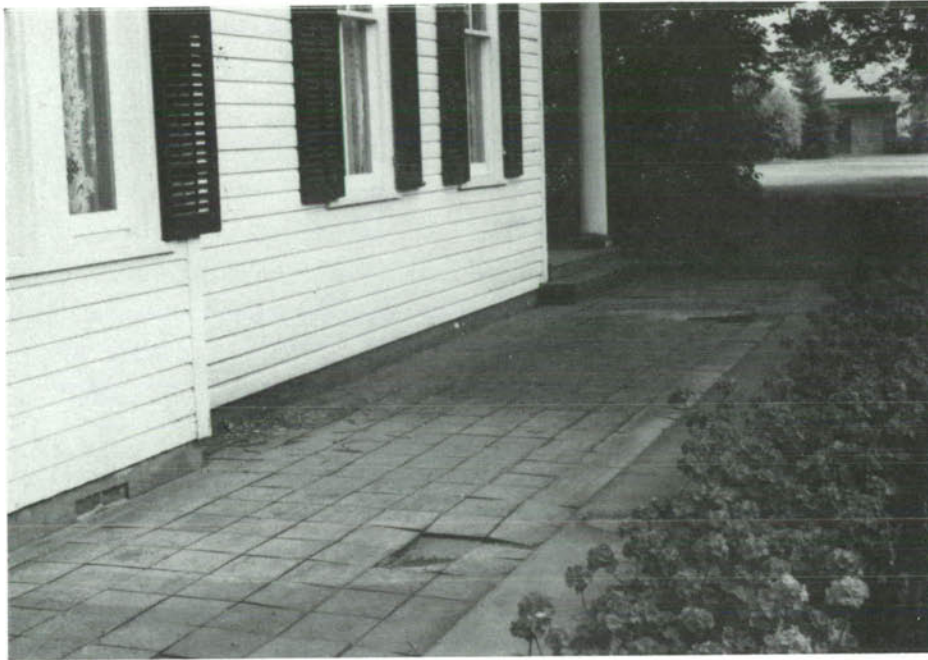
CP-21, 1904 bay window replace the original windows and door to the sitting room. Joist pockets of removed arbor are visible above the side windows.
