LAWNFIELD  
HISTORIC STRUCTURE REPORT

JAMES A. GARFIELD NATIONAL HISTORIC SITE

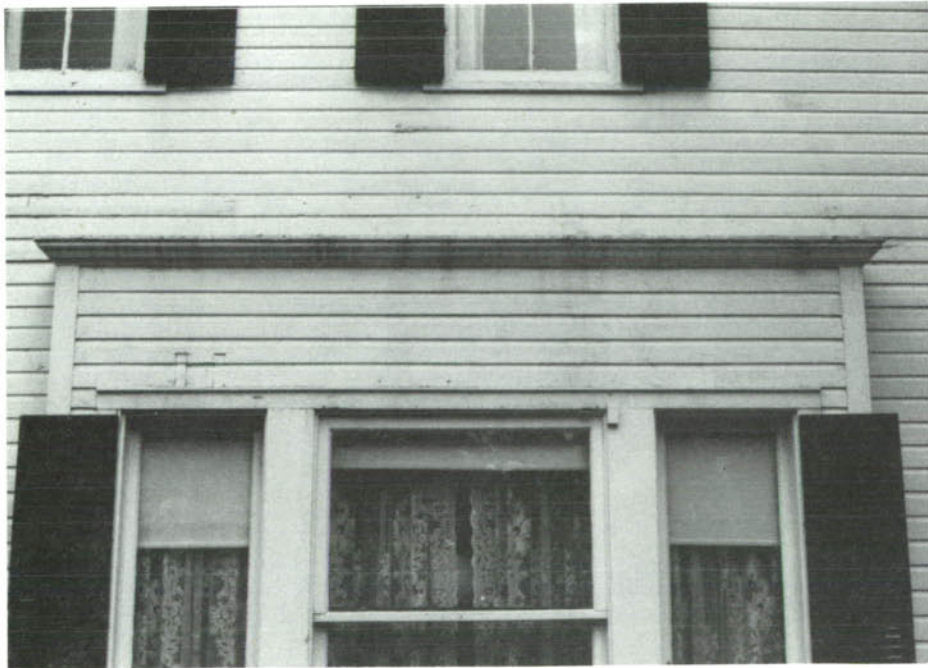
CP-22, Tiled floor of the arbor is washing out, causing dangerous walking conditions.

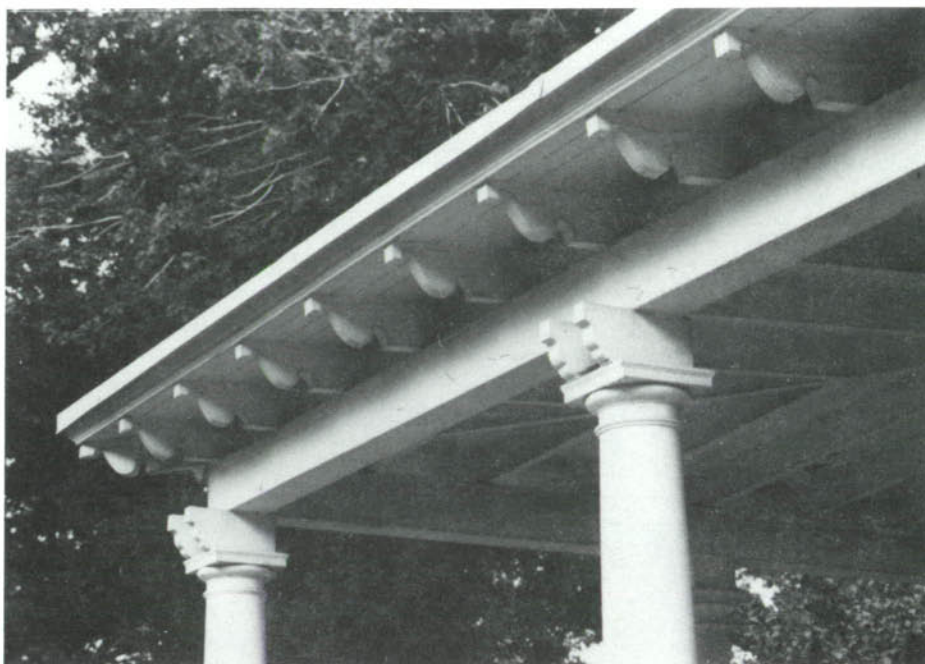
CP-23, Detail of the south porch roof. The east porch roof is similar.

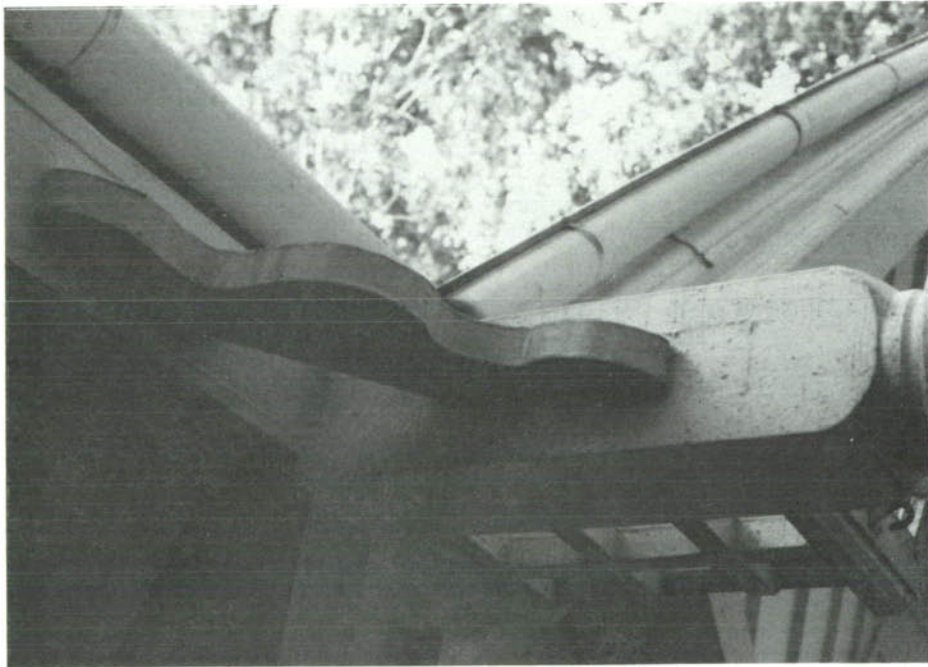
CP-34, West porch, shadow of original porch brackets is visible below the replacement.

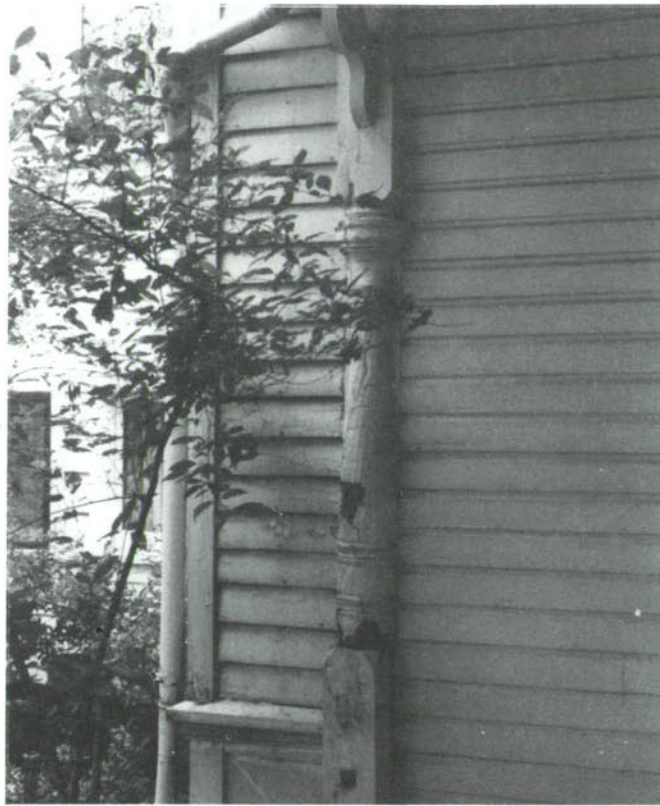
CP-35, Roof and flashing problems have caused severe deterioration at the exterior of the parlor stair and west porch. Engaged porch column, siding, trim are rotted. Porch rail is missing entirely.

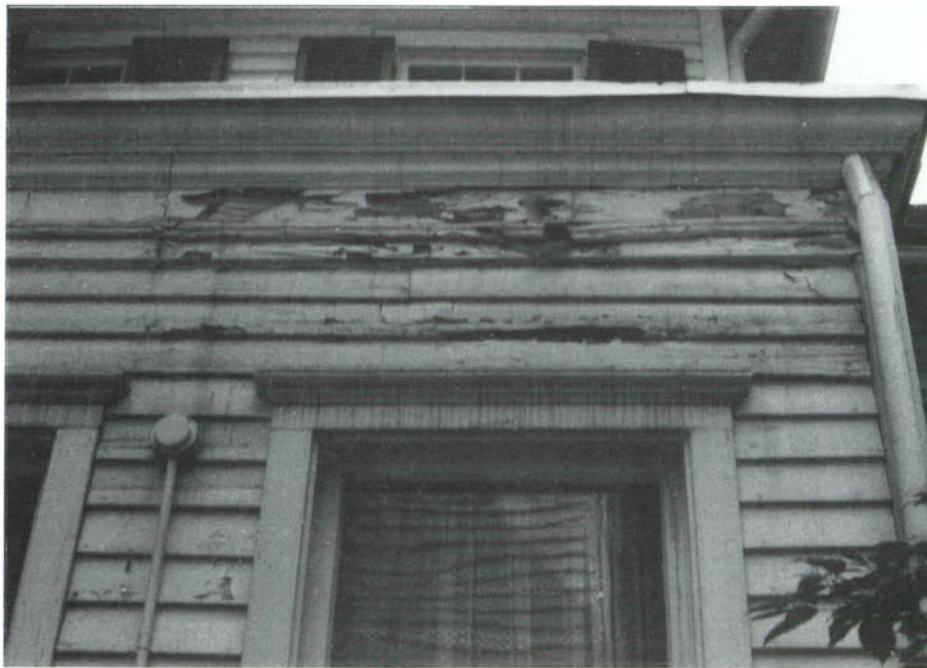
CP-36, Another view of the rotted siding at the parlor stair. There is most likely structural damage within the wall as well.

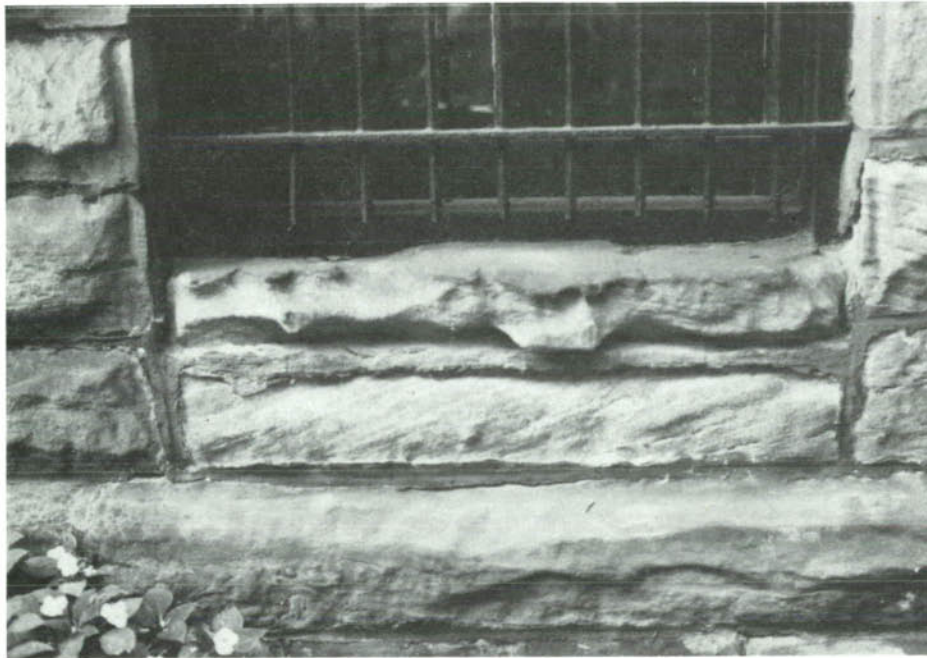
CP-37, Severe sandstone erosion at the memorial library first-floor window (W:114). This sill requires replacement.

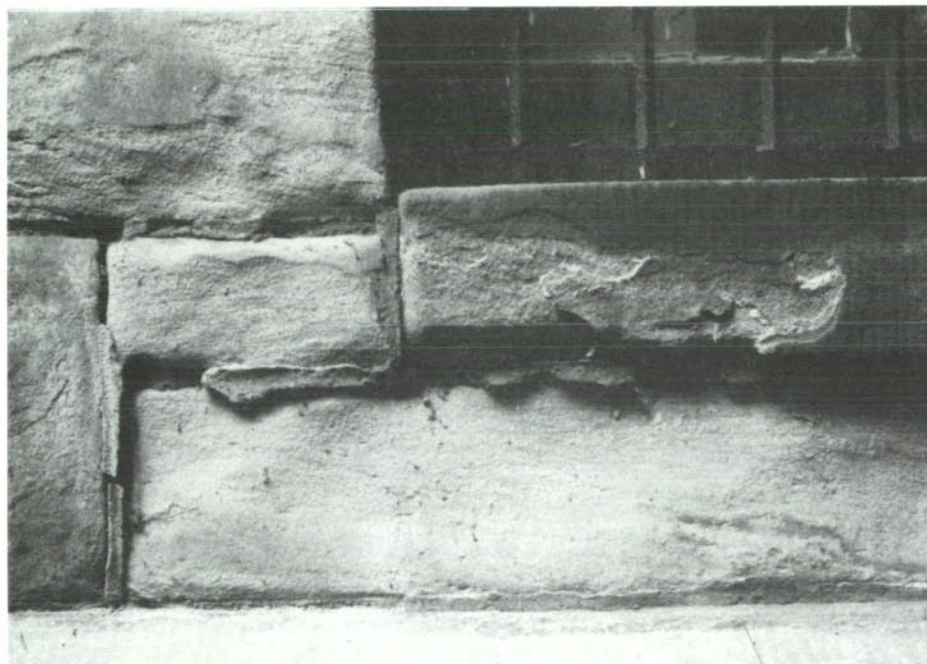
CP-38, All ground level memorial library stone window openings have stone problems, although not as severe as the above window.

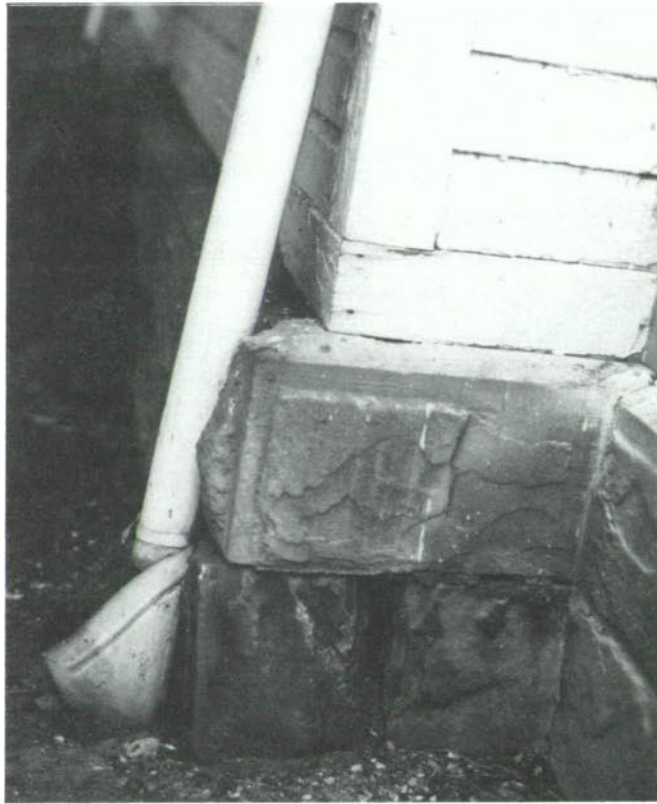
CP-39, An often blocked drain and separated stone veneer channeling into the foundation wall have caused deterioration of the brick masonry.

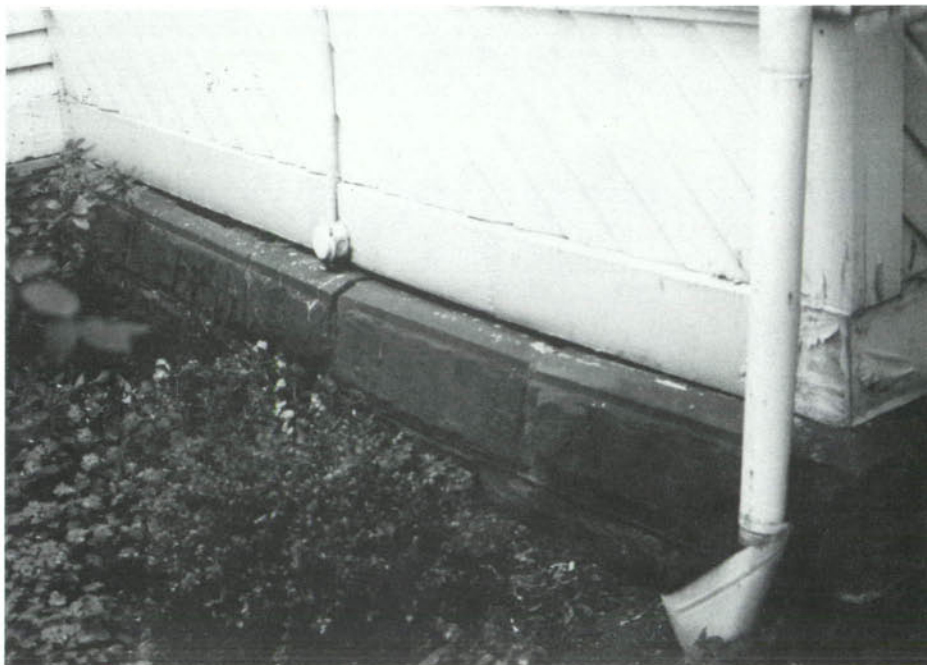
CP-40, Typical separation of sandstone foundation veneer channels moisture into the masonry.

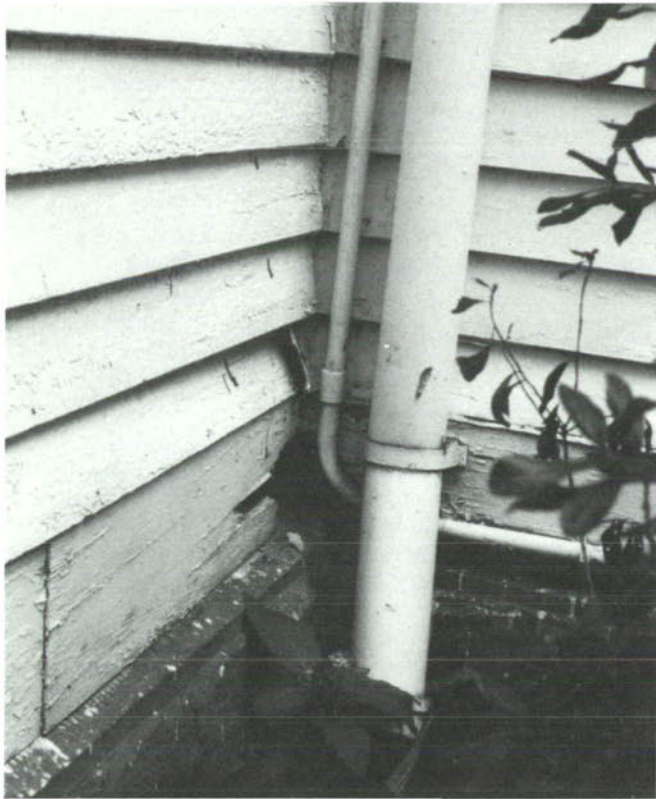
CP-41, Inside corner at 1885 kitchen. Water intrusion in the wall from the gutter above has caused severe deterioration from roof to foundation.

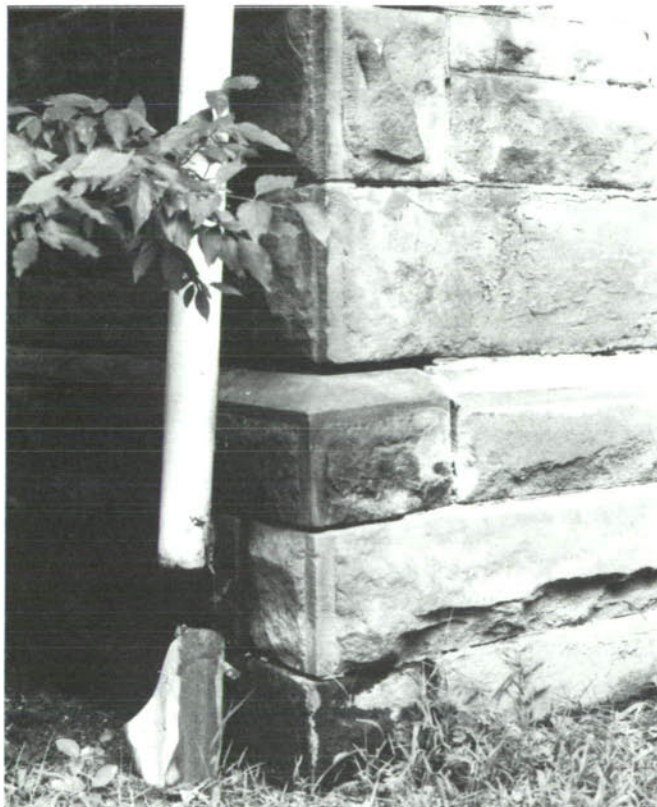
CP-42, Downspout is not connected to the drain and the back side seam is open allowing water to wash over the stone, leaching mortar from the joints.

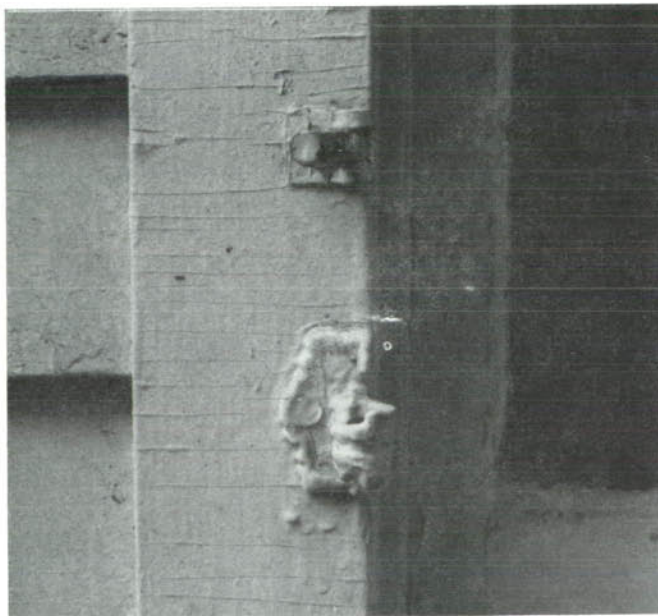
CP-46, Paint clogged surface on mounted self-locking type cast-iron shutter hinges. Several types are found on the house. Most of the shutters are original to the 1880 period (see discussion, "Wall Openings, Shutters"). The clip above the hinge was to hold later storm windows in place.

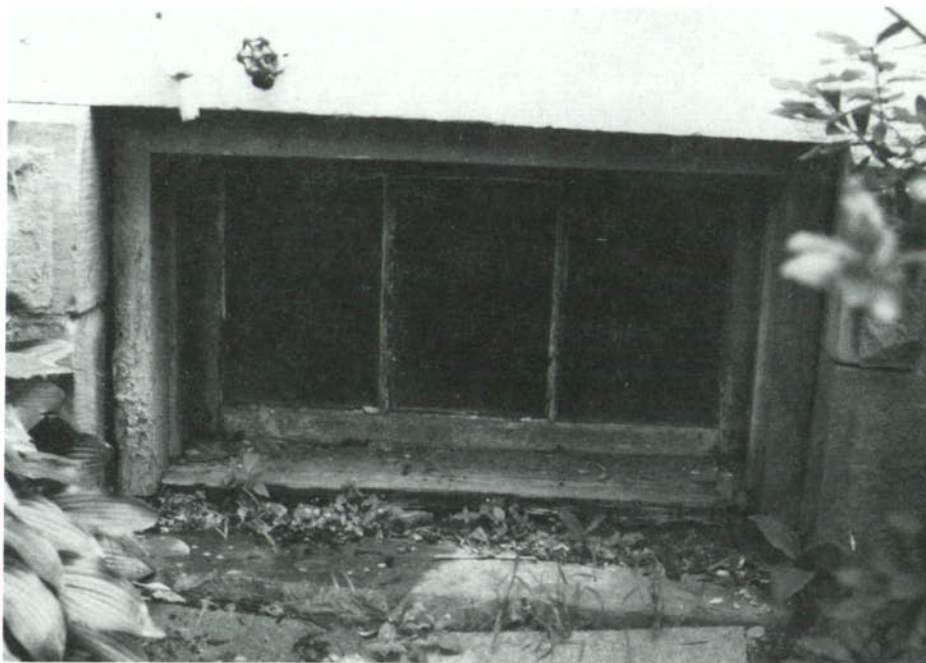
CP-47, Typical deteriorated basement window. The grade is too high and the foliage is too close to the wood frames, keeping them continuously damp.

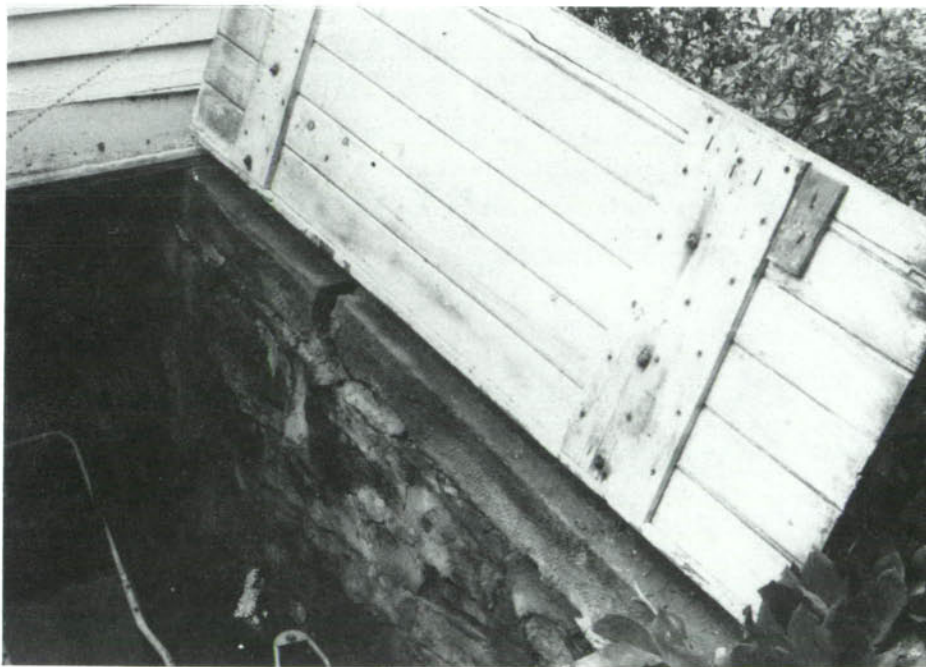
CP-48, Wood doors and stone walls of the cellar entrance are in poor condition, allowing moisture to enter and providing little security.

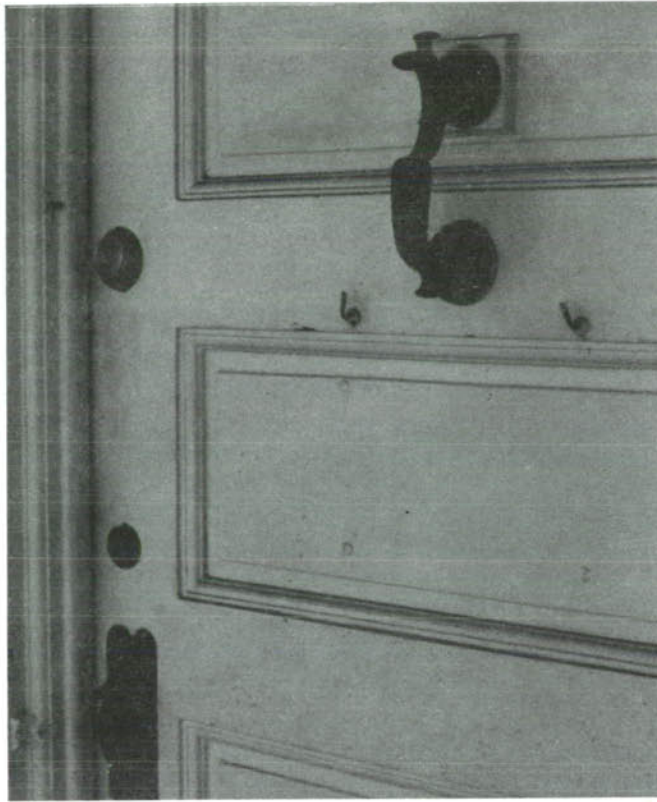
CP-49, Large bronze knocker and thumb latch at the west porch entry may date back to 1885. The two-cylinder locks are newer.

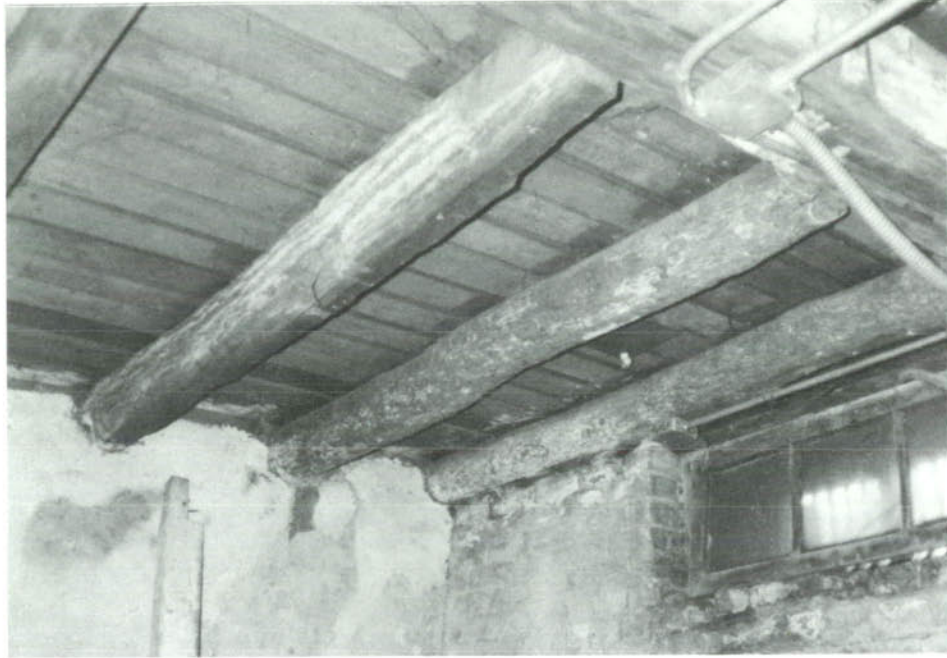
SP-1, Southeast foundation corner, room 103.

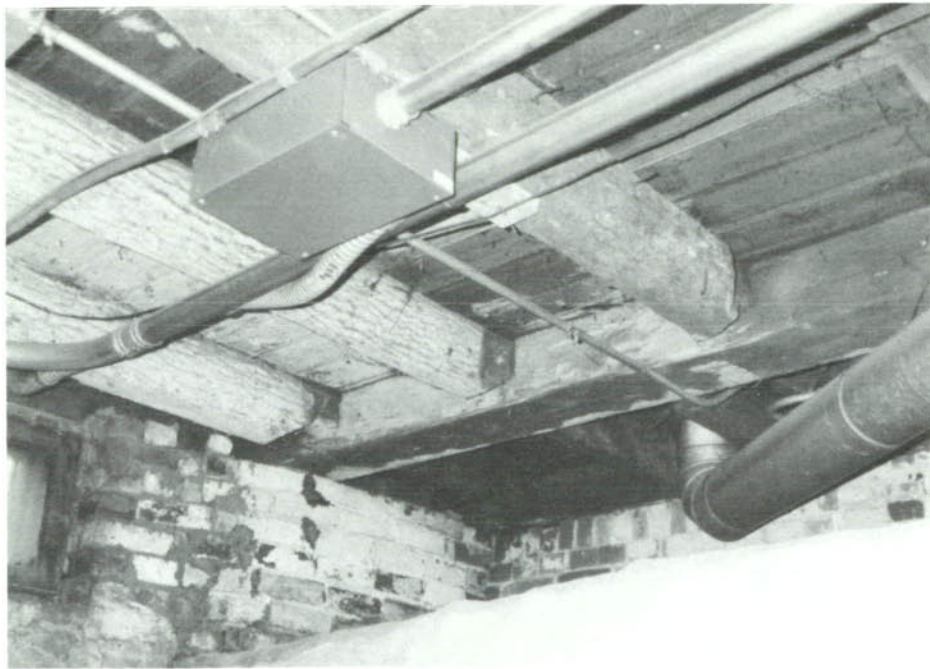
SP-2, Northeast foundation corner, room 103.

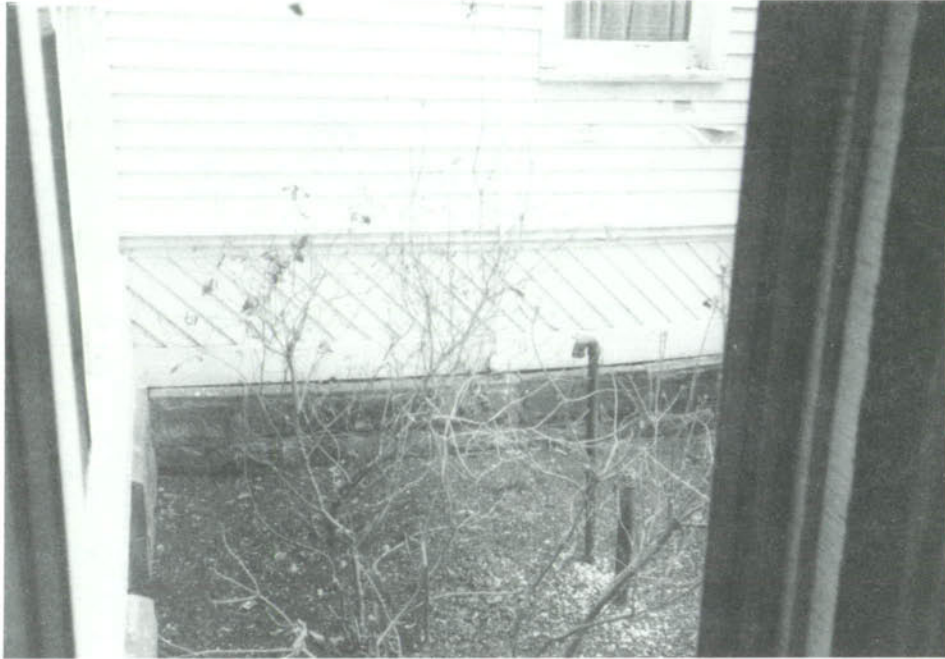
SP-3, Limestone veneer outside stair.

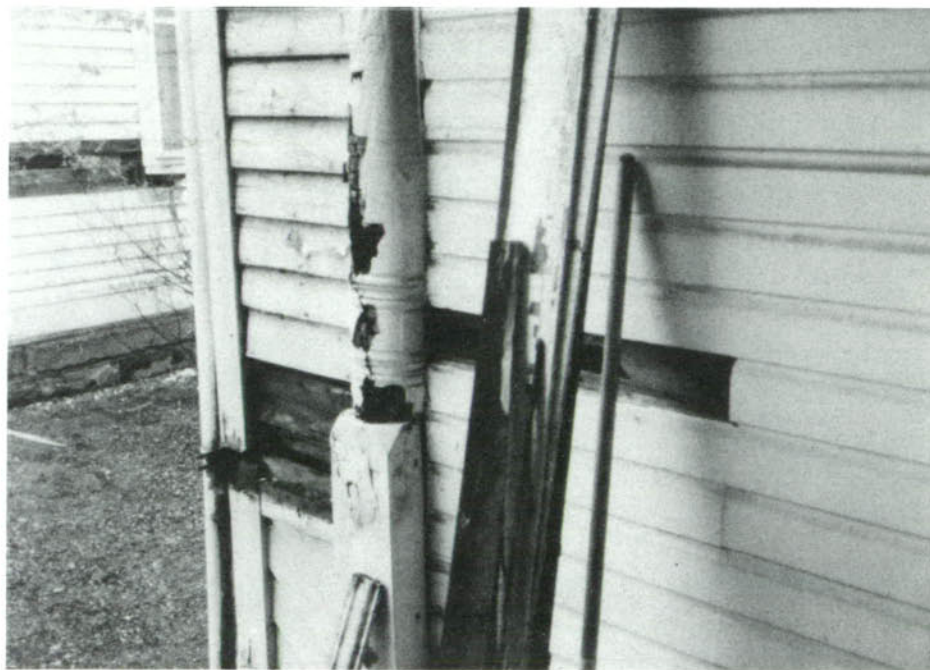
SP-8, Wall deterioration adjacent to the porch.

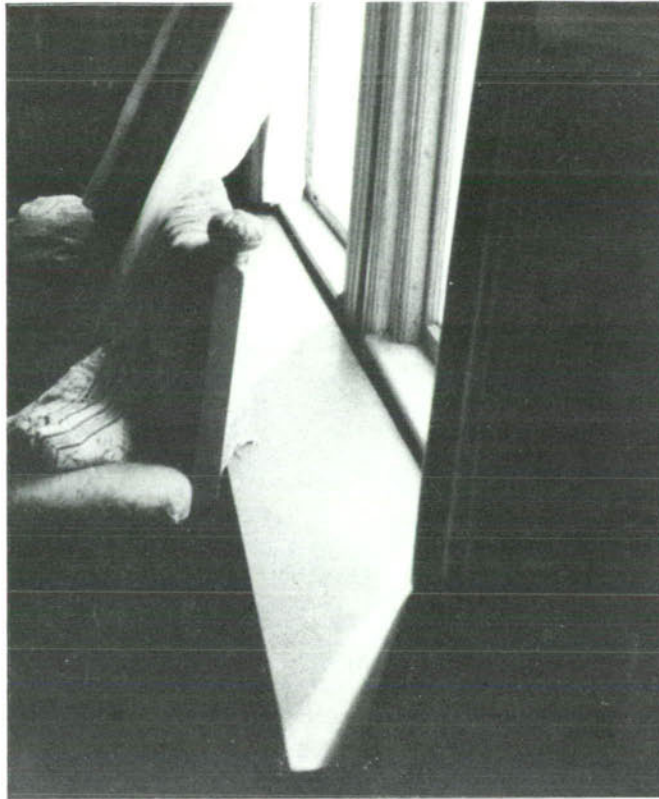
SP-9, Library window, interior view.

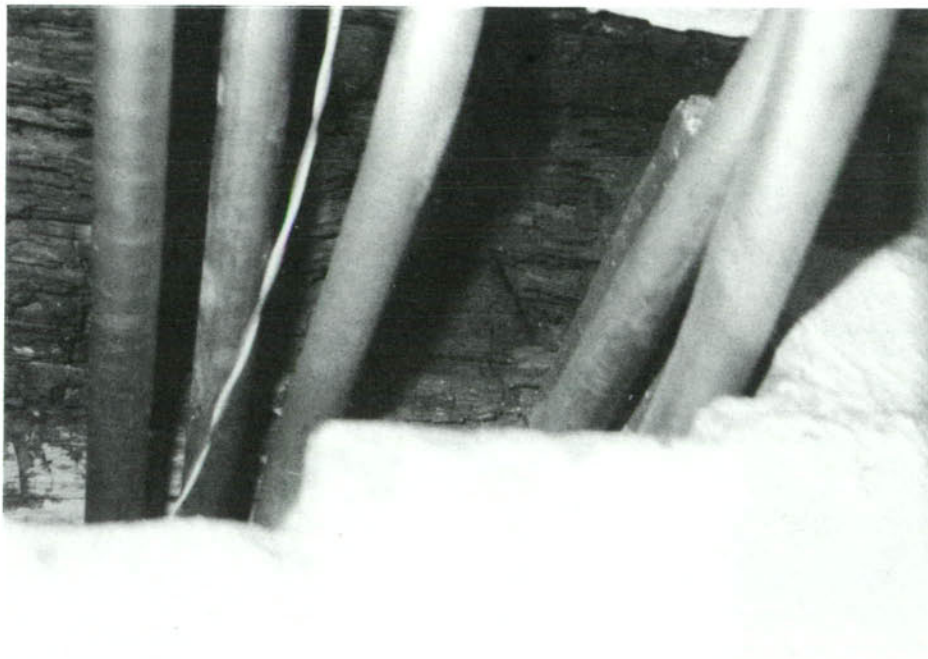
SP-24, Sill plate rot.

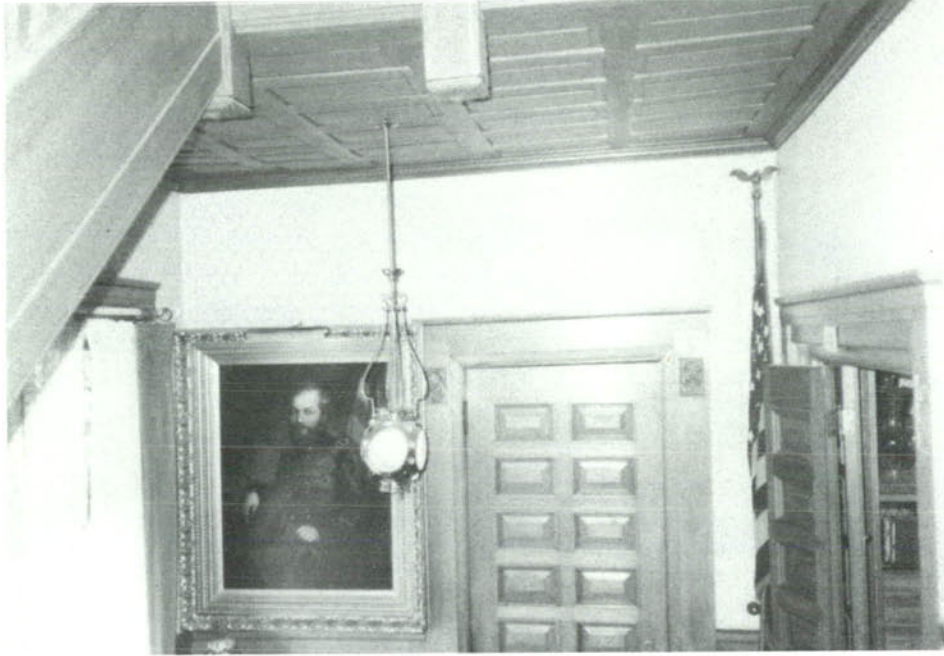
SP-25, Exterior wall displacement outside the library.

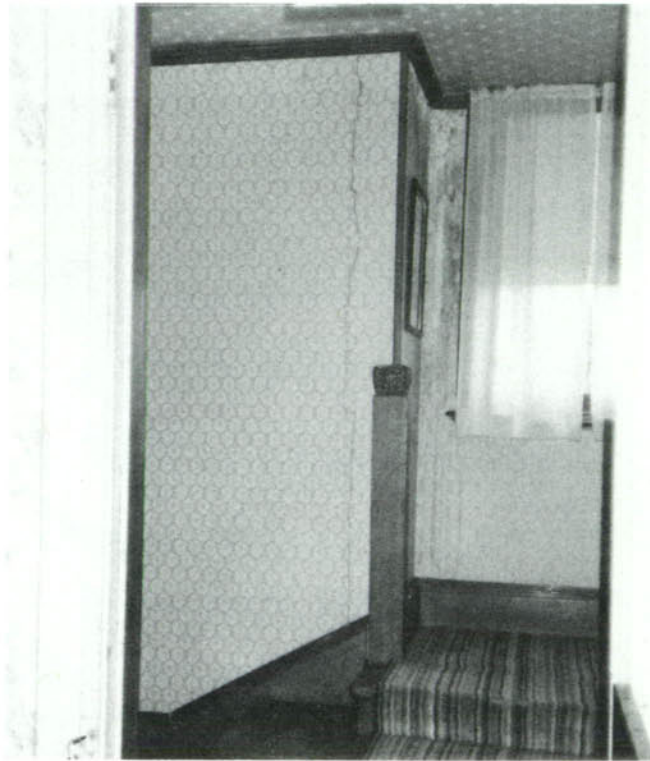
SP-28, Second-floor wall crack at the main stair.

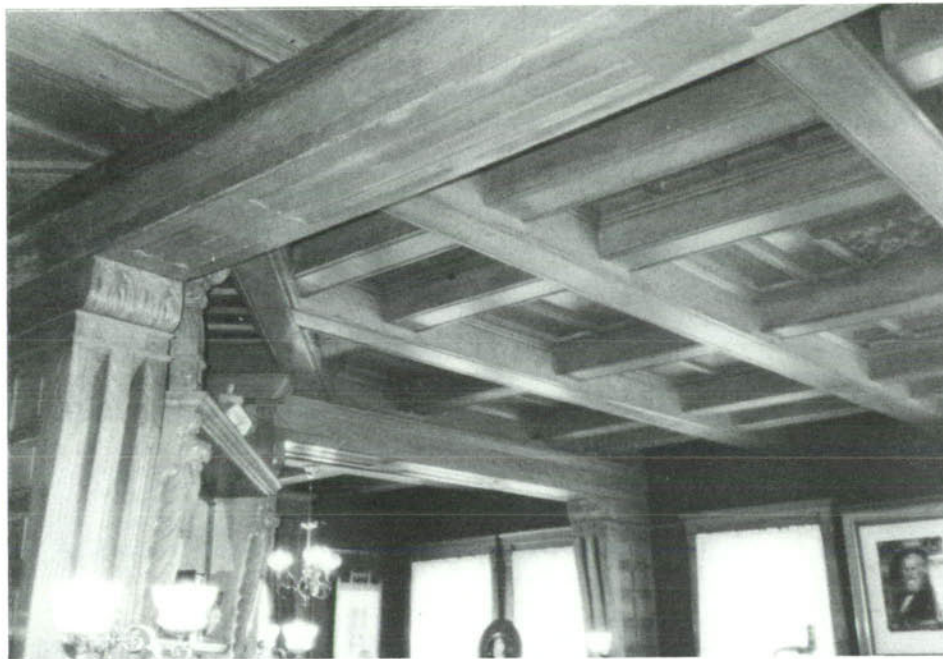
SP-29, Library ceiling, northeast view.

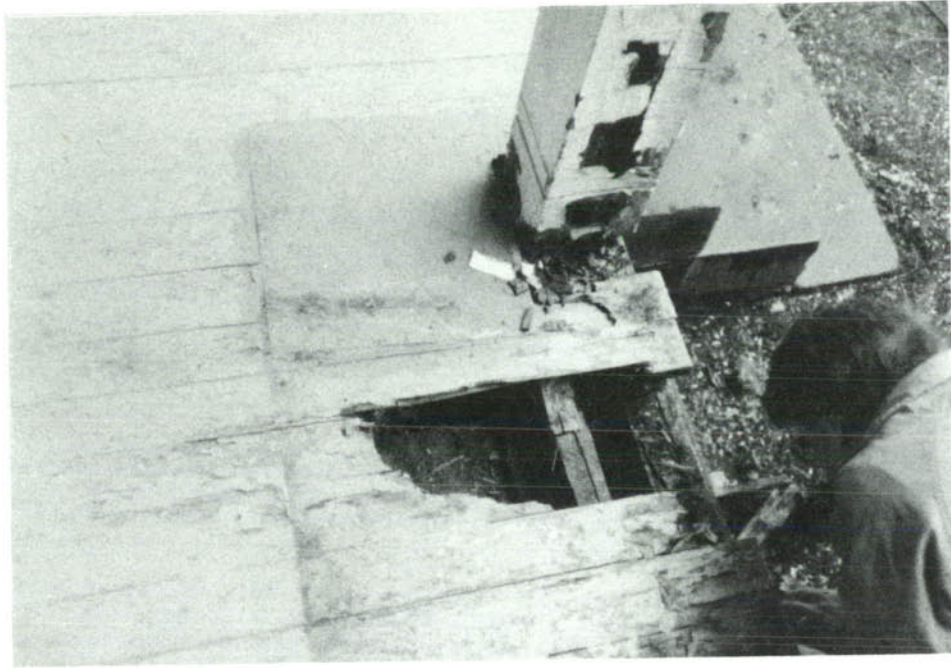
SP-41, Deck rot at the carriage porch.

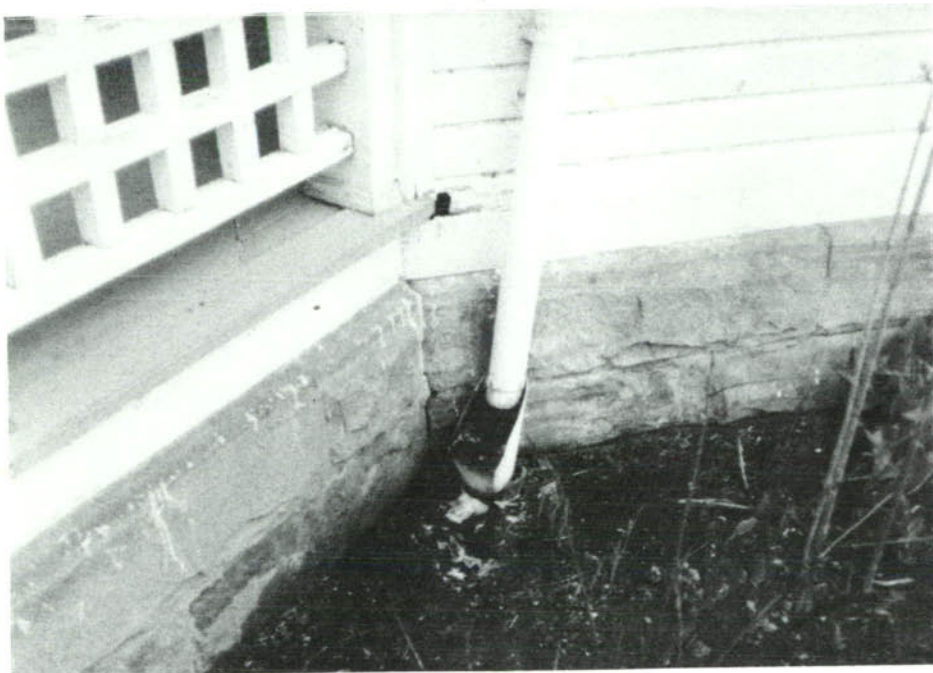
SP-42, Downspout drain overflowing.

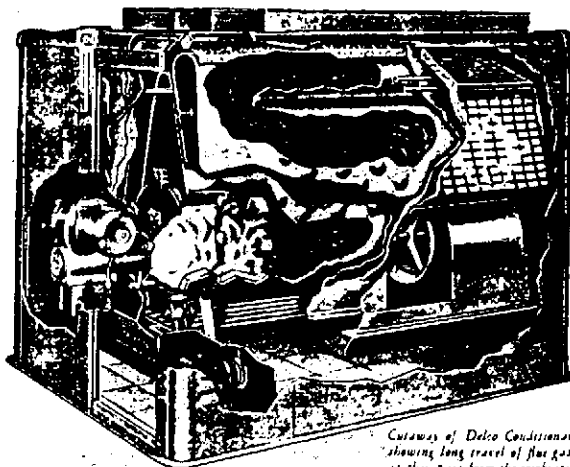
*Cutaway of Delco Conditionair, showing long travel of flue gases as they pass from the combustion chamber to the chimney.*

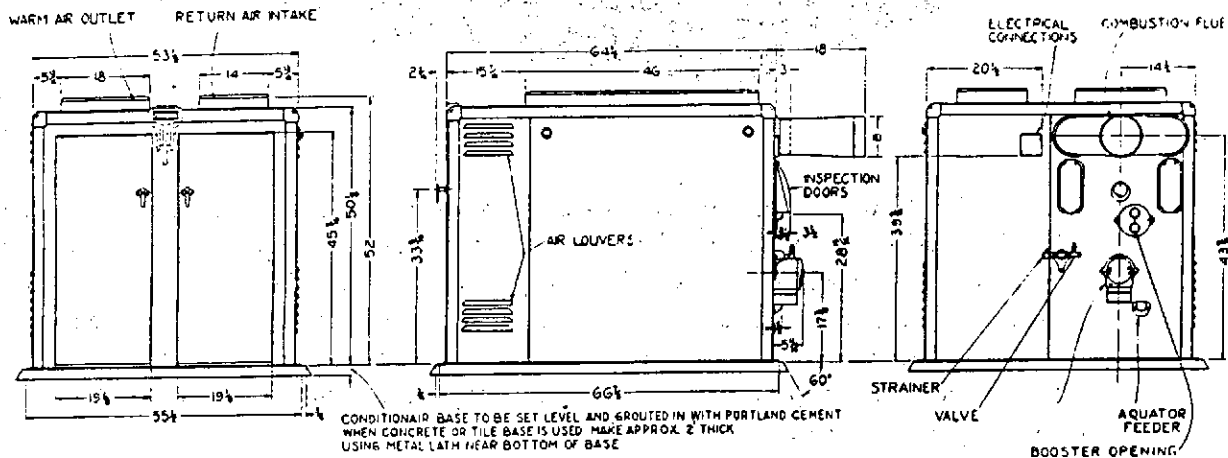
**Capacity:**  
Maximum output at plenum ..... 250,000 BTU/Hr.  
Net output at registers ..... 170,000 BTU/Hr.\*  
\*15% normal transmission loss; varies with duct design.

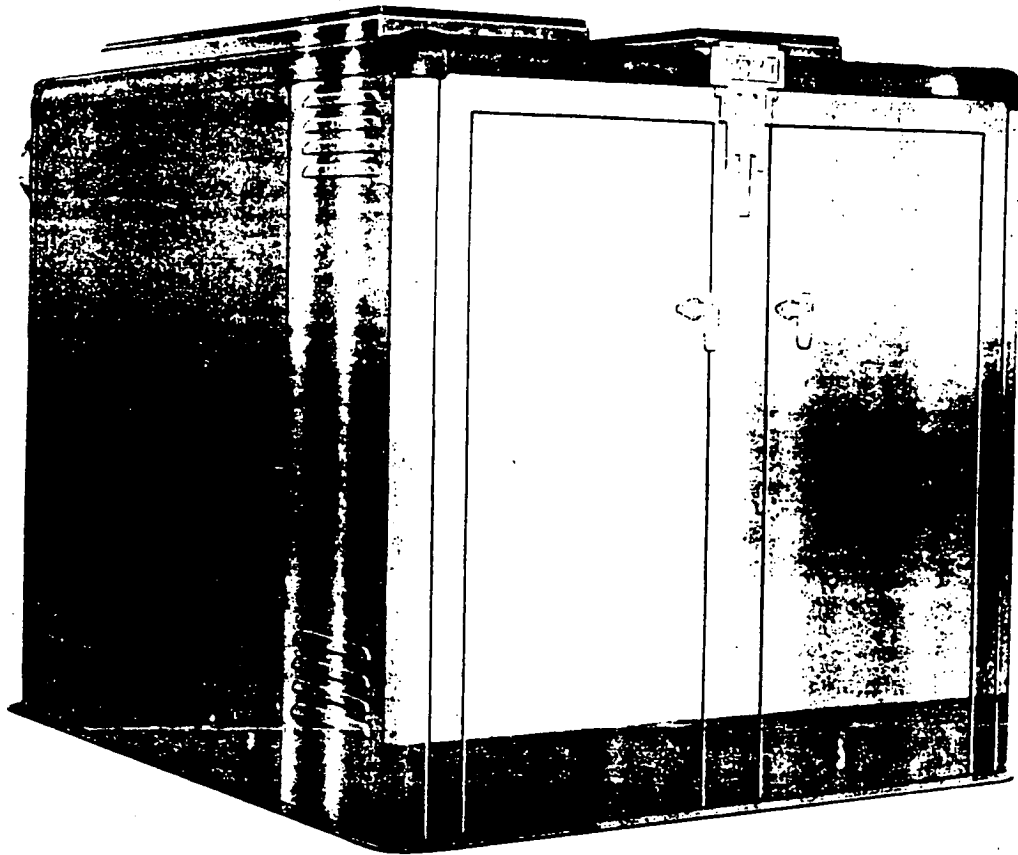
The Delco Conditionair coordinates the famous fuel-saving Delco Oil Burner and its "Thin-Mix" Fuel Control with a specially designed winter air conditioning unit. It provides true winter air conditioning by circulating cleaned, humidified and properly heated air to every part of the house. All operating parts are enclosed within the attractive steel cabinet with its gleaming enamel finish. Where the duct system has been properly designed for the purpose, a condensing unit and cooling coil may easily be added to provide year round comfort.

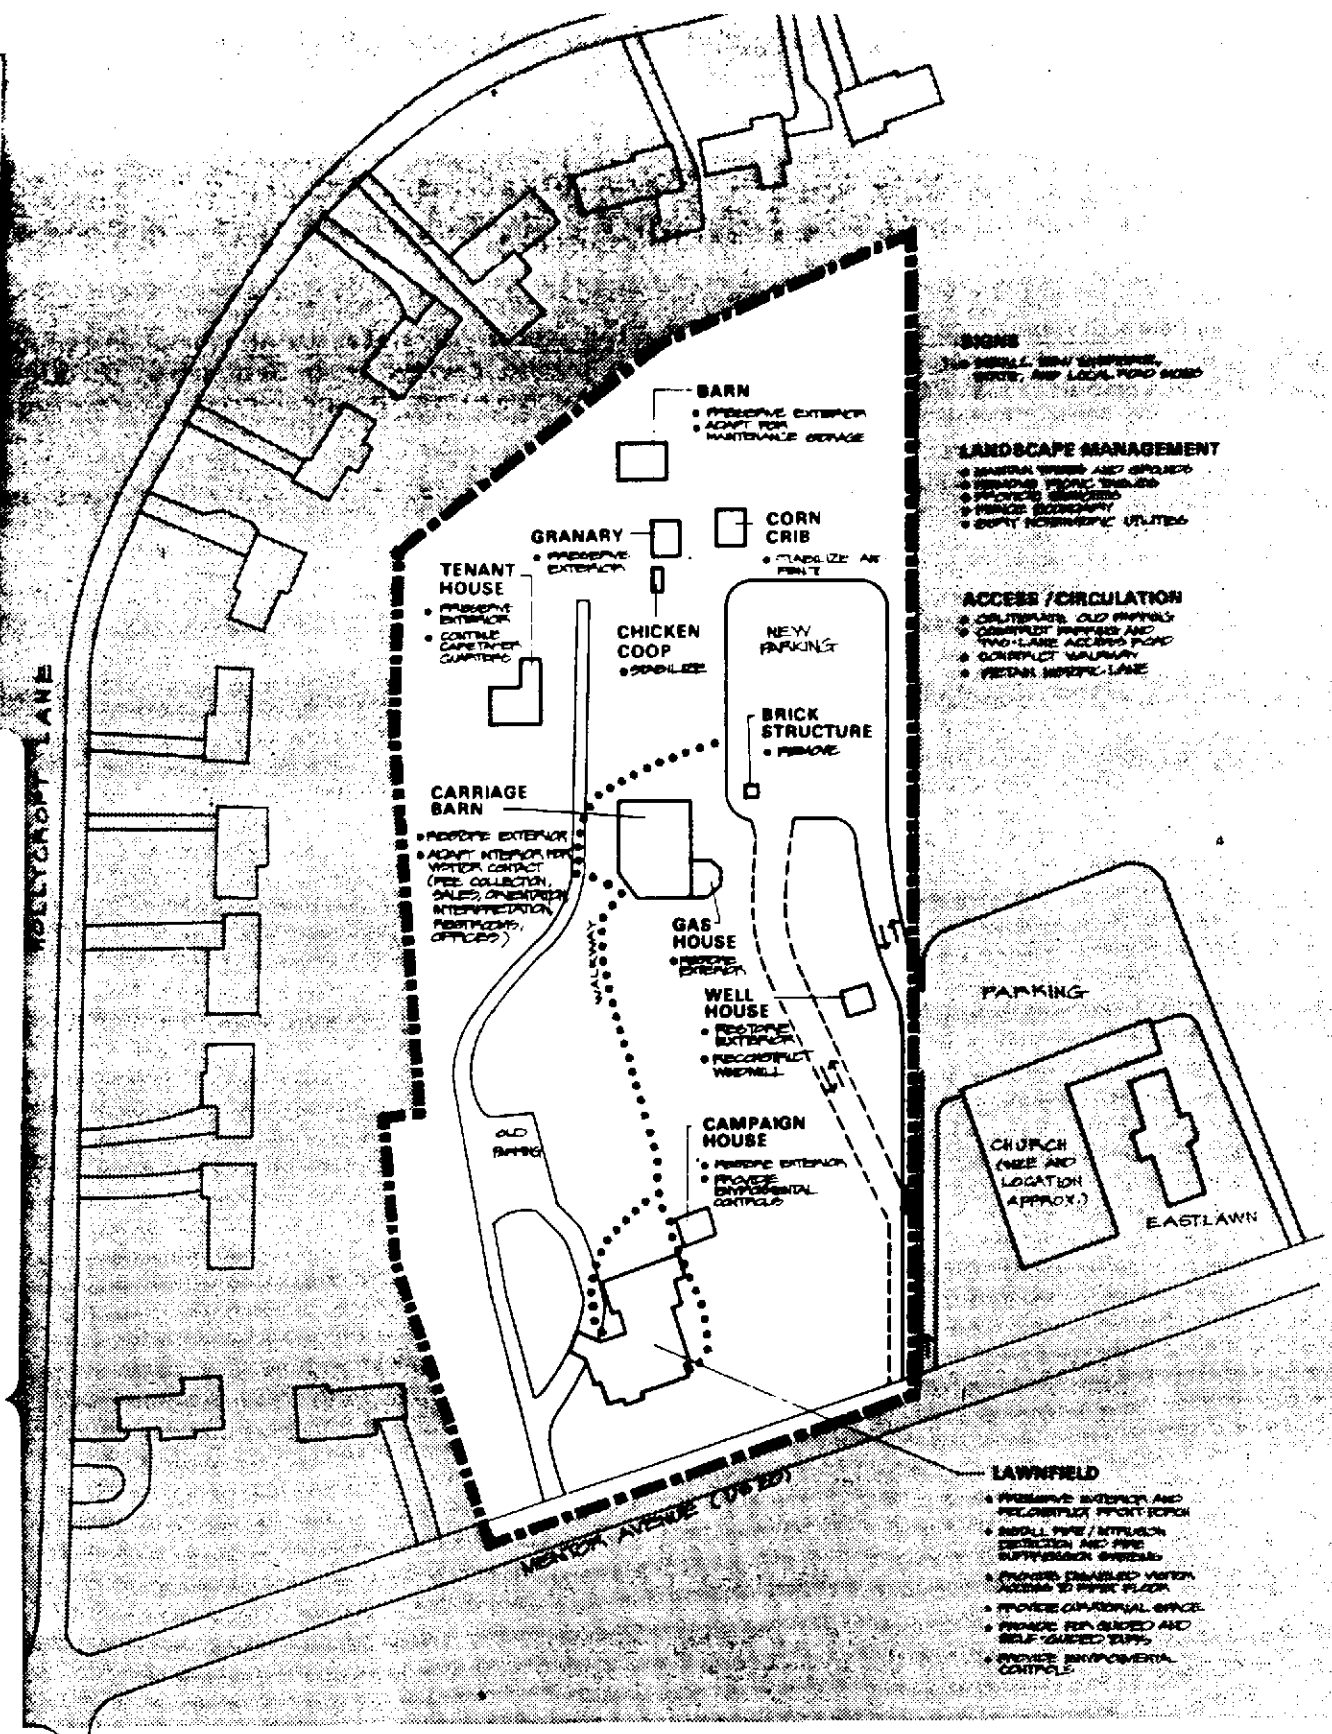
**STONES**  
 • SMALL, SEMI-CIRCULAR, STONE, AND LOCAL POND STONES

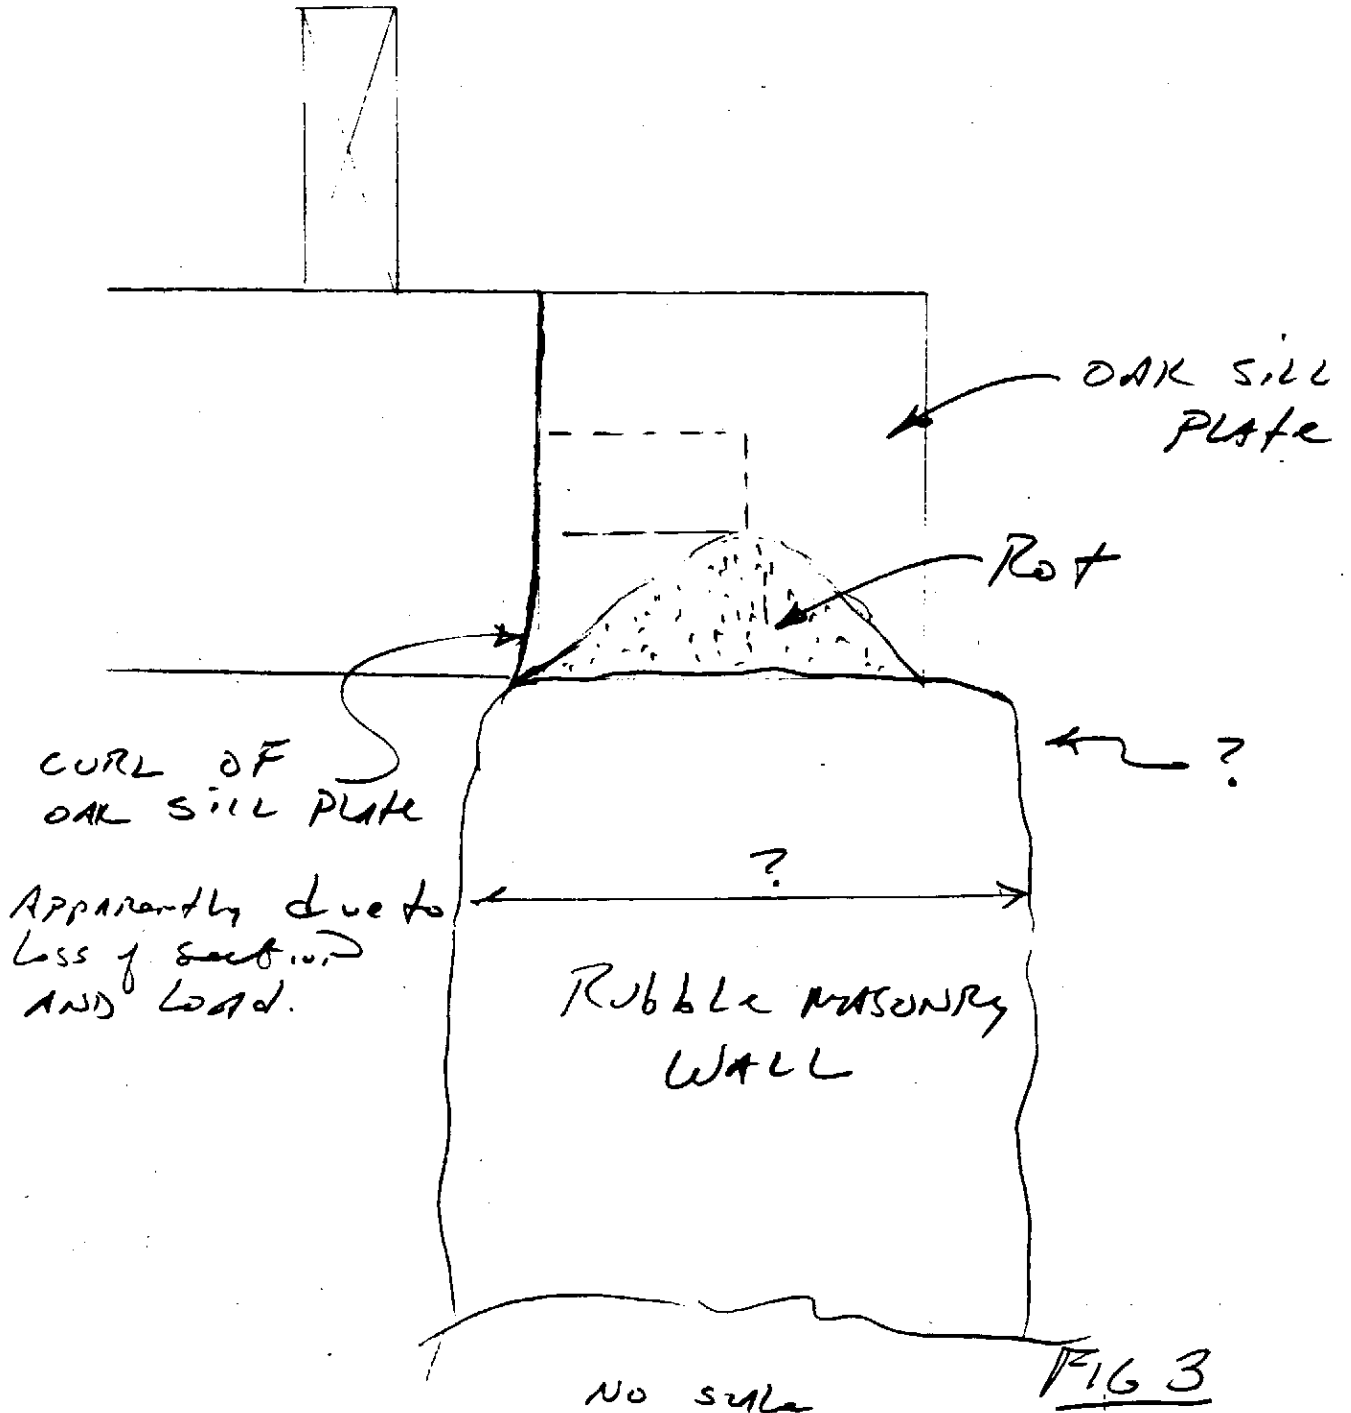
Subject: SILL PLATE Rot.
