HISTORIC STRUCTURE REPORT
THE SOUTH FORK DAM
HISTORICAL DATA
JOHNSTOWN FLOOD NATIONAL MEMORIAL
PENNSYLVANIA
PACKAGE NO. 124

Harlan D. Unrau

DENVER SERVICE CENTER
BRANCH OF HISTORIC PRESERVATION
MID-ATLANTIC/NORTH ATLANTIC TEAM
NATIONAL PARK SERVICE
UNITED STATES DEPARTMENT OF THE INTERIOR
DENVER, COLORADO

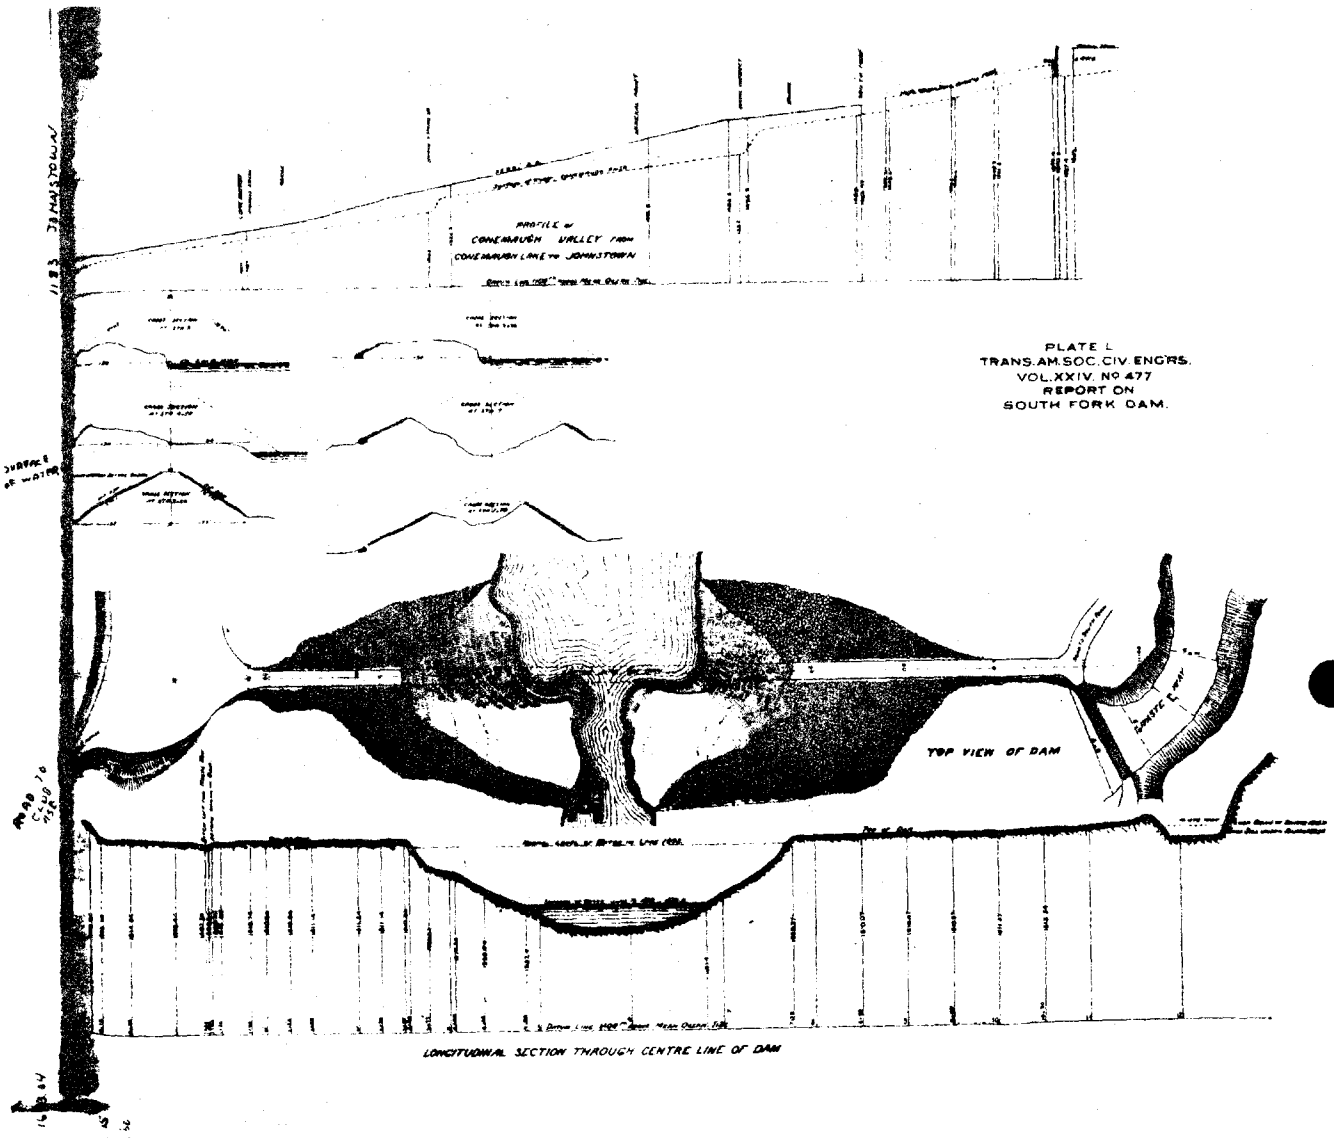
Mr. Parke's observation of the rise of 9 inches in an hour was evidently made when the height in the

132. The drawing, labeled Plate L in the "Report of the Committee on the Cause of the Failure of the South Fork Dam," illustrates this information. A copy of the plate may be seen on the following page.

reservoir averaged about 7½ feet above the floor of the wasteway. At this height the area of the reservoir was 471.62 acres, and the accumulation was at the rate of

$$\frac{471.62 \times 43.560 \times 0.75}{60 \times 60} \quad 4,280 \text{ cubic feet per second.}$$

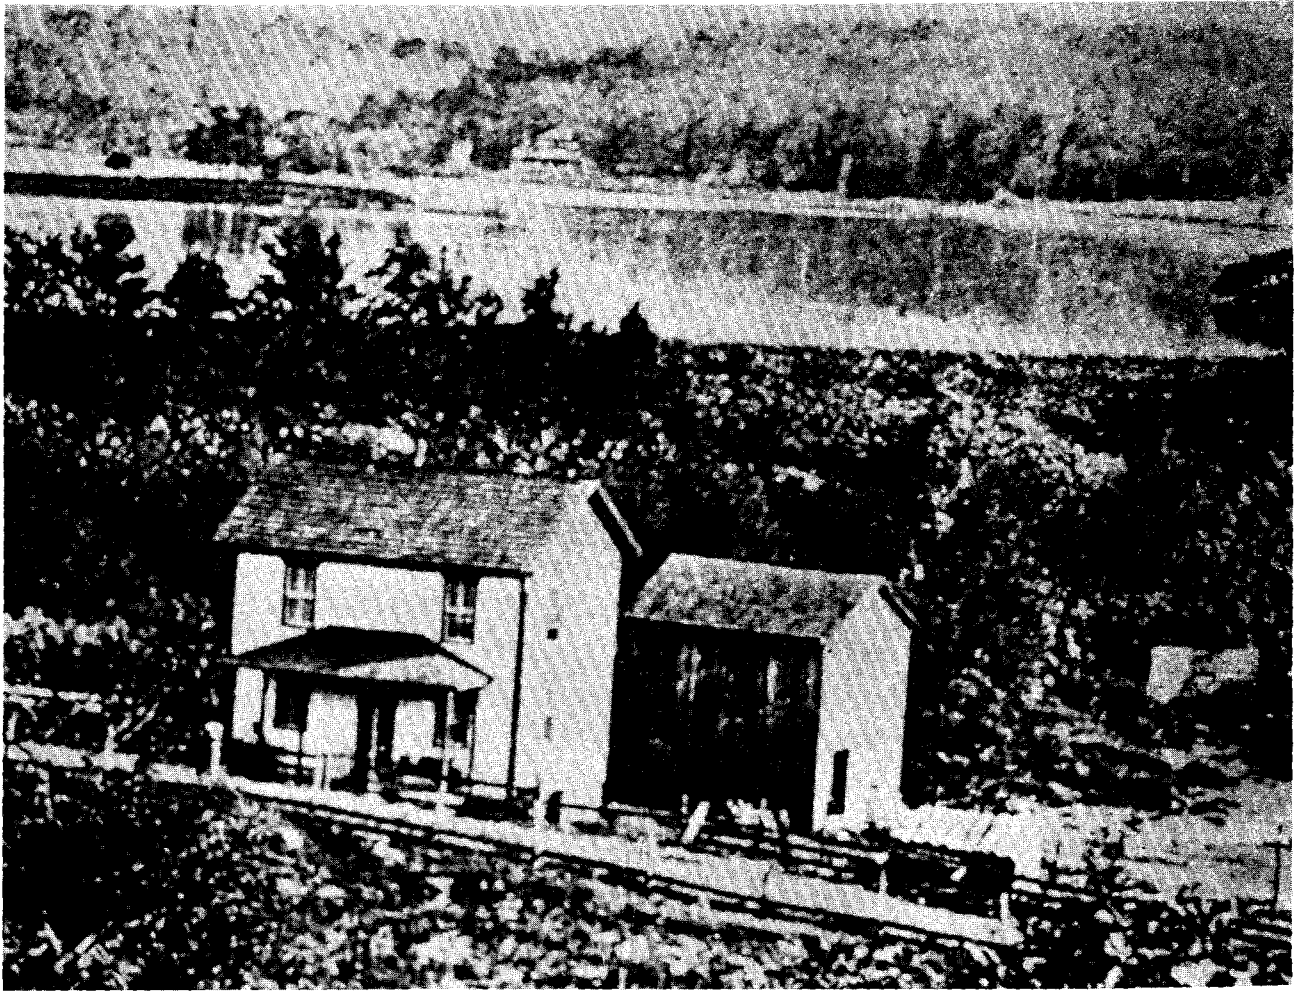
Photograph No. 1

Photograph of South Fork Dam looking generally south toward Lake Conemaugh with resort cottages in background. The arched stone culvert is in the lower right hand corner. Note that trees are growing at each end of the dam but that there is no foliage in the center. This was due to the fact that the center of the dam was patched in 1880-81.

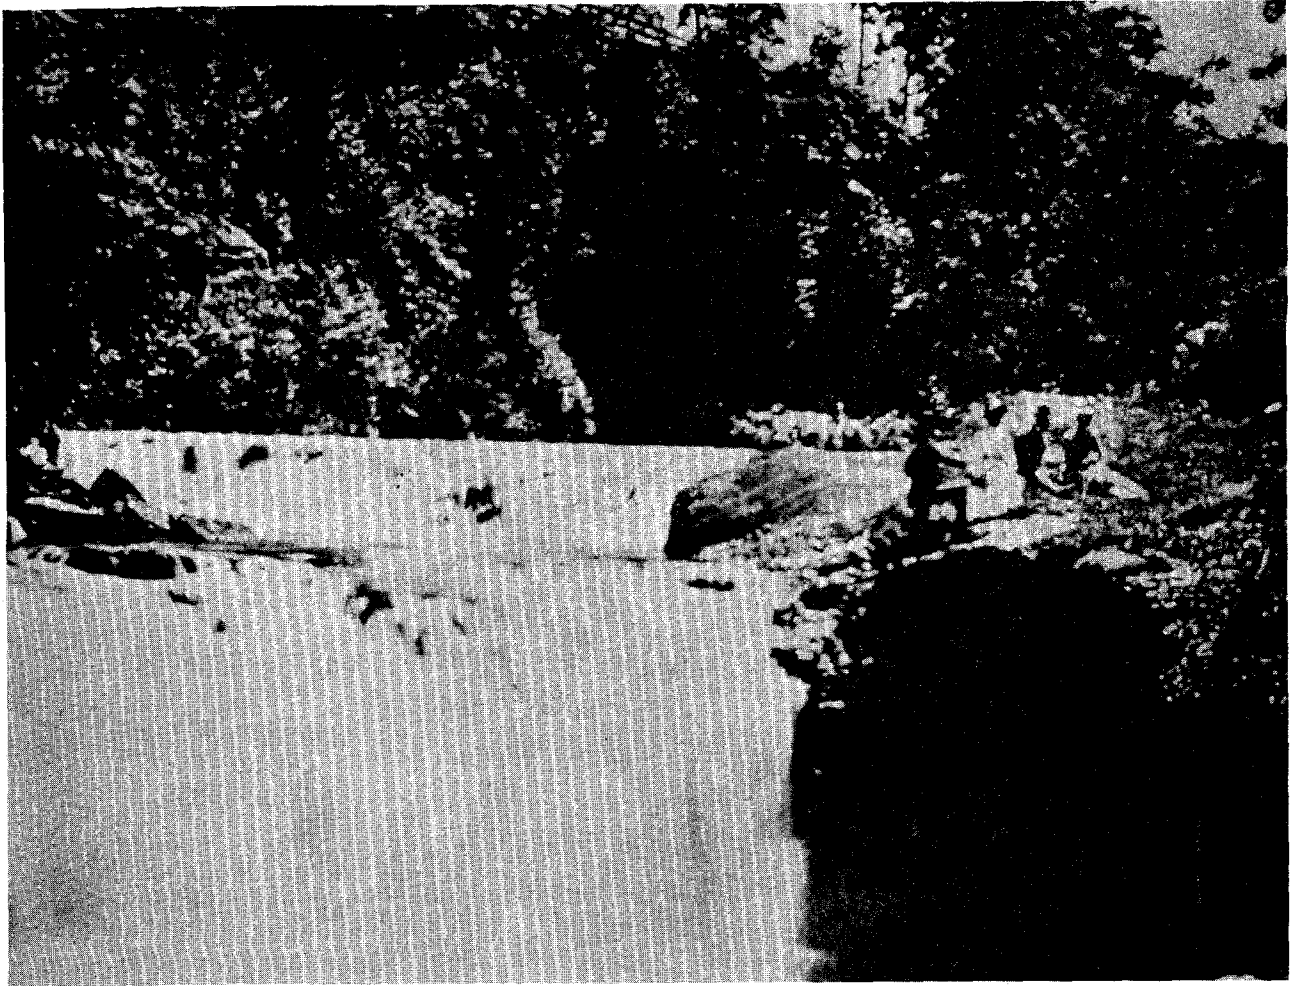
Photograph No. 2

Photograph of spillway showing large volume of water pouring through it. Vacationers are seated at its rim to the right.

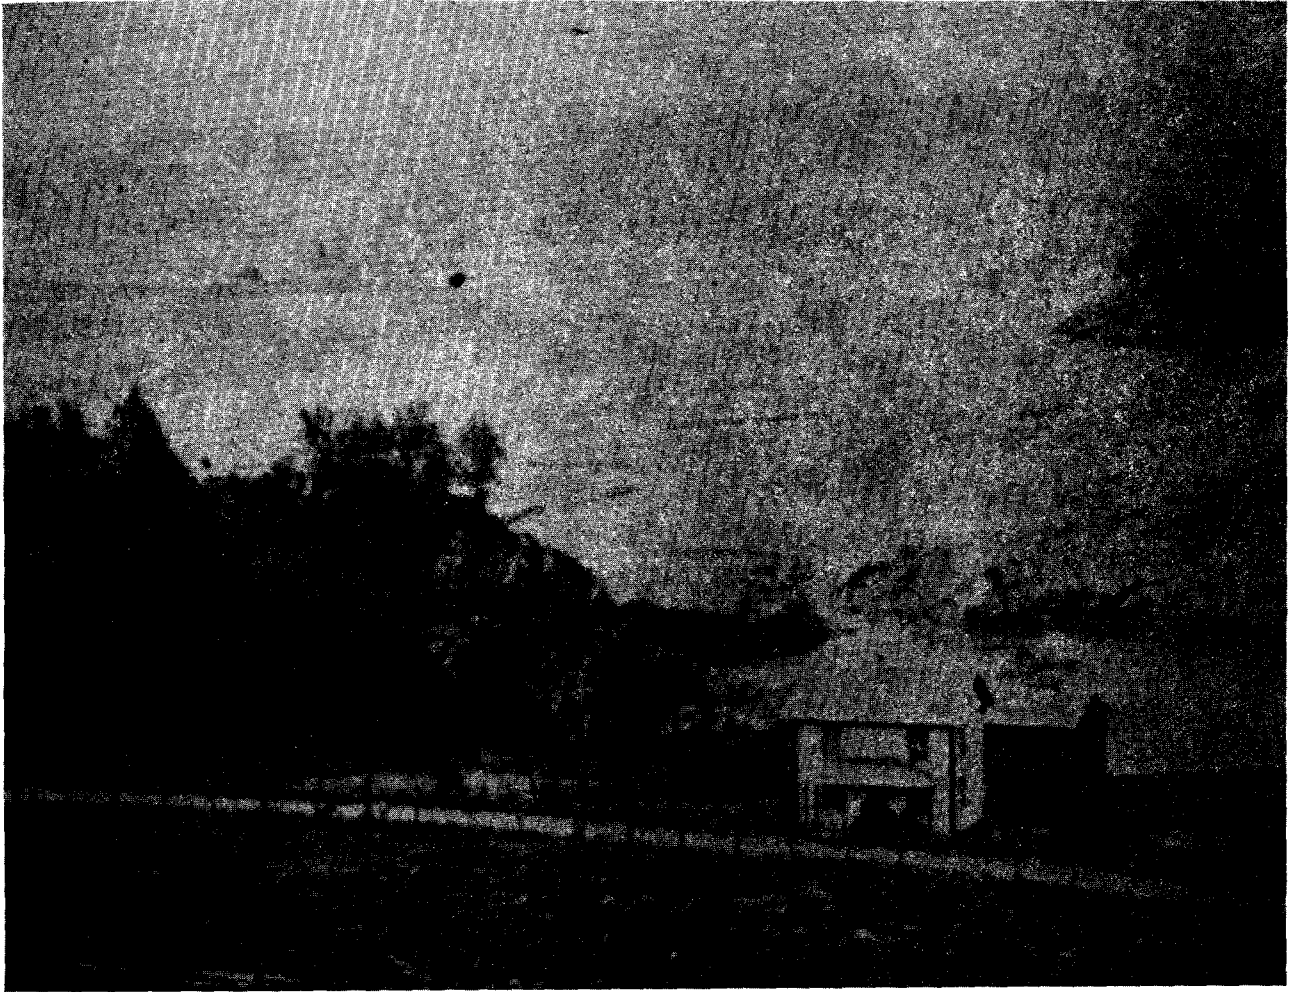
Photograph No. 5

Photograph of the broken South Fork Dam after the 1889 flood looking south toward the emptied Lake Conemaugh.

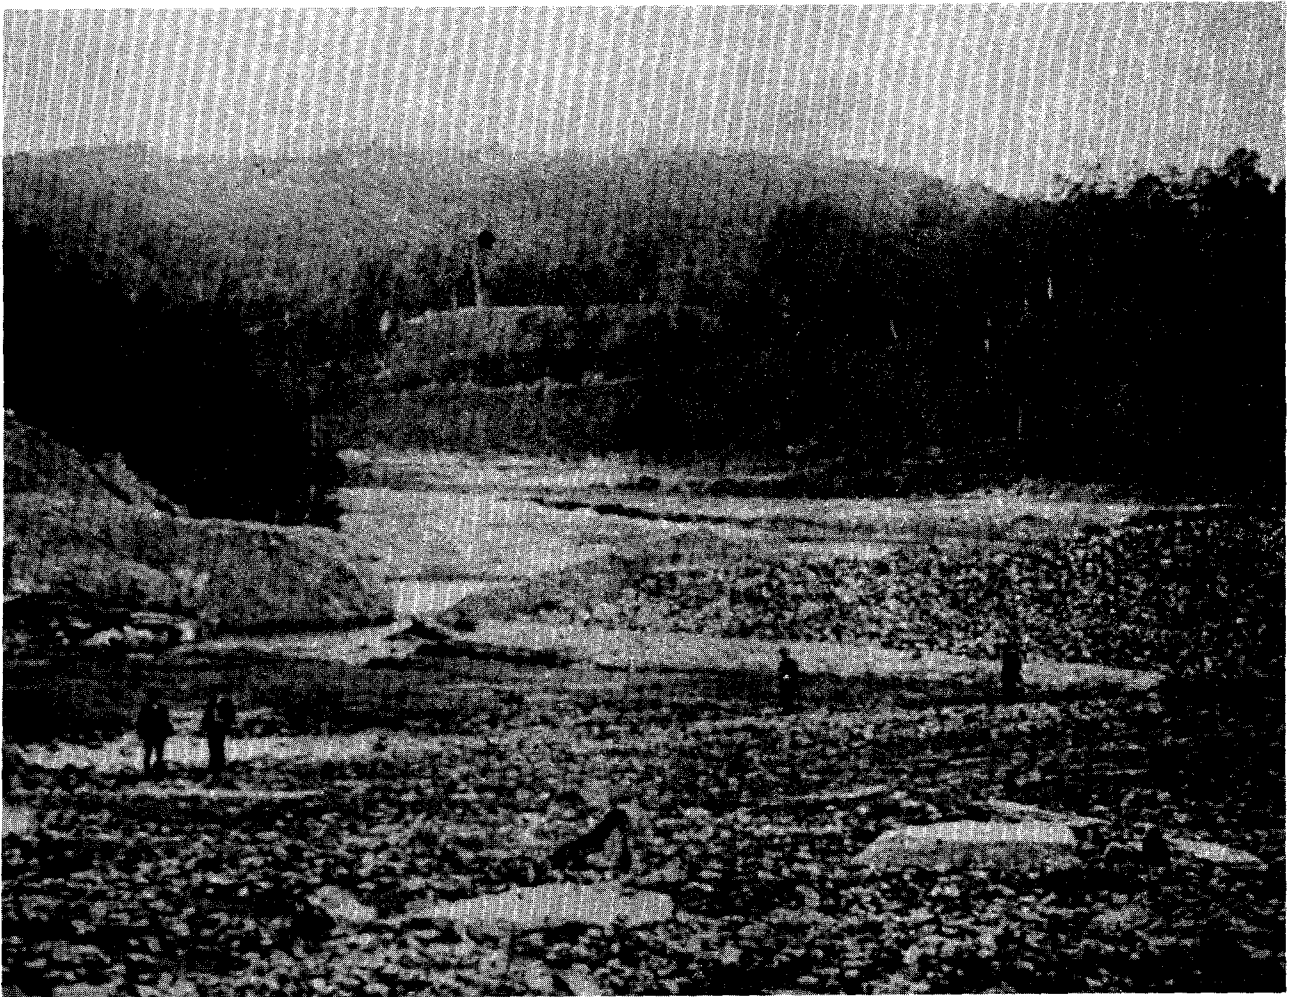
Photograph No. 6

Photograph of the broken South Fork Dam after the 1889 flood taken from the emptied bed of Lake Conemaugh.

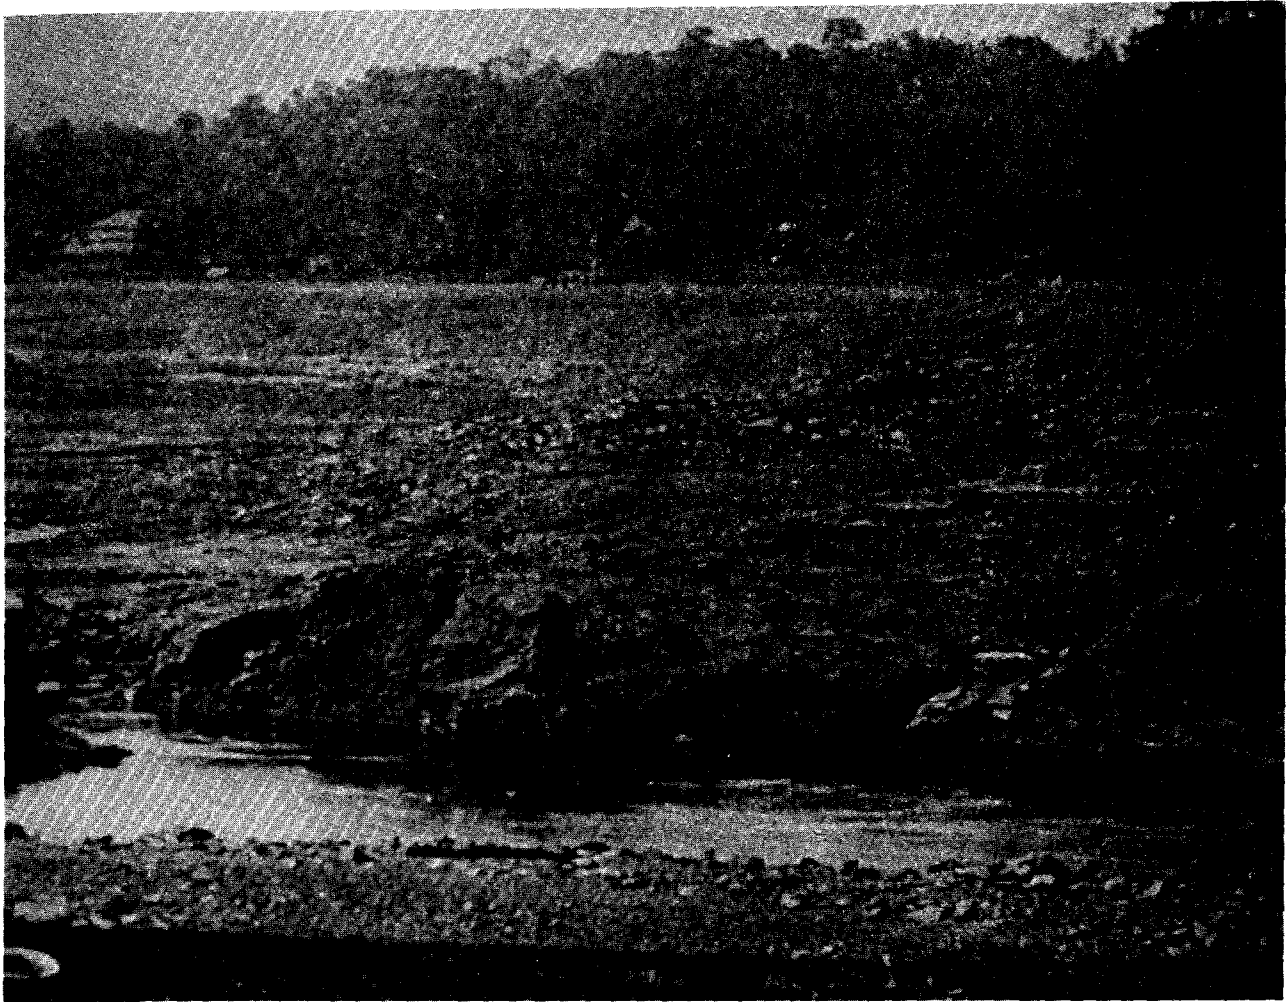
Photograph No. 7

Photograph of the broken South Fork Dam after the 1889 flood looking across the emptied Lake Conemaugh toward the club house.

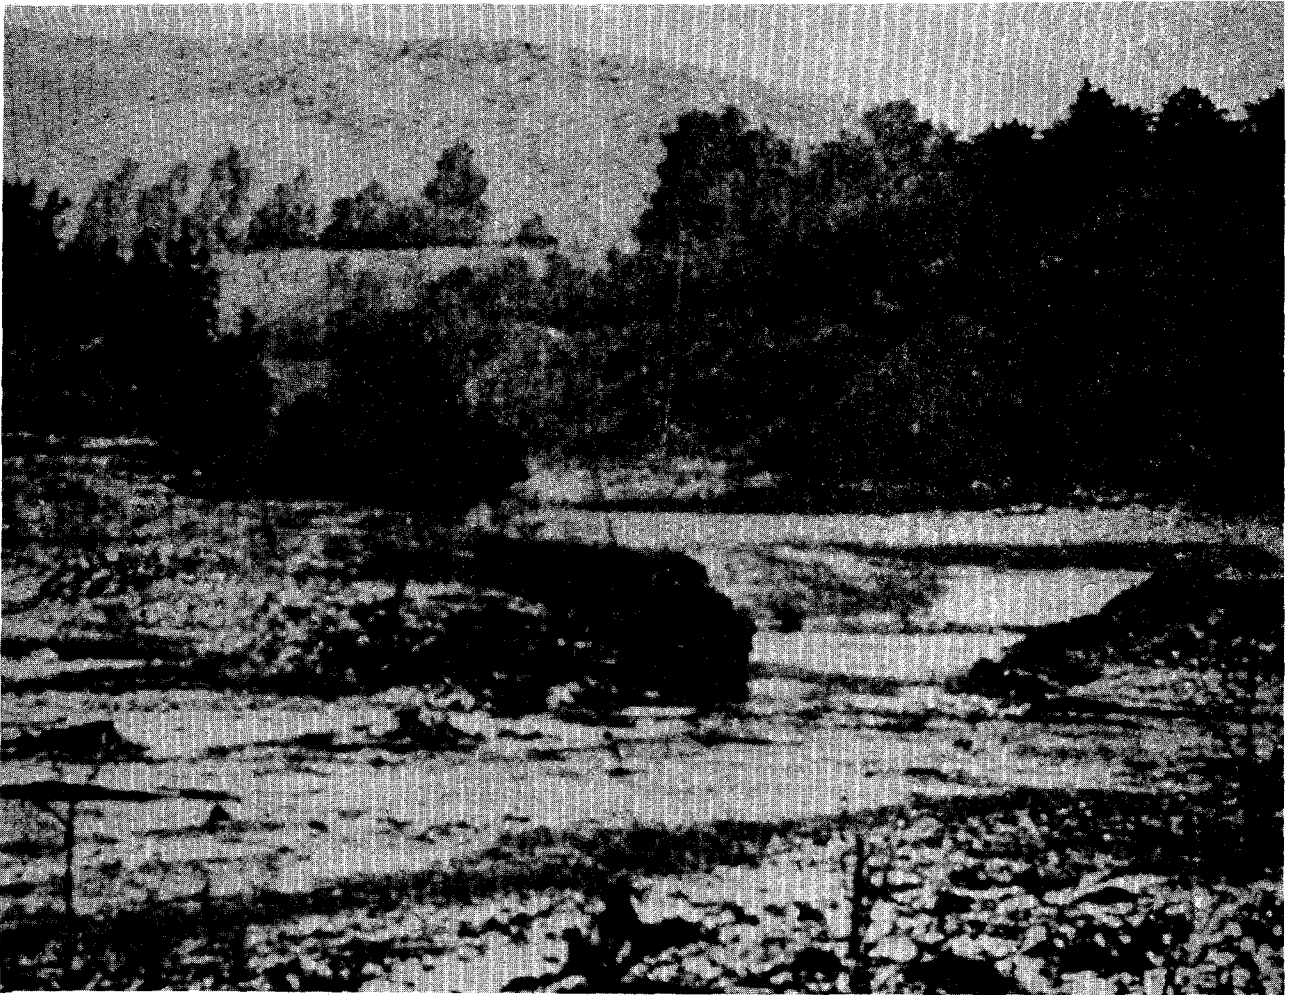
Photograph No. 8

Photograph of the broken South Fork Dam after the 1889 flood taken from the emptied bed of Lake Conemaugh.

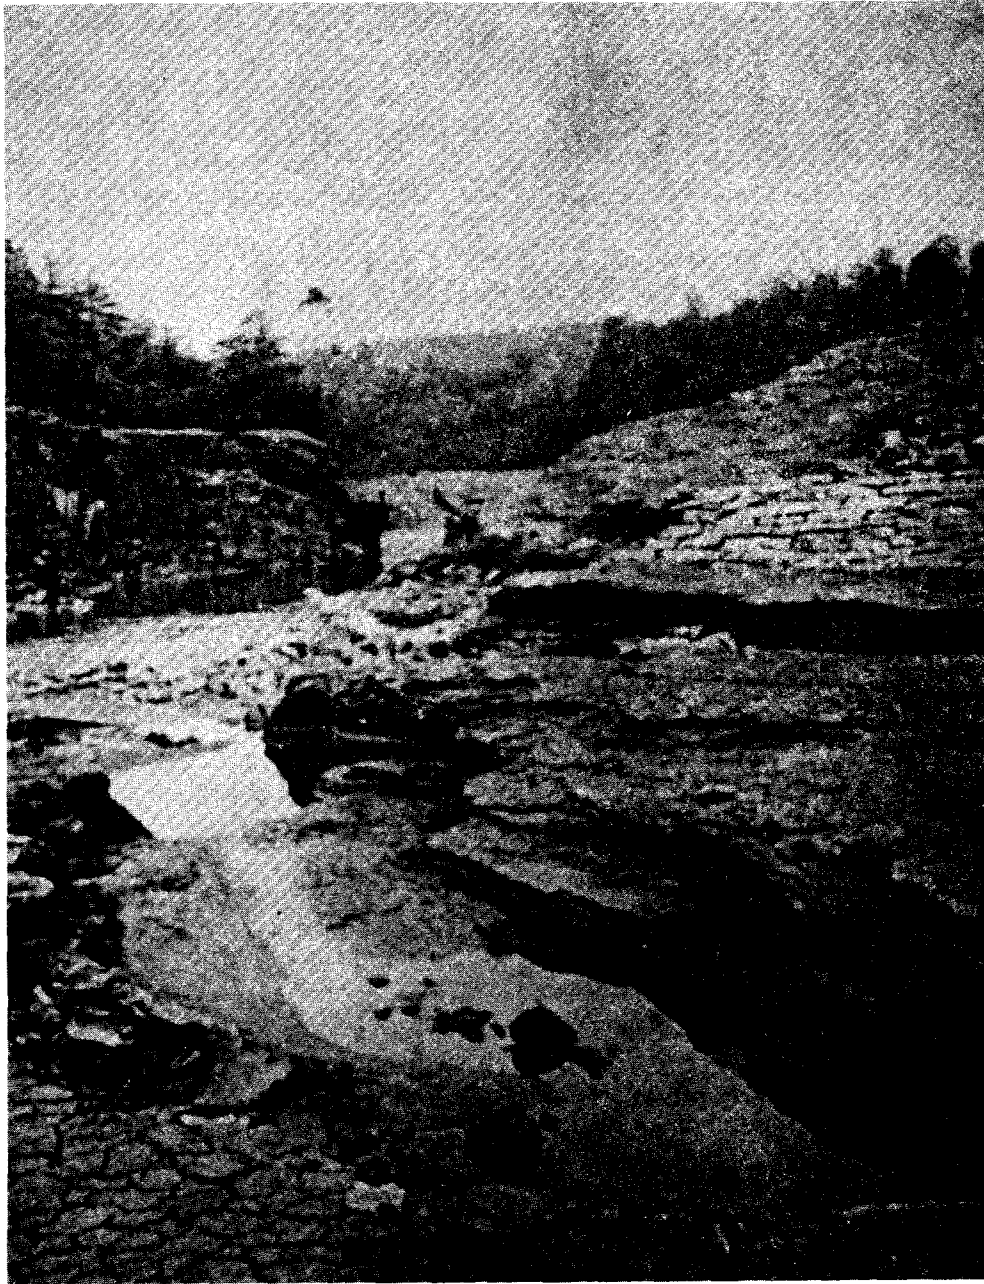
Photograph No. 9

Photograph of the broken South Fork Dam after the 1889 flood taken from the emptied bed of Lake Conemaugh. The remains of the arched stone culvert are at the left.

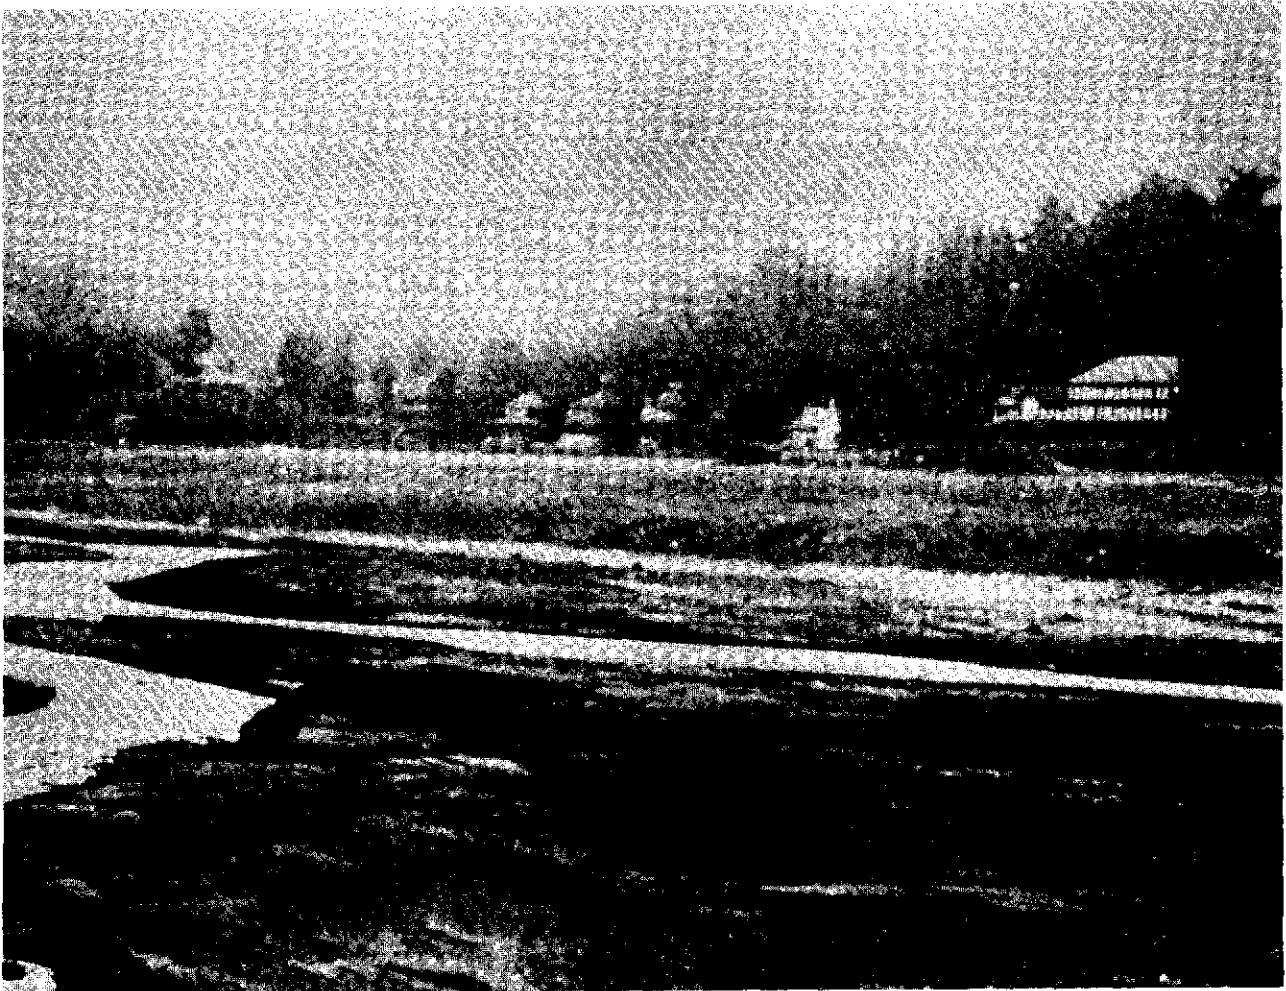
Photograph No. 10

Photograph of emptied Lake Conemaugh after the 1889 flood with the resort cottages in the background.

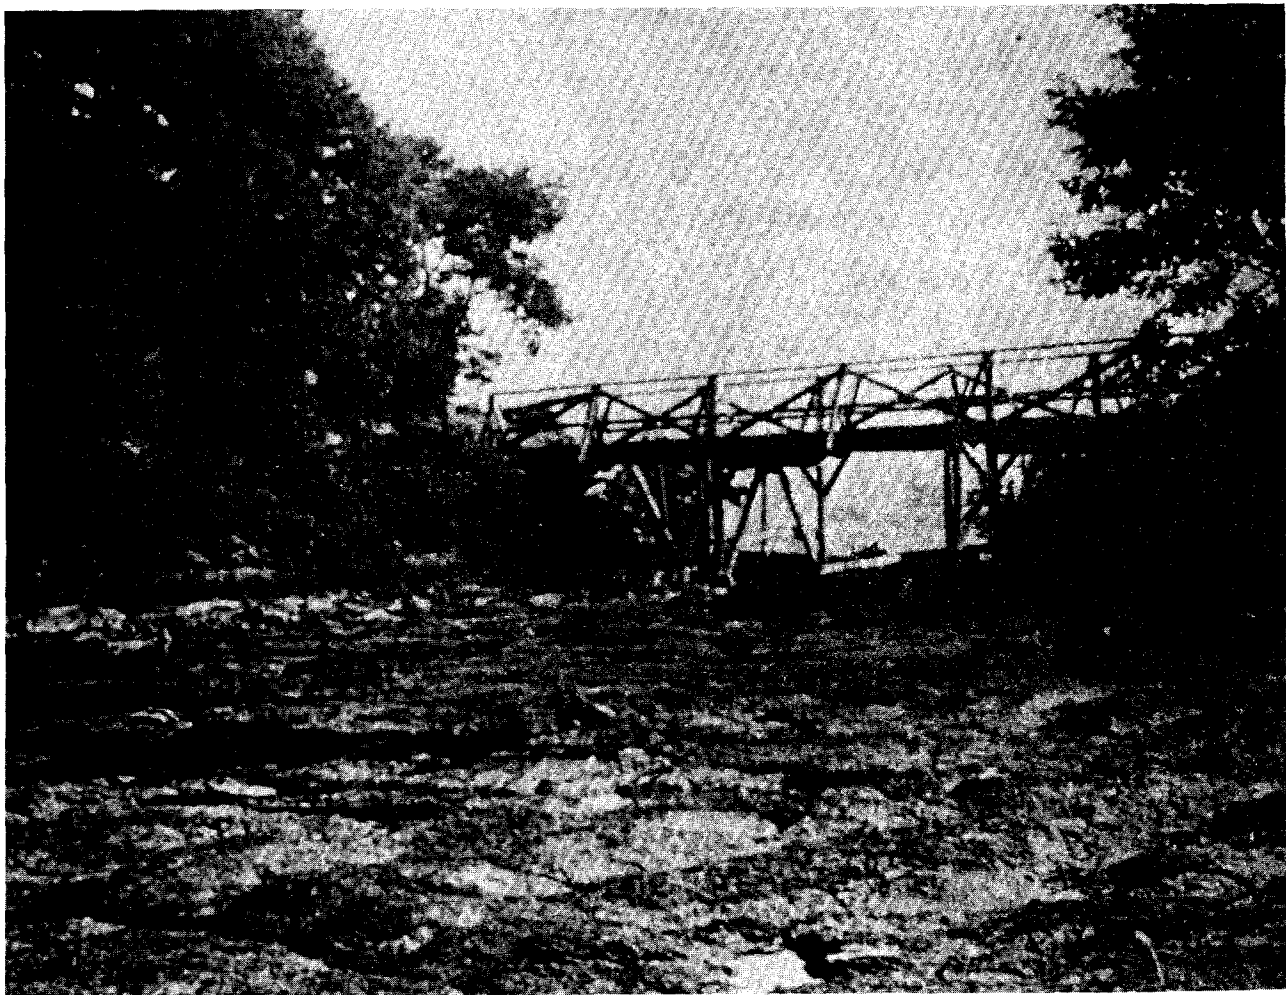
Photograph No. II

Photograph of the spillway and the spillway trestle bridge after the 1889 flood.

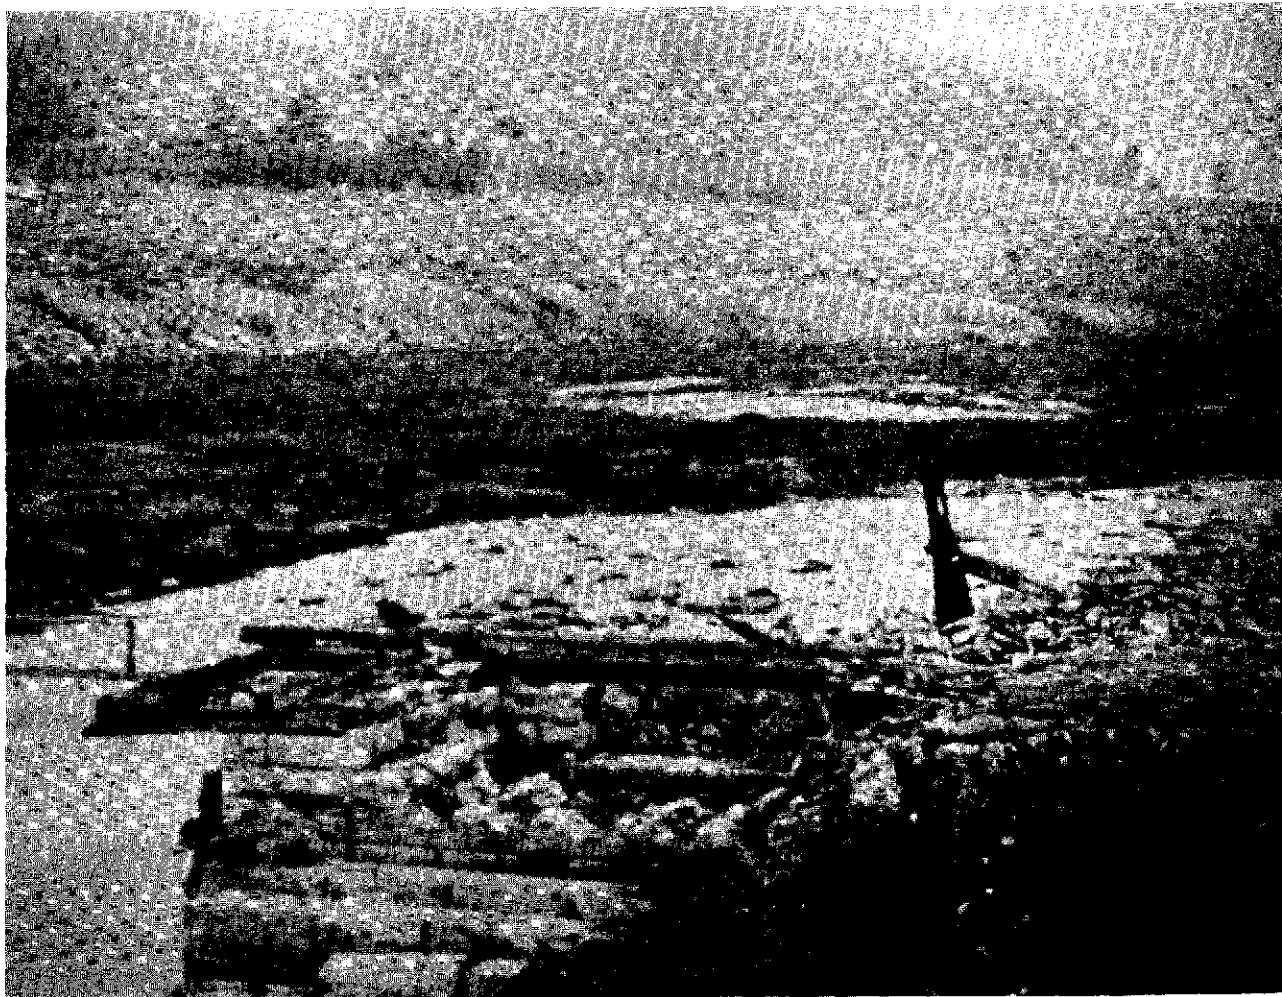
Photograph No. 12

Photograph showing the remains of the arched stone culvert after the 1889 flood with the emptied Lake Conemaugh in the background.

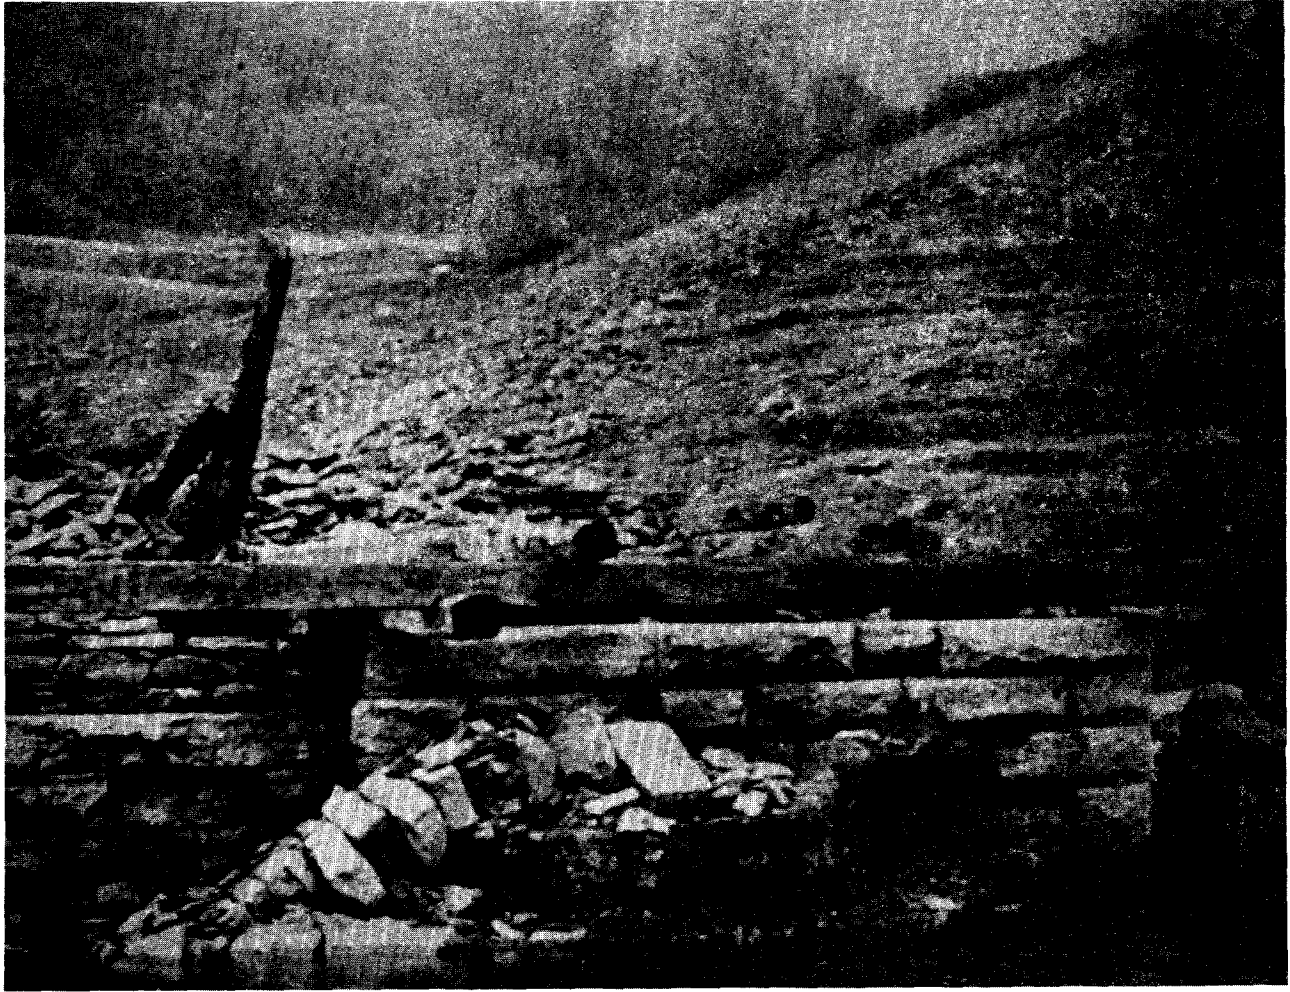
Photograph No. 13

Photograph showing the remains of the arched stone culvert and the east end of the dam after the 1889 flood.
