HISTORIC STRUCTURE REPORTS
FOR TEN BUILDINGS

ADMINISTRATIVE, PHYSICAL HISTORY AND ANALYSIS SECTIONS
KLONDIKE GOLD RUSH NATIONAL HISTORICAL PARK
SKAGWAY, ALASKA

Prepared by
Catherine H. Blee, Archeologist,
Robert L. Spude, Historian
and
Paul C. Cloyd, E.I.T. Historical Architect

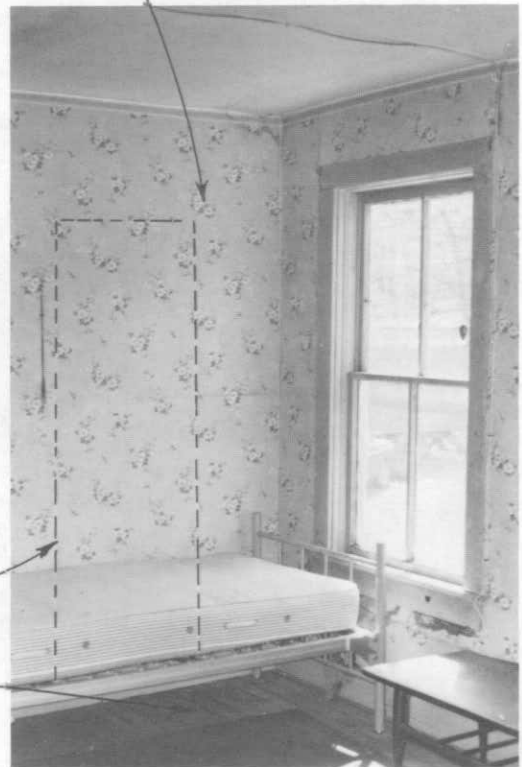
Photograph 31. Southeast corner.

Repair floor as required

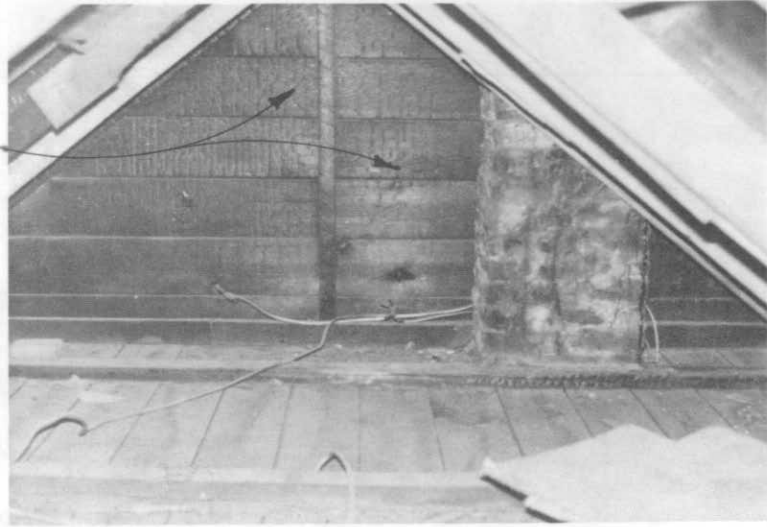
Photograph 48. West end.

Damage from 1973 fire

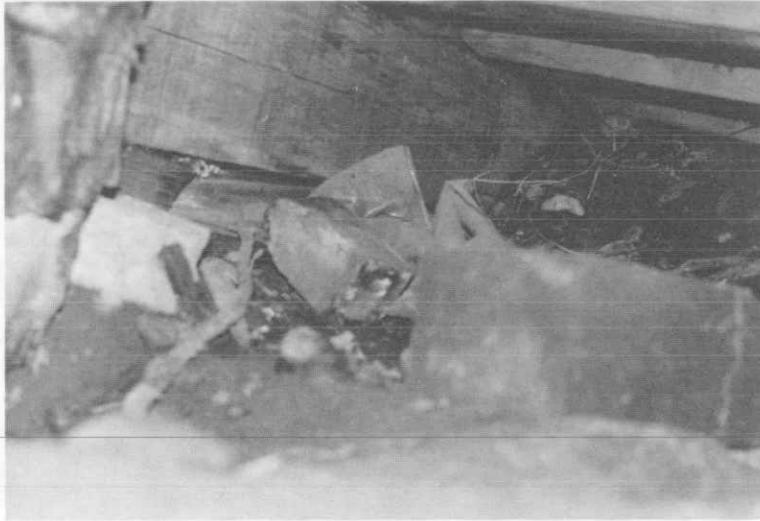
Photograph 50. West building, southwest foundation.

Earth fill in area of foundation failure

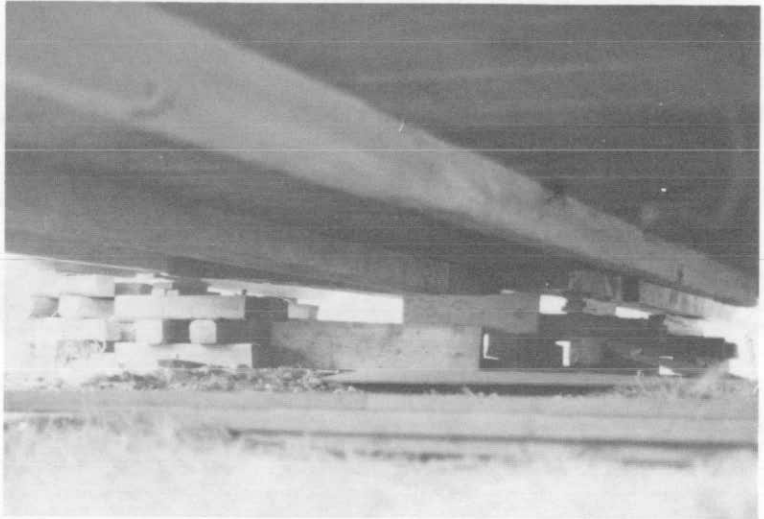
Photograph 27.

Remove cribbing, install permanent foundation

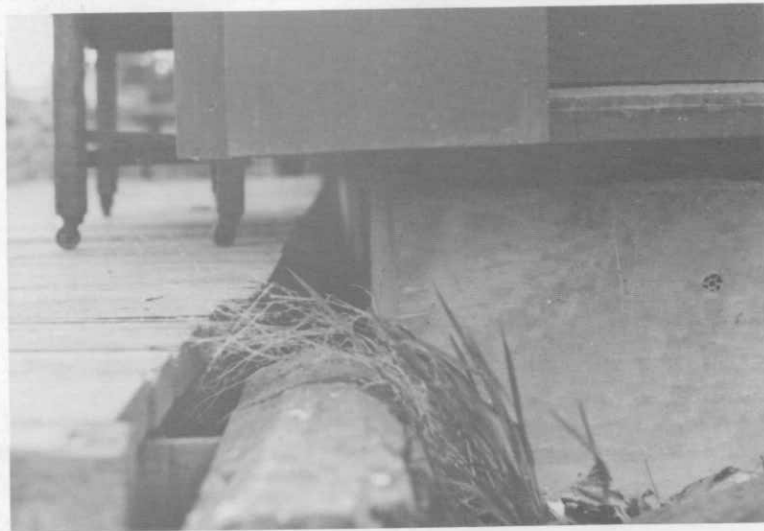
Photograph 22. 1981. Southwest corner.
Building offset from foundation.

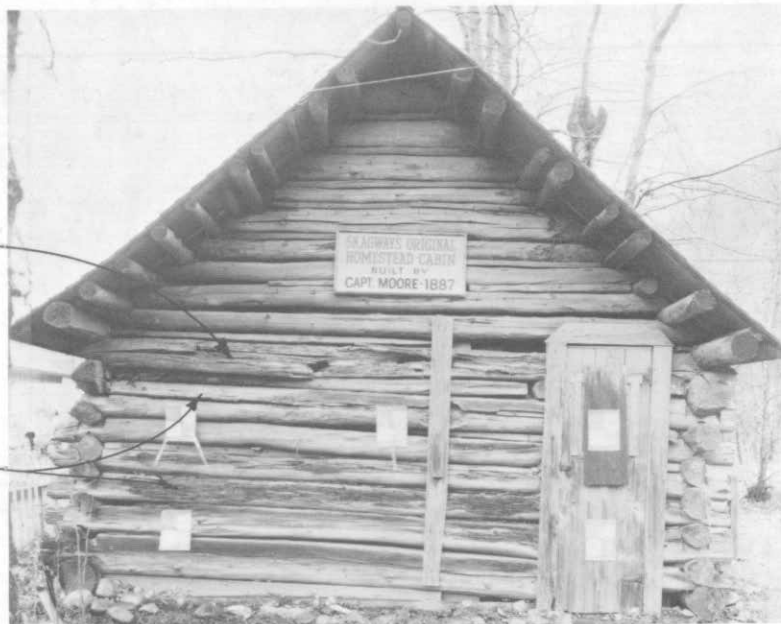
Photograph 64. Moore Cabin, south elevation.

Remove and replace log

Rest treat with epoxy consolidant

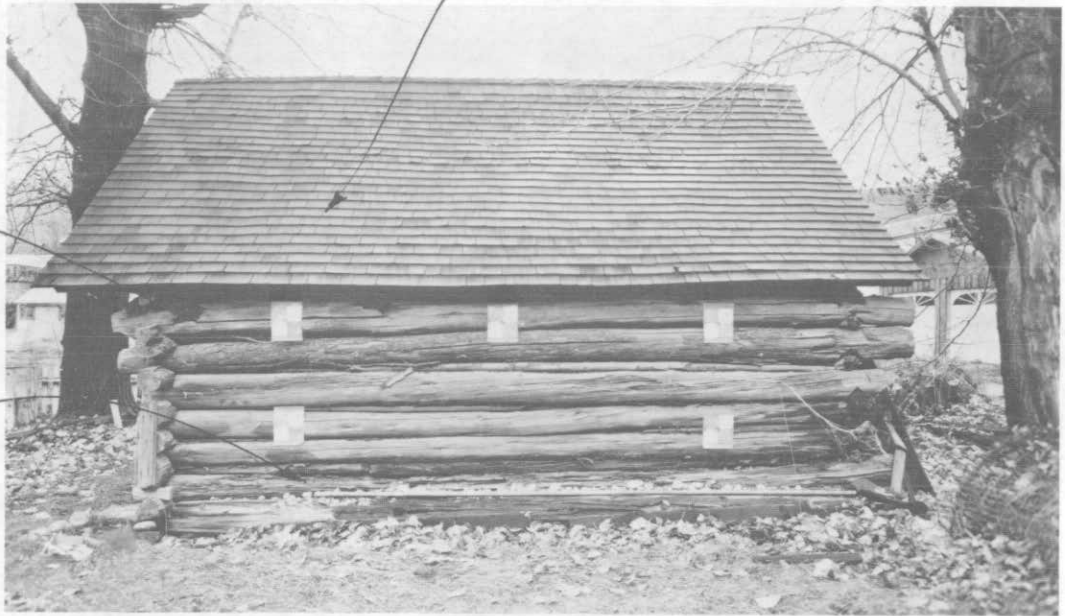
Photograph 66. Moore Cabin, east elevation.

Remove and
replace log

Remove shingles

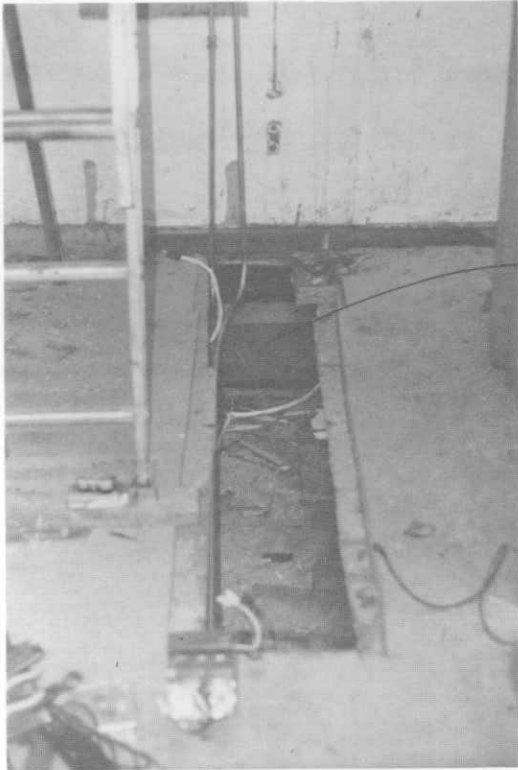
Photograph 42. Room 102, west end.

12 x 12 floor timber resting on grade.
Entire floor structure to be removed
and replaced.

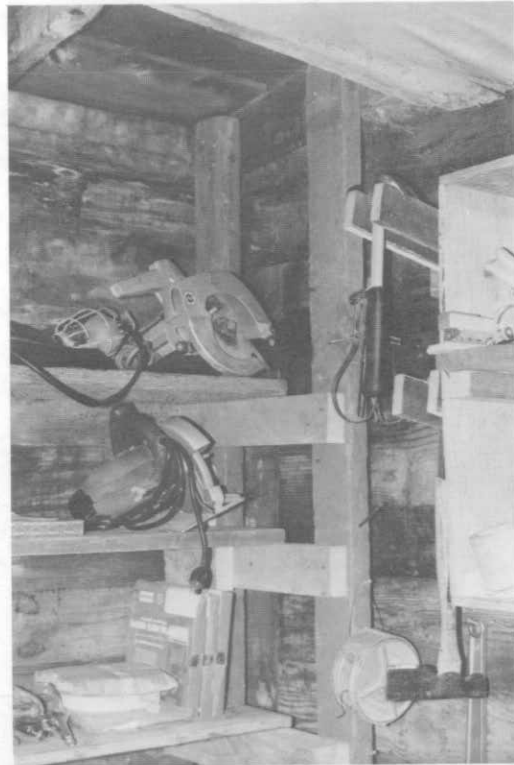
Photograph 60. Room 107B.
Northwest corner.

Remove portions of wallpaper finishes to allow inspection and repair of water damage.

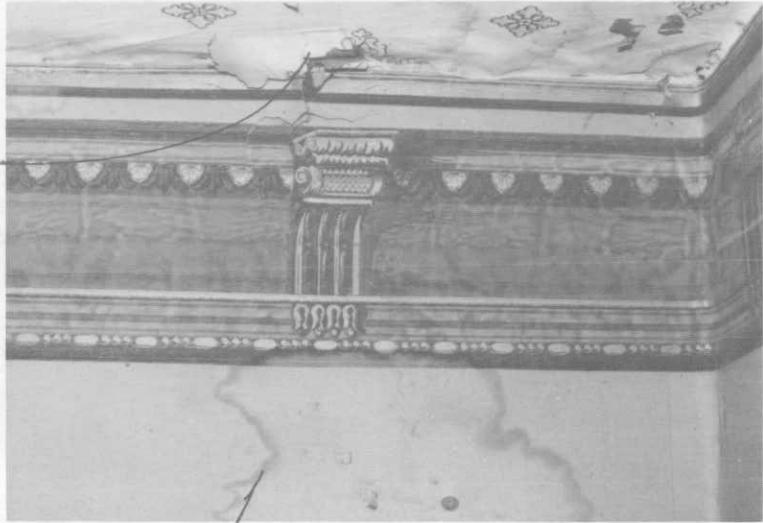
Photograph 61. Border paper detail.

Retain wallpaper in place where no damage is evident

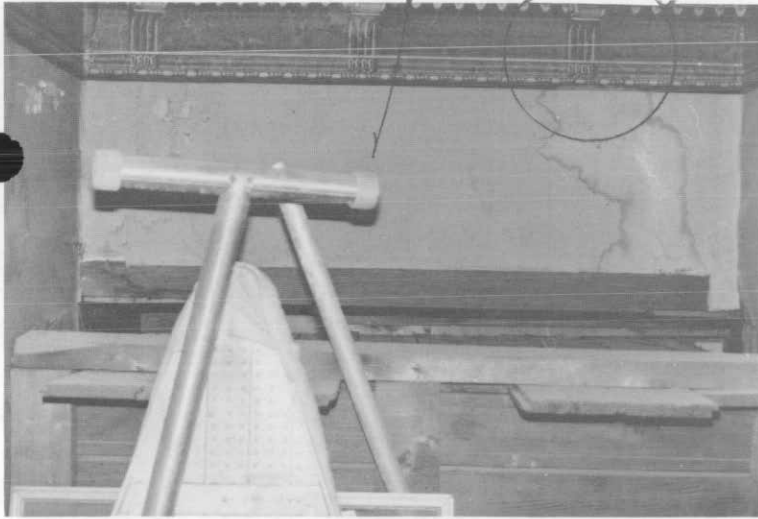
Photograph 62. Room 202, north wall.

Rehabilitate and weatherstrip doorway

Clean and repair floor boards as required
