HISTORIC STRUCTURE REPORT

CHARLES E. ARNOLD HOUSE (HS-20)

Lincoln Home National Historic Site
Springfield, Illinois

August, 1994

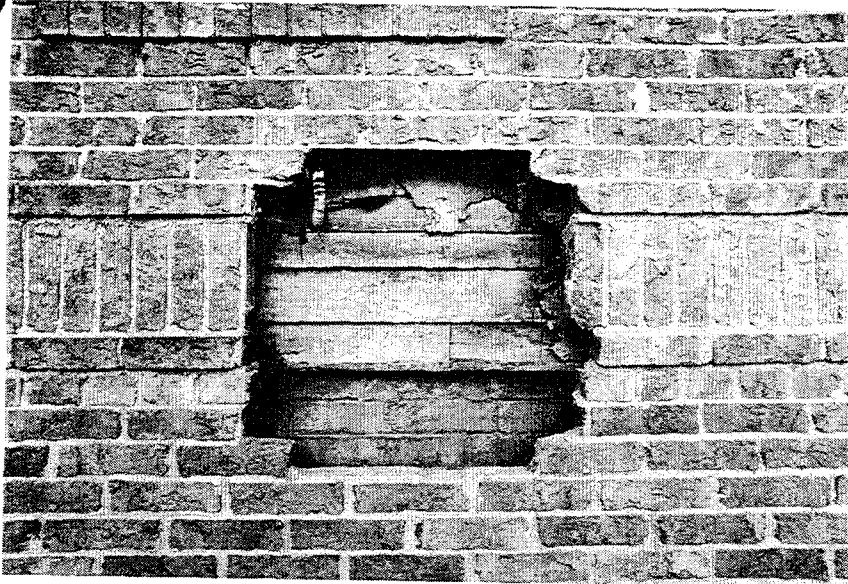
FIGURE 3.5: CLAPBOARD SIDING

This clapboard siding was found behind the brick veneer on the north elevation. Note the narrow spacing of the exposed siding.

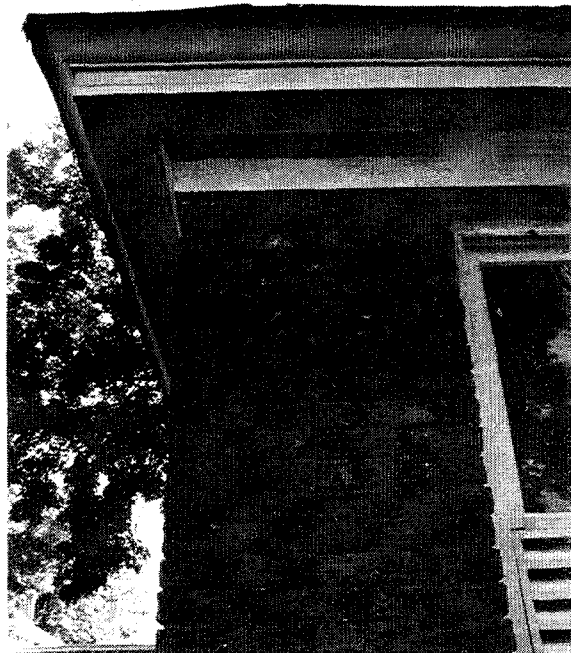
FIGURE 3.6: EAVE DETAIL

Note the missing and repaired section of cove.

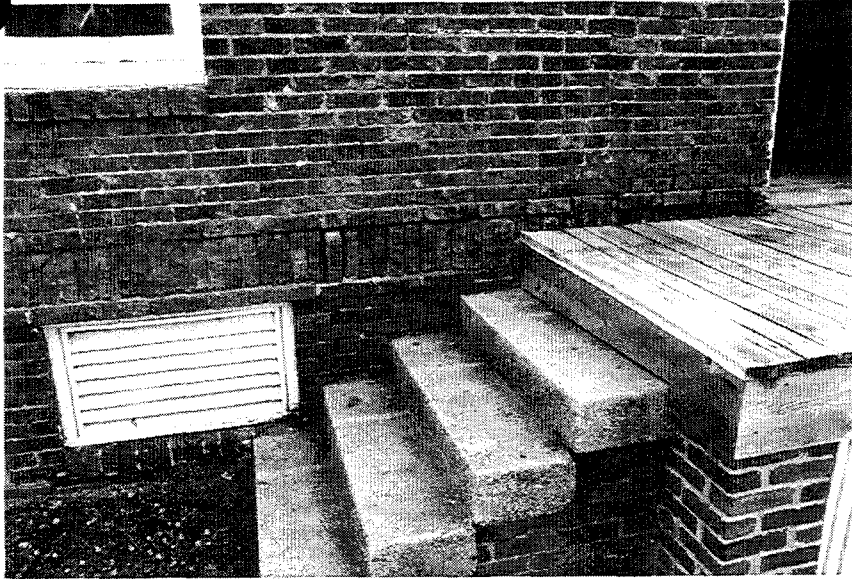
FIGURE 3.7: BRICK BELT COURSE

Deteriorated brick belt course at south porch.

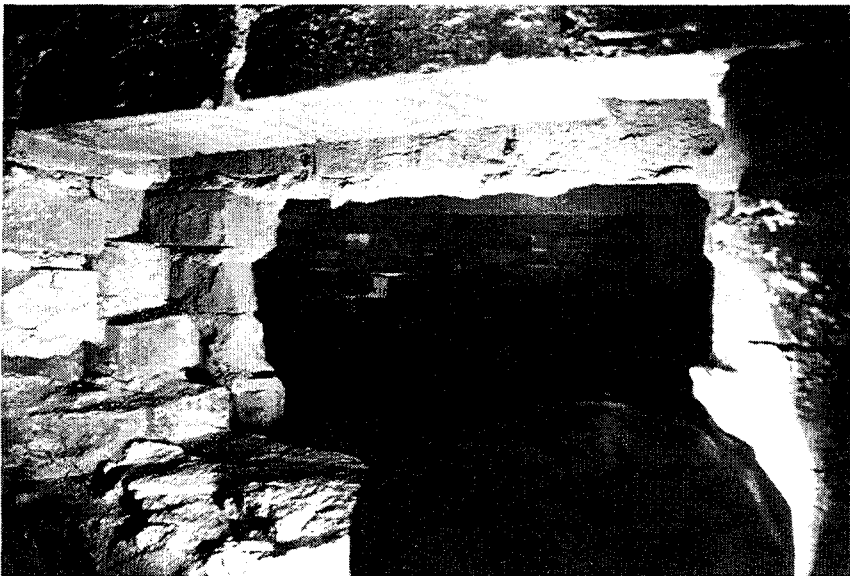
FIGURE 3.8: FOUNDATION WALL AND BRICK VENEER

Opening through the foundation wall and modern brick veneer.

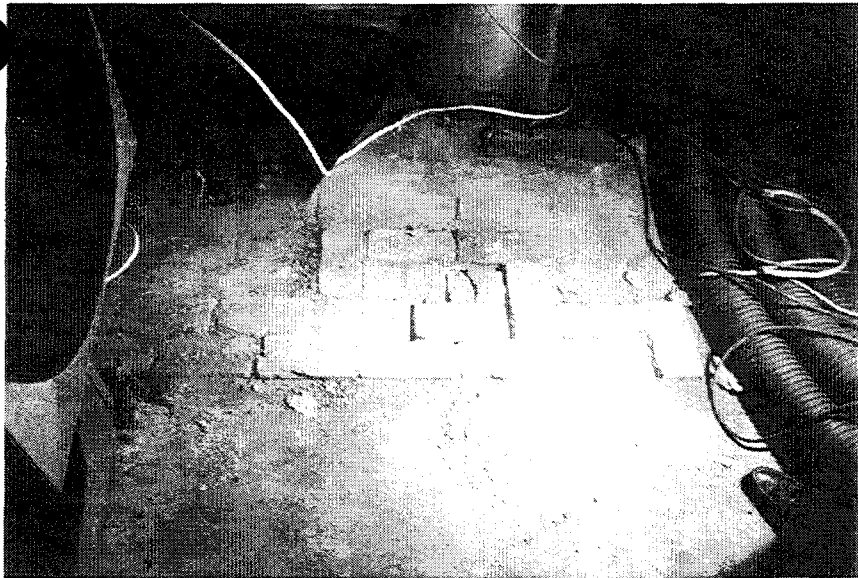
FIGURE 3.9: CHIMNEY FOUNDATION

Brick foundation remnants at the non-extant second chimney.

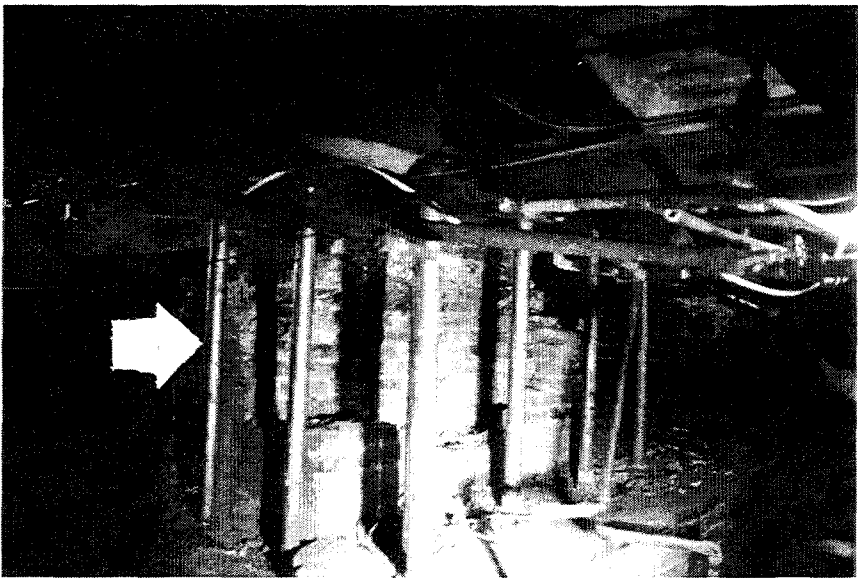
FIGURE 3.10: CHIMNEY FOUNDATION

Brick foundation remnants at non-extant chimney in the 1840 cottage. Note the numerous severed joist-end support columns.

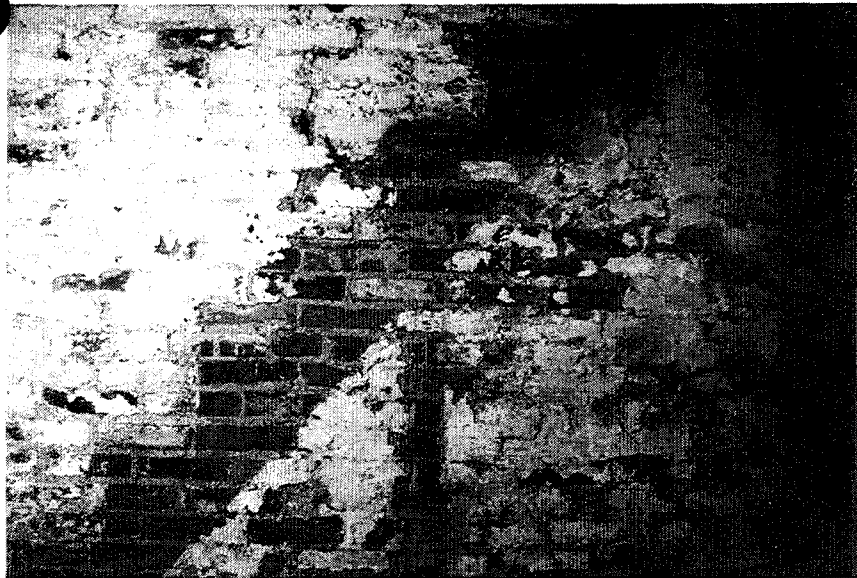
FIGURE 3.11: EVIDENCE OF BASEMENT STAIR

Paint line image of non-extant interior basement access stair.

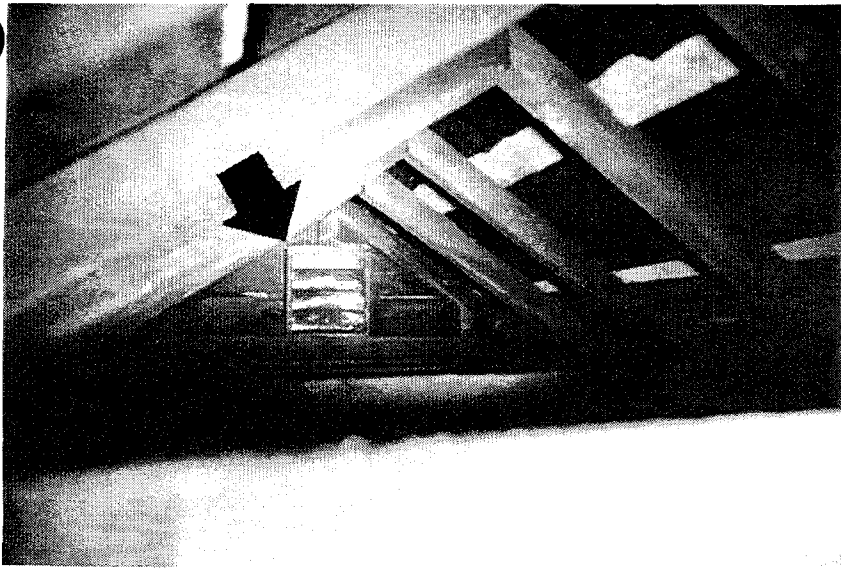
**FIGURE 3.31: ROOF AND GABLE
ENDWALL FRAMING**

View of roof rafters and gable end condition. Note the severed stud at the attic vent louver.

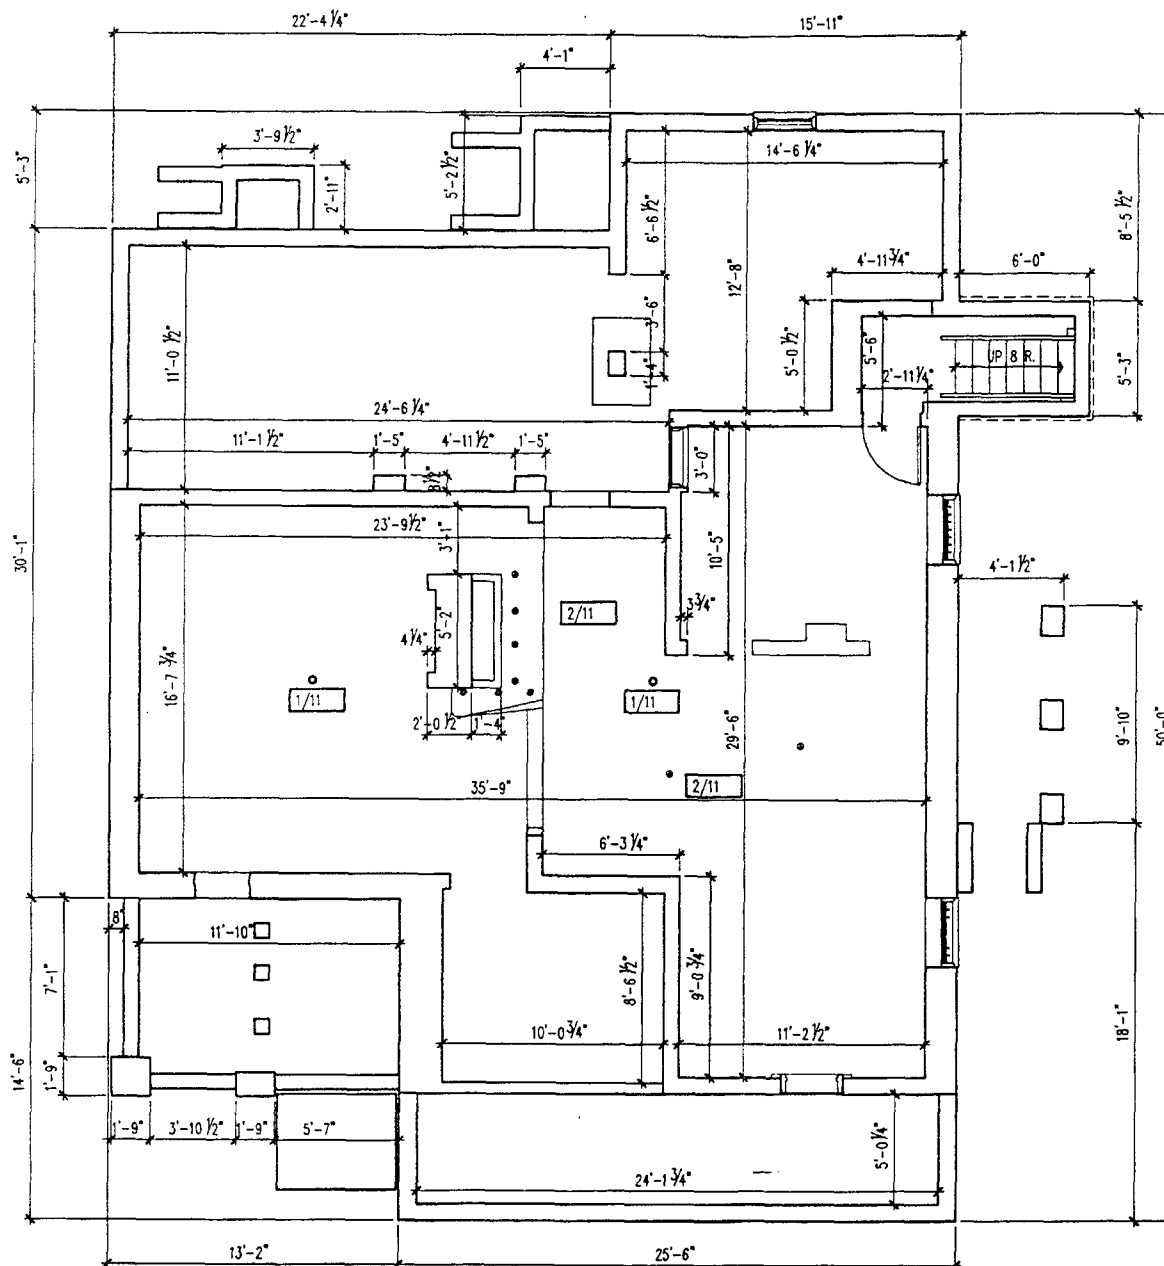
FOUNDATION PLAN
 SCALE: 1/4" = 1'-0"
 0 5 10 FEET

1. AREA OF SIGNIFICANT INSECT DAMAGED SILL BEAM
2. AREA OF SIGNIFICANT MOISTURE DAMAGED SILL BEAM
3. LOCATION OF NON-EXTANT BEAM (LIKELY WOOD) 1"x12" NOTCHES AT BOTTOM OF JOISTS
4. CROSS-BRIDGING AT MIDSPAN OF JOISTS IN THIS AREA
