HISTORIC STRUCTURE REPORT

JULIA SPRIGG HOUSE (HS-11)

Lincoln Home National Historic Site
Springfield, Illinois

May 1995

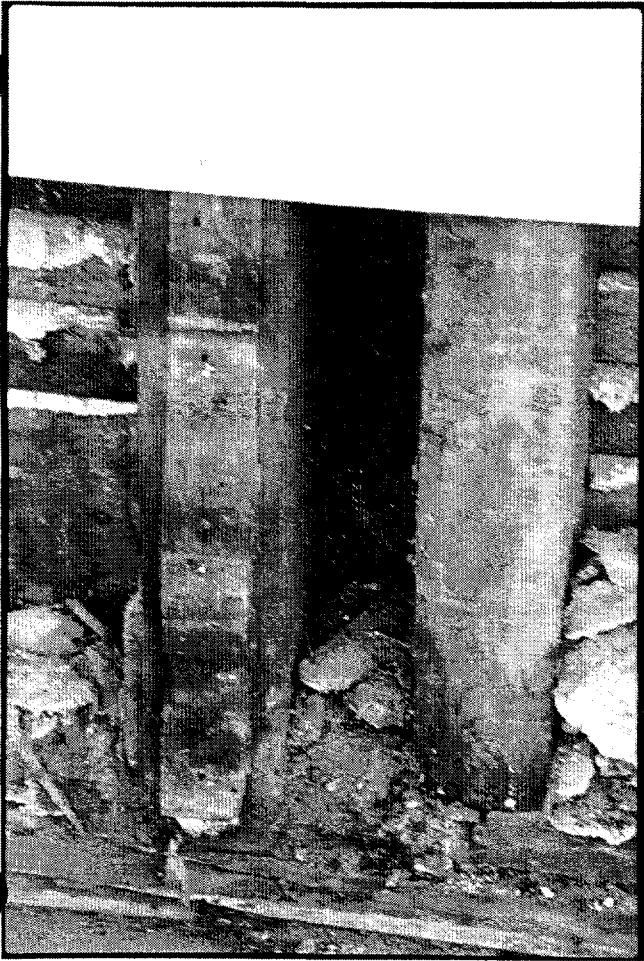
FIGURE 3.18 JOISTS AT THE SOUTHWEST PORCH

These floor joist ends are at the north limits of the southwest porch of the 1851 cottage.

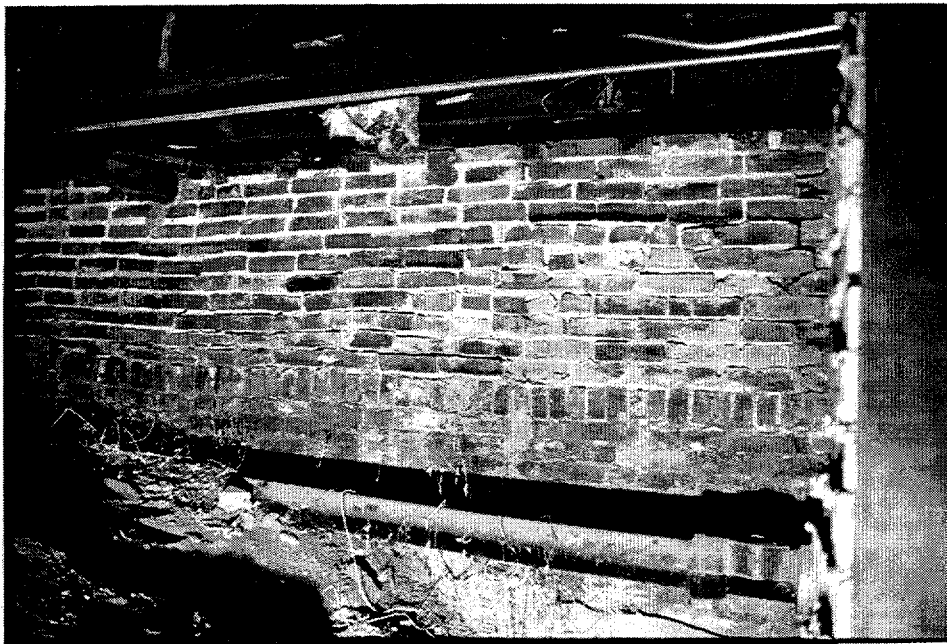
FIGURE 3.20 FOUNDATION WALL AT THE 1874/1879 ADDITION

This is a view of the south foundation wall at Crawl 001 (near the southwest corner). Note the deterioration of the mortar joints and the general failure of the wall itself. Some sunlight can be seen through this wall.

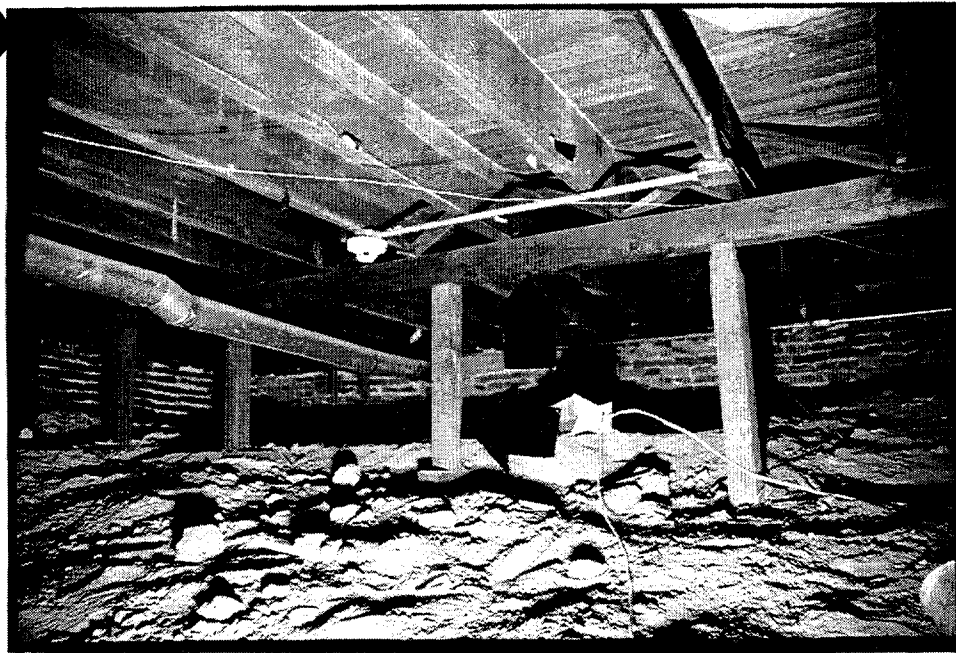
FIGURE 3.21 FIRST FLOOR JOISTS AT THE 1874/1879 ADDITION

This is a view of the first floor joists at Crawl 001. Note the supplemental framing added at mid-span.

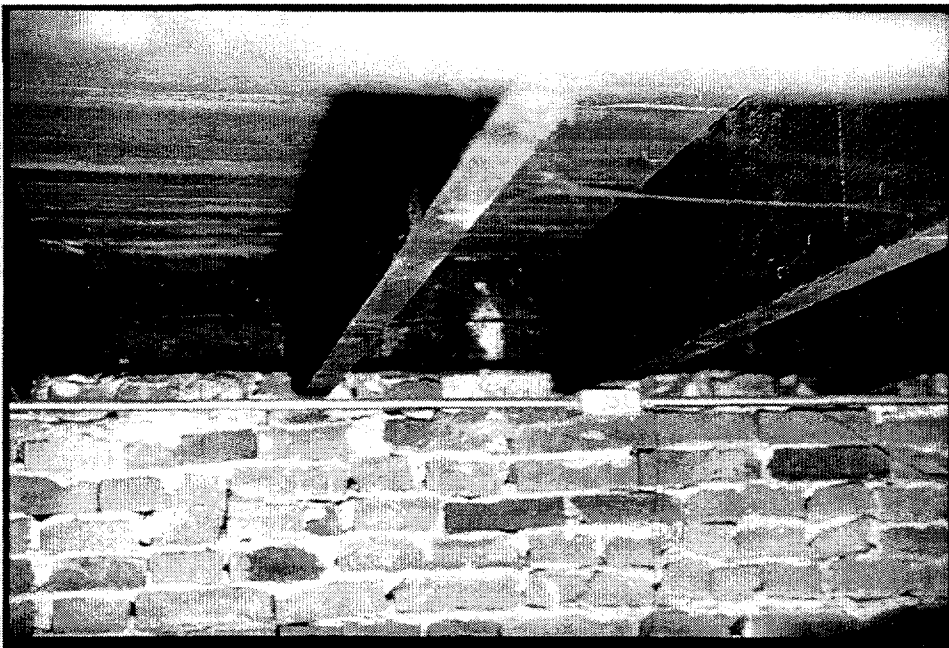
FIGURE 3.22 FIRST FLOOR JOISTS AT THE FOUNDATION WALL

This view shows the bearing condition at the east end of the first floor joists of the 1874/1879 addition in Crawl Space 001.

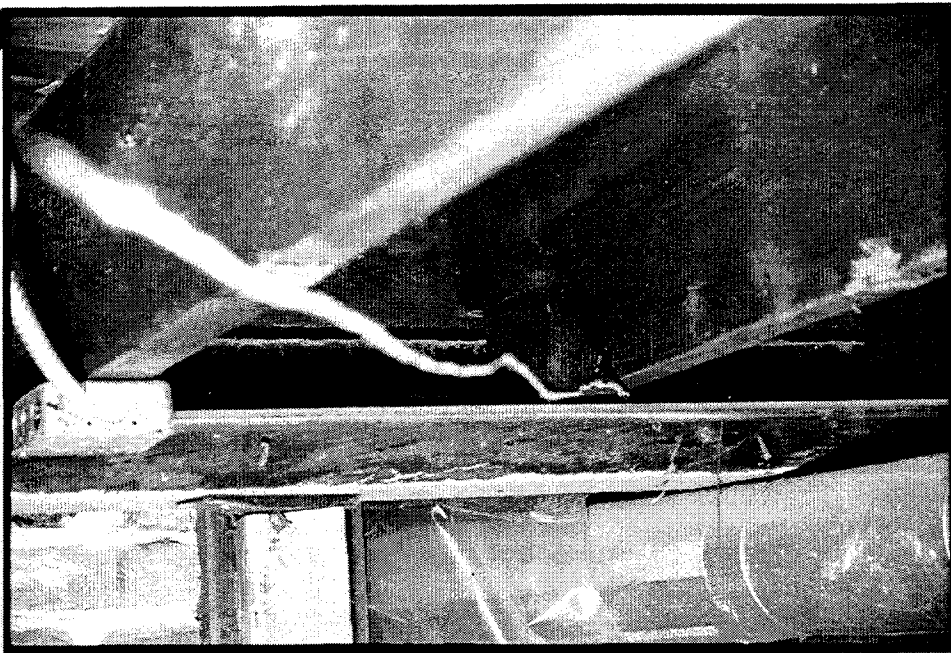
FIGURE 3.23 FIRST FLOOR JOISTS AT THE WEST SILL BEAM

This is a view of the bearing condition at the west end of the first floor joists of the 1874/1879 addition in Crawl Space 001.

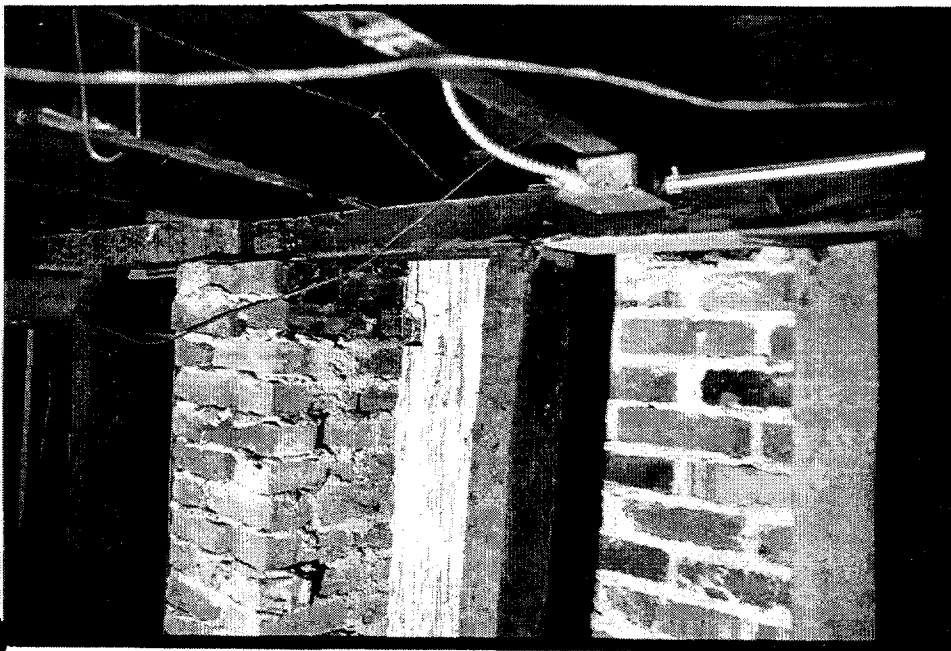
FIGURE 3.24 FIRST FLOOR JOISTS AT THE WEST SILL BEAM

This is a view of supplemental framing added under the west ends of the first floor joists of the 1874/1879 addition in Crawl Space 001. This beam rests on brick columns.

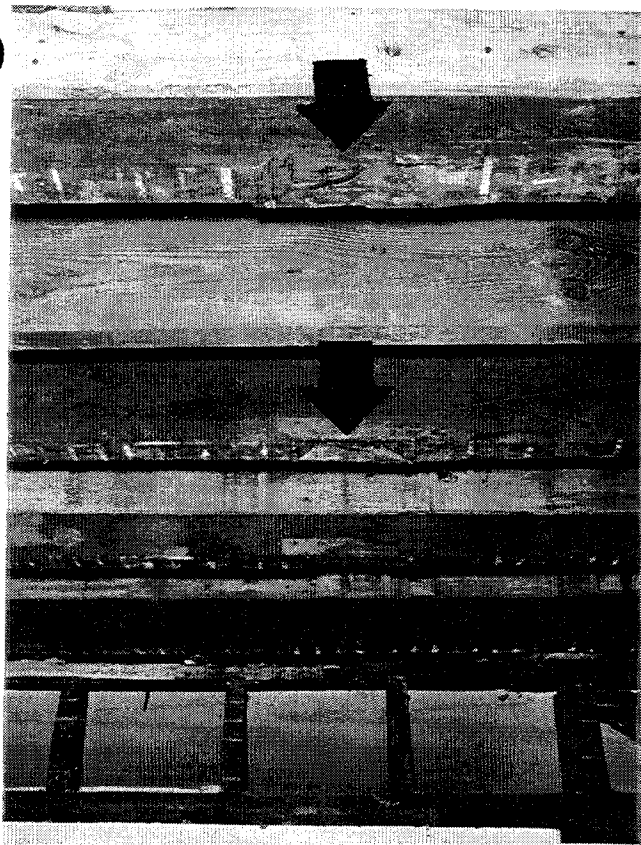
**FIGURE 3.35 1851
COTTAGE CEILING
JOISTS AT ROOM 103**

This notched condition occurs at each of the 1851 ceiling joists at Room 103. Additionally, there are existing extra large cut nails (or spikes) at each notch. These notches indicate the location of an interior partition wall aligned with a non-extant intermediate east wall post and the north wall of the southwest porch.

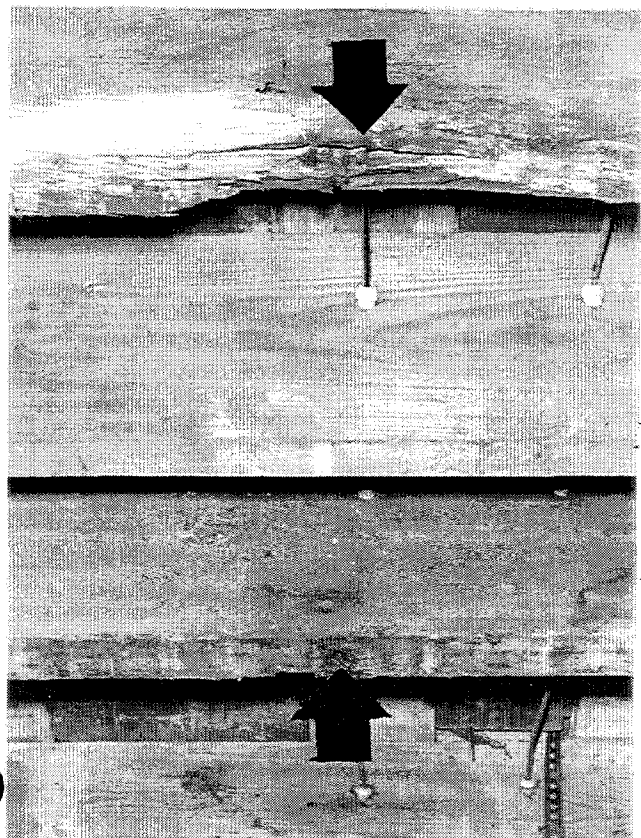
**FIGURE 3.36 1851
COTTAGE CEILING
JOISTS AT ROOM 107**

These extra large cut nails (or spikes) occur at each of the 1851 ceiling joists at Room 107, indicating the location of the north wall of the southwest porch. Additionally, this wall aligns with not only the interior partition wall indicated in Figure 3.35, but also with a braced corner post at the west wall.

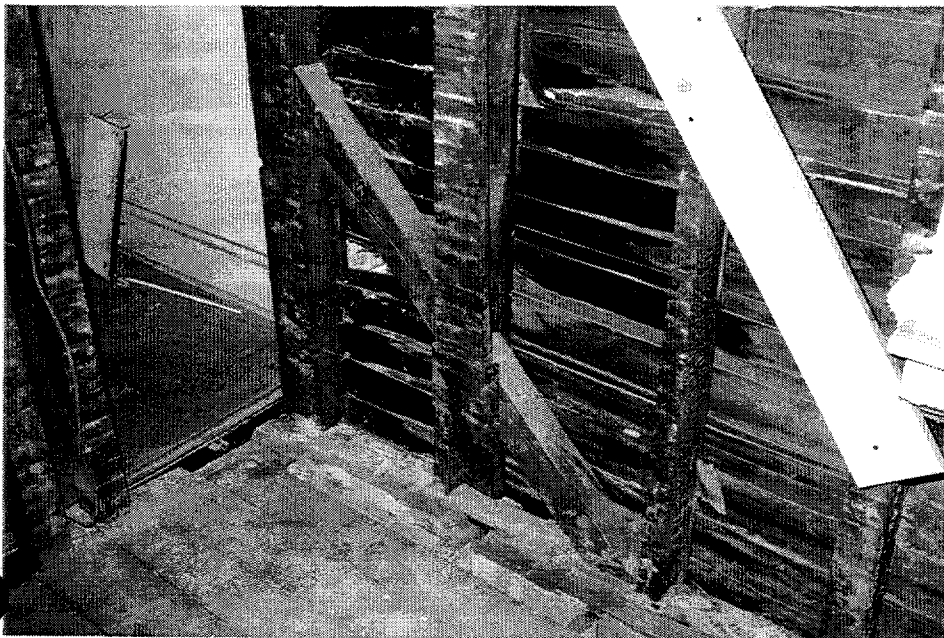
**FIGURE 3.38 BRACED
CORNER POST**

Similarly braced corner posts still exist at many of the cottage's outside corners.

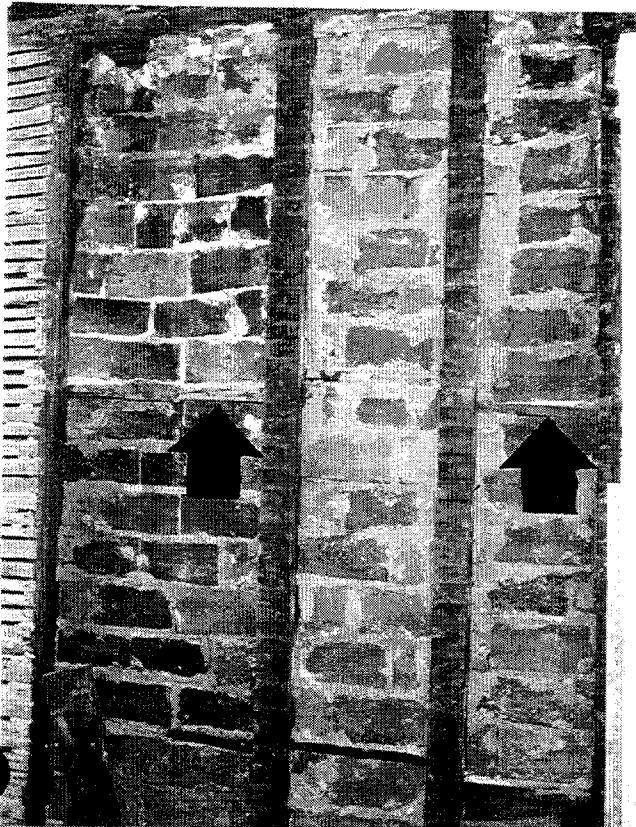
FIGURE 3.40 BRICK NOGGING

This brick nogging was found inconsistently throughout the north and east exterior walls of the cottage. Note the wood shelves (see arrows) at varying locations in the nogging.

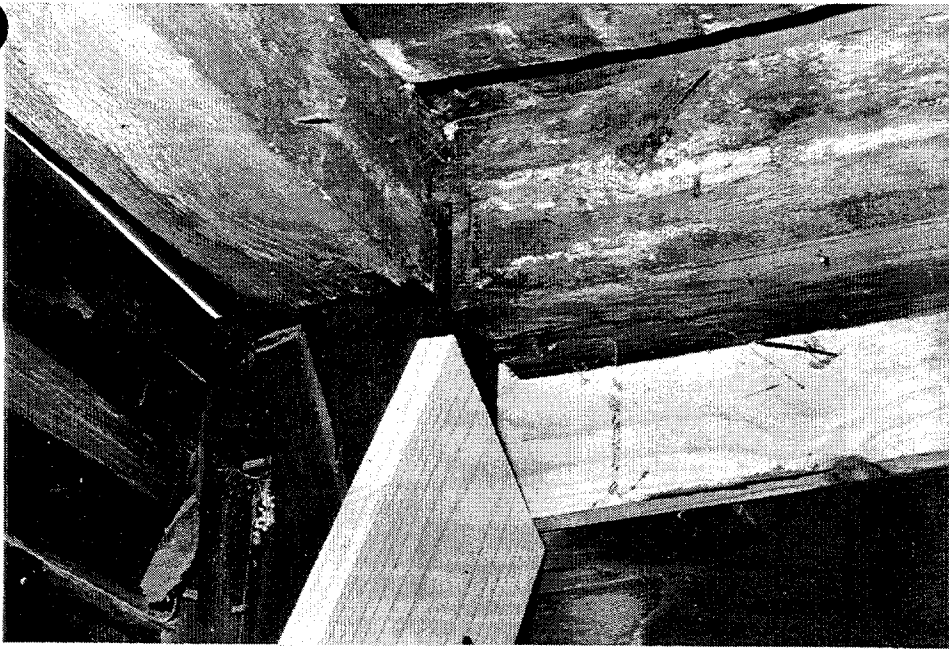
**FIGURE 3.41 SOUTH-
WEST PORCH COR-
NER POST**

This 1851 cornerpost was discovered in place in the wall of Room 107. Note the framing conditions of the post's intersection with the beams.

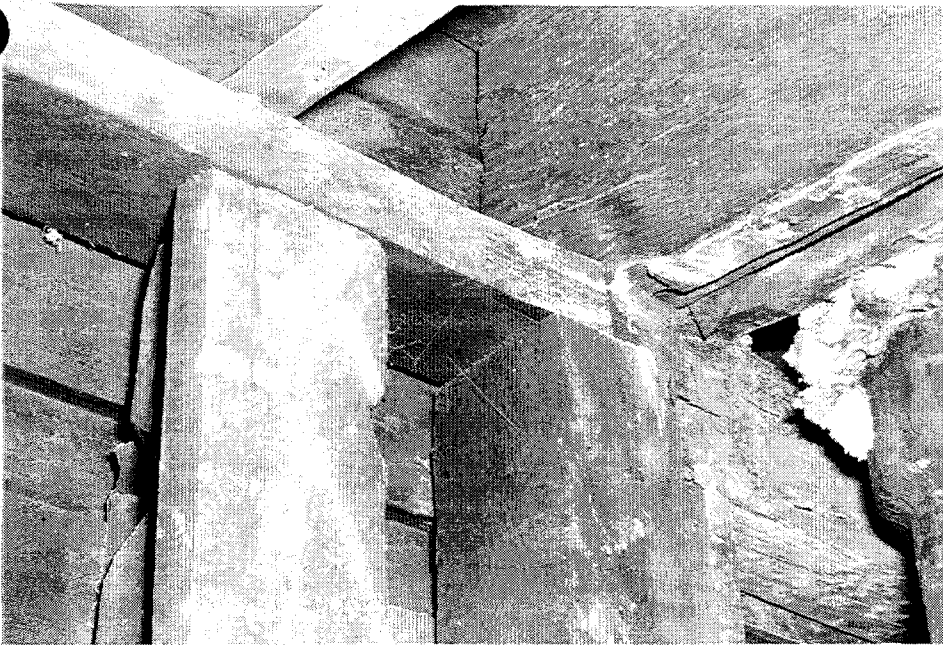
FIGURE 3.43 SOUTH PORCH BEAM OF SOUTHWEST PORCH

This view shows the framing condition of the south beam of the southwest porch at the south wall corner post.
