LINCOLN HOME  
INTERIOR AND EXTERIOR RESTORATION  
LINCOLN HOME NATIONAL HISTORIC SITE  
HISTORIC STRUCTURE REPORT  
ARCHITECTURAL DATA SECTION - VOLUME II

Architectural Data Section - Volume II of II

Lot 8 - Block 10  
Lincoln Home National Historic Site  
Springfield, Illinois

20 February 1984

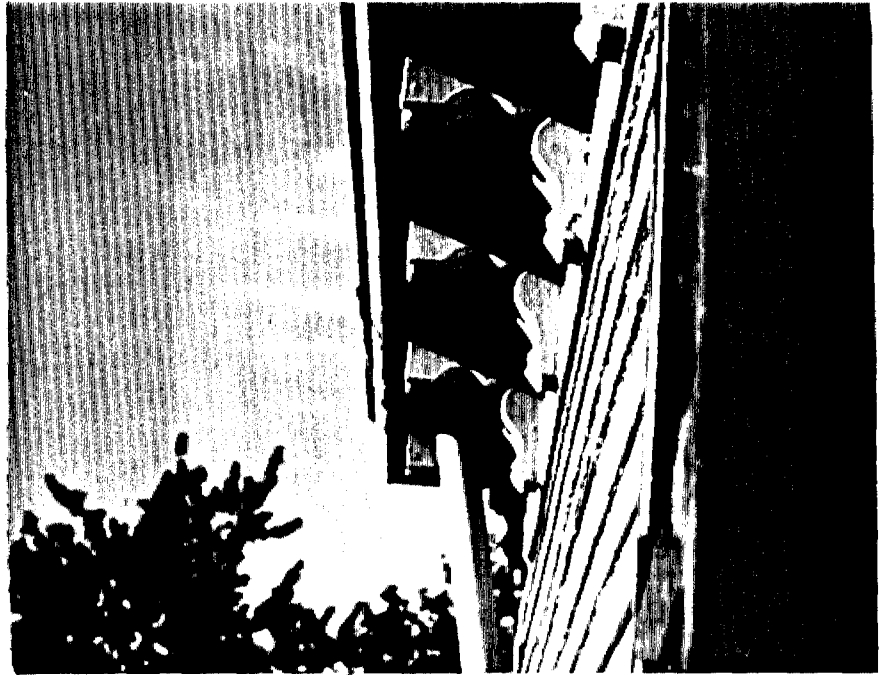
Photo showing deteriorated paint on siding, faceboards, and brackets. Top part of building, east side.

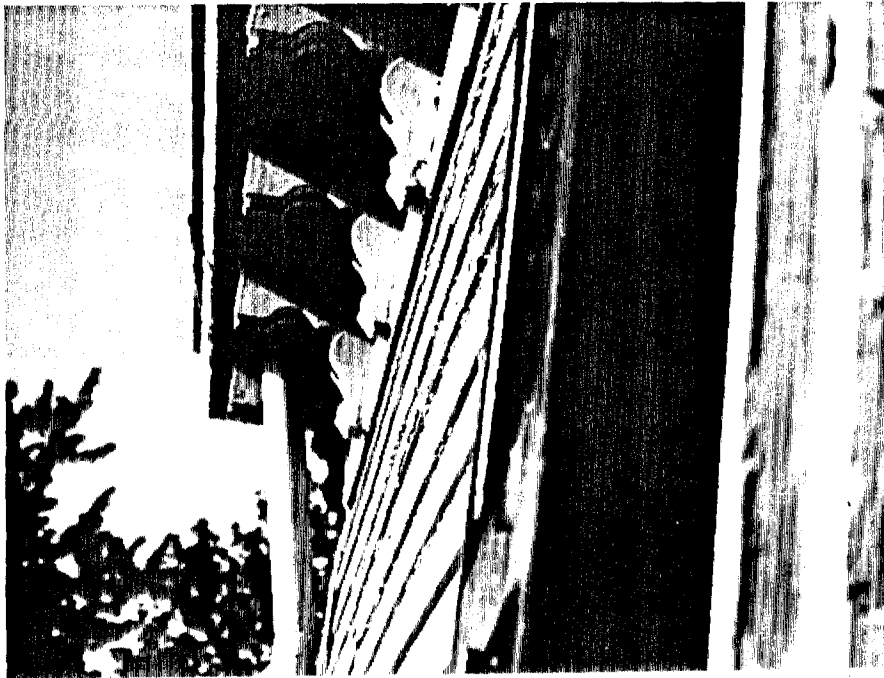
Photo showing badly deteriorated paint on board siding of wall, east side. Also part is original paint.

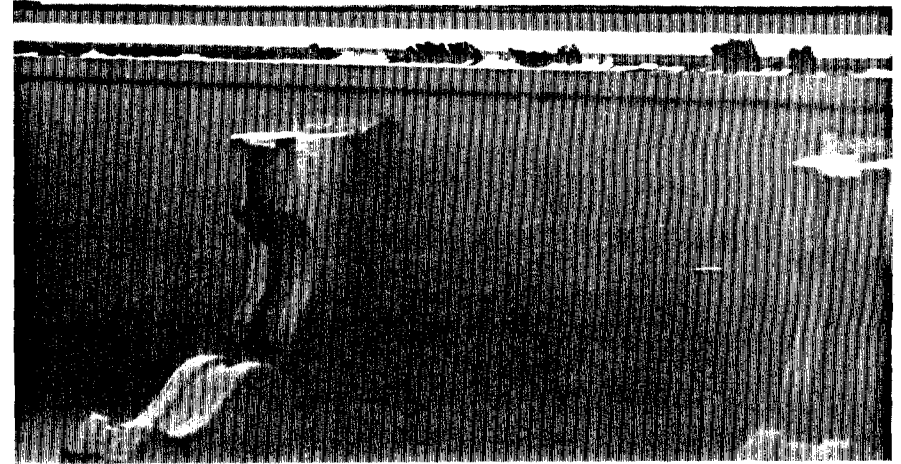
Photo showing deteriorated paint on facer board and soffit brackets on back side, east. About 31 layers of paint on this area.

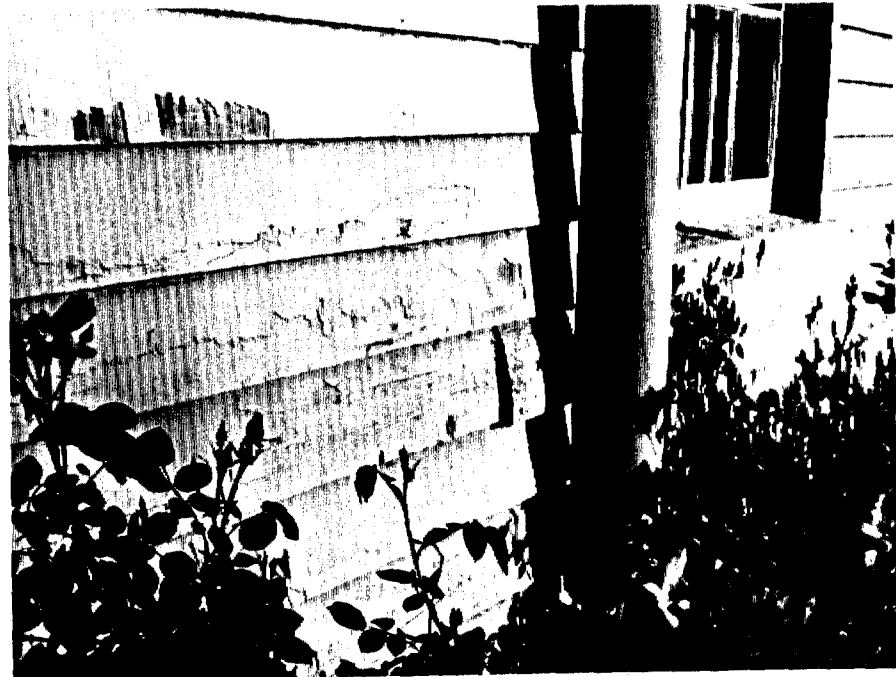
Photo showing deteriorated paint on siding boards on back side, east. Also some of these siding boards had 31 layers of paint; part of this paint is the original paint.

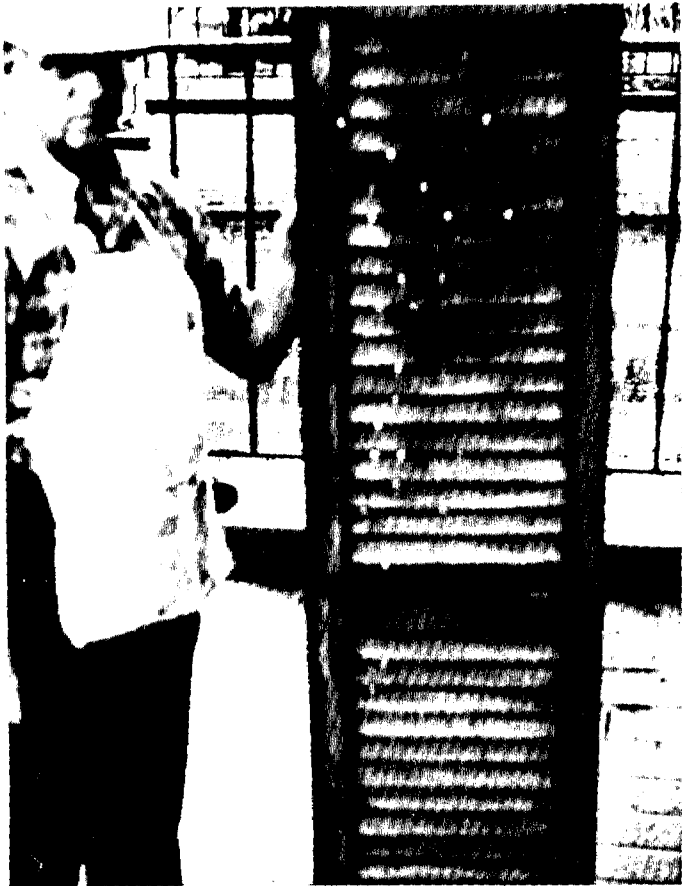
Photo showing paint removed from shutter. All of the shutters had the paint removed the same way with caustic Soda-Flake - 76%  $\text{NA}_2\text{O}$ .

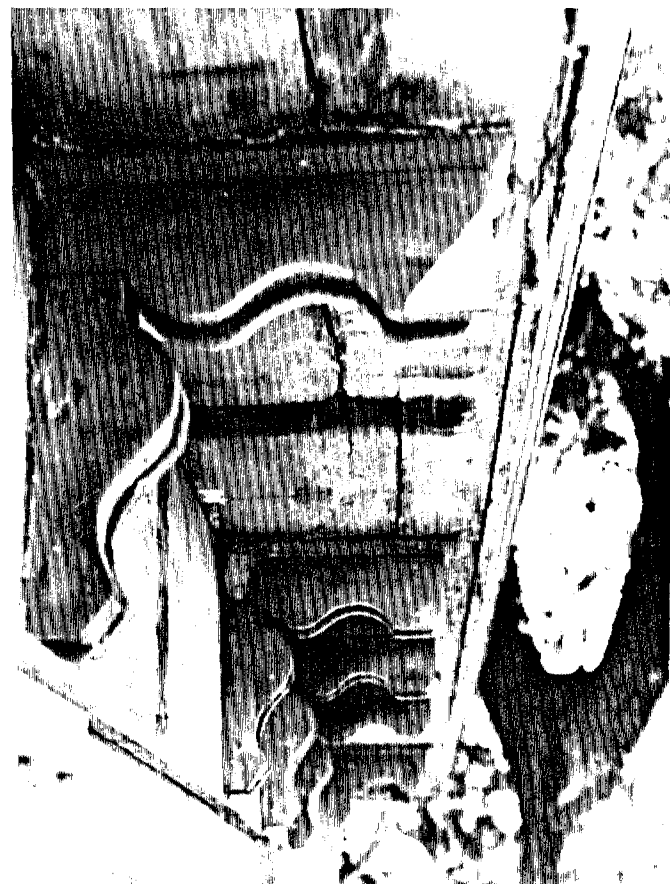
Photo showing paint completely removed from eave and brackets. Also showing some deterioration in wood on back side, east.

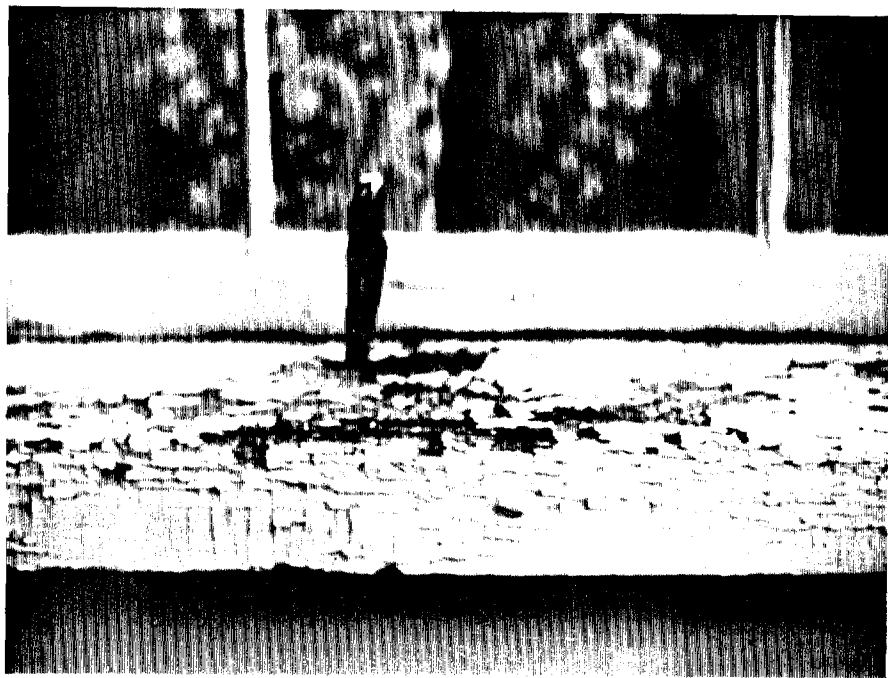
Photo showing deterioration of windowsill on south side.

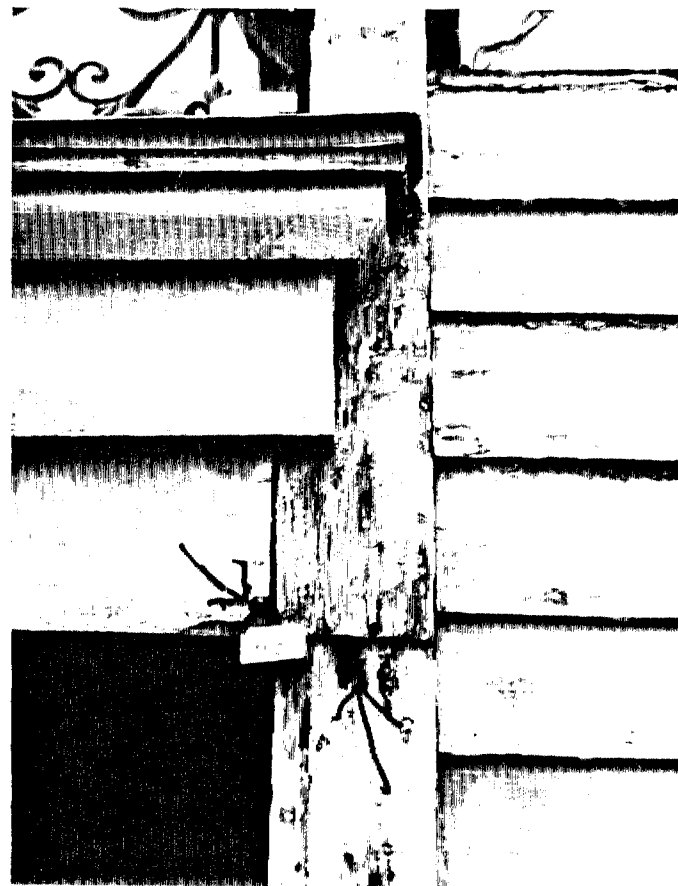
Photo showing some of the deteriorated areas in the materials trim and siding. Arrow shows these areas.

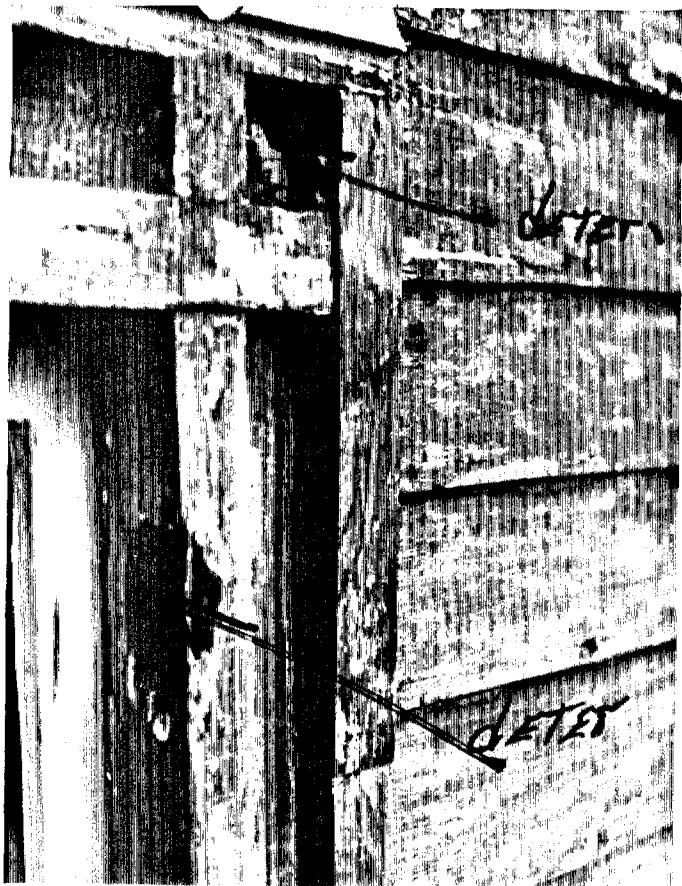
Photo showing deterioration in trim and siding. Arrow showing this.

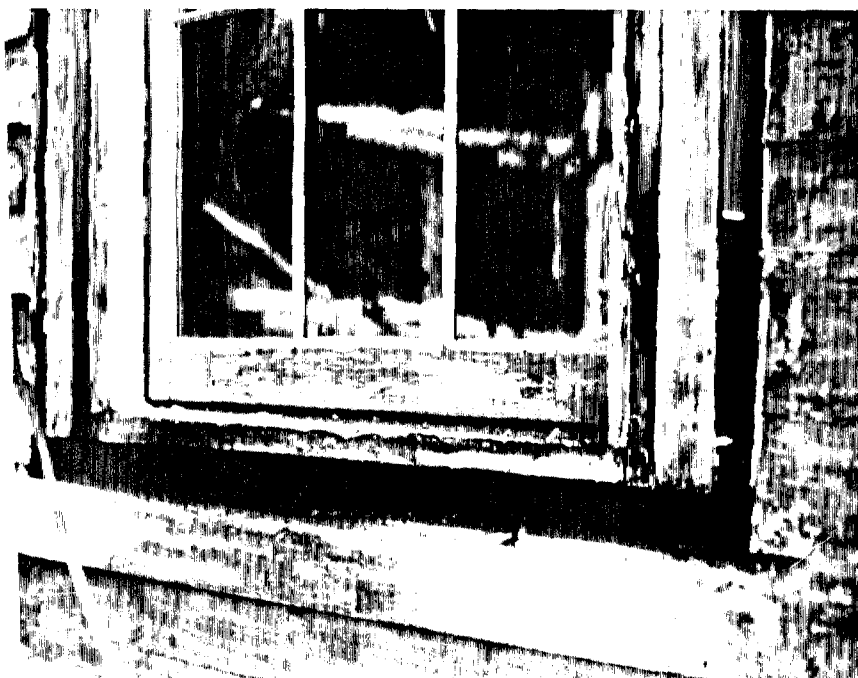
Photo showing deteriorated trim removed around window jamb, front (west).

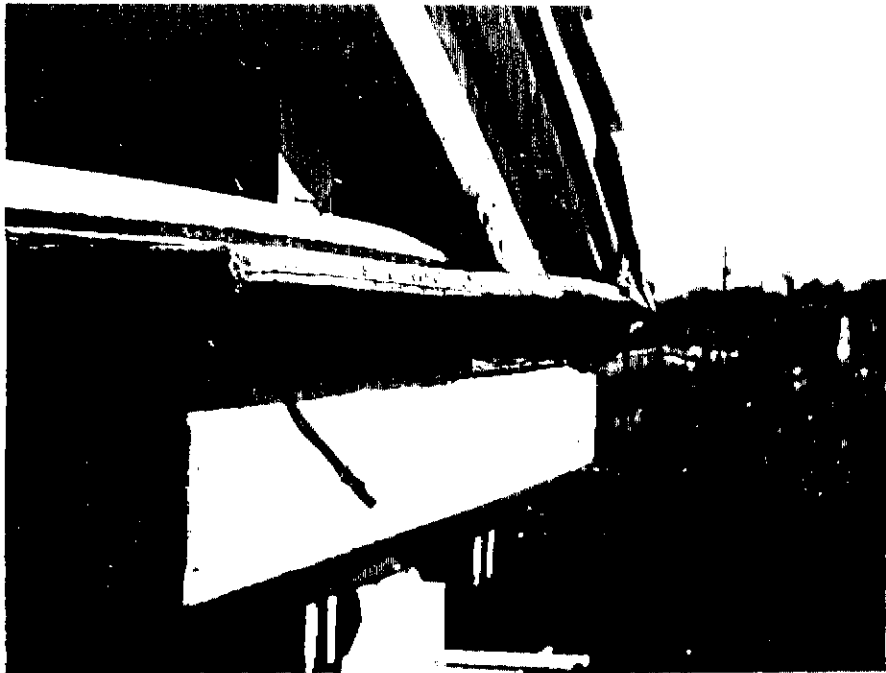
Photo showing deteriorated trim from soffit removed. Arrow shows this, south side.

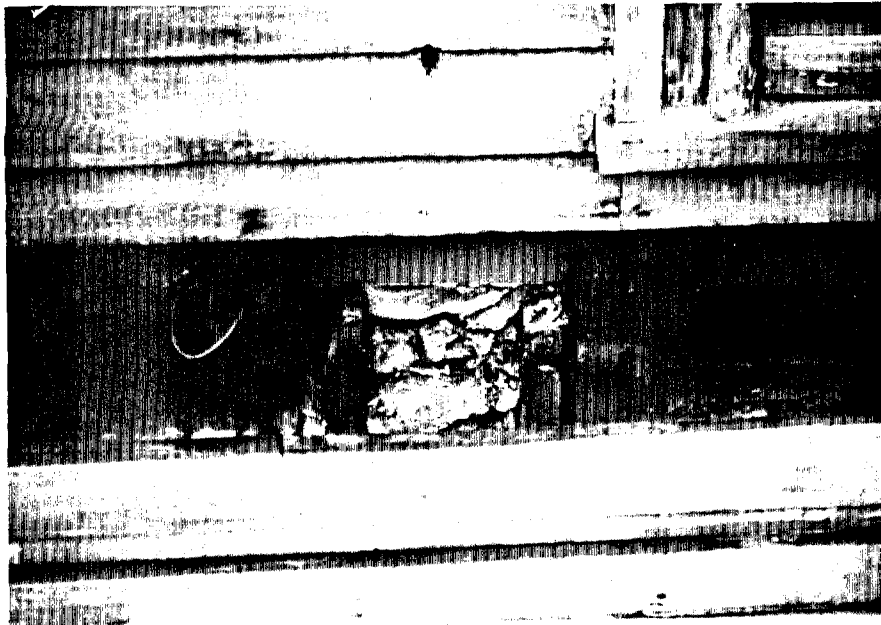
Photo showing deteriorated board (siding) removed. Also original floor joist. This is on second floor, south side.

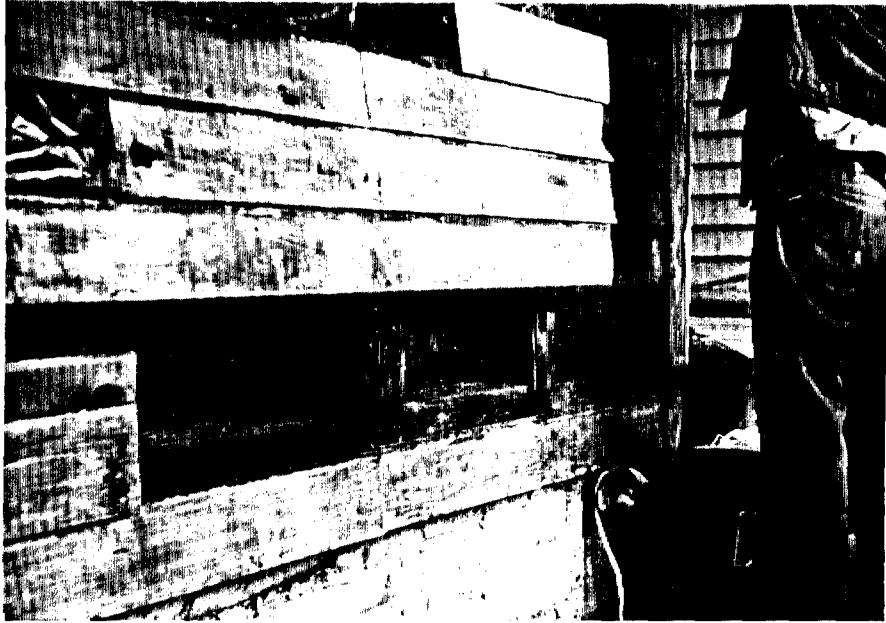
Photo showing deteriorated siding removed. Also showing plate sill (bottom). Note hand-hewn log. Arrow showing log, east side, back by porch.

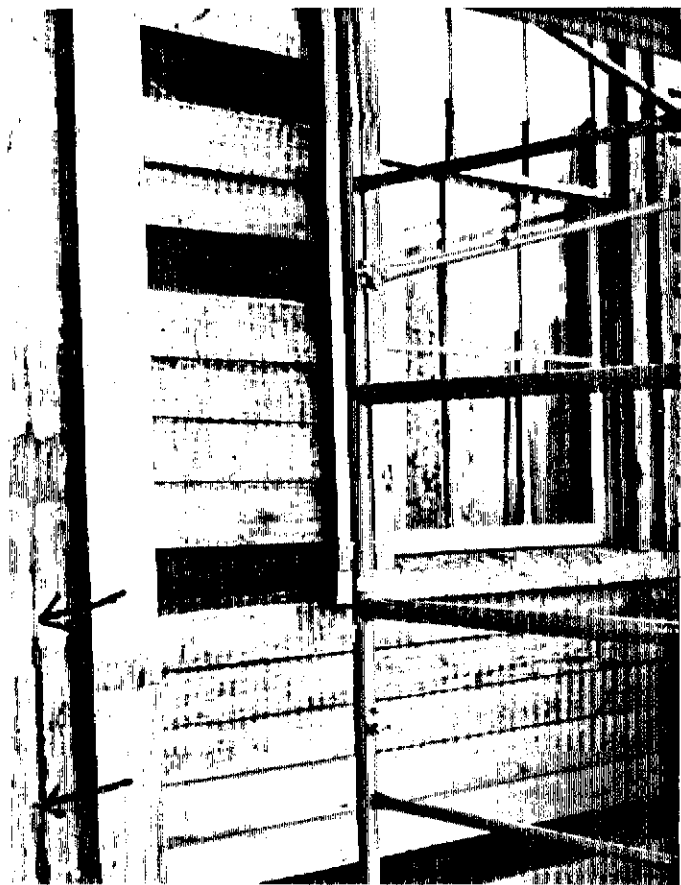
Photo showing deteriorated board siding from some of the areas on west side (front). Also arrow showing structural epoxy used on deteriorated areas.

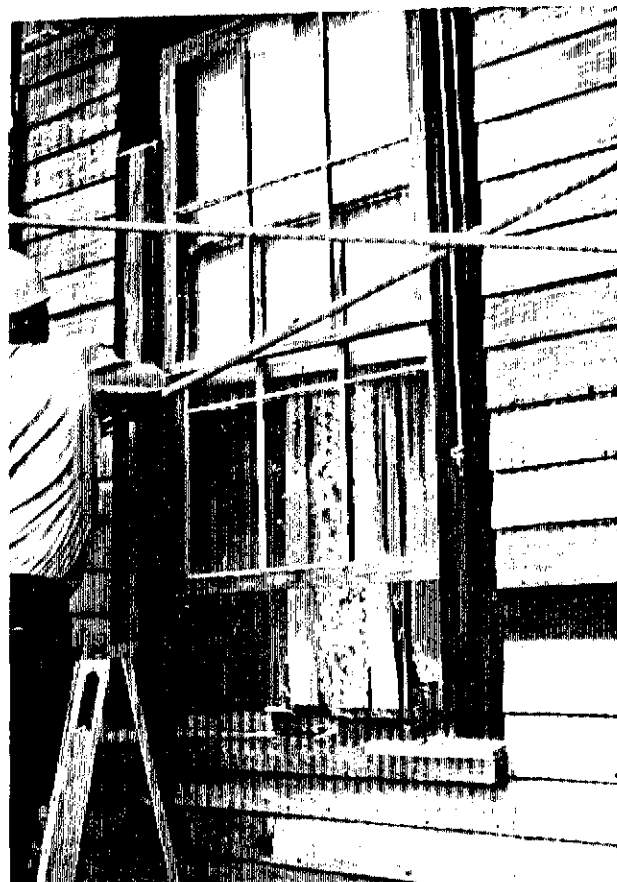
Photo showing part of deteriorated window trim cut off lower window in front, (arrow) southwest end. Also showing patched sill.

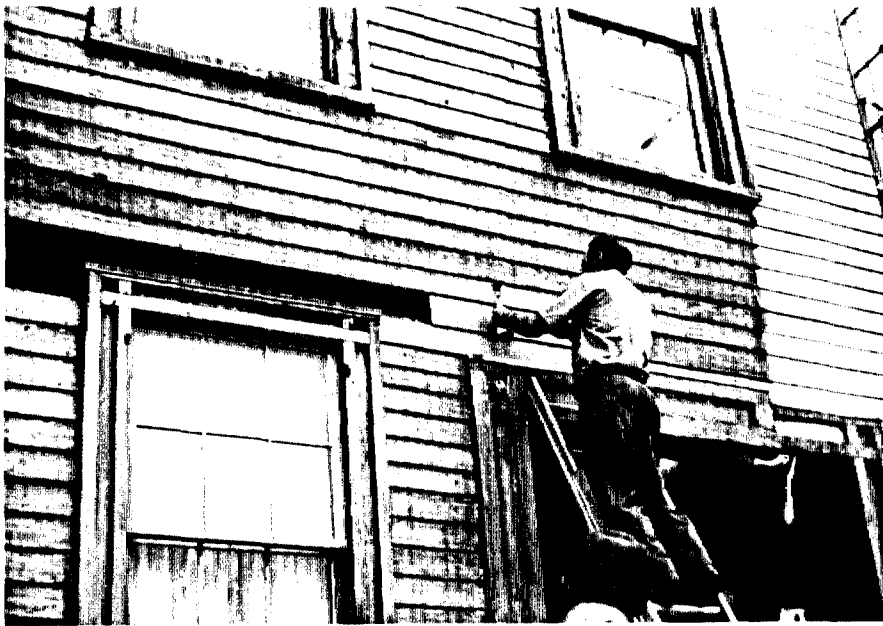
Photo showing workman replacing deteriorated siding board with nonhistoric old materials. Arrow showing board.

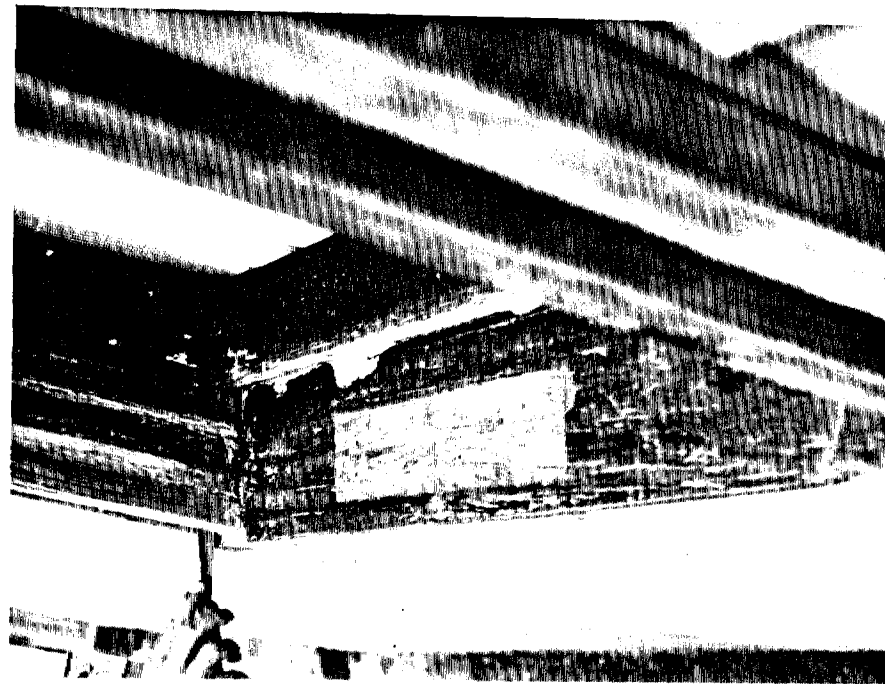
Photo showing windowsill wood plant. Also structural epoxy used on partly deteriorated sill.

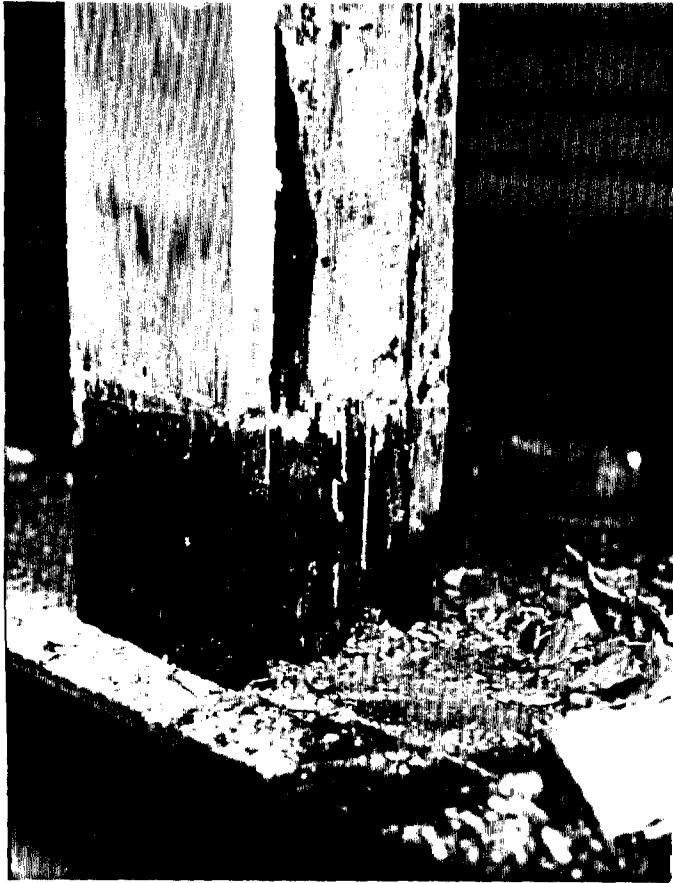
Photo showing deteriorated porch column before treatment, on south side.

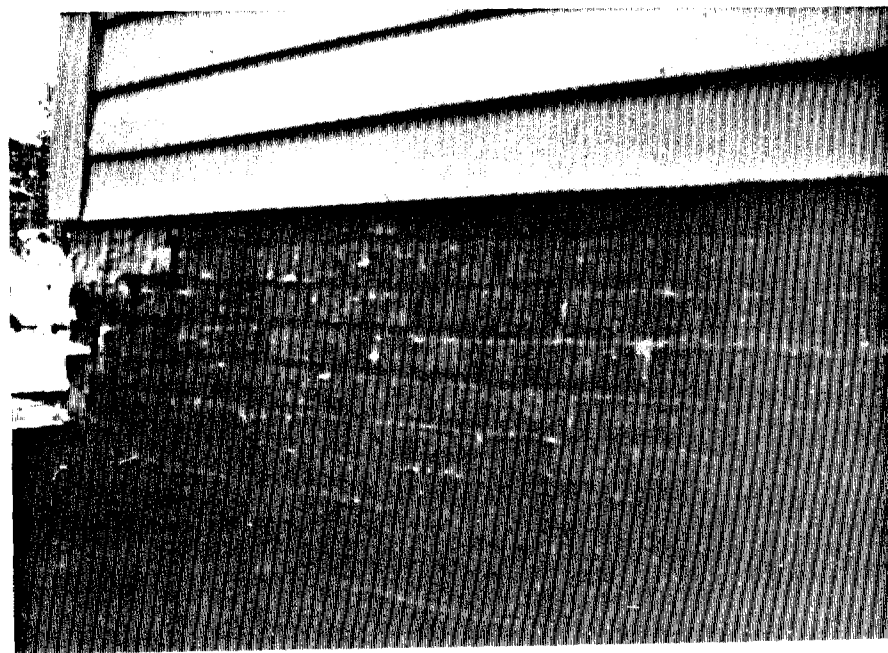
Photo showing deteriorated mortar from joints.  
Almost all the old mortar had a cut-back.

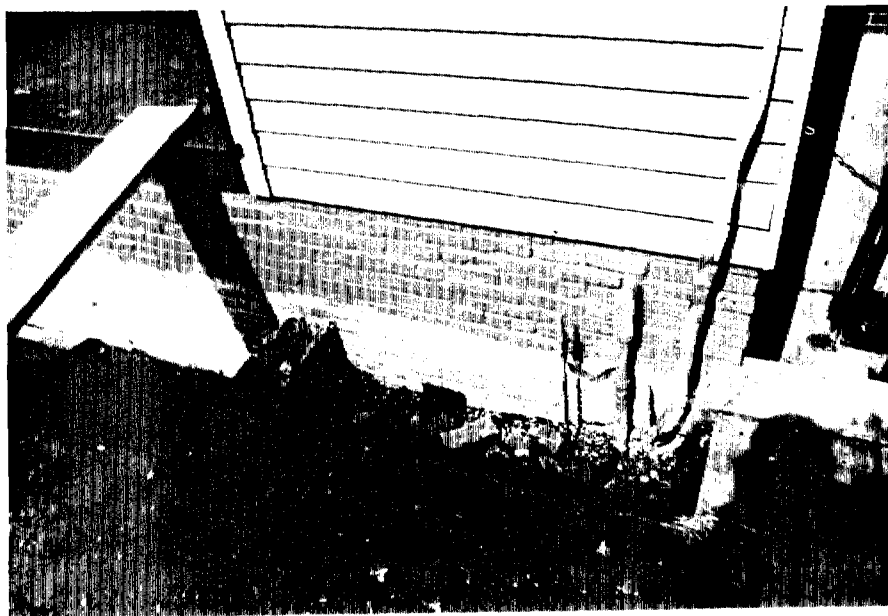
Photo showing new mortar in joints. Also brick painted Exterior Masonry, Munsell Color Gray 5 BY 5/1. East side.
