HISTORIC STRUCTURES REPORT
ARCHITECTURAL DATA, PART I

REHABILITATION AND RESTORATION
OF THE
DOGAN HOUSE

MANASSAS NATIONAL BATTLEFIELD PARK
Virginia

April 1960

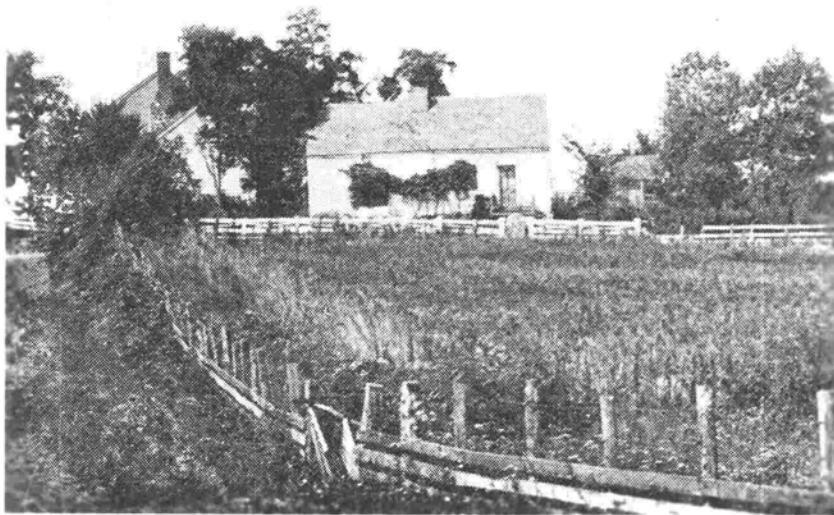
ILLUSTRATION NO. 3 SOUTH EAST VIEW

This view from the south-east shows the relationship between the W. H. Dogan House and the crossing of the Warrenton Pike (U.S. No. 29-211) and the Groveton-Sudley Road (Va. No. 622). This house is the last remaining structure at Groveton dating back to the Civil War.

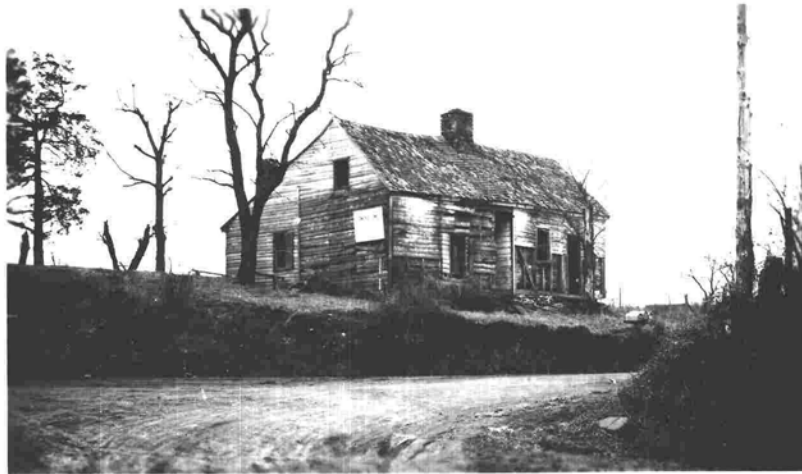
ILLUSTRATION NO. 4 VIEW FROM SOUTH EAST

Sign indicates early interest of community in the Dogan House as a building of historical importance. It reads "Groveton, Old Dogan House, shelled during Second Battle." Very little participation in its preservation occurred until 1947, when the house and 4914 square feet of land was purchased from W. H. Dogan by the Prince William County Chamber of Commerce and a subsequent stabilization occurred.

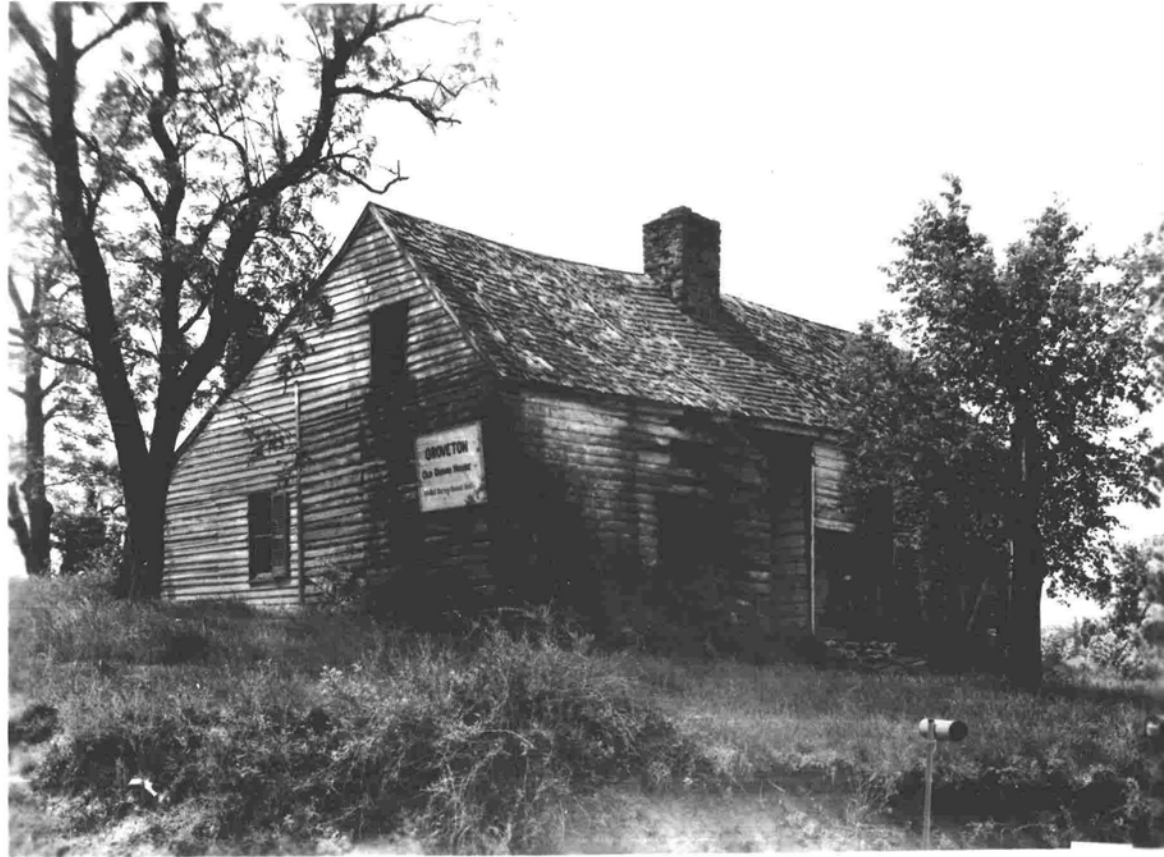
ILLUSTRATION NO. 5 EAST ELEVATION

Early view taken from the east shows the Logan House prior to stabilization. Tradition says that a cannon ball, fired from a Confederate field piece, crashed through the west wall, skidded across the floor, under the dining table, and out the west wall while the occupants were having breakfast. Notice nine holes in fascia board which former owners say were cut out for bird nests. A section of shelving can be seen in place in the small pantry room located opposite the chimney in center of photograph. House to rear was erected after 1865. Note wood shingle roof.

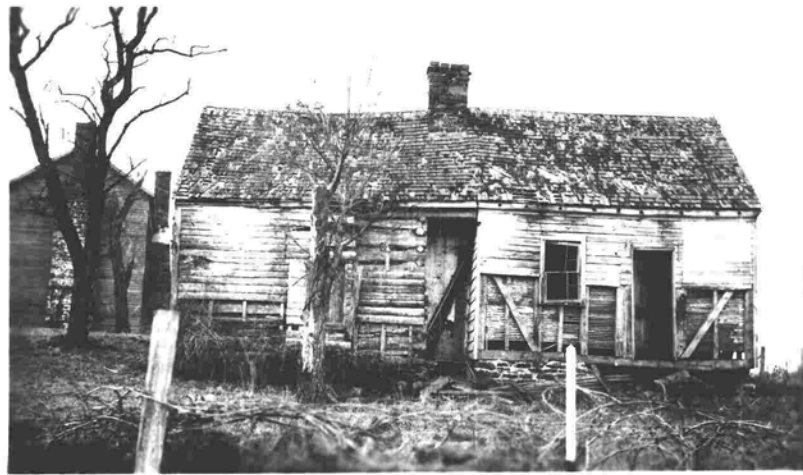
ILLUSTRATION NO. 6 VIEW FROM NORTH WEST

View of 1881-1882 addition to the west side
of the Logan House. Prior to demolition of addition.

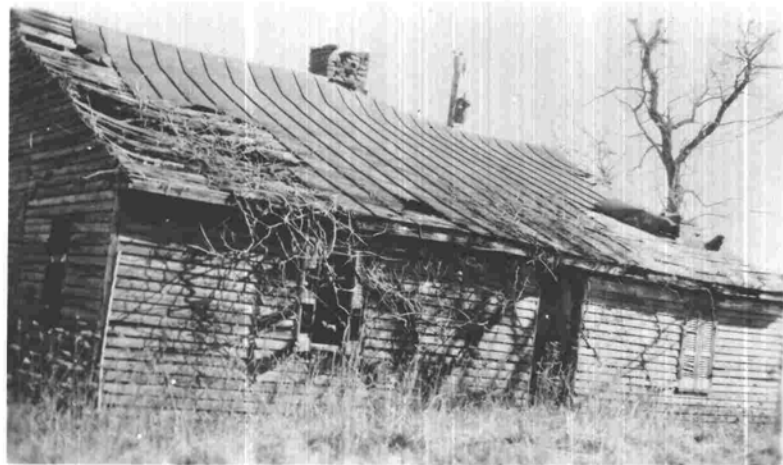
ILLUSTRATION NO. 7 NORTH ELEVATION

View of the 1881-1882 addition to the west
(right) shortly before its demolition. Most of the
exterior wood work dates back to 1881-1882.

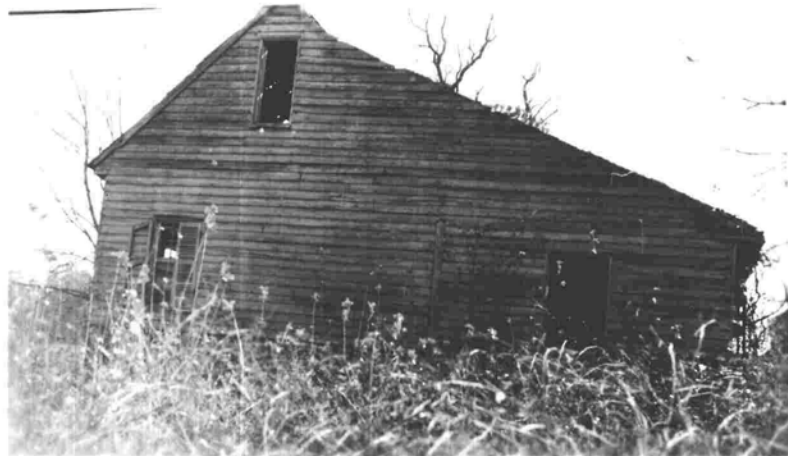
ILLUSTRATION NO. 8 NORTH WEST VIEW

This photograph shows the demolition of later addition to the Jogan House. Work was accomplished in 1948 by Mr. Raymond H. Cross, carpenter, under the supervision of the Prince William County Chamber of Commerce. Note door and window frame covered over by lath and plaster.

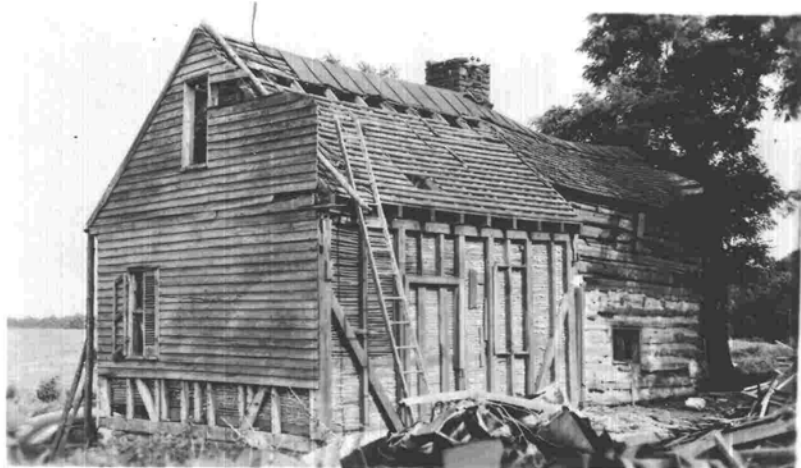
ILLUSTRATION NO. 9 SOUTH WEST VIEW

View of demolition progress. Notice the abundance of original members were still intact on the building, many have since been removed.

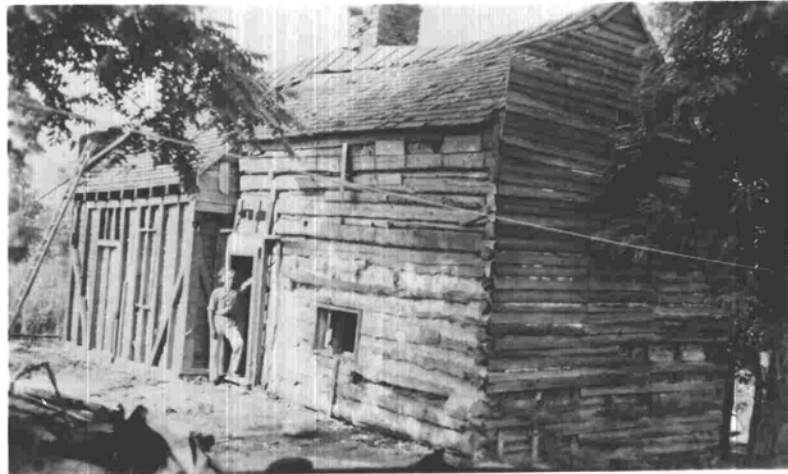
ILLUSTRATION NO. 10 SOUTH WEST VIEW

This photograph shows the complete view of the demolition of the non-historic addition and the subsequent stabilization. A false roof was laid over the original at this time to preserve all the original structure possible. Some weatherboarding was applied, also repair and repointing of the stone foundation and chimney.

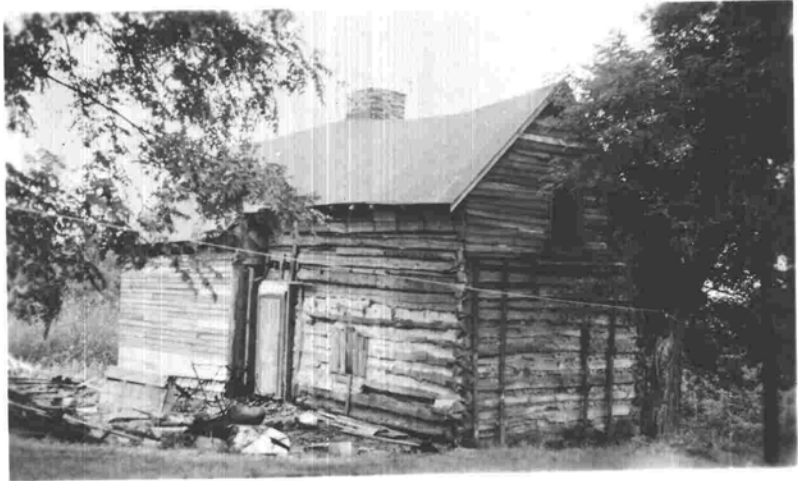
ILLUSTRATION NO. 11 NORTH EAST VIEW

This view taken from the Groveton-Sudley Road shows the completed stabilization of the Dogan House as executed by the Washington Home Improvement Company in 1950. Work was supervised by the National Park Service on a contract basis. Most significant feature accomplished was the replacement of the roof structure over the log building, re-roofing with wooden shingles and the removal of the interior floors and wooden trim.

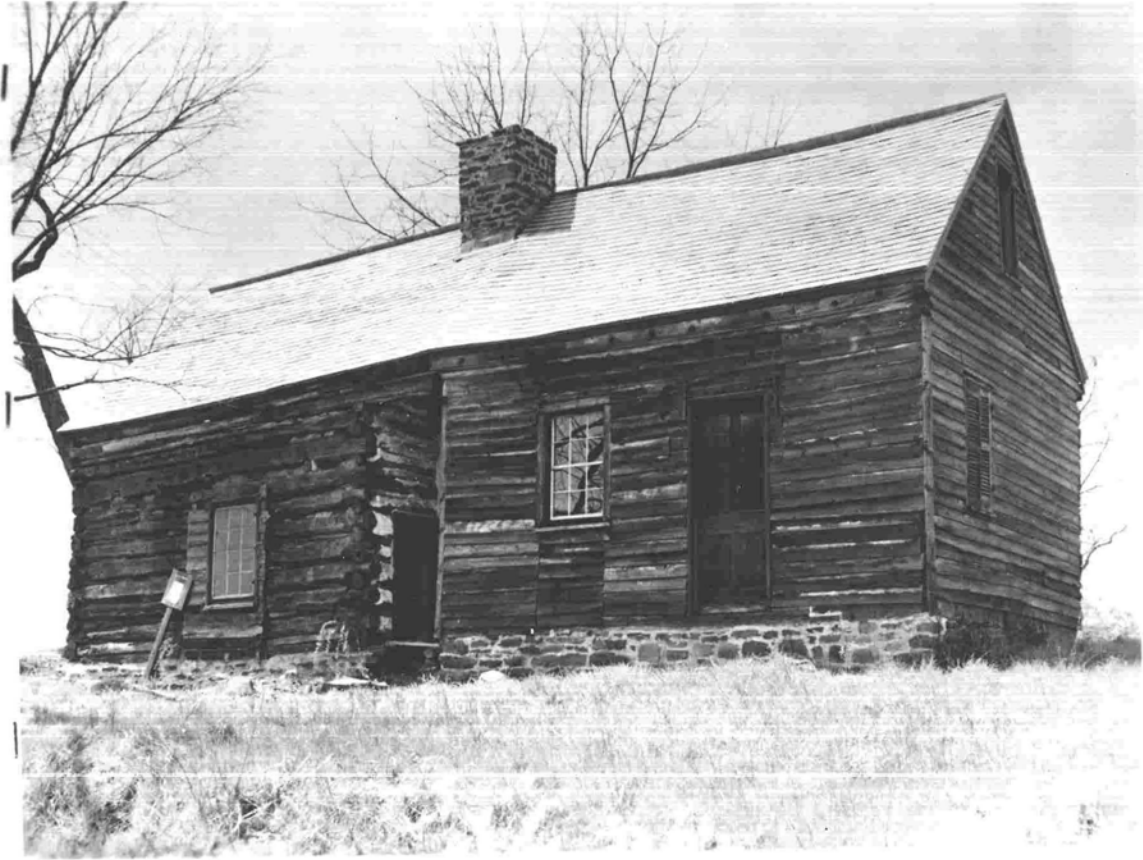
ILLUSTRATION NO. 12 VIEW FROM NORTH EAST

Latest photograph of the Dogan House taken from the Croveton-Sudley Road in 1959. The straight break in roof to the right of the chimney represents the junction of the early log structure and the frame portion.

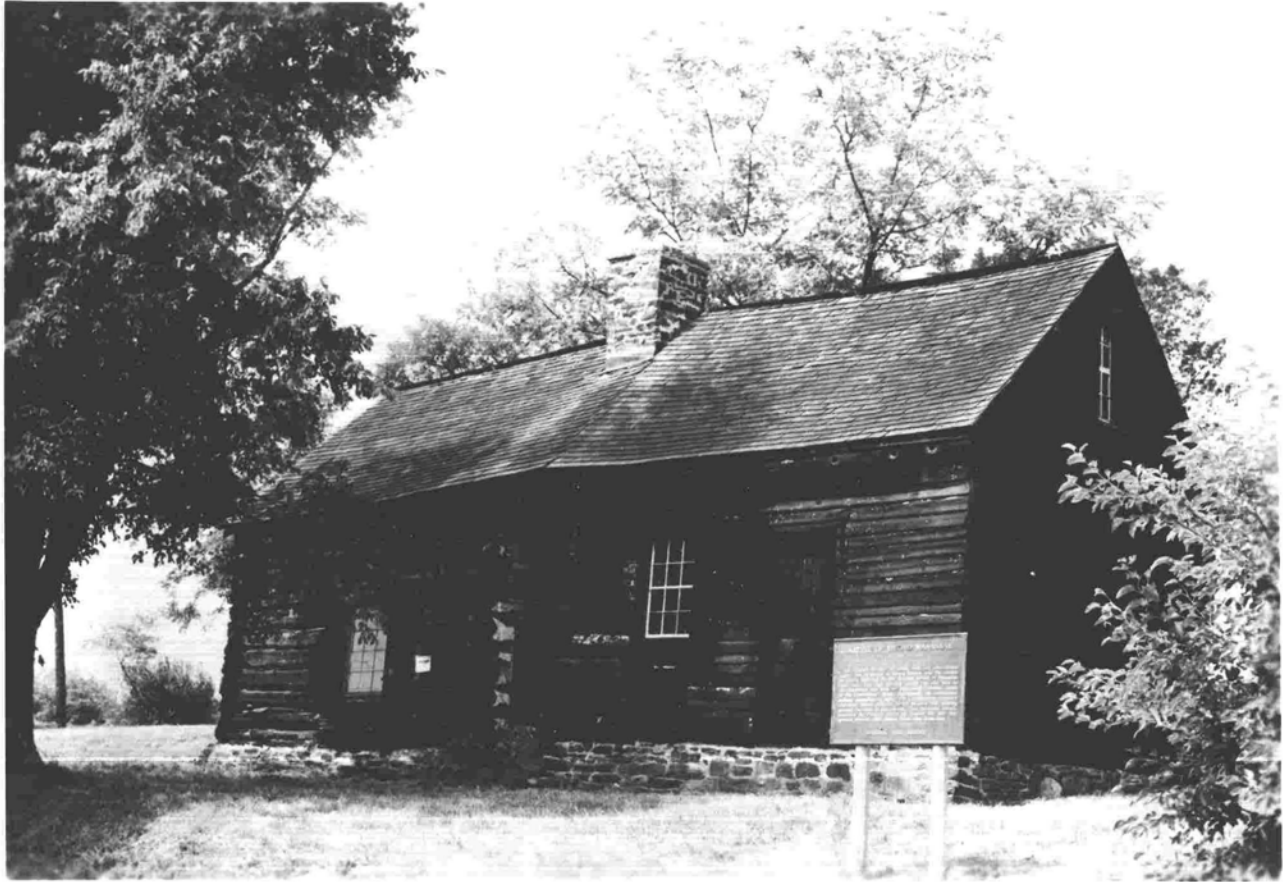
ILLUSTRATION NO. 13 JUNCTURE OF LOG AND FRAME BUILDING OF EAST

This view shows the juncture of the early log structure, left, with frame addition. The frame addition is known to have been attached to the log building in 1860 by Lucinda Degan, and the house used as a residence. The space seen between the two buildings is said to have been used as an enclosed pantry. The door seen is 2'-5 $\frac{1}{2}$ " X 4'-10". The plaster stone chimney can be seen in the rear.

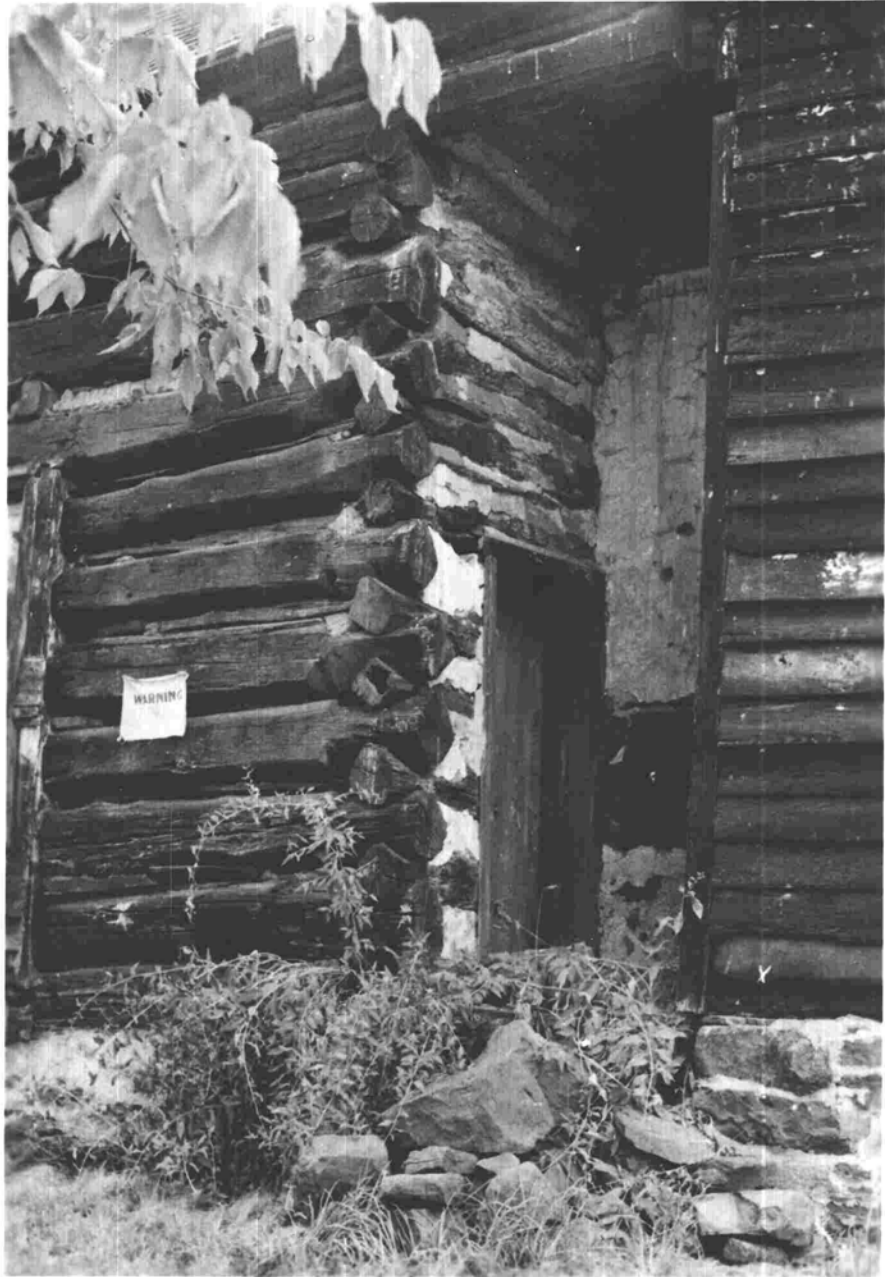
ILLUSTRATION NO. 14 EAST WINDOW, LOG STRUCTURE

This view shows an alteration to an early door opening on the east side of the original log structure. The door frame is still intact and this view shows the logs butting up against the door frame. Later alterations changed the doorway to a window opening as shown.

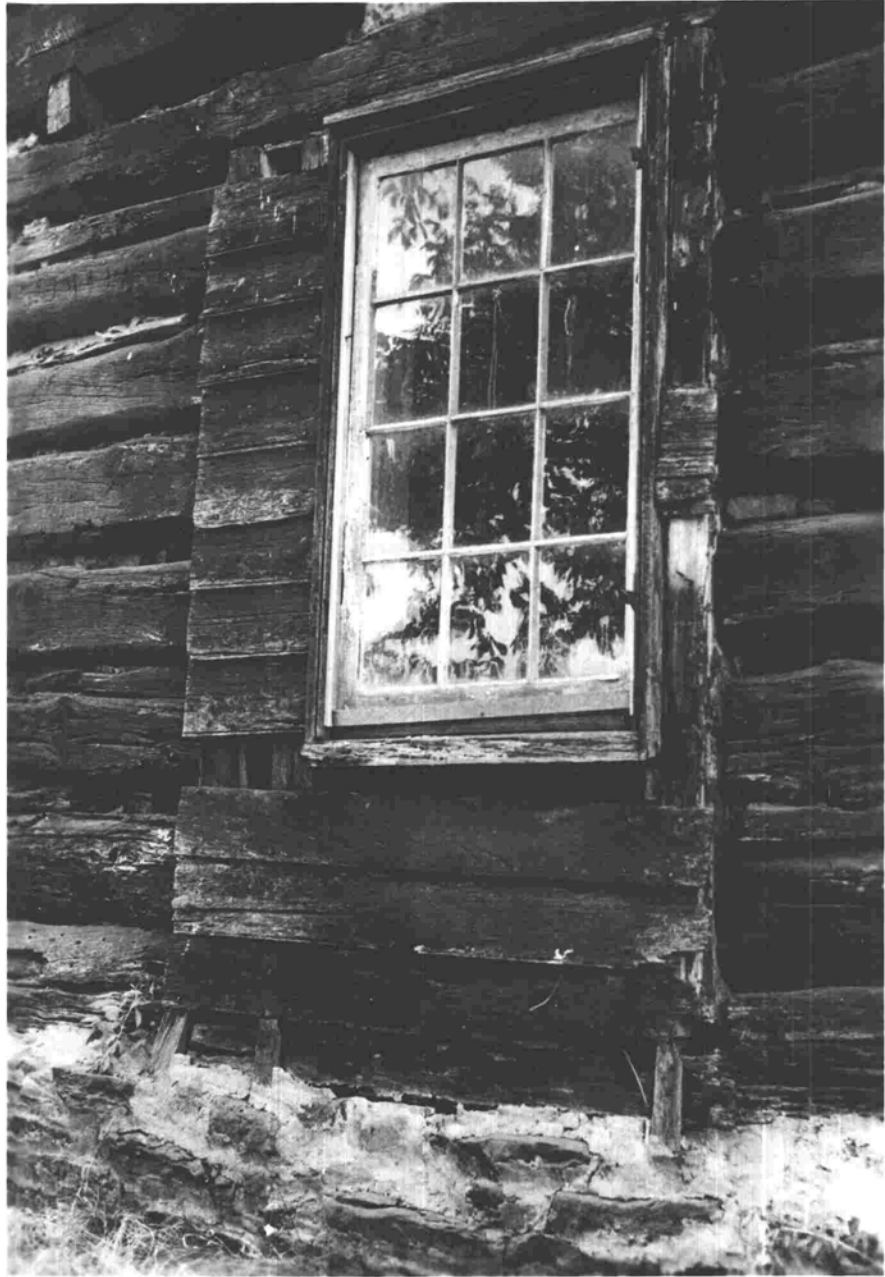
ILLUSTRATION NO. 15 VIEW FROM SOUTH WEST

The log structure seems to have suffered more abuse than its frame counterpart. Due to the deterioration of the lower logs in the south wall, the log building has settled approximately two feet, and as a result, this section of the house has separated from the frame addition. Photo Illustration No. 15 shows the physical break in the roof at the juncture of the two buildings.

Further repairs by the National Park Service in 1950 are visible in this photograph. A new wood shingle roof, removal and replacement of the roof structure over the log structure, removal of the floor board and interior trim was achieved at this time.

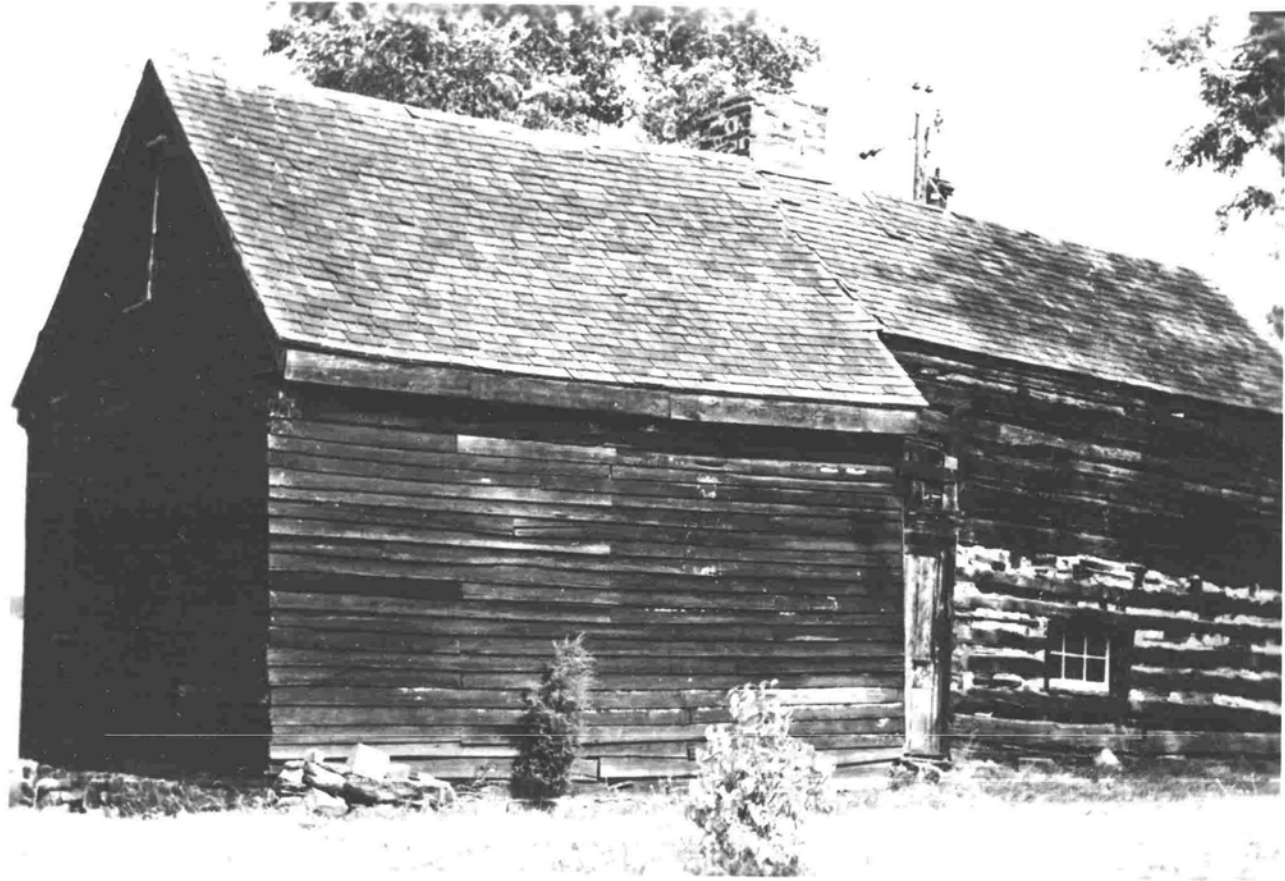
ILLUSTRATION NO. 16 WEST ELEVATION OF THE LOG STRUCTURE

This view shows the gradual settling of the log structure on the right due to deterioration of the logs next to the ground. The spliced log at the lower part of this photograph was replaced in 1950. Notice rotar chinking in lower part of building and wooden chinking above 2nd floor joists. Logs above 2nd floor appear to have been added at a different period. Notice difference in end notchings of logs from upper to lower part.

Frame: Straighten and level existing building; replace all rotted members in log structure and frame addition.

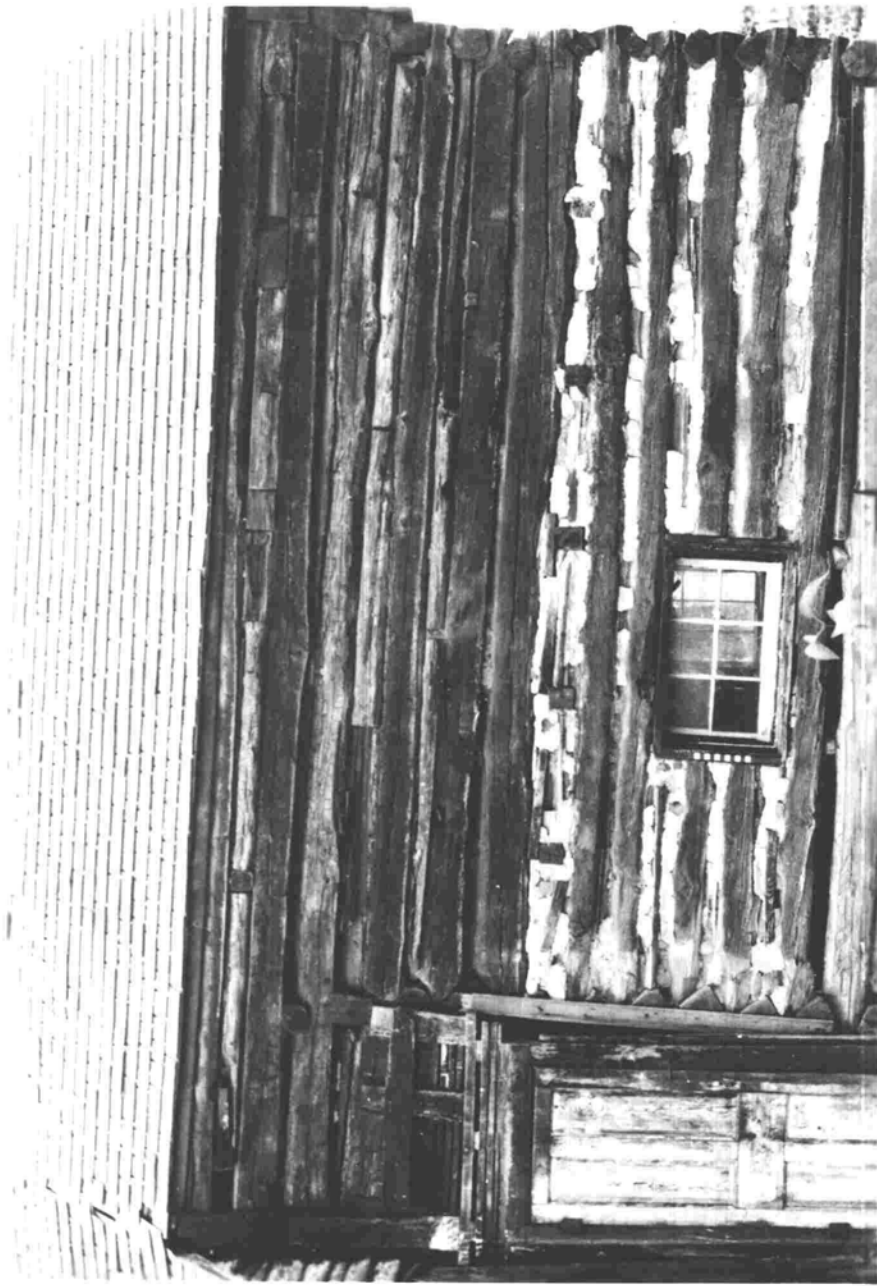
ILLUSTRATION NO. 17 WEST ENTRANCE

This doorway leads to small hall, (4' X 4')
which gives access into both rooms on the 1st floor. The
door in this location is part of the later alteration.

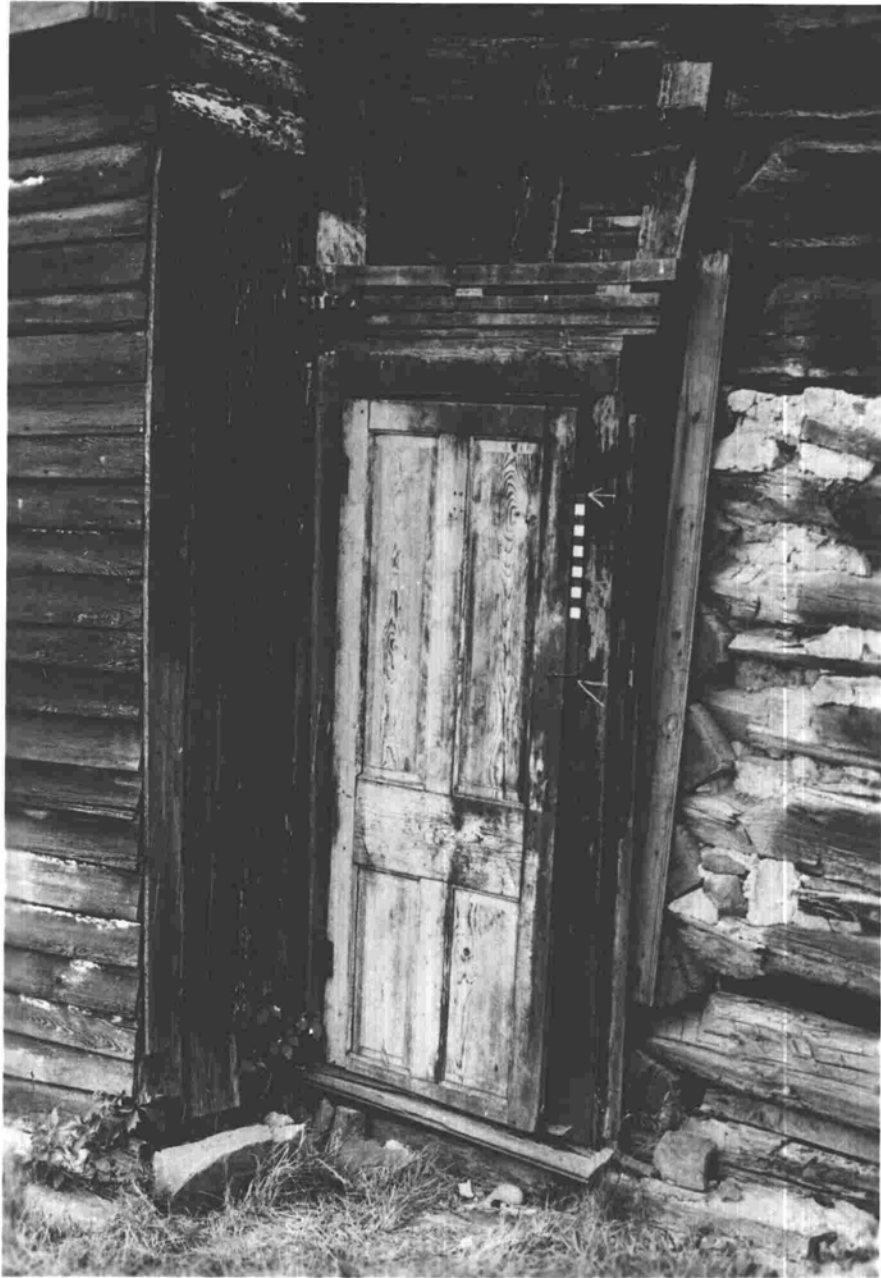
ILLUSTRATION NO. 18 WEST ENTRANCE

A detailed view showing the accumulation of many alterations extending over several decades of time. This view was taken above the west doorway at the junction of the log and frame buildings. The original beaded weatherboards can be seen in the gable end of the frame portion. Visible signs of whitewash can be seen on the exterior surfaces of the same weatherboards.

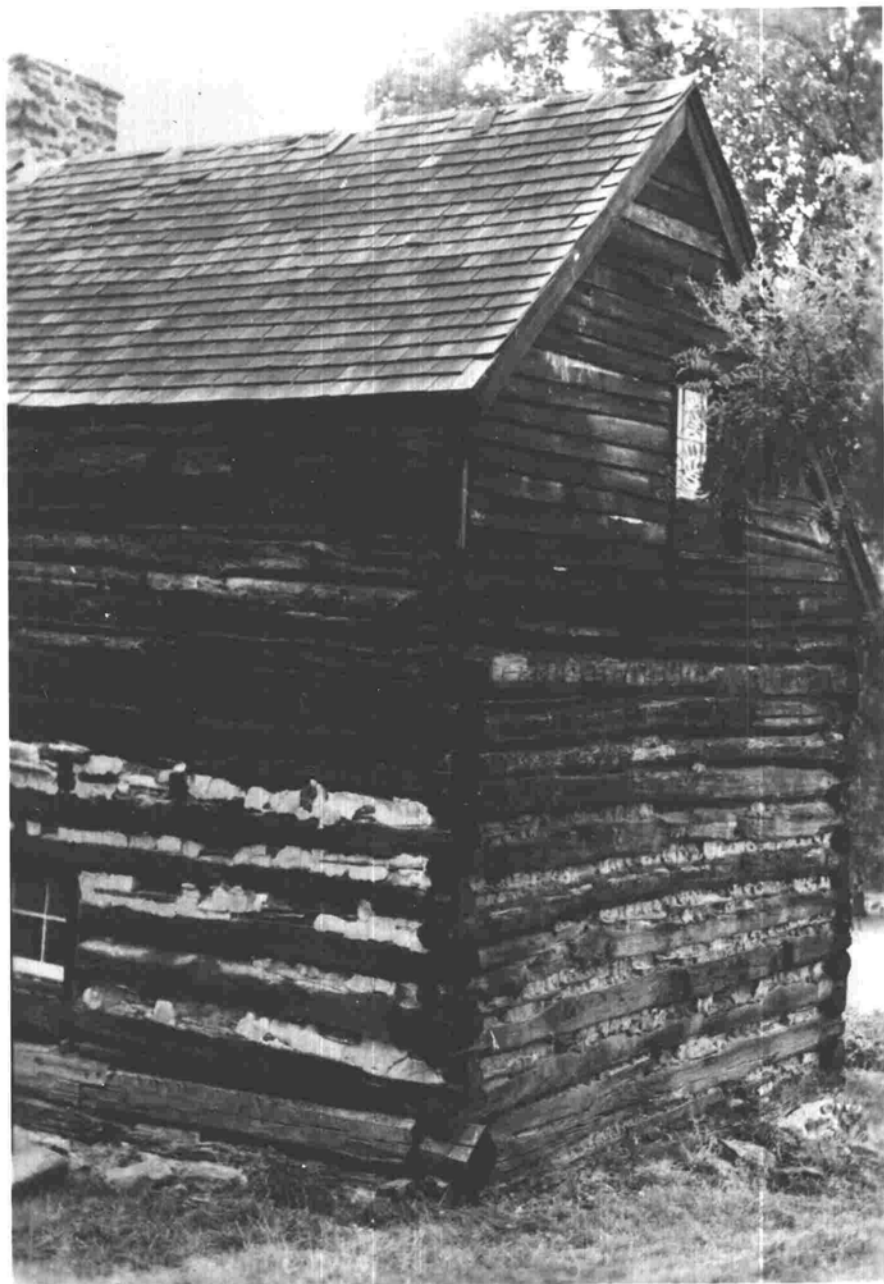
ILLUSTRATION NO. 20 SOUTHEAST CORNER

This photograph shows a more detailed view
of the serious deterioration occurring in the lower
logs. Log to the lower left is a 1950's replacement.

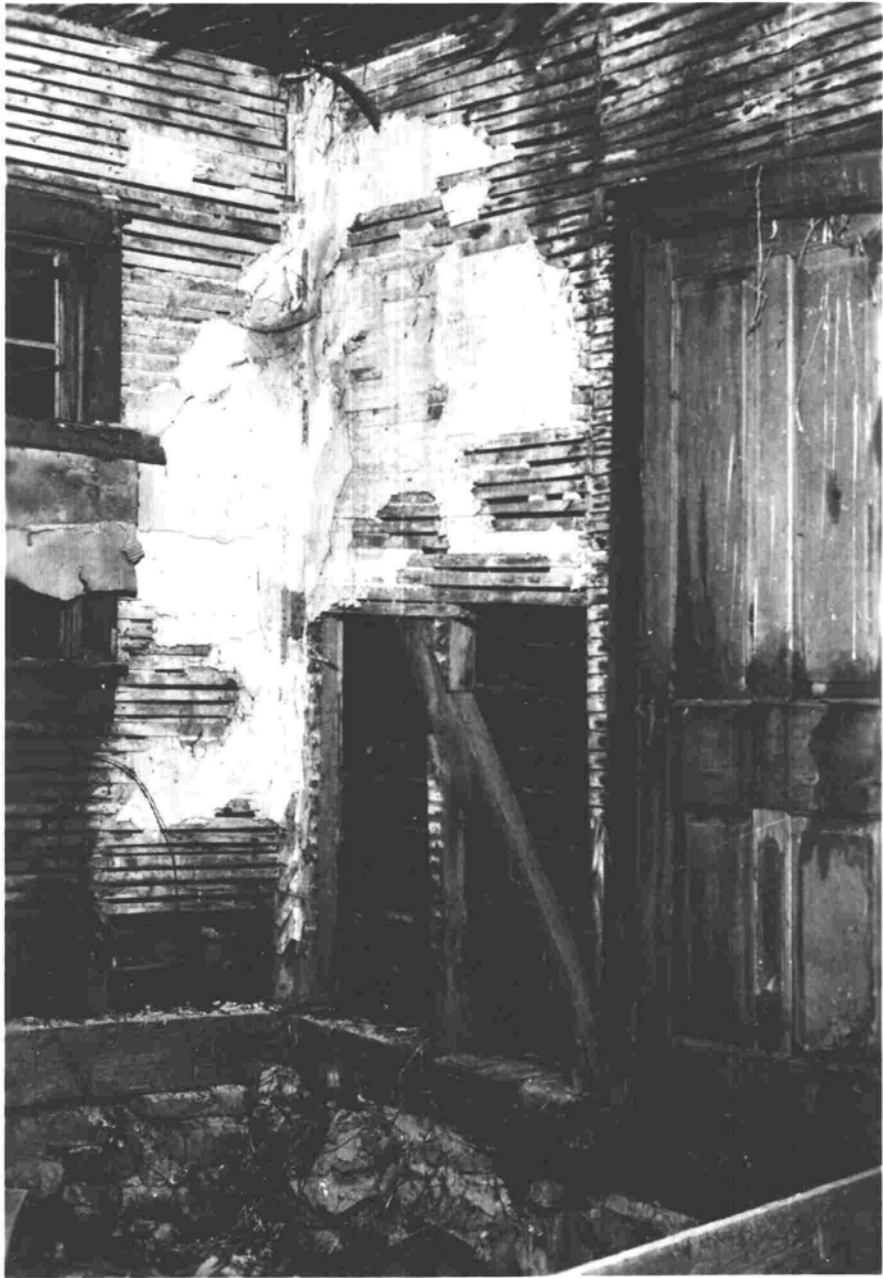
ILLUSTRATION NO. 27 NORTH WEST CORNER, FRAME ADDITION

Some of the original split wood lath and plaster can be seen in this view. Baseboards and chairrails have been removed leaving spaces in the plaster to the right.

Walls: Remove and replace existing lath and plaster on the first floor. Replace chairrail, baseboard and mantel (s).

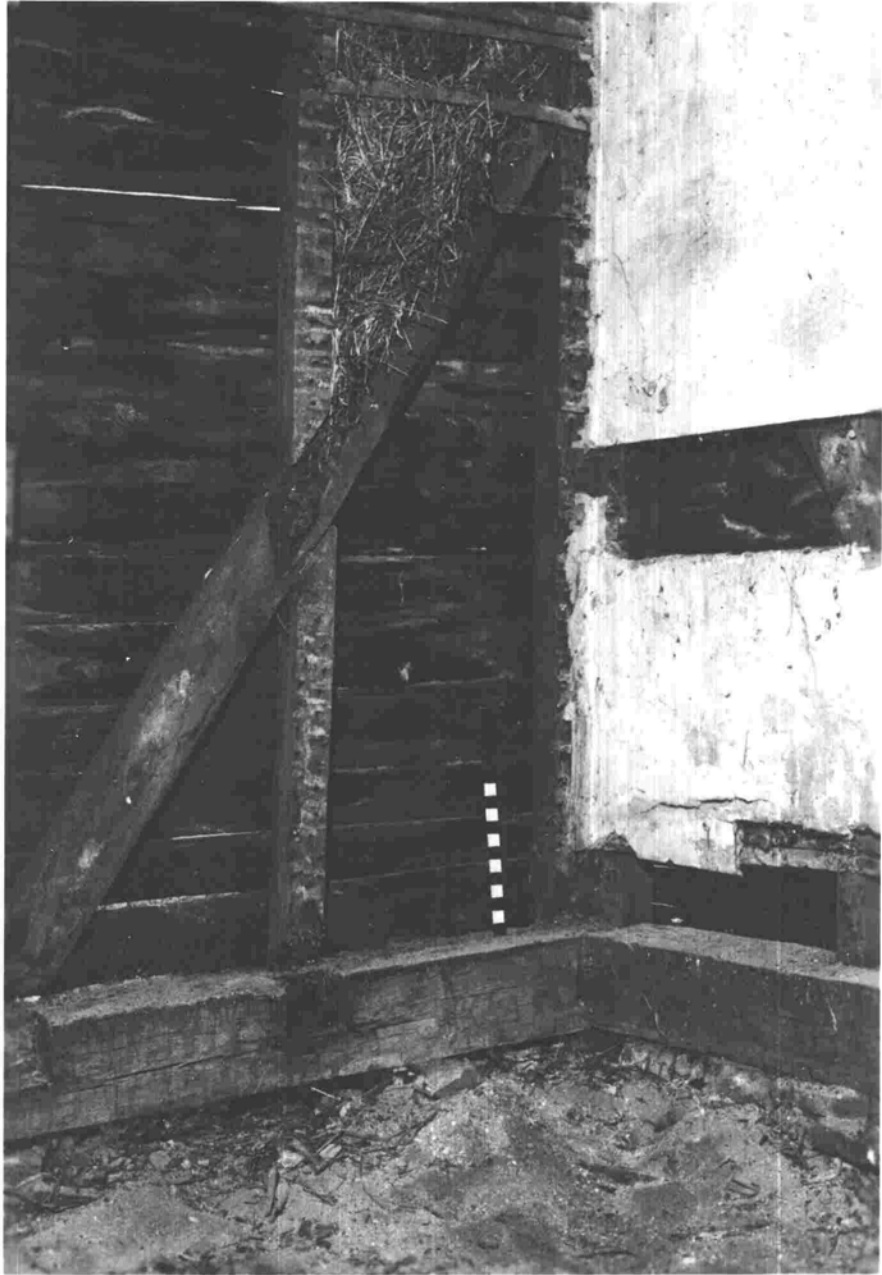
ILLUSTRATION NO. 26 FIREPLACE, FRAME ADDITION

View of living room fireplace located in the
frame addition. Mantel and hearth have been removed as
well as chairrail, baseboard and floor boards.

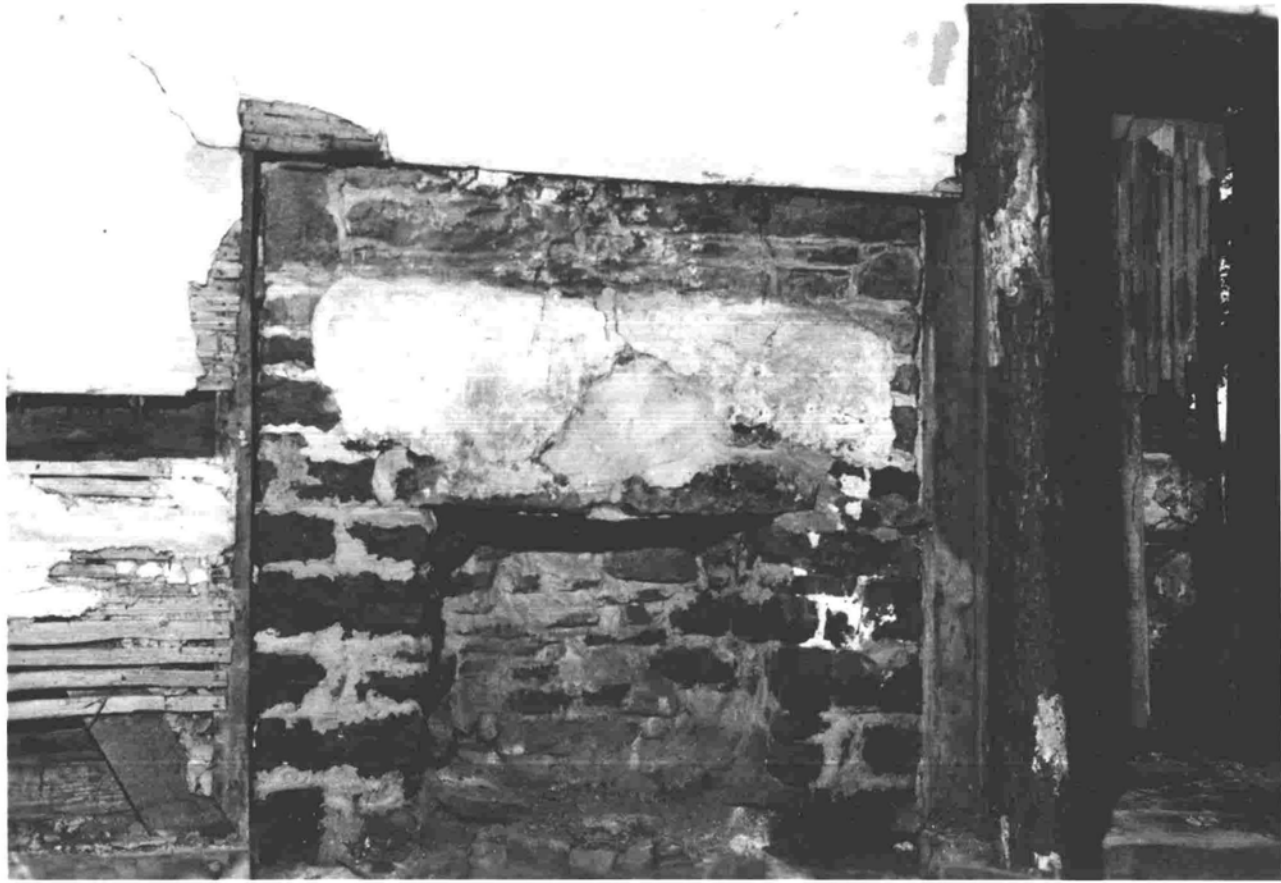
ILLUSTRATION NO. 29 FIREPLACE, LOG STRUCTURE

Conditions as found in 1959 of the fireplace in
1st floor room of the log section of the Dogan House. To
the right of the fireplace can be seen the pantry door and
the door to the left, the only means of access into the
log portion of the house. Floor boards were also removed from
this room.

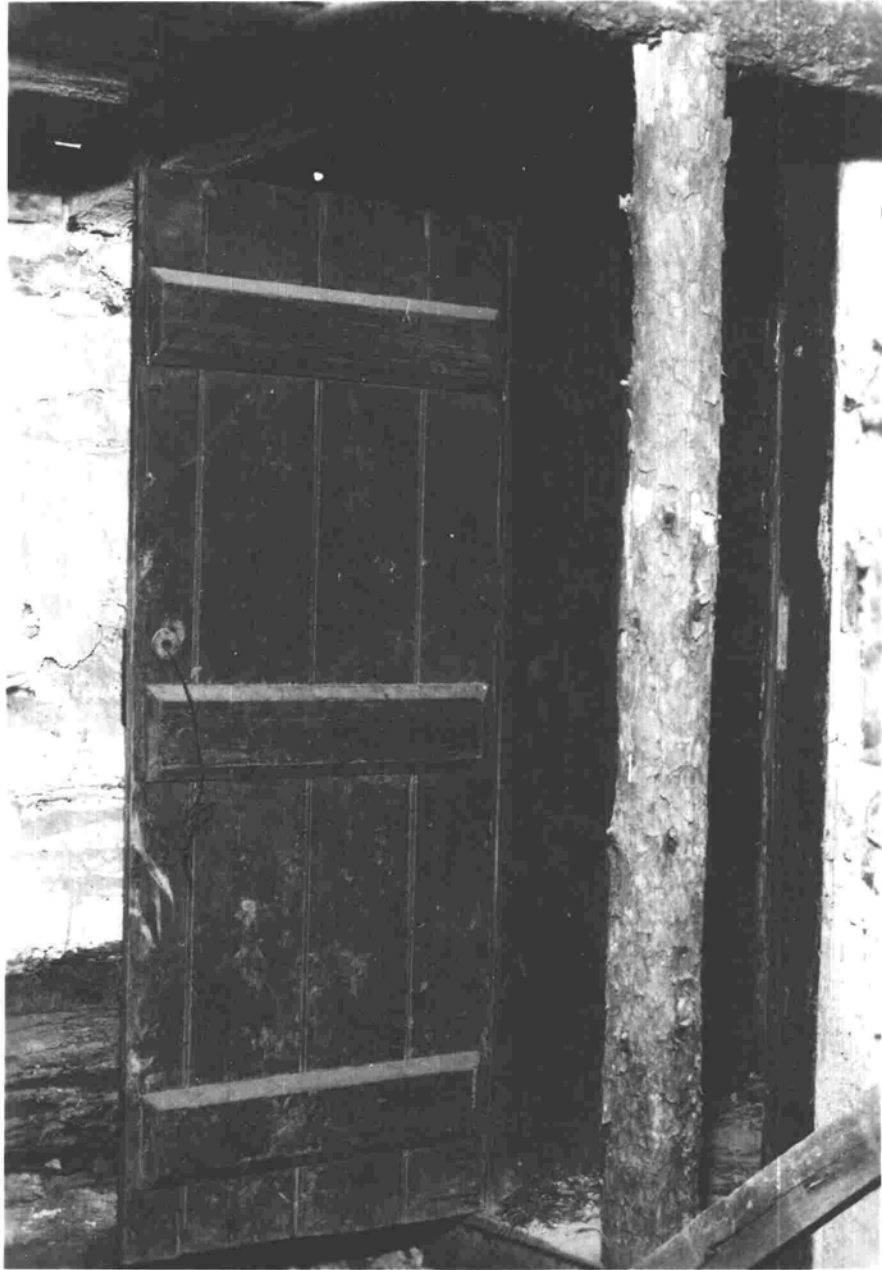
ILLUSTRATION NO. 32 STAIRWAY REMAINS

This view shows the last remnants of the "dog-leg" stairway located in the south-east corner of the log building. The stairway was once enclosed and the board and batten door at the foot of the stairway is visible to the entrance left.

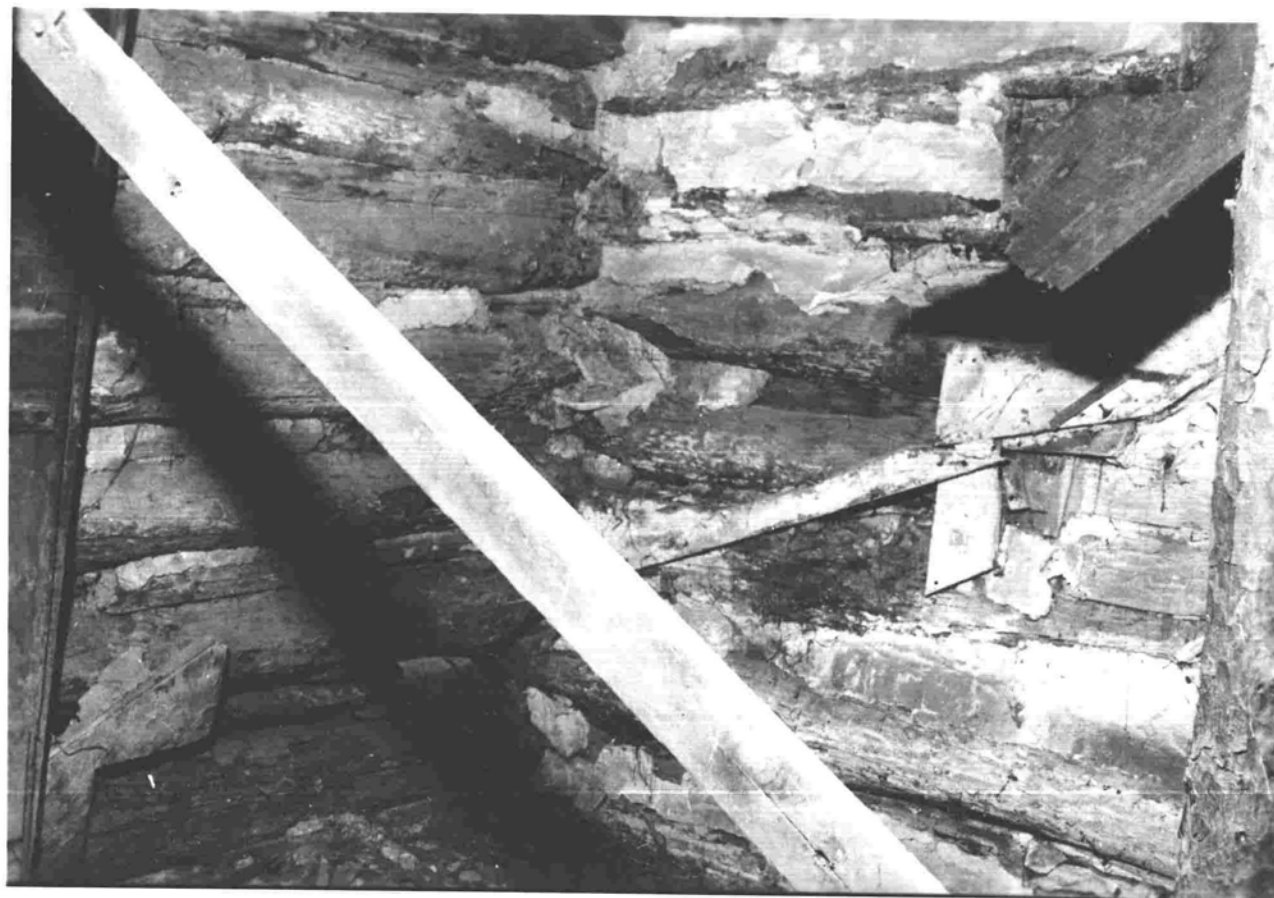
ILLUSTRATION NO. 33 STAIR, LOG TO FRAME ADDITION

Access from the 2nd floor of the log structure to the attic room in the frame addition is achieved by the combination of two board steps and one log. Notice logs cut through to provide access into attic room beyond. Much of the beaded weatherboarding seen in rear is the original. Plastered chimney is right.

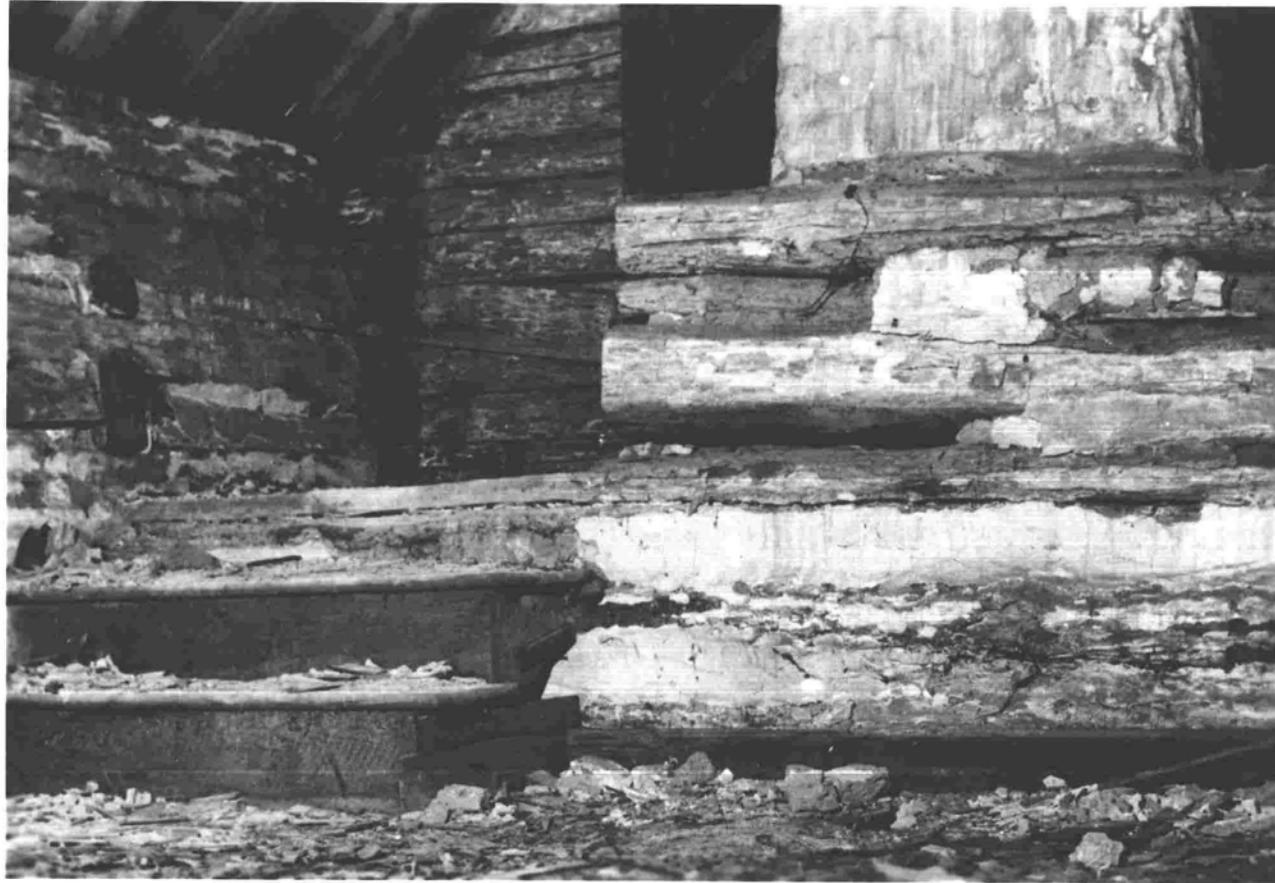
ILLUSTRATION NO. 34 ACCESS DOOR 2nd FLOOR

One studding has been removed to allow a doorway cut between the attic room of the frame addition and the 2nd floor room of the log structure. Looking south into the log structure beyond. Roof sheathing above has been reused. Roof over the log structure was replaced with 2" X 16", 16" on centers.
