HISTORIC STRUCTURES REPORT
ARCHITECTURAL DATA, PART II

REHABILITATION AND RESTORATION
OF THE
DOGAN HOUSE

MANASSAS NATIONAL BATTLEFIELD PARK
Virginia

August 1960

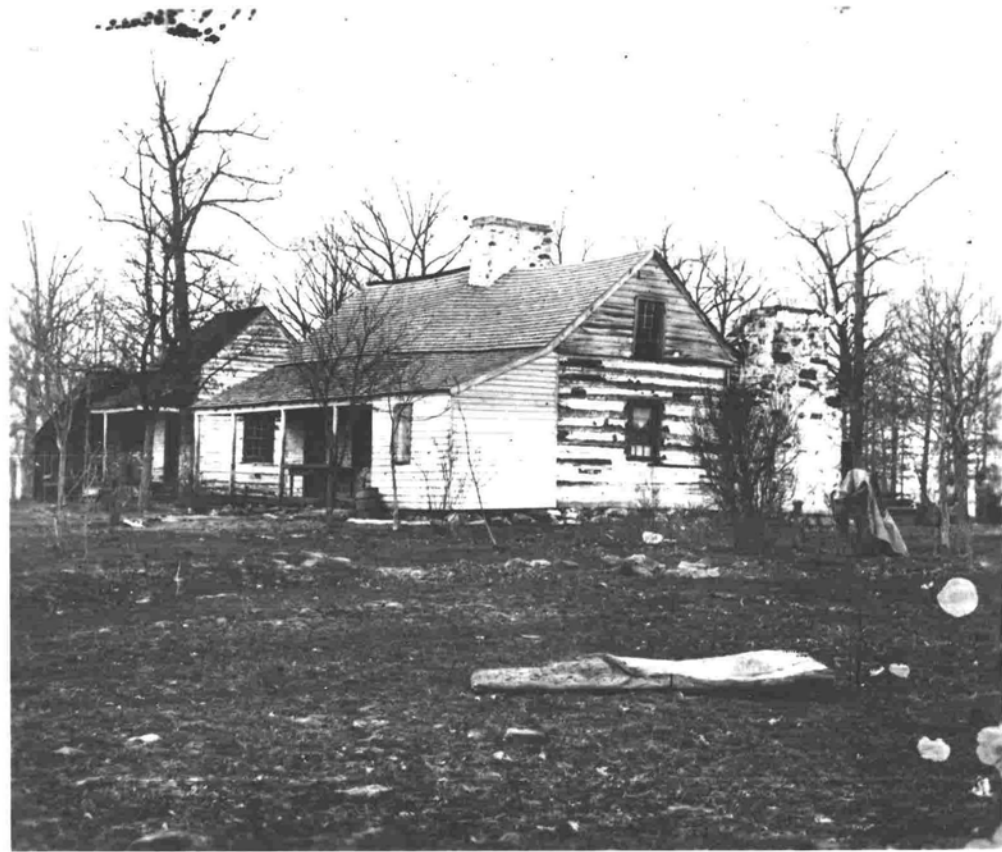
ILLUSTRATION NO. 12

DOGAN HOUSE FROM SOUTHWEST

This view shows the conditions of the Dogan House just prior to architectural investigation and exploratory excavations.

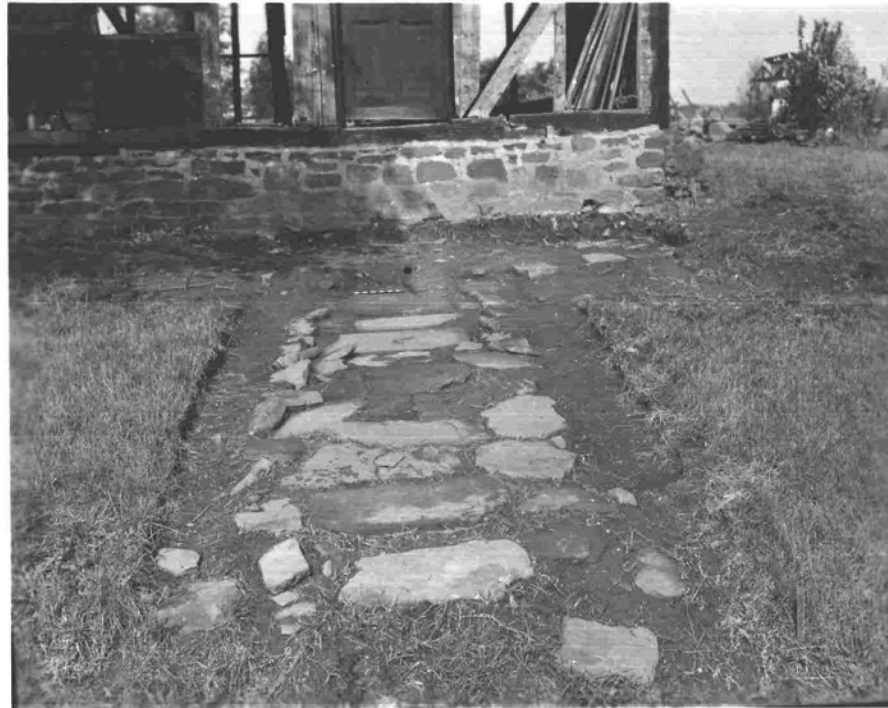
ILLUSTRATION NO. 16

EAST EXCAVATION

This small area east of an original door opening was uncovered in an attempt to locate footings for steps, porches or platforms. A bayonet was uncovered just to right of picture in extended digging.

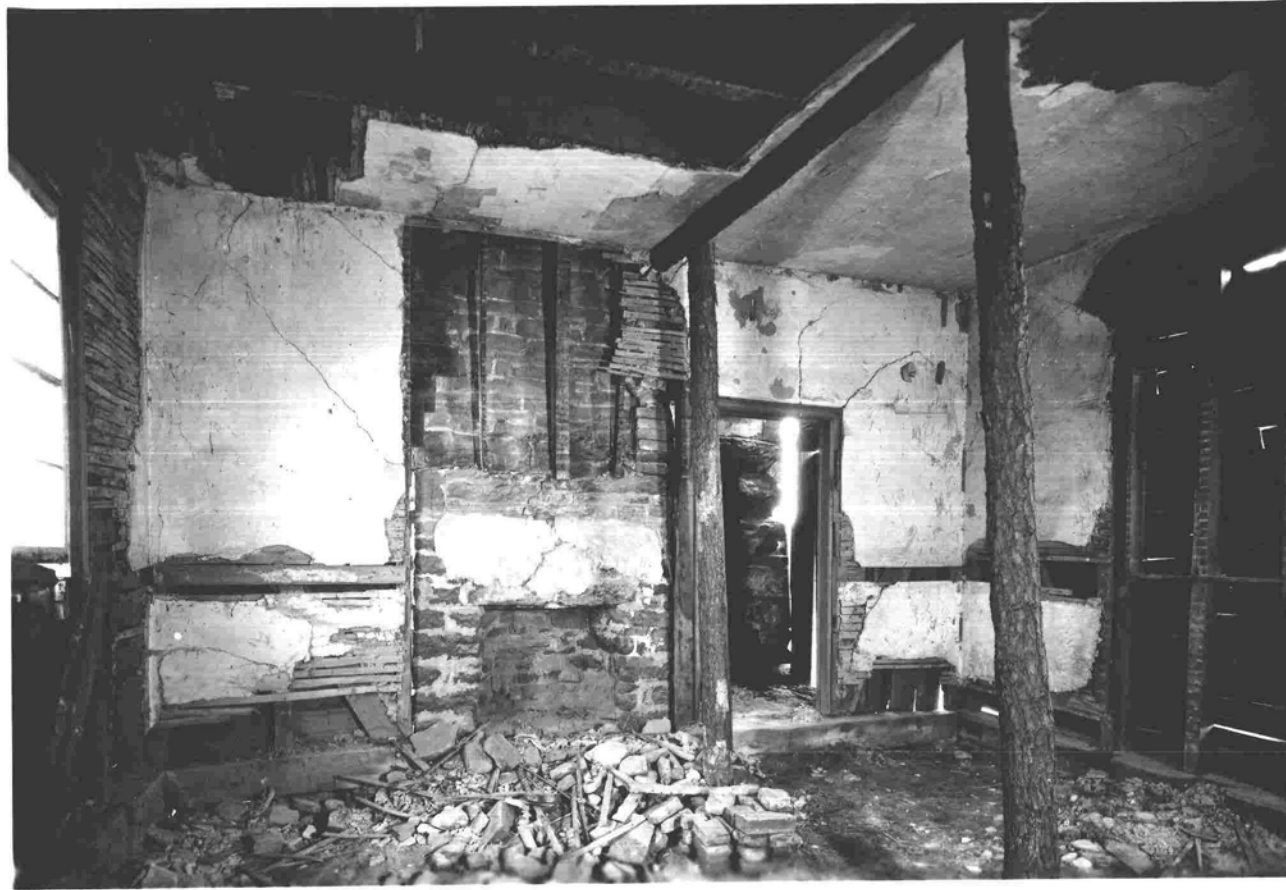
ILLUSTRATION NO. 18

The window in the north wall appears to date from 1881 alterations. Approximately four feet of an original stud was cut off to allow for the installation of the window while a rough circular-sawn pine studs were placed in the wall to support the window frame and to provide a nailing surface for the sawn lath. The type of window frame and trim used in this window conforms to those used in the two-room 1881 addition removed in 1949, rather than to the original frame and trim found in the east wall.

NORTH WALL, FIRST FLOOR

It has been assumed that the use of sawn pine lath occurred during the alterations of 1881-1882 and the use of hand split chestnut-oak lath for the original 1840 structure. This view shows the use of the sawn pine lath nailed over areas where a stairway was removed in 1881-1882. Whitewashed studs were enclosed by stairway. The window is also an 1881 addition. Note original stud cut off to accommodate window frame.

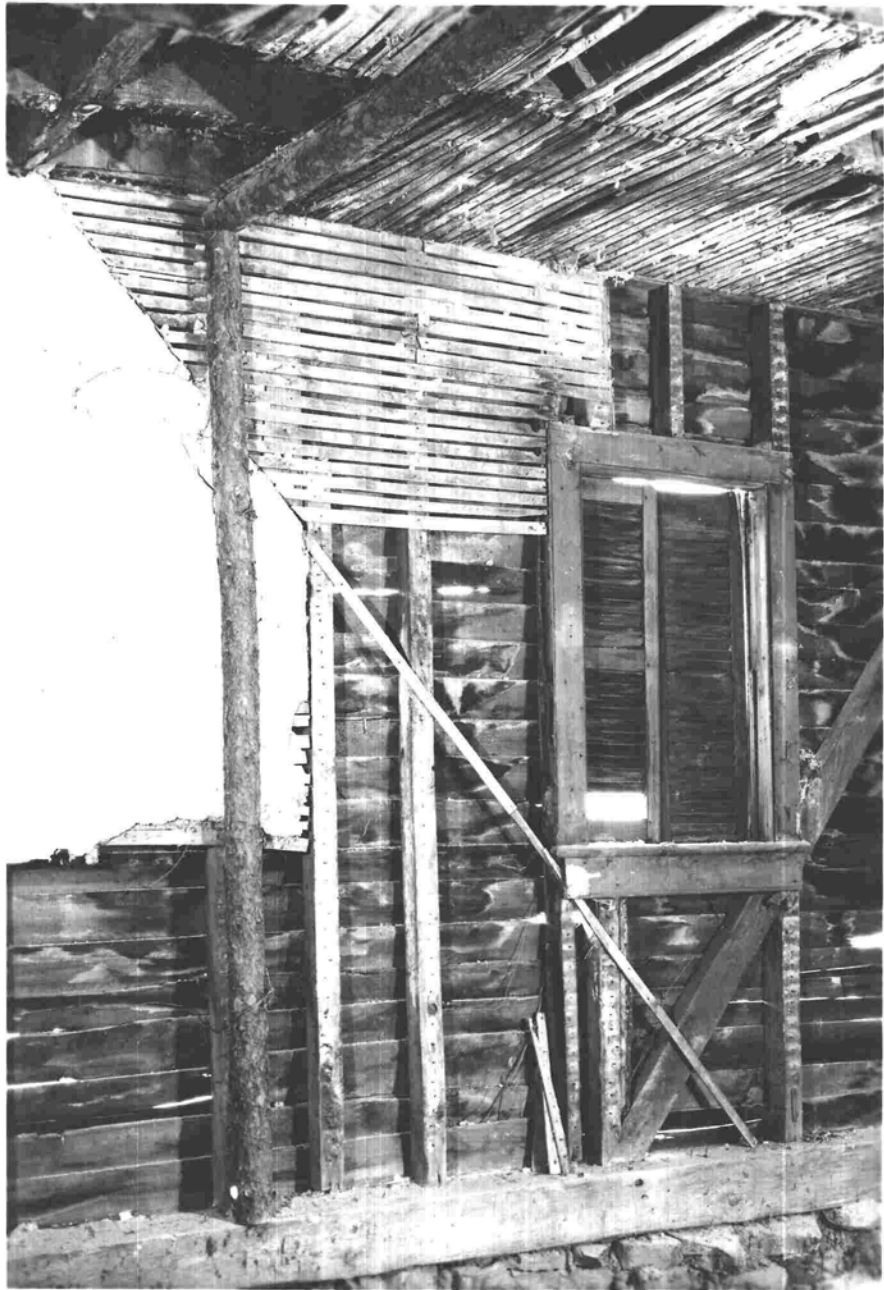
ILLUSTRATION NO. 19

NORTHEAST CORNER, FIRST FLOOR

Other 1881-1882 alterations indicated by the use of sawn pine lath is the change in width of the east door. Original opening matches size of old door frame found in west wall, see Illustration No. 13. When the chimney was removed this area was re-lathed and plastered. One notch for stairway stud can be seen in ceiling joist in upper right of photograph. Compare stairway design with Illustration No. 5.

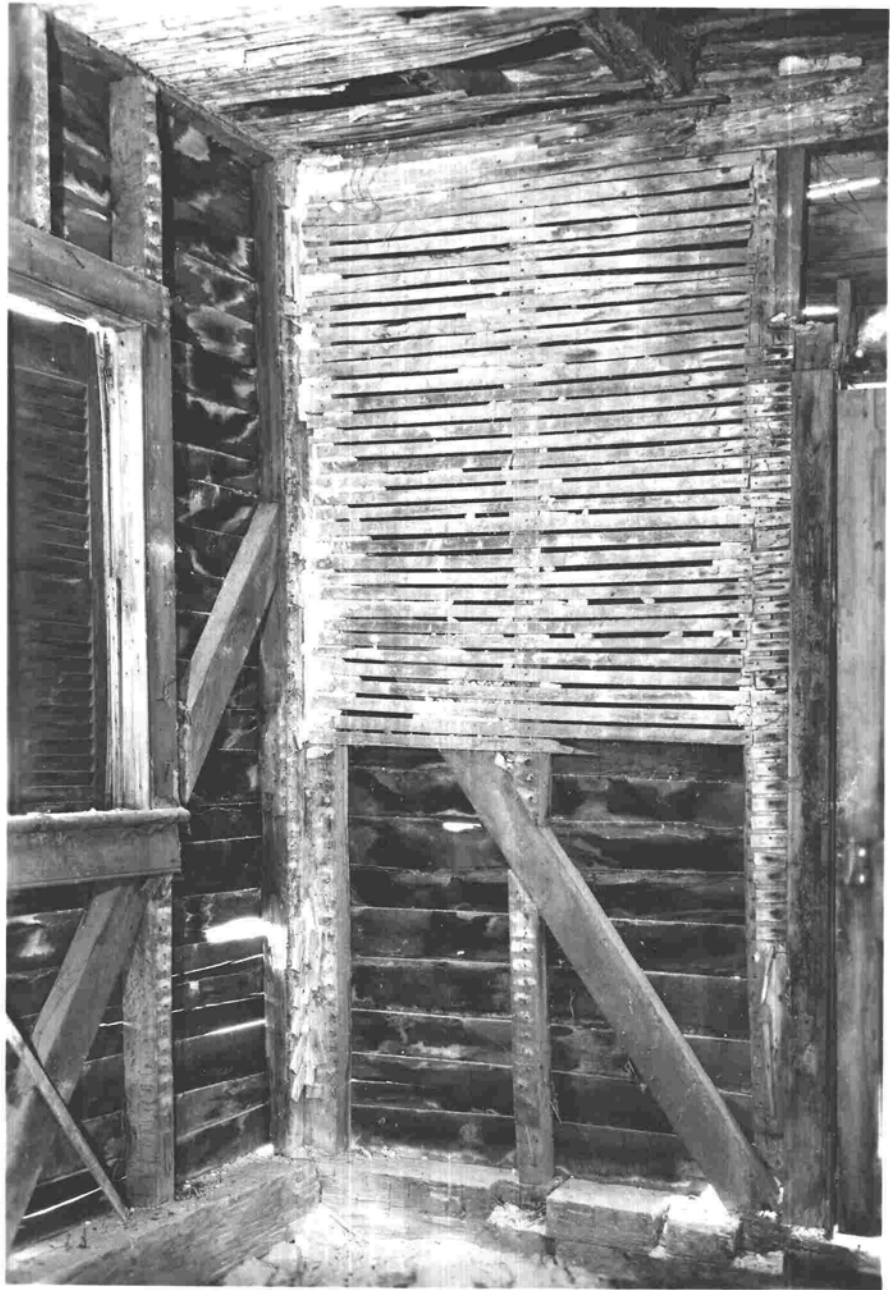
ILLUSTRATION NO. 20

Architectural investigations exposed a lodged Minnie ball between the old door jamb and its frame. In tracing the angle of the bullet it was found that its path would have had to pass through the present window frame. The window frame has no scars to indicate that this happened. This evidence confirms assumption that the door was in use during the Second Battle of Manassas, August 28-30, 1862, and not until 1881 was the doorway altered into a window. The knowledge that the change from a door to a window occurred in 1881 is useful in dating the remaining door and window frames in the Dogan House that have a similar type of construction. Two doors and three additional windows have identical details to the window described above. It is proposed that the window be removed in the east wall and the door restored to its original opening.

EAST DOOR FRAME, LOG CABIN

An original door frame enclosed by the 1881-1882 alteration. Sawn lath was used to cover over opening between window and door frame.

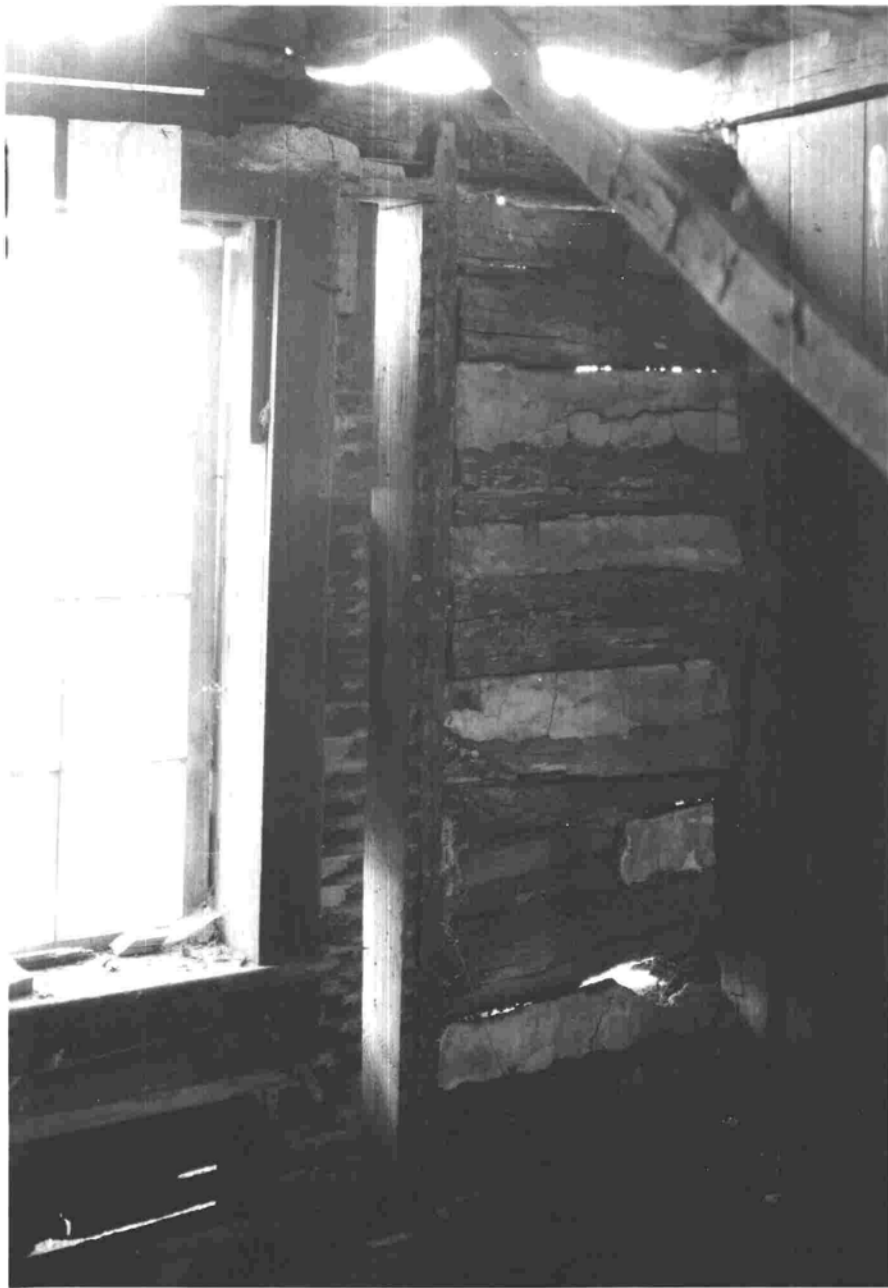
ILLUSTRATION NO. 21

SECOND FLOOR, FRAME ADDITION

Looking north, second floor of frame addition. Wall was covered with sawn lath and plaster indicating that the changes were made in 1881-1882. Remainder of walls and ceiling were whitewashed. Floor boards show where repairs were made when the stairway was removed.

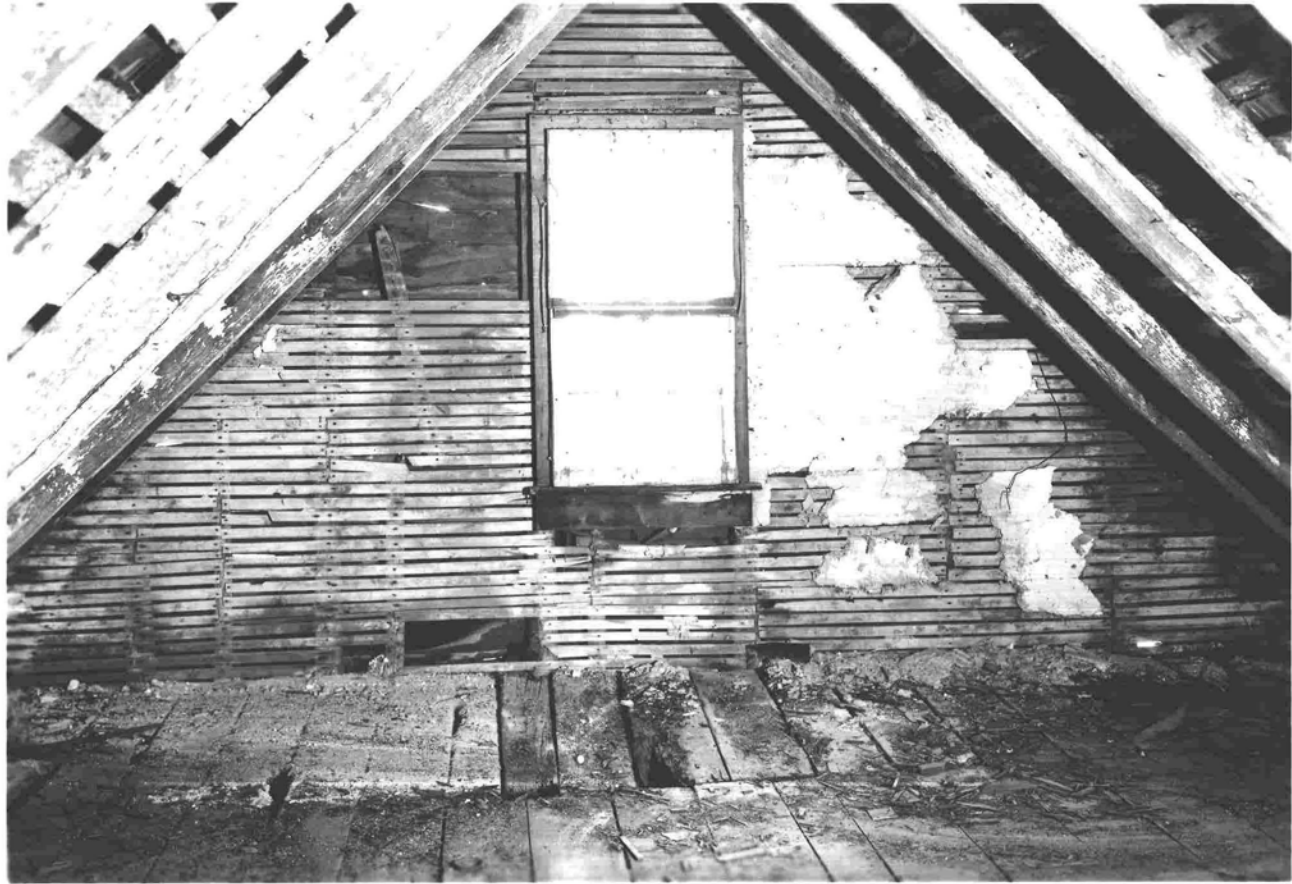
ILLUSTRATION NO. 22

SECOND FLOOR, LOG CABIN

View of the south wall, second floor of the log cabin. Log wall to right was raised to present height in 1860 when frame building was added to the north side of the log cabin. Notice the diagonal brace in the right corner intended to stabilize the logs above the adjoining wall. When the ridge of the roof was raised, it was necessary to build up one of the wall heights to compensate for the log cabin being narrower in width than the frame addition. Window was found to be one added in 1881-1882. Present roof structure was constructed in 1950 by the Washington Home Improvement Company.

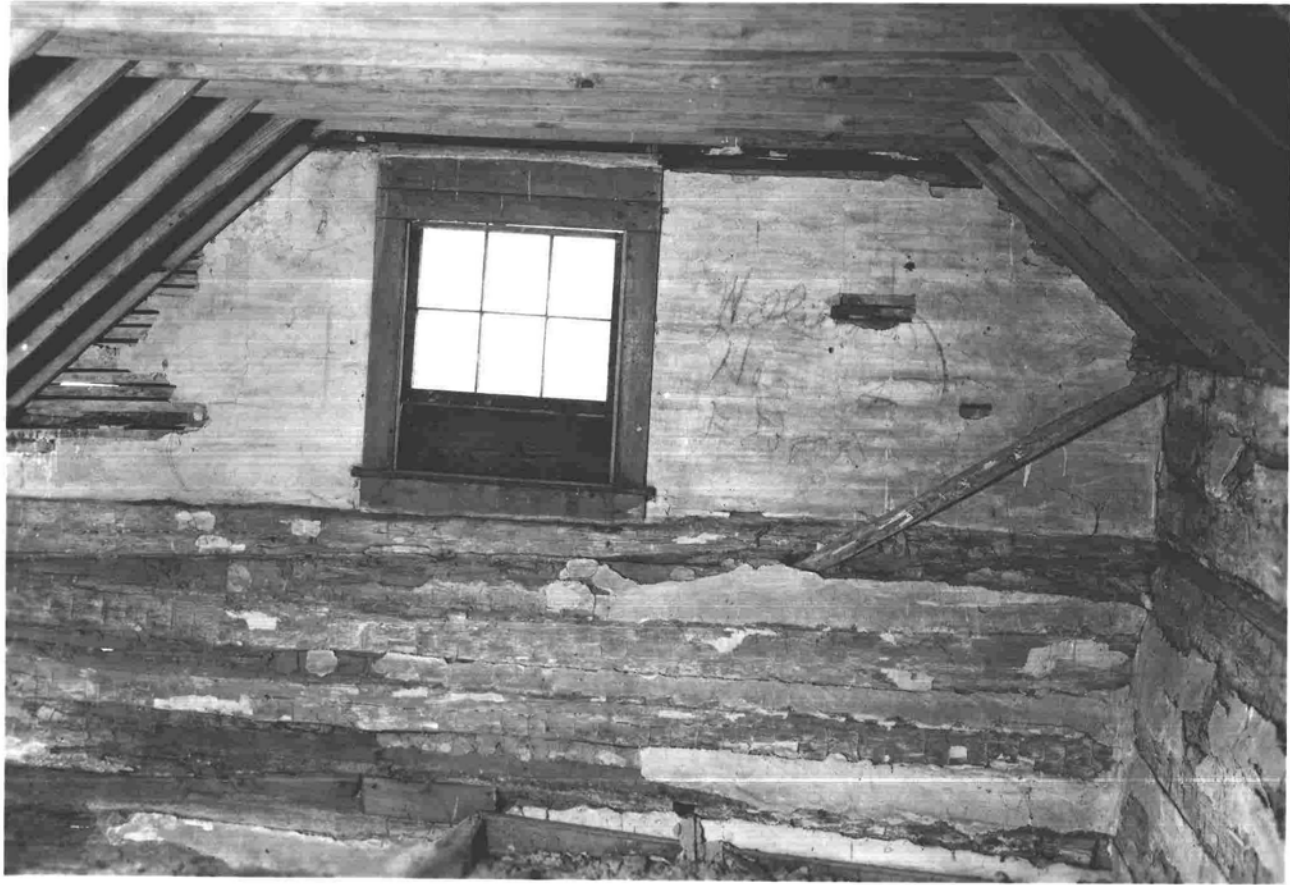
ILLUSTRATION NO. 23

Illustration No. 23 shows this condition with the notch for the diagonal brace visible in the top log of the west wall just under the plate. The original wall line of the log cabin can be distinguished by the whitewash marks left on the weatherboarding of the frame addition. The steps shown in the same photograph are 1881, although the platform beyond over the hall is thought to be in its original location. Illustration No. 22 shows a similar condition existing at the south-west corner of the room. The condition of the north wall must have looked much like the south wall in 1860 when the upper part of the walls in the log cabin were raised.

DETAIL - STEPS, SECOND FLOOR

Log Portion to second floor level, frame (North) portion. Probably installed in 1881.

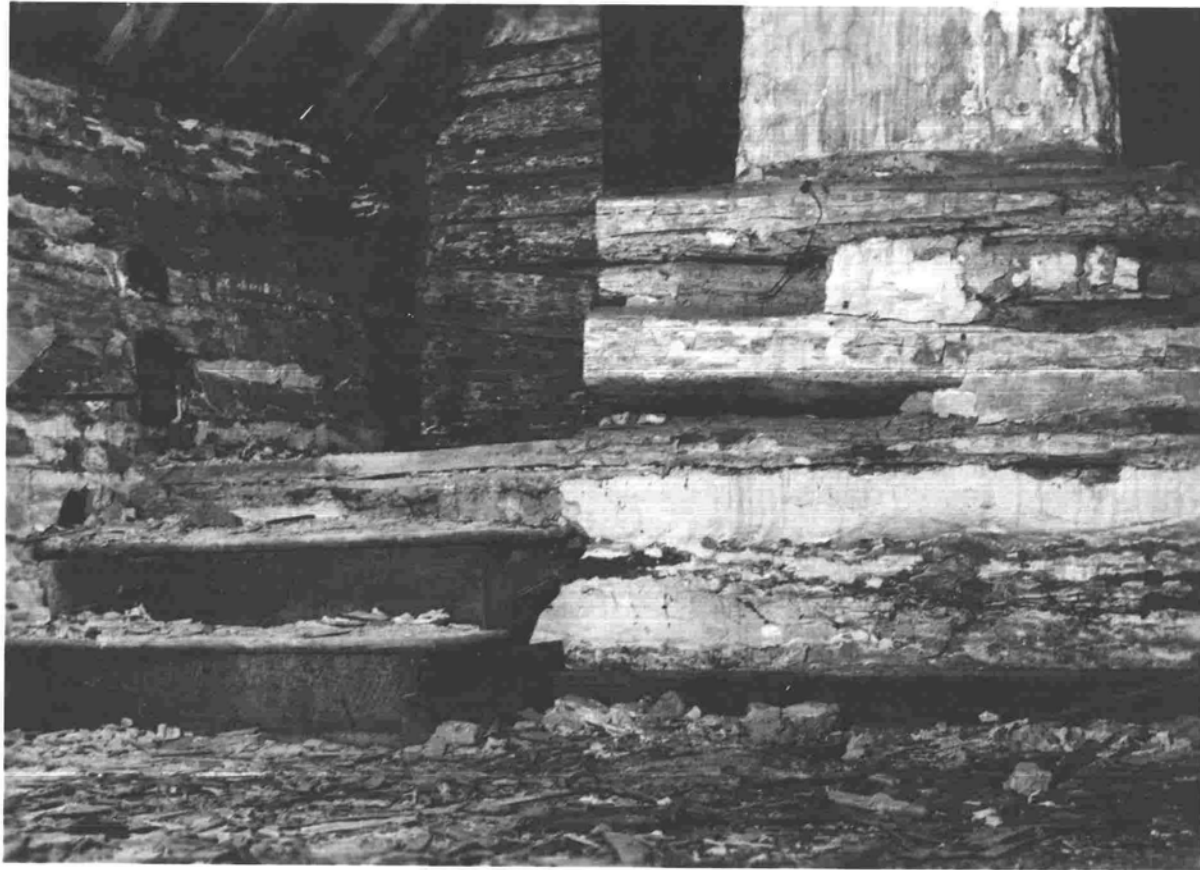
ILLUSTRATION NO. 24

This view shows the changes that occurred in 1881 to the south wall, second floor of the frame addition. A four light window was removed and a doorway cut through for access into the log cabin. Outline of the original window sill and trim can be seen on the stud to the left. To the right, the outline of the stud can be seen on the weatherboarding above and from the original mortice and tenon joint at floor level.
