Historic Structures Report

DOGAN HOUSE

Manassas National Battlefield Park

Prepared by
Orville W. Carroll
June 1962

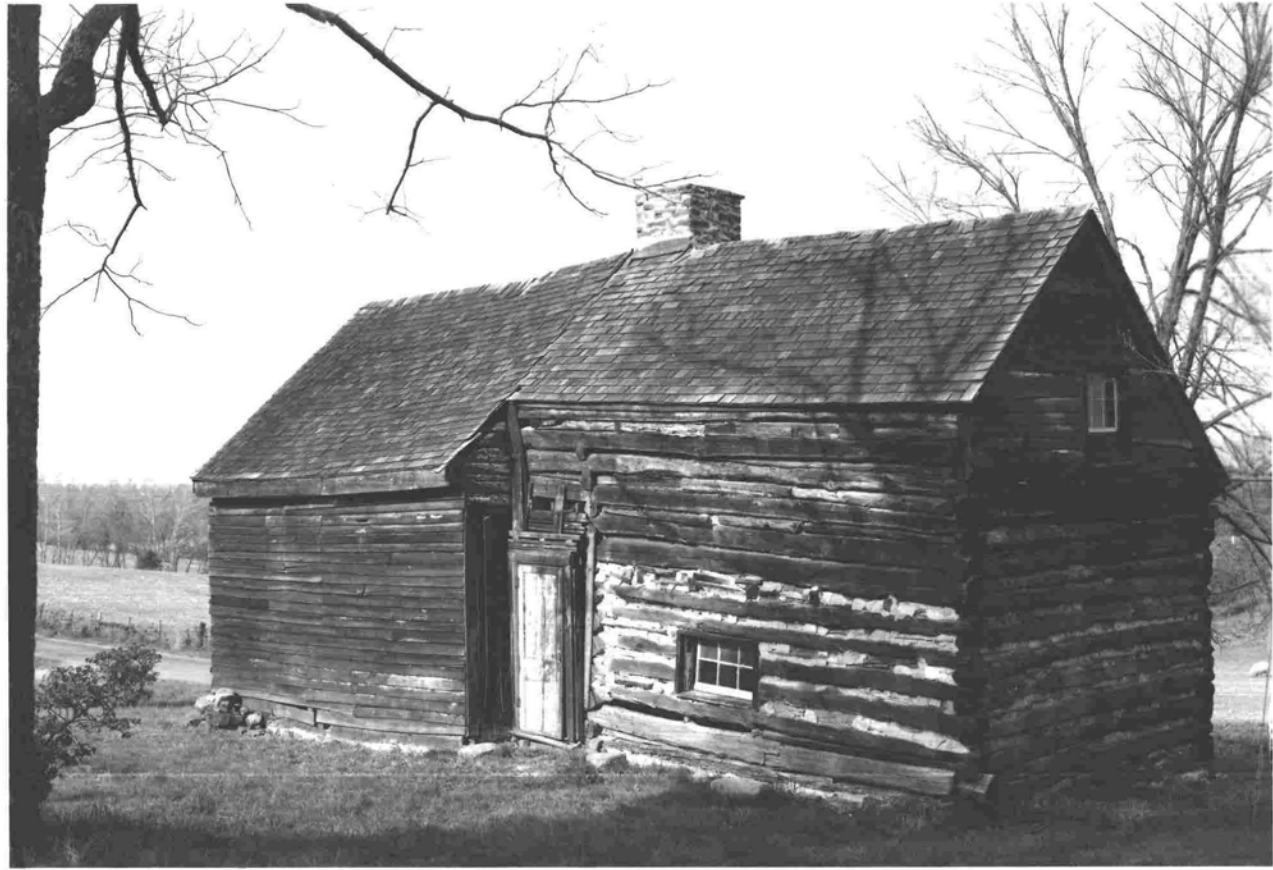
ILLUSTRATION NO. 6

A view of the west or rear side of the Dogan House prior to architectural investigations and exploratory excavations started in April 1960. Very little of the exterior fabric is original.

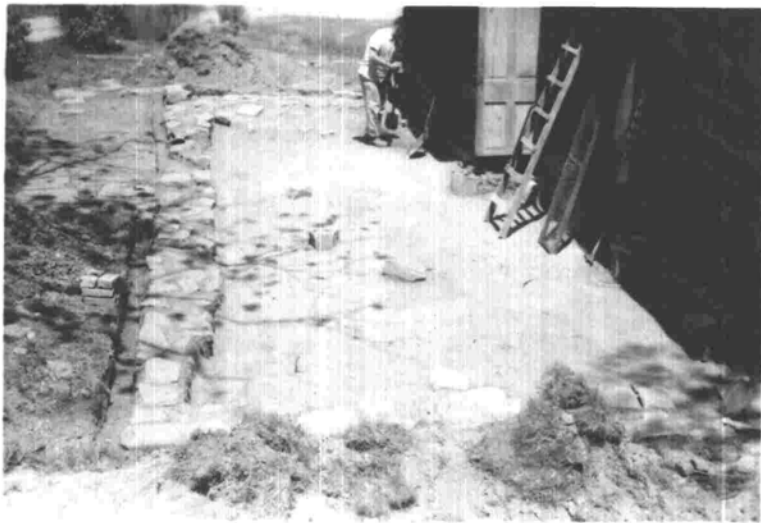
ILLUSTRATION NO. 7

Exploratory excavations on the west side of the Dogan House were carried out to determine if former porch footings could be found. If any existed, they were obliterated when the 1882 foundation which was built of granite rock rather than the red sandstone found in the foundation of the house. In the background is Raymond Smith.

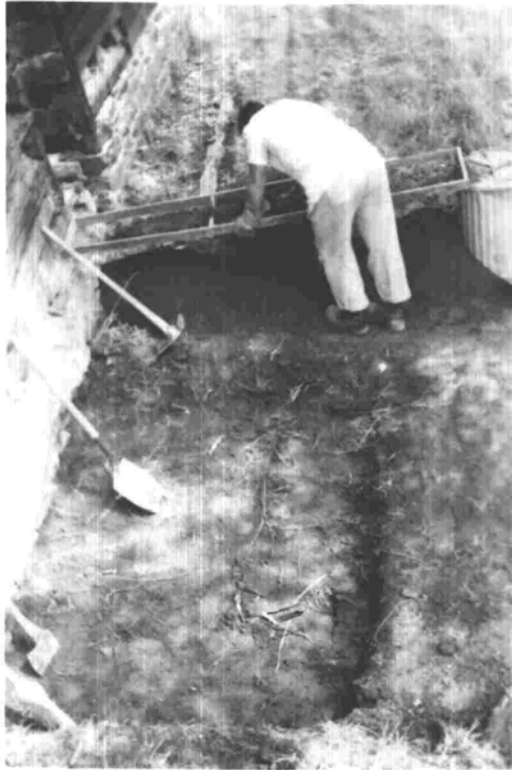
ILLUSTRATION NO. 8

An attempt was made to locate either porch or step footings across the east side of the Dogan House. No footings were found. Raymond Smith is shown screening soil for rifle balls. A bayonet and several rifle balls were found in this location.

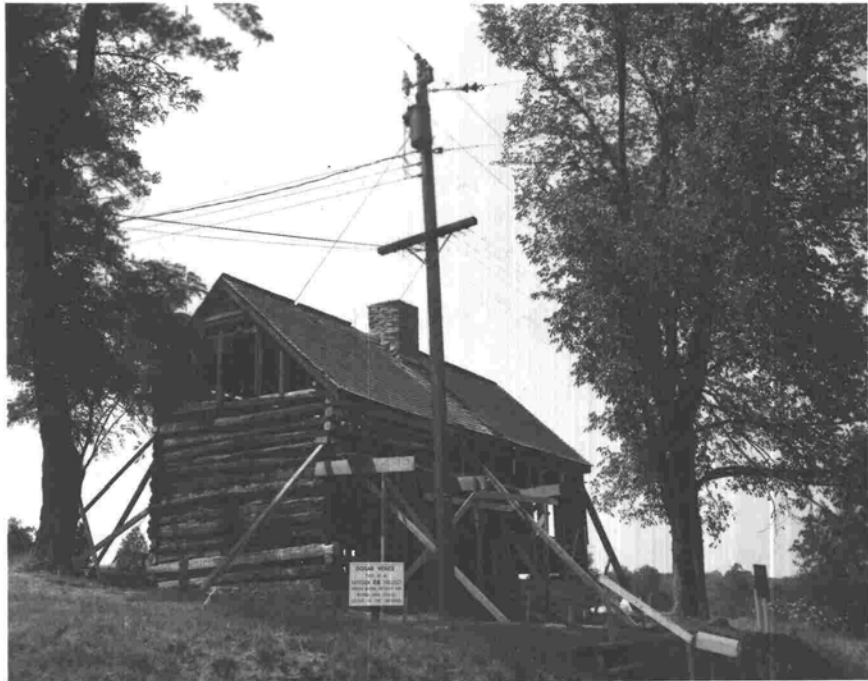
ILLUSTRATION NO. 9

Restoration work started June 15, 1960 with leveling and straightening of the existing structure. The lower three logs in the log cabin have been replaced by this time. The upper three logs have also been spliced with new material.

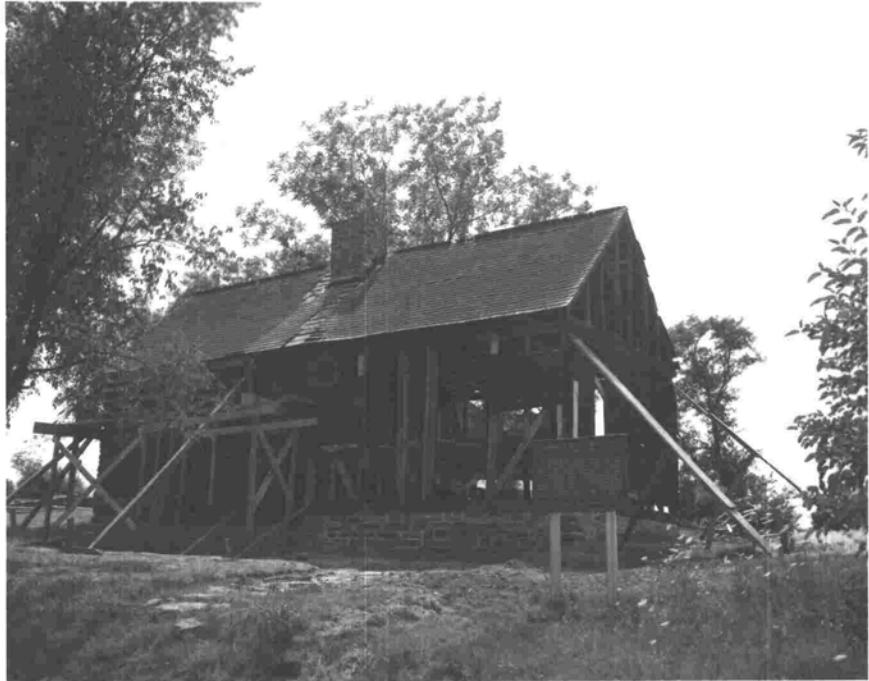
ILLUSTRATION NO. 10

This photograph shows the completed foundation walls as rebuilt by Ervin Sisler, mason from Falls Church, Virginia. Work was completed during July. The stone walk appearing in the foreground was uncovered during exploratory investigations of the surrounding grounds.

Masonry work: A great deal of the original foundation was still intact under the Dogan House but it was found in very poor condition. In the east wall of the frame addition, it was possible to replace many of the stones back into their respective positions. The corner stones were also replaced as they were removed but by and large no attempt was made to place each small stone back into its former location.

The type of mortar joints used in the final finish was copied from the existing masonry work found in the chimney where most of the work remains original. It is an inverted "V" or ridge type of joint. The mortar mix was made with Northern Virginia yellow sand, white cement, and crushed red sandstone for coloring. Pulverized lime lumps were added to give the appearance of unslaked lime particles.

A 4" tile drain was installed around the exterior of the foundation at footing level. The drain runs eastward from the northeast corner to the roadway where it empties into the drain ditch.

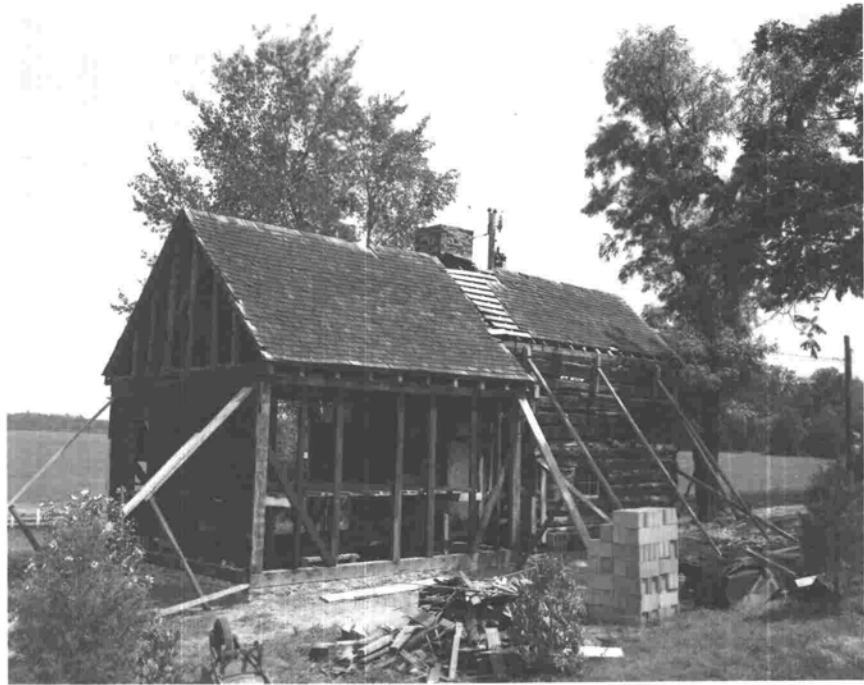
ILLUSTRATION NO. 11

Most of the original framework that was found to be in good condition was used. If a structural member was found to contain some rot, this was cut out and the remaining piece spliced with new material. In some places, such as the west and east sills of the frame addition, a completely new piece was required.

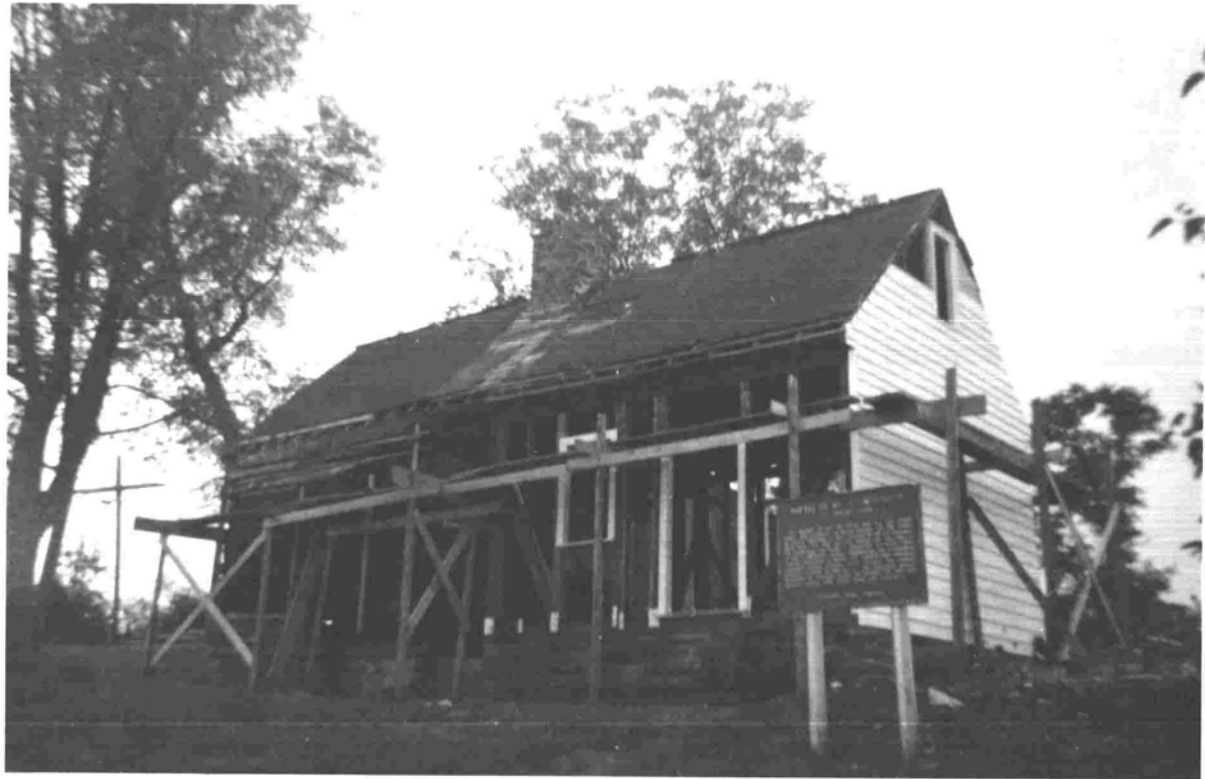
ILLUSTRATION NO. 12

Progress view of work accomplished up to August 1960. The 1950 shingled roof was left in place during the application of the exterior weatherboarding. The weatherboarding was hand-planed and primed with two coats of white lead paint prior to its final whitewash coat.

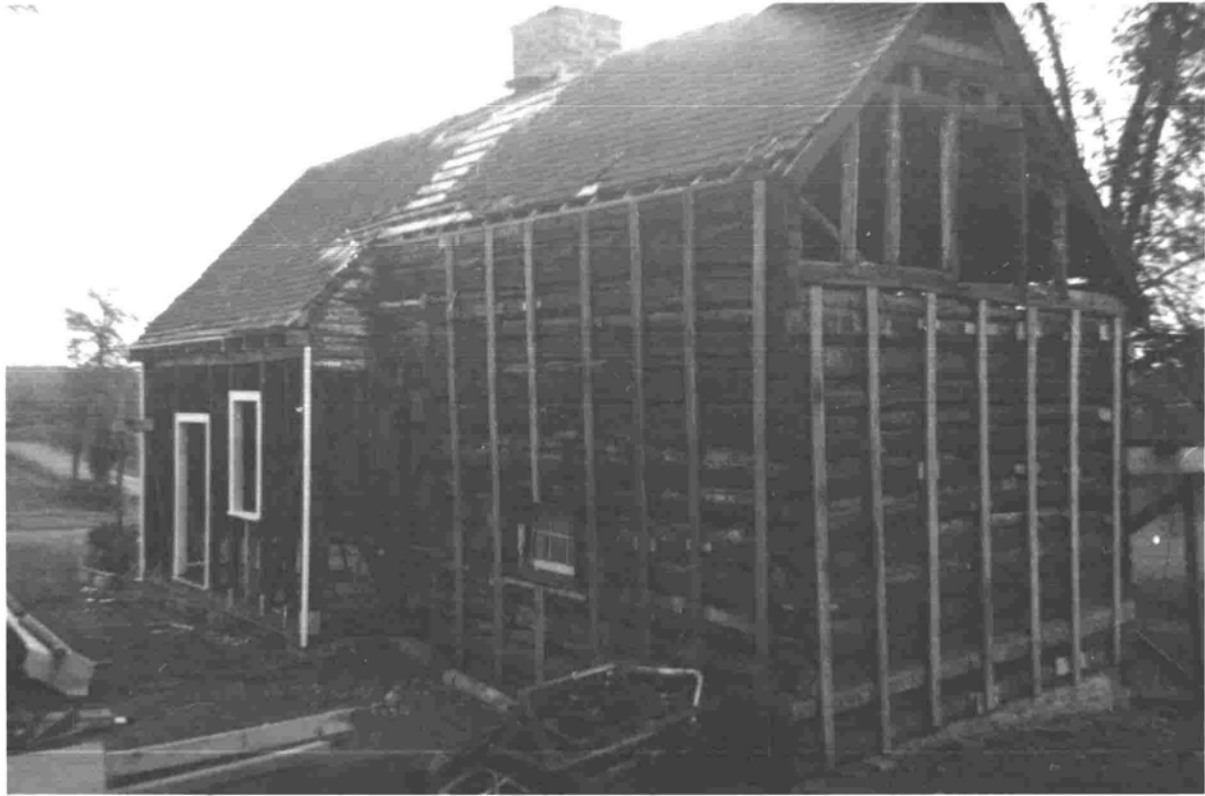
ILLUSTRATION NO. 13

It is thought that the log cabin was covered with weatherboarding in 1860 when the frame building was pulled over from the old "Peach Grove" site and added to it in an attempt to unify the exterior appearance. The upper portion of the log wall was built up to allow the roof ridge to join. Because of a difference in widths of the two buildings, the west side of the log cabin, being on the rear, was raised about two feet higher than the east and south walls. The weatherboarding was nailed into vertical nailing strips. The window in the south gable end wall was enlarged during the 1882 remodeling to accommodate a larger window frame.

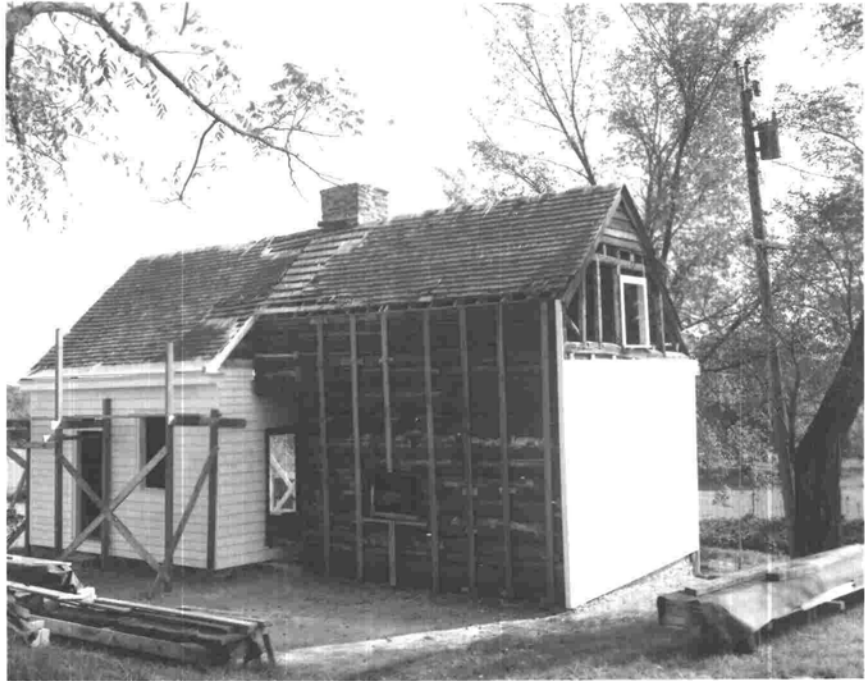
ILLUSTRATION NO. 14

View of work on August 27. Work was accomplished by two local carpenters from Haymarket and one local laborer. Much of the work to begin with was straightening and leveling of the two structures and replacing rotted members. The spacing of the weatherboarding was determined by measuring the spacing of the original nails still visible in the oak studding. The window and door frames were patterned after original pieces found in the walls of the building.

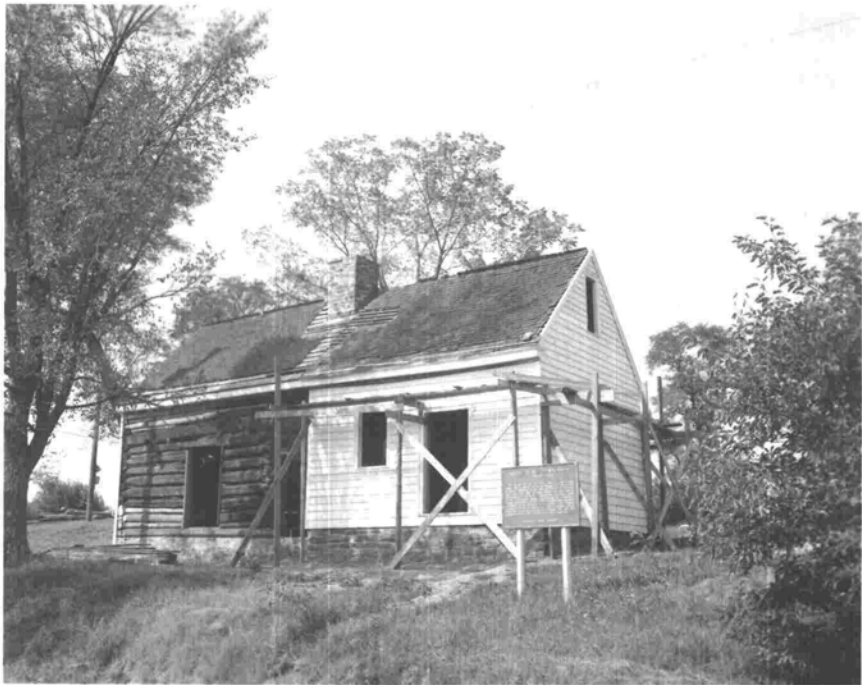
ILLUSTRATION NO. 16

View from the northeast showing the extent of the restoration work, August 27. We were fortunate in finding one window and door frame intact as well as two cornerboards and the cornice (in part) on the east wall of the frame addition. A more accurate restoration might have been possible if the building had not undergone two stabilization jobs in 1948 and 1950. The door opening in the log cabin was proven authentic when a rifle ball was found lodged in the door frame.

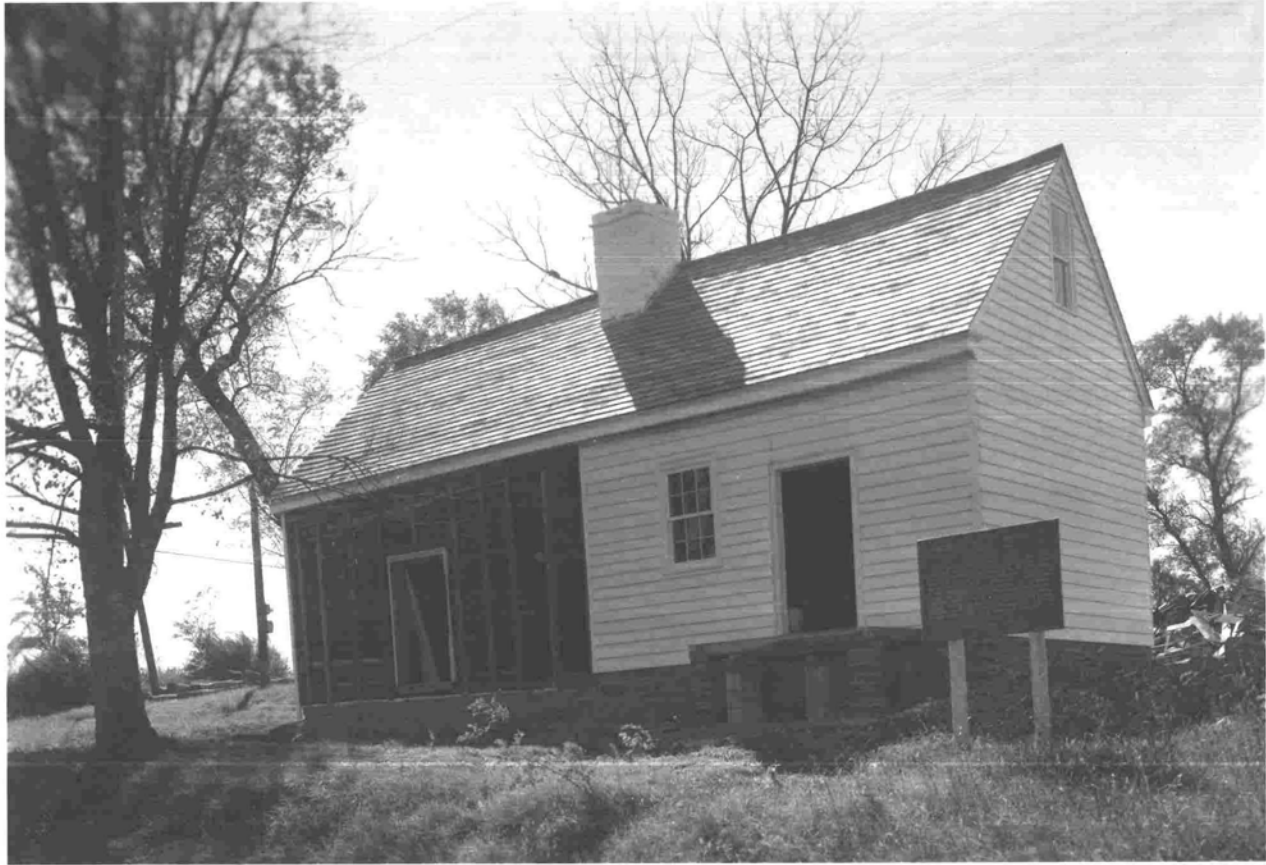
ILLUSTRATION NO. 18

Photograph taken October 1, shows the completed cornice and the wood shingled roof. The chimney has been repaired and whitewashed. Work has begun on the front stoop. The weatherboarding was given a second coat of white lead paint after it was nailed in place. No attempt was made to eliminate the sag in the roof of the frame addition as this was felt to be part of its historic appeal.

The chimney stack was repointed on the exterior. The chimney cap which was missing was rebuilt according to the visual evidence seen in the older photographs.

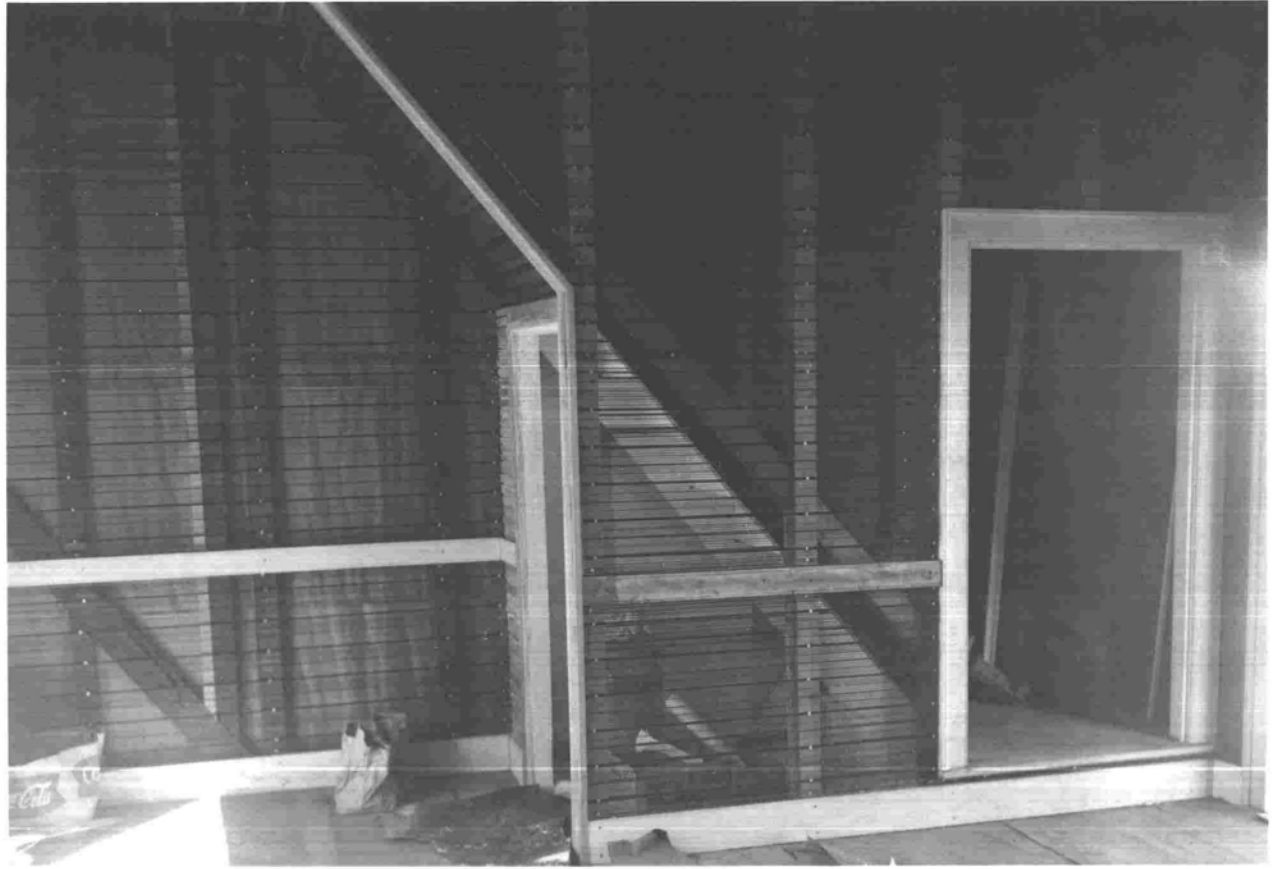
ILLUSTRATION NO. 19

This view shows the partial reconstruction of the stairway in the frame addition removed from the house during its 1882 remodeling. In a interview with Mrs. Ferrill, daughter of W. H. Dogan (IV) she stated "Yes, daddy had the stairs removed to make the room bigger." The short piece of chair rail used on the stairway wall was an original piece discovered in the house. Modern metal lath was used in the reconstruction of the interior.

Stairways: The 1860 stairway located in the frame addition was replaced using the physical evidence that was found and the remaining design based on the interior stairway found in the "Gheen House" near Centreville (See Illustration No. 5, Part II Report).

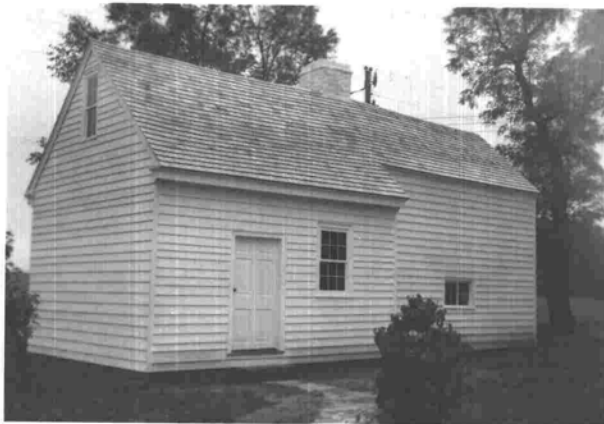
ILLUSTRATION NO. 23

An original door and window frame was found in the west wall of the frame addition covered over during the 1881-82 remodeling. The two openings are shown in this view, restored to their original positions. Both openings are identical to the door and window positions in the opposite wall.

Doors: One door frame complete with door sill was found in the west wall where it had escaped the 1881-82 and subsequent remodeling jobs. Both door openings in the east and west walls, as well as the window openings, were found to be identical when the framing of the house was studied. No door trim was found consequently the replacements were patterned after the window trim.

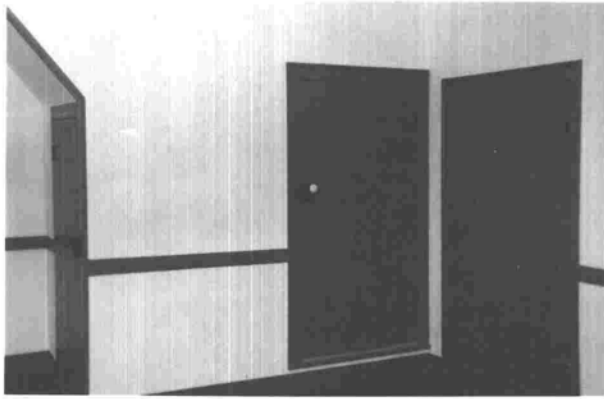
ILLUSTRATION NO. 25

A view of the reconstructed stairway located against the north wall of the frame addition. The original stairway was removed in 1881-82 to enlarge the room on the 1st floor.

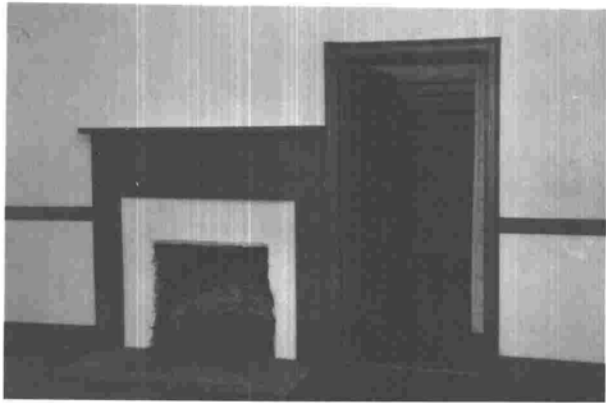
ILLUSTRATION NO. 26

A view of the south wall in the frame addition showing the reconstructed mantel, hearth and floor. The ceiling and wall areas were relathed and plastered and given three coats of whitewash.

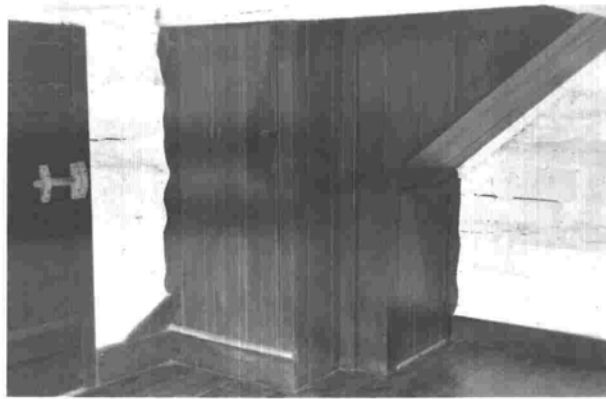
ILLUSTRATION NO. 27

This view shows the reconstructed stairway located in the southeast corner of the log cabin, 1st floor. Most of the reconstructed work depended upon the visual interpretation of a ca. 1958 photograph showing much of the old stairway before its destruction by vandals. The board and batten door at the foot of the stairway is an original. The front door is a reconstructed board and batten door. Holes used for supporting a pintel type hinge were found in the original door frame. The design of the wooden latch was patterned after one found at "Sully" a Chantilly, Virginia estate of the early 19th century.

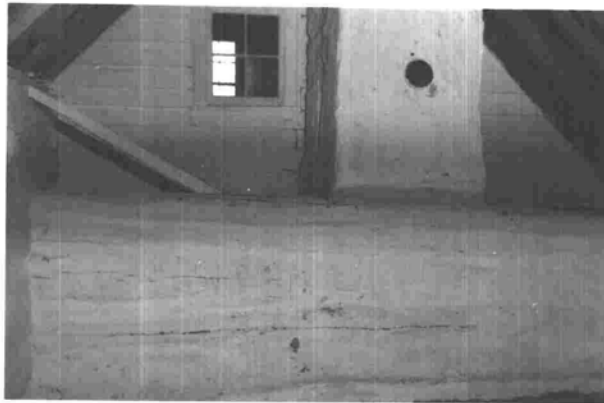
ILLUSTRATION NO. 29

A view on the 2nd floor, looking north showing the restored log wall and window opening (in frame addition) much like it appeared in 1860. In 1881-82, the stairway was removed from the frame addition to enlarge the room on the 1st floor. As a result, access into the attic room of the frame addition was created by removing the diagonal brace and cutting through short sections of two logs. Steps were installed and the window opening was converted into a doorway. After 1882, the only stairway in the house was located in the southeast corner of the log cabin.

The steps between the log cabin and the frame addition on the 2nd floor, added in 1881, were removed and the openings replaced to their earlier appearance. (See Illustration No. 29).

The door opening cut between the log cabin and the frame addition on the 2nd floor in 1881 was restored to its earlier condition with a four light window. (See Illustration No. 29).

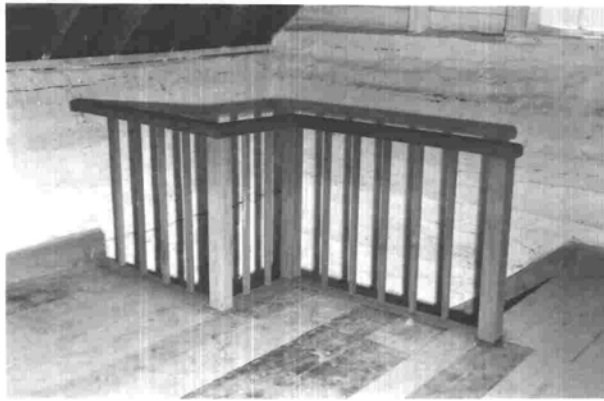
ILLUSTRATION NO. 30

The final finishing touches to the interior of the log cabin was completed during May 1961. Approximately one-half of the floor boards required replacement and the stair railing rebuilt according to what remaining evidence could be found. The roof structure seen is that installed in 1950 and was left undisturbed during restoration work.

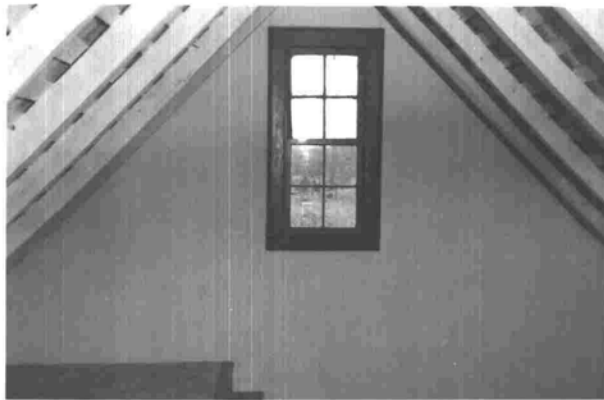
ILLUSTRATION NO. 31

This view shows the north end of the attic space in frame addition as it probably appeared in 1860. Prior to 1860, the frame addition stood as an independent structure at nearby "Peach Grove" some 400 yards to the northwest and contained its own stairway to the attic room. In 1881-82, the stairway was removed to enlarge the room below. Access into the attic room was made possible by removing a small window in the south wall and cutting a low narrow doorway through the wall into the second floor of the log cabin. At this same time, all the window and door openings (except two) were either altered or changed. In this instance, the gable window was changed somewhat to accommodate a larger window frame.
