ARCHITECTURAL FABRIC INVESTIGATION AND
DOCUMENTATION OF THE

ROBINSON HOUSE

MANASSAS NATIONAL BATTLEFIELD
MANASSAS, VIRGINIA

Final Report

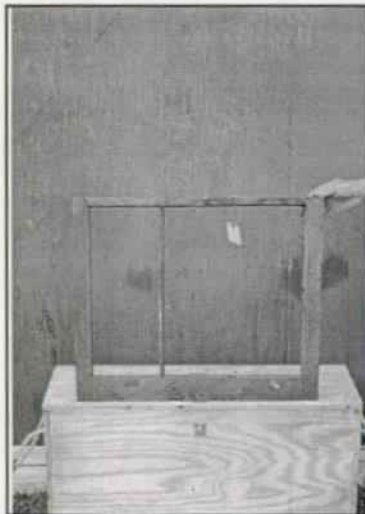
WPTC photograph showing Architectural Artifact #0098

This sash was found loose in the east attic room with a loose shutter and may be sash W of the "Fairweather Report" (WPTC window opening designation A/S13) which Fairweather requested saved.

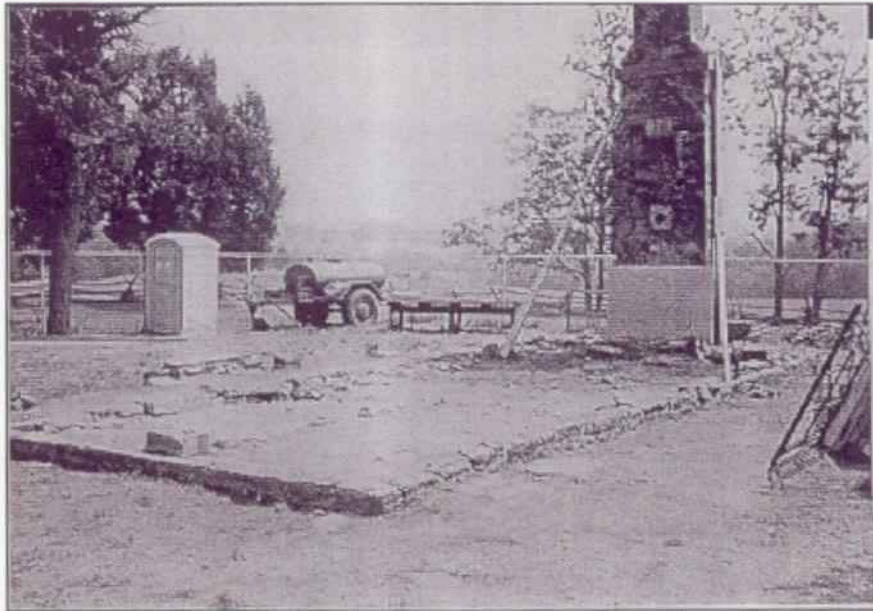
WPTC Photograph #85 of foundation and stabilized chimney.

⁸ The stone chimney and the foundation were left in place at the conclusion of the architectural fabric investigation project. The chimney required temporary wooden bracing. Information regarding the decision to stabilize the chimney can be found in a memorandum dating June 28th, 1994 from the Superintendent, MANA regarding a meeting held on site on June 23, 1994.

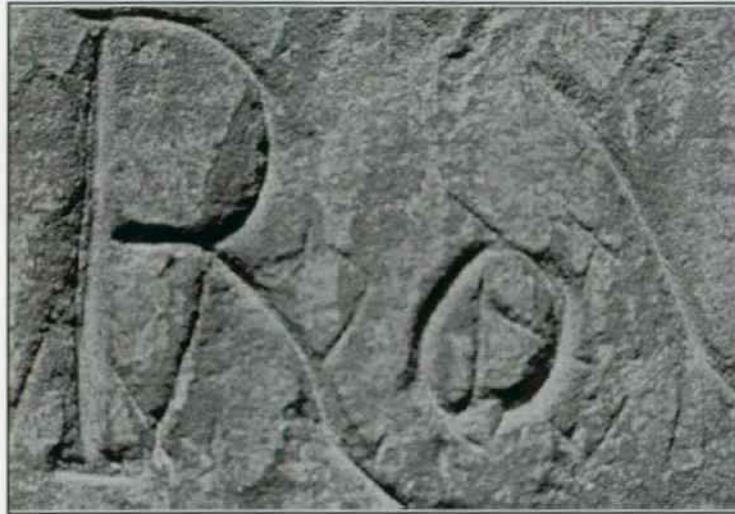
The stone chimney has a date stone installed on it's eastern face and was inscribed J. Robinson 1888. A few other stones have names or initials inscribed on them and their significance will need to be determined if and when the chimney is disassembled.

WPTC Photograph #73 enlargement of inscription on chimney stone.

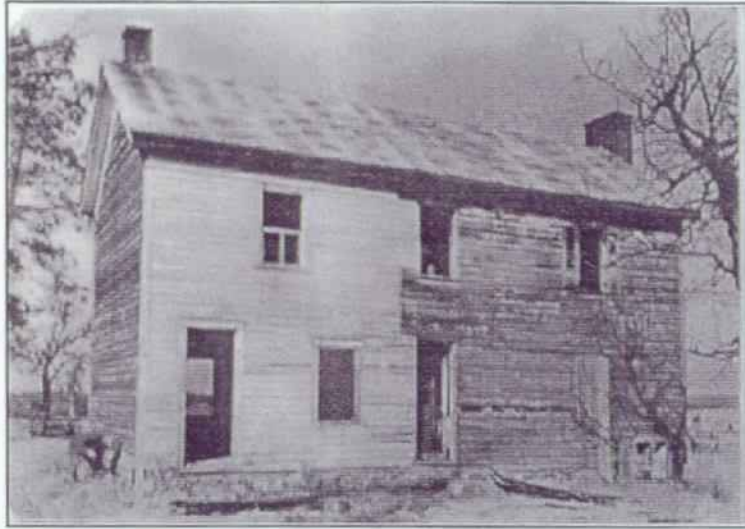
According to Fairweather on page 2, paragraph 3, he states, "The exterior trim and siding on the East Elevation and the east end of the South Elevation is badly weathered or broken. The siding is of 1/2" x 6" material applied directly to the studs,..."

Sheffield photograph #3 / WPTC photograph #95 - north elevation.

The siding described by Fairweather is the "lap" siding found mostly on the 1926 addition. The "german siding" installation can be directly attributed to the National Park Service maintenance work, due to the fact that this type siding was found in areas where Fairweather called for replacements in item # 3 of the "Repairs Required for Preservation" section of his report. The Sheffield photo's numbered 3,4,5,6,& 8 illustrate the poor condition of the siding encountered by Fairweather. The lines which separated the two varieties of siding in these photographs from 1941 are the same as those encountered by WPTC at the start of the project.

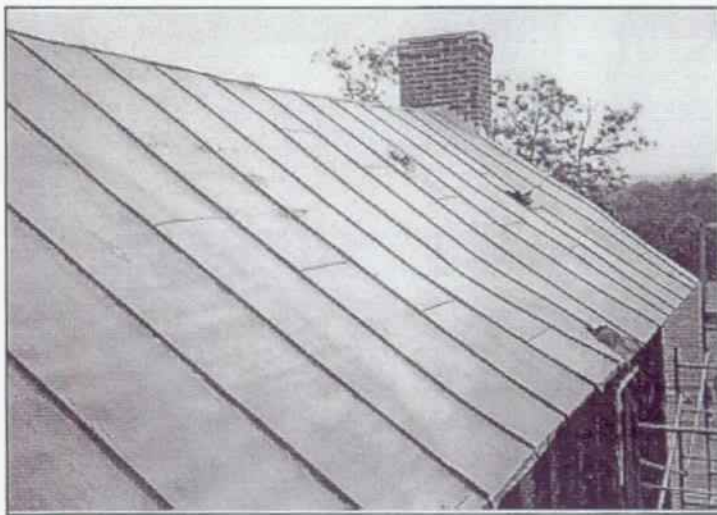
A single run of an earlier roofing material was found at mid span on the north pitch of the roof. This roofing was a green, mineral surfaced, asphalt, rolled roofing (sometimes called "double coverage") which was run peak to eave, lapped and tarred at the seams. This material was fastened with 1 1/4" roofing nails. Nailing patterns were observed for this roof covering on roof sheathing members.

WPTC Photograph # 33 roof covering and sheathing, (above).

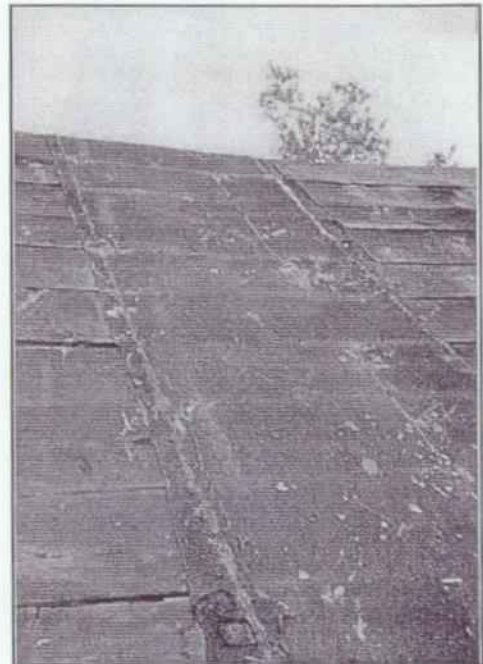
WPTC Photograph # 46 roll roofing, (right).

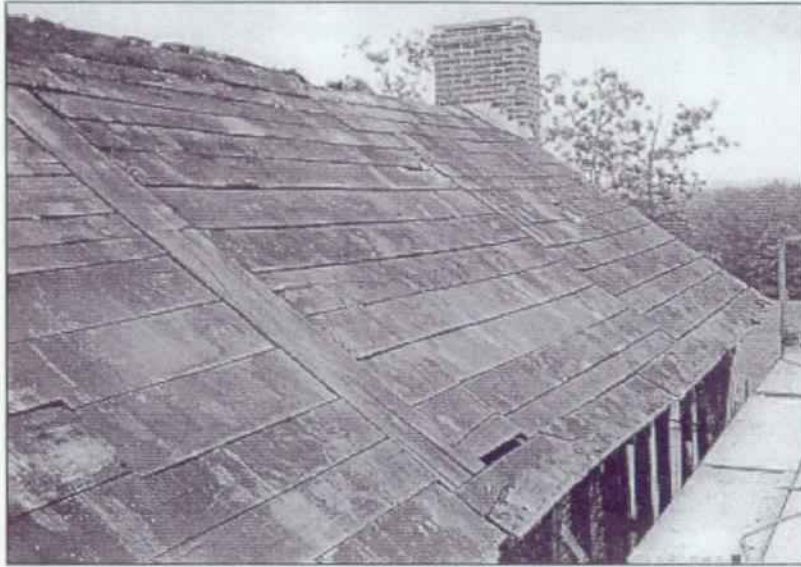
An opening was cut in the roof sheathing near the northeast corner of the 1926 addition. The opening was rectangular measuring 8" x 11" and it's center was located 39" from the north eave and 6" west of the eastern most 1926 rafter.

WPTC Photograph #40 showing roof sheathing.

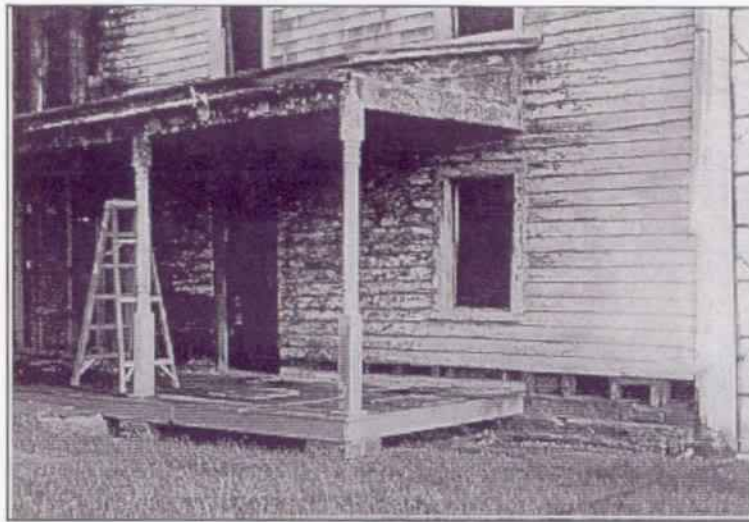
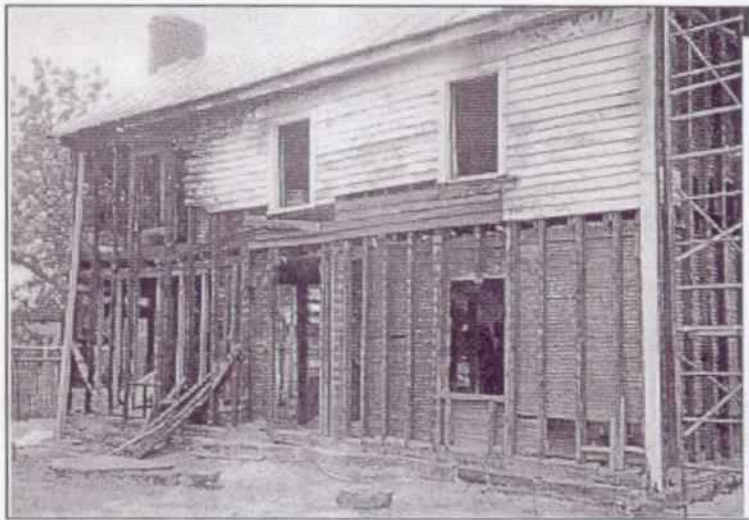
Fairweather noted on page 2, paragraph 3, that "...the porch, (is) of newer material than the remaining exterior finish..." and on page 3, paragraph 1, Fairweather states that the condition of the porch is fair.

The WPTC photographs #9 & #31 above show the porch from the west (before removal, top) and the north elevation after removing the porch (bottom).

The north elevation porch piers were reconstructed and stoop itself was repointed by Park maintenance during the 1980's.¹¹ No investigative work was performed on them since they were left in place along with the foundation and chimney. Future archeological work should reveal any previous porch related features or masonry as well as aiding in the dating of the foundation and chimney.

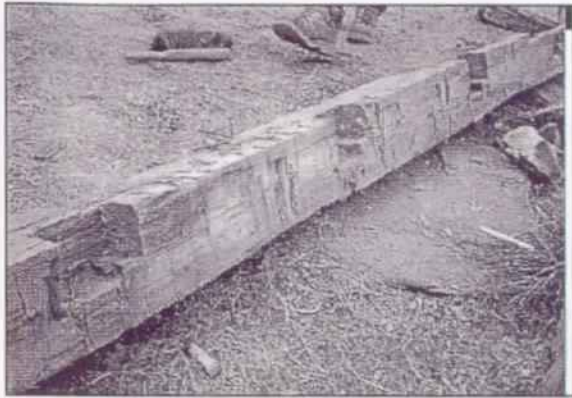
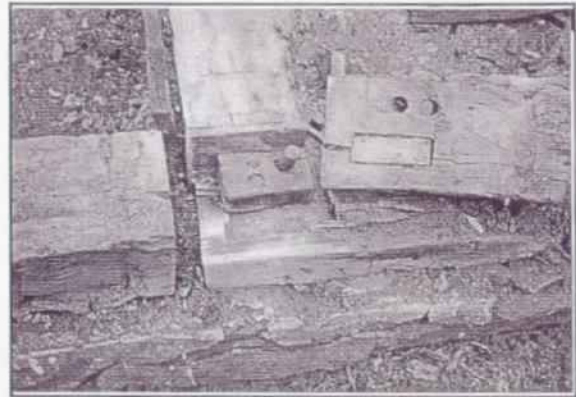
The sill under room W was broad axe hewn and was half lapped at the northwest and south west corners and butted against the 1870s sill at the northeast and southeast corners. The sill on the west elevation was shimmed with a 3/4" thick, full length, circular sawn, board. The north sill was shimmed with a 1/2" thick, circular sawn, board, for 90% of the length. In addition, the north and south sills of the 1926 structure had their joist pockets recut to hold the existing joist.

WPTC photographs # 82 (left) and #83 (right), showing sill joinery details.

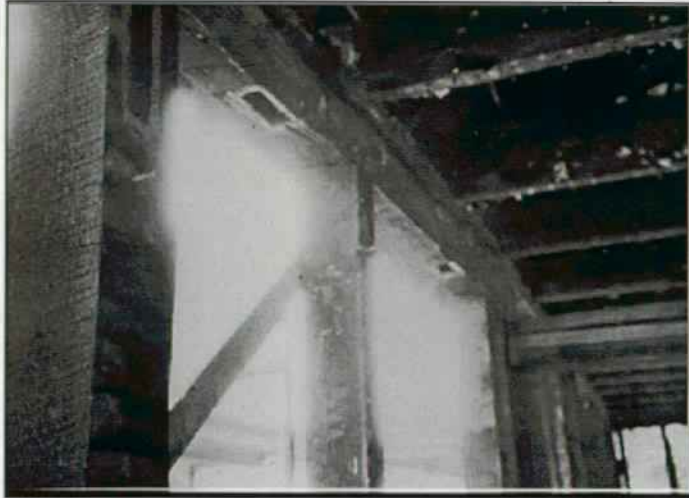
Top Plates for rooms E2-C2 on the north and south elevations were both 4" x 6", broad axe hewn members and had mortises for posts and vertical studs. On the east and west elevations they were mortised for studs and tenoned into the corner posts. These top plates had a full dimensioned circular sawn 2" x 4" plate nailed to the top of them before the third floor joists were installed. (This feature is perplexing since it did not add much to the overall height of the second floor but appears to have been installed for just that purpose. If viewed outside the construction chronology an argument could be made that these plates were added to the top plates to bring the 1870s roof to the height of the 1926 roof.) The top plates of the north, south, and west elevation of the 1870s addition were intriguing. These members had mortise pockets cut into their bottom face that were similar in dimensions and layout to the stud mortises but for some reason were not used.

WPTC photograph #55, showing unused mortise pockets.

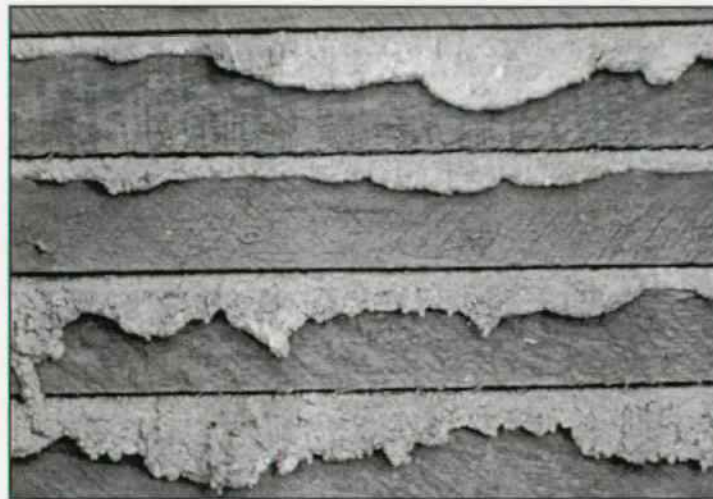
The plaster of the 1870s and 1926 additions is of the same consistency and appearance. Even though the lath was attached with wire nails in the 1926 addition and cut nails in the 1870s addition the walls could have been entirely replastered at a later date (this is highly unlikely) or the plaster mix could have coincidentally stayed fairly consistent between these two plastering campaigns. Visual examination did not reveal any difference between the plaster samples. Further laboratory analysis would be needed to determine differences in the two mixes. Samples were gathered from each room and were bagged and tagged along with samples of lath and nails.

WPTC Photograph #32 showing circular saw marks on lath.

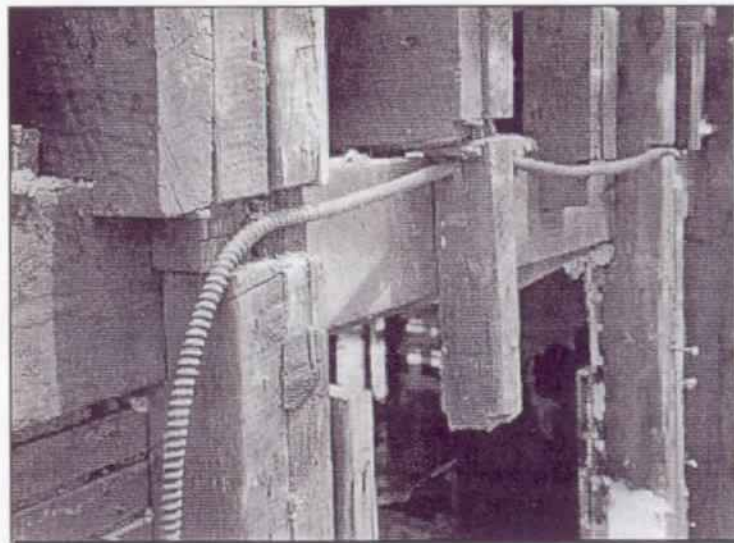
The electrical conduit was run loosely throughout the house in between studs and joist of the frame. Holes were drilled into the joist when the conduit was run east and west above the first floor ceiling. The conduit was then dropped to the light fixtures centered in the ceilings of rooms E1 and W. This dates the conduit to before or during the installation of the first floor ceiling or the second floor flooring. The conduit was run loosely in the attic over the ceiling joist of the second floor and then down to the light fixtures in rooms E2 and W2. On the porch, the conduit is run through the north wall from room W into the area above the porch ceiling. This means the installation predates the installation of the porch ceiling boards or roofing. The studs of the south elevation of the 1926 addition were notched above doorway #2/S10 to run "romex" conduit to a switch west and inside the door. Conduit was also run in the ceiling joist along the east wall of room E1 and then down the north wall to a switch beside door #1/N5. Interior photographs should be referenced for even more information about the electrical receptacles and switches.

WPTC photograph # 25 showing flexible conduit found in walls.

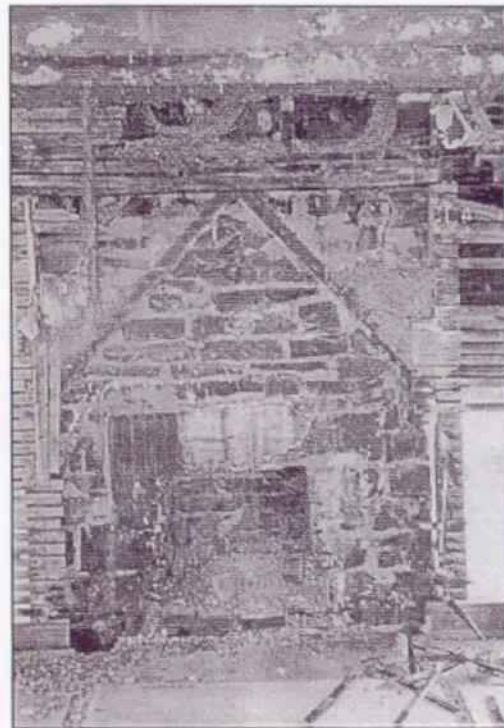
4. What was the purpose of the stepped stonework above the room E2 firebox.

WPTC photograph #49 showing peculiar stepped stonework above firebox in room E2.
