historic structure report
architectural data section
volume 1
june 1985

MARTIN VAN BUREN

HISTORIC STRUCTURE REPORT

LINDENWALD

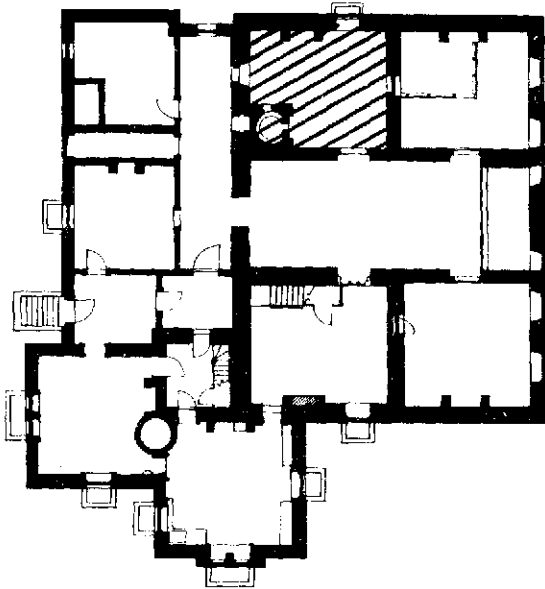
a. Room 001 - Furnace

Room 001 occupies the northwest corner of the 1797 house. To the best of our knowledge, there is no documentary or photographic evidence concerning the earliest appearance or uses of this room. The historic hot-air furnace and the modern oil-fired boiler in this room provide eloquent proof of its use from the last years of Van Buren's life to the present. (The furnace is dated to Van Buren's lifetime by the patent date "August 22, 1854" on its cast-iron firebox door and by the inscription on its sheet metal access door, "Hon. M. Van Buren/Kinderhook, N.Y.") See section IV.C.2. for a full description of the historic heating system.

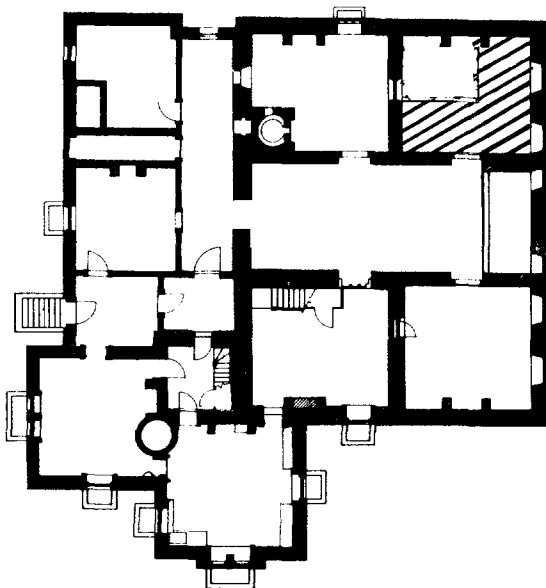
b. Room 002 - Storage

Room 002 occupies the northeast corner of the 1797 house. The northwest corner of this room was separated by a wood stud and board partition creating room 002A (discussed below). No documentary or photographic evidence relating to the historic use and appearance of this room survives. However, wrought-iron hooks in the ceiling, a "cistern" in the floor, and shelves in room 002A suggest that its primary function was food storage of some sort.

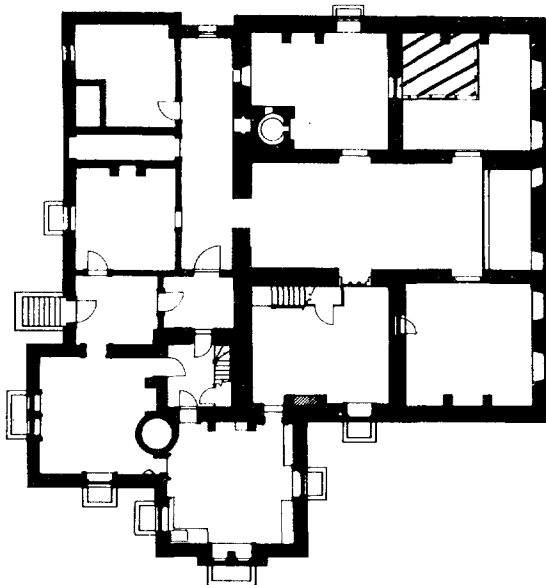
c. Room 002A - Storage

Room 002A is the space that was partitioned off in the northwest corner of room 002. It is apparent from the shelving, the lock evidence on the door, and the jars and bottles still on the floor and shelves that the room was used for food storage.

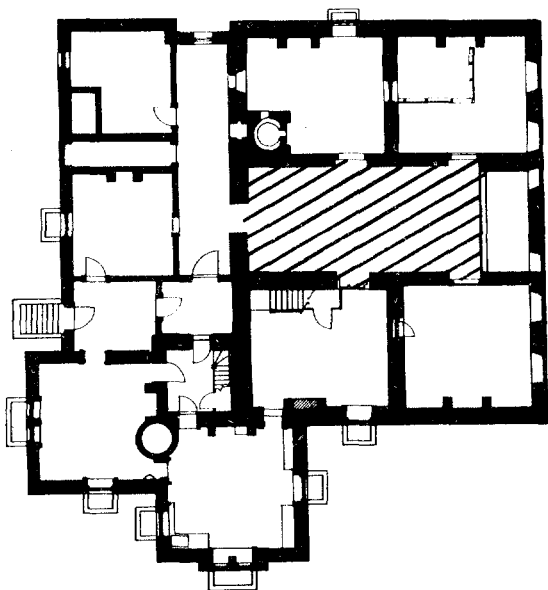
d. Room 003 - Hall

Room 003 is the central hall of the 1797 part of the basement. It provides access to rooms 001, 002, 003A, 004, and (originally but not during the historic period, 1850-62) 005. It is entered from room 012. Access was its primary function, but it may also have been used as a nonsecure storage area.

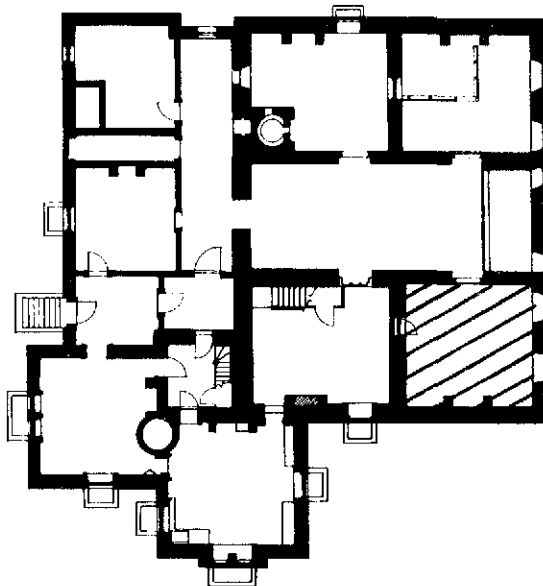
f. Room 004 - Wine Storage

Room 004 occupies the southeast corner of the 1797 basement. The surviving racks and barrels suggest that the room was used for storage of beverages. Evidence below leads to the conclusion that these fixtures are historic.

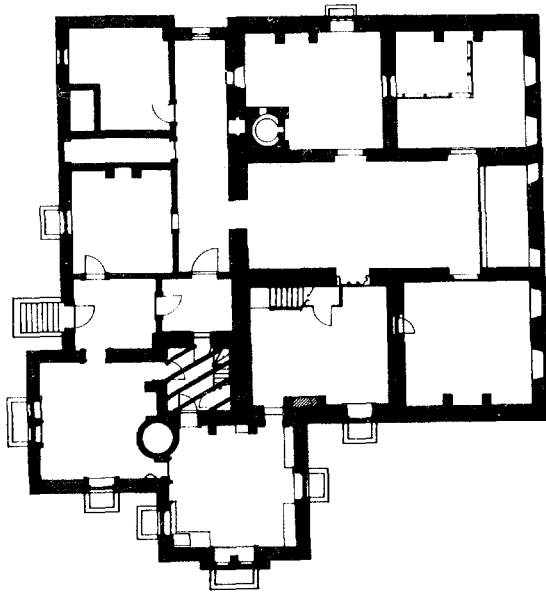
j. Room 008 - Stair Hall

Room 008 is the lowest level of the tower stair and the primary interior access to the basement. The walls of the room are whitewashed, two-coat plaster directly on masonry walls. The north and east walls are rubble stone construction; the south and west walls are brick. Aside from minor damage to the south wall (caused by rising damp) and to the northwest corner (probably caused by leaking pipes), the plaster and masonry are in good condition. The east wall under the stair consists of a board partition with a board-and-batten door, both of which have a painted wood-grain finish. The underside of the stair and the

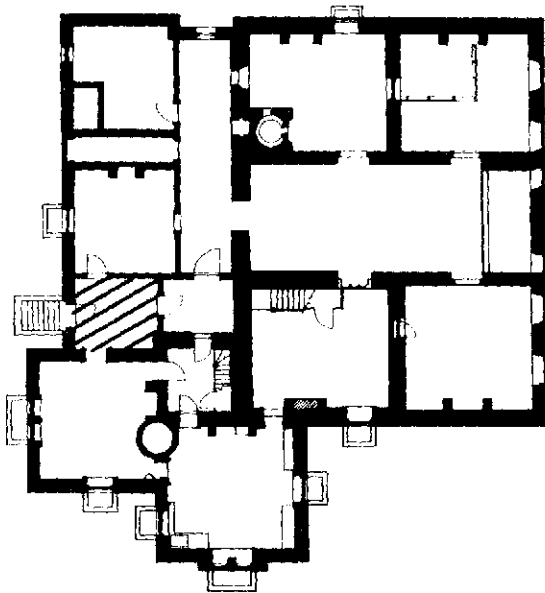
k. Room 009 - Basement Entry

Room 009 is a vestibule/entry space. Door 012 in the west wall of the room gives access to the bulkhead stair. The historic cesspool is under the floor of this room. There is also evidence that suggests the brick platform in the southeast corner may have supported a water heater.

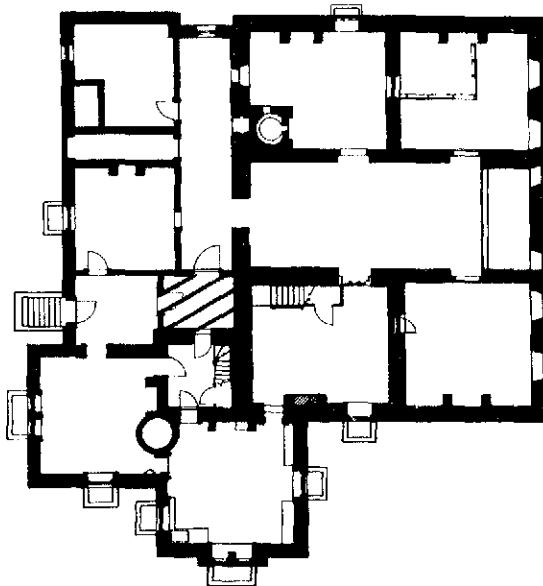
I. Room 010 - Transitional Space

Room 010 is east of room 009 and north of room 008. It is a small rectangular space 10' by 7'6" whose only apparent use is as a transitional space between rooms 008, 009, and 012.

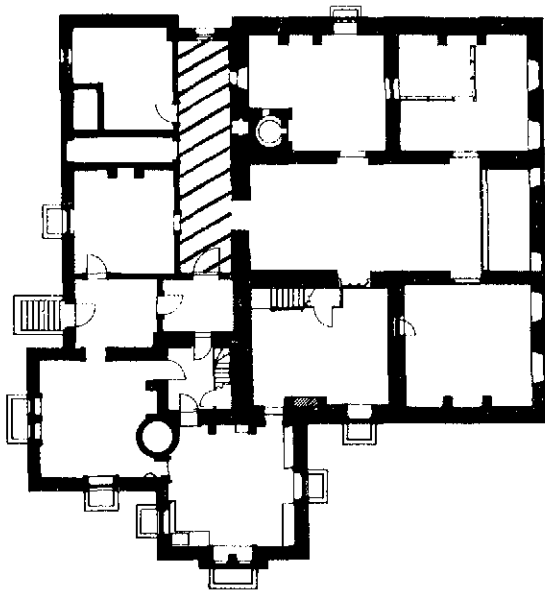
n. Room 012 - Back Hall

Room 012 is the back hall of the basement. It provides access from room 010 to rooms 003, 013, and 015. In recent years (and possibly earlier) it has been used as a storage area.

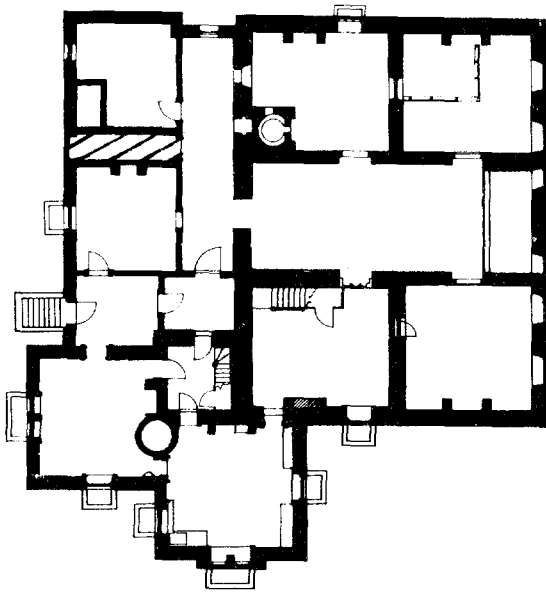
o. Room 013 - Vaulted Tunnel

Room 013 is a long, narrow room, 3'6" by 14'6", between rooms 011 and 015 (see IP024). It is bounded on the east by room 012 and on the west by the exterior foundation wall. Its historic and subsequent uses are a subject of considerable interest. The most plausible hypothesis is that this room and an adjacent small chamber to the west were used for cold food storage and ice storage respectively. The evidence supporting this hypothesis is presented in the following paragraphs.

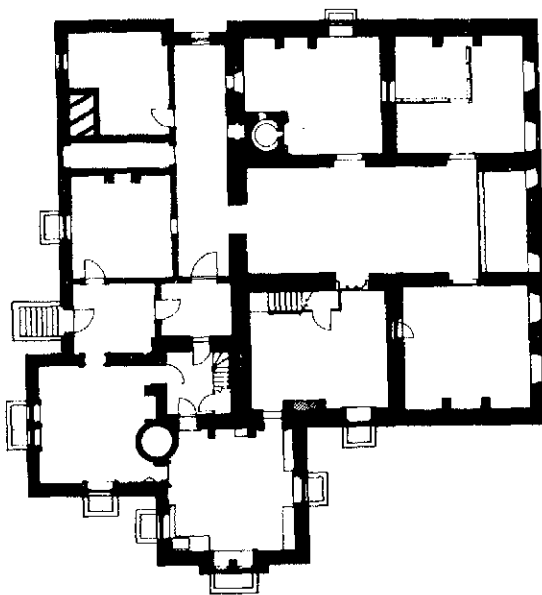
p. Room 014 - Privy Pit

Room 014 is not really a room at all. It is the interim repository for human wastes from room 121 pending their ultimate disposal in another place. It is along the west wall of the basement, adjacent to room 013 and seemingly carved out of the southwest corner of room 015. Interior dimensions are approximately 3'6" by 6'0". Its proximity to the ice and food storage areas seems unsanitary, but as demonstrated by the presence of the cesspool in room 009, either sanitation was not well understood by the architect and owner or it was not a matter of great concern.

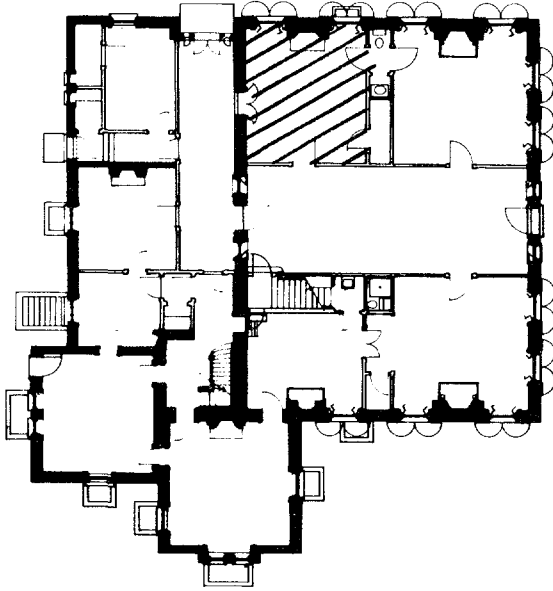
a. Room 101 - Bedroom

Room 101 is in the northwest corner of the 1797 house. Direct access is from the 1797 central hall, room 105, on the south wall (D101). Door 104 at the north end of the east wall opens into a small closet, room 102, and allows one to pass into the northeast room 104. Originally room 102 was connected to a larger closet, room 103. A door opening in the west wall has functioned as a closet since 1849 (D105). The north wall has a central chimney breast and windows (W109, 110) at either side.

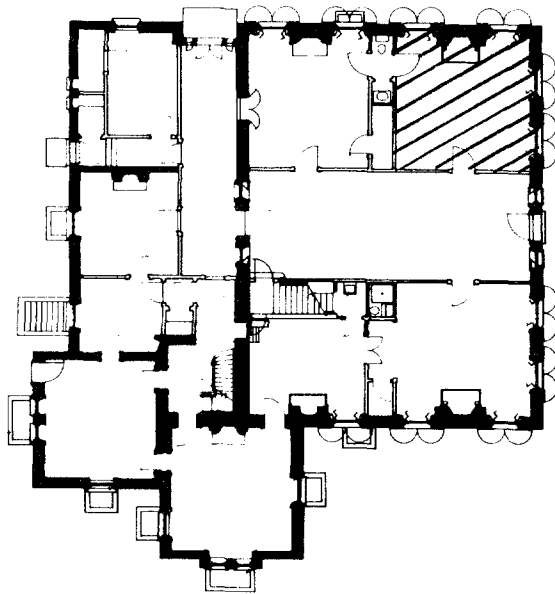
d. Room 104 - Parlor

This room occupies the northeast corner of the 1797 house. It is entered from the central hall, room 105 (D102), and also has access to closets 102 and 103 and through to room 101. The east (front) wall has two window openings (W105, 106), and the north wall has a central chimney breast flanked by window openings (W107, 108).

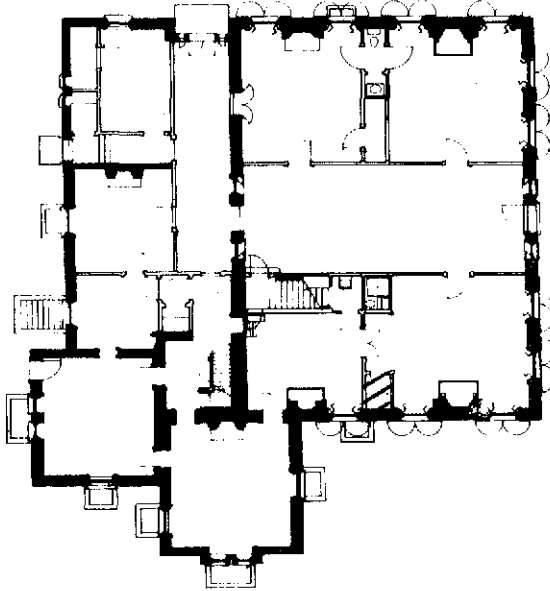
g. Room 107 - Storage

Room 107 is a small closet on the south side of the 1797 house between rooms 106 and 109. This closet is entered through a door opening (135) in the north wall from an alcove in room 106, the drawing room. Rooms 107 and 108 maintain a symmetrical relationship with rooms 102 and 103 on the north side of the central hall, room 105. The treatment of the four closets is different, however.

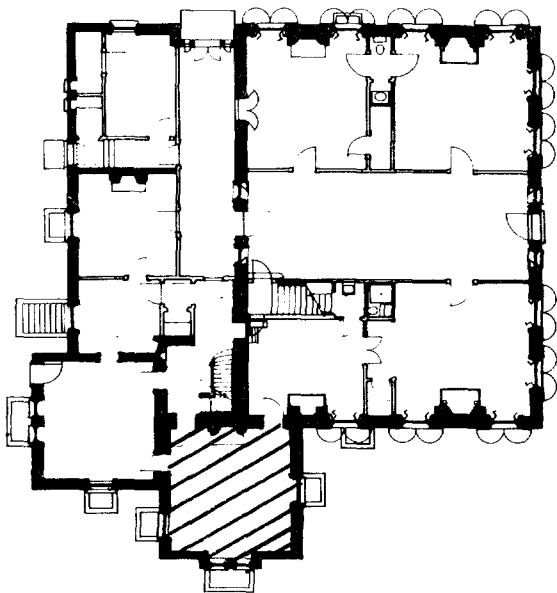
k. Room 111 - Library

As part of the 1849 additions designed by Upjohn, this room is assumed to have been the library. The plan records of Upjohn's office include details for the bay window of the library (Upjohn Planbook), and room 111 is the only first-floor room with a bay window. This room adjoins the south side of the 1797 house so that access is not only from room 113 (D126), the tower stair hall, and the bedroom, but also from room 109 (D128), the breakfast room.

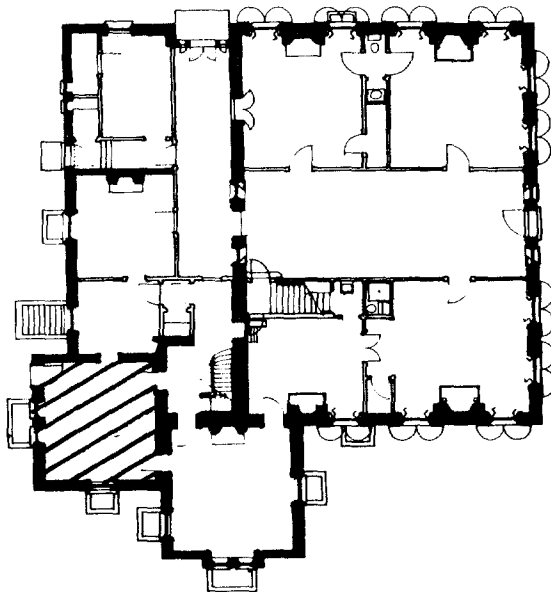
I. Room 112 - Bedroom

This room projects farther west than the other portions of the one-story 1849 addition. It is under its own batten-seam terneplate gable roof immediately to the west of the tower. The room may be entered from the tower stair hall, room 113 (D125); the library, room 111 (D127); the bathroom, room 114 (D122); and from an exterior door in the west wall (D124). There is one window in the south wall, a double-arched window in the west wall, and a fireplace in the east wall.

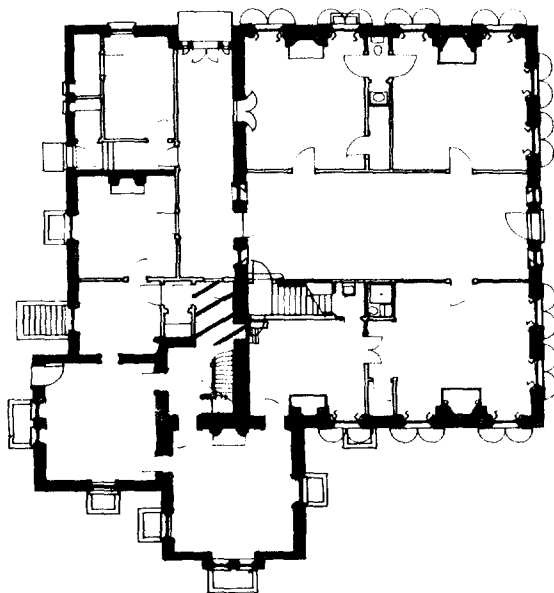
o. Room 117 - Hall

This hall was added as part of the 1849 additions, and although it is currently divided from the tower stair hall, room 113, they were originally connected. The arched opening between rooms 113 and 117 was filled in with a vertical board partition, probably by the Wagoner family in the last quarter of the 19th century. The date of this alteration is supported by paint, hardware, and molding evidence.

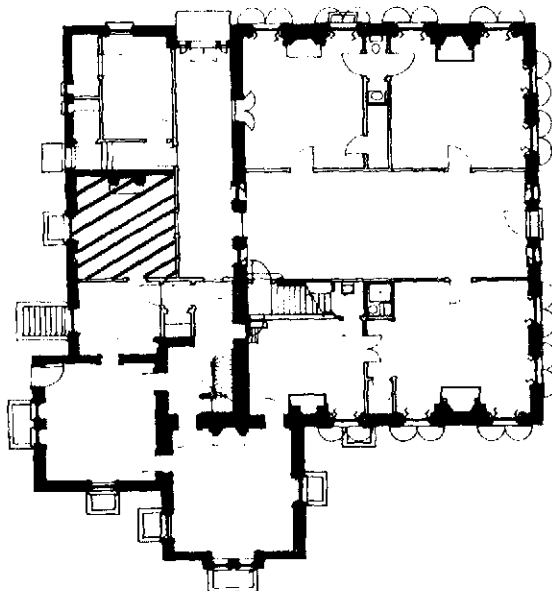
p. Room 118 - Nursery

Room 118 is directly to the west of the 1797 central hall, room 105, and between the small hallway, room 120, on the north and the bathroom, room 114, on the south. The entry for May 30, 1849, in Upjohn's planbook lists "cornices of hall, nursery, bedroom and bathroom." Having identified the hall, bedroom, and bathroom, Room 118 is the only remaining space with a cornice molding. Barney McGuire stated in a letter of October 4, 1849, to Richard Upjohn that the width of the chimney breast in the nursery was 5'4". This corresponds to the present condition in room 118.

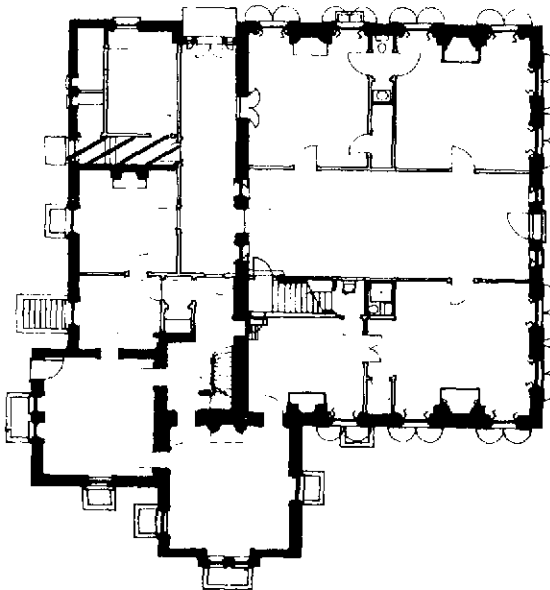
r. Room 120 - Hall

This hallway in the 1849 addition runs in an east-west direction. Before other door openings were added in the latter part of the 19th century, this hallway provided the only exit from the first floor to the west, or back, side of the house. The space is perpendicular to and midway along the west wall of the large Upjohn entry hall (room 119). Access from other parts of the house is through room 119 only (D114). This small hallway, in addition to providing an exit to the exterior, provides access to room 123, a bedroom (D113), and room 121, a privy (D121).

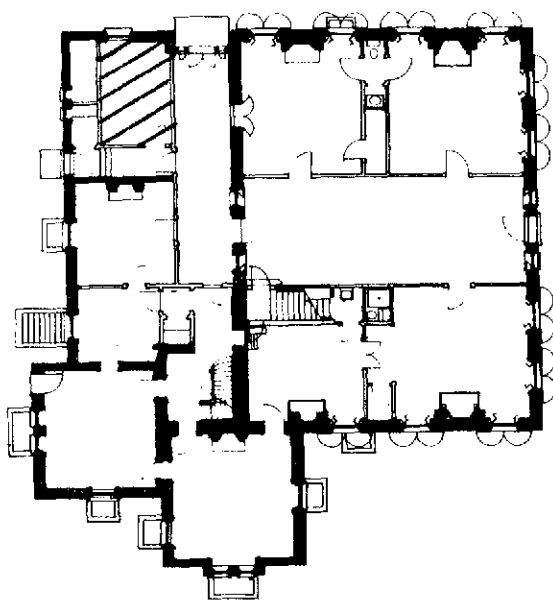
u. Room 123 - Chamber

This is a small, rectangular room at the north end of the Upjohn addition, which is entered from a small hallway, room 120 (D113), and has a large, attached closet (room 122). The simplicity and size of the space suggest a children's or servants' bedroom. No plans or detail drawings are listed in Upjohn's planbook for this room that would support a specific function.

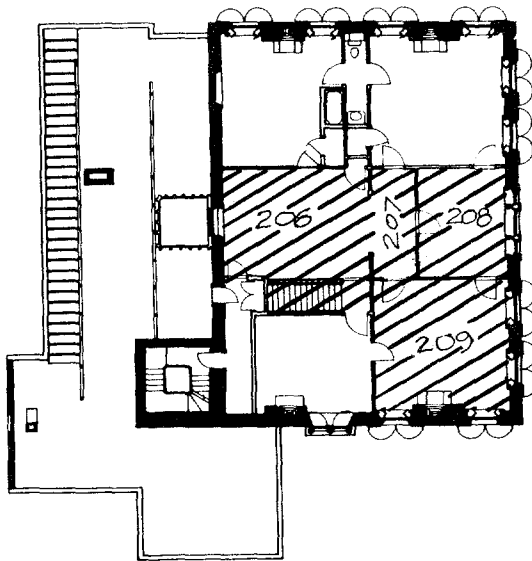
d. Rooms 206/207/208/209 - Stair Hall/Game Room/Entry/Two Chambers

These four rooms are grouped together because of their inextricable relationship in the original and ca. 1849 plans for the second floor rooms of Lindenwald. In the ca. 1797 second-floor plan, room 206 was the upstairs hall, containing the U-shaped stairs. Rooms 207, 208, and 209 formed one large room, possibly a ballroom. (Ascribing the function of a ballroom to room 207/208/209 is only hypothetical. No documentary evidence indicating this use has been found.) By the time Van Buren purchased Lindenwald, the existing room divisions had been built. Room 206 continued to function as the central hall, with

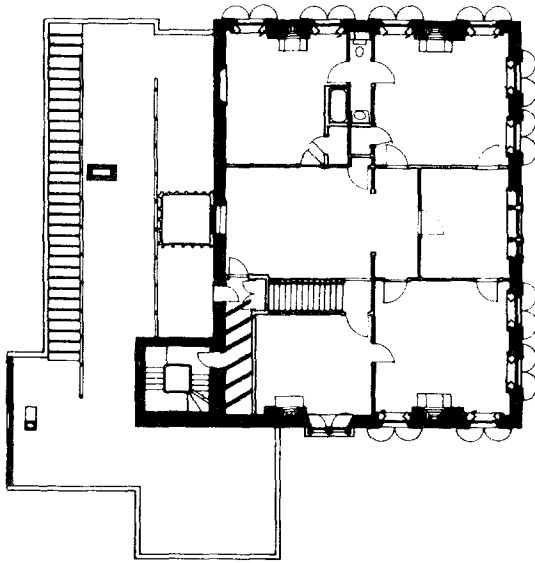
f. Room 211 - Hall

Room 211 occupies a narrow rectangular space in the extreme southwest corner of the 1797 house (see IP054). This passage from room 206 to the tower stair hall and to the Upjohn attic was separated from room 210 in 1849. The door from room 206 (D211) is in the north. Doors into room 213, the Upjohn attic (D212), and room 212, the tower stair hall (D214), are in the west wall. There is a closet in the north end of the east wall, and the lower portion of window 315 is in the south wall.

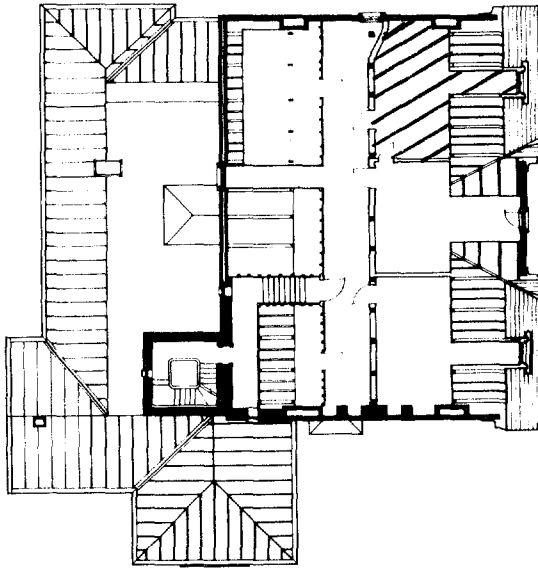
d. Room 303 - Servant's Chamber

Room 303 is in the northeast corner of the third floor. It is essentially an 11'1" by 19'6" rectangle with a 3'1" by 9'8" dormer extension to the east. The northeast chimney protrudes 2'6" by 1'4" into the northeast corner and the north end of the west wall curves into the room parallel to the wall of room 302. The room was probably used as a servants' bedroom during the historic period (see IP061).

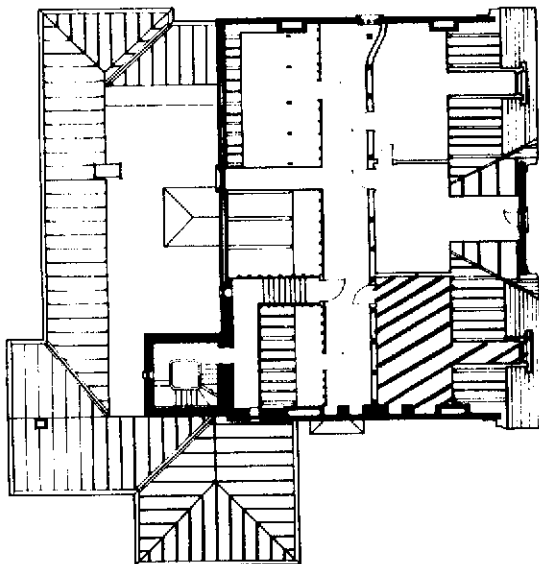
f. Room 305 - Servant's Chamber

Room 305 consists of an 11'1" by 18'7" rectangle with a smaller (3'1" by 9'8") rectangular dormer extension appended to its east side. The room occupies the southeast corner of the third floor. It, too, was probably used as a servants' bedroom during the historic period.

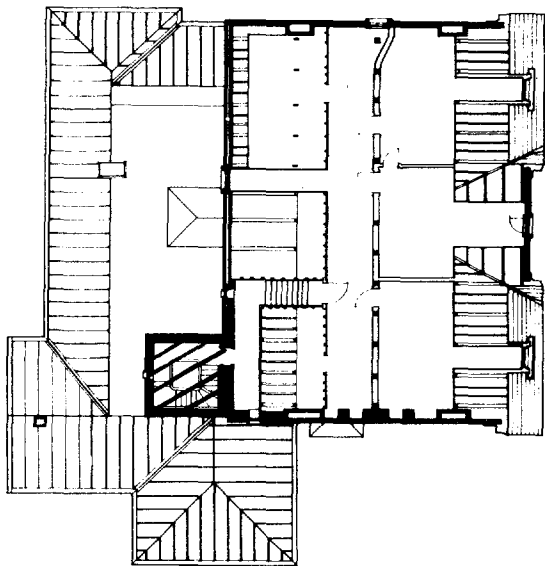
i. Room 308 - Tower Stair

Room 308 is the third-floor level of the tower stair. It is a square room approximately 9'8" by 9'10" whose only function was to provide vertical access to all the floors in the house.
