ELISHA JONES HOUSE AND SHED

HISTORIC STRUCTURE REPORT

Minute Man National Historical Park Concord, Massachusetts

Historic Architecture Program Northeast Region, National Park Service U.S. Department of the Interior Lowell, Massachusetts

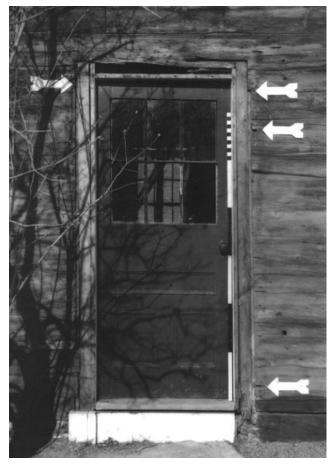
Figure 16. Elisha Jones Shed: Doorway D107, with arrows indicating evidence of original doorway. Upper arrows indicate height of original doorway, and lower arrows on right side indicate holes for original hinge pintles.

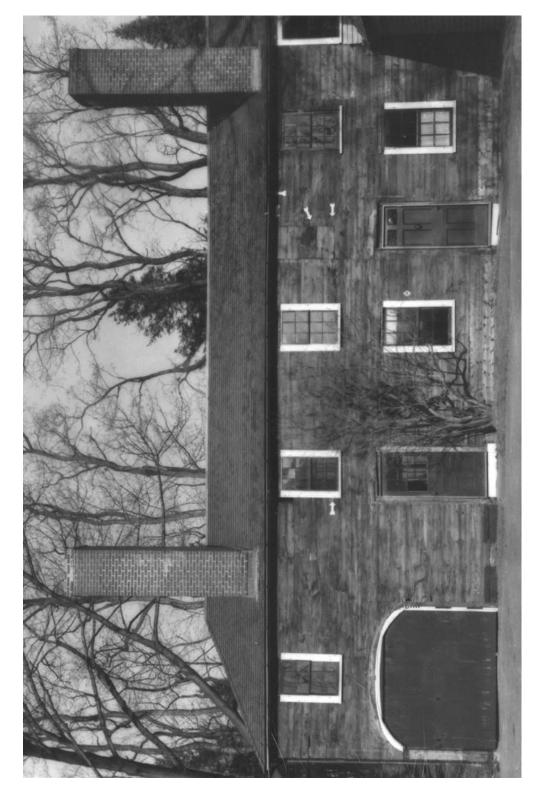
Figure 18. Elisha Jones Shed: West elevation, with arrows indicating evidence of original window openings. The left window (W224) was reused by John Keyes, and the right one was boarded over in 1865.

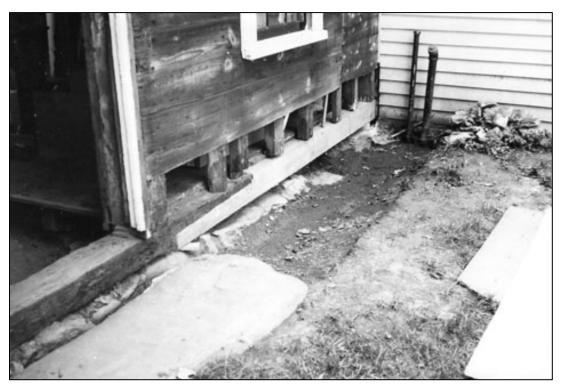
Figure 34. Elisha Jones Shed: West- wall sill repairs at south end of building, with a section of original sill (at left side of photograph) intact, 1974.

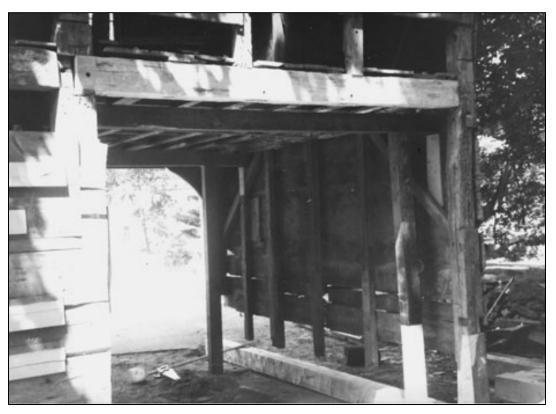
Figure 35. Elisha Jones Shed: East and north wall repairs, including replacement of east- wall girt and north- wall sill, and splicing of posts and studs, 1974.

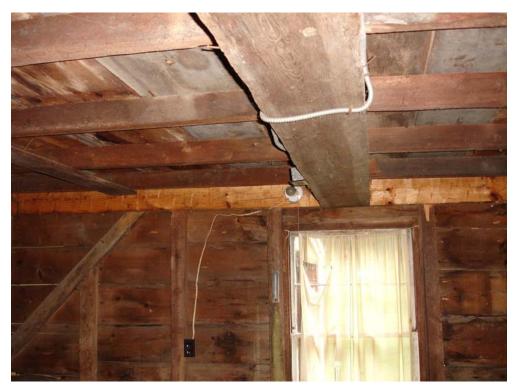
Figure 62. Elisha Jones Shed: Shed Room 104, east wall, exposed framing including summer beam, 1974 replacement girt, studding, and bracing (2006).

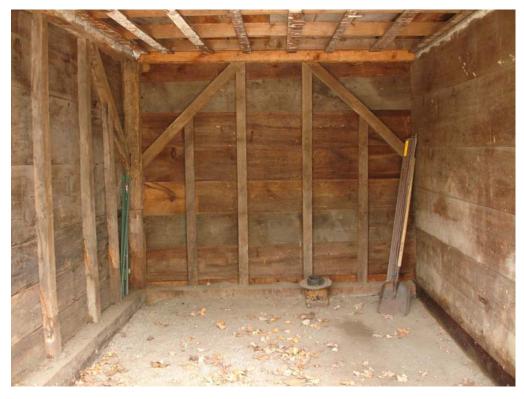
Figure 63. Elisha Jones Shed: Chaise stall, north and east walls, exposed framing including 1974 replacement sill and east girt, spliced studding and corner post, and bracing (2006).
